**AIRCRAFT GROUND-FLOTATION INVESTIGATION
PART V DATA REPORT ON TEST SECTION 4**

W. BRABSTON and W. HILL, JR.

AIRCRAFT GROUND-FLOTATION INVESTIGATION

PART V DATA REPORT ON TEST SECTION 4

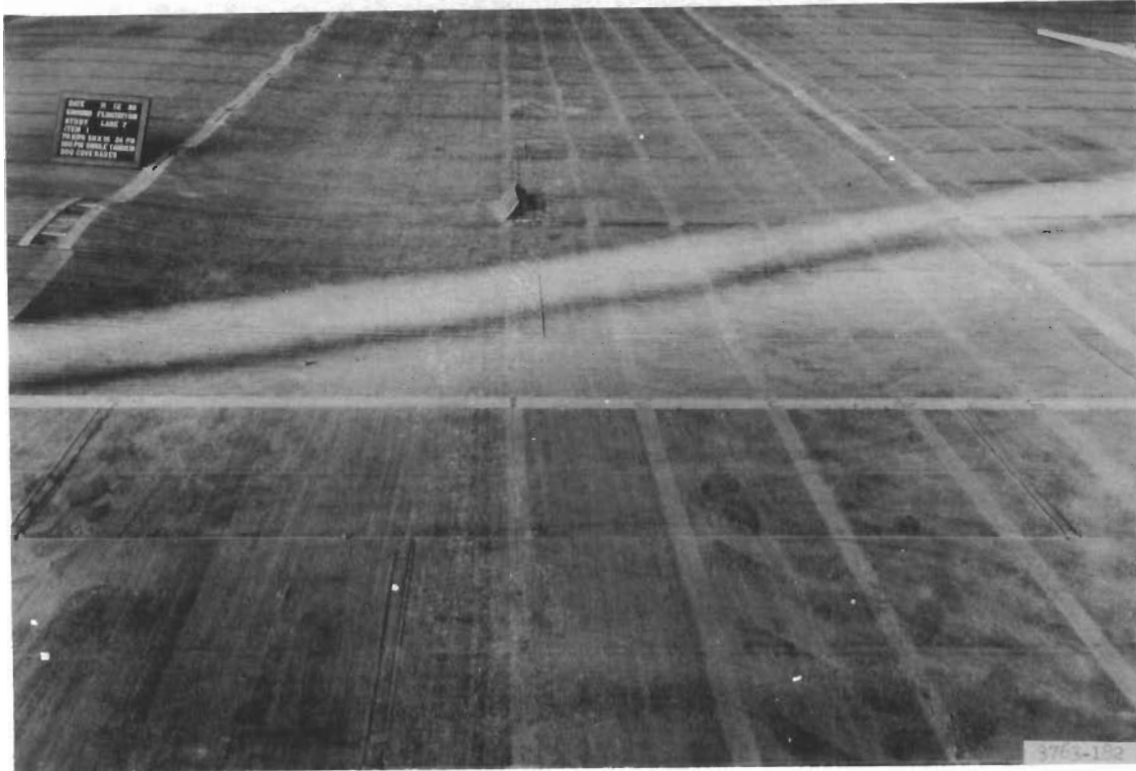
- e. Mat breaks. Numerous mat breaks occurred in tracking the item to failure. Mat breaks were classified and recorded by type (table 1). An unusually severe mat failure occurred in run 4, panel 8, causing 6 in. of one end of the panel surface to tear loose and protrude upward at an angle of approximately 45 deg (Figs 4 and 5).

Fig 4. Lane 7, item 1; general view at 300 coverages (failure)

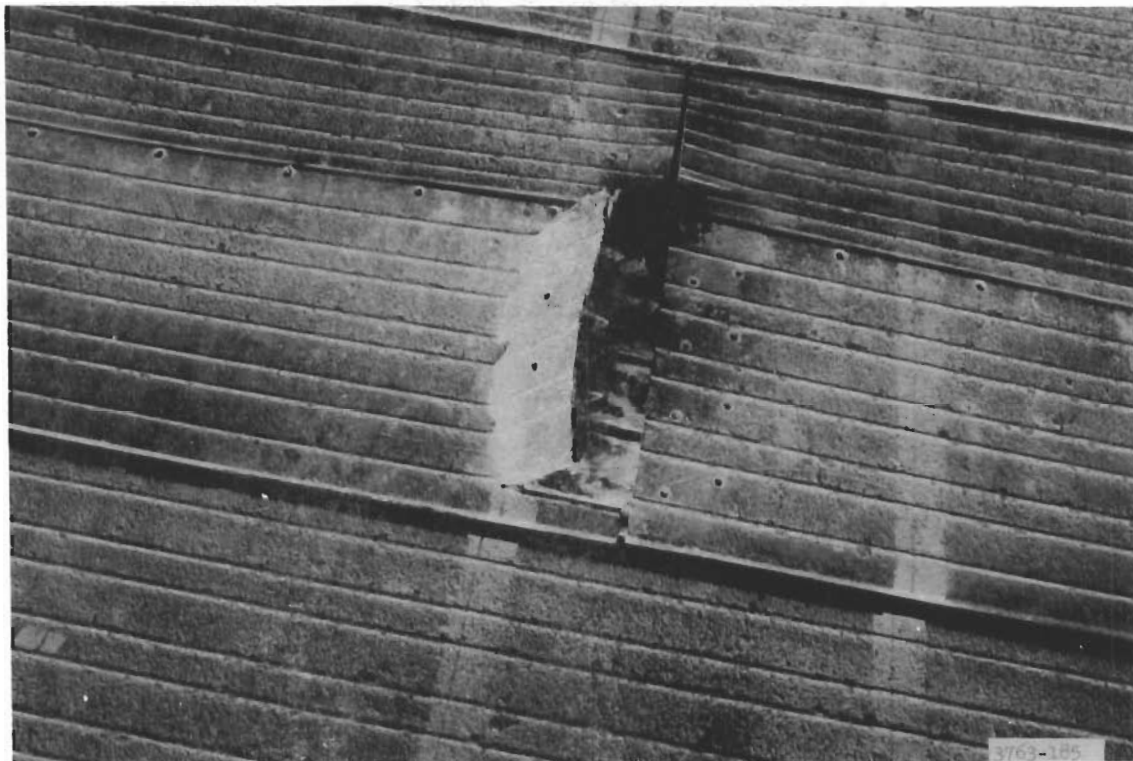
Fig 5. Lane 7, item 1; closeup view of severe mat break at 300 coverages (failure)

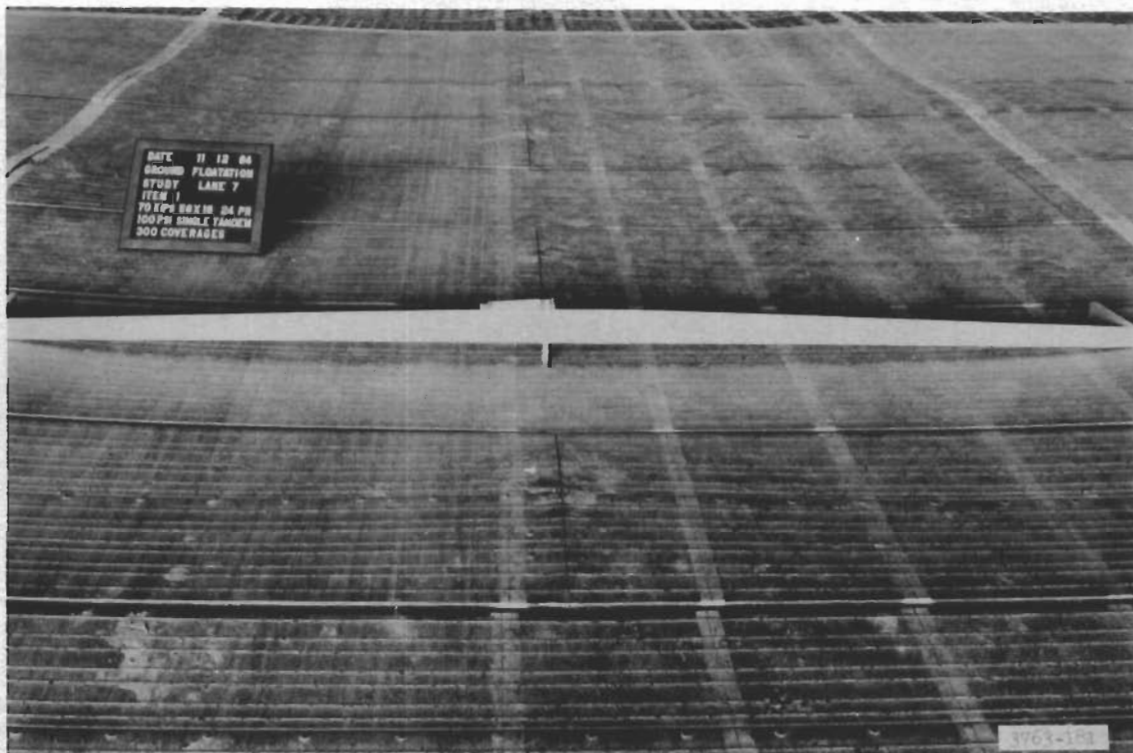
Item 1. **Fig 3** shows item 1 prior to traffic. The mat surface remained in excellent condition through 40 coverages and deteriorated gradually with trafficking thereafter. The item was considered failed due to roughness and mat deterioration at 300 coverages (**Figs 4** through **7**). At failure, many mat breaks and rivet failures were evident. The rated CBR of the item was 2.1.

Fig 6. Lane 7, item 1. Transverse straightedge shows roughness at 300 coverages (failure)

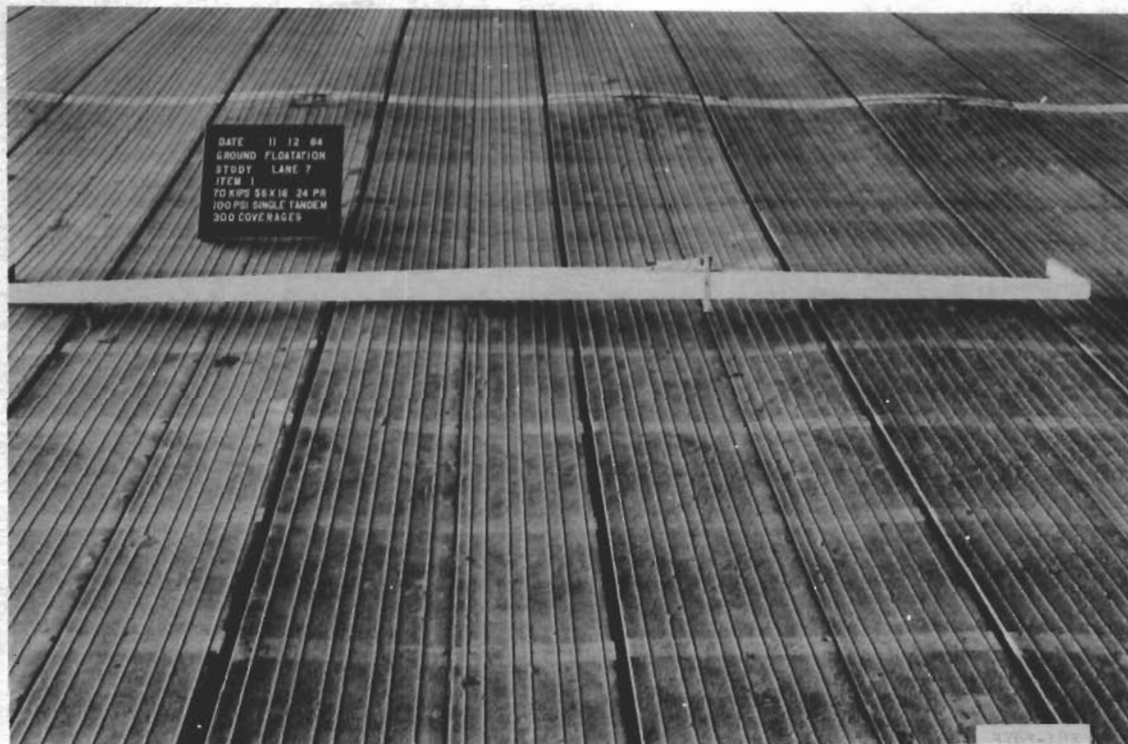
Fig 7. Lane 7, item 1. Longitudinal straightedge shows roughness at 300 coverages (failure)

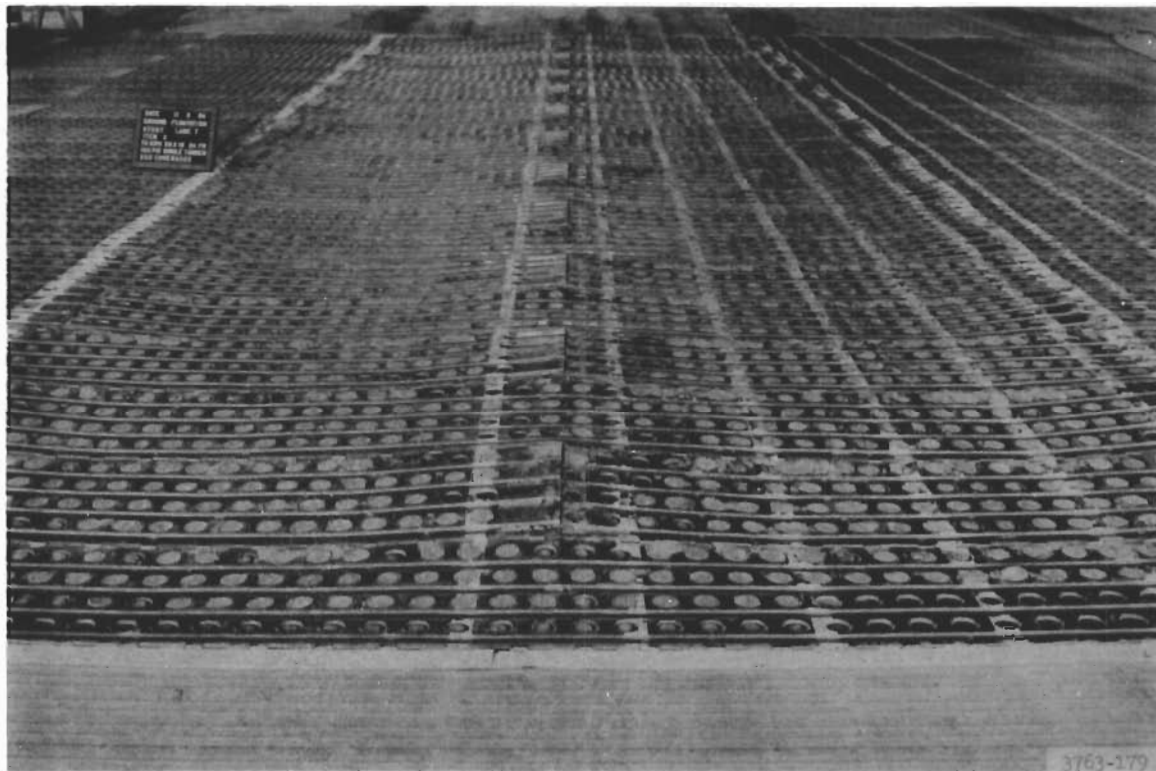
Item 2. **Fig 8** shows item 2 prior to traffic. The M8 mat surface did not have a large number of breaks at 200 coverages when the item was considered failed due to roughness (**Figs 9** and **10**). At coverage levels near the failure point, the panel ends at the mat joint near the center line began to project upward (**Figs 9** and **10**). The rated CBR of the item was 4.9.

Fig 9. Lane 7, item 2; general view at 200 coverages (failure)

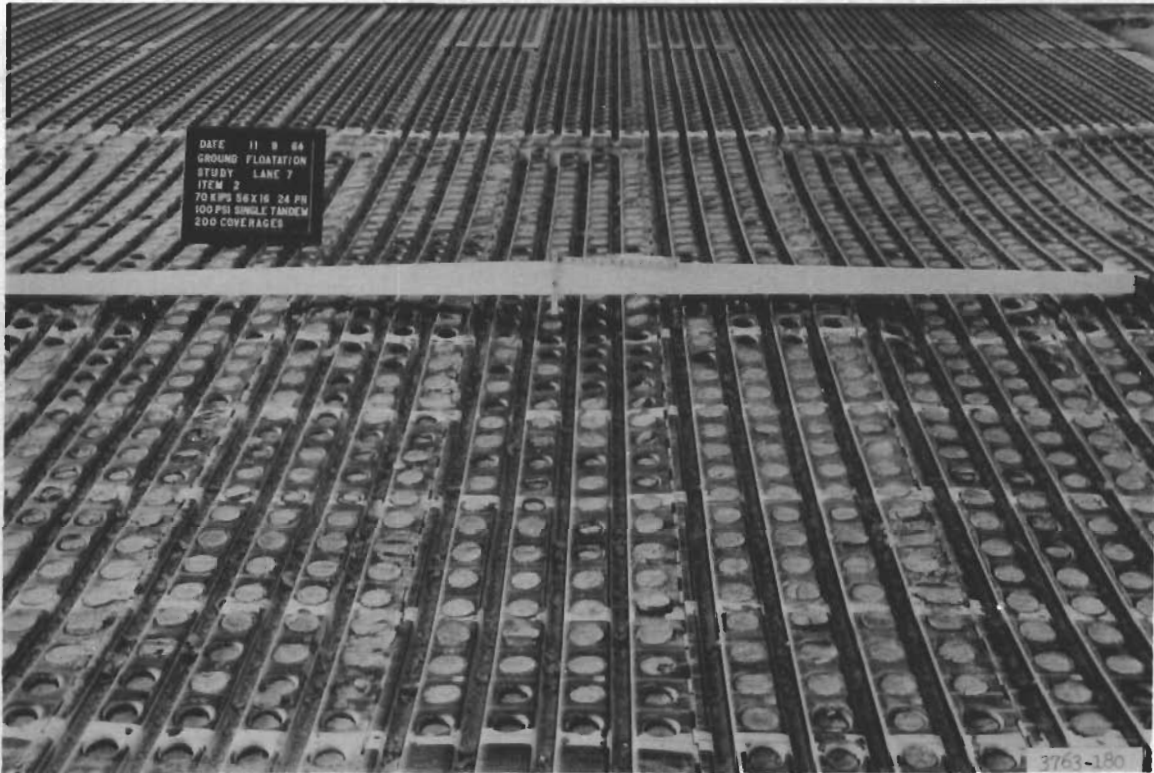
Fig 10. Lane 7, item 2. Longitudinal straightedge shows roughness along mat joint line at 200 coverages (failure)

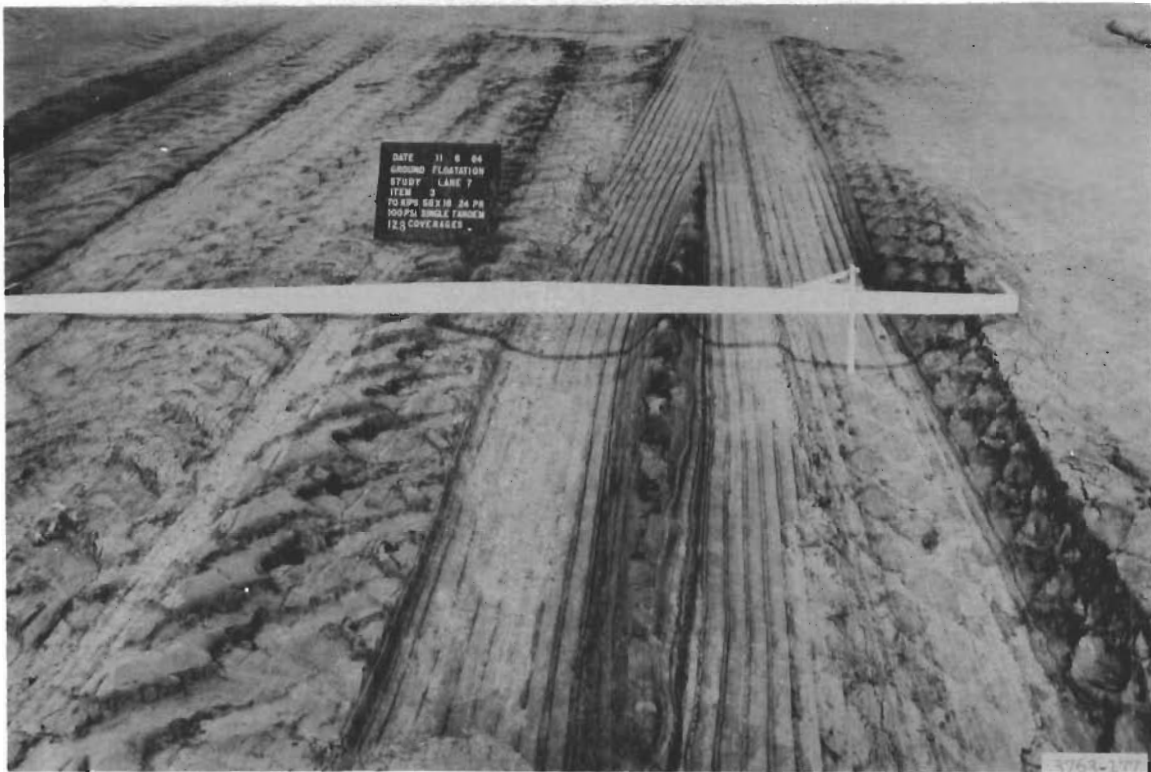
Item 3. Item 3 prior to traffic is shown in **Fig 11**. The item was in serviceable condition at 80 coverages, but had greatly deteriorated when data measurements were again taken at 128 coverages (**Fig 12**). After studying data collected at 128 coverages, it was decided to antedate the time of failure to 100 coverages. Failure was due to excessive rutting. The rated CBR of the item was 9.3.

Fig 12. Lane 7, item 3. Transverse straightedge shows rutting at 128 coverages (28 postfailure coverages)

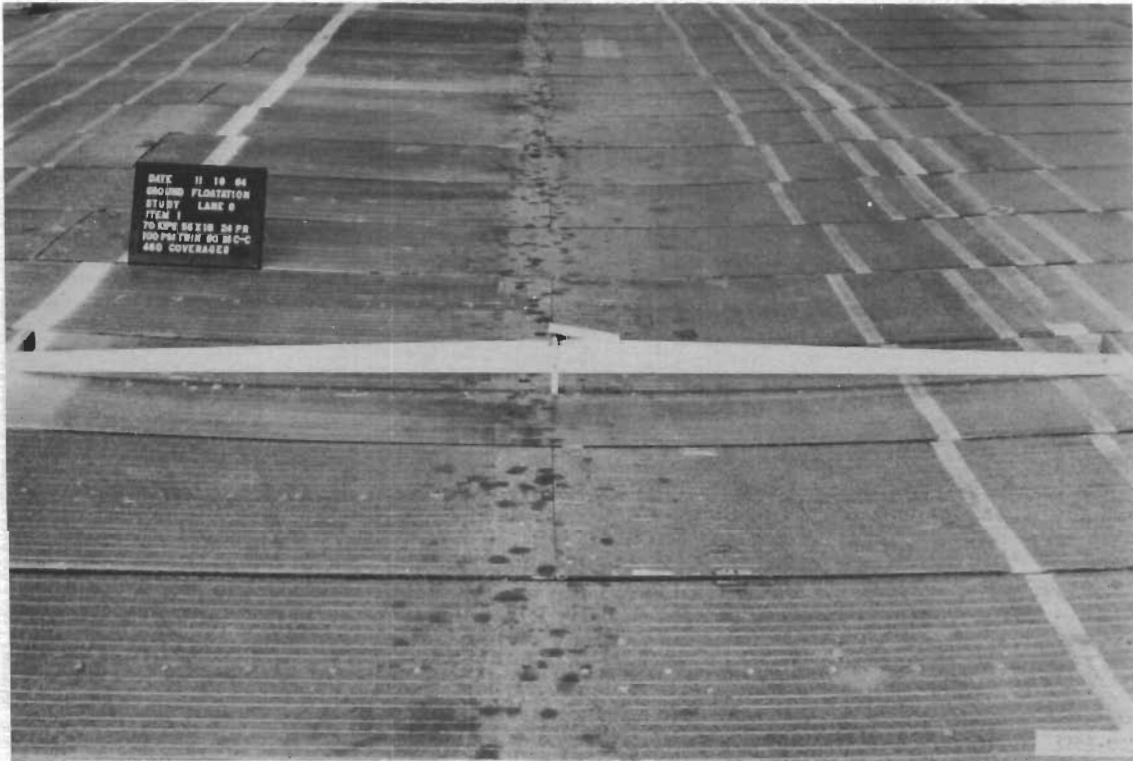
Item 1. Item 1 is shown prior to traffic in **Fig 13**. The item held up well under traffic and did not have an excessive number of mat breaks at any time. Traffic was applied to the 460-coverage level when the item was considered failed due to roughness (**Fig 14**). The rated CBR for the item was 2.4.

Fig 14. Lane 8, item 1. Transverse straightedge shows roughness at 460 coverages (failure)

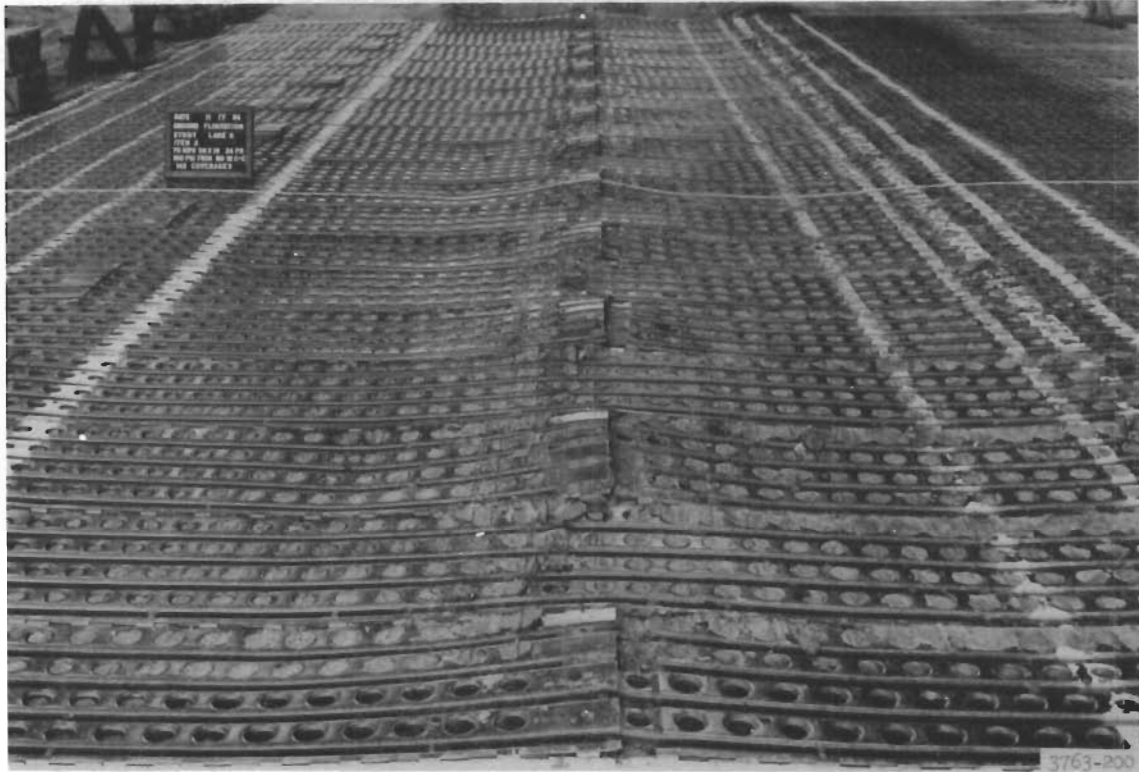
Item 2. **Fig 15** shows item 2 prior to traffic. On mat runs having the mat joint located near the lane center line, the panels deformed in a concave upward shape along their length causing the panel ends to extend upward at the joint. This condition contributed to transverse and diagonal roughness in the lane. No mat breaks occurred during testing. At 142 coverages the item was considered failed due to roughness (**Figs 16** and **17**). The rated CBR was 4.0.

Fig 16. Lane 8, item 2; general view at 142 coverages (failure)

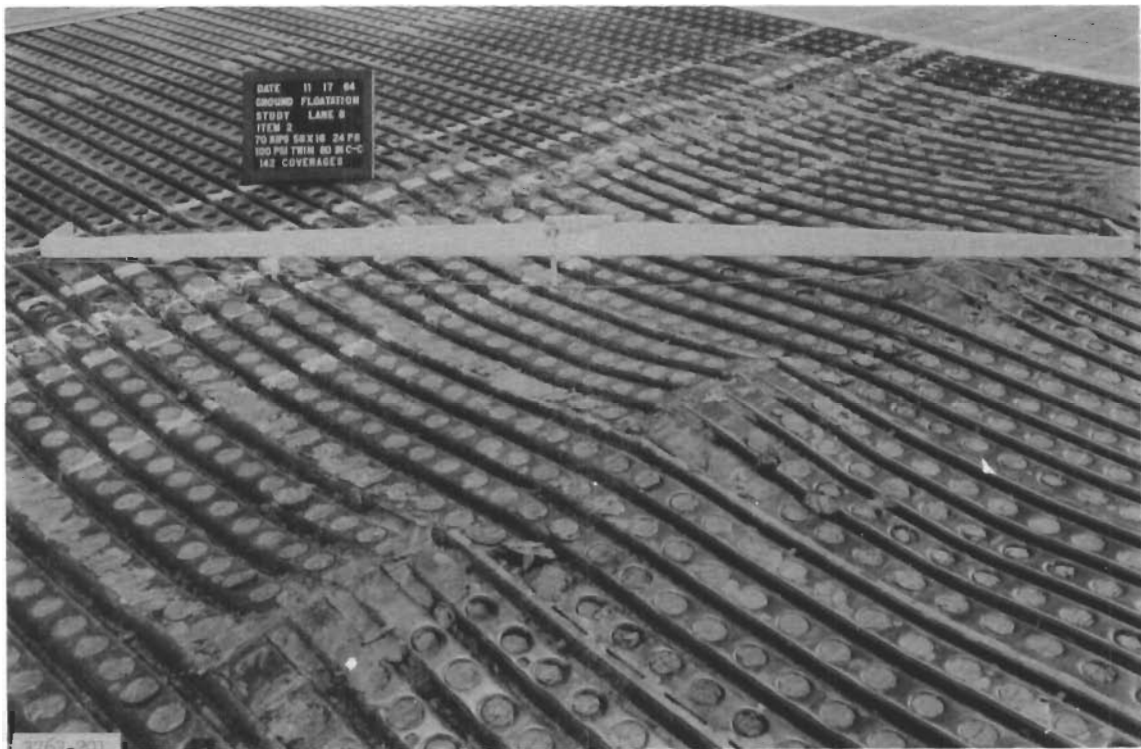
Fig 17. Lane 8, item 2. Diagonal straightedge shows roughness at 142 coverages (failure)

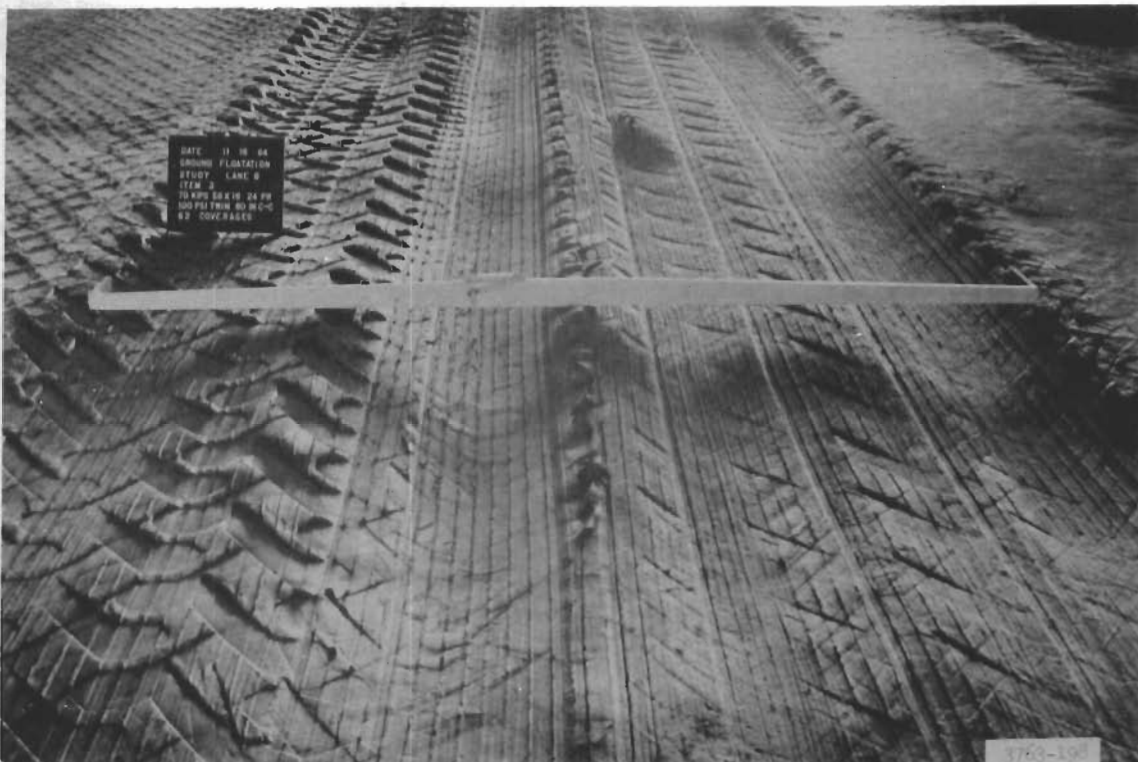
Item 3. Item 3 prior to traffic is shown in Fig 18 . The item remained in good condition through 20 coverages with rut depths averaging 1.56 in. Continued trafficking resulted in progressive rutting and failure of the item at 62 coverages (Fig 19), . The rated CBR for the item was 9.8.

Fig 19. Lane 8, item 3. Transverse straightedge shows rutting at 62 coverages (failure)

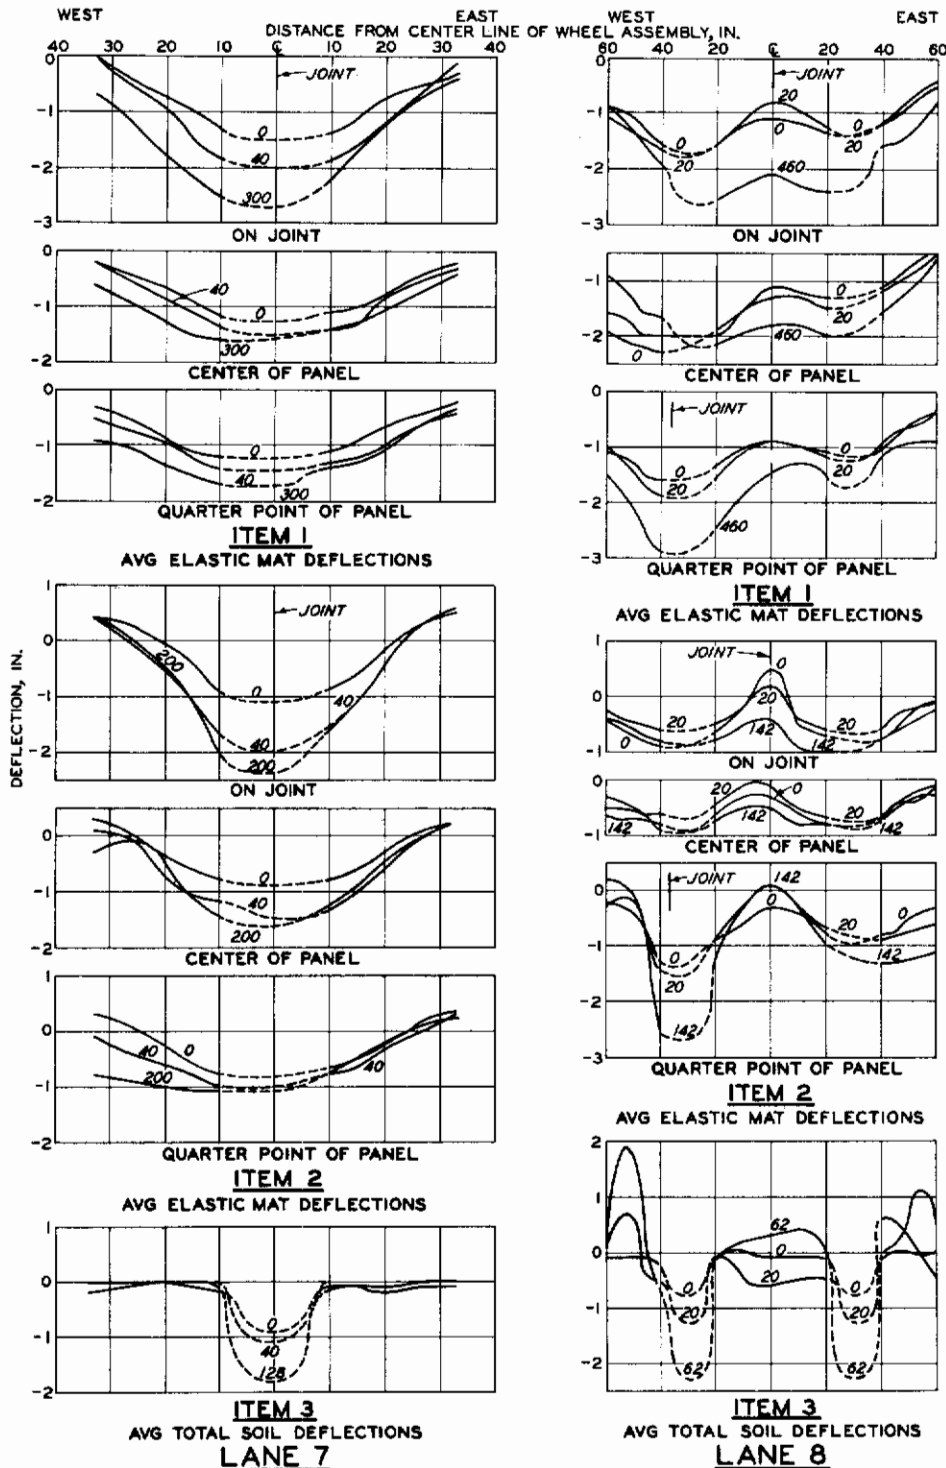
AVERAGE DEFLECTIONS
TEST SECTION 4
LANES 7 AND 8

- c. Deflection. Average elastic mat deflections under static load of the load vehicle (Fig 25) increased consistently with traffic coverages. Maximum deflection occurred with the panel joint at center line of the wheel assembly. Elastic subgrade deflection was not determined for the item.

- c. Deflection. Average elastic mat deflections under static load of the load vehicle are represented in Fig 25 for 0, 40, and 200 coverages. Deflections for three positions of the load vehicle relative to mat joint locations are plotted. Maximum deflection occurred with center line of the load assembly at the mat joint with an average of 2.4 in. Elastic subgrade deflections at 0 and 40 coverages were 0.6 and 0.8 in., respectively.

- c. Deflection. Average total soil deflections are plotted in **Fig 25**. At 128 coverages a maximum average deflection of 1.8 in. is shown. Elastic soil deflections at 0, 40, and 128 coverages measured 0.3, 0.5, and 0.5 in., respectively.

- c. Deflection. Average elastic mat deflections measured at 0, 20, and 460 coverages are plotted in Fig 25 for three positions of wheel assembly relative to mat panel joints.

- c. Deflection. Average total soil deflections under static load of the load wheels are plotted in Fig 25 for 0, 20, and 62 coverages. Increasing deflections were consistent with increasing number of coverages. Maximum average deflection was 2.3 in. at failure of the item. Elastic subgrade deflections are shown in table 1 and reached 0.5 in. at failure.
