FAILURES OF THE M72A2 LAW ROCKET SYSTEM

G. A. Bruggeman
Army Materials and Mechanics Research Center
Watertown, Massachusetts 02172

Over a period of several years, the M72A2 LAW Rocket has experienced a number of malfunctions traceable to failures of either the rocket motor closure or the rocket motor itself. Both of these components are made of 7001 aluminum alloy heat treated to the T6 temper, an alloy known to possess low fracture toughness properties and also to be highly susceptible to stress corrosion cracking. The role of stress corrosion in a number of these malfunctions is discussed, and the remedies chosen to alleviate each problem as it occurred are described. Comparisons are made between the mechanical and physical properties of material from production lots manufactured during different time periods, and comments are made regarding factors that would appear to be contributing to the on-going stress corrosion problem.

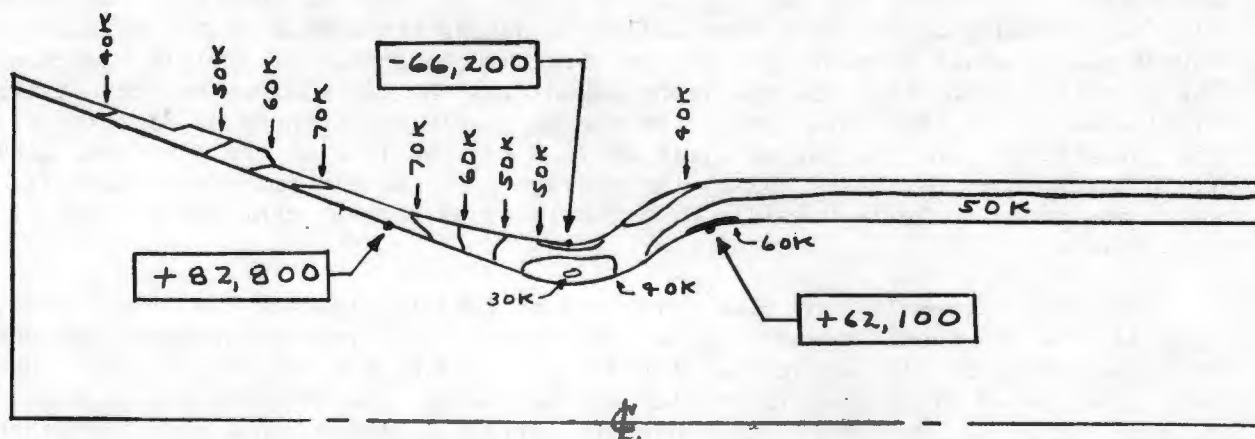
Figure 2. Finite element stress analysis of the LAW rocket motor during launch-effective stresses.

The strength requirements imposed by the rocket motor design adopted for the LAW mandated the selection of 7001-T6 as the motor material. Figure 2 presents the results of a finite element stress analysis of the LAW rocket motor during launch, showing a maximum effective stress of 83,000 psi occurring in the throat

area of the rocket nozzle. Of the commercially available aluminum alloys, only 7001-T6 has a yield strength high enough to withstand this level of stress. Unfortunately, at the time when this alloy selection was made, the concepts of fracture mechanics were not widely used, and the potential for catastrophic failure inherent in the use of a material with low fracture toughness and high stress corrosion susceptibility was not adequately appreciated.

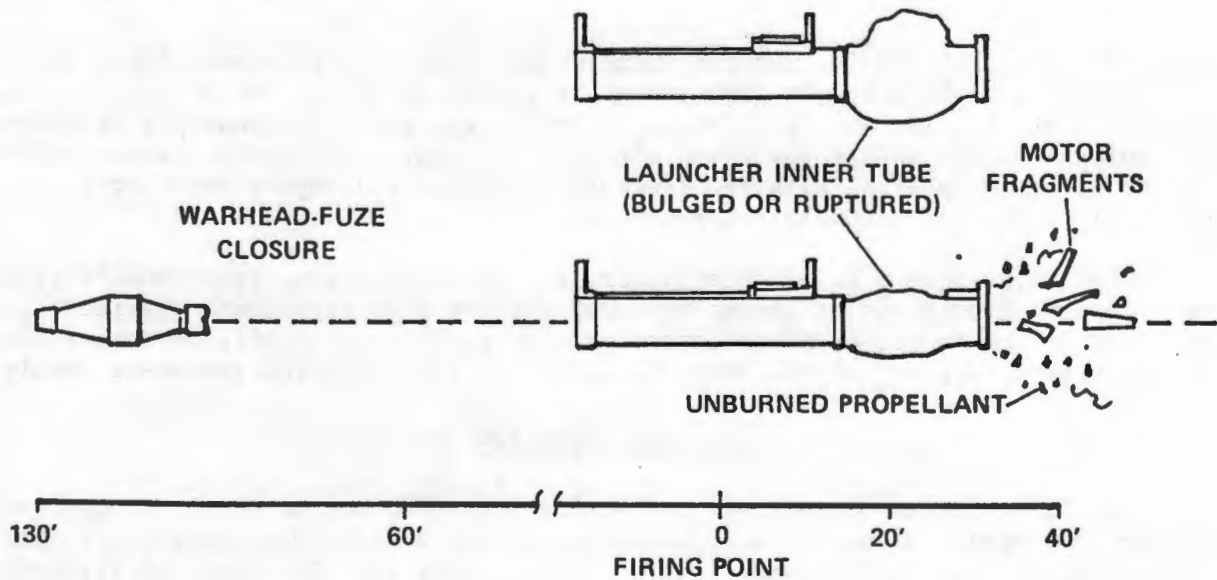
Figure 3. Schematic representation of typical LAW rocket motor malfunction.

This new round of malfunctions was confined to rocket motors produced by a single manufacturer (hereafter referred to as Manufacturer A). The typical failure signature is illustrated schematically in Figure 3. Upon firing, failure of the

rocket motor occurred with little or no rocket travel in the launcher, expelling unburned propellant and motor fragments to the rear and propelling the warhead and closure a short distance forward of the launch point. The launch tube was bulged or ruptured, but miraculously no serious operator injury took place.

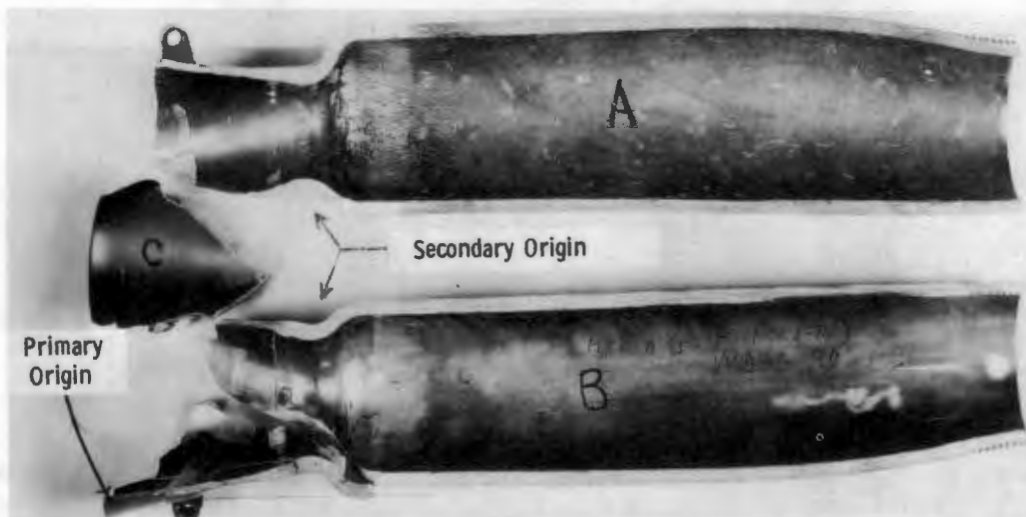
Figure 4. Typical LAW motor failure.

Typically, the rocket motor broke into two or three major fragments, as shown in Figure 4, with the primary fracture path running longitudinally the full length of the motor. Following the chevron markings on the fracture surface allowed the fracture path to be traced back to the point of primary origin, which almost invariably was located on the nozzle rim. Secondary fracture origins in the throat of the nozzle were often activated by the bending forces which developed following the initial fracture. Close examination of the fractures showed the primary origins to be stress corrosion cracks on the order of one millimeter (0.040 inch) in depth (Figure 5), which exhibited the intergranular appearance typical of stress corrosion in the scanning electron microscope, as shown in Figure 6. Verification of stress corrosion cracks in the nozzle rim as the operative failure mechanism was obtained by test firings of rockets with machined notches cut into the rim of the nozzle; the failure signature that resulted was identical to the actual malfunctions. It was later demonstrated that the condition leading to the formation of these stress corrosion cracks was most likely introduced by one of the proof tests used as a quality assurance measure during motor production.

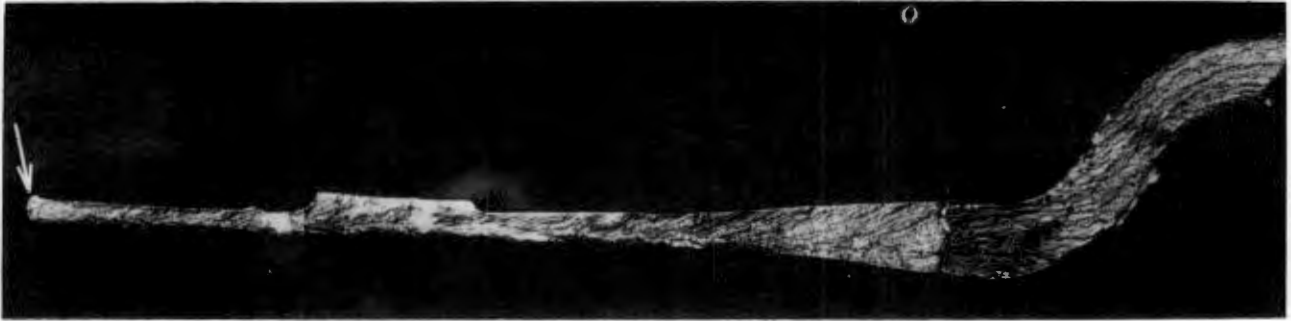
Figure 5. Primary fracture surface in LAW motor failure showing the primary initiation site (Reference 2). Mag. 3.5X

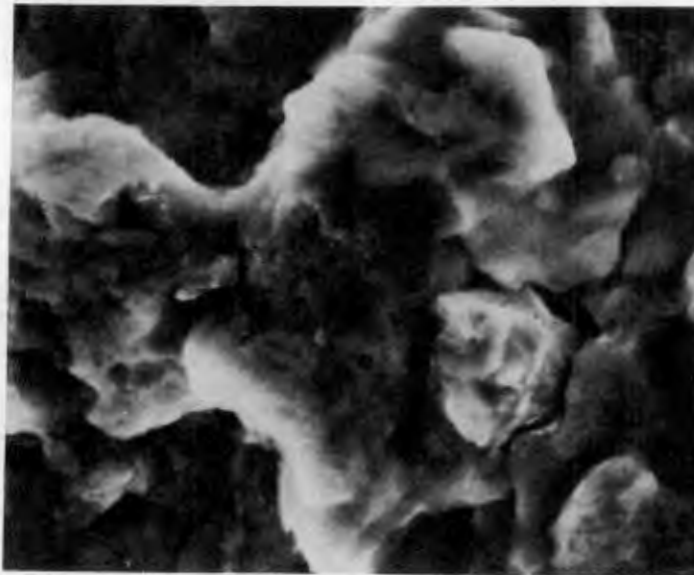
Figure 6. Fracture surface at primary initiation site showing intergranular fracture (Reference 2). Mag. 1500X

Fracture toughness measurements performed on specimens taken from motors of the affected manufacturer produced K_{IC} values as low as $7 \text{ ksi}\sqrt{\text{in}}$ with the average being $10\text{-}11 \text{ ksi}\sqrt{\text{in}}$. Taking $K_{IC} = 10 \text{ ksi}\sqrt{\text{in}}$ and assuming a stress of 45 ksi (35 ksi launch plus 10 ksi residual stress) a critical flaw depth of 0.3 mm (0.012 inch) was calculated, supporting the contention that the observed stress corrosion cracks were indeed supercritical².

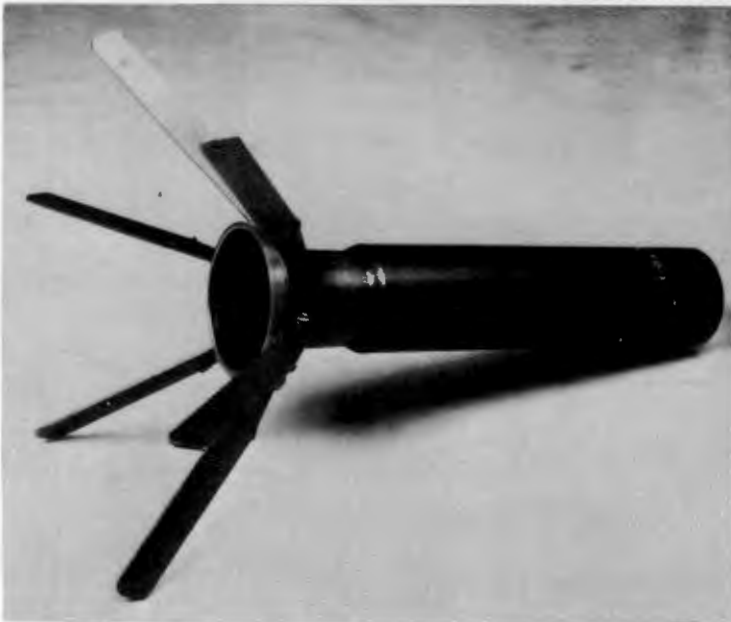
Figure 7. Fiberglass wrapped LAW rocket motor.

Again, the situation should have been clear that the basic problem stemmed from the use of 7001-T6 aluminum, a material with very low flaw tolerance and with high stress corrosion cracking susceptibility. Nevertheless, the decision was made to salvage the remaining stockpile by again overwrapping the affected component (this time the rocket motor) with fiberglass. In detail, the fix involved machining a small quantity of material from the nozzle rim to remove any stress corrosion cracks already present, followed by a fiberglass overwrap of both the rim and the throat areas of the rocket nozzle, as shown in Figure 7. The throat wrap was for the purpose of reinforcing the most highly stressed area of the motor and to arrest any cracks which might initiate and propagate from the nozzle rim. The rim wrap was to prevent ejection of metal fragments from the rear of the launcher in the unlikely event of a motor failure. Firing tests of pre-flawed motors showed the wrap to be effective in both these points. The basic deficiencies of 7001-T6 aluminum were still ignored, however, and history was soon to be repeated.

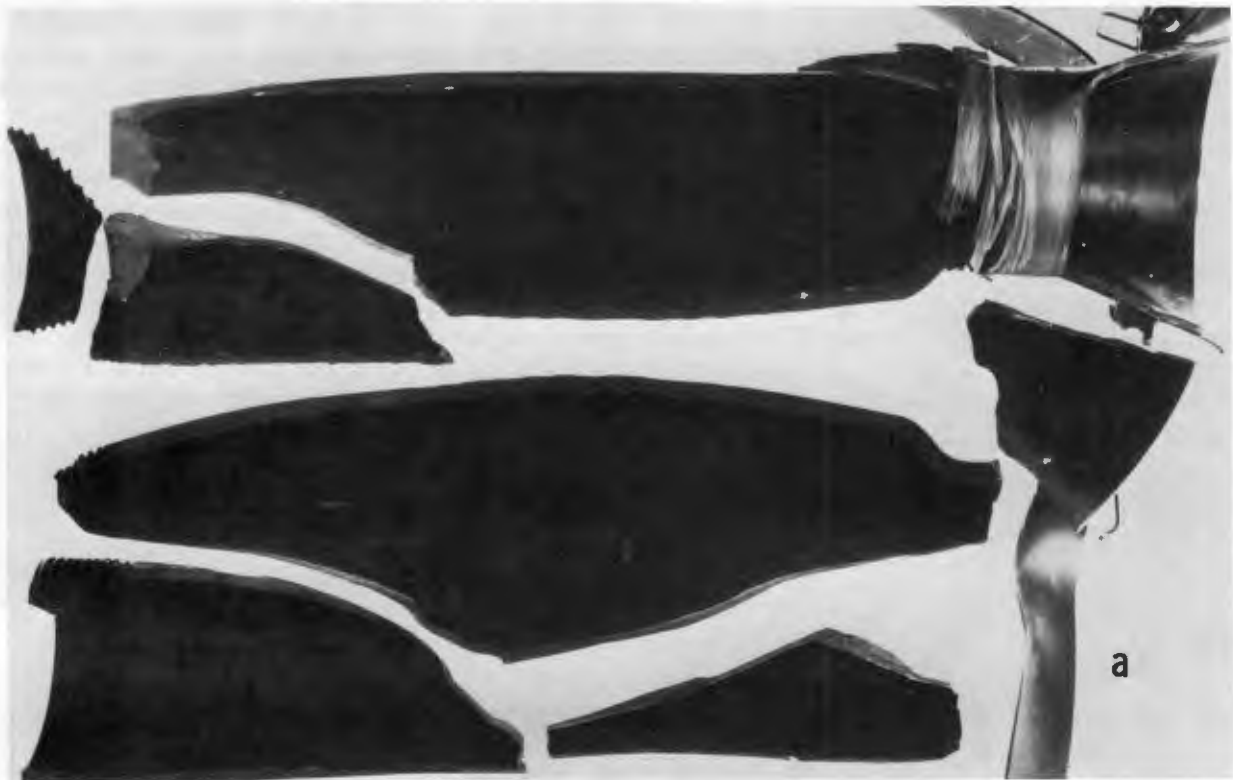
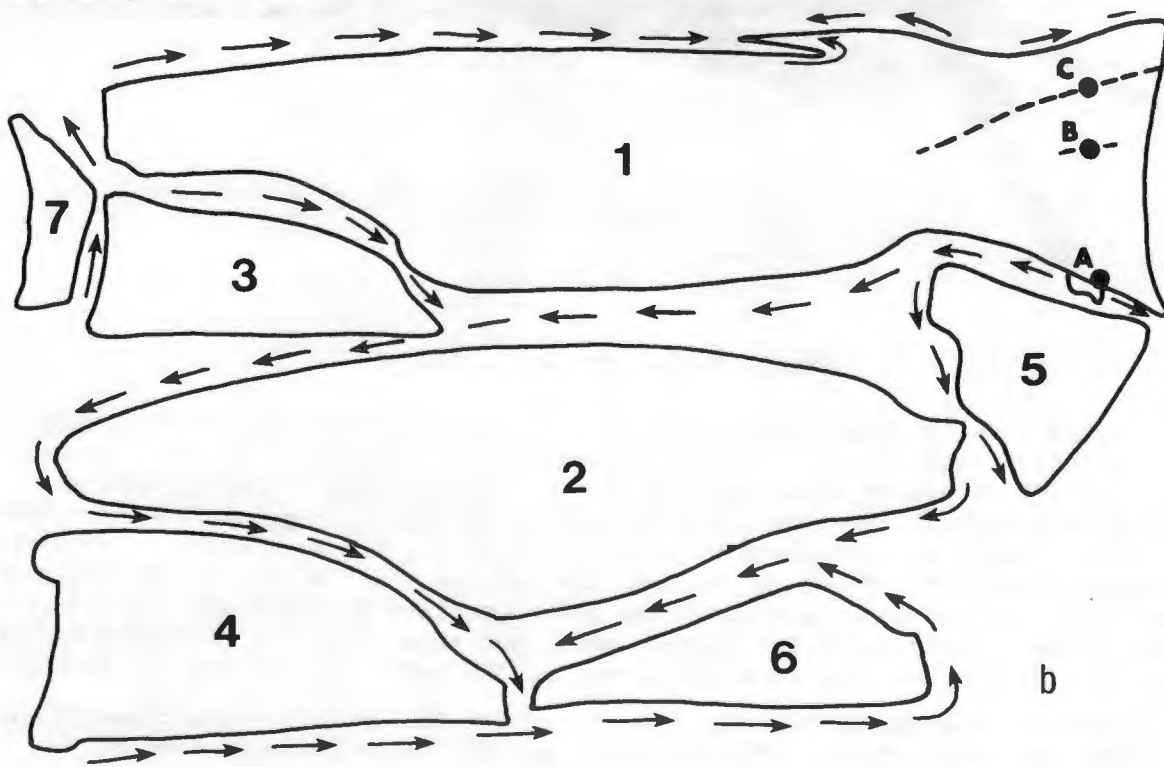
Figure 8. Fragments from fiberglass wrapped LAW motor failure (Reference 3).

In the span of a few weeks in mid 1978 two malfunctions occurred in fiberglass wrapped rocket motors. The failure signature resembled, in most aspects, the signature of the previous motor failures: a few large fragments with a primary longitudinal fracture. Figure 8 shows the motor fragments recovered from one of these malfunctions along with a diagram of the fracture path³. The primary fracture initiation site is at point A, the base of the fin slot on the lug rim, rather than at the rim of the nozzle as in the earlier malfunctions. A finite element stress analysis of the wrapped motor had shown that the region of maximum stress would be moved away from the throat of the nozzle to the lug rim by the

application of the fiberglass. Thus the failure of the wrapped motor appears to have initiated at a location near the point of maximum stress. Secondary crack initiation sites were also located in equivalent locations B and C at the base of other fin slots on the lug rim. These secondary cracks were unrelated to the primary fracture and apparently developed independently.

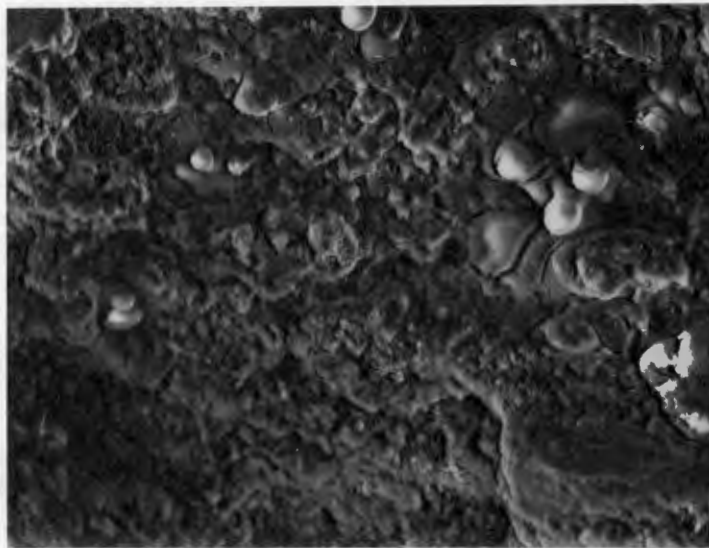
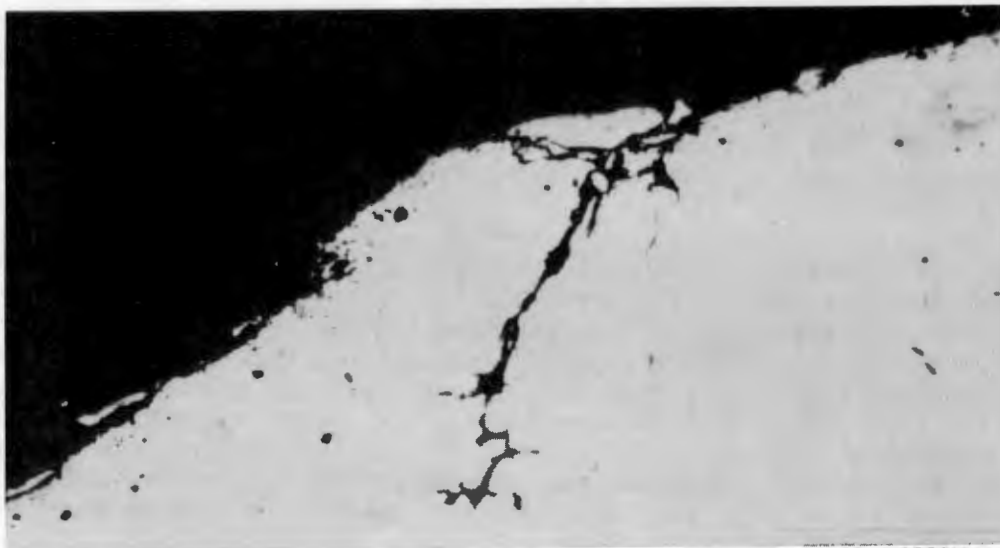
Examination of the fracture surface near the primary initiation point again gave evidence of intergranular fracture and crack branching (Figure 9), suggestive of a stress corrosion failure mechanism. Similar features were observed at the

Figure 9. Primary fracture initiation site in fiberglass wrapped motor failure showing (a) "mudcracking" and intergranular fracture, and (b) crack branching (Reference 3).

secondary crack initiation sites at B and C, as well. However, no pre-existing flaws could be identified. It was speculated that the anodized coating at the base of the fin slots may have been damaged when the fins were moved for the fiberglass wrapping operation, and that this contributed to a later corrosion problem.

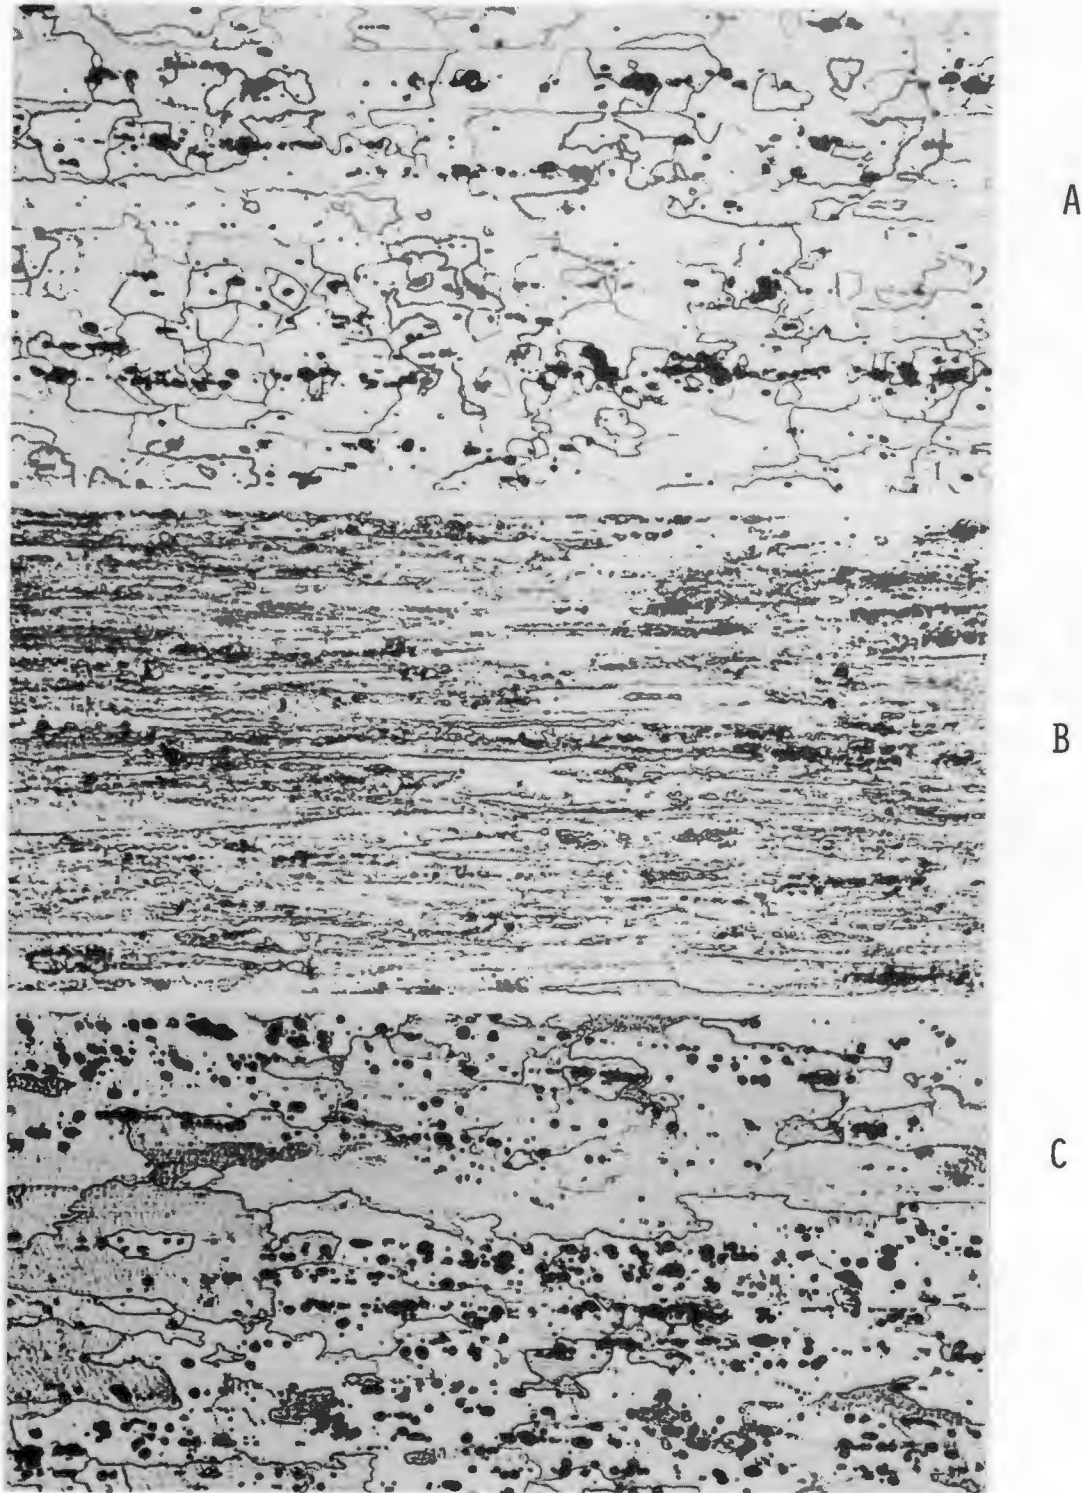
Figure 10 compares the longitudinal microstructures taken from the nozzle area of the three manufacturers' motors. Manufacturers A and C both exhibit recrystallized microstructures whereas Manufacturer B's motors contain a cold worked, unrecrystallized microstructure in this area (partial recrystallization is achieved away from the nozzle). The dark second phase particles in all the microstructures are chromium and iron bearing intermetallics. The maximum size and volume fraction of these intermetallics appears greater for Manufacturers A and C. Quantitative metallography performed on these microstructures tended to confirm this observation with typical data appearing in Table 5. On this basis one might expect that Manufacturer C would have as many problems as Manufacturer A, but this has not occurred.

Figure 10. Typical longitudinal microstructures in the nozzle area of motors produced by the three manufacturers. Mag. 200X
