**AIRCRAFT GROUND-FLOTATION INVESTIGATION  
PART VII DATA REPORT ON TEST SECTION 6**

*W. BRABSTON and W. HILL, JR.  
U. S. ARMY ENGINEER WATERWAYS EXPERIMENT STATION*

PART VII DATA REPORT ON TEST SECTION 6

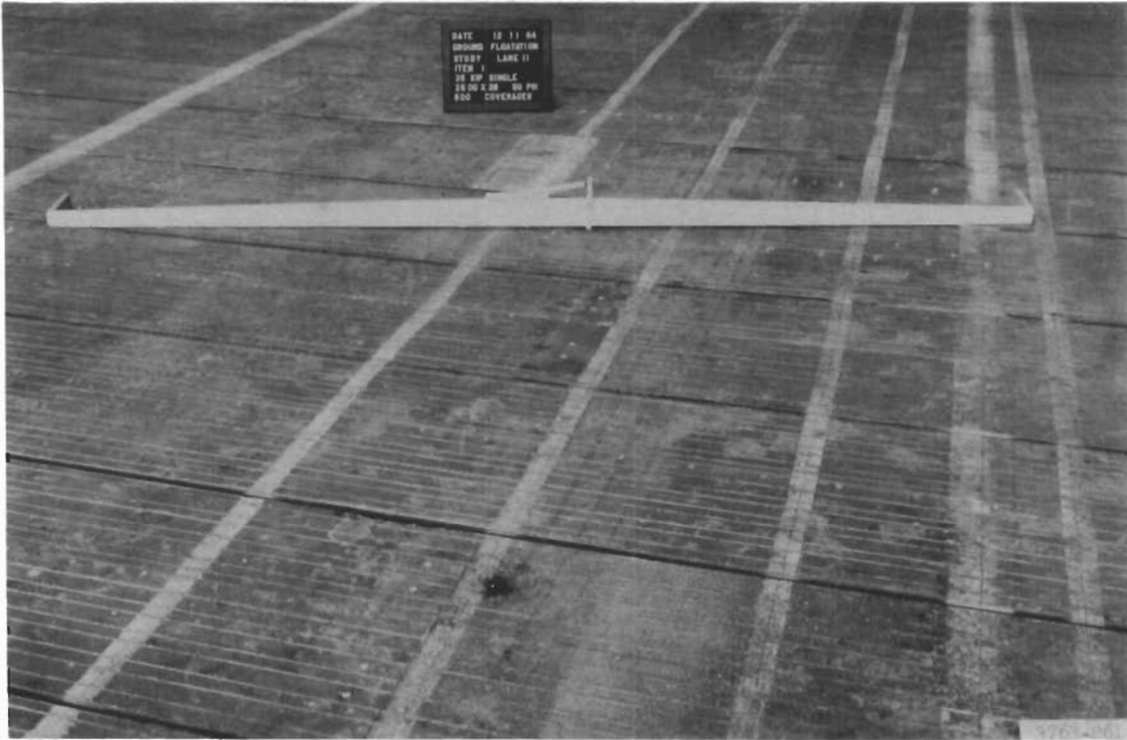
Item 1. Figure 3 shows item 1 prior to traffic. The item sustained 600 traffic coverages without developing appreciable deformations or roughness. No signs of failure were in evidence when traffic was suspended at 600 coverages (figure 4). The rated CBR of the item was 1.5.

Figure 4. Lane 11, item 1. Diagonal straightedge shows slight deformations at 600 coverages

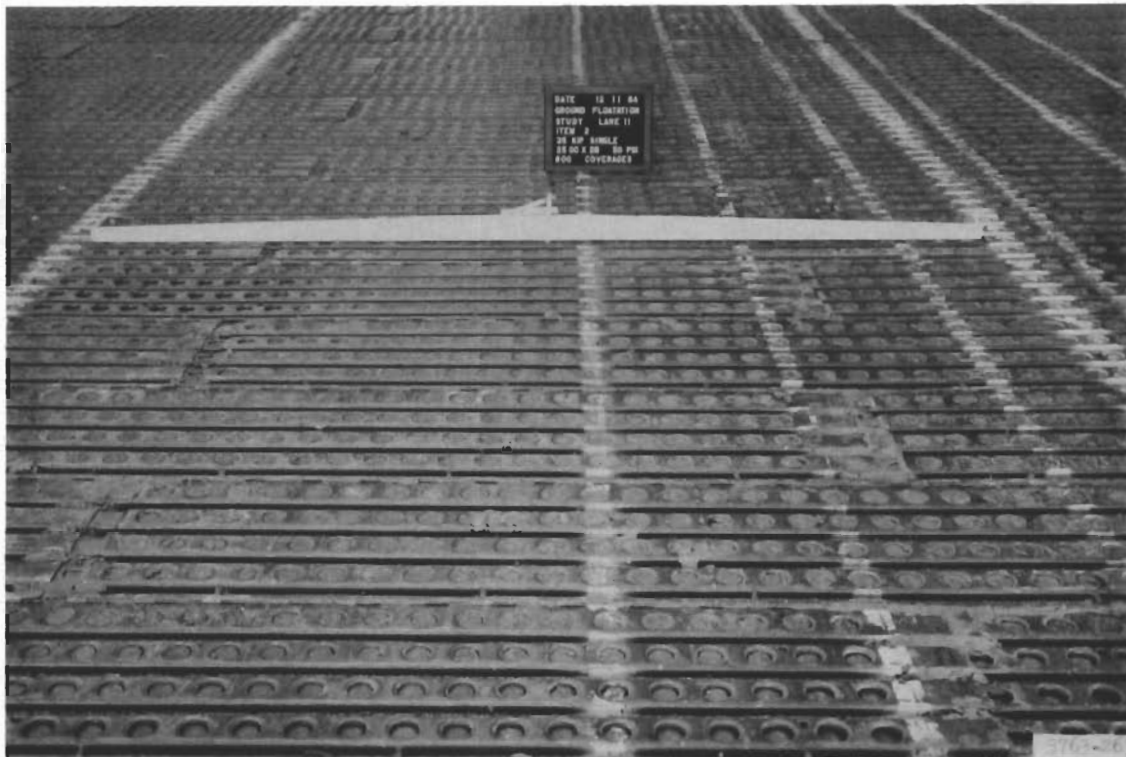
Item 2. Figure 5 shows item 2 prior to traffic. Traffic was suspended at 600 coverages with no discernible damage evident (figure 6). The rated CBR was 4.1.

Figure 6. Lane 11, item 2. Transverse straightedge shows slight deformations at 600 coverages

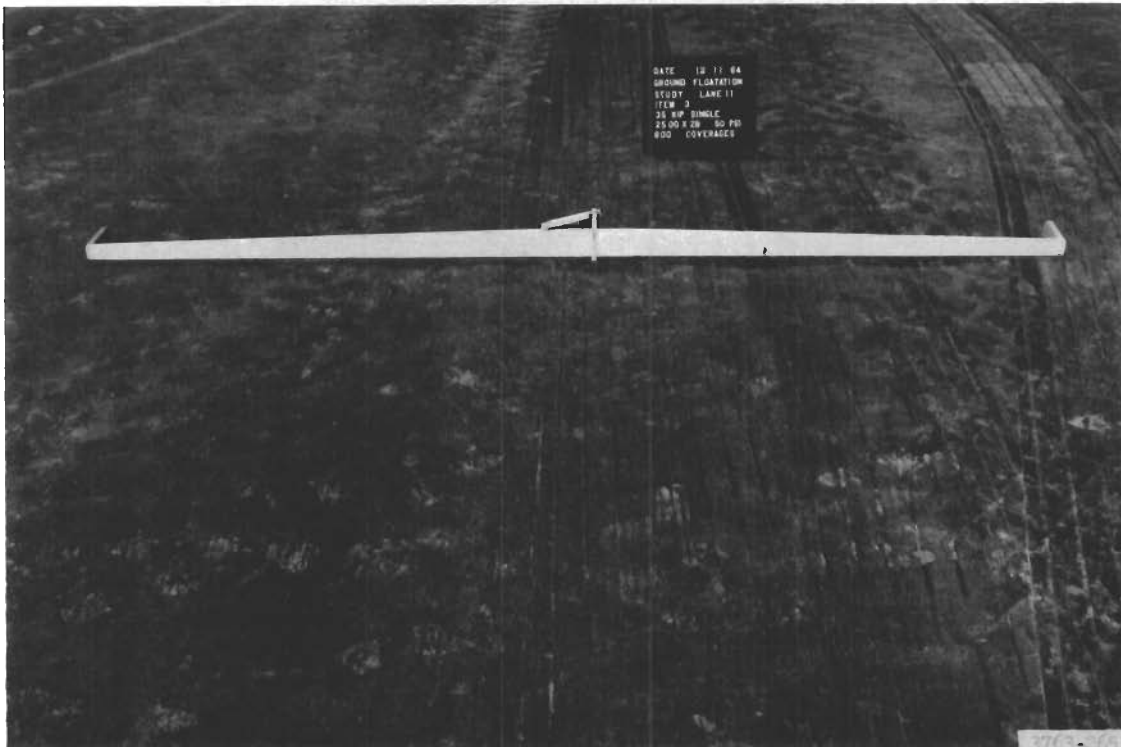
Item 3. Figure 7 shows item 3 prior to traffic. Very shallow surface deformations were evident when traffic was suspended at 600 coverages (figure 8). The item remained in good condition. The rated CBR was 12.

Figure 8. Lane 11, item 3. Transverse straightedge shows slight deformations at 600 coverages

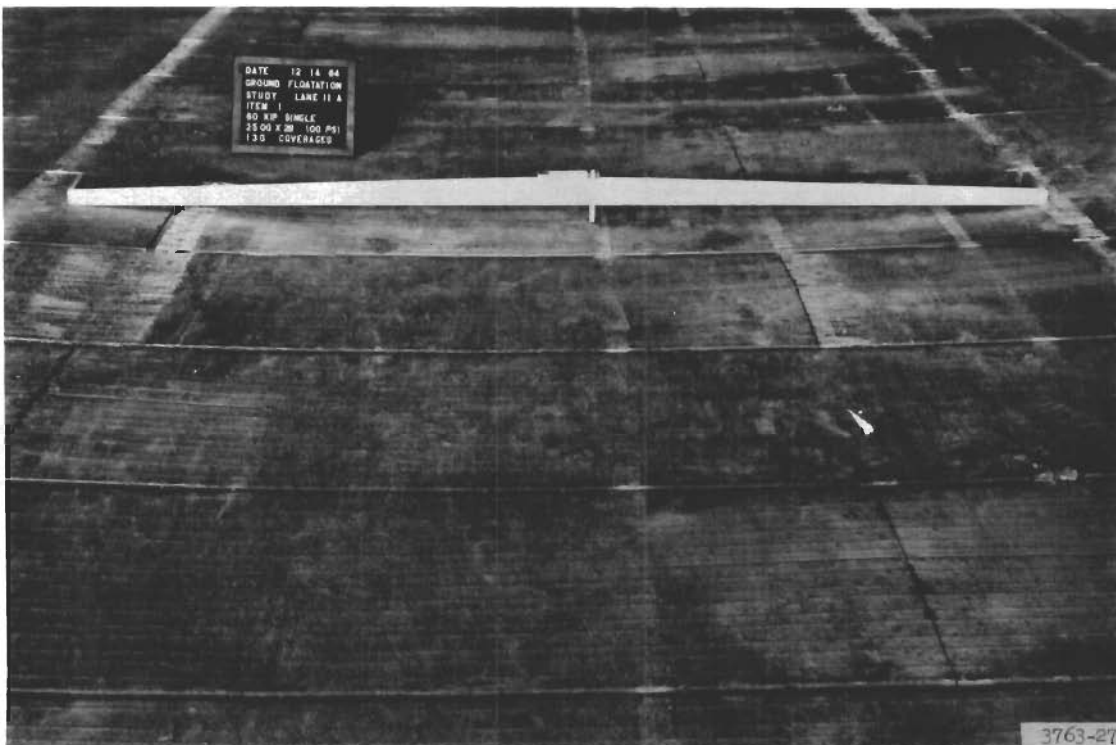
Item 1. Item 1 prior to renewed trafficking is shown in figure 4. At 130 coverages, the item was considered failed due to roughness (figure 9). The rated CBR of the item was 2.3.

- a. Roughness. Differential deformations that developed with trafficking are recorded in table 1. At failure the average longitudinal, transverse, and diagonal differential deformations measured 1.16, 2.19, and 1.88 in., respectively. Average dishing reached 0.47 in. at failure.

Figure 9. Lane 11A, item 1. Transverse straightedge shows deformations at 130 coverages (failure)

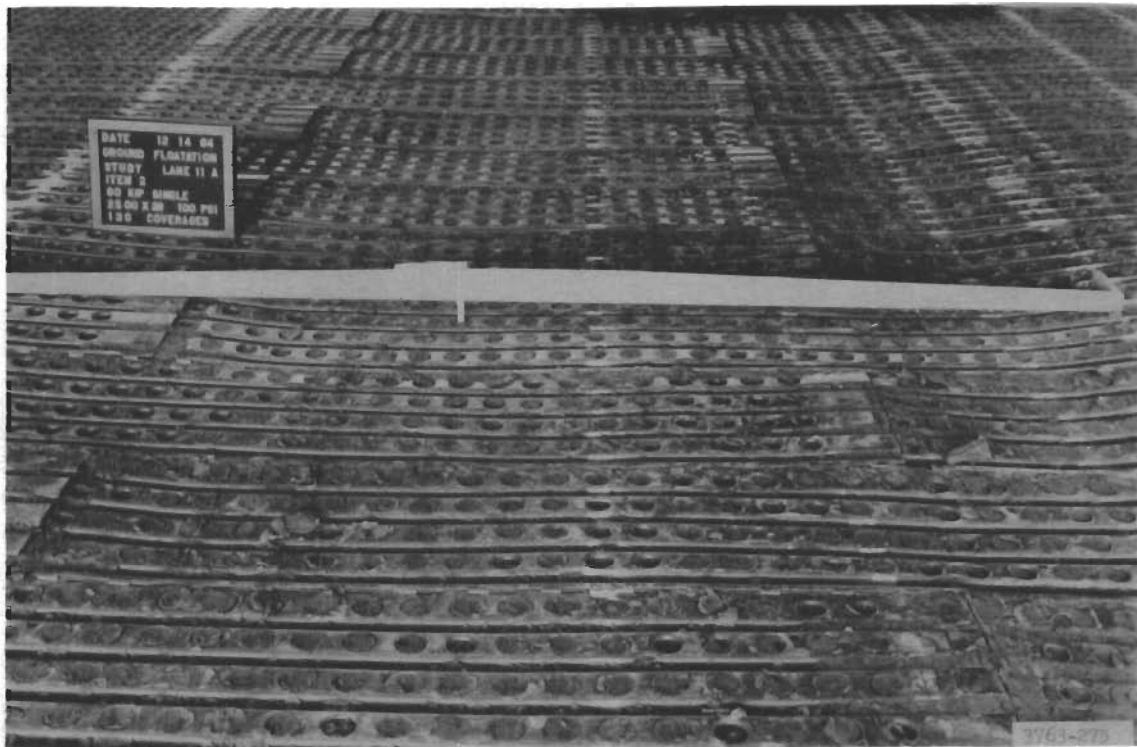
Item 2. Item 2 prior to renewed trafficking is shown in figure 6. The item was considered failed due to roughness at 130 coverages (figure 10). The rated CBR was 4.3.

- a. Roughness. Differential deformations that developed with trafficking are shown in table 1. A consistent increase in differential deformations occurred up to the time of failure. At failure the average longitudinal, transverse, and diagonal differential deformations were 1.47, 2.00, and 1.91 in., respectively. Average dishing reached 0.41 in.

Figure 10. Lane 11A, item 2. Transverse straightedge shows deformations at 130 coverages (failure)

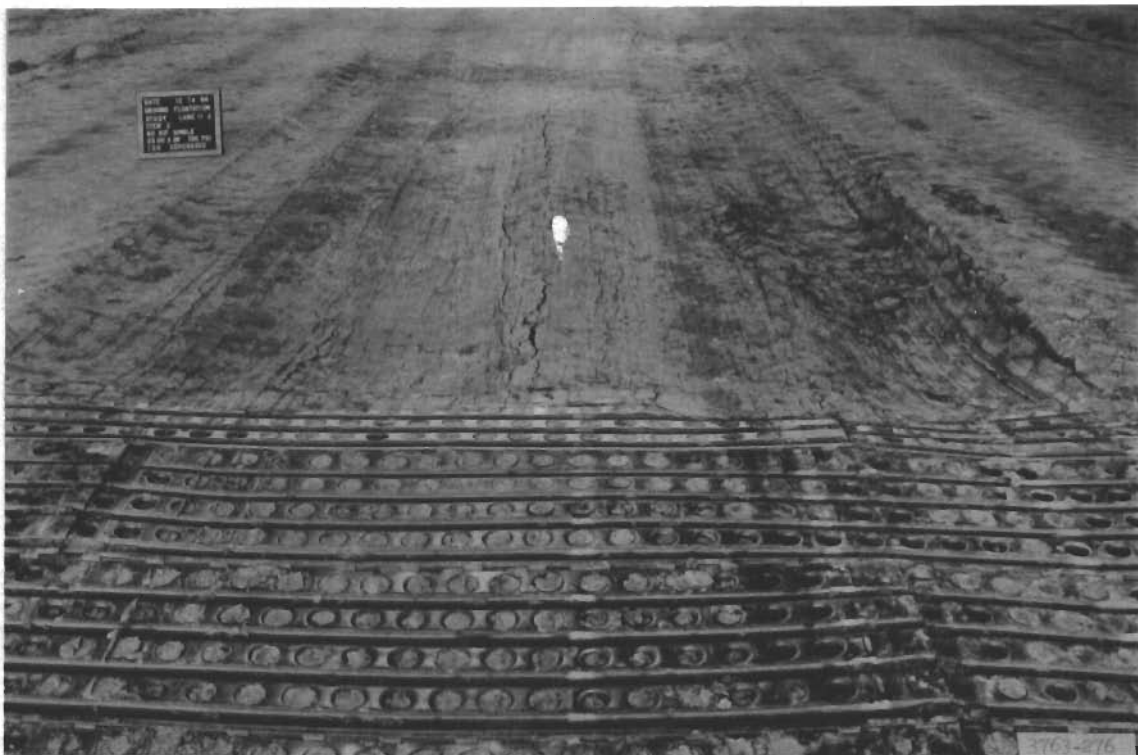
Item 3. Item 3 prior to renewed trafficking is shown in figure 8. At 112 coverages the south end of the item (sta 0+80 to 0+95) was considered failed due to rutting; the north end of the item was in good condition. The north and south ends were then designated segments 3B and 3A, respectively, and traffic was continued to 130 coverages at which time segment 3B was considered failed due to rutting (figure 11). As the figure shows, the principal area of deterioration was along one side of the lane where a severe rut developed reaching a maximum depth of 3.32 in. The rated CBR of segment 3A was 12. Segment 3B had a rated CBR of 16.

- a. Roughness. Development of differential deformations and rut depths with trafficking is shown in table 1. In segment 3A, rut depths averaged 2.88 in. at 112 coverages (failure). Rutting of segment 3B was limited to one side of the lane and measured 3.32 in. at 130 coverages.

Figure 11. Lane 11A, item 3; general view of item at 130 coverages (failure)

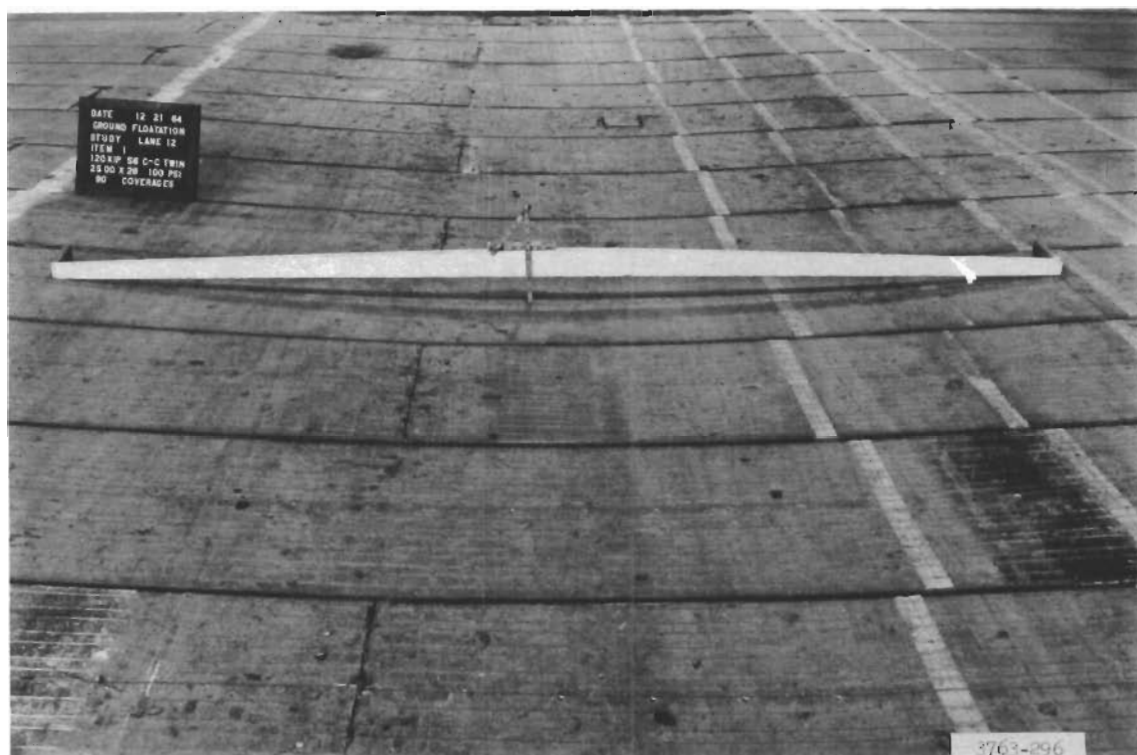
Item 1. Figure 12 shows item 1 prior to traffic. The item was still in good condition when measurements were recorded at 44 traffic coverages. Additional trafficking produced progressive deterioration of the item until it was considered failed due to roughness at 90 coverages (figure 13). The rated CBR was 2.9.

- a. Roughness. Table 1 shows the consistent increase in differential deformations with trafficking. At failure the average longitudinal, transverse, and diagonal differential deformations were 1.47, 3.34, and 2.53 in., respectively. The average dishing was 0.38 in.

Figure 13. Lane 12, item 1. Transverse straightedge shows deformations at 90 coverages (failure)

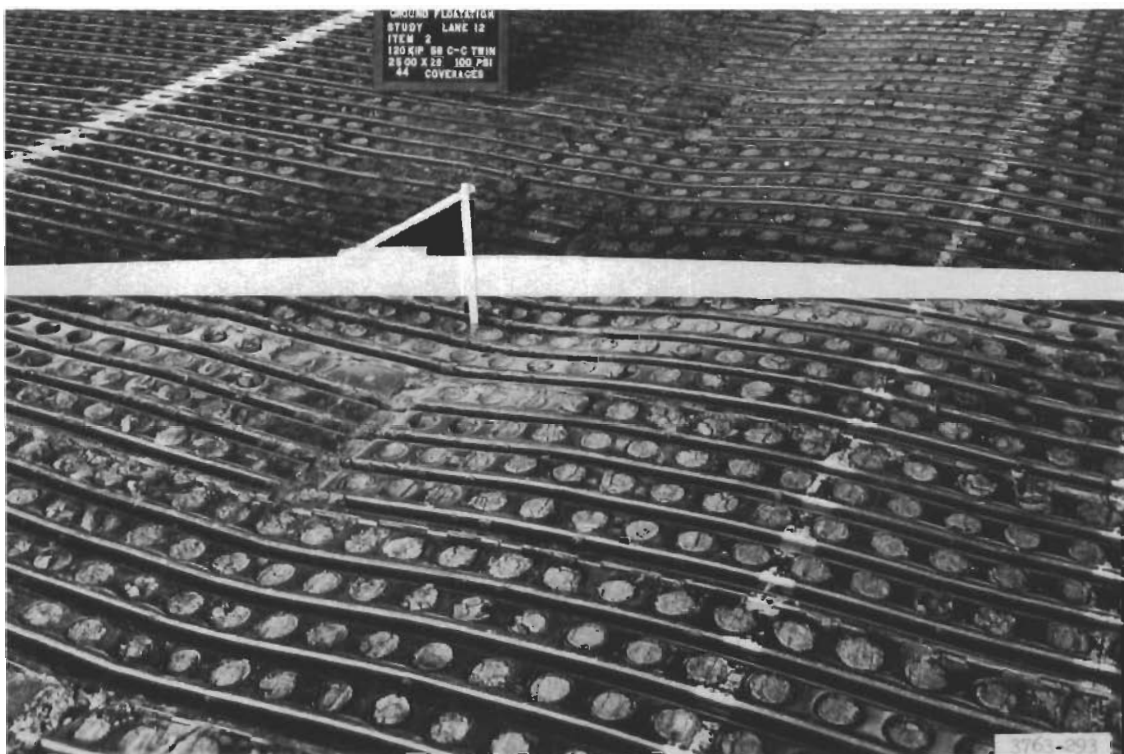
Item 2. Figure 14 shows item 2 prior to traffic. The item was considered failed due to roughness at 44 coverages (figure 15). At failure the plank ends along the mat joint line near the lane center were bent downward into the subgrade in contrast to the upward protrusion of plank ends encountered in previous test lanes. The rated CBR was 4.2.

- a. Roughness. Differential deformations as measured at intervals during trafficking are shown in table 1. Average longitudinal differential deformation decreased to 0.44 in. at failure from the value of 0.85 in. at 20 coverages. Average transverse

and diagonal differential deformations were 2.22 and 1.88 in., respectively, at failure. Dishing was slight, averaging 0.25 in. at failure.

Figure 15. Lane 12, item 2. Transverse straightedge shows deformations at 44 coverages (failure)

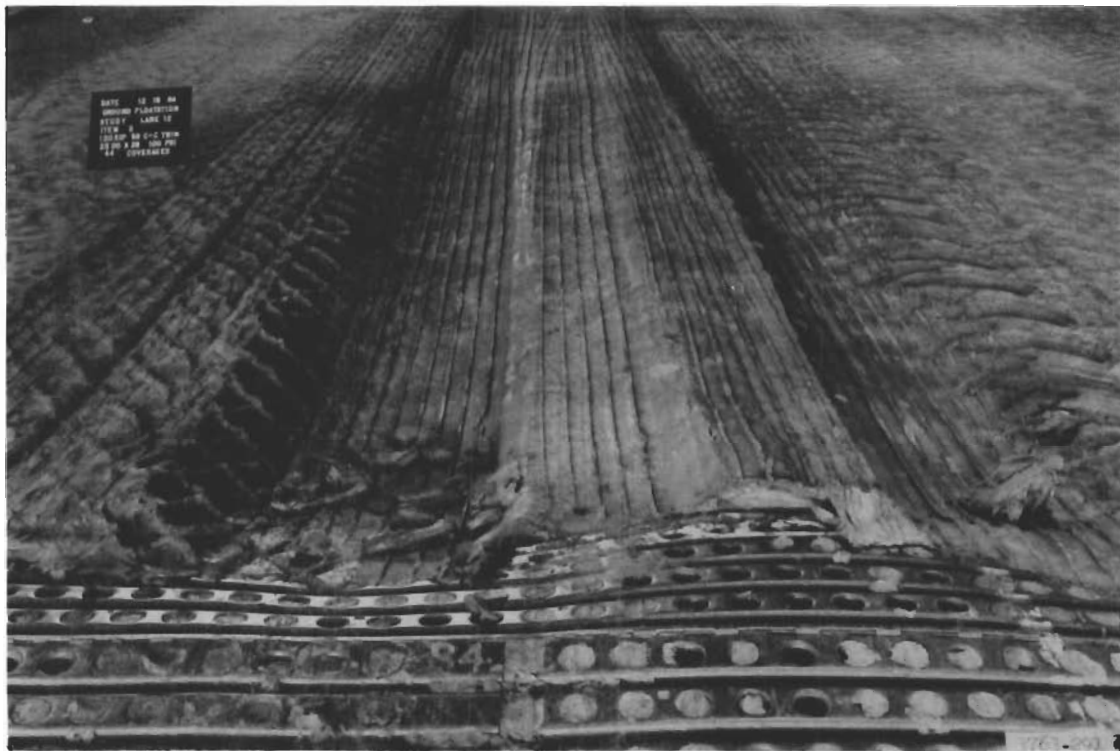
Item 3. Figure 16 shows item 3 prior to traffic. After 20 coverages the surface remained in good condition. At the 44-coverage level the

item was considered failed due to roughness (figure 17). The rated CBR was 9.0.

- a. Roughness. Differential deformations and rut depths measured at 20 and 44 coverages are shown in table 1. Rut depths at failure averaged 2.75 in. Transverse and diagonal differential deformations averaged 3.75 and 3.44 in., respectively, at failure.

Figure 17. Lane 12, item 3; general view of item at 44 coverages (failure)

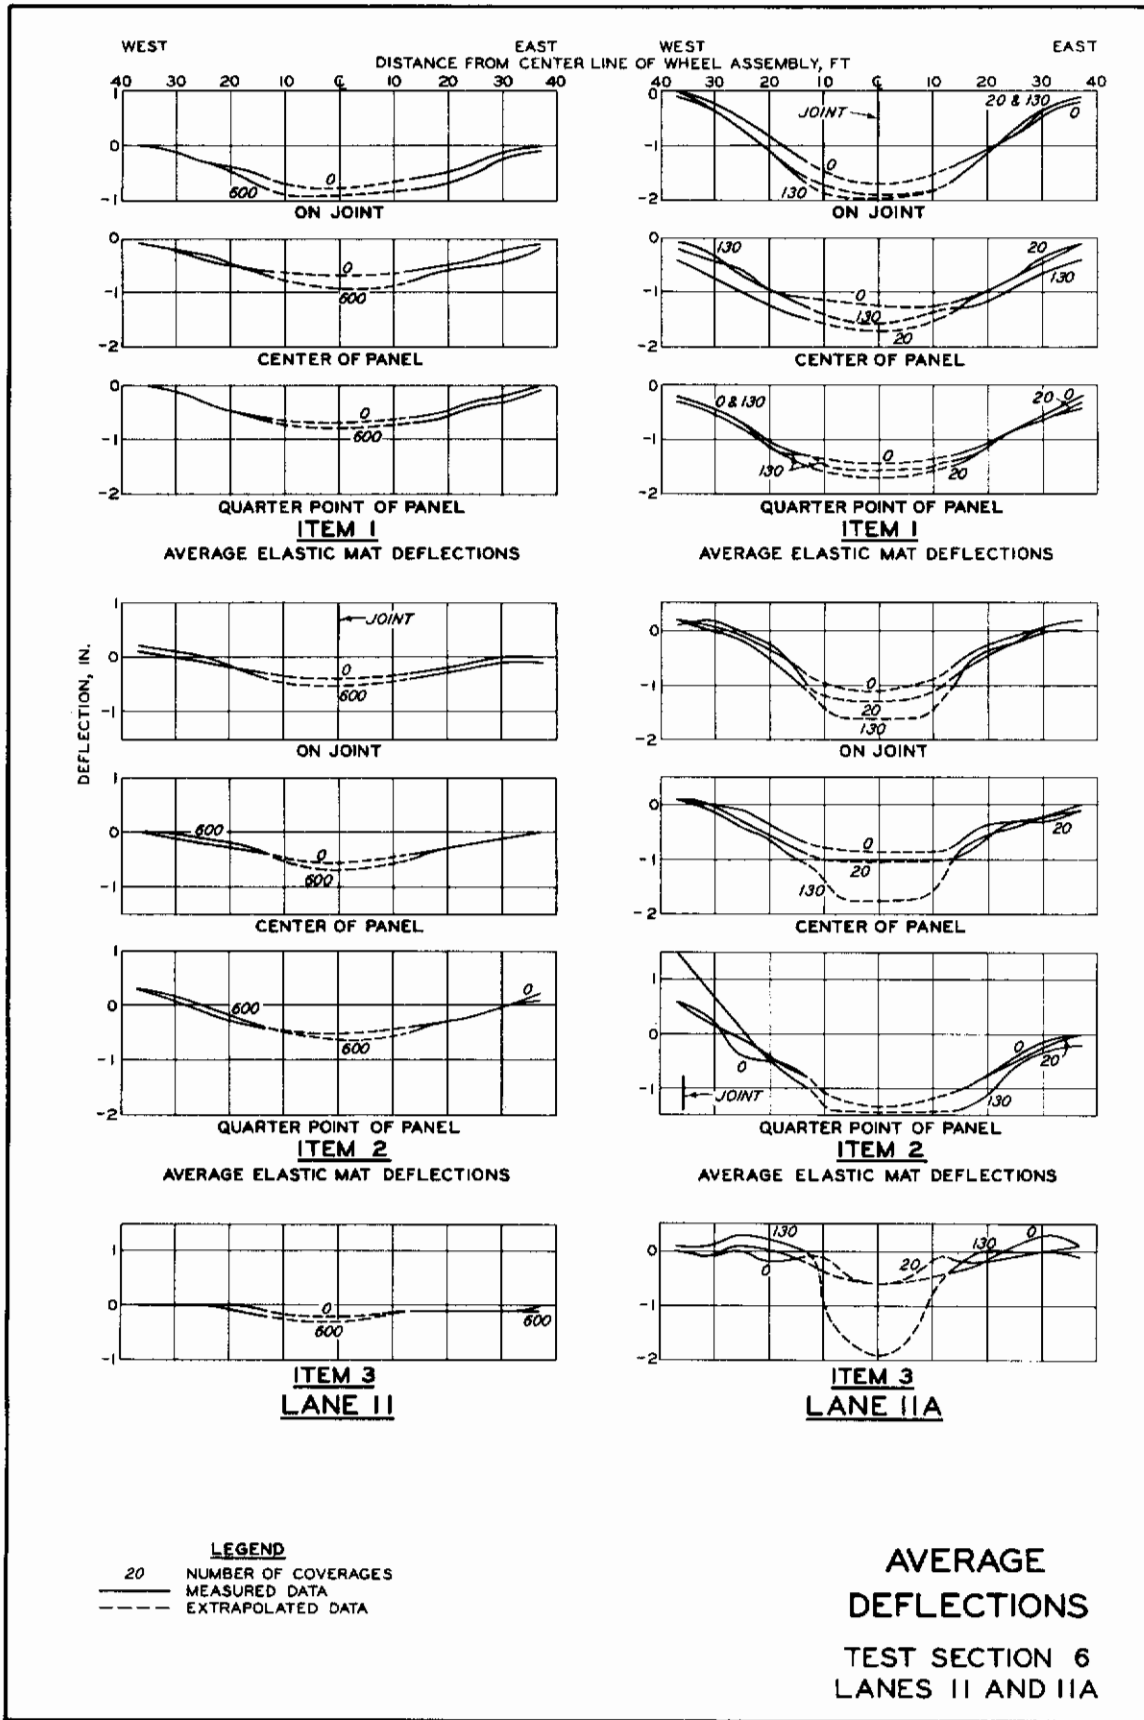
Figure 23

- c. Deflection. Average elastic mat deflections under static load of the load-wheel assembly are shown in figure 23 for three positions of the assembly relative to mat end joints. Elastic soil deflection at failure was 2.1 in.

- c. Deflection. Average elastic mat deflections under static load of the load-wheel assembly are presented in figure 23 for three positions of the assembly relative to mat end joints. Elastic soil deflections are shown in table 1 and reached 0.9 in. at failure.

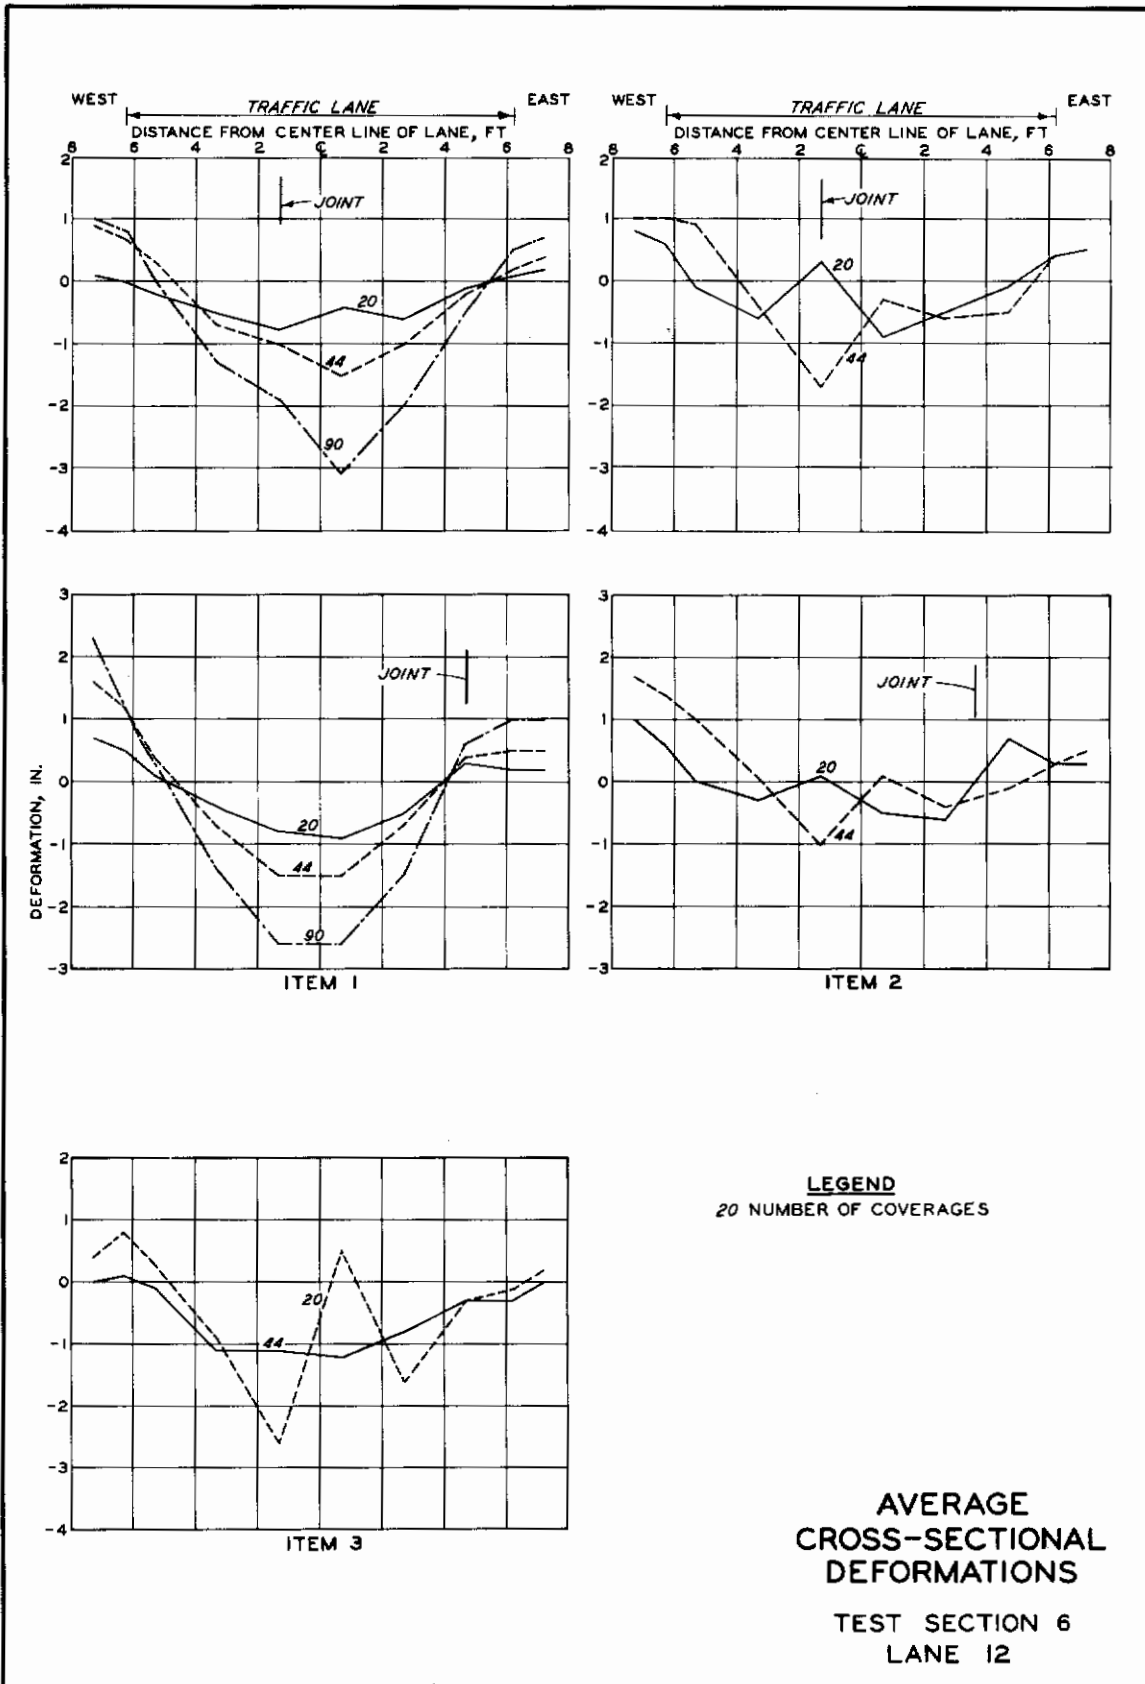
- b. Deformation. Figure 24 shows average cross-section deformations at several coverage levels for two typical mat runs. Center-line profiles are shown in figure 25. Deformations are seen to follow a consistent pattern of increasing severity with trafficking, reaching maximum values at failure of the item.

- b. Deformation. Figure 24 shows average cross-section deformations at 20 and 44 coverages for two typical mat runs. Center-line profiles are shown in figure 25 for the same coverage levels. The downward bend of the panel ends along the mat joint line near the lane center is illustrated in a cross-section plot (figure 24). In previous tests, the panel ends along a mat joint line most commonly protruded upward at failure, as was the case at 20 coverages in this item.

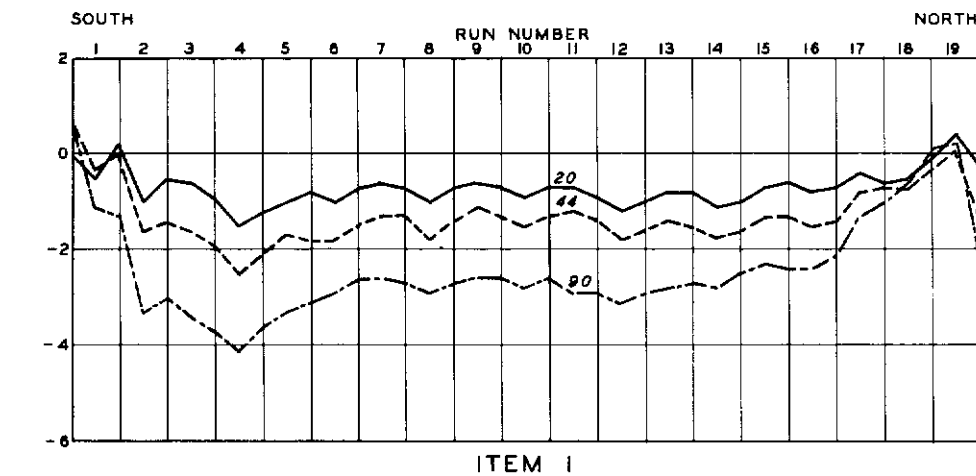
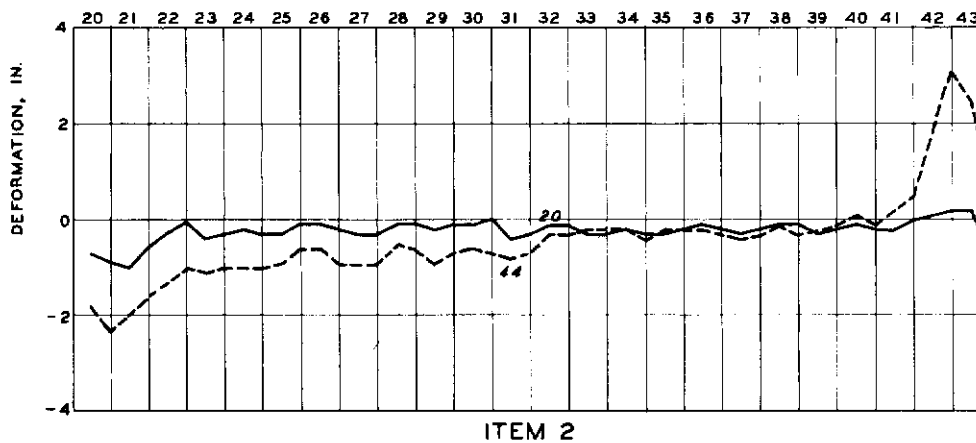
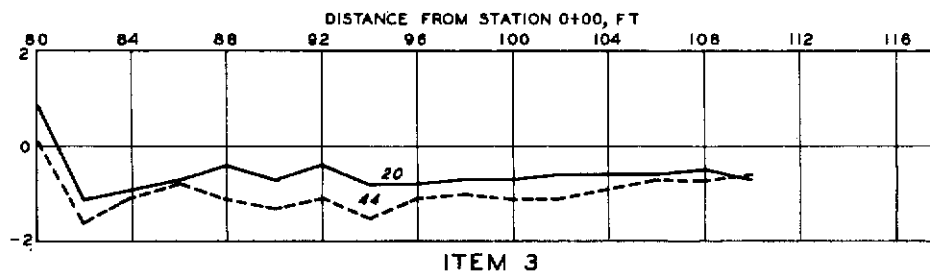
Figure 25

**PERMANENT PROFILE  
DEFORMATIONS  
TEST SECTION 6  
LANE 12**

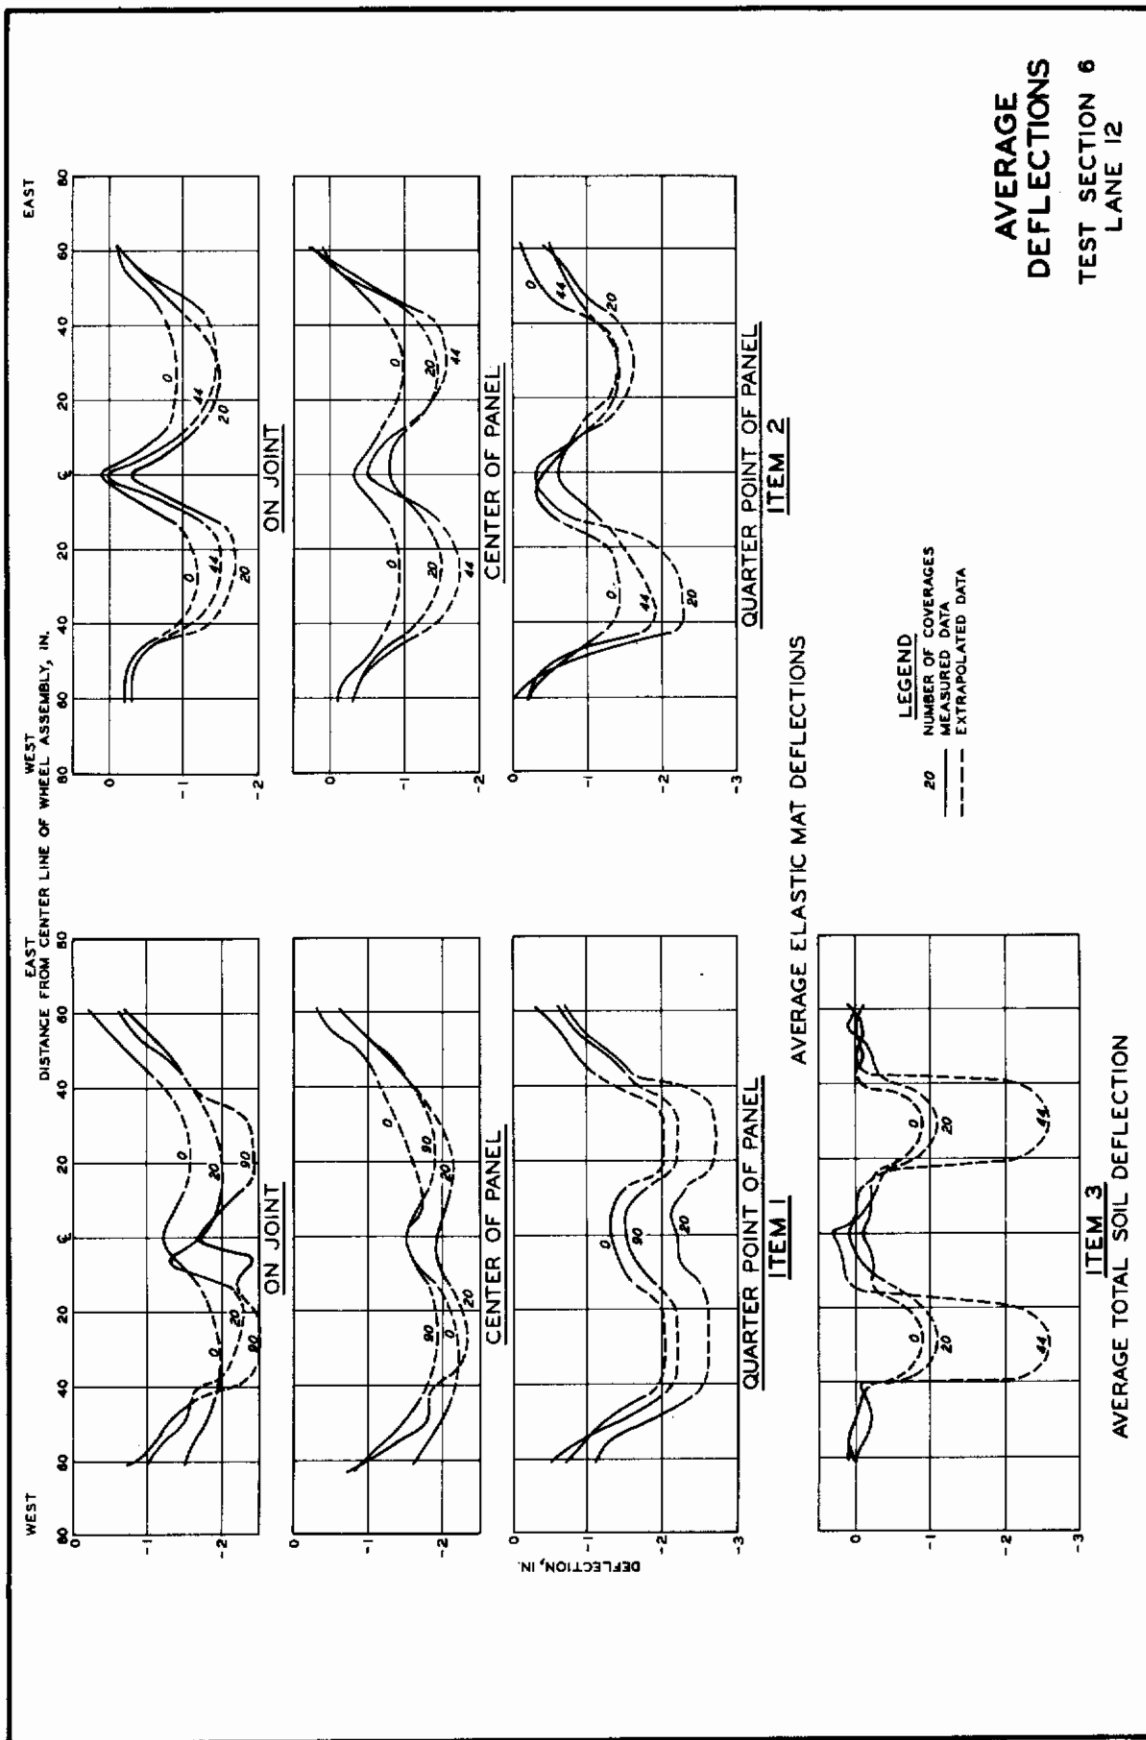
Figure 26

- c. Deflection. Average elastic mat deflections under static load of the load-wheel assembly are shown in figure 26 for three positions of the assembly relative to mat end joints. Deflection measurements were not always consistently greater with higher coverage levels, but decreased in some cases from earlier measurements. Elastic soil deflection at failure measured 2.5 in.

- c. Deflection. Average elastic mat deflections under static load of the load-wheel assembly are shown in figure 26 for three positions of the assembly relative to mat end joints. In some instances, it is seen that the greatest deflections did not always correspond with higher coverage levels. Elastic soil deflections, shown in table 1, measured 1.2 in. at failure.

- c. Deflection. Average total soil deflections are shown in figure 26 for 0, 20, and 44 coverages. A large increase in total deflection is noted at 44 coverages. Elastic soil deflections are shown in table 1. The maximum elastic deflection value recorded was 0.7 in. at failure of the item.
