AIRCRAFT ANTENNA CORROSION CONTROL

I. S. Shaffer
Naval Air Development Center
Warminster, Pennsylvania

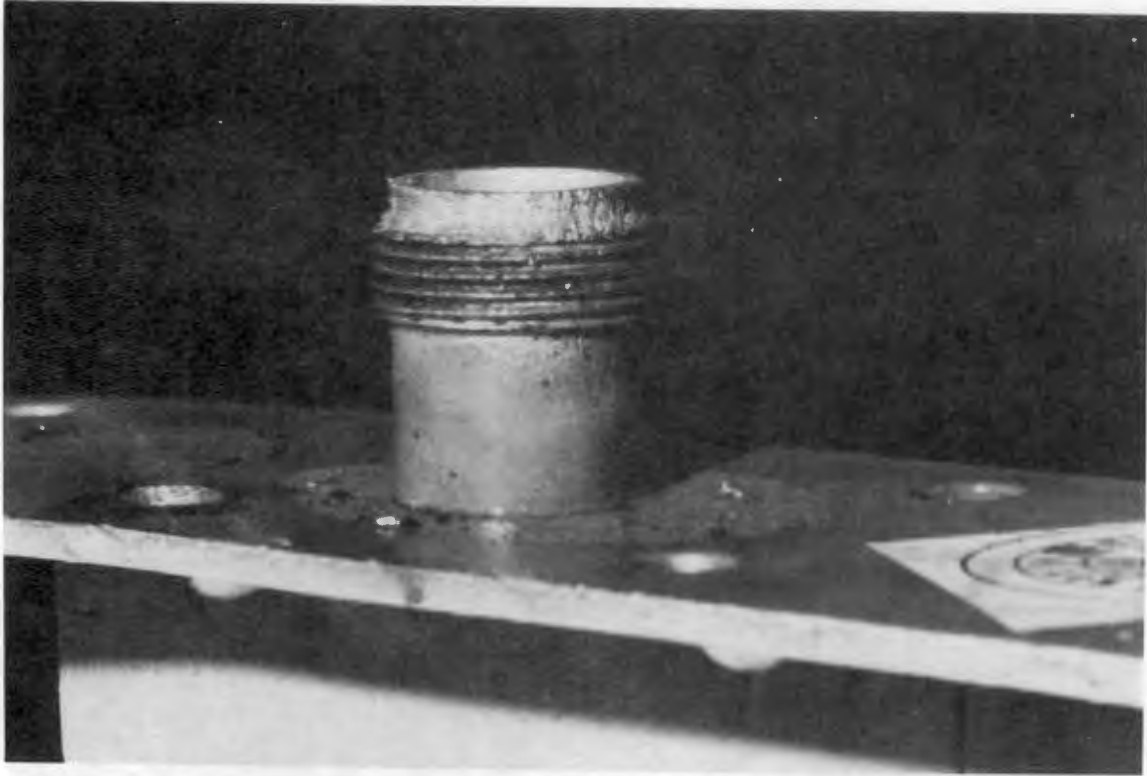
Corrosion inside of an antenna coaxial connector is a principal cause of antenna performance degradation (Figure 7). Therefore, the cleaning and preserving of the antenna connectors is important to reduce effects of

Figure 7. Corrosion on Lower TACAN/IFF Antenna Coaxial Connector

- a. With the connector sections mated, corrosion was removed with an abrasive mat.
- b. Connectors were opened and internal sections were cleaned.
- c. The internal areas were sprayed with a water displaying corrosion preventive compound MIL-C-81309, Type III. The MIL-C-81309 material forms an ultra thin tacky (soft) film that is designed so that it is displaced by the wiping action of a sliding electrical contact, yet the film is self healing (reforms) in non-contact areas after displacement. The resultant lack of disruption to DC continuity through the male/female type of connections due to a MIL-C-81309, Type III, film has been well established.^(3,4)

- d. The connectors were then mated and a coating of another water displacing corrosion preventive compound, MIL-C-85054⁽⁵⁾, was applied to the exterior surface of the connector. This material dries to a relatively thick (1 to 2 mils) hard, clear finish and has been used successfully on naval aircraft to protect exterior skin surfaces in areas where paint has chipped or cracked leaving exposed bare metal.

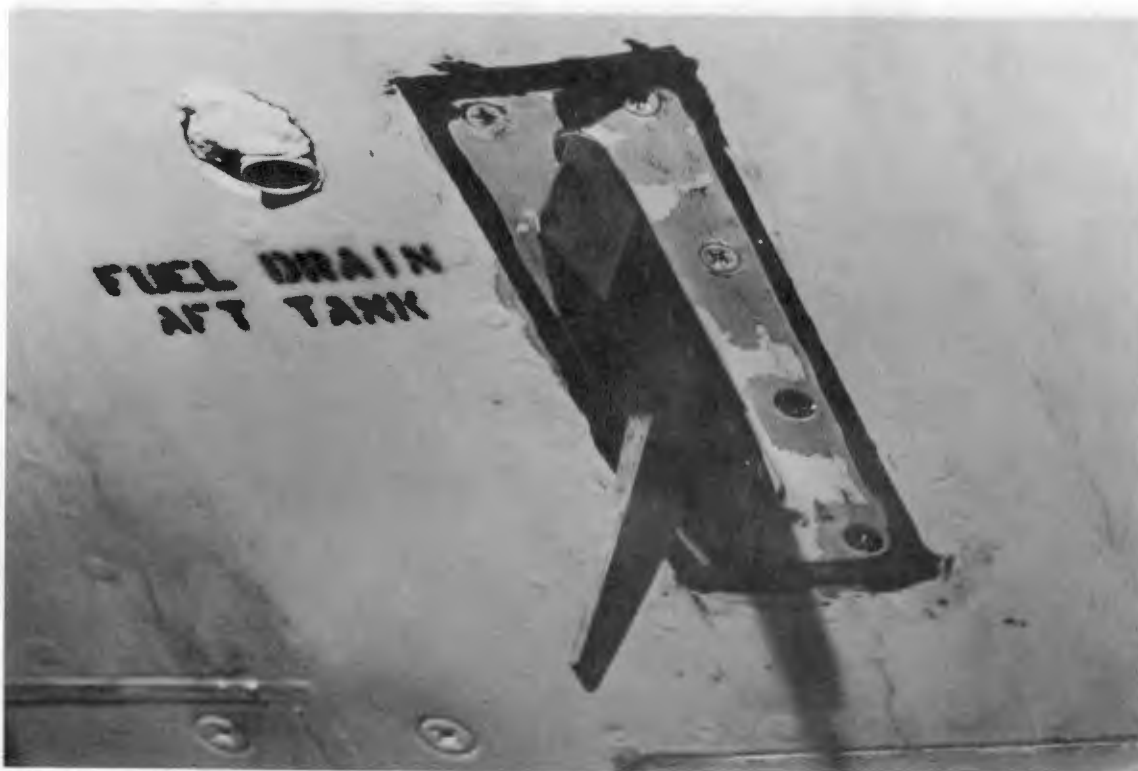
a. In the evaluation of sealants as applied around the bases of antennas, the two assigned A-7E lower TACAN/IFF antennas were removed (Figure 8) with no difficulty in the removal due to the sealant applied around the circumference of the bases. The inspection of the sealants indicated that MIL-S-8802 and MIL-S-81733 both are effective in resisting deterioration due to solvents, detergents, cleaning materials, etc. Upon removal of the antenna, a combination of fluids (hydraulic oil and water) were present; however, the Corrosion Preventive Compound, MIL-C-16173, Grade 4 prevented these fluids from affecting the antenna and the aircraft skin mounting area. There were no visible

Figure 8. Sealed A-7 Lower TACAN/IFF Antenna

- e. Applied a fillet of corrosion inhibited polysulfide sealant, MIL-S-81733, Type II, around the outside of the antenna base on one aircraft and a fillet of MIL-S-8802 polysulfide sealant without inhibitors on the antenna on the other aircraft to form a watertight seal.

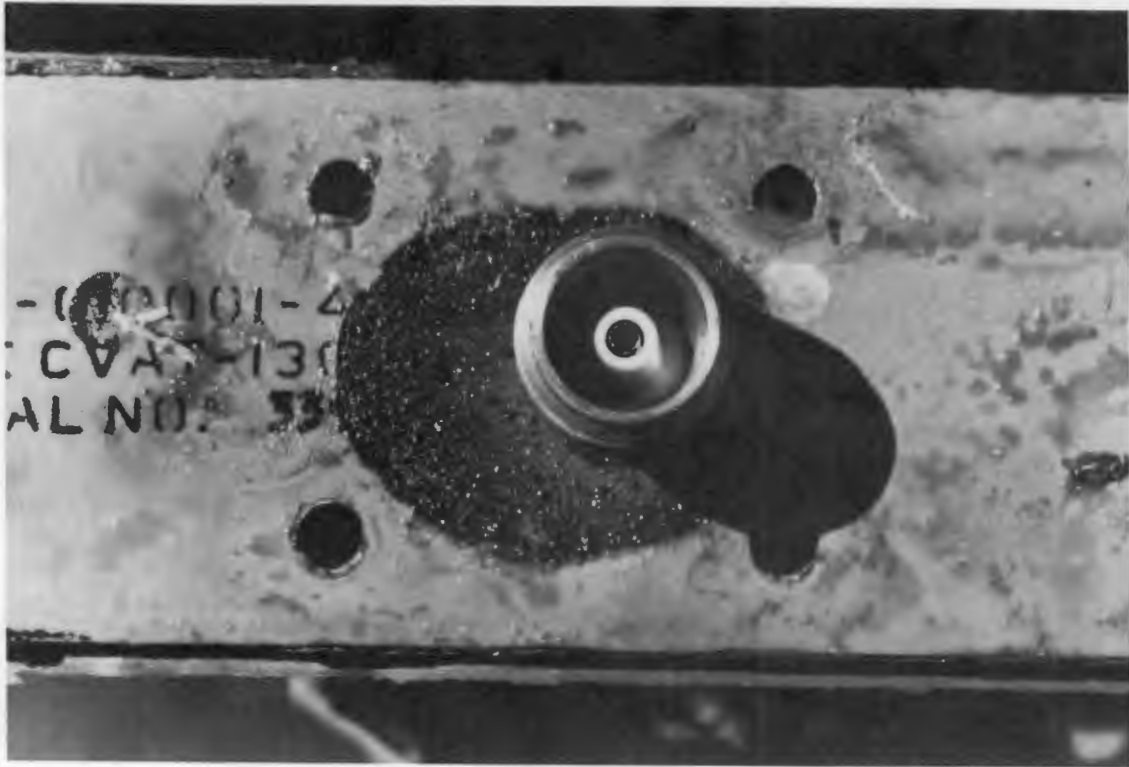
signs of corrosion. When the antenna connectors were disconnected they were in the same material condition as when they were connected at the beginning of the evaluation period. There was no evidence of external connector corrosion. As the photos (Figure 9) show, the antenna coaxial connector appears to be clean after the six months tests even though the photo clearly shows that fluids, foreign matter, etc. from the inside of the aircraft are all around the base of the connector.

Figure 9. A-7 Lower TACAN/IFF Antenna Coaxial Connector

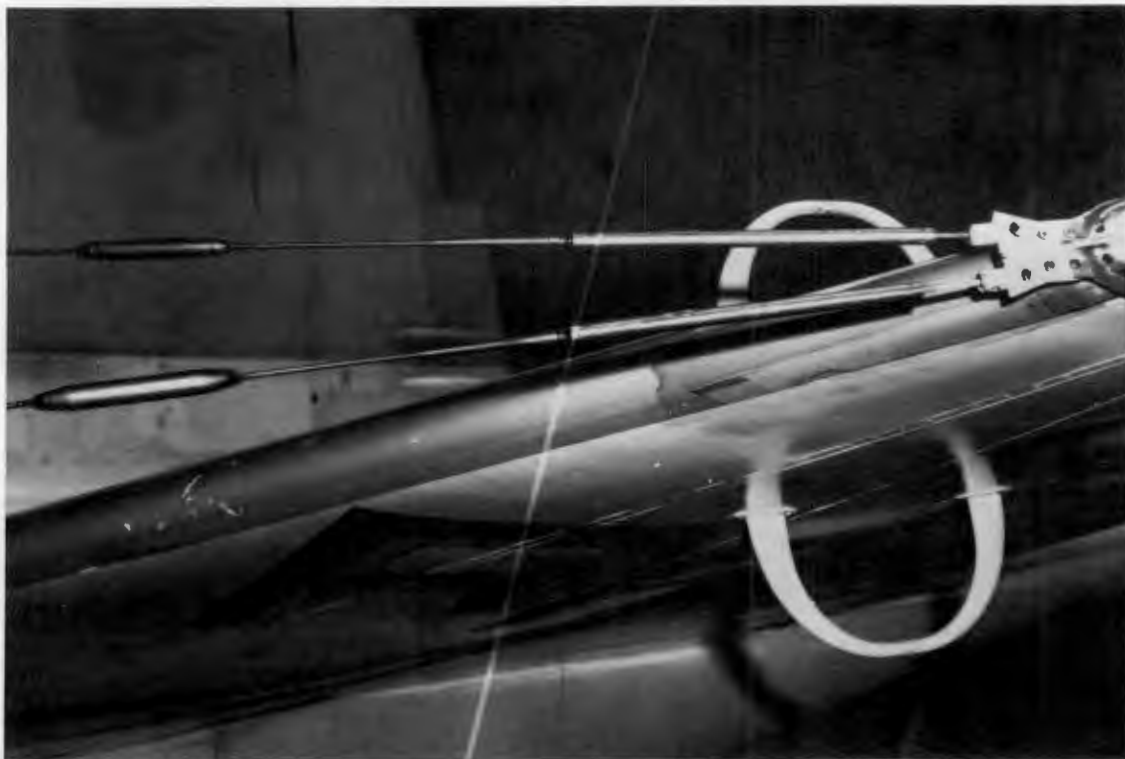
b. The P-3C evaluation results indicate that the procedures of applying Adhesive Sealant, RTV 3140, clear, MIL-A-46146, to the HF Long Wire antenna insulator wire connection ends were beneficial for preventing moisture from entering the insulator in this area. The use of Corrosion Preventive Compound, MIL-C-85054, Type I, over the attaching hardware was also effective in preventing corrosion in these areas. However, the procedure for applying the Adhesive Sealant, RTV 3140, clear, MIL-A-46146, over the tensioner (Figure 10), alignment slot was not adequate. The sealant appeared to be lifted from the alignment slot area.

Figure 10. P-3 HF Long Wire Tensioner

- a. Removed dirt, oil and grease from the long wire/DF attachment components with Dry Cleaning Solvent, P-D-680.
- b. Removed surface corrosion on the antenna mast cable shackle, clevis bolts, etc., with an abrasive mat.
- c. Cleaned by wiping with Cleaning Cloth, dampened with Cleaning Compound Solvent, MIL-C-81302. This step removes any petroleum residue and other materials left by the use of the abrasive mat.
- d. With the long wire/DF antenna installed, applied a coating of Corrosion Preventive Compound, MIL-C-85054, Type I, over the attaching hardware.
- e. Applied Adhesive Sealant, RTV 3140, clear, MIL-A-46146, where the wire feeds into the insulator.
- f. Applied Adhesive Sealant, RTV 3140, clear, MIL-A-46146, where the wire feeds into the take-up tension assembly, and over the tension take-up assembly alignment slot.
