WADC TECHNICAL REPORT 57 - 298

IRON-ALUMINUM ALLOY SYSTEMS

PART 14 WELDING OF IRON-ALUMINUM ALLOYS

**FORD MOTOR COMPANY
MANUFACTURING RESEARCH OFFICE**

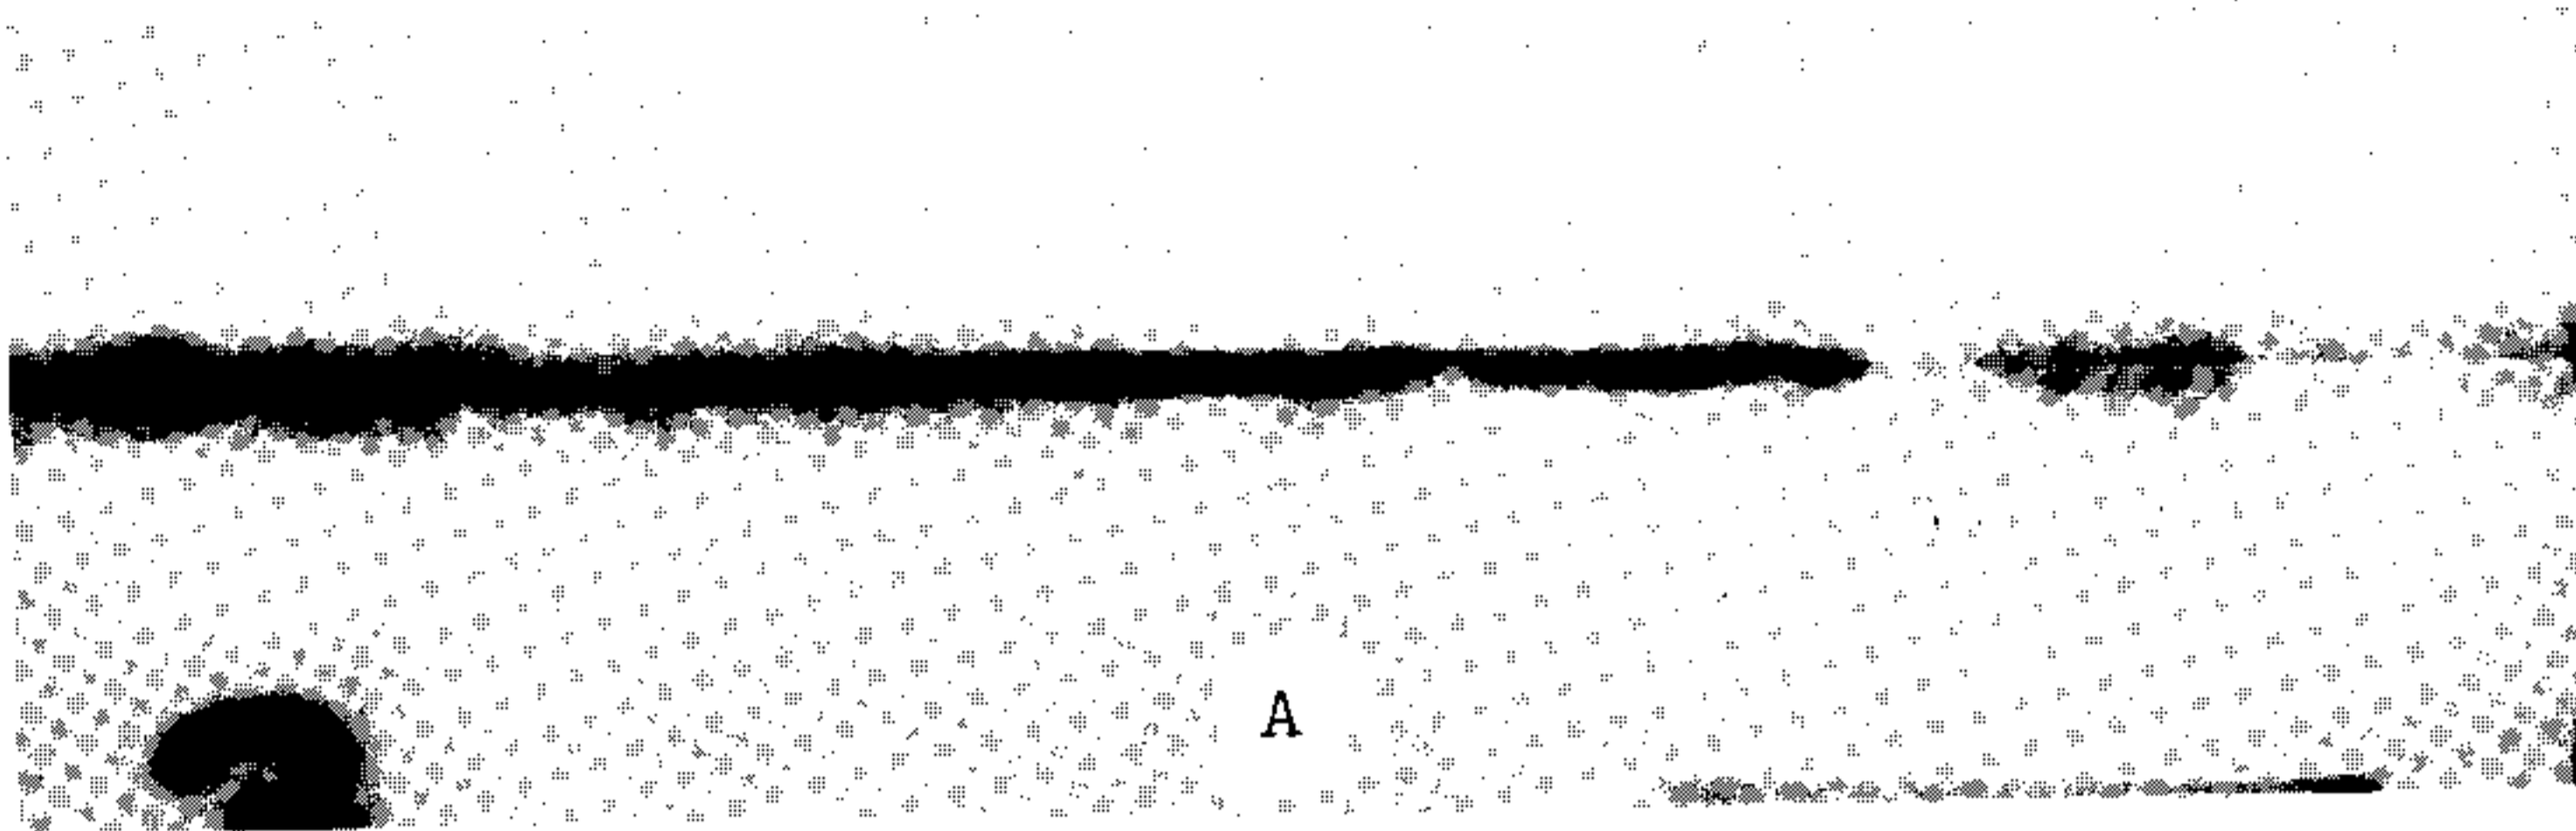
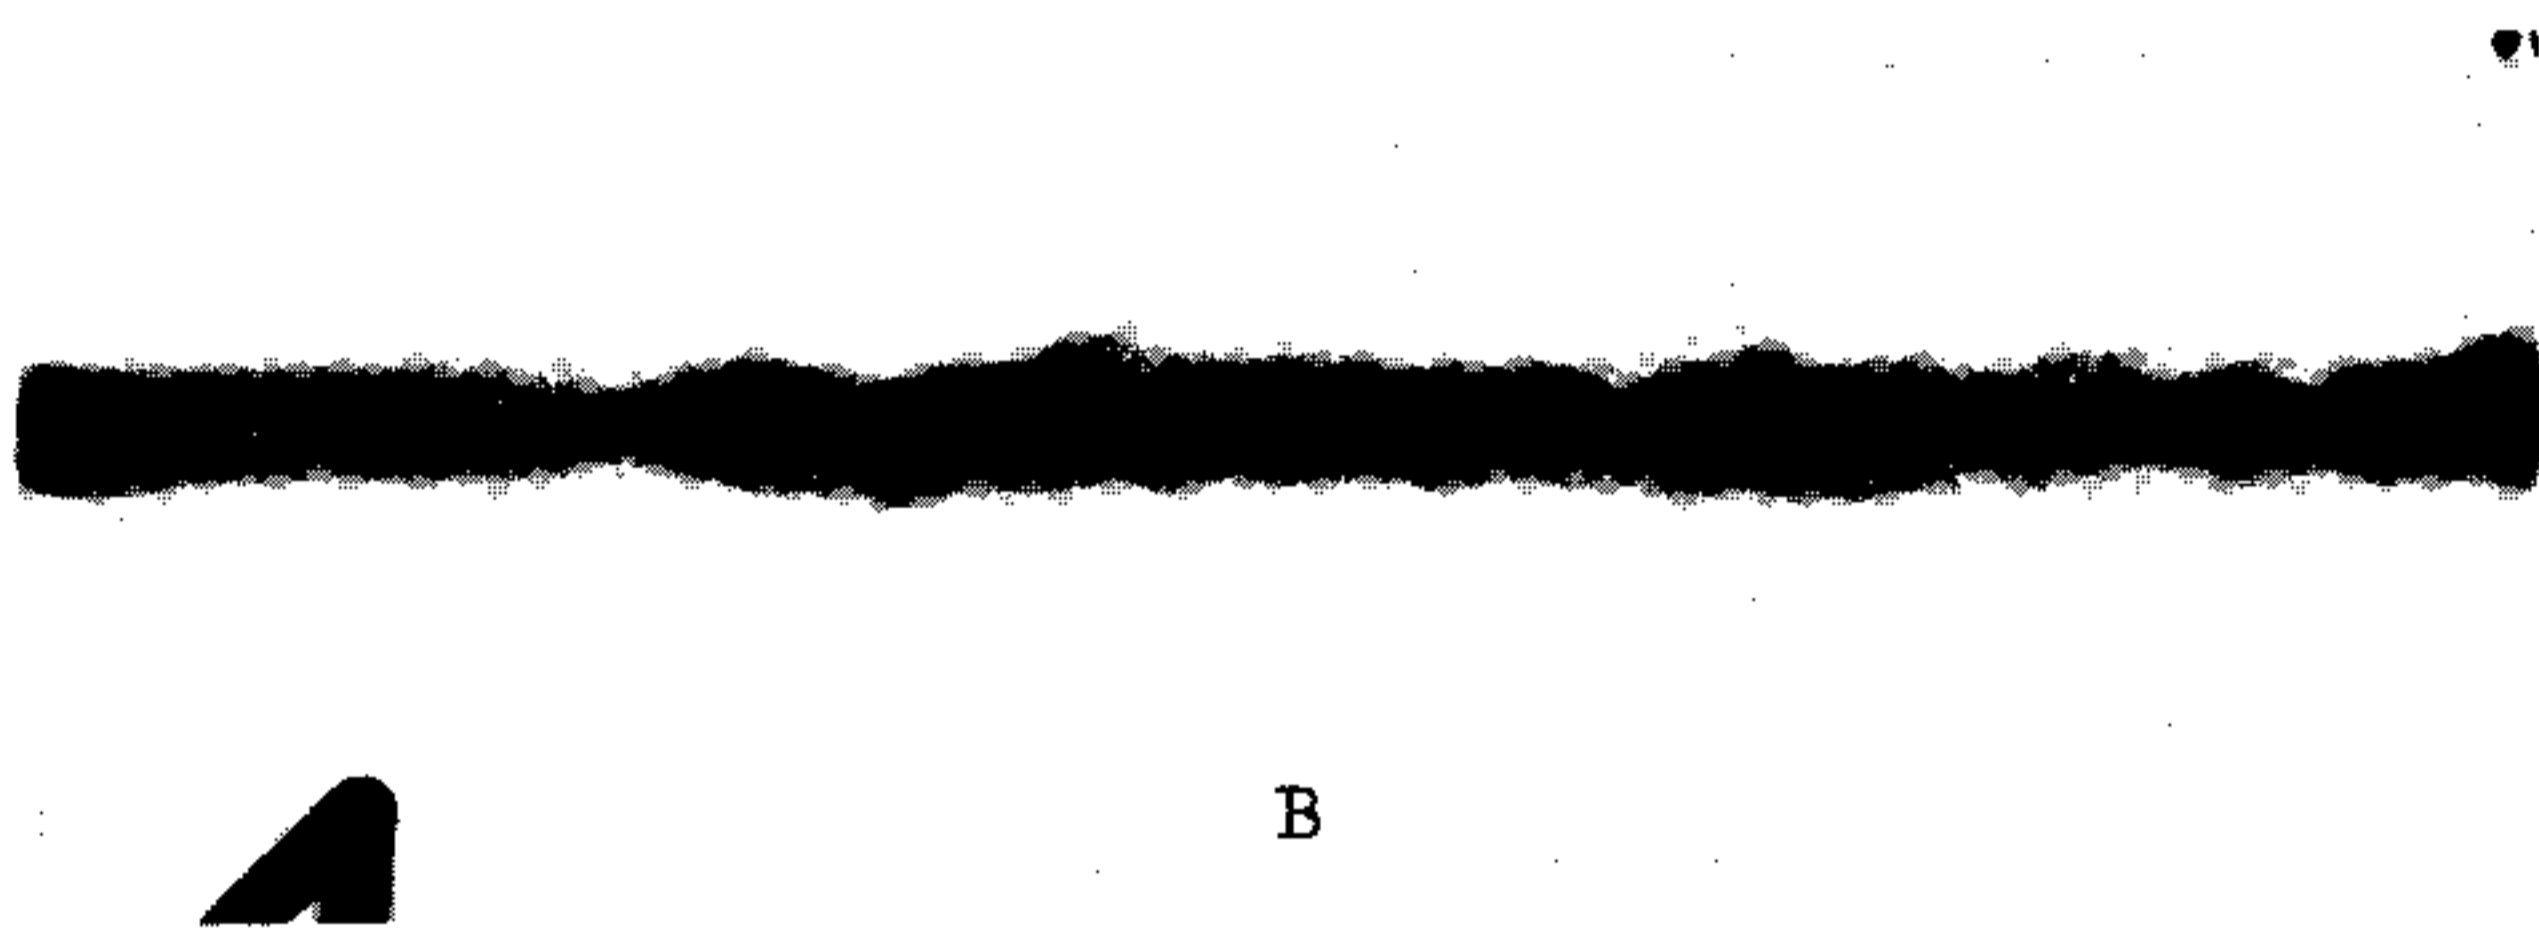
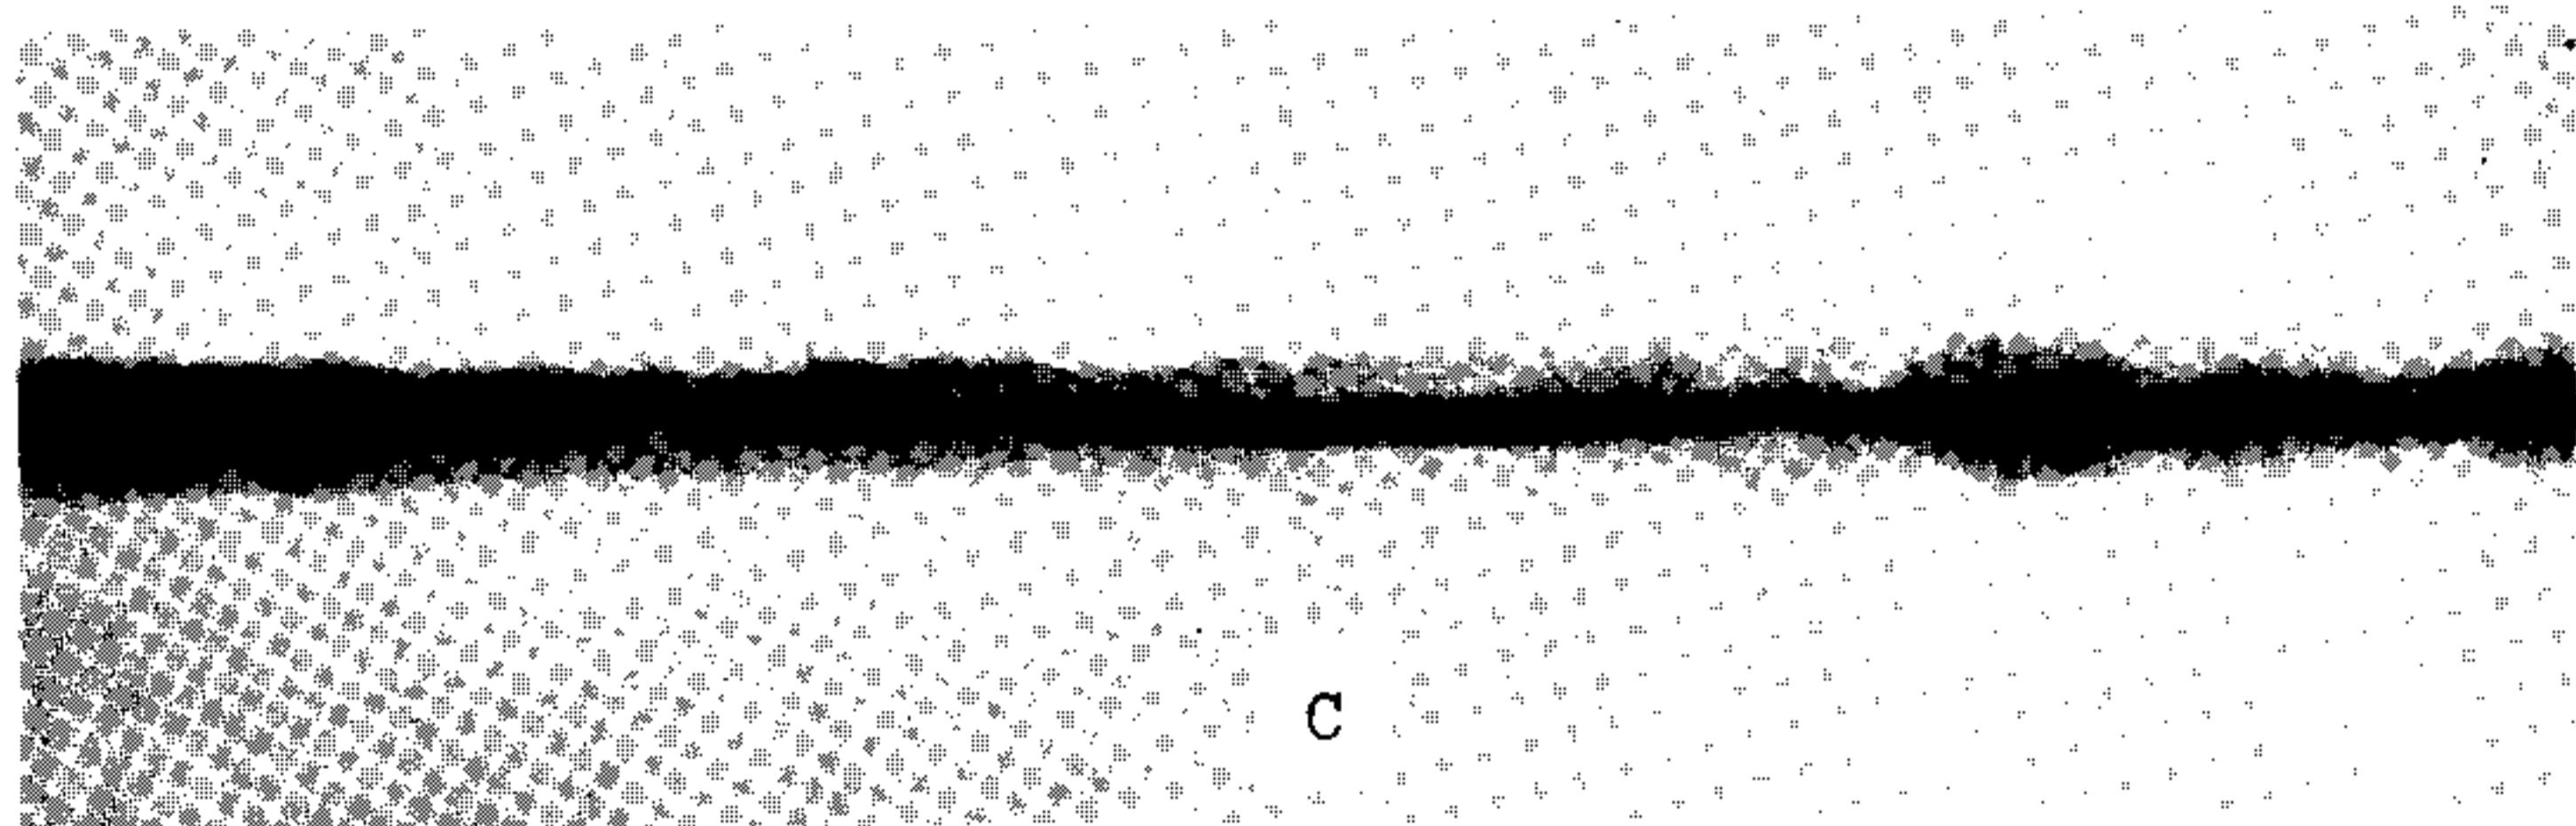
Figure 1 shows radiographs of three crack-free welds in the .093" stock and Figure 2 shows two similar welds on .031" material.

Figure 1 - Radiographs of Manual Tungsten Arc Welds on Iron-Aluminum Heat A-13361, .093" Thick.

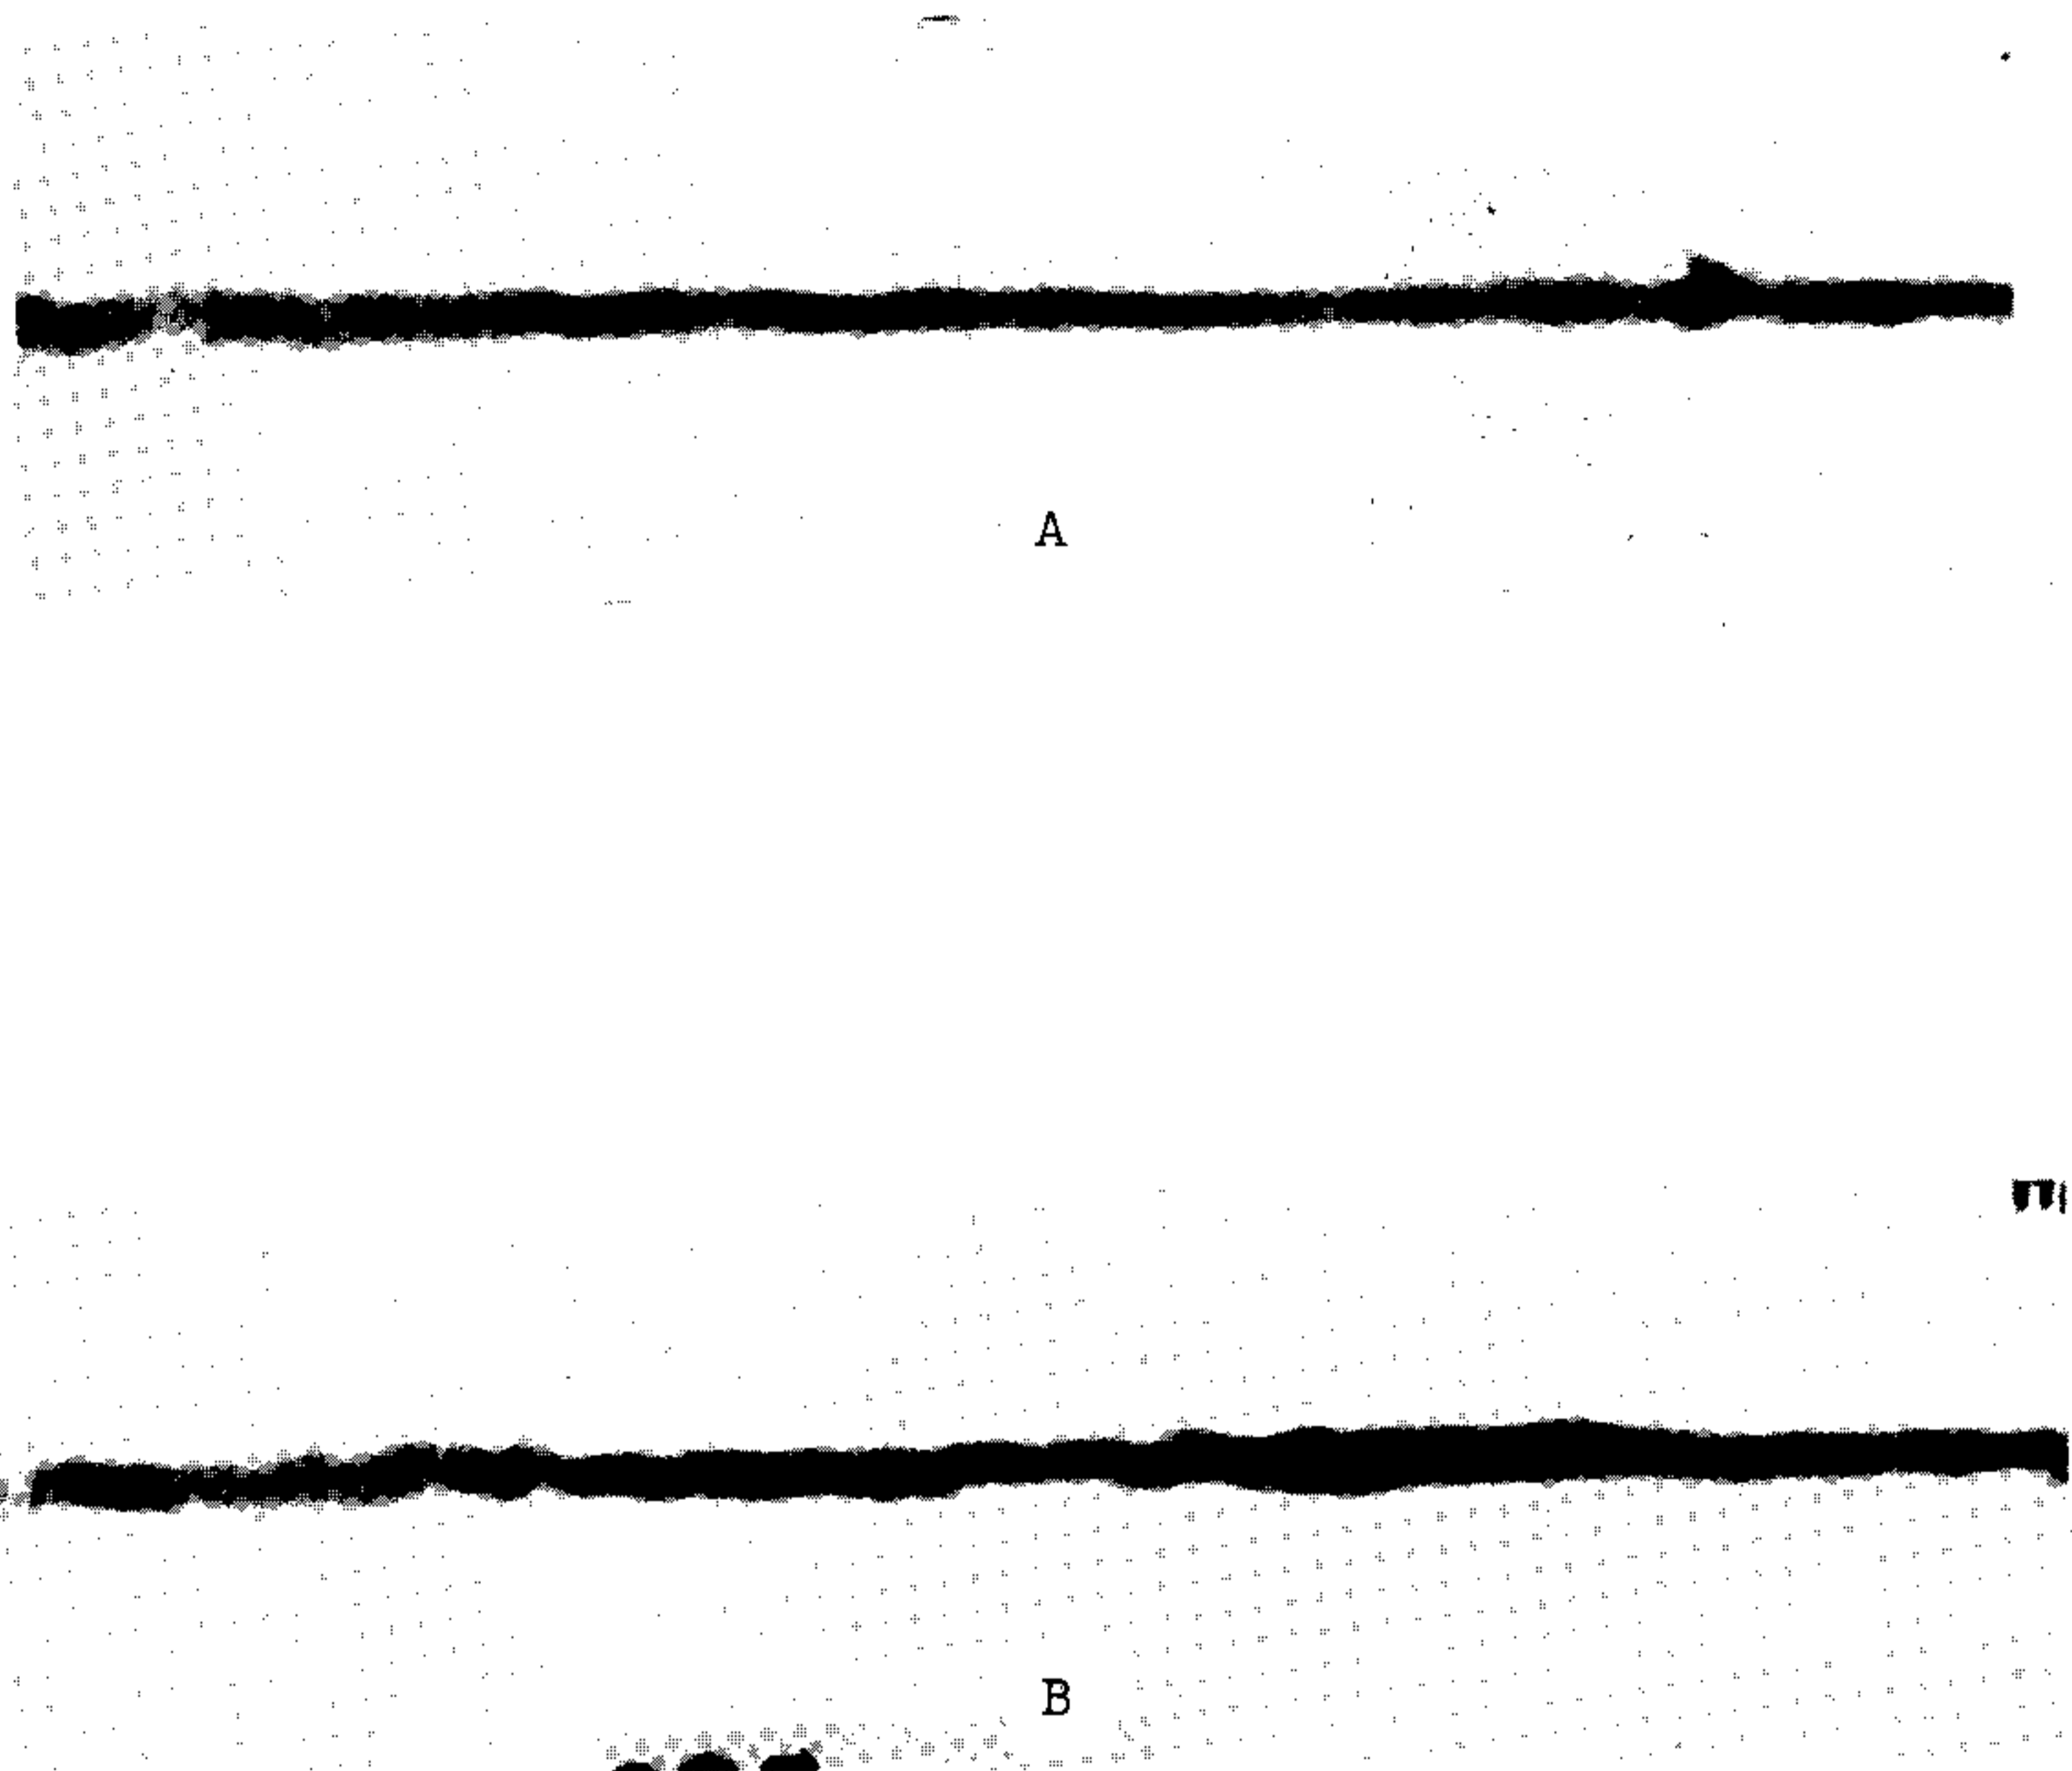
Figure 2 - Radiographs of Manual Tungsten Arc Welds
on Iron-Aluminum Heat A-13361, .031" Thick.

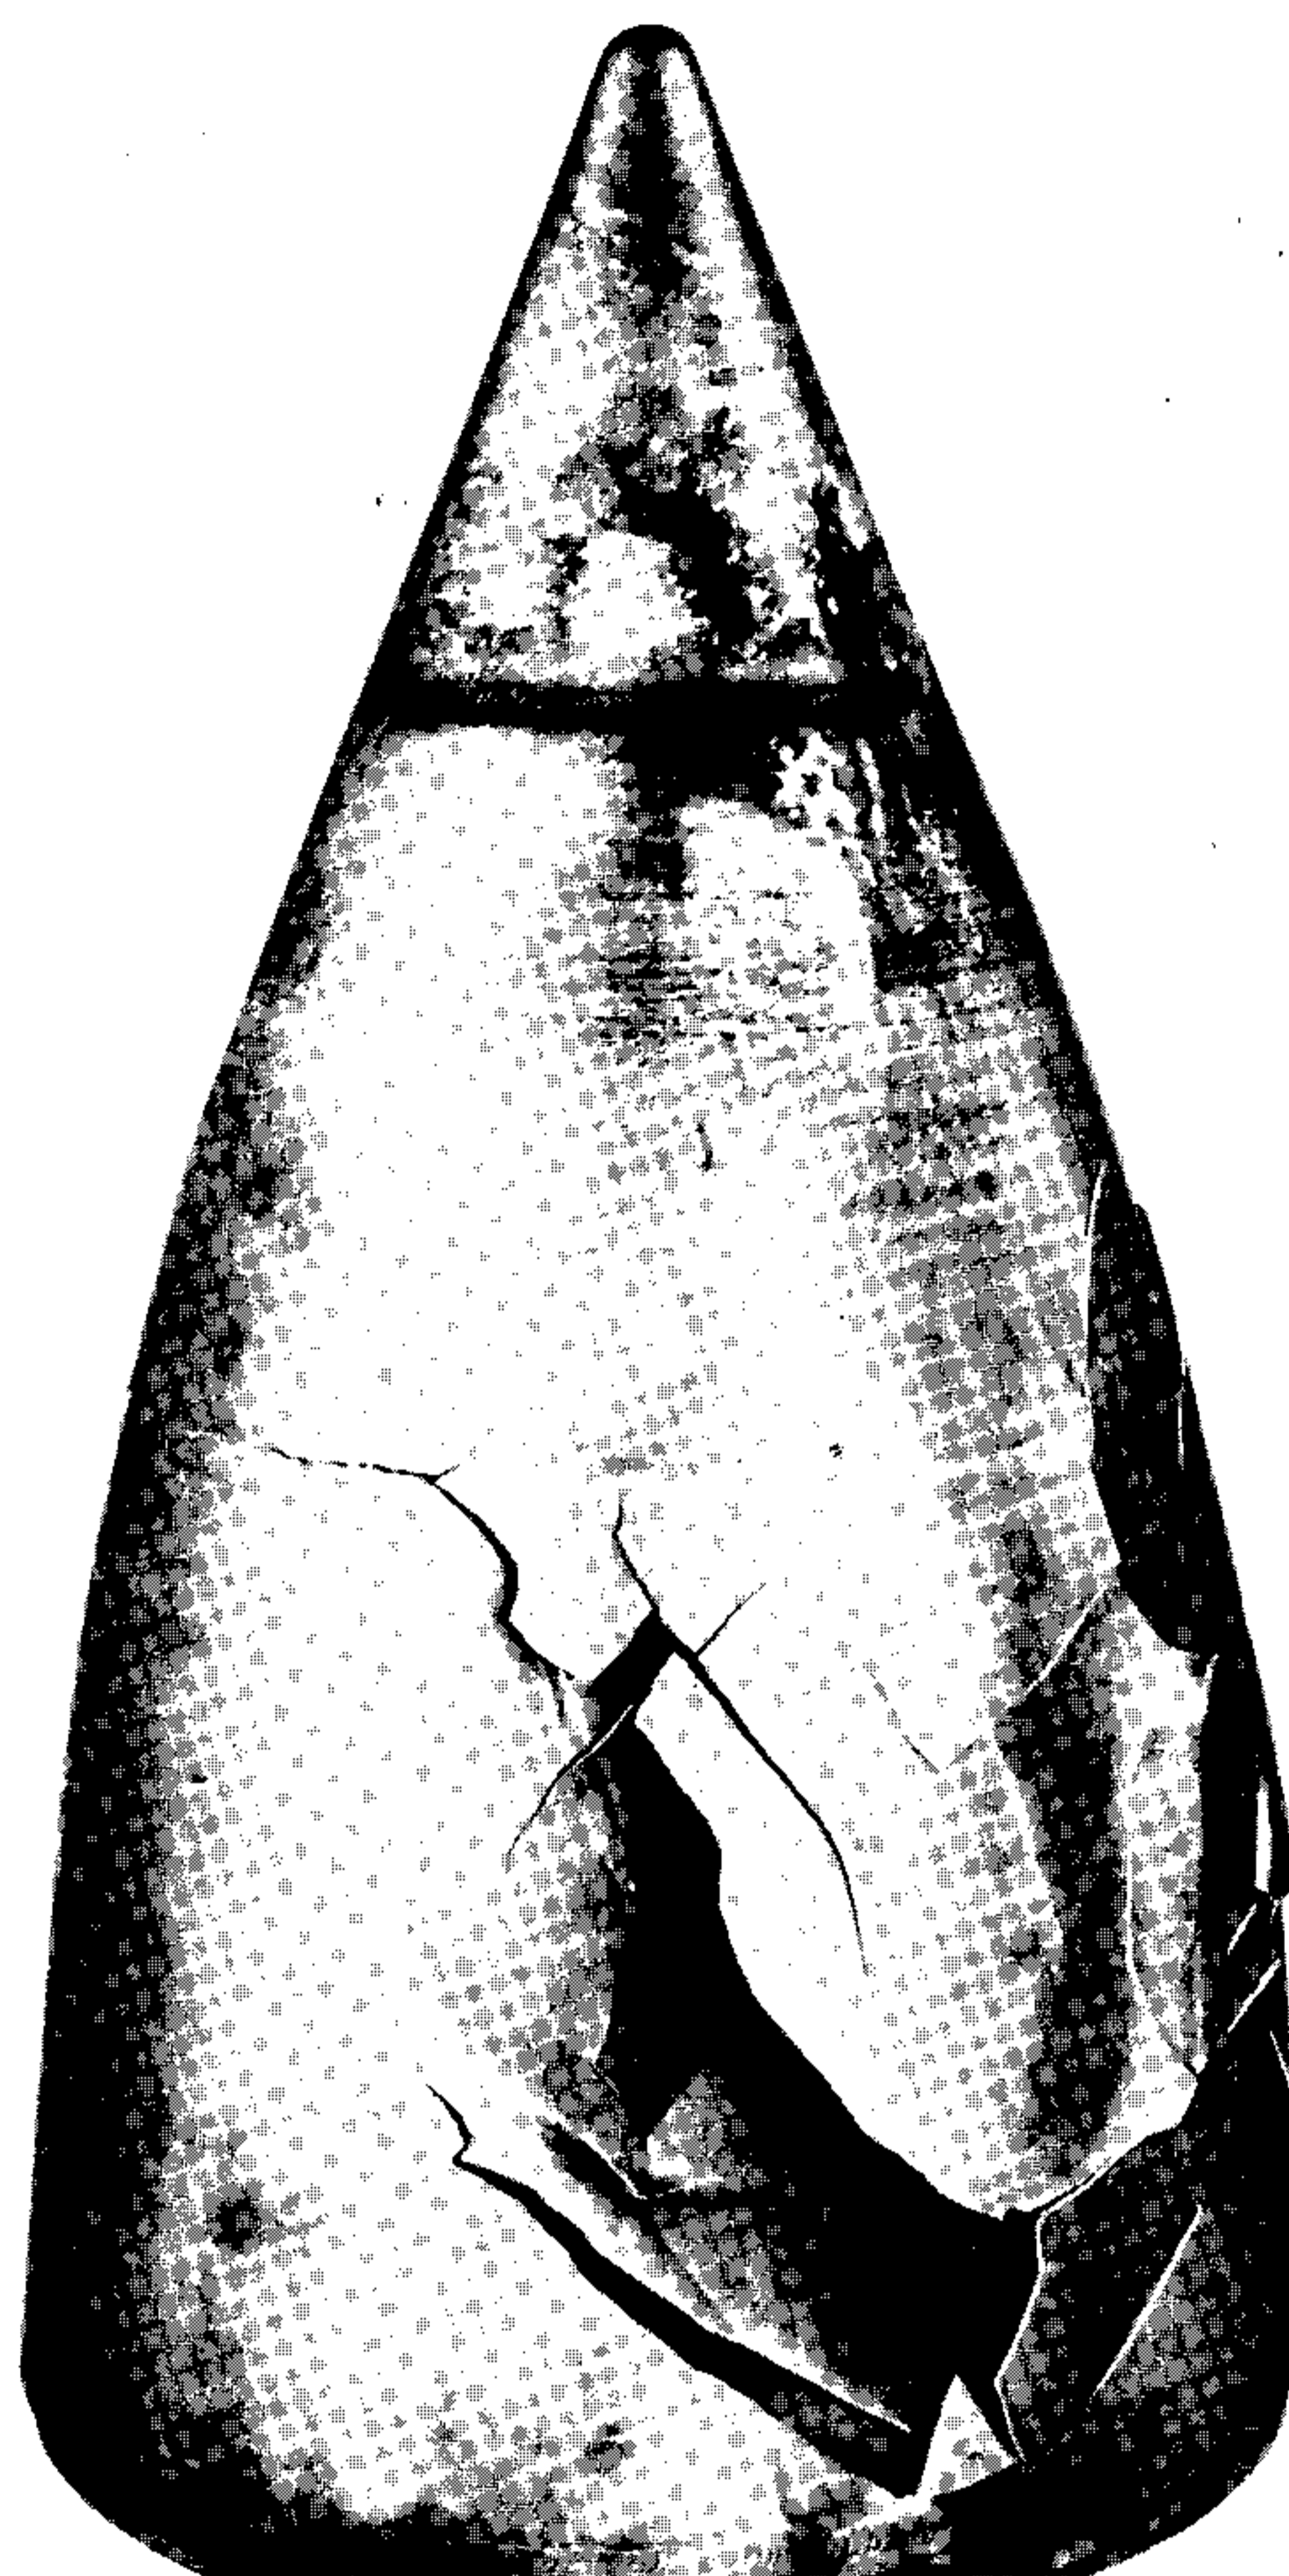
This cone was damaged during endurance testing. The flight nozzle, which is used in engine testing to simulate flight conditions, became loose and put a large dent in the cone assembly. Visual examination of the cone before disassembly did not reveal any cracks or breaks in the metal. However, it can be assumed that internal stresses were set up when the nozzle hit the cone because, while removing the assembly from the engine, the cone shattered. Figures 6, 7 and 8 show various views of the damaged cone after an accumulation of 137 hours and 17 minutes test time.

Figure 6 - Turbine Exhaust Cone - Broken Pieces Assembled to Show Impact Area

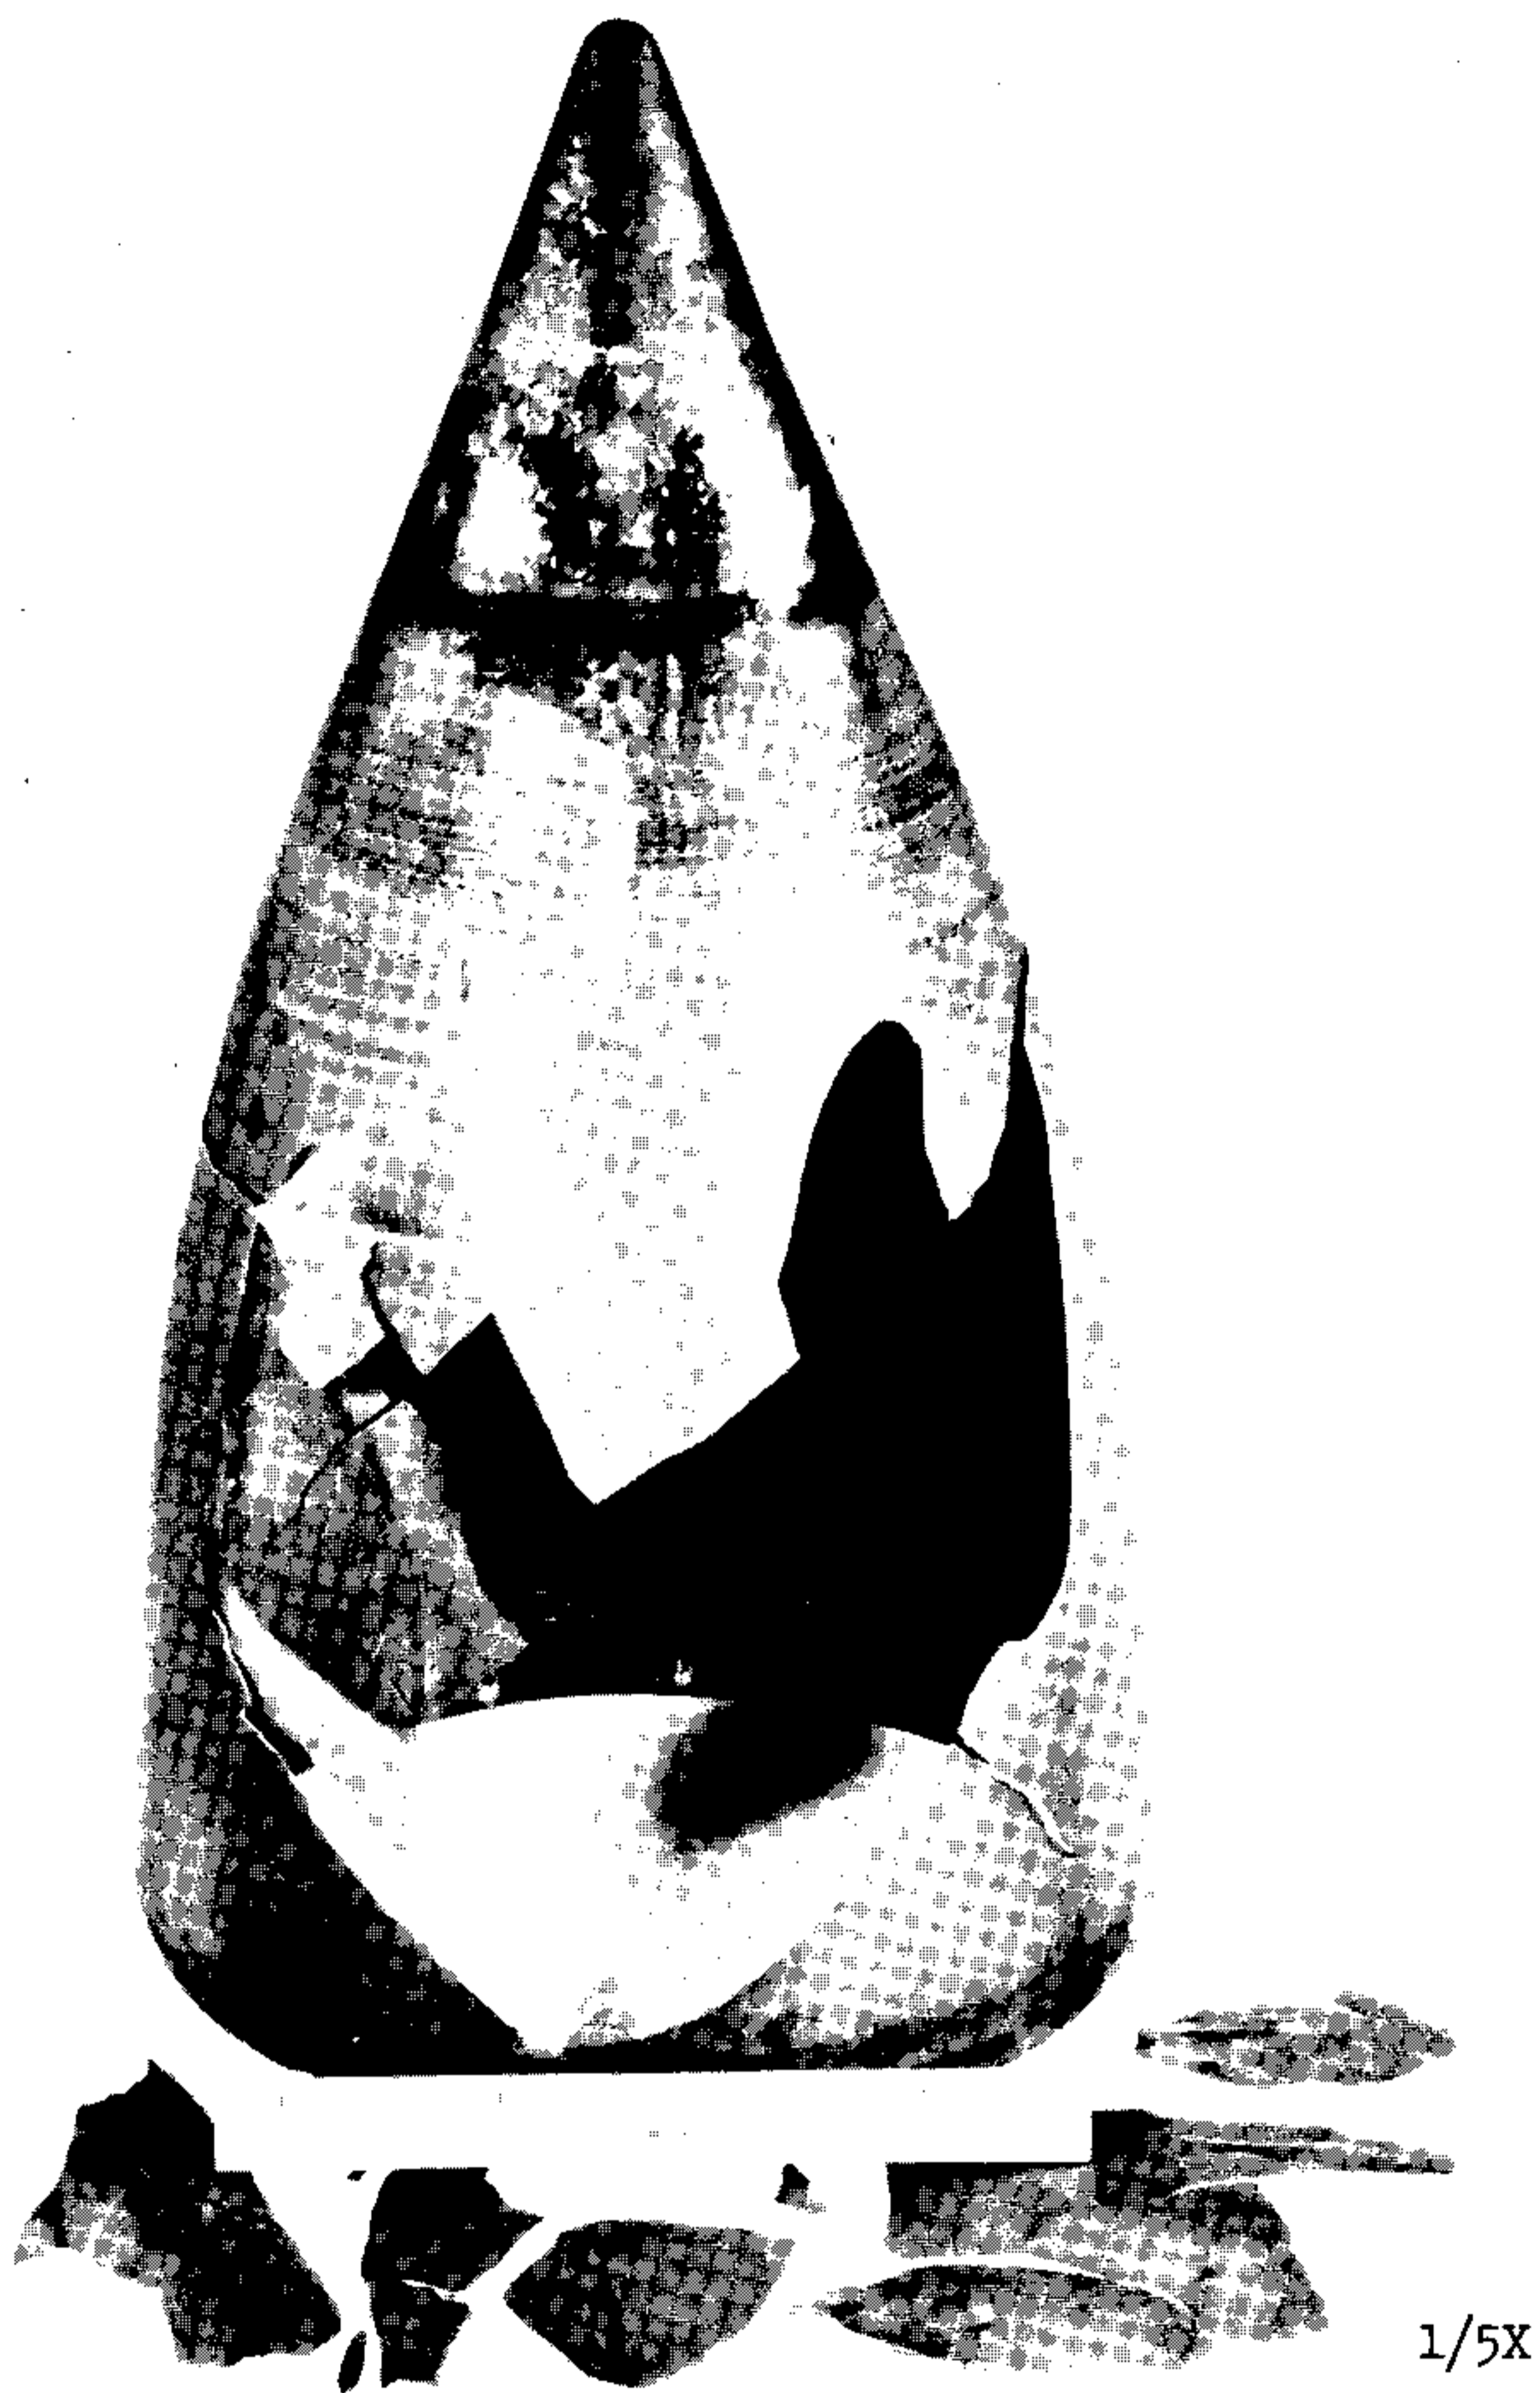
Figure 7 - Turbine Exhaust Cone -
Failure After Being Removed from Engine

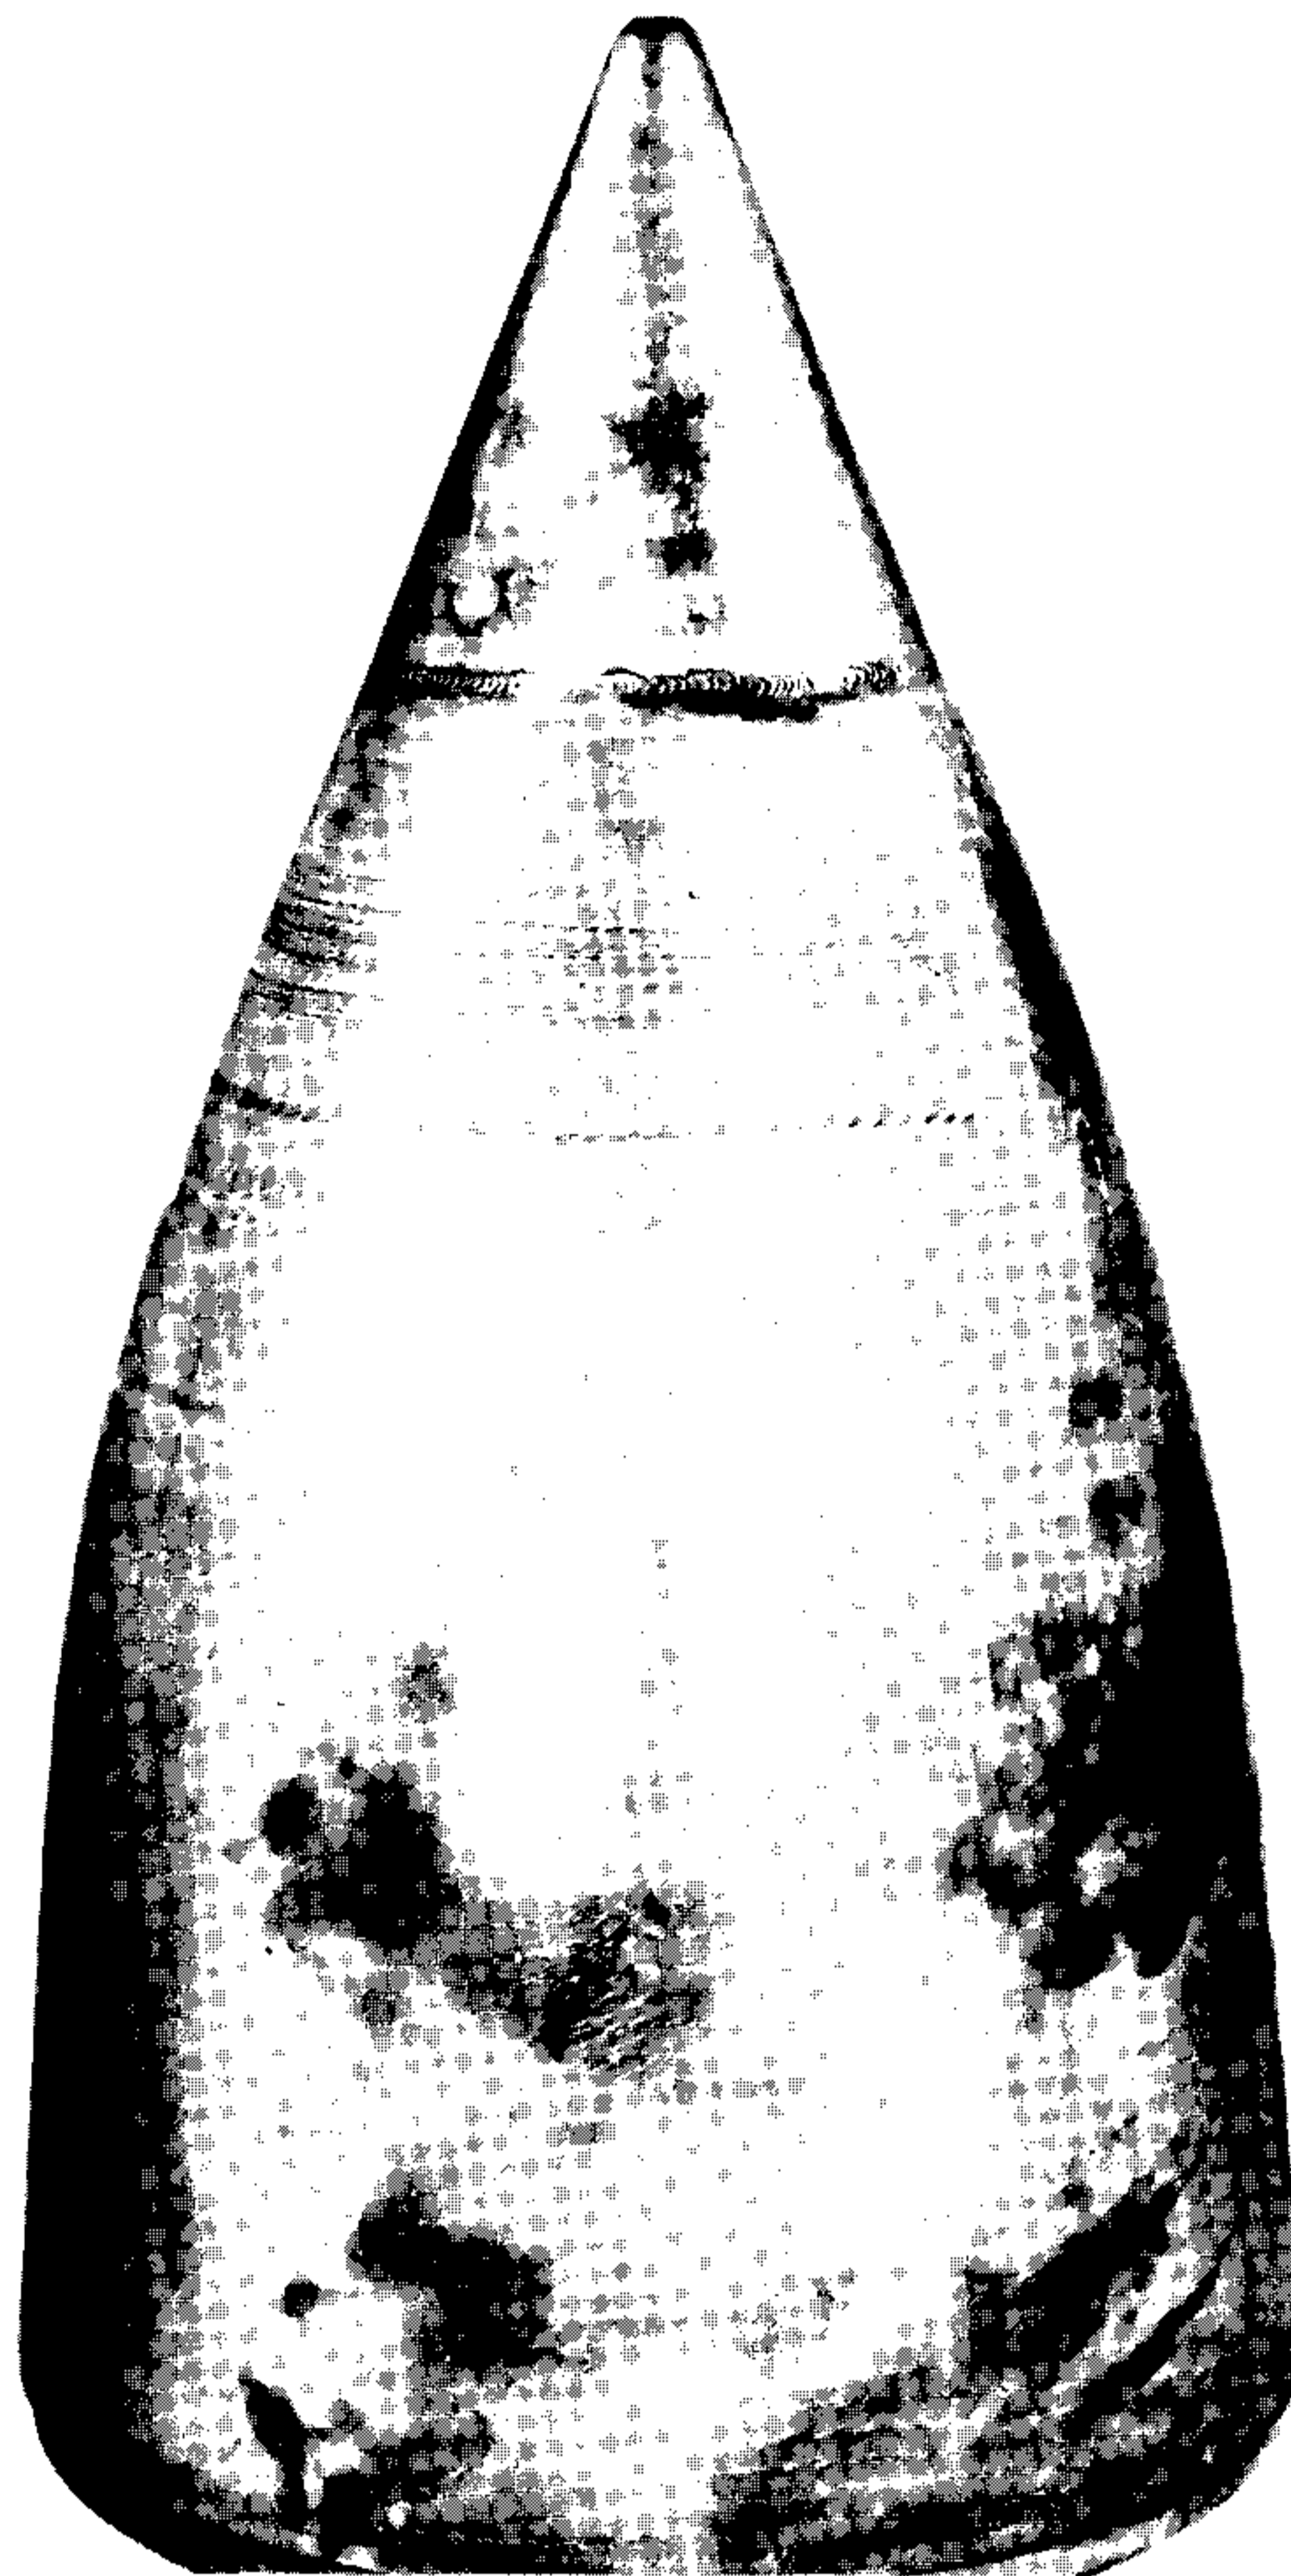
Figure 8 - Turbine Exhaust Cone Turned 180° in Reference to Damaged Area
