CORROSION PROBLEMS IN AIRCRAFT COMPONENTS--

CASE STUDIES OF FAILURES

W. R. Coleman, R. J. Block and R. D. Daniels
University of Oklahoma
Norman, Oklahoma 73019

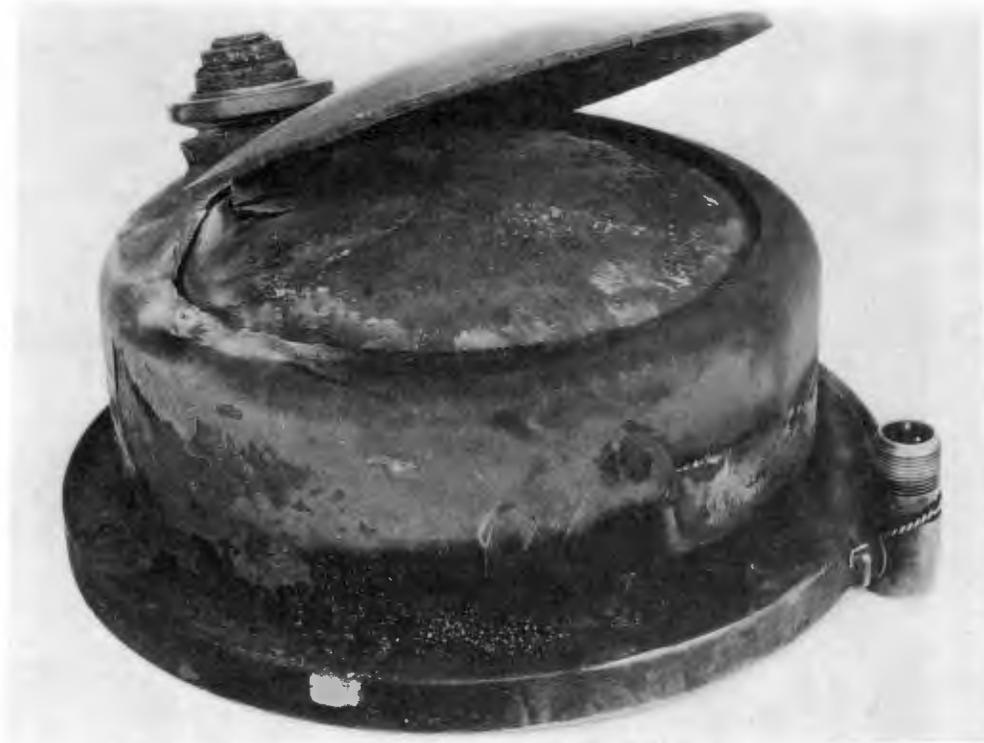
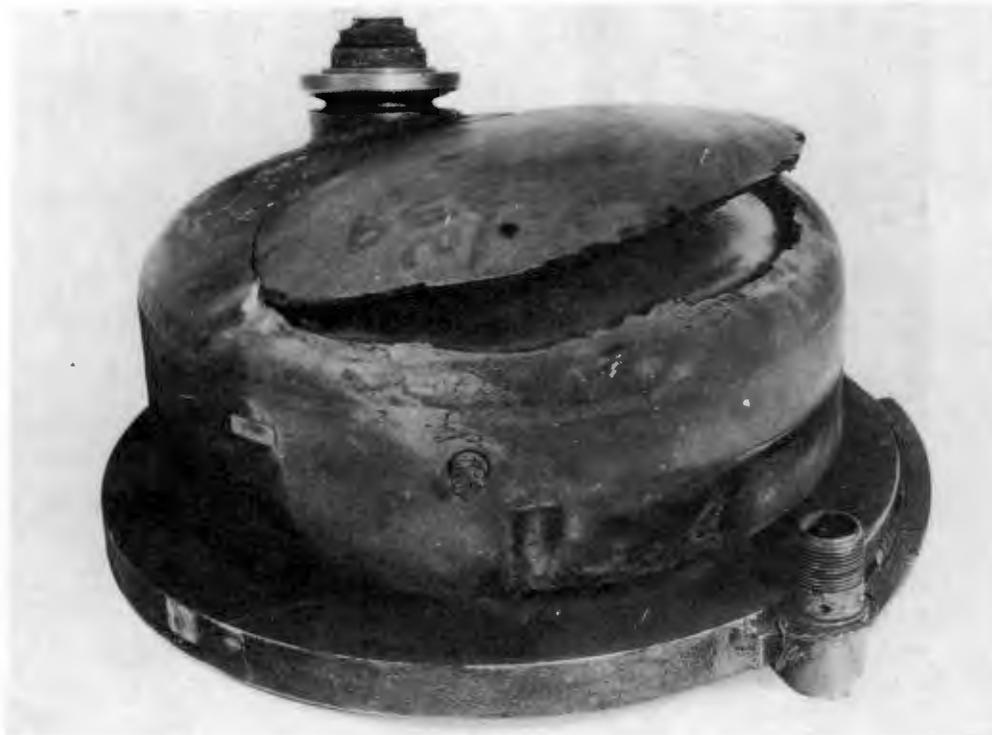
Figures 1 and 2 show examples of typical failures in the steel breech chambers. The dome blows out at a location opposite the hot gas discharge nozzle. The failures occur in the region of highest stresses (according to stress analysis) at the change in section where the dome meets the body of the chamber. The photographs show the internal heat shields exposed by the failure. The shields are not sealed to the discharge duct and are not pressure containing components. Circulation of the cartridge combustion products can occur around the shields making cleaning of the residues difficult and uncertain.

Figures 1 (above) and 2. Breech chambers which have suffered dome blowout failures.

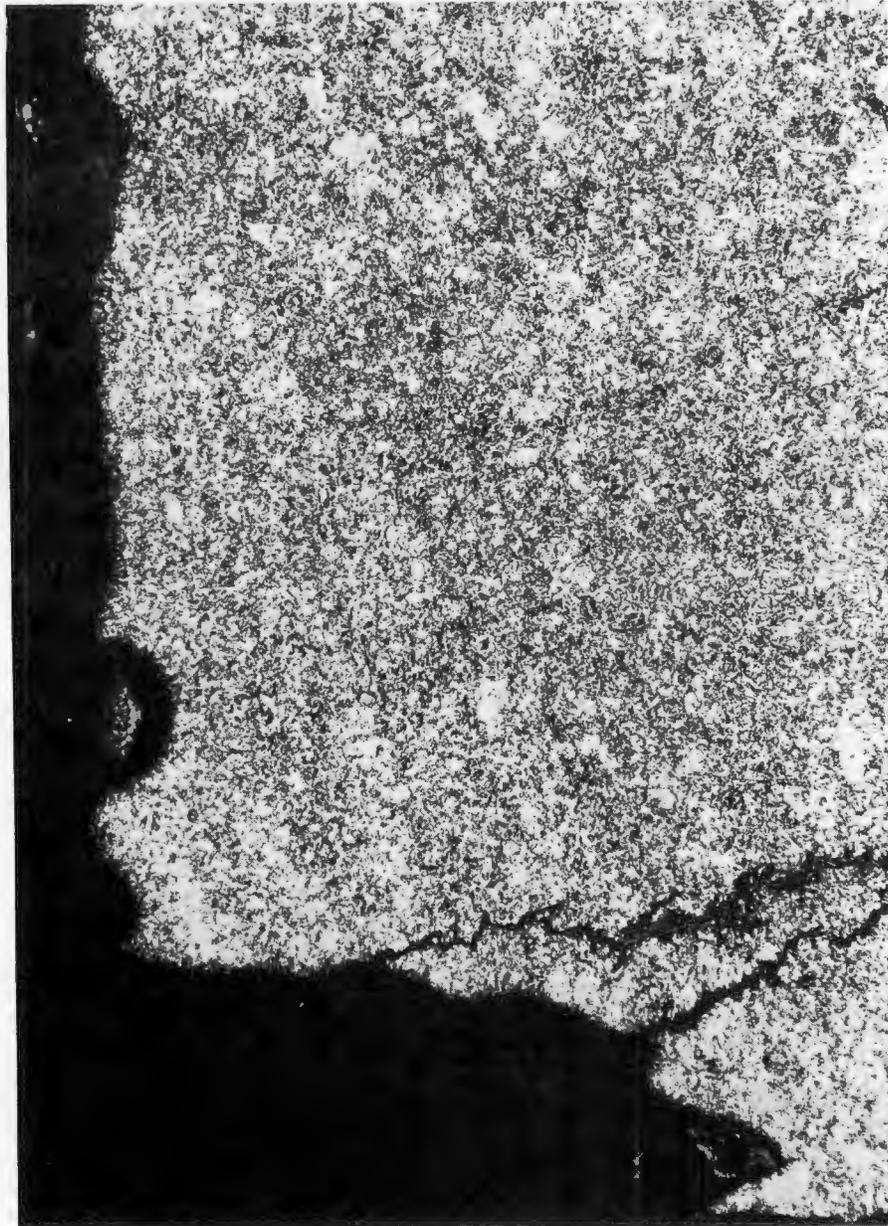
Analysis of the failures is often made difficult by flame erosion and deterioration of the fracture surfaces. The changes produced obliterate necessary details of the fracture origin. The internal surfaces of the failed components are generally covered by a heavy layer of combustion products and are generally degraded by corrosion. Figure 3 is a photomicrograph of a cross-section through the failed chamber wall adjacent to the fracture origin. The photograph shows pitting of the internal wall. The pitting was noted to be quite deep in some places. Figure 4 shows a higher magnification view of the cross-section at the failure origin. One may note jagged, branching cracks which appear to follow the prior austenitic

grain boundaries in the heat treated structure. Some of the cracks contained a heavy deposit of oxide scale indicating their existence over prolonged periods prior to the failure. The cracks shown in the photograph are reasonably clear of oxide indicating they are of relatively recent origin.

Figure 3 150 X Nital-Picral Etch
Photomicrograph of a cross section through the
breech chamber wall. Internal wall (left ver-
tical edge) exhibits a pitted surface. Prior
austenitic grain boundaries are outlined by a
jagged crack.

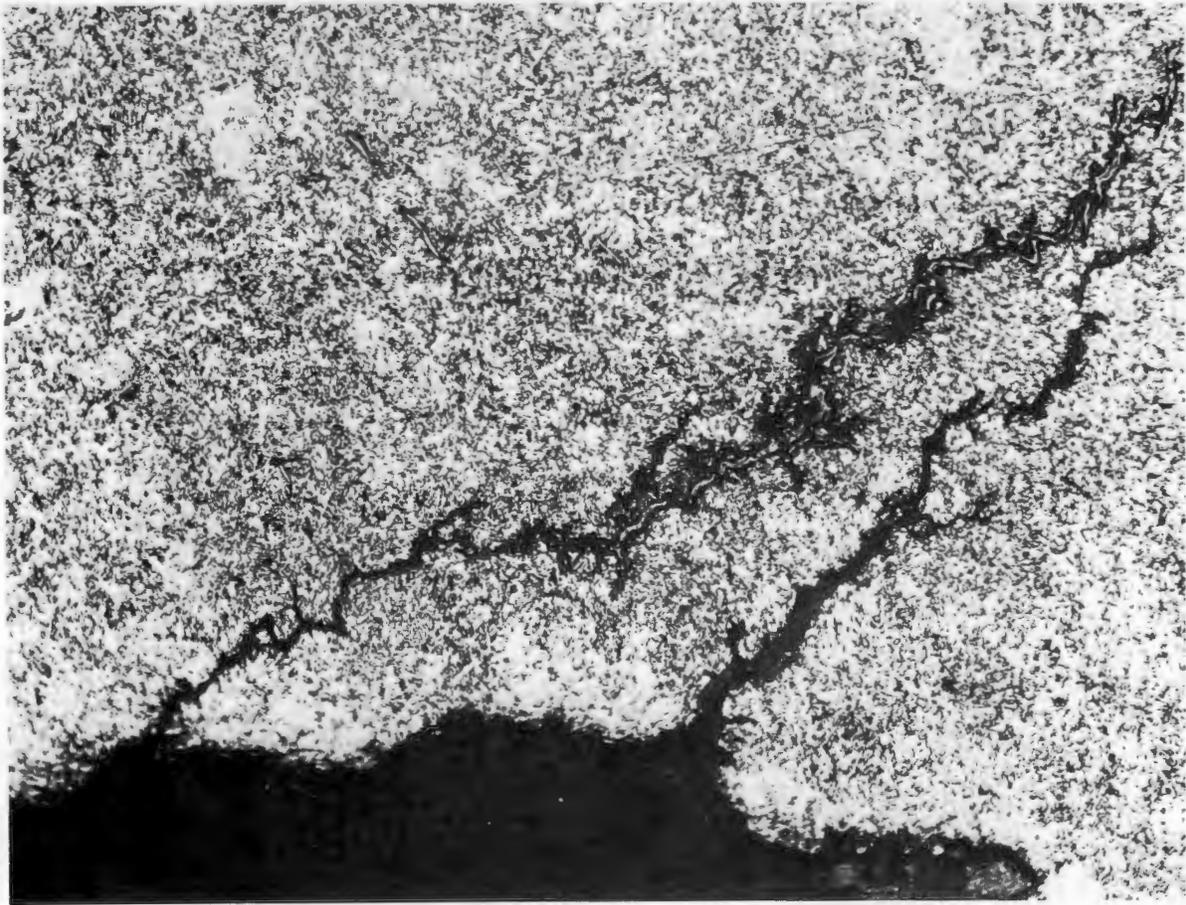
Figure 4 300 X Nital-Picral Etch
High magnification view of the jagged crack shown in Figure 3.
The stress corrosion crack winds through a microstructure of
tempered martensite; hardness Rockwell C 35.

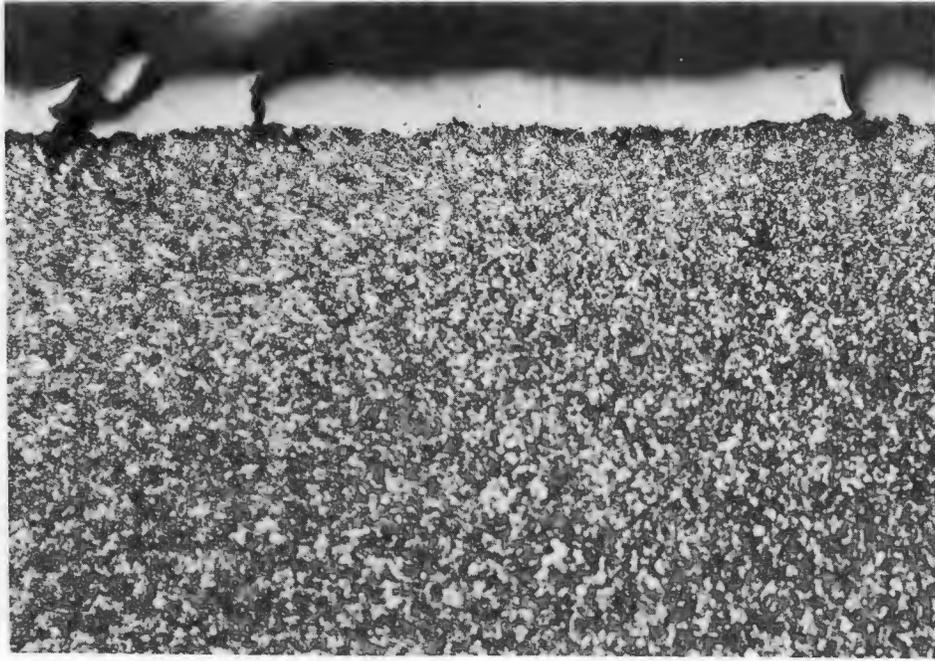
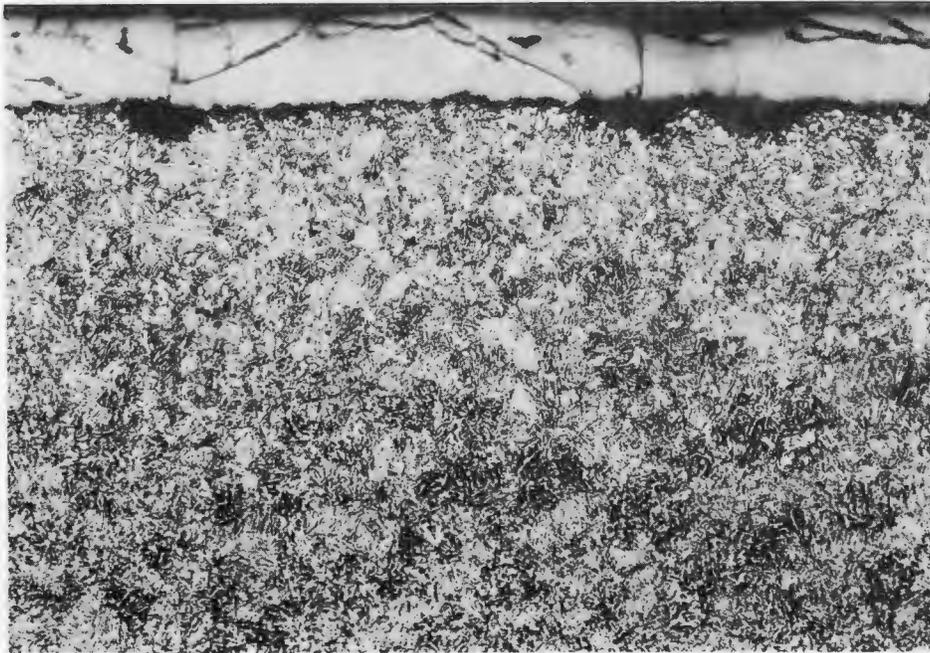
Figure 5 300 X Nital-Picral Etch

The internal surfaces of the chambers which are exposed to the combustion products are not coated for corrosion protection. The external surfaces, specifically the dome, are covered with a coating of electroless nickel. The logic of this design is not immediately obvious in view of the potential sources for the most serious corrosion attack. Further, it should be recognized that the coating is inherently quite brittle. As the chamber is used it is subjected to internal pressure and thermal stresses in each service cycle. These stresses induce brittle cracking of the coating as shown in Figure 5. Corrosion attack of the base metal was often noted to be associated with these cracks. Figure 6 shows a typical example. The corrosion observed is most probably the result of galvanic coupling of the more noble nickel coating with the active steel chamber. The galvanic corrosion process appears to be a slowly progressing failure mechanism which should be capable of inducing fracture in the absence of other more rapid processes. The other processes do operate and an externally induced failure has not been observed thus far.

Figure 6 300 X Nital-Picral Etch
Photomicrographs revealing nature of brittle nickel coatings.

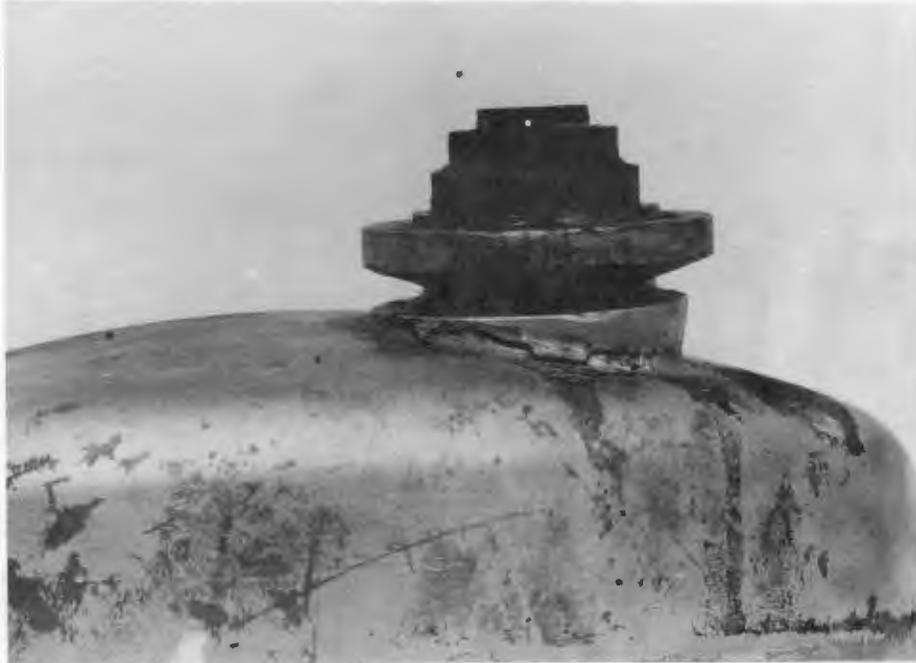
A particularly striking example of galvanic corrosion produced by the nickel coating was exhibited by a chamber which failed due to a complete separation encircling the bayonet locking connector. This chamber also contained the fracture at the hot gas nozzle, shown in Figure 7. The failure appears as a brittle, jagged crack extending about halfway around the nozzle. The fracture is of the same character as the fractures shown in Figures 3 and 4. This crack morphology is usually taken as evidence of failure by stress corrosion cracking (SCC). On the external surface of the chamber there is a craze pattern of trenches that extends beyond the failure crack at the base of the nozzle, Figure 8. Figure 9 shows a cross-section through the trenches associated with the craze pattern.

Figure 7. Fracture encircling the hot gas nozzle of a chamber which has also failed in the bayonet lock.

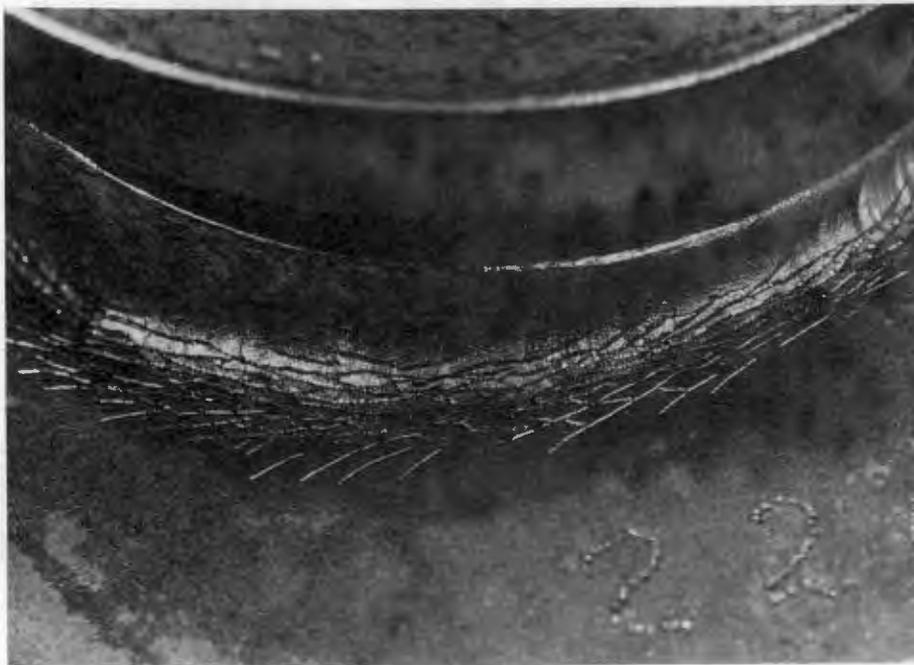
Figure 8. Craze pattern of trenches extending beyond the main failure and at the base of the nozzle.

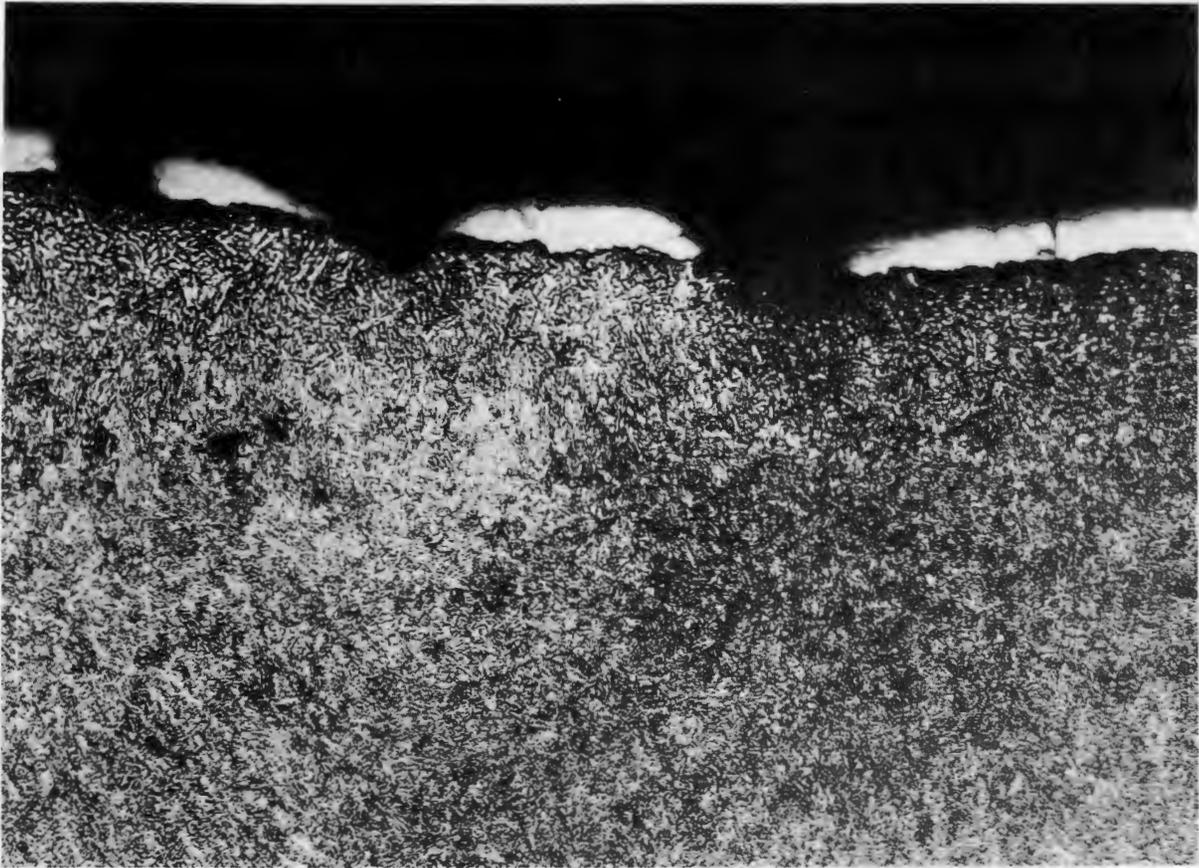
Figure 9 300 X Nital-Picral Etch
Cross section through the trenches associated with the craze
pattern identified in Figure 8.

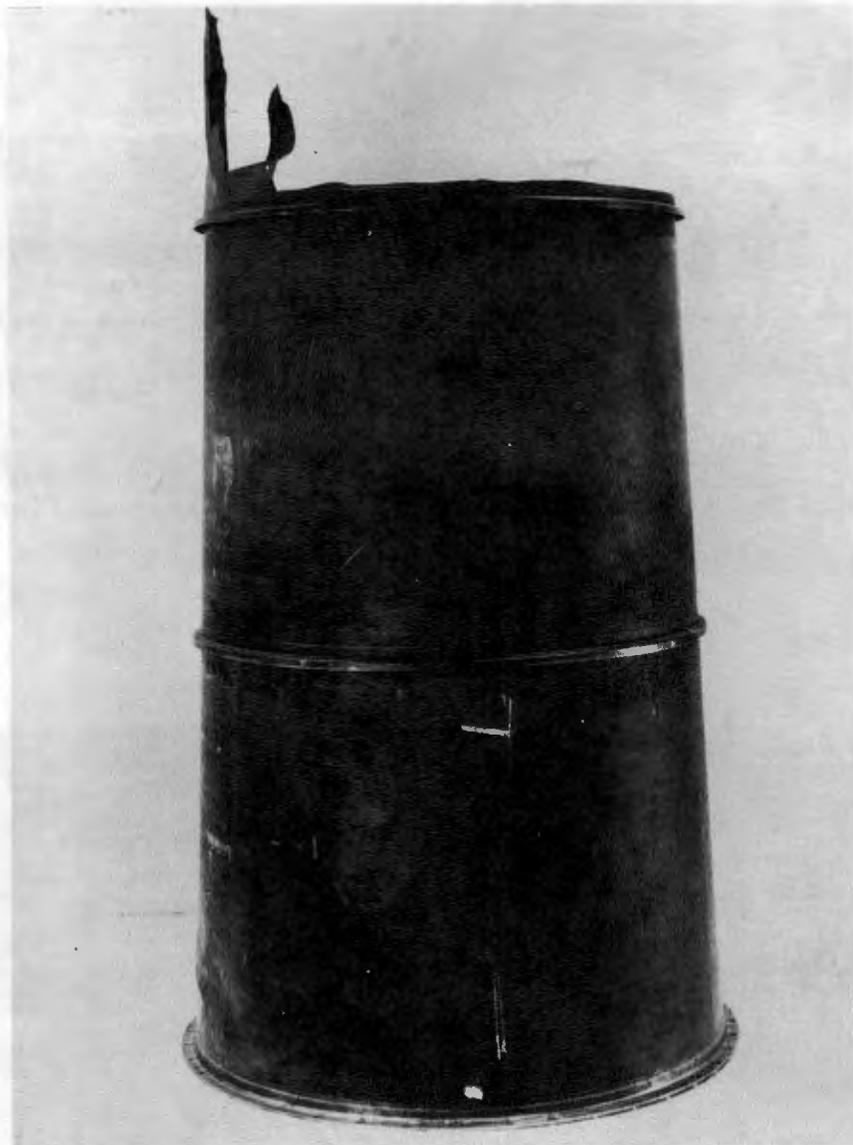
An unusual problem for which failure analysis was required involved the separation of a portion of the exhaust tailcone from an A-7D aircraft. About one-third of the assembly fell away from the airplane during a flight over Pittsburgh, Pennsylvania and the part was never recovered. Figure 10 shows an overall view of the portion of the cone that remained. The original cone tapered from about three to two feet in diameter, was about six feet long and was formed from sheet approximately 0.020 inches in thickness. The structure was stabilized with circumferential stiffeners on the outside. The piece that fell off in-flight was large enough to do considerable damage.

Figure 10. Overall view of the separated tailcone assembly. A-7D aircraft.

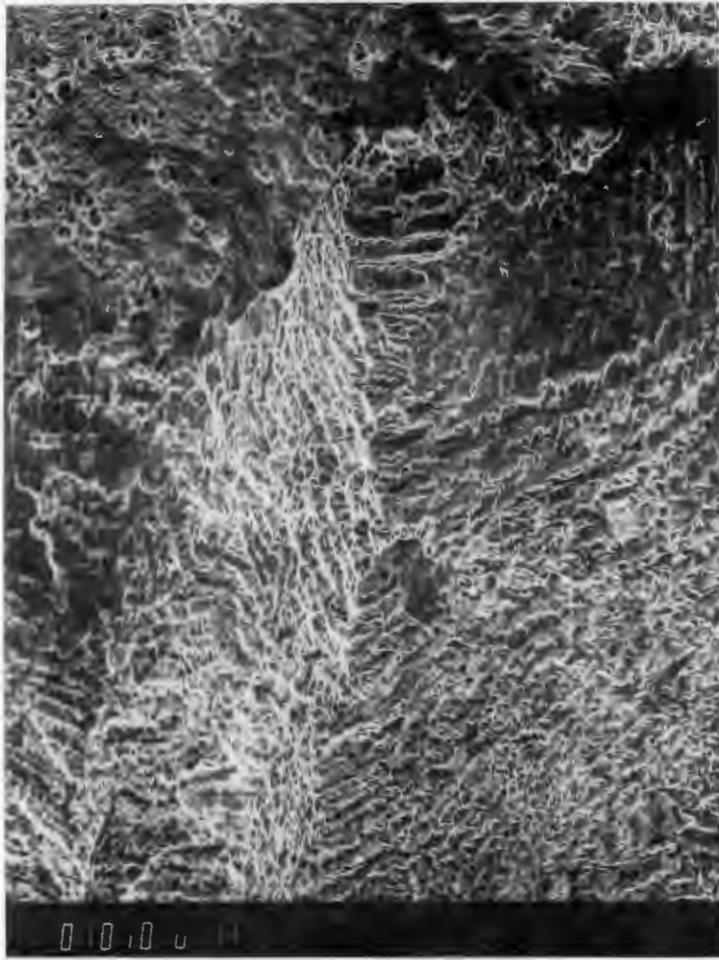
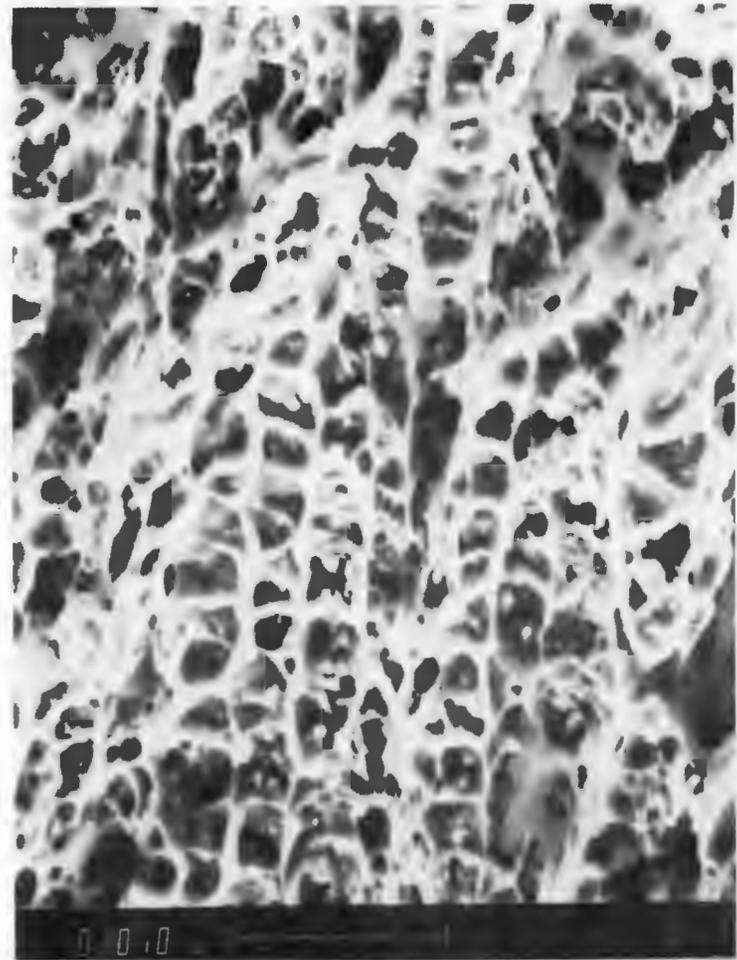
The contour of the fracture surface which encircled the body of the tailcone indicated that the origin of the failure occurred at the junction between the longitudinal and circumferential welds. Figure 14 and 15 are scanning electron micrographs of the fracture surface near the failure origin. As demonstrated by the photographs the majority of the failure exhibited dimple rupture evidencing failure due to simple overload. More detailed examination, in this same area revealed a pattern of metal degradation on the inside surface of the tailcone. Figures 16 and 17 show a network of coarse and fine cracks extending into the metal.

Figures 14 (left) and 15. Scanning electron micrographs of the tailcone fracture near the failure origin. Low and high magnification views indicating dimple rupture due to simple overload.

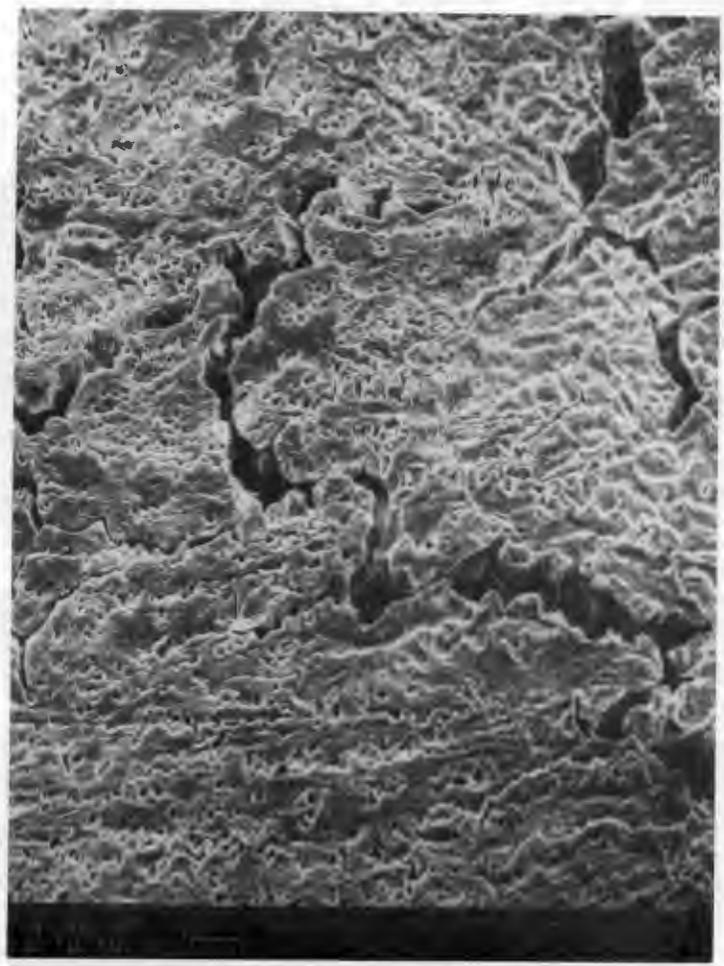
The jagged, branched character of the cracks shown in the photomicrographs are indicative of stress corrosion cracking. The geometry of the tailcone configuration at the failure origin appears to be capable of producing the persistent stresses required for SCC. The crossing of a longitudinal and a circumferential weld would normally result in residual stresses when the metal cooled from the final weld. These stresses may not anneal out at the temperatures produced during normal use of the assembly.

Figures 16 (left) and 17. Low and high magnification scanning electron micrographs showing crack network adjacent to the failure extending into the metal wall.

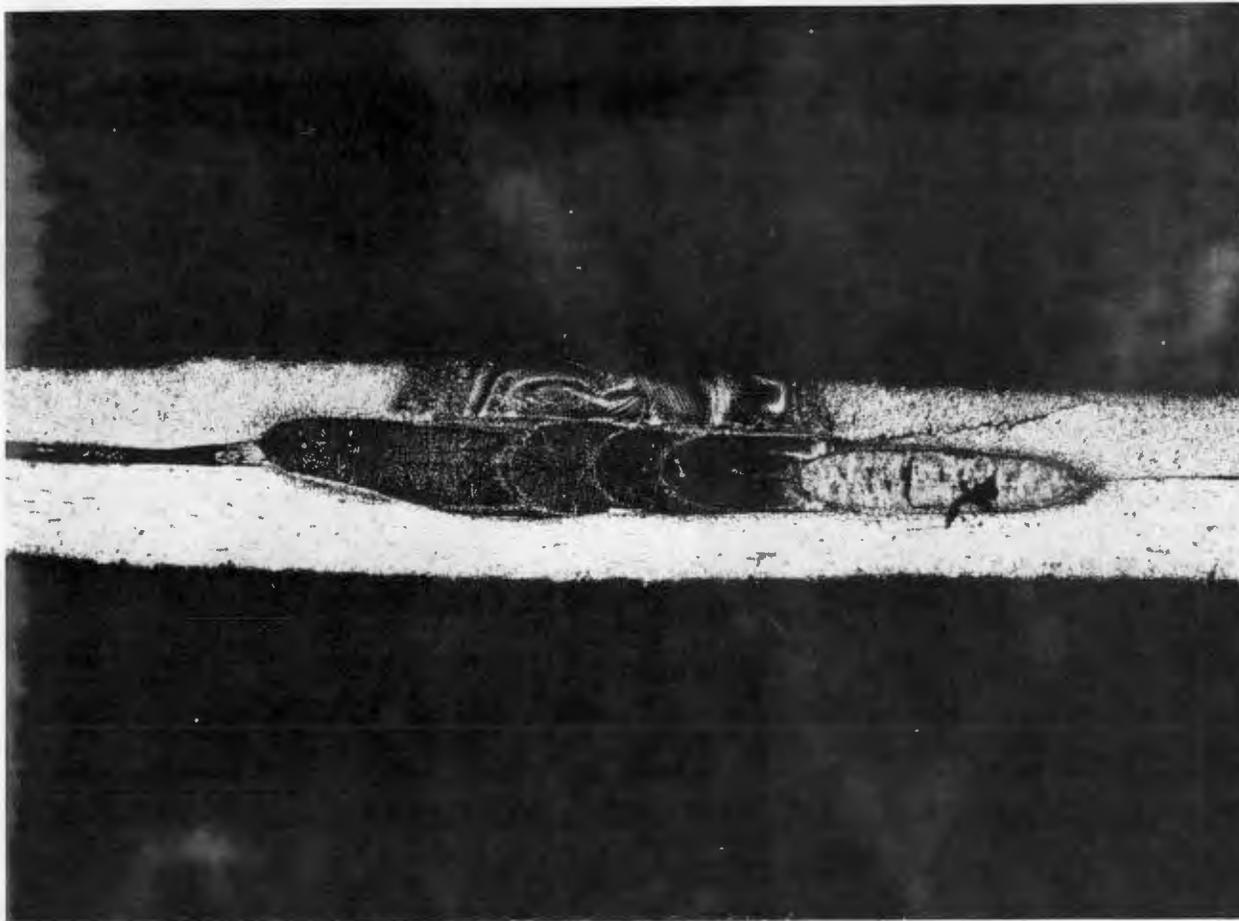
A cross-section was made through the junction of the longitudinal weld in the body and the circumferential stiffener weld at the stiffener adjacent to the large end of the cone (shown in Figure 10) where no failure had occurred. Figure 18 shows a photomicrograph of the weld nugget and the parent metal from both the stiffener and the body. In the more detailed view of Figure 19 one may note severe intergranular degradation of the weld which has isolated many of the metal grains. Figures 20 and 21 show intergranular attack of the parent metals.

Figure 18 230 X Electrolytic: 10% Oxalic Acid
Weld nugget and parent metal from the stiffener and the body.
Figures 19 and 20 show high magnification views taken near the
left extreme of the weld nugget.

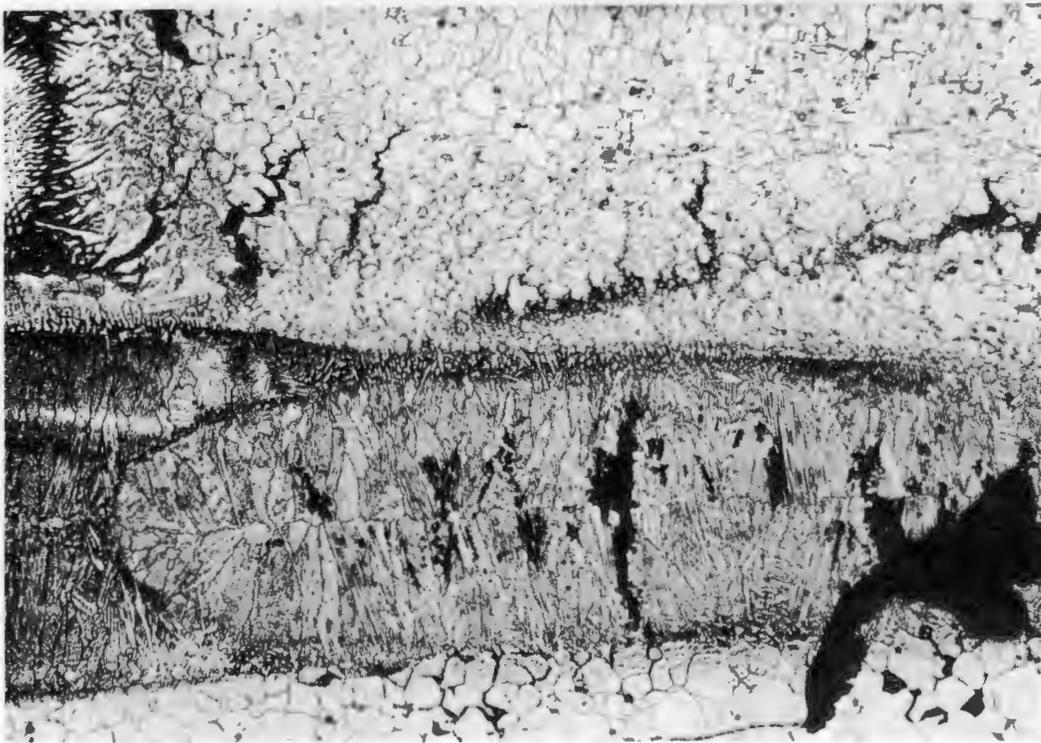
The photomicrographs also demonstrate that the structure as revealed by electrolytic oxalic acid etching shows clearly defined grain boundaries or the "trench" type structure defined by ASTM A-262. The metal is thus shown to be disposed toward intergranular corrosion because of precipitate formation in the grain boundaries. The specific agent responsible for crack formation was not determined, but may be assumed to be a component of the engine exhaust gas stream.

Figure 20 130 X Electrolytic: 10% Oxalic Acid
Severe intergranular degradation of the weld and parent metal.

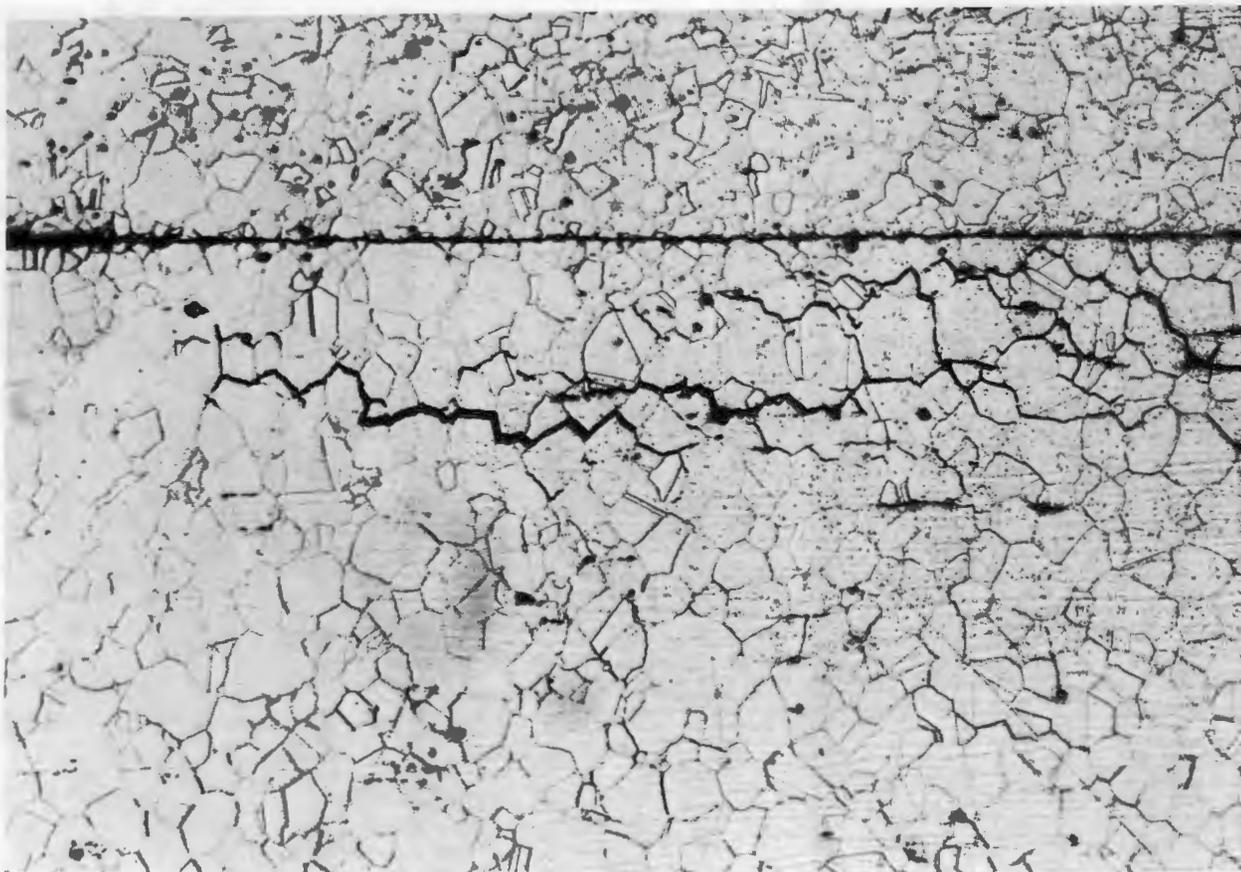
Figure 21 200 X Electrolytic: 10% Oxalic Acid
Intergranular attack extending outward in directions opposite of
the weld nugget.

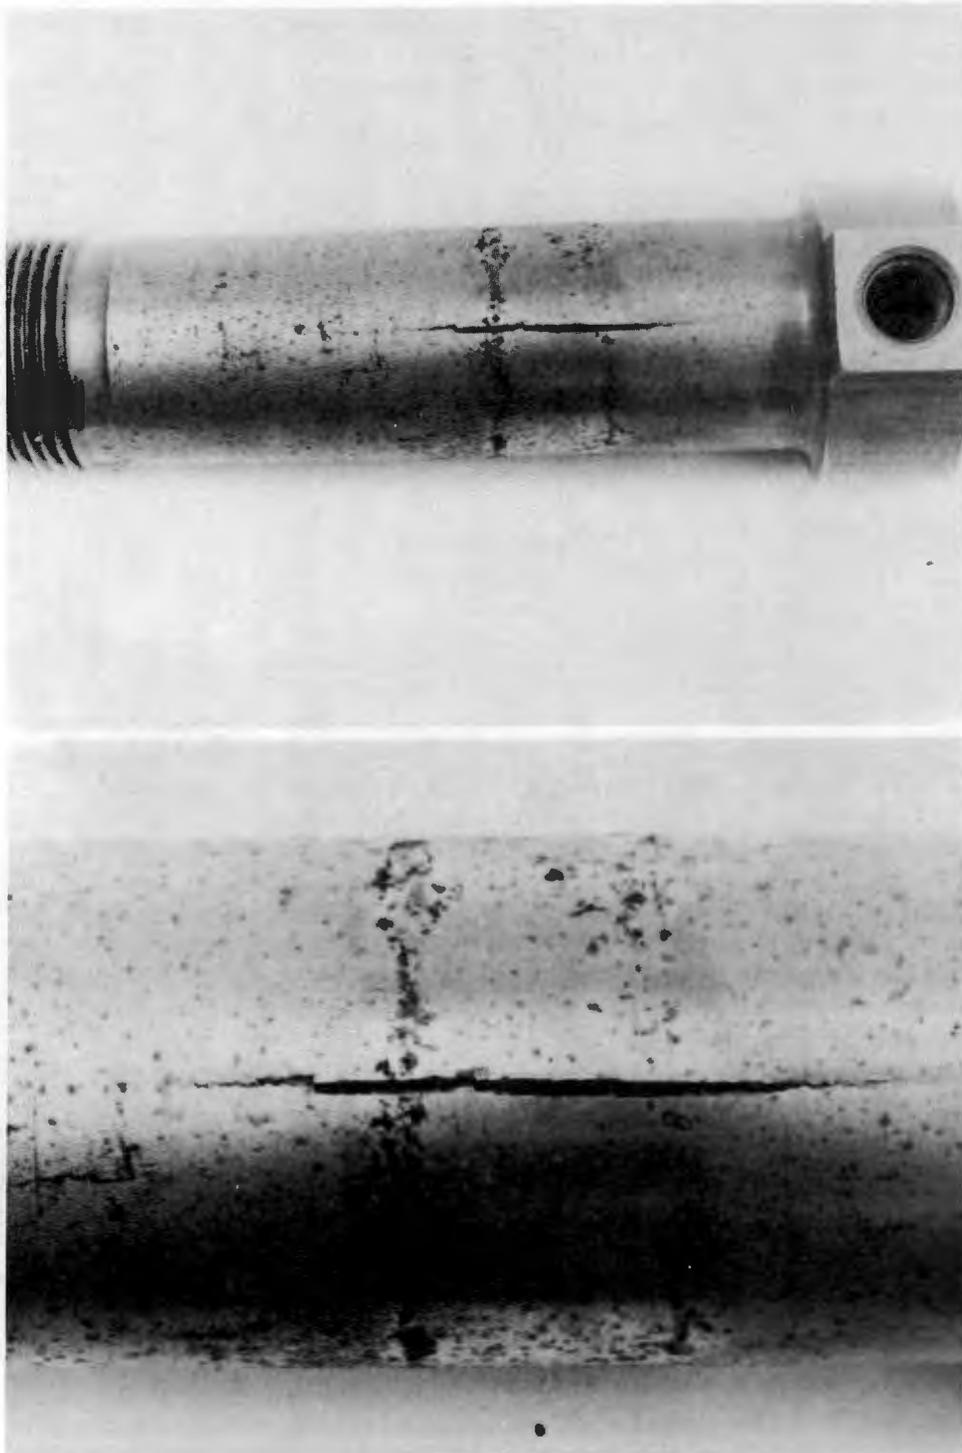
The last class of component failures to be discussed involves various types of hydraulic cylinder bodies. Figure 22 shows an overall view of the inner landing gear door actuator cylinder from an F-101 aircraft. The material was reported to be 2024-T4 aluminum; this was verified by chemical analysis and hardness measurement. Figure 23 shows a close up view of a through wall crack in the cylinder. The metal surface is pitted and there is evidence of an identification band having been located in this area. The bands are typically attached with a rubber-like adhesive material.

Figures 22 (above) and 23. Selected views of the inner landing gear actuator cylinder exhibiting a failure oriented longitudinally in the cylinder wall.

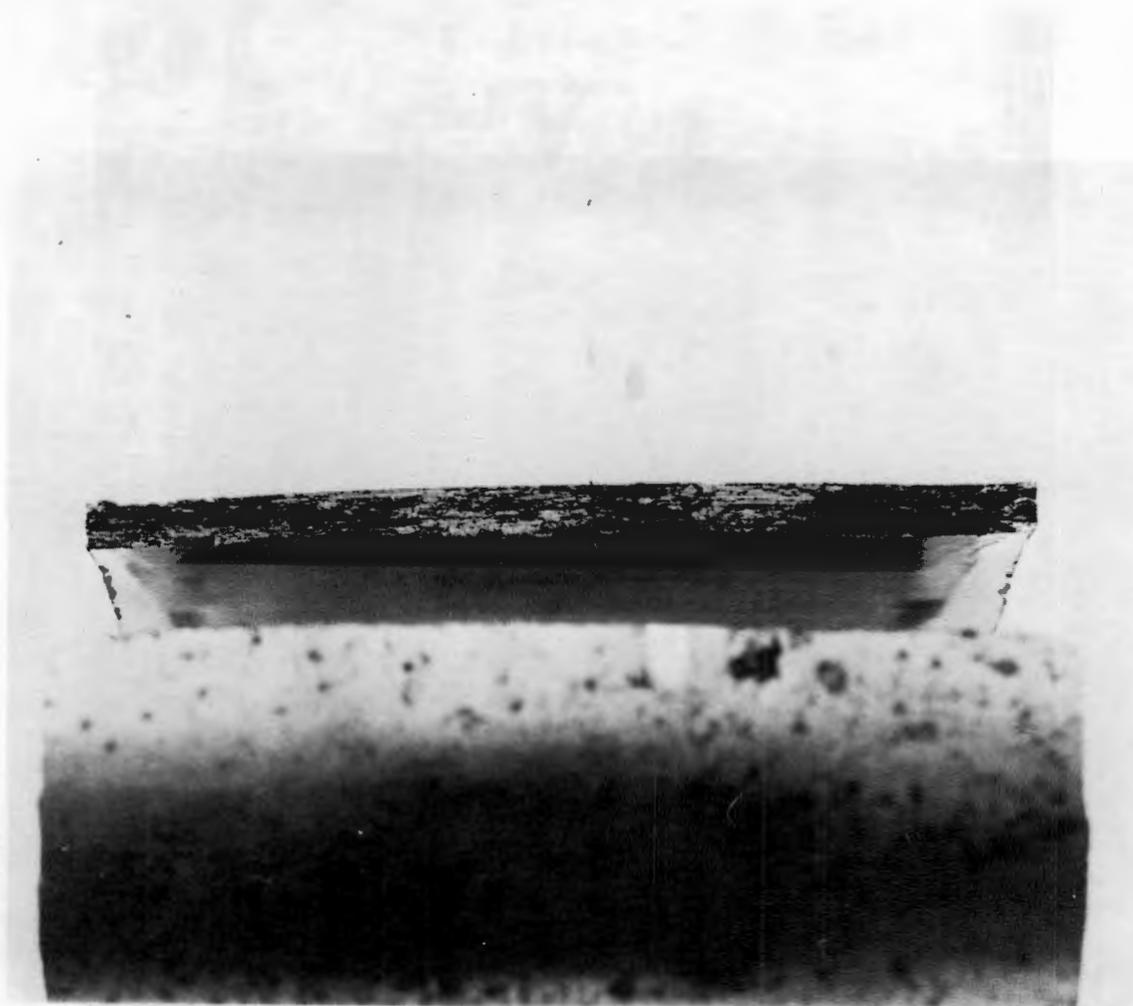
Figure 24 shows the fracture surface associated with the crack. The area shown is believed to be the origin of the failure. Here the metal exhibited a "woody" appearance. A more detailed view of this area, revealed by SEM is presented in Figure 25. The metal shows the results of corrosion attack and typical exfoliation damage. It appears likely that this damage initiated the failure process. Areas of the fracture surface adjacent to the origin showed clear evidence of fatigue striations (Figures 26 and 27) obviously introduced as the cylinder was pressure cycled in use.

Figure 24. Fracture surface associated with the longitudinal failure in the cylinder wall.

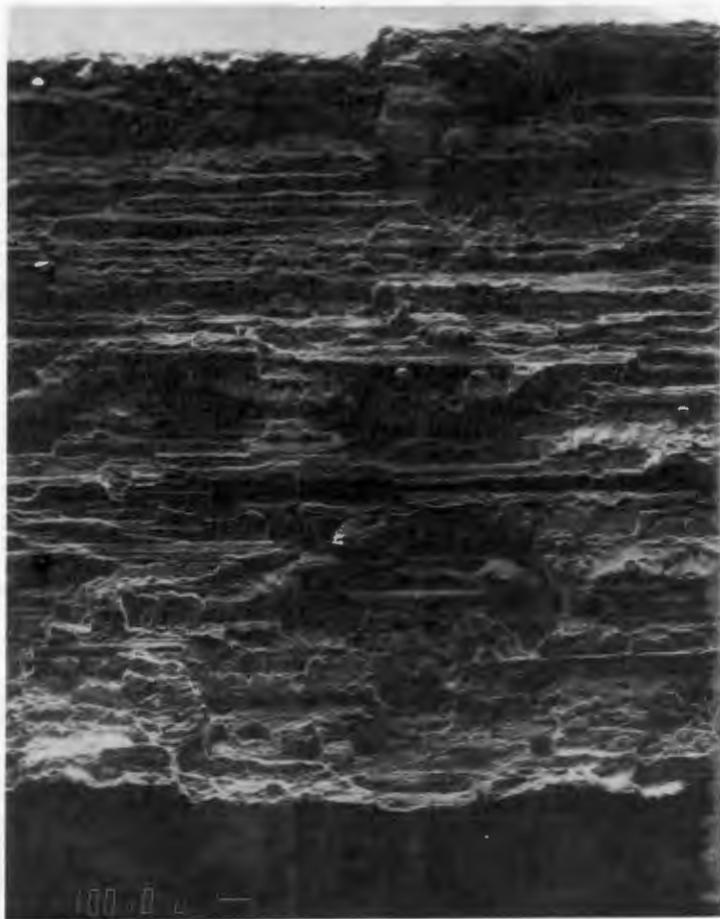
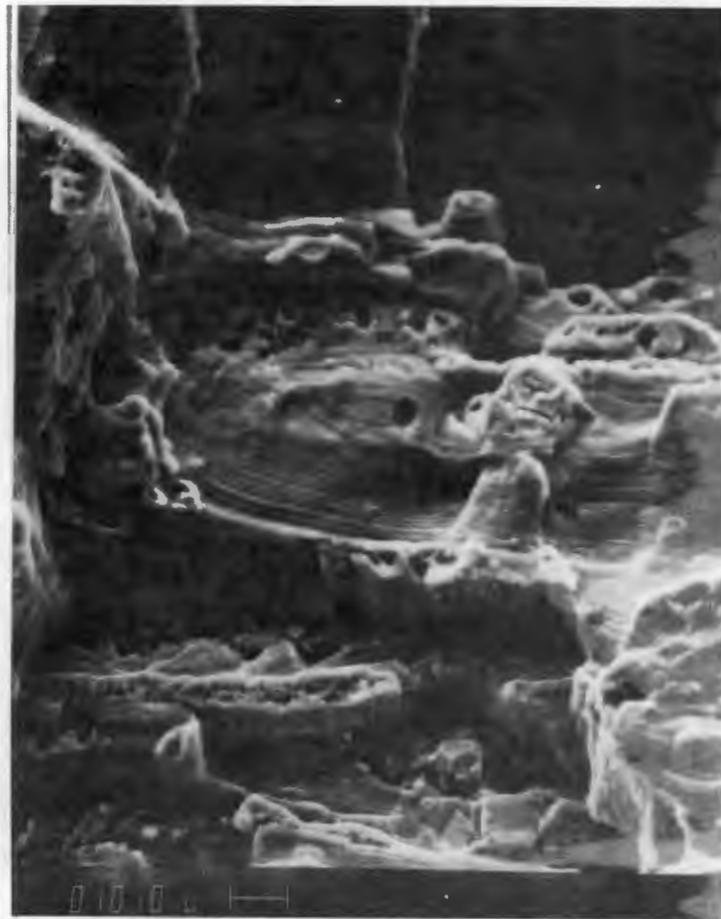
Figures 25 (left) and 26. SEM views of the fracture surface shown in Figure 24. "Woody" features dominate the image in Figure 25 which appeared to have initiated the evidence of fatigue failure in Figure 26.

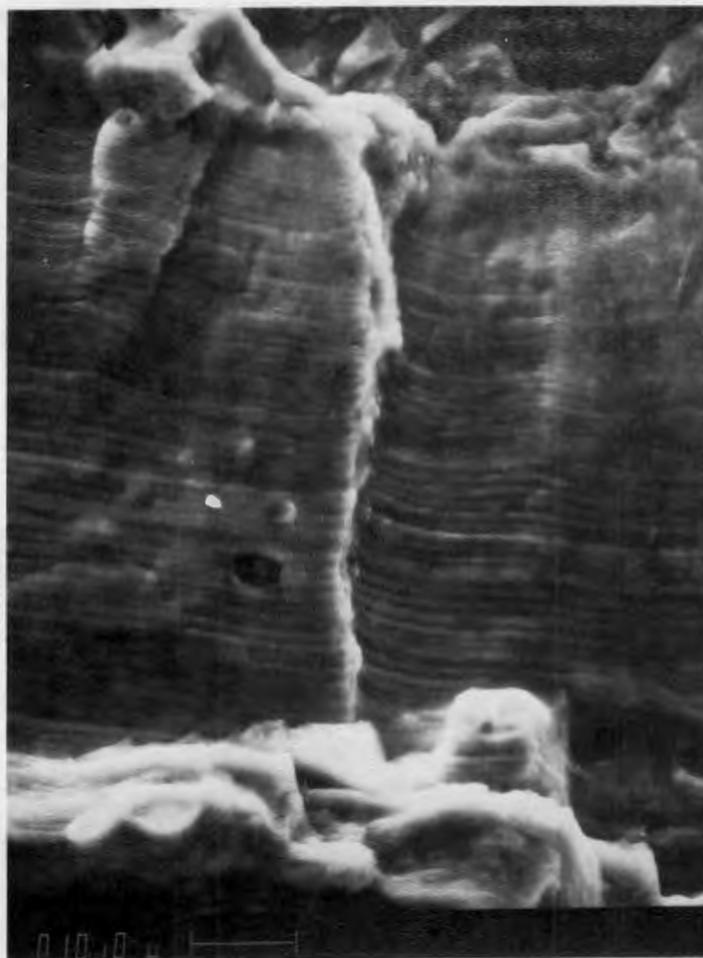
Figure 27. Another view of fatigue striations in the cylinder wall.

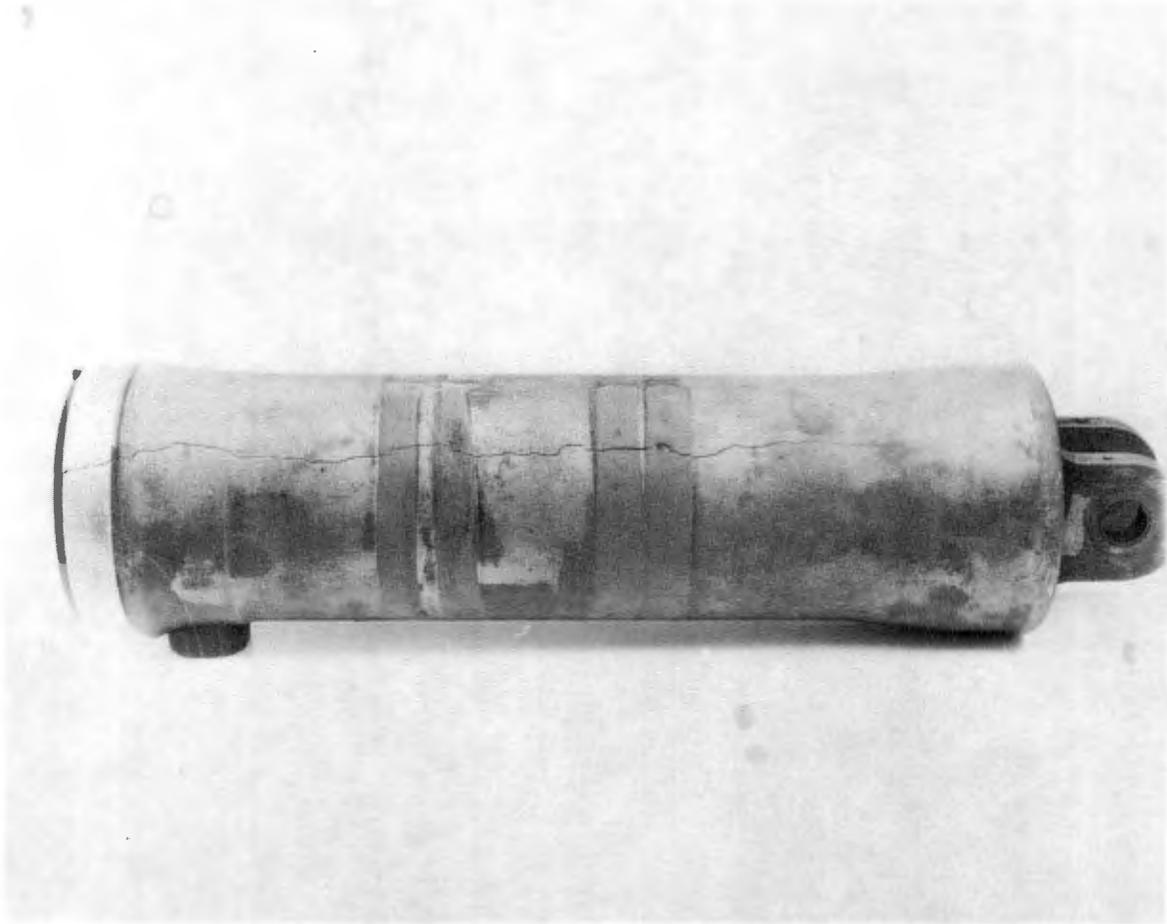
A number of failures were studied all of which appeared to be associated with identification bands attached to hydraulic cylinders. Figure 28 shows the main landing gear actuating cylinder from a C-141 aircraft. The material is 2014-T6 aluminum. The closer view of the surface shown in Figure 29 shows a crack which has opened in the wall beneath the band. Figure 30 shows an area of the surface where a small piece of metal was lost either because of a forging defect or because it was isolated by corrosion. The appearance of a normal, overload fracture in the cylinder wall (Figure 31) may be compared with the fracture surface near the failure origin (Figures 32 and 33). The latter exhibits the same woody appearance which characterizes exfoliation attack. Here again attack was induced by differential aeration and was the result of a band attached to the cylinder surface. Once initiated, failure proceeded by fatigue as evidenced by the striations shown in Figure 34.

Figure 28. Overall view of the failed main landing gear cylinder. Note the anomaly in the wall.
