CORROSION PROBLEMS IN AIRCRAFT COMPONENTS--

CASE STUDIES OF FAILURES

W. R. Coleman, R. J. Block and R. D. Daniels
University of Oklahoma
Norman, Oklahoma 73019

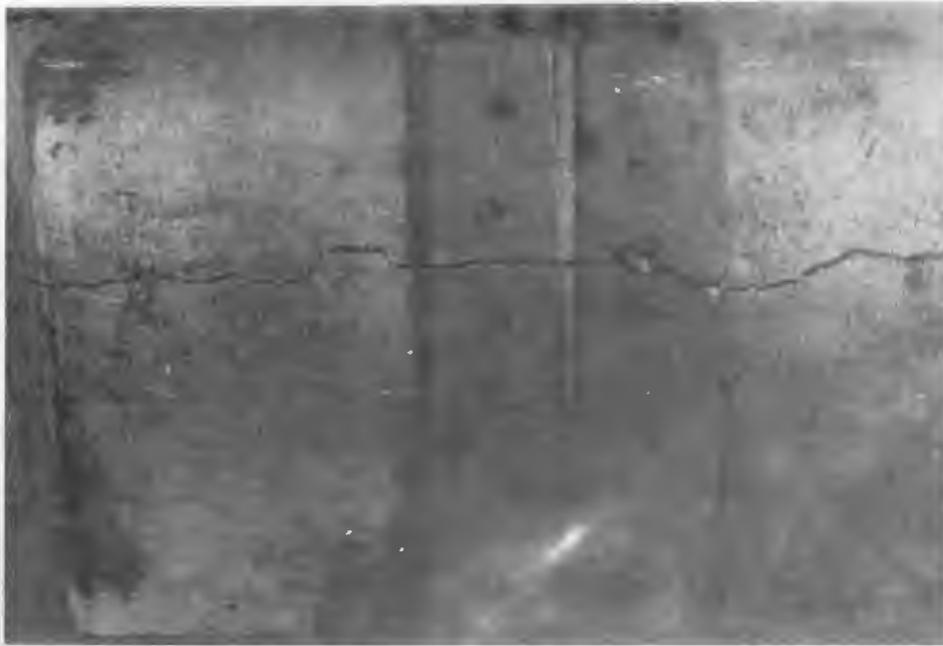
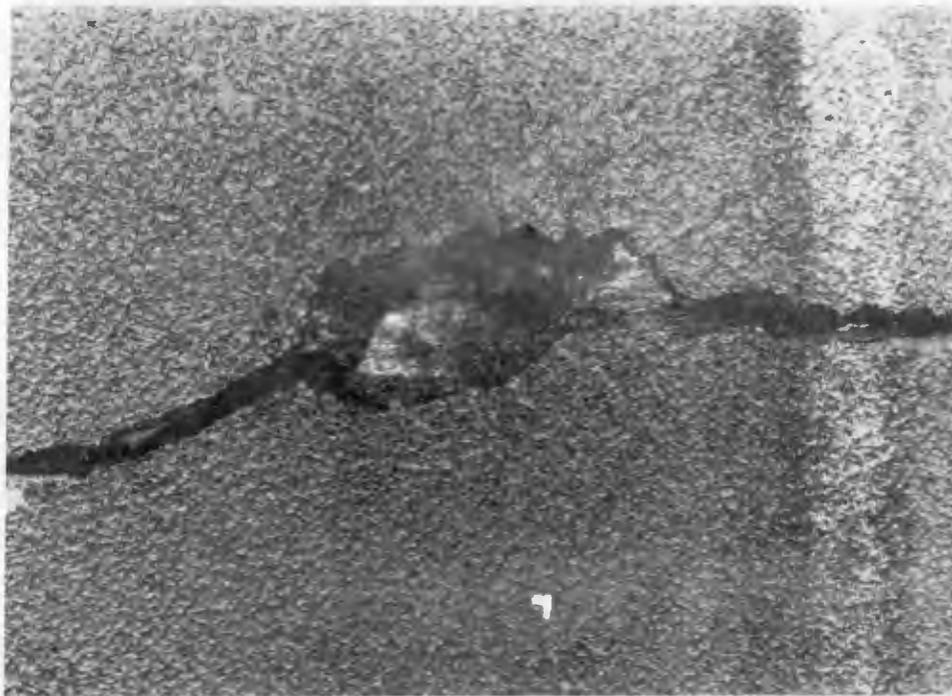
Figures 29 (above) and 30. Close up views of the fracture in the longitudinal wall. Note the light stripes around the outside diameter in Figure 29.

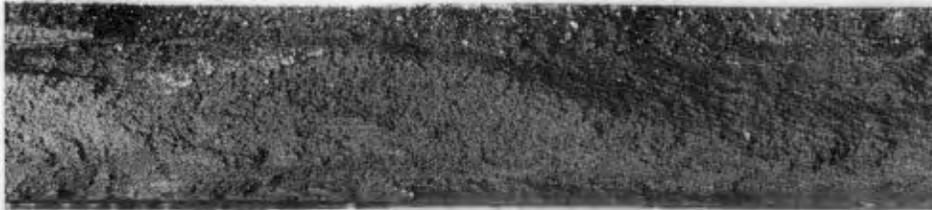
Figures 31 (above) and 32. Areas in the failed wall exhibiting different fracture modes. Normal ductile failure remote from the origin (Figure 31) contrasted with a laminated or exfoliated character in the vicinity of the origin (Figure 32).

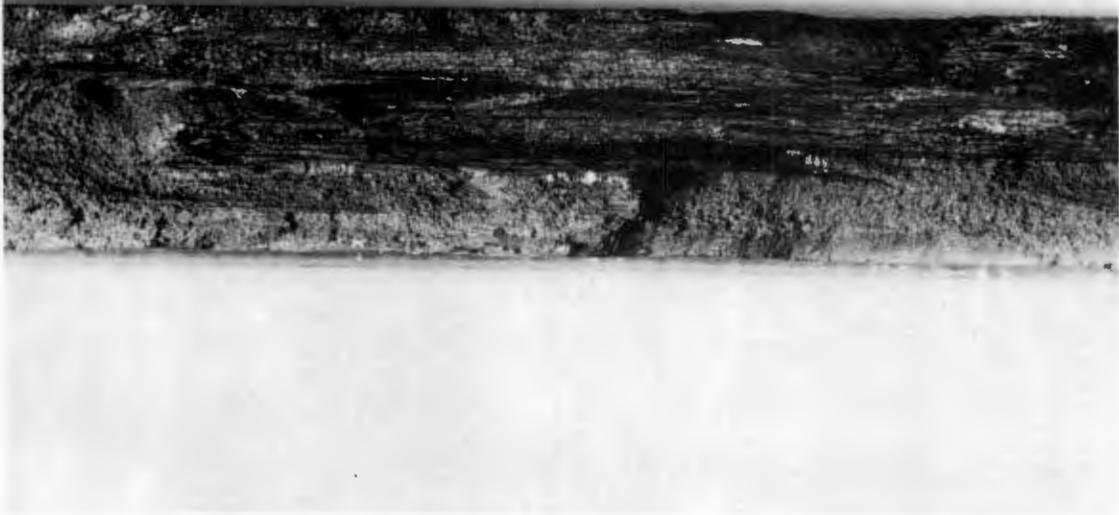
Figure 33. Example of exfoliation attack near the failure origin. Again characterized by the laminations in the wall.

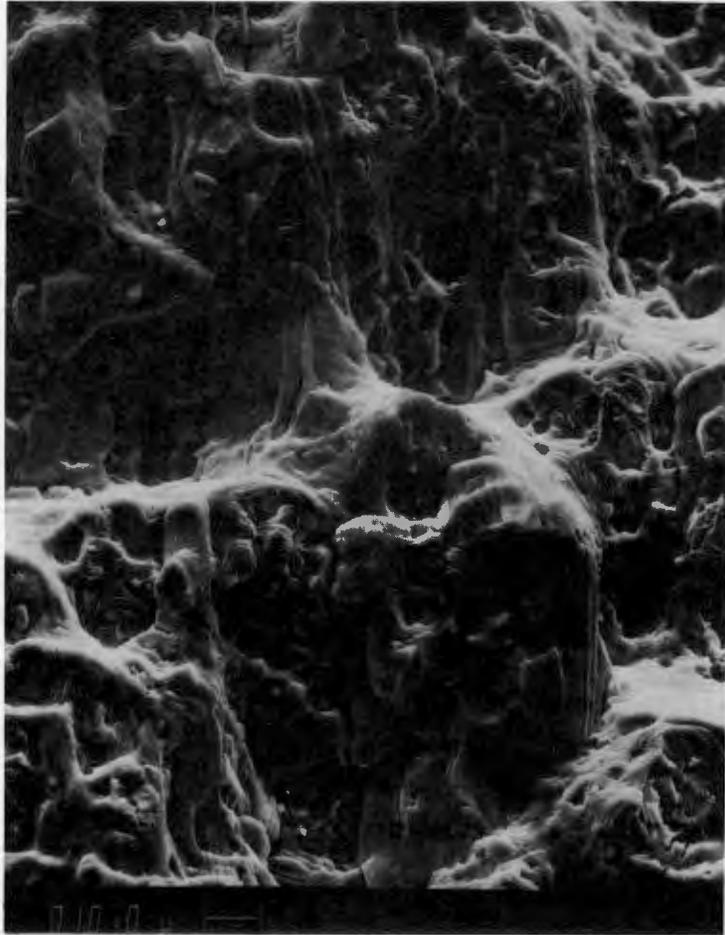
Figure 34. Fatigue within the laminated areas of the cylinder wall.
