WADC TECHNICAL REPORT 53-192  
PART XIII

## **MECHANISM OF RAIN EROSION**

**Part XIII. Mechanism Studies on Neoprene Coatings**

*National Bureau of Standards*

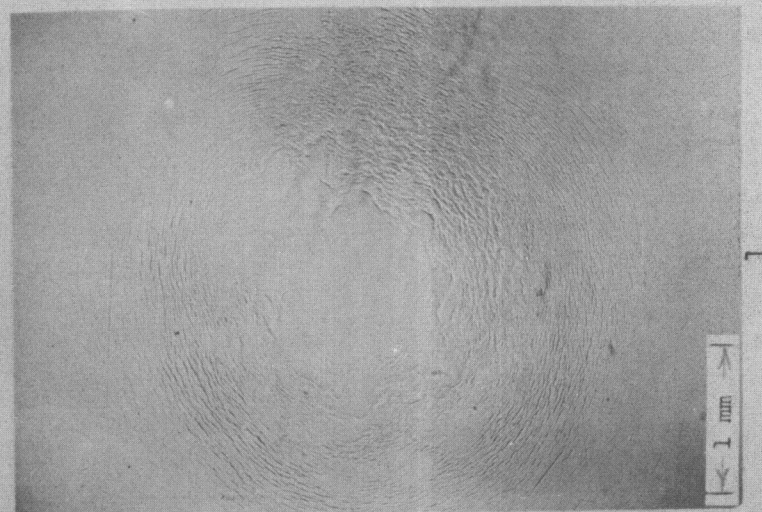
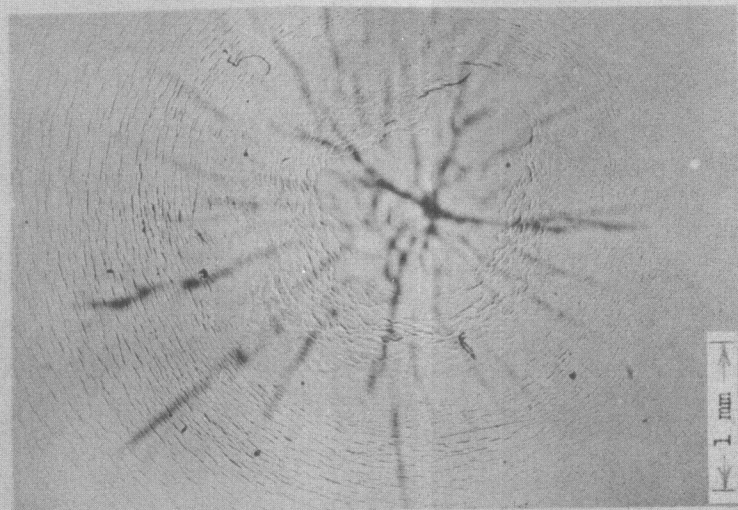
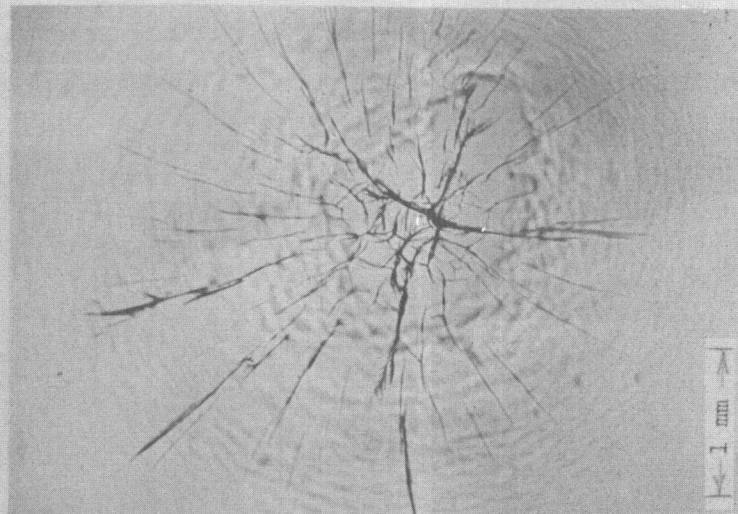
FIGURE 1 DAMAGE MARKS MADE BY IMPACT OF OIL-FILLED GELATIN CAPSULES ON 1/8-IN. LUCITE SHEET

Damage marks that were made on 1/8-in. and on 1/4-in. Lucite sheet are shown in Figures 1 and 2. Two points of similarity between these damage marks and those that were produced on methyl methacrylate by impingement of steel spheres, deforming lead pellets, and waterdrops are that:  
(a) the damage mark consists of a circle of crazing and  
(b) the center spot of the collision, which is under compression during the collision, is undamaged. These similarities in the appearance of the damage marks indicate that the mechanism by which the marks were produced is the same.

1. GELATIN CAPSULE SOAKED FOR 2 MIN; IMPACT VELOCITY 720 FT/SEC
2. GELATIN CAPSULE SOAKED FOR 2 MIN; IMPACT VELOCITY 900 FT/SEC
3. OPPOSITE SIDE OF LUCITE SHEET FOR THE DAMAGE MARK OF PICTURE 2

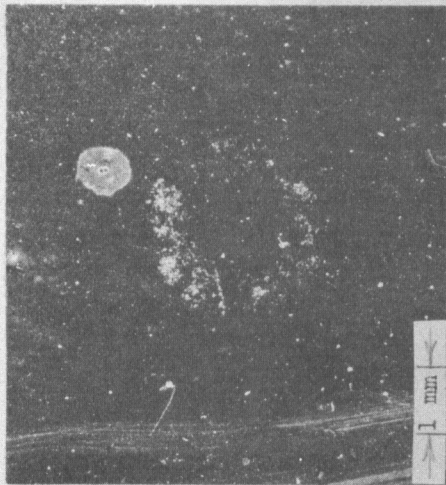
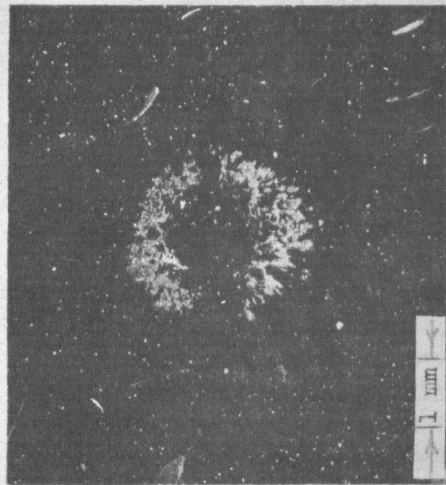
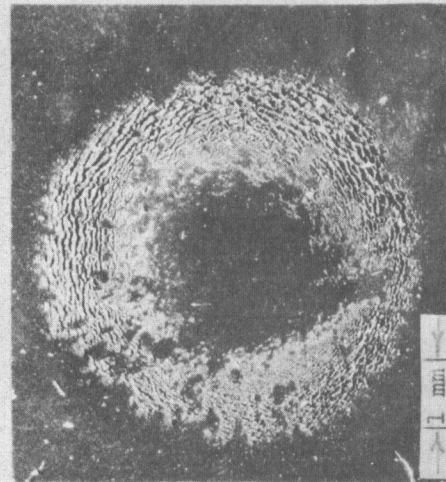
Oil-filled gelatin capsules were fired at a flat panel coated with MMM EC-539 neoprene. Each of the oil-filled gelatin capsules that was fired was soaked in water for 2 min before it was inserted in the gun barrel. The point of the gun was maintained at approximately 12 in. from the target panel for each shot. Views of the damage marks that were made by the impinging oil-filled gelatin capsules are shown in pictures 1, 2, and 3 of Figure 3.

At low magnification the damage mark that was produced at an impingement velocity of 320 ft/sec appeared to consist of a very dim, more or less circular trace. It is shown at approximately X10 magnification in picture 1 of Figure 3. When the magnification was increased the trace was seen to consist of raised edges of the coating along short irregular wrinkles or cuts.

The damage mark made by an oil-filled gelatin capsule at an impingement velocity of about 720 ft/sec was similar in general appearance to that made at an impingement velocity of 320 ft/sec. However, the damage was more severe; at low magnification the circular trace appeared not only to consist of a removal of gloss but of distinct wrinkles. When the magnification was increased the damage appeared to be a coarse irregular wrinkling as though the surface skin of the coating had been given a two-dimensional stretch to the point of permanent set and then released. In some areas the wrinkling was more regular and took on the appearance of more or less parallel ridges. The edges of some of these wrinkles were so sharp that it seemed possible that they might be edges of coating that had curled or turned up along an array of cuts in the coating. Picture 2 of Figure 3 shows this damage mark at approximately X10 magnification.

The damage mark that resulted from the impact of an oil-filled gelatin capsule at an impingement velocity of about 900 ft/sec had the same general appearance as the damage marks made at the lower impingement velocities. However, the impression that the wrinkles are the rolled back edges of cuts in the coating is even stronger. Picture 3 of Figure 3 shows this damage mark at approximately X10 magnification. When this damage mark was viewed with a stereomicroscope it could be seen that it is not flat as it appears to be in the picture. The undamaged center is not depressed but the circle of wrinkles or cuts is depressed.

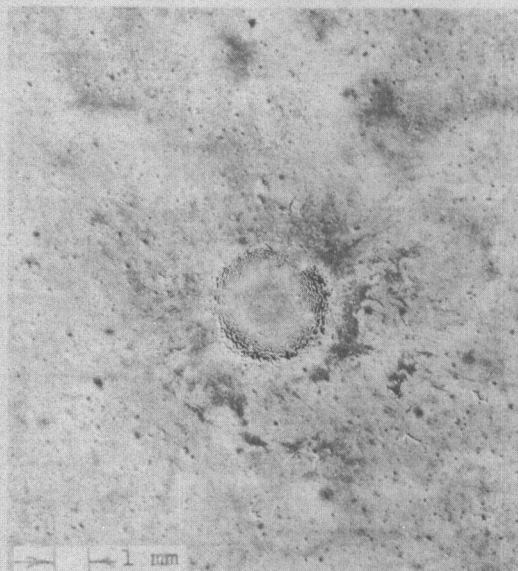
1  
COATING-A

On Coating-A no marked damage was observed as a result of the shot made at a velocity of about 320 ft/sec. The shot made at a velocity of approximately 720 ft/sec produced a hardly discernible semicircle of what appeared to be cuts or wrinkles in the coating. The shot made at a velocity of about 900 ft/sec produced a complete circle of what appeared to be cuts or wrinkles in the coating. A view of this damage mark is shown in picture 1 of Figure 7.

The section of Coating-A containing the damage mark shown in picture 1 of Figure 7 was cut loose from the aluminum plate and the circle of damage was inspected at high magnification. The circle of damage was seen to consist of raised ridges or edges of rubber. The same type of damage (raised flaps of rubber) results when a sharp pointed marking pencil or a razor blade is dragged across the neoprene surface. Such kinds of damage are shown in Figure 8. This type of damage to rubber has been discussed by Schallamach [4, 5, 6] and has been characterized as rubber abrasion. Throughout the remainder of this report this type of damage to the surface of a neoprene coating will be referred to as rubber abrasion. The way in which this abrasion is produced is discussed in Section 4.1.

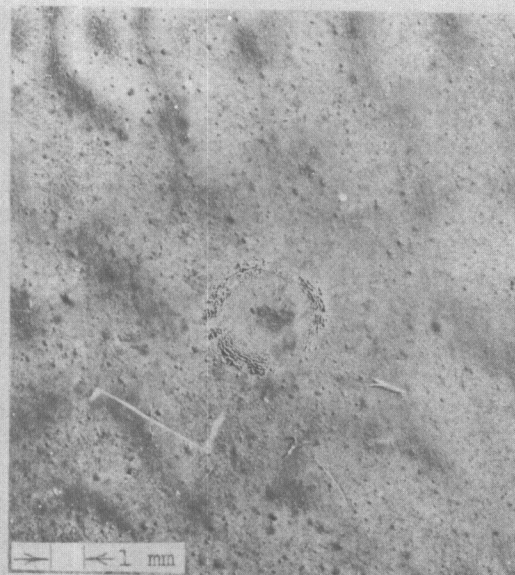
2  
COATING-B

On Coating-B no damage was produced by the shots that were made at the approximate velocities of 320 and 720 ft/sec. The shot made at a velocity of about 900 ft/sec produced arcs of what appeared to be cuts or wrinkles in the coating. A view of this damage mark is shown in picture 2 of Figure 7.

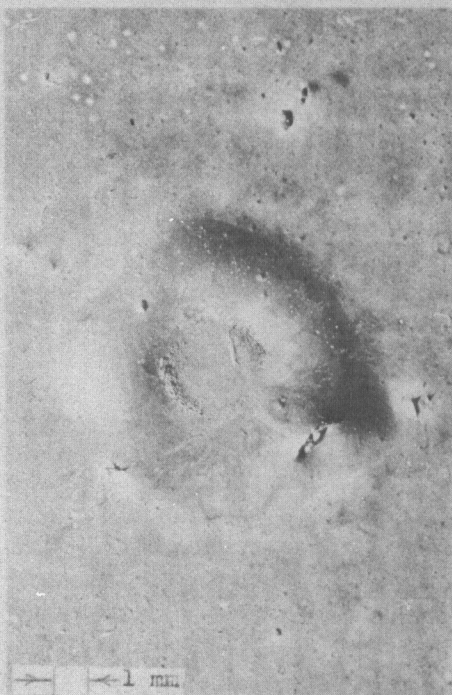
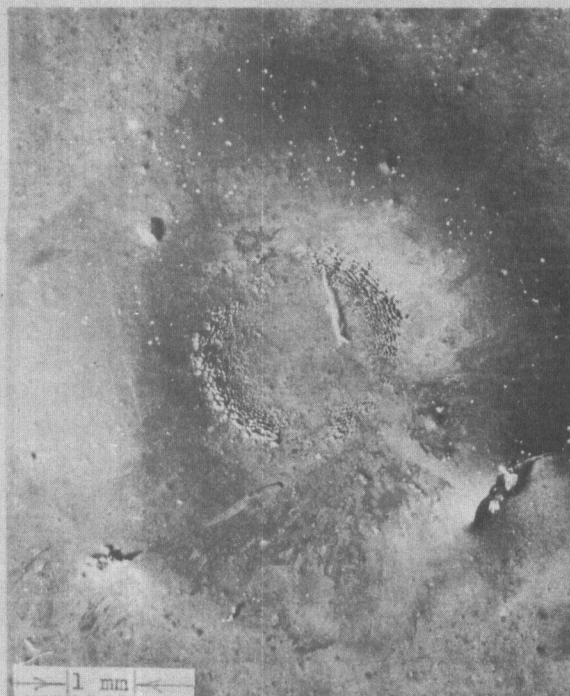
On Coating-C no marked damage was produced by the shot made at a velocity of about 320 ft/sec or by the shot made at a velocity of approximately 720 ft/sec. The shot made at a velocity of about 900 ft/sec produced arcs of what appeared to be cuts or wrinkles in the coating. This damage was surrounded by a large blister of coating. A view of this damage mark is shown at two magnifications in pictures 3 and 4 of Figure 7.

The pictures of Figure 7 show that only Coating-C failed due to loss of adhesion. From Table 1 it can be seen that Coating-C had the lowest percent elongation of the three coatings. If a rubber coating has a high degree of rigidity a shear stress exerted on its surface may be transmitted through it to the adhesion bond and if the stress is sufficiently great the adhesion bond may fail. The area of coating that was given a radial stretch to the point of permanent set during the collision will then be raised from the surface to which it had been bonded in the form of a coating bubble or coating blister.

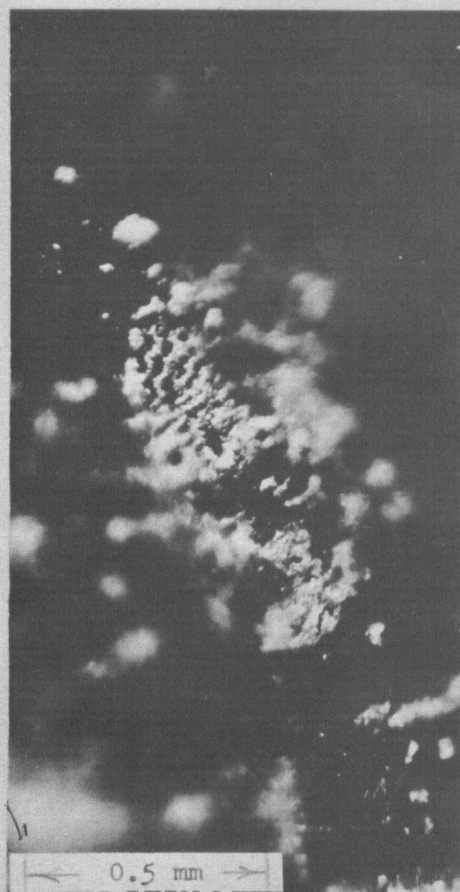
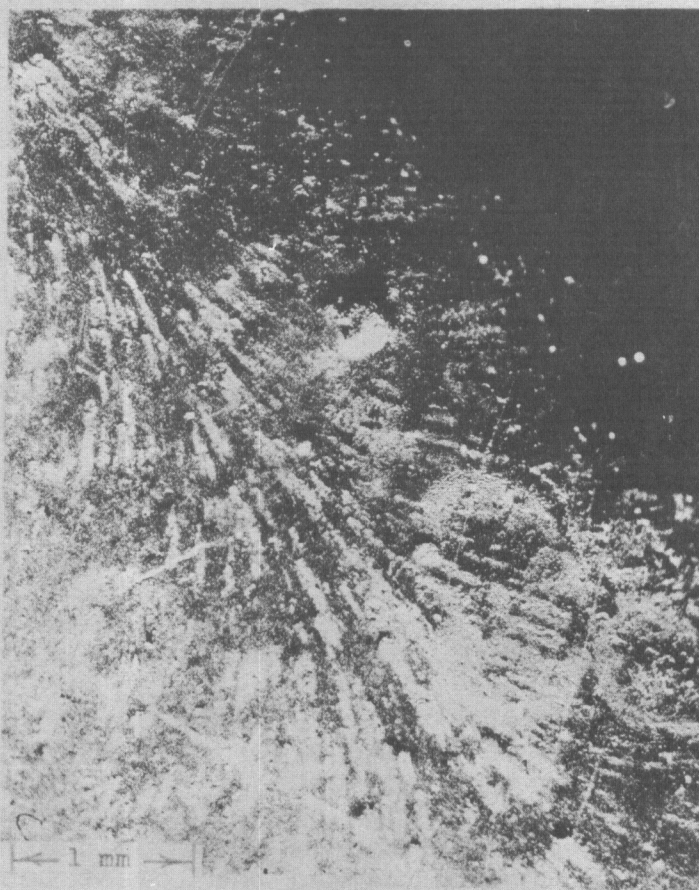
FIGURE 9 VIEWS OF WATERDROP IMPINGEMENT DAMAGE ON COATING-C

Examination of the specimens of Coating-A, Coating-B, and Coating-C that were tested for 25 sec, 1 min, and 2 min provided the information that the coatings on all of these specimens were characterized by irregular patches of the small more or less parallel shallow trenches of rubber abrasion. In many cases these patches were circular or consisted of arcs of circle. Picture 1 of Figure 9 is a view at high magnification that shows the parallel-trench structure; this picture was taken on a specimen of Coating-C. It is difficult to take pictures at high magnification on the rain-erosion test specimens because of their curvature.

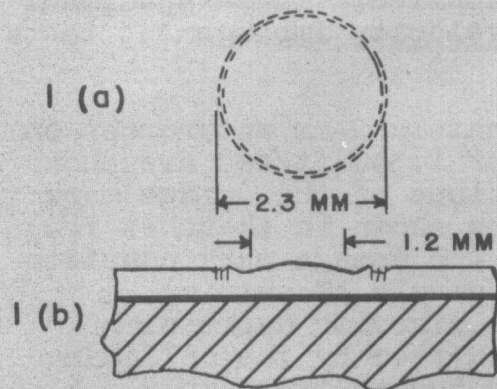
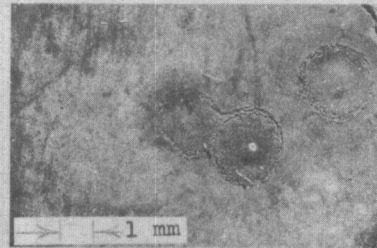
VELOCITY 1540 FT/SEC

FAILURE OF COATING BONDED TO METAL BY PRIMER

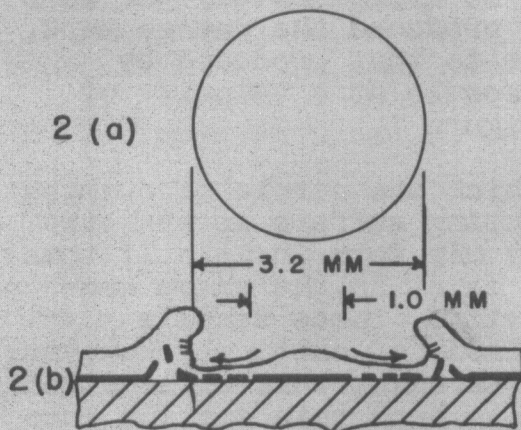
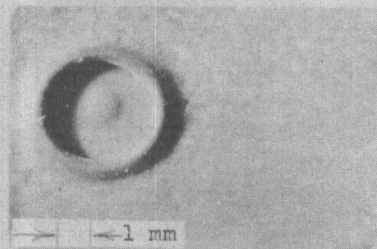
VELOCITY 2480 FT/SEC

The damage mark produced at an impingement velocity of 2,480 ft/sec is shown in picture 2(c) of Figure 10. This damage mark consists of a central mound in the coating surrounded by a circular fold of coating. Dimensions of the damage mark are shown in sketches 2(a) and 2(b) at the left of the picture.

RADIAL ELONGATION OF COATING AFTER FAILURE OF PRIMER

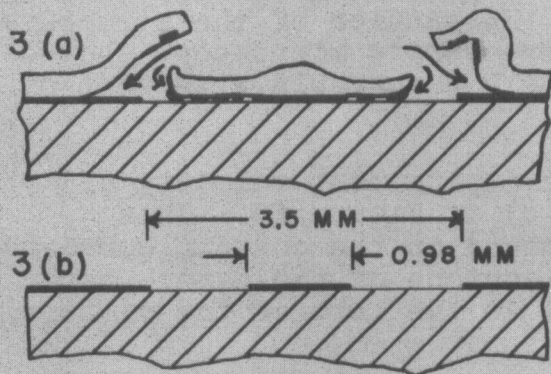
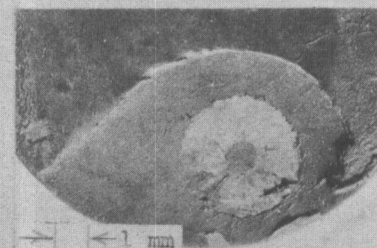
VELOCITY 2588 FT/SEC

REMOVAL OF COATING BY RADIAL WATER FLOW

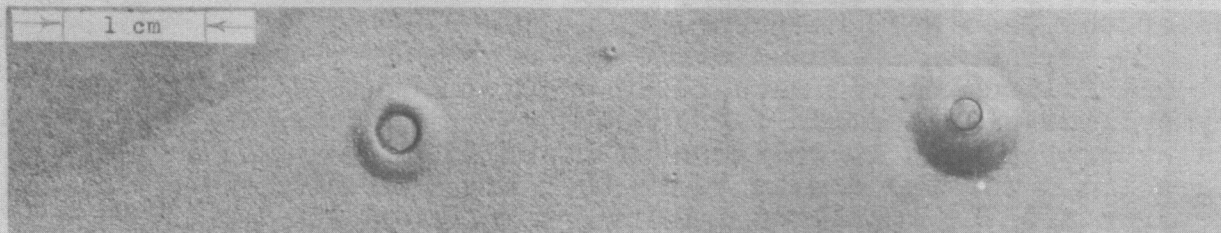
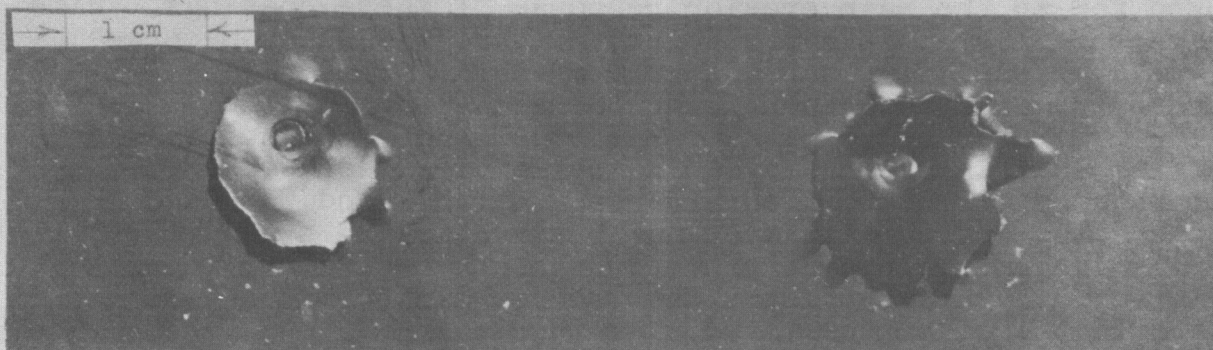
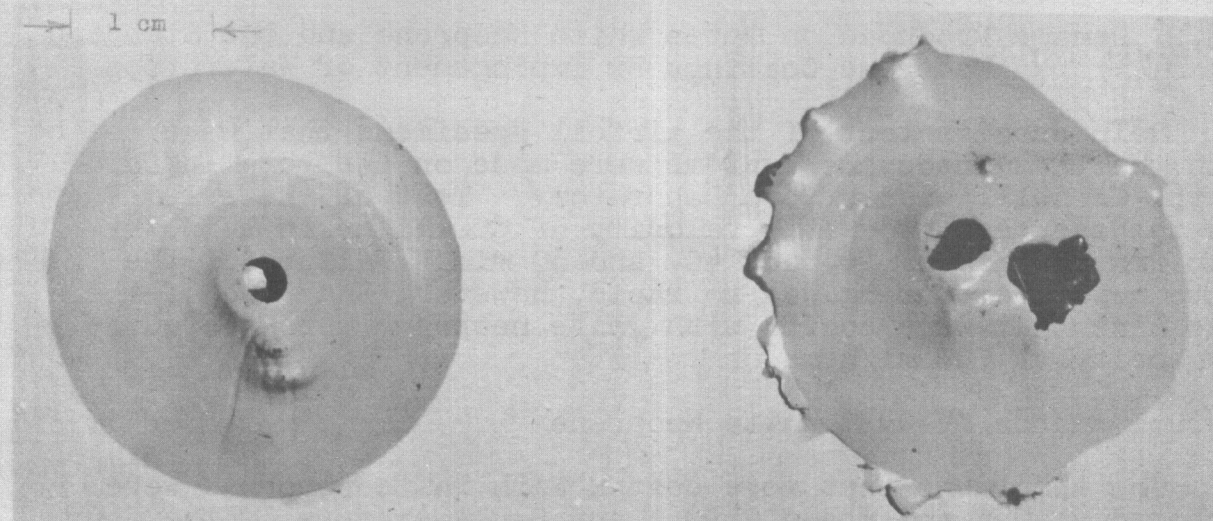
At a velocity of 640 ft/sec there is no tearing of the Gaco N-79 neoprene at the periphery of the coating bubble but such tearing did occur both in the Goodyear 23-56 neoprene and in the Gates KV-9433 white neoprene. There is some abrasion of the neoprene surface around the circular cut in the coating in the case of the white neoprene and rather extensive abrasion in the

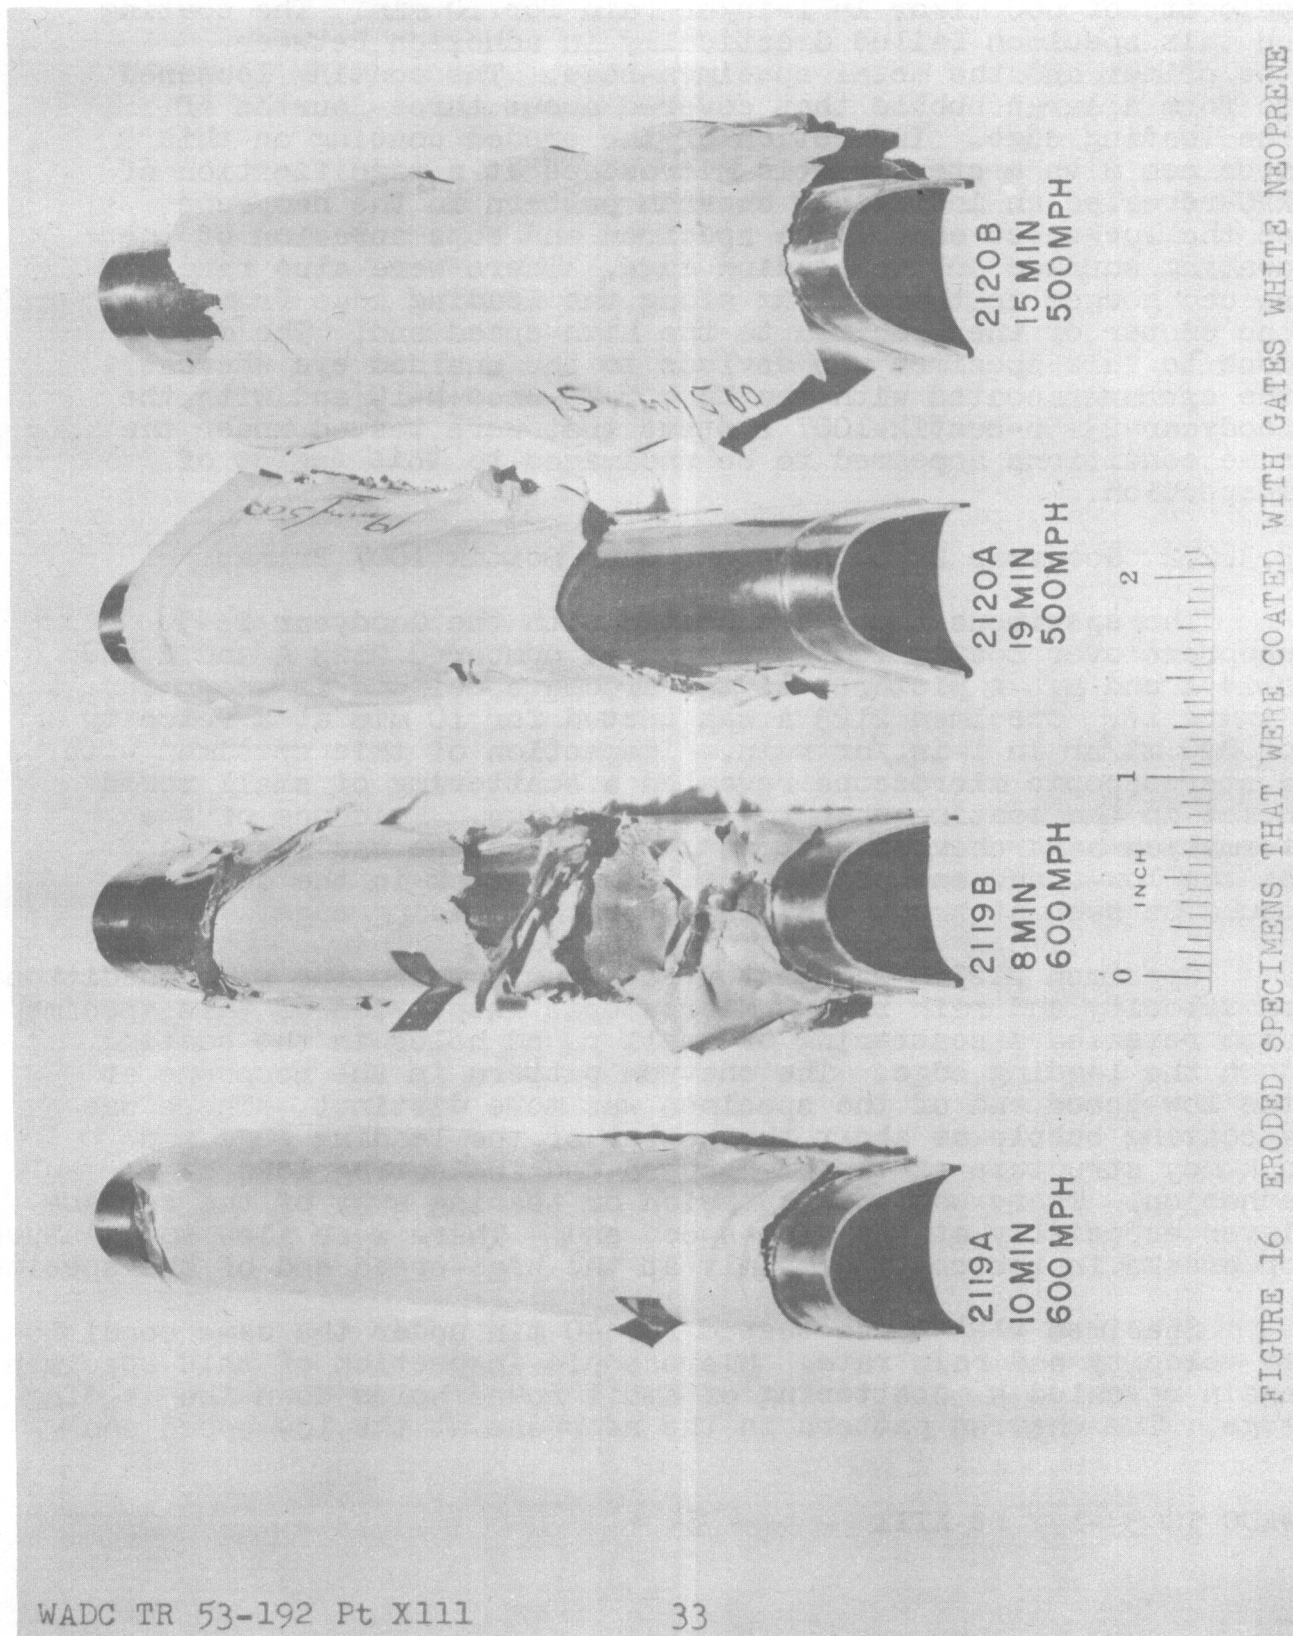
The specimens that were coated with white neoprene were numbered 2119 A and B and 2120 A and B. A picture of the four eroded specimens is shown in Figure 16. Only one specimen was tested at a velocity, in a rain density, and for a time interval comparable with that used for the other neoprene coating

systems. This was specimen 2119 A which was tested at a velocity of 600 mi/hr in 1-in/hr rain for 10 min. The coating on this specimen failed drastically in adhesion between the primer and the metal specimen-base. The coating loosened to form a large bubble that covered about three-fourths of the leading edge. Inspection of the eroded coating on this specimen with a stereoscopic microscope at a magnification of X20 revealed an indistinct chevron pattern in the neoprene at the low-speed end of the specimen and some abrasion of the coating surface on the leading edge. There were also randomly spaced gouges in the coating along the leading edge from about the center of the specimen to the high-speed end. The damage done to this specimen was obvious to the unaided eye whereas the specimens coated with the Gaco N-79-Gaco-N-15 and with the Goodyear-23-56-Bostik-1007 systems that were tested under the same conditions appeared to be undamaged to this degree of inspection.

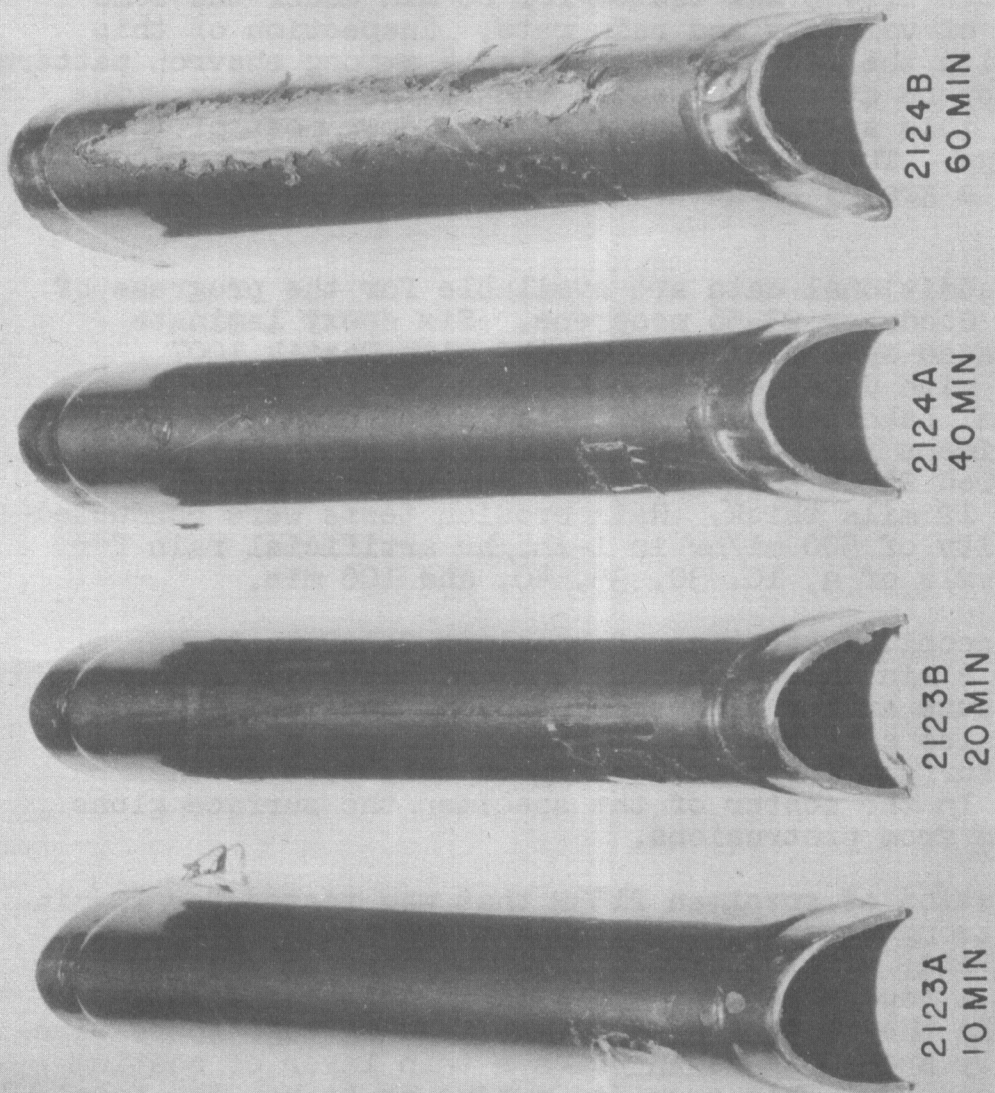
FIGURE 17 ERODED SPECIMENS THAT WERE COATED WITH GOODYEAR 23-56 NEOPRENE

Specimen 2124 A was tested for 40 min under the same conditions of velocity and rain rate. Microscopic inspection of this specimen again revealed a scattering of small round holes down the leading edge. The chevron pattern in the neoprene at the low-speed end

was distinct. There was strong bubbling or lifting of the coating along the leading edge indicating loss of adhesion, and there was abrasion by scuffing up of the surface layer especially at the high-speed end. There were also some sutures or cracks in the coating.

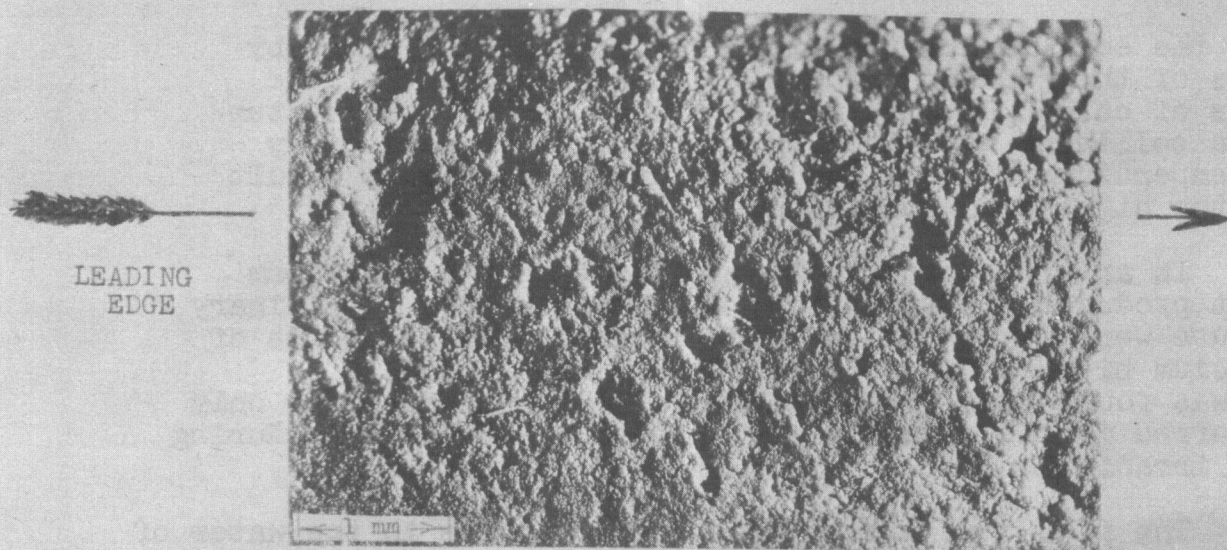
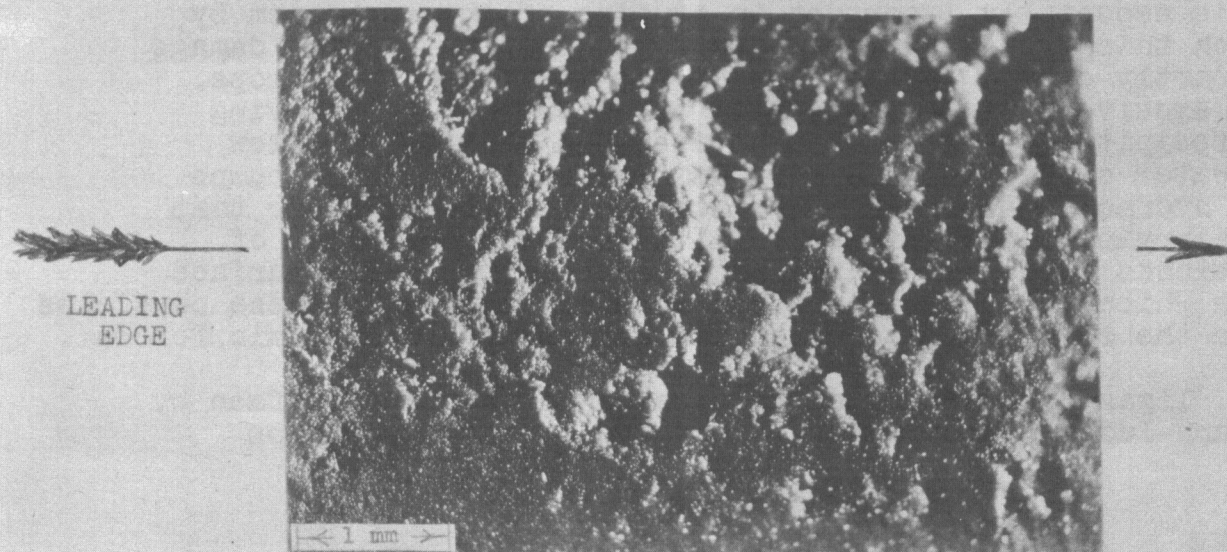
FIGURE 18 VIEWS OF GOODYEAR 23-56-BOSTIK 1007 NEOPRENE COATINGS AFTER TWO INTERVALS OF TEST AT A VELOCITY OF 500 MI/HR IN 1-IN/HR RAIN

At a velocity of 600 mi/hr the mode of failure is the production of a chevron pattern along the trajectories of water flow from the impinging drops. There is a notable cementitious deposit especially on the ends of a specimen that was tested at a velocity of 600 mi/hr whereas this deposit is negligible when the test is carried out at a velocity of 500 mi/hr. Precipitation of calcium salts appears to occur in the water of the intercepted drops when solid specimens are rotated through the artificial rain of tap water at a velocity of 600 mi/hr. The hardness in parts per million of calcium carbonate for the tap water used is 22. This is a relatively low hardness.

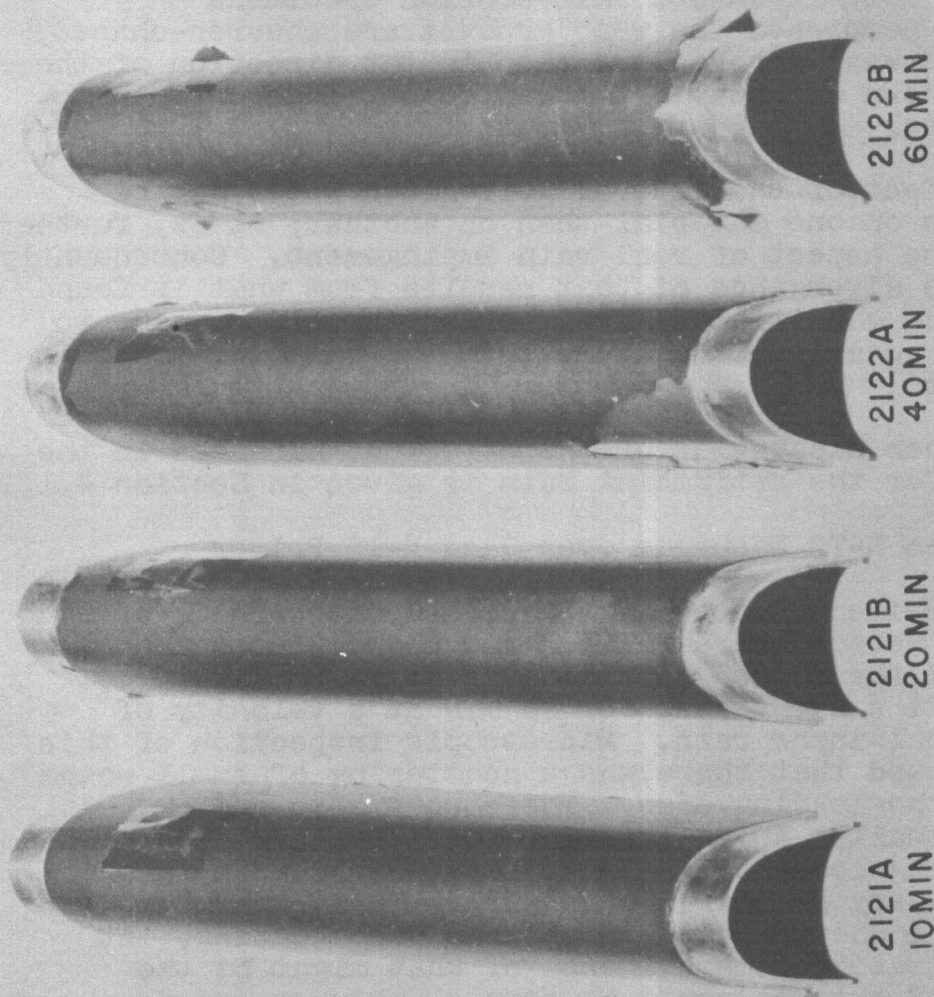
FIGURE 19 ERODED SPECIMENS THAT WERE COATED WITH GACO N-79 NEOPRENE

Specimen 2121 B was tested for 20 min under the same conditions of velocity and rain rate. Microscopic inspection of this specimen again revealed a scattering of small round holes down the leading edge. The coating was, furthermore, peppered with the smaller holes that were noted on specimen 2121 A. There was an abrasion or tearing away of surface layers especially around the small holes of both sizes. There was no evidence of a chevron pattern

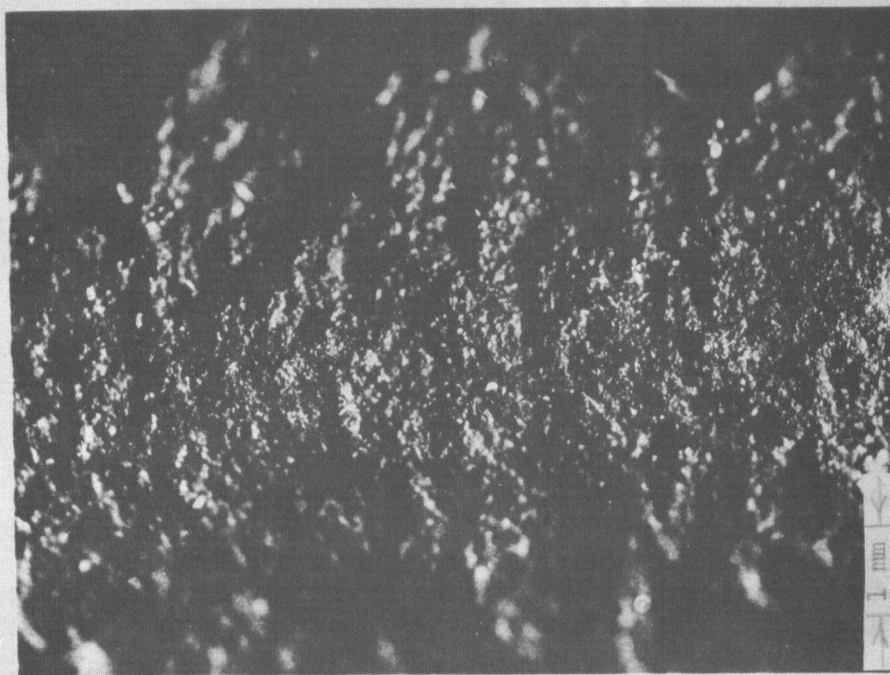
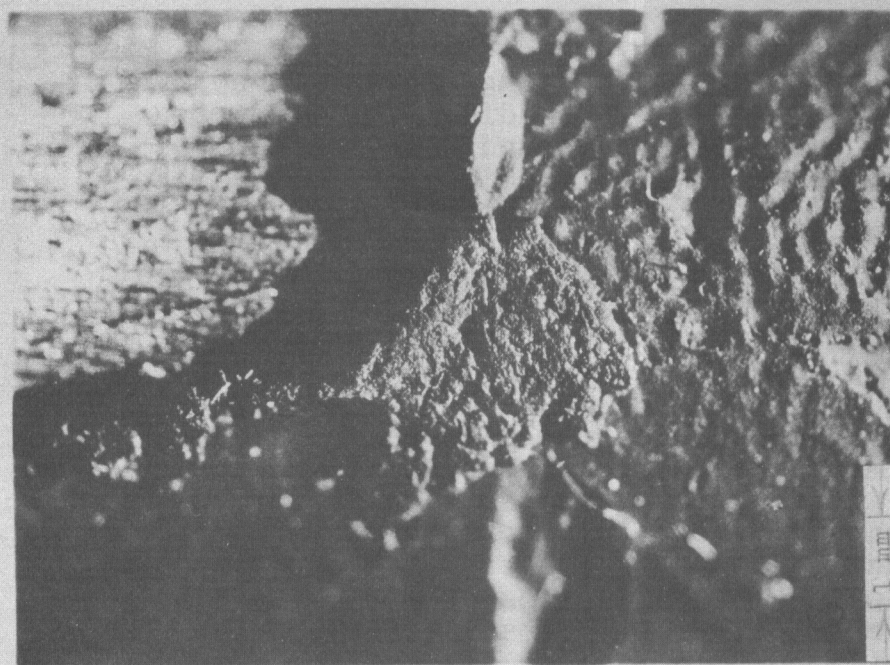
Specimens 1893 A and B were tested at a velocity of 500 mi/hr in 1-in./hr artificial rain. Ordinary hydrant water having a hardness of 22 ppm was used to make the artificial rain. The Cornell Aeronautical Laboratory reported that the coating started to erode in 12 min. The test was stopped at the end of 50 min. At the end of this length of time the high speed end of the leading edge of each specimen was strongly eroded; the low-speed end was eroded to a lesser degree. See picture 1 of Figure 21. Inspection of these specimens showed very little, but some, evidence of a cementitious deposit from the water.

SPECIMEN 1893 A HIGH SPEED END

SPECIMEN 1896 B SHOWING UNDERSIDE OF  
TURNED BACK FLAP OF COATING

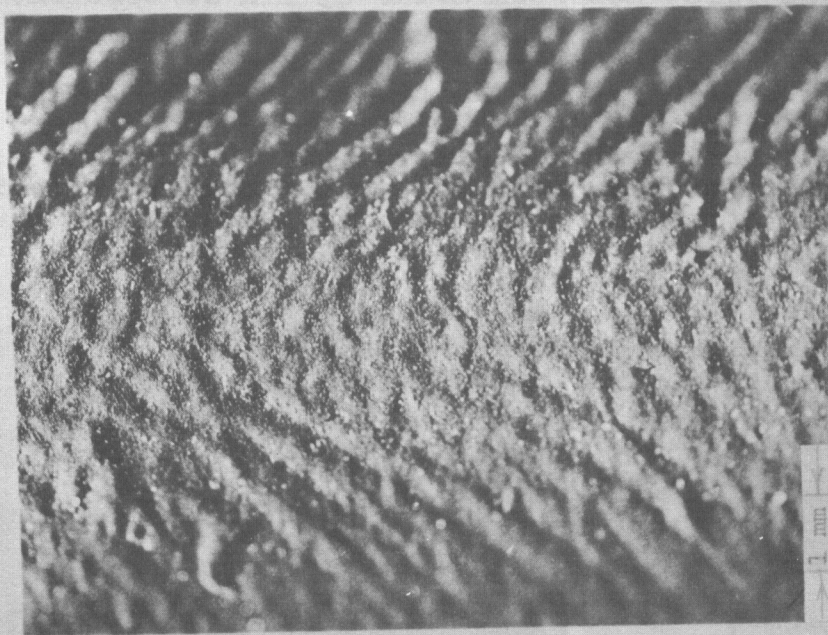
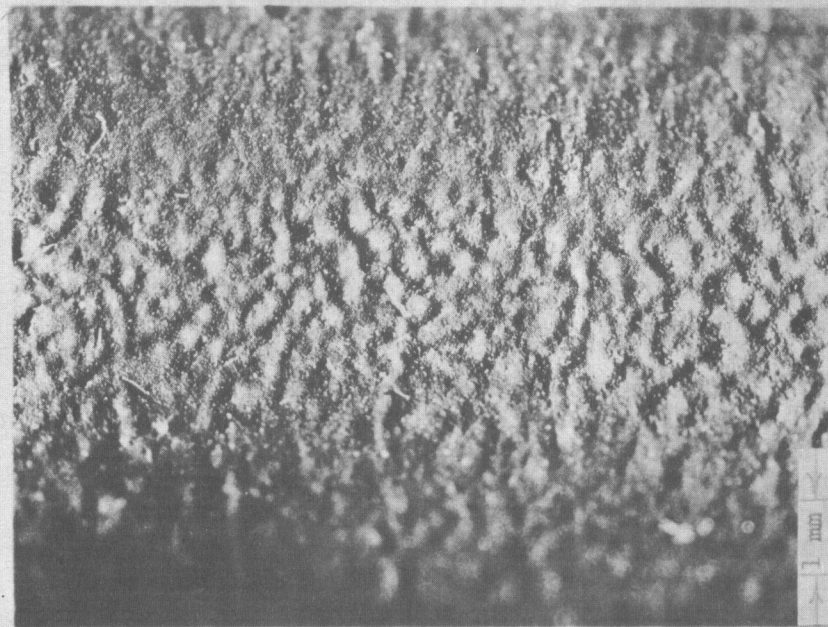
The low-speed end of the leading edge was characterized by a chevron pattern of erosion in the neoprene coating. See picture 1 of Figure 22. The point of the chevron faced the

SPECIMEN 1894 A, LOW SPEED END

SPECIMEN 1894 A, HIGH SPEED END

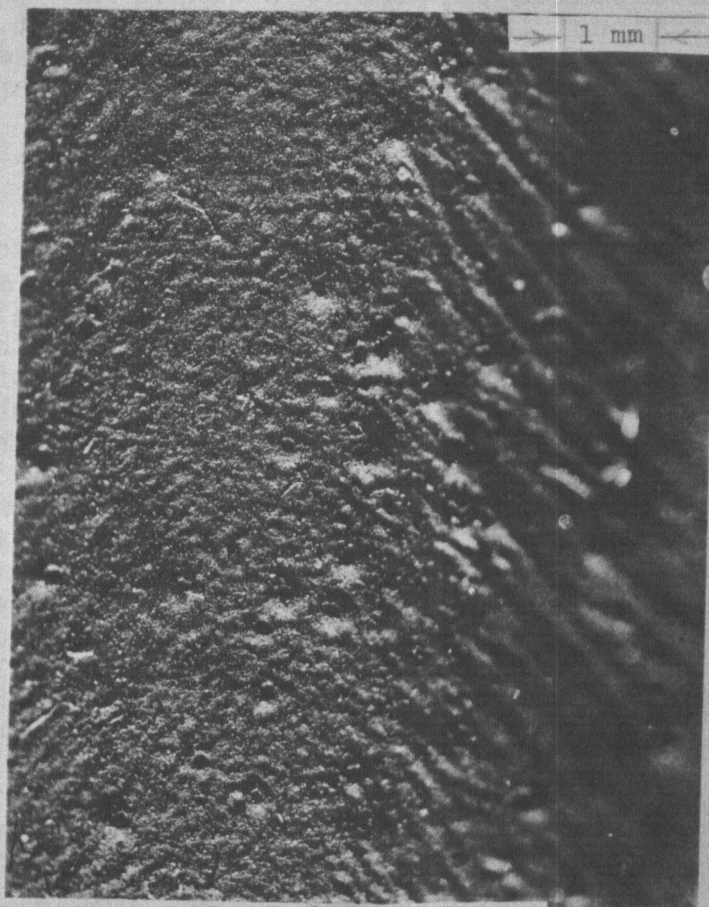
SPECIMEN 1390B

The coating on specimen 1390 B, which was a control that had no surface treatment, is peppered over the entire leading edge with many round small holes (See Figure 24) that have a raised collar of neoprene around them. They may have been caused by air bubbles in the coating that were broken open by the waterdrop impacts. Some small bumps exist that have no hole in them and it is possible that these are air bubbles in the neoprene that are near the surface. There is a dim chevron pattern in the coating at the low-speed end of the specimen and a pebbled structure at the high-speed end of it that is fine in texture in comparison with the beady structure of specimen 1894 A. Coating-bubbles that involve the entire thickness of the coating also exist; two of these have been torn open so that the surface of the 2024-0 specimen-base can be seen. Many cracks and sutures also can be seen in the coating.

FIGURE 24 VIEW OF SMALL ROUND HOLES AND DIM CHEVRON  
PATTERN IN A GOODYEAR 23-56-BOSTIK 1007 NEOPRENE  
COATING AFTER EROSION TEST AT A VELOCITY OF  
600 MI/HR
