This report was prepared by the University of Dayton Research Institute on Air Force Contract No. AF 33(616)-7838. This contract was initiated under Project No. 7381, "Materials Application," and Task No. 738103, "Materials Information Development, Collection, and Processing." The work was administered under the direction of the Air Force Materials Laboratory, Wright-Patterson Air Force Base, Ohio, with Lawrence N. Hjelm as the project engineer.

ABSTRACT

A metallographic analysis of coating failures in the XLR-99 thrust chamber of the X-15 research aircraft and the subsequent development of a thermal shock test with the plasma-jet for sprayed ceramic coatings are discussed. The results of an extensive evaluation of protective coatings and the field test verification of these results are presented.

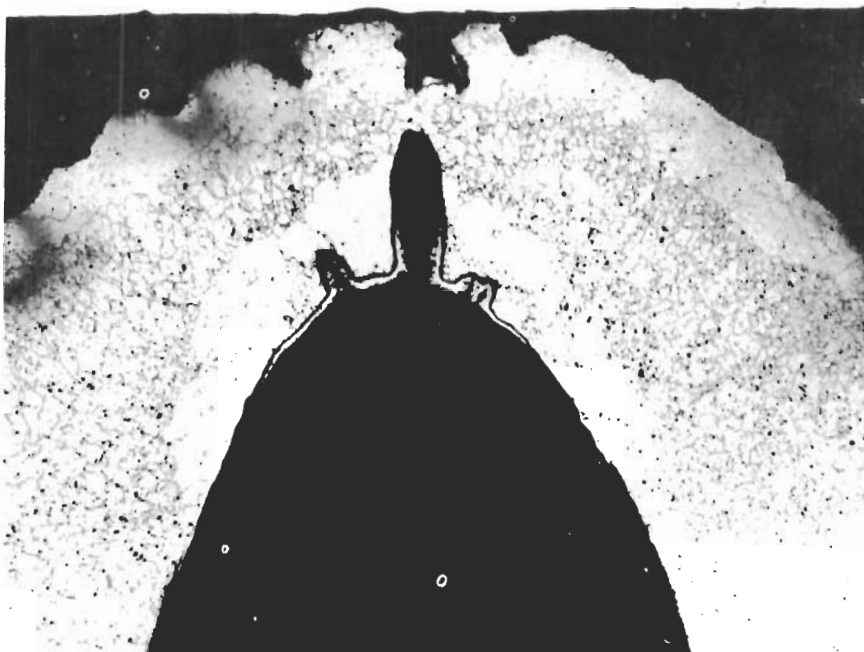
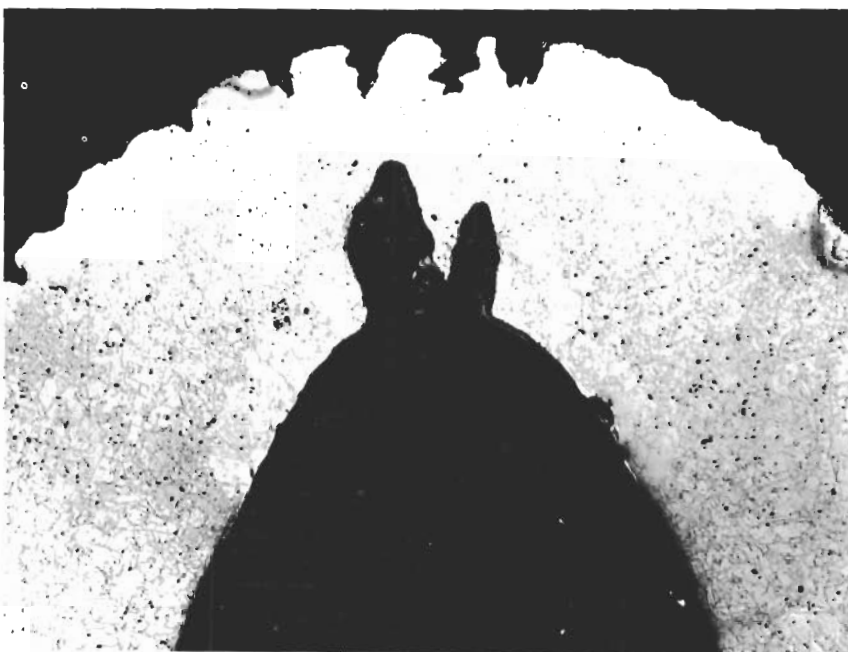
Figure 94. Both Photomicrographs Are Duplicates of Figure 93 after Etching with 10% Oxalic Acid, Electrolytic 6 V.D.C.

Inspection of the coating in the throat section revealed a pattern of divergent white streaks running down the interior of the chamber (Figure 92). These white streaks appeared to correspond to the radial location of the fuel injectors and therefore the regions of maximum temperature. It was within these white areas that tube failures and extensive coating loss had occurred. Metallographic examination of several failed tubes revealed a complete loss of coating and substantial erosion of the tube surface as shown in Figures 93 and 94. The inside surface of the tubes contained a second phase apparently due to a reaction of the liquid ammonia with the stainless steel. This phase which can be seen in Figure 93 and even more clearly in Figure 95 appeared to be quite brittle and exhibited considerable cracking in the diffusion zone. Tubes adjacent to ones which had failed revealed some surface erosion of the stainless steel and a thinner diffusion zone on the inside surface as shown in Figure 96.

It was concluded from the examination of the failure and of adjacent areas that Rokide loss resulted in the formation of a brittle diffusion zone, very susceptible to cracking. The internal cracking coupled with erosion of the stainless steel outer surface reduced the effective cross-sectional area of the tube to such an extent that it burst. It was further concluded that tube failures were the ultimate result of complete Rokide loss.

On the basis of this analysis, it was recommended that a program be initiated with an organization competent in the area of sprayed ceramic coatings to develop a coating with improved adherence under normal engine operating conditions.

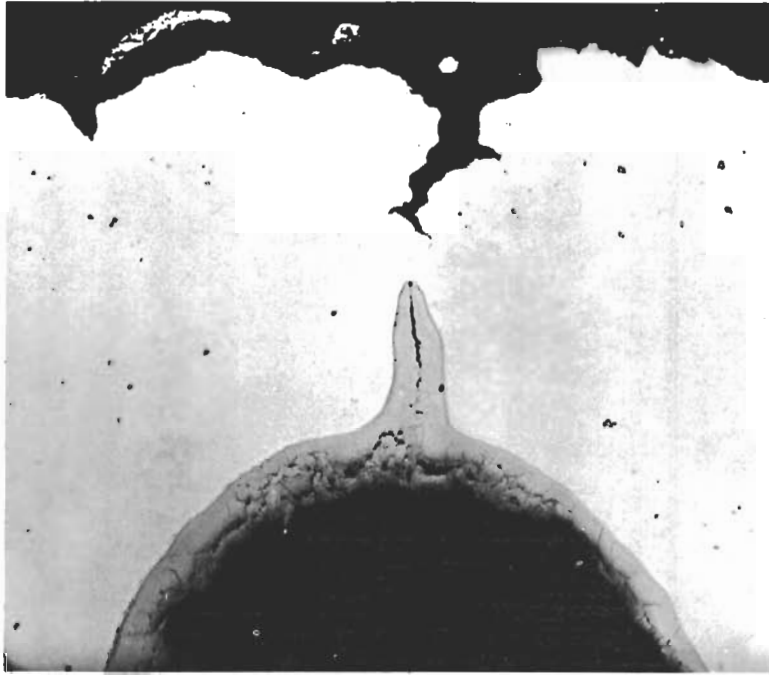
Figure 95. Microstructure of Failed Tube Showing Crack and Diffusion Zone.

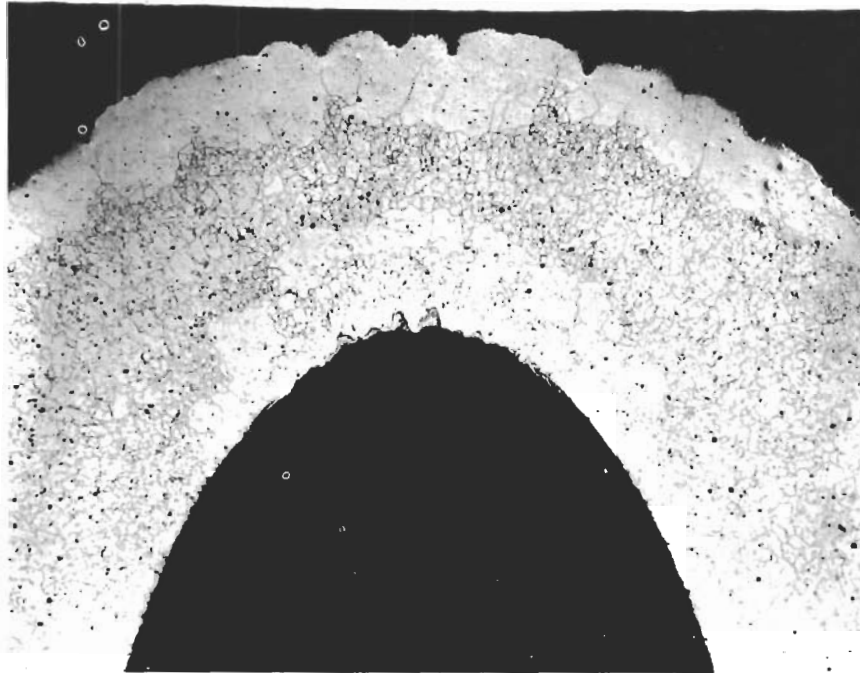
Figure 96. Microstructural Condition of an Alternate Tube to That Which Contains the Crack.

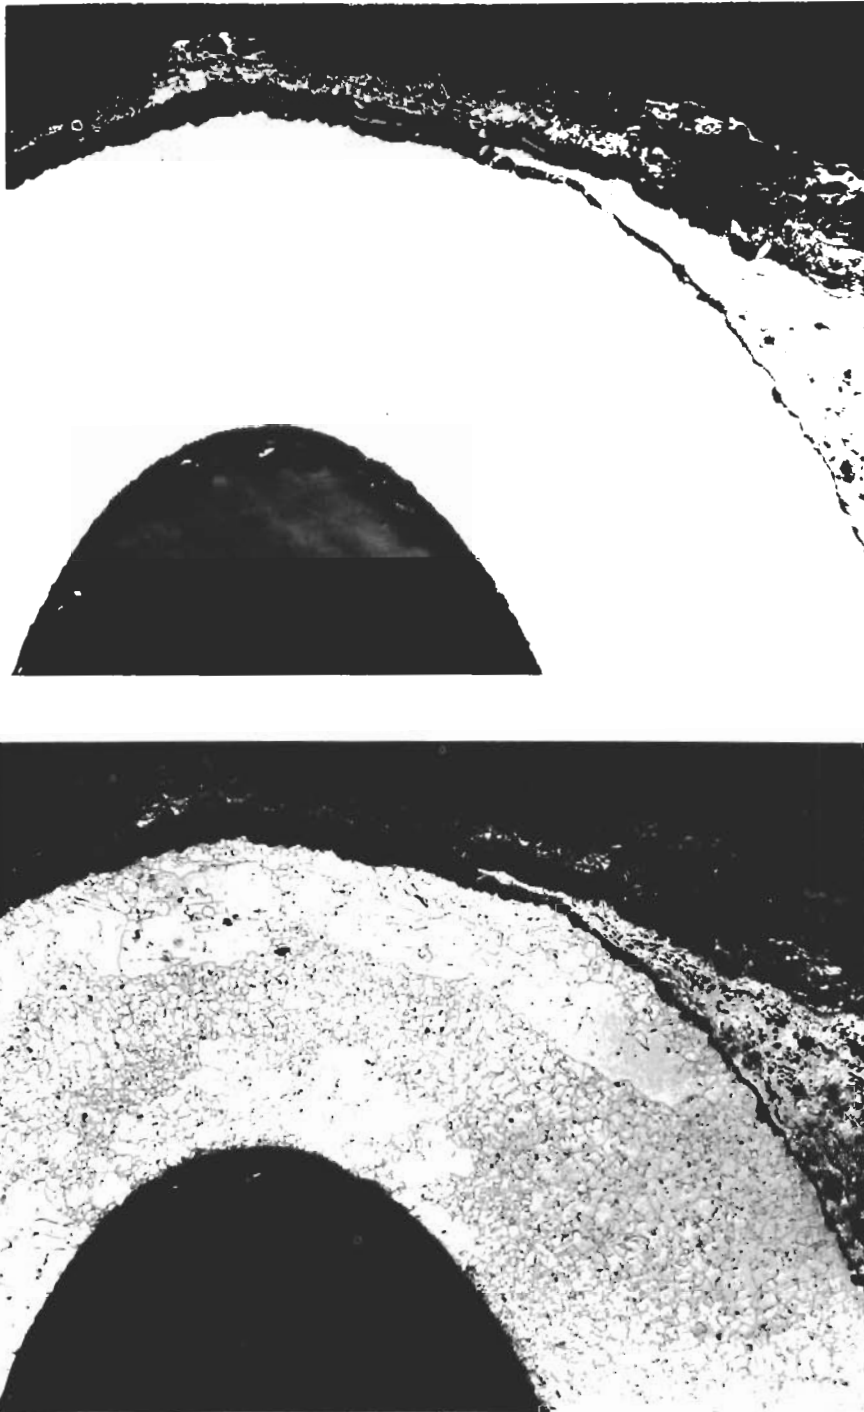
Examination of the white areas where the Rokide coating remained intact revealed some erosion of the Rokide Z (Figure 97). In this area, as well as in those where the coating was completely eroded, recrystallization of the stainless steel was observed on both the inside and outside diameters. Significantly, no evidence of the diffusion zone was observed in those areas where only partial erosion of the coating had occurred.

Figure 97. Microstructural Condition of the Rokide Coating in an Area Where It Had Become White during Engine Operation.

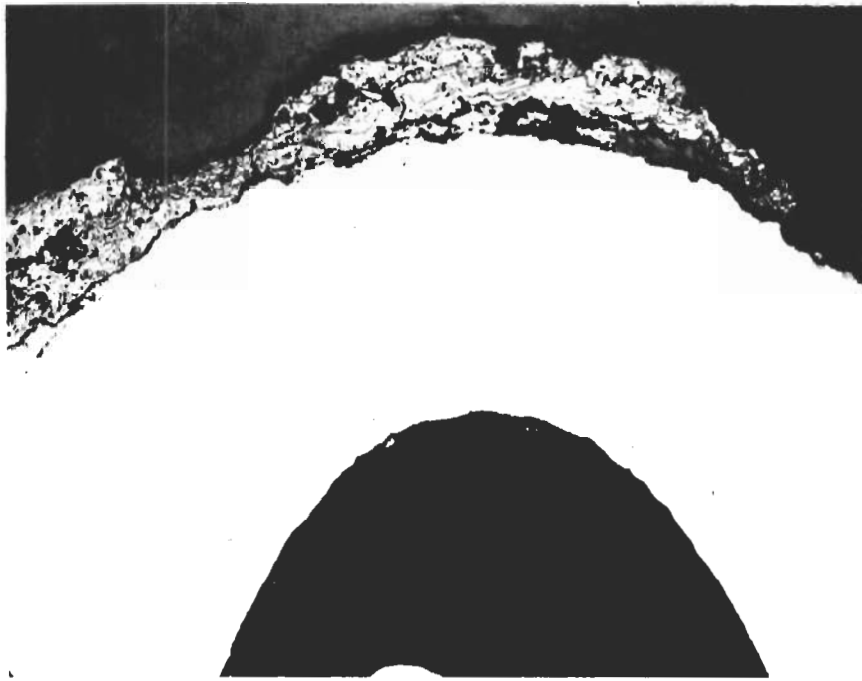
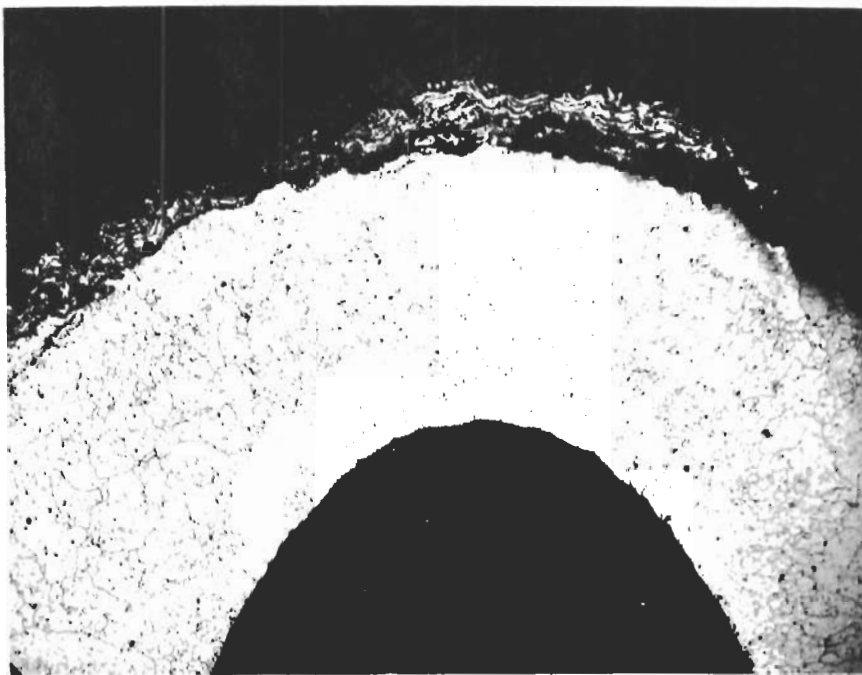
A white area away from the throat section is shown in the photomicrographs of Figure 98. In this area non-uniformity of the coating is quite evident as well as grain growth at the inside and outside diameters. No evidence of the diffusion zone was observed in this area.

Figure 98. Microstructure of a Stainless Steel Tube and Coating in a "White" Area Away from the Throat Section of the Nozzle.
