AIRCRAFT GROUND-FLOTATION INVESTIGATION
PART III. DATA REPORT ON TEST SECTION 2

W. BRABSTON, A. RUTLEDGE, and W. HILL

PART III DATA REPORT ON TEST SECTION 2

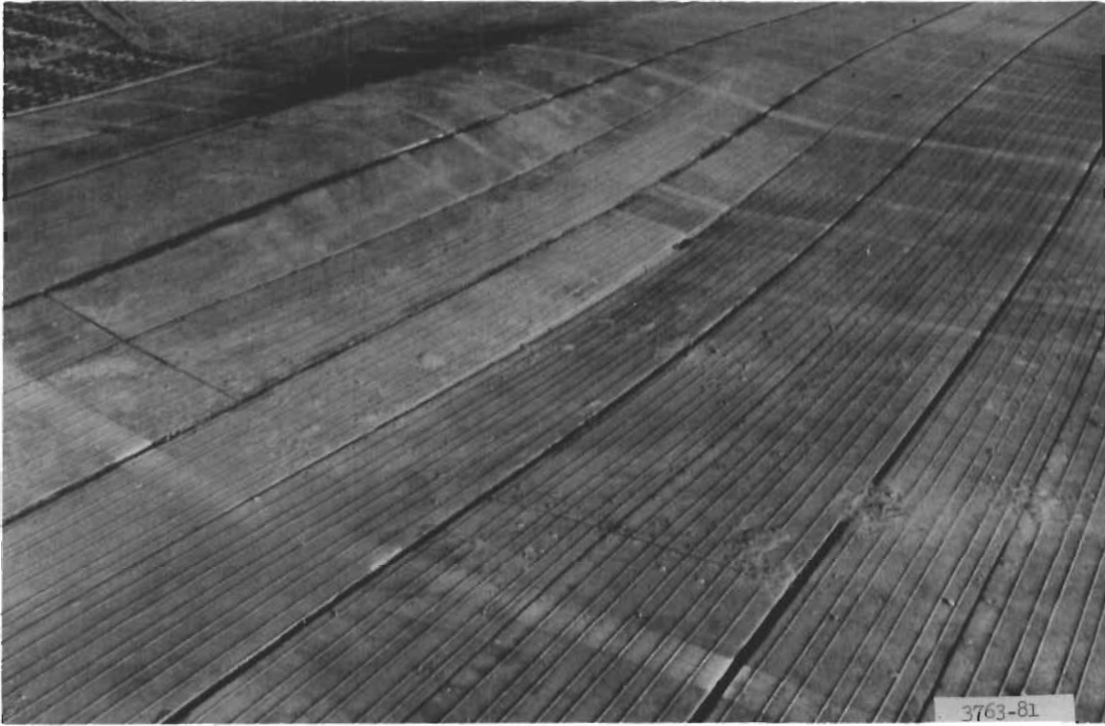
Item 1. A general view of item 1 prior to traffic is shown in **Figure 3**. Prior to 200 coverages, displacement of subgrade at the transition between item 1 and the previously failed item 2 (see profile in **Figure 29**) became evident. At 458 coverages, it became necessary to remove mat runs 15 through 19 (**Fig 27**) and level the subgrade prior to mat replacement. **Figures 5 and 6** show the hump which had developed at the transition. After replacement, the five affected mat runs were no longer considered in performance evaluation, as transition zones are not considered representative of item condition. Item 1 was judged failed at 600 coverages due to excessive roughness (**Figures 7 and 8**). The rated CBR was 2.6.

Figure 4. Lane 3, item 1, showing severe localized mat damage at 458 coverages

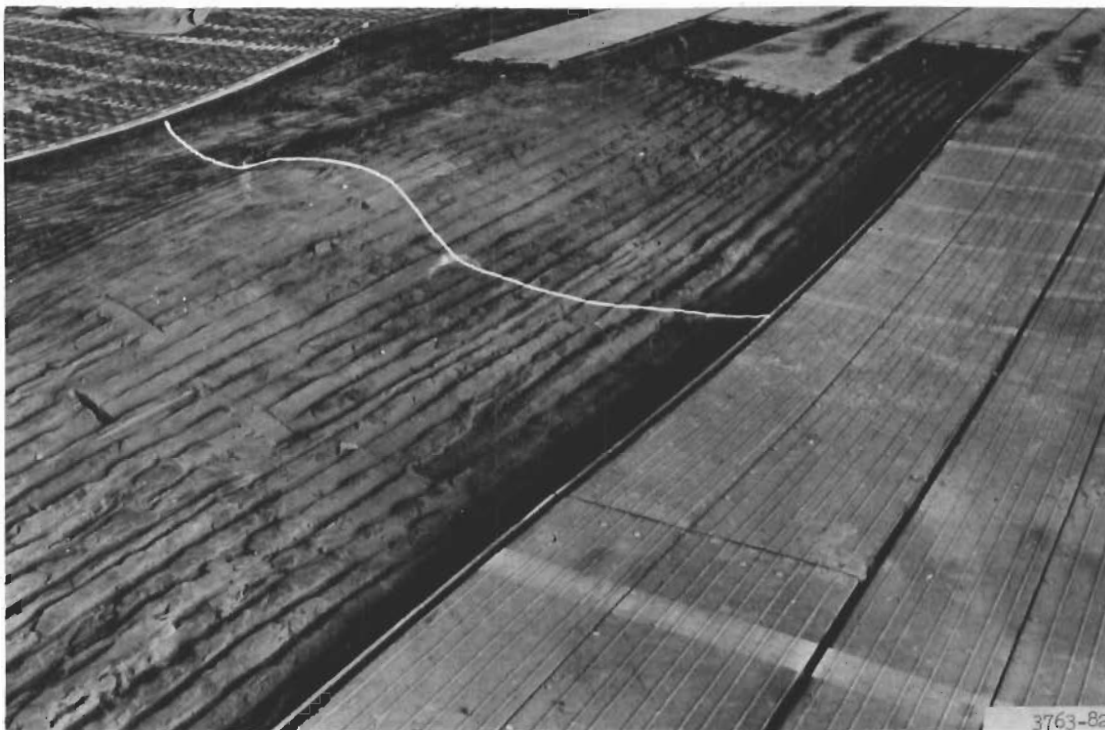
Figure 5. Lane 3, item 1, showing displaced subgrade after mat removal at 458 coverages

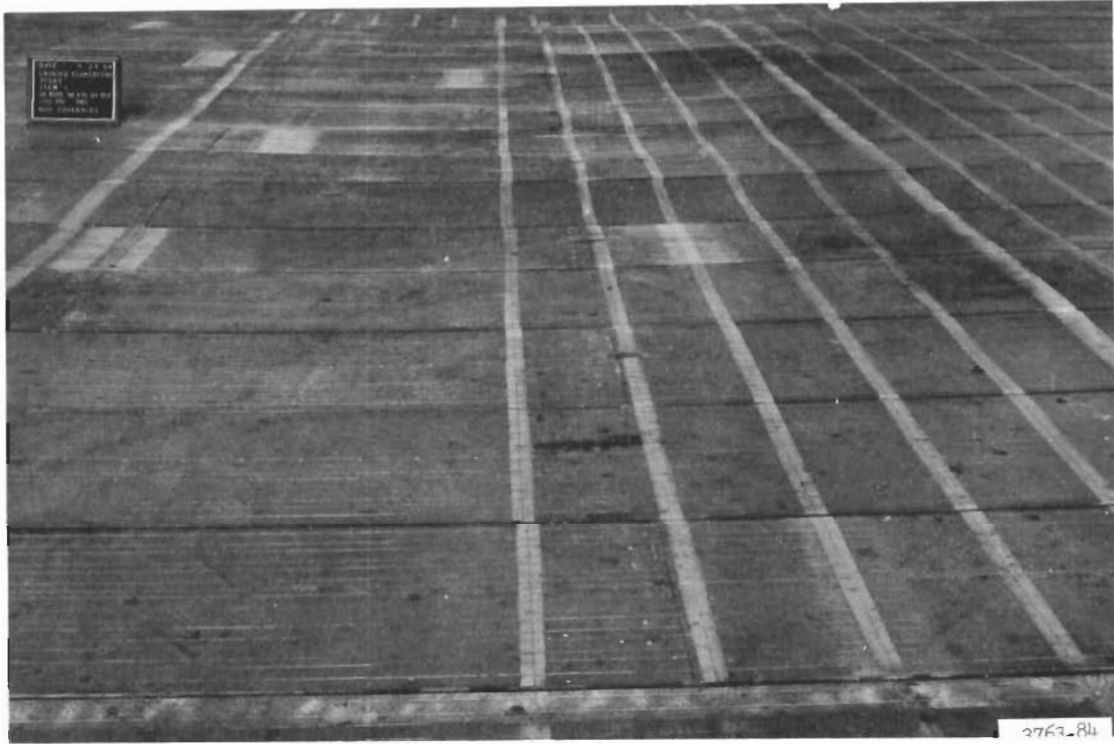
Item 1. Item 1 was considered failed due to roughness at 600 coverages. The following information was obtained from traffic tests on item 1.

- a. Roughness. At failure, the maximum transverse and diagonal differential deformations were 1.75 and 2.25 in., respectively.

Figure 6. Lane 3, item 1, at 600 coverages (failure)

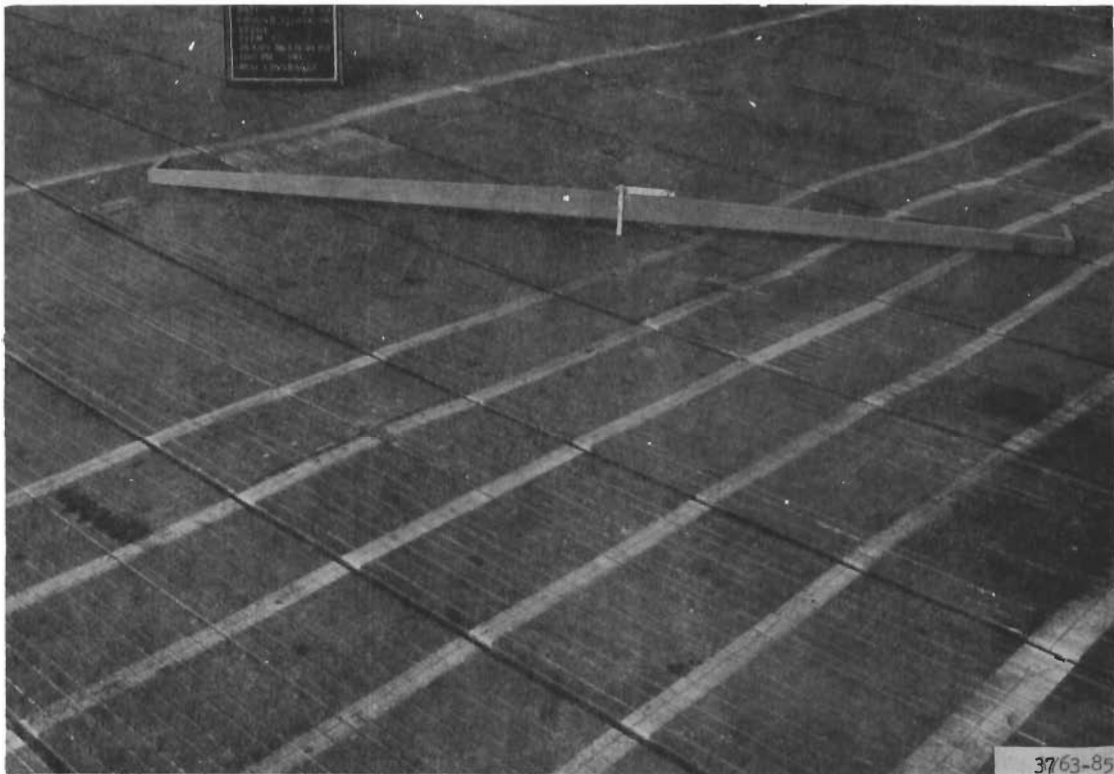
Figure 7. Lane 3, item 1; diagonal straightedge shows roughness at 600 coverages (failure)

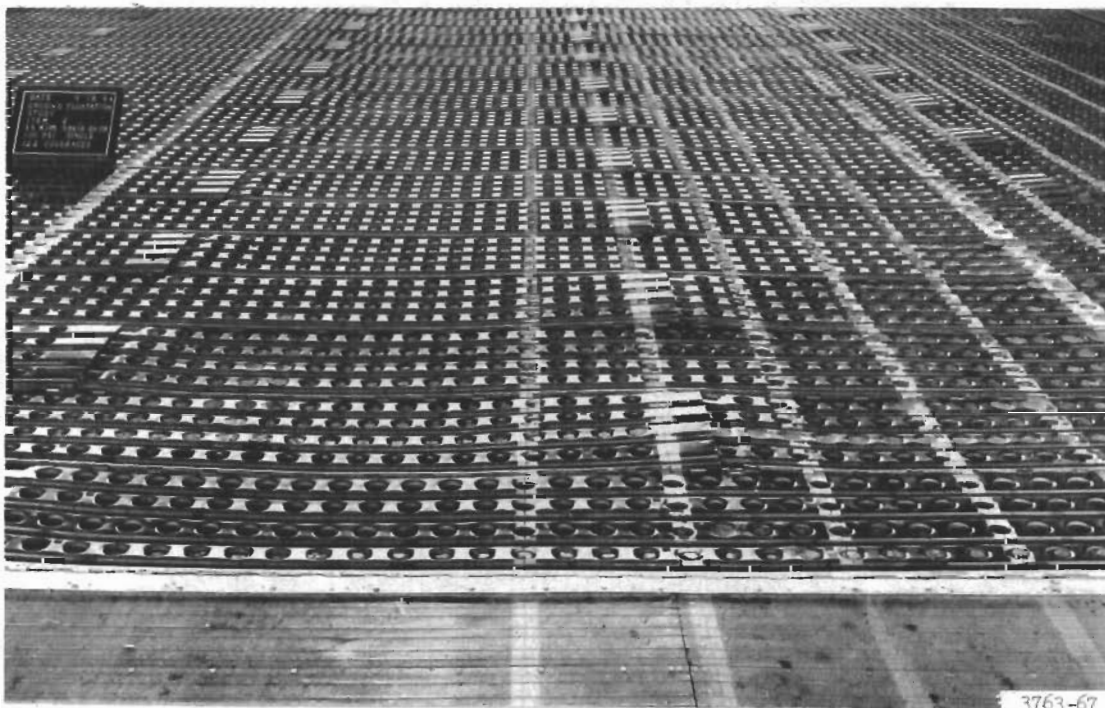
Item 2. Item 2 is shown prior to traffic in **Figure 8**. By 20 coverages, bending of the mat panels along their long axis resulted in a "standoff" of the mat from the subgrade at the end joints of the mat panels. Embedment of the mat at midpoint of the panels remained good. The ductility of the M8 mat allowed a wide variation in the degree of embedment of the ends of the mat panels. Immediately following a pass by the load wheel directly over the mat end joints, reasonable embedment was attained. However, the ends of the panels became unembedded after a pass off the line of joints. At 120 coverages, the item was considered failed due to roughness (**Figures 9 and 10**). Traffic was continued beyond 200 coverages to observe postfailure behavior of the mat (**Figure 11**). The rated CBR for item 2 was 5.1.

Figure 9. Lane 3, item 2, at 122 coverages
(2 postfailure coverages)

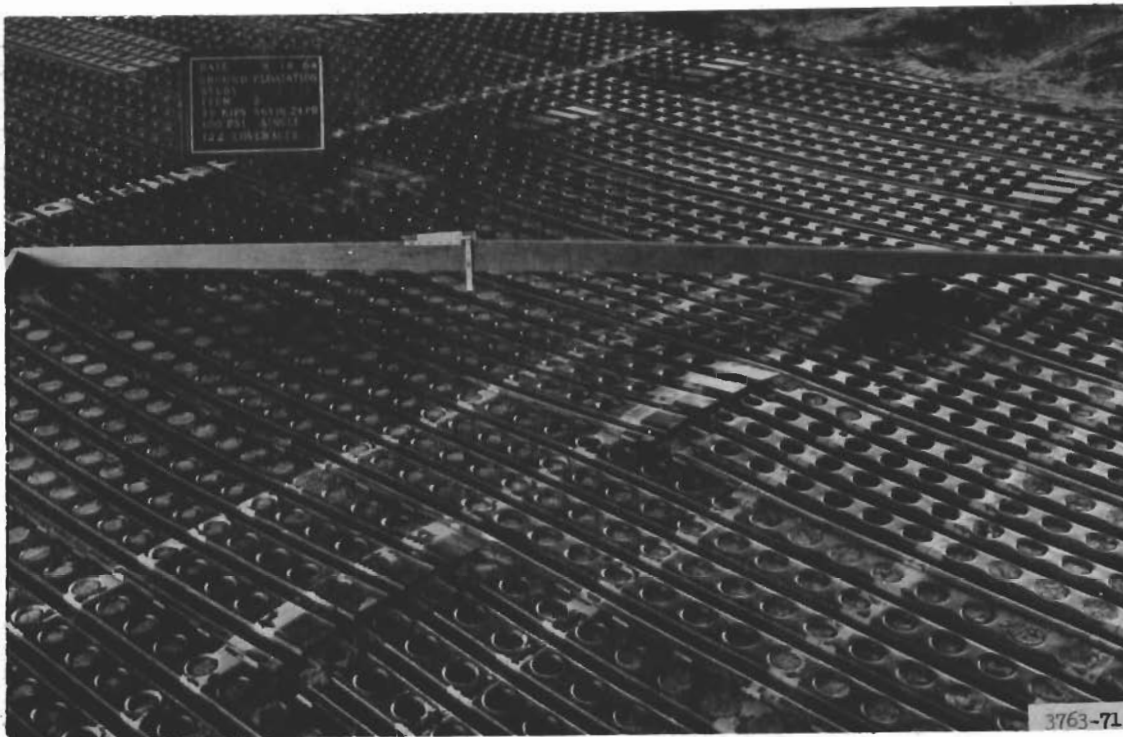
- a. Roughness. At failure, the maximum transverse and diagonal differential deformations were 1.50 and 2.00 in., respectively (table 1). Table 1 also gives differential deformation at intermediate and postfailure coverage levels. The maximum dishing for item 2 (table 1) was 0.56 in.

Figure 10. Lane 3, item 2; diagonal straightedge shows roughness at 122 coverages (2 postfailure coverages)

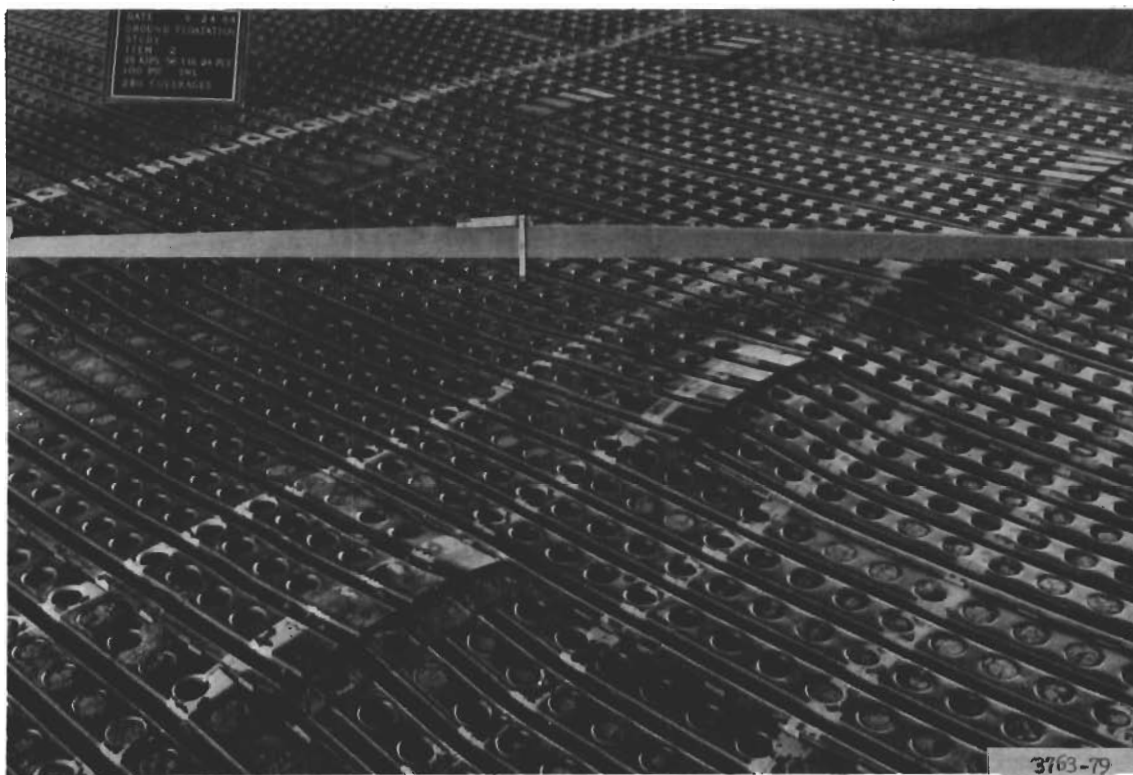
Figure 11. Lane 3, item 2; diagonal straightedge shows roughness at 280 coverages (160 postfailure coverages)

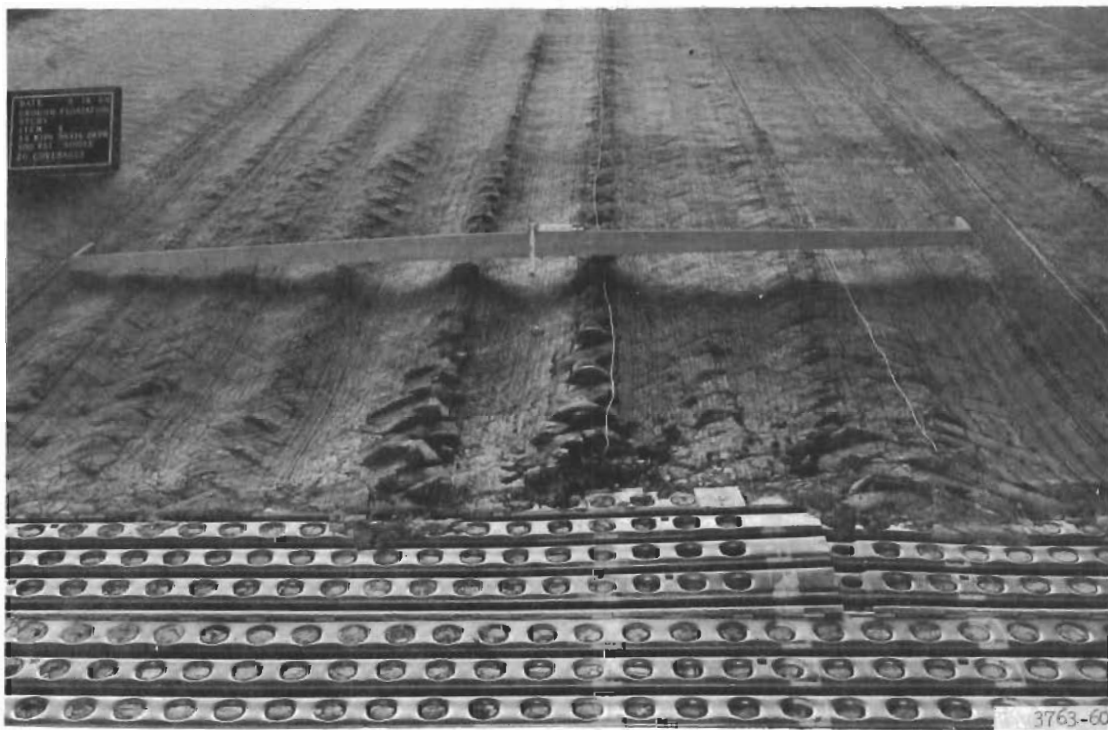
Item 3. Item 3 is shown in **Figure 12** prior to trafficking. Ruts had begun to develop by 20 coverages (**Figure 13**), and at 60 coverages the ruts were severe enough to constitute failure of the item (**Figure 14**).

Figure 13. Lane 3, item 3; transverse straightedge shows roughness at 20 coverages

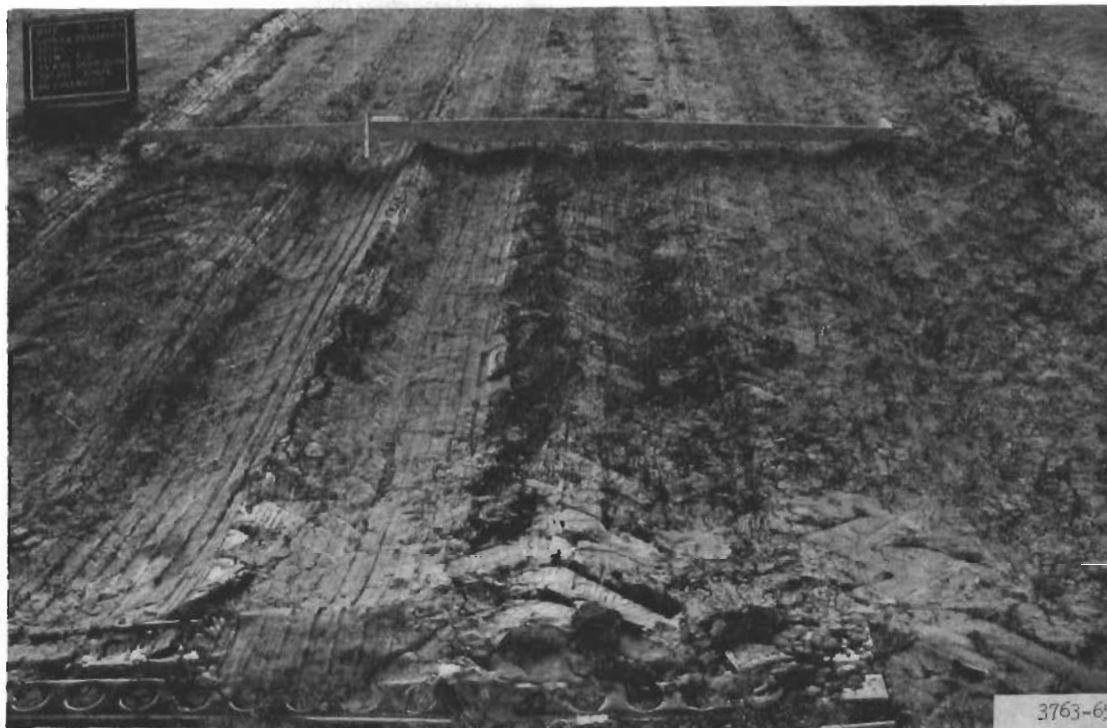
Item 3. Item 3 was considered failed due to excessive rutting at 60 coverages. Traffic was continued to 122 coverages at which time drawbar pull values were recorded and photographs were taken of the postfailure condition. The following information was obtained from traffic tests on item 3.

Figure 14. Lane 3, item 3; transverse straightedge shows roughness at 60 coverages (failure)

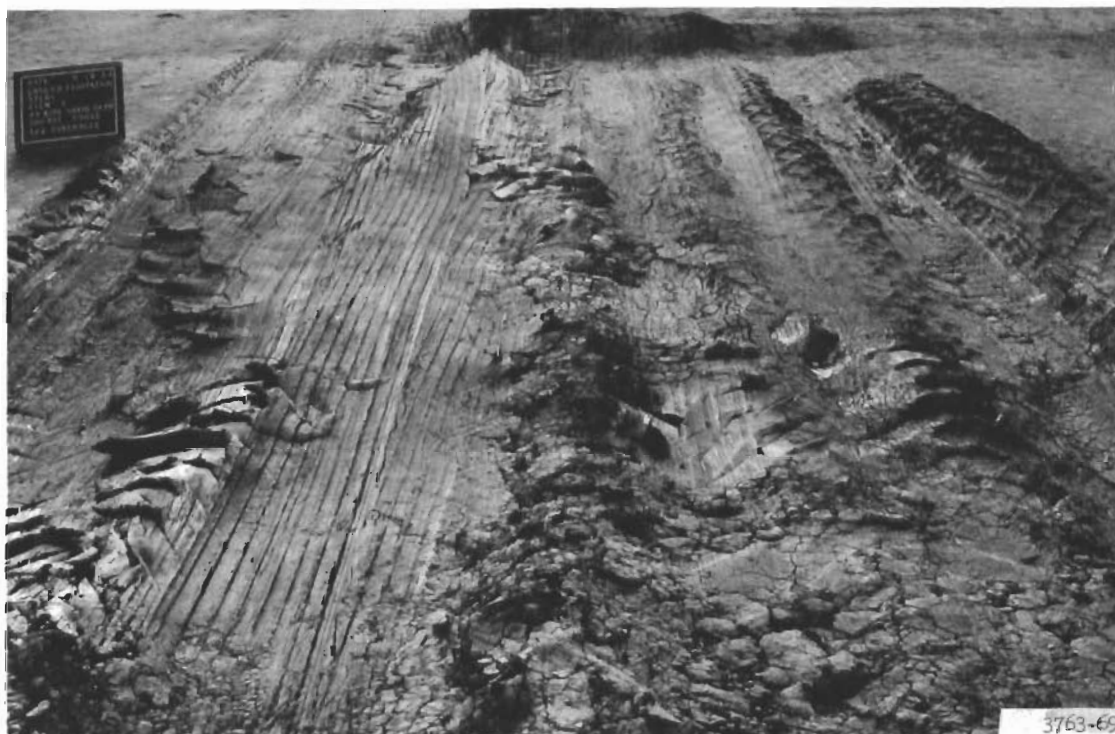
To observe postfailure behavior of the item, traffic was continued to 122 coverages. **Figure 15** shows the poor condition of the item after 62 postfailure coverages. The rated CBR of the item was 9.5.

Figure 15. Lane 3, item 3, at 122 coverages (62 postfailure coverages)

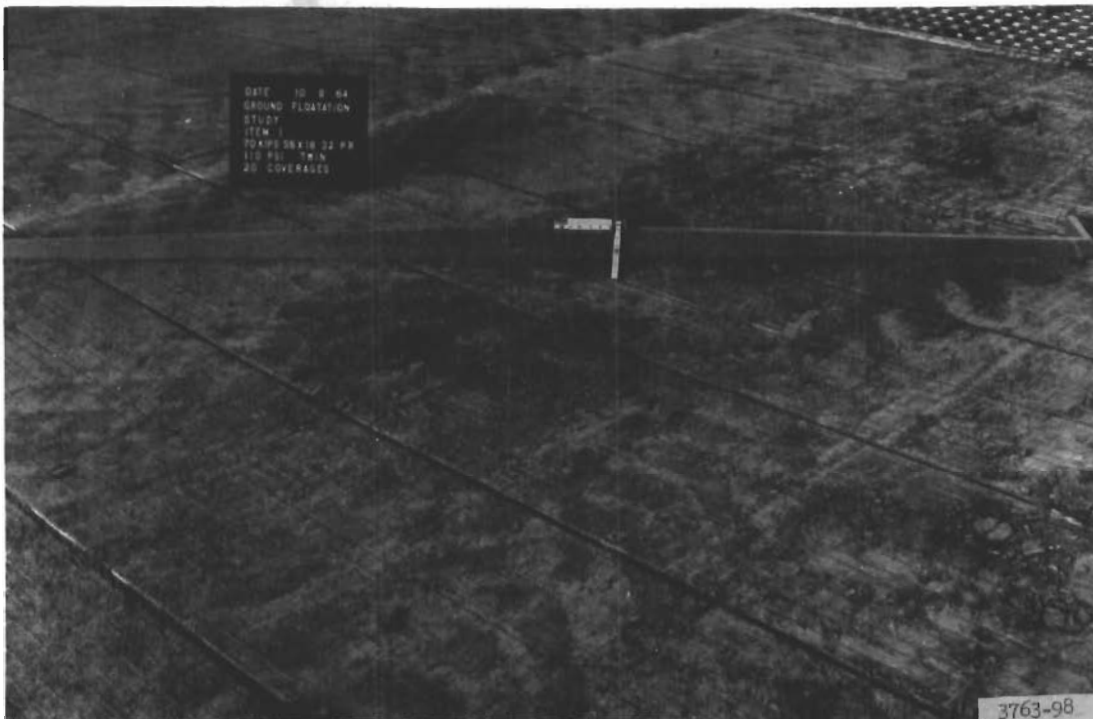
Item 1. Item 1 prior to traffic is shown in **Figure 16**. At 12 coverages, mat breaks were observed, especially along the center lines of the panels where sheared rivets were common. Types and number of mat breaks are given in table 1. Deterioration of the mat was rapid with additional traffic coverages and the item was considered failed due to roughness and subgrade failure at 20 coverages (**Figures 17 and 18**). The rated CBR was 2.3.

- a. Roughness. At failure, the maximum differential deformations exceeded 3 in. for each position of the 10-ft straightedge. A maximum diagonal differential deformation of 4 in. was recorded. Dishing of individual panels was pronounced, reaching a maximum of 1.8 in.

Figure 17. Lane 4, item 1, at 20 coverages (failure)

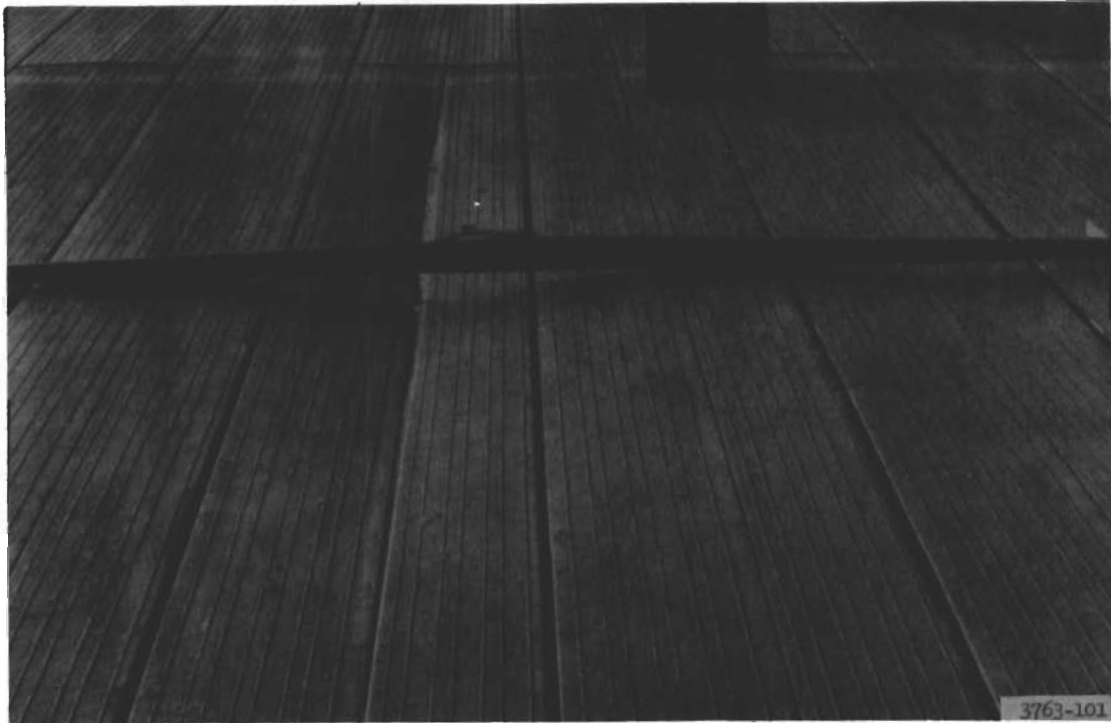
Figure 18. Lane 4, item 1, broken panel in run
15 at 20 coverages (failure)

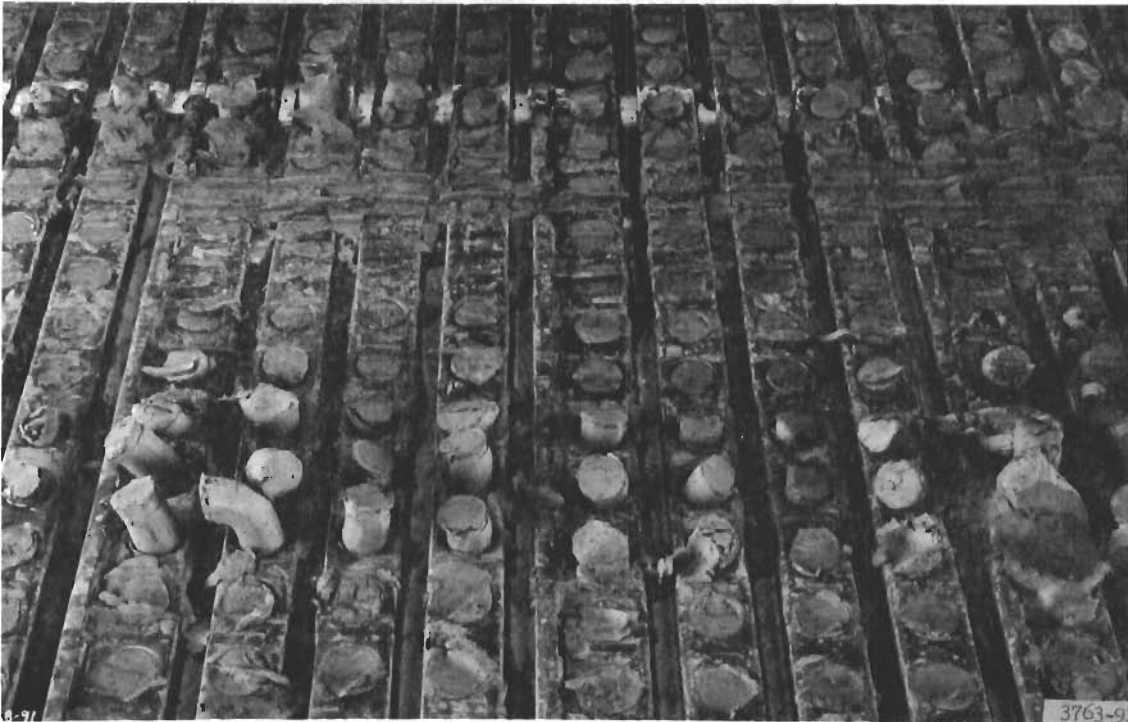
Item 2. Item 2 prior to traffic is shown in **Figure 19**. Preliminary passes of the load cart over the item to record drawbar pull data caused considerable extrusion of subgrade soil through the tubular holes of the M8 mat, as shown in **Figure 20**. At 20 coverages the item was

Figure 20. Lane 4, item 2, after two passes of load vehicle, showing extruded soil

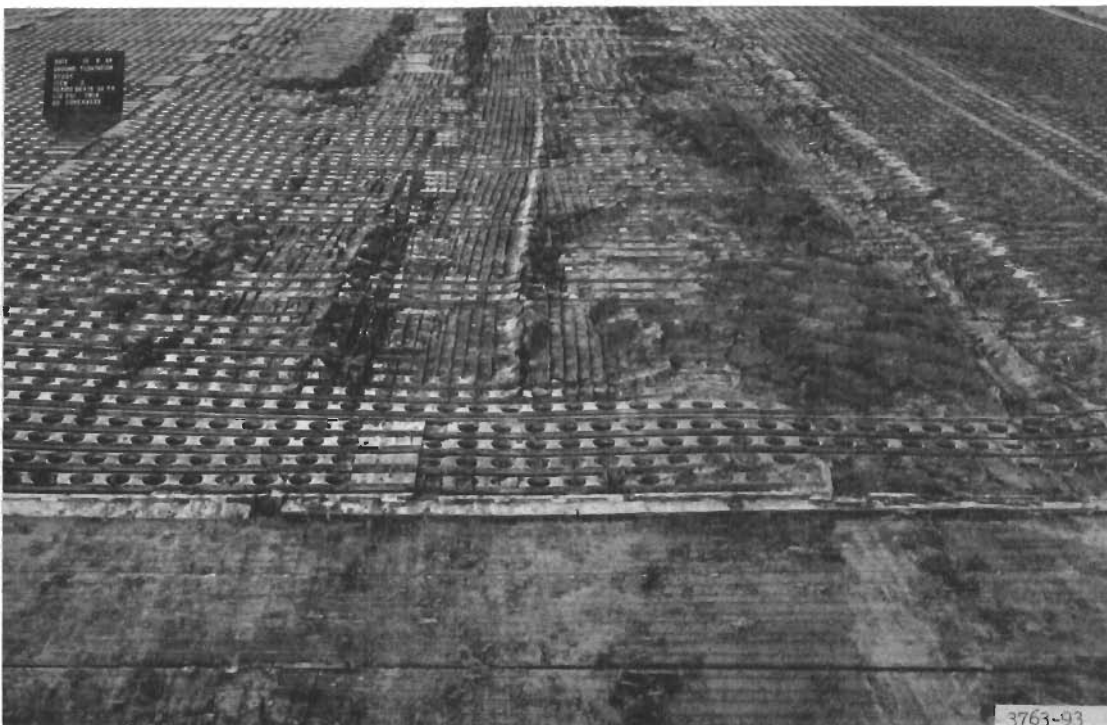
considered failed due to the large amount of subgrade extrusion which caused surface roughness and mat deformations (**Figures 21 and 22**). No mat breakage was found at failure. **Figure 23** shows the deformed mat surface after removal of the extruded soil. The rated CBR of the item was 3.6.

Item 2. Item 2 was considered failed due to roughness at 20 coverages. A large amount of soil was extruded through the M8 mat holes, thus contributing to roughness through uneven subsidence of the mat and buildup of soil on the mat surface. The following information was obtained from traffic tests on item 2.

Figure 21. Lane 4, item 2, at 20 coverages (failure)

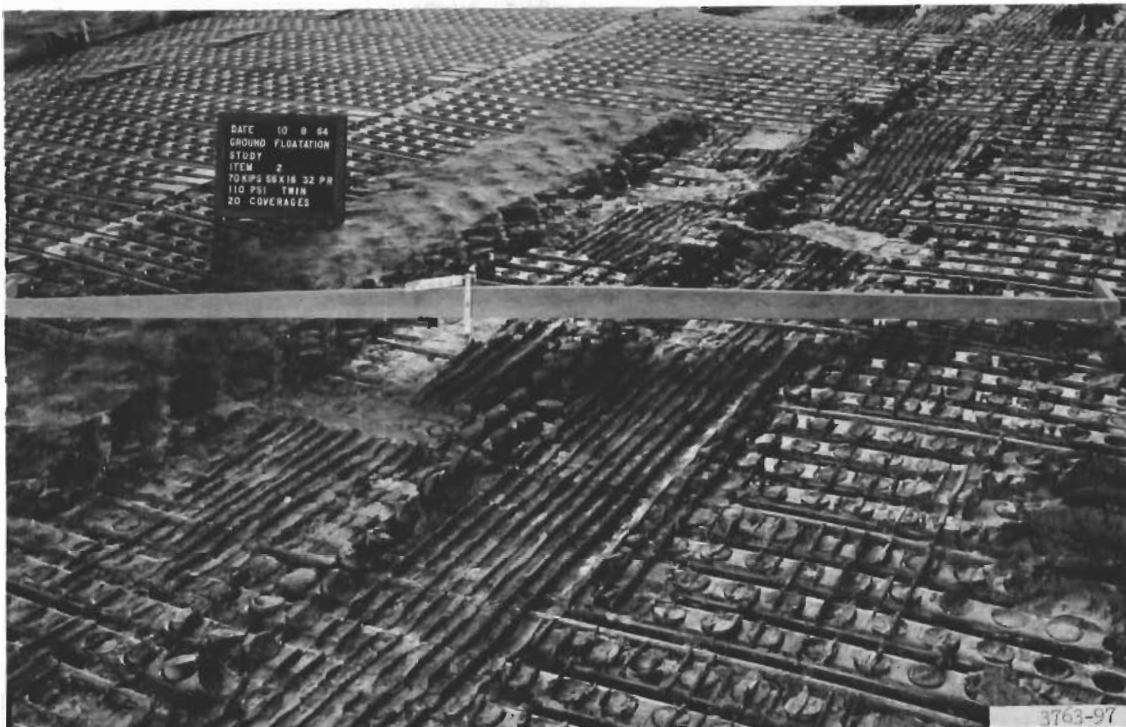
a. Roughness. At failure, the maximum transverse and diagonal differential deformations were 3.1 in. (table 1). Dishing of individual panels was slight, reaching a maximum of 0.5 in. at 20 coverages.

Figure 22. Lane 4, item 2; diagonal straightedge shows roughness at 20 coverages (failure)

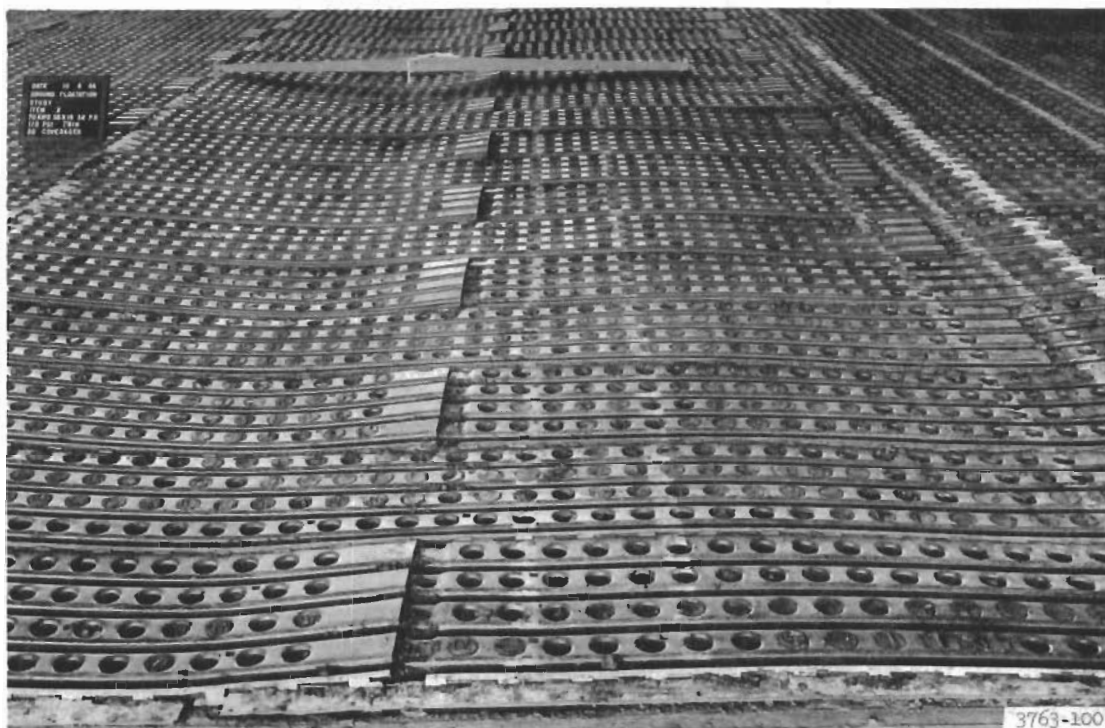
Figure 23. Lane 4, item 2, at 20 coverages (failure) after removal of extruded soil

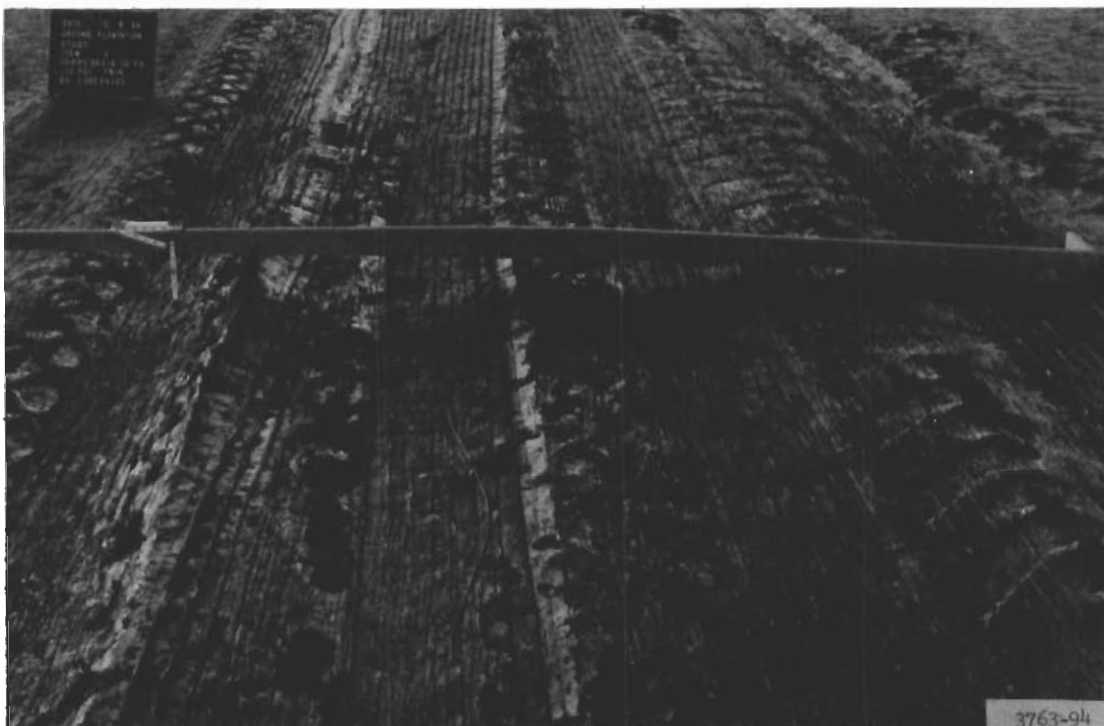
Item 3. **Figure 24** shows item 3 prior to traffic. At 20 coverages the item was considered failed due to severe rutting (**Figure 25**). The rated CBR for the item was 10.

a. Roughness. Maximum transverse and diagonal differential deformations (table 1) reached 5.8 and 5.1 in., respectively, at 20 coverages. Rut depth was 5.6 in. at failure.

Figure 25. Lane 4, item 3; transverse straightedge shows rutting at 20 coverages (failure)
