## SERVICE FAILURE ANALYSIS INVOLVING BRITTLE CRACKING MECHANISMS

Lt. W. F. Payne  
Applications Laboratory

ASD TDR 62-396

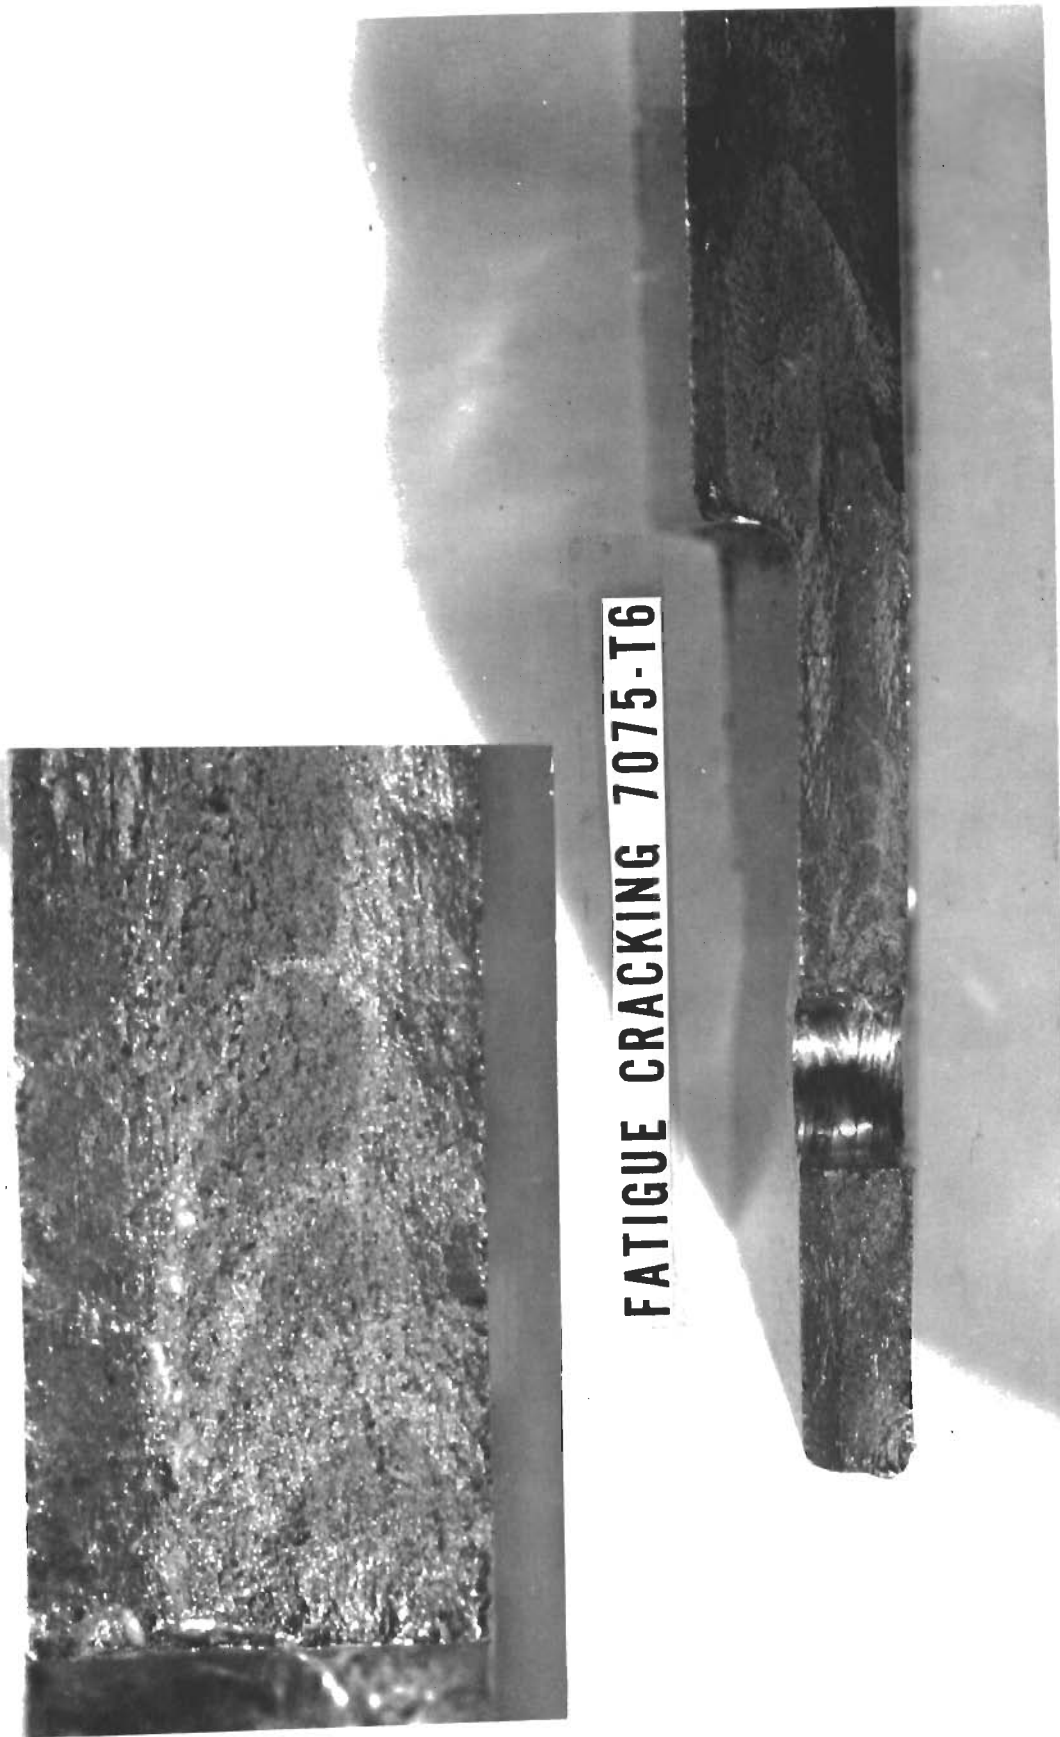
Figure 4. Low Cycle-High Stress Fatigue

For comparison, figure 4 shows the fracture surface of a structural panel where fatigue cracking occurred during a high stress-low cycle loading profile. The origin is again at the surface but the symmetrical progression markings have a much rougher texture and a different interpretation. Once fatigue cracking was permanently initiated by the rough machined surface, the maximum stresses in the loading profile were enough to initiate normal slow crack growth for a short time (the dark fracture areas) and this was followed by another stage of fatigue cracking (the shiny fracture areas). The next stress peak caused an additional slow crack progression stage, followed by another stage of fatigue cracking, and so forth. Thus, for this case of high stress-low cycle fatigue cracking, the symmetrical progression markings indicate actual changes in cracking mechanisms, from slow crack growth to fatigue cracking. The crack front was halted, in this example, as it advanced into a region where the stresses were too low to sustain fatigue cracking.

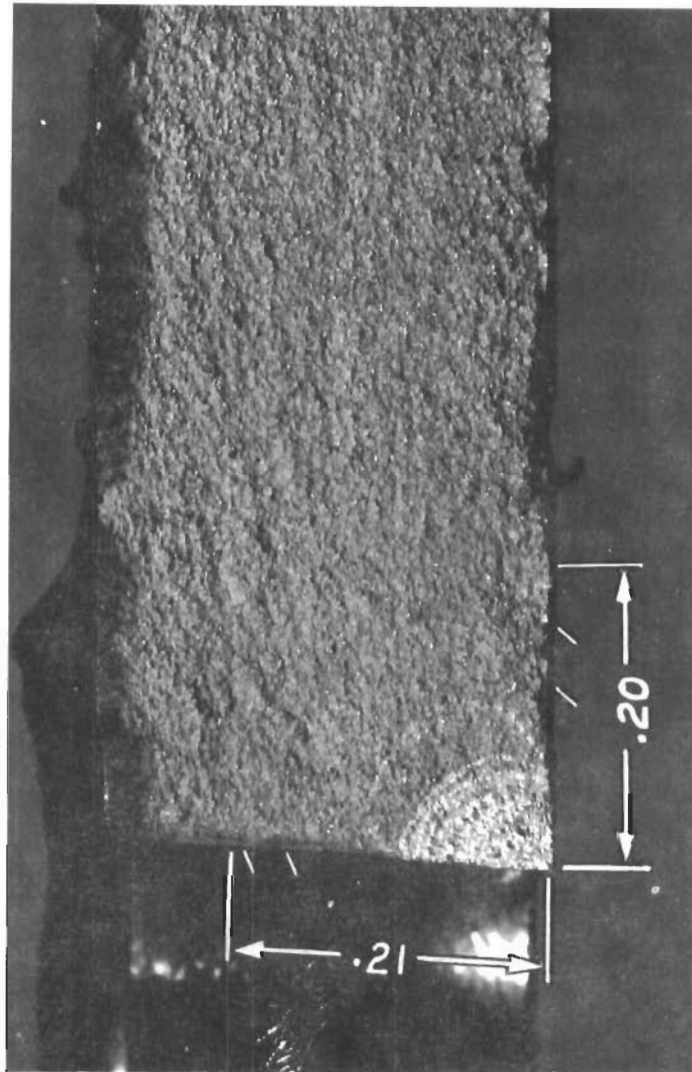
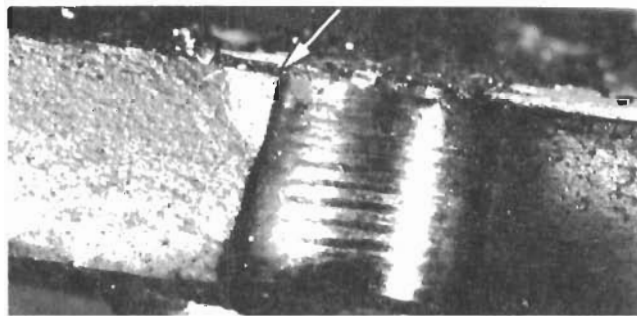
Figure 5. Catastrophic Failure Integral Wing Skin Panel Low Cycle-High Stress Fatigue

The most extensive damage from fatigue cracking (including catastrophic failure) has occurred when the problem of fatigue was not anticipated. Figure 5 shows the fractured surface of a high strength aluminum alloy skinplate with a fatigue crack originating at the bottom of a bolt hole. The presence of this small fatigue crack initiated a catastrophic failure of an entire wing during flight and resulted in loss of several lives and an aircraft worth several million dollars. The actual fatigue crack is far too small to be detected in real aircraft with present inspection capability and this structural design is an unreliable design -- the price paid for excessive notch sensitivity of an alloy for the given design. The problem of acoustical fatigue, first encountered with resonant vibration of turbine blades, is becoming more severe for structural skins with the increasing noise level of propulsion systems, and is a source of fatigue cracking occasionally overlooked.

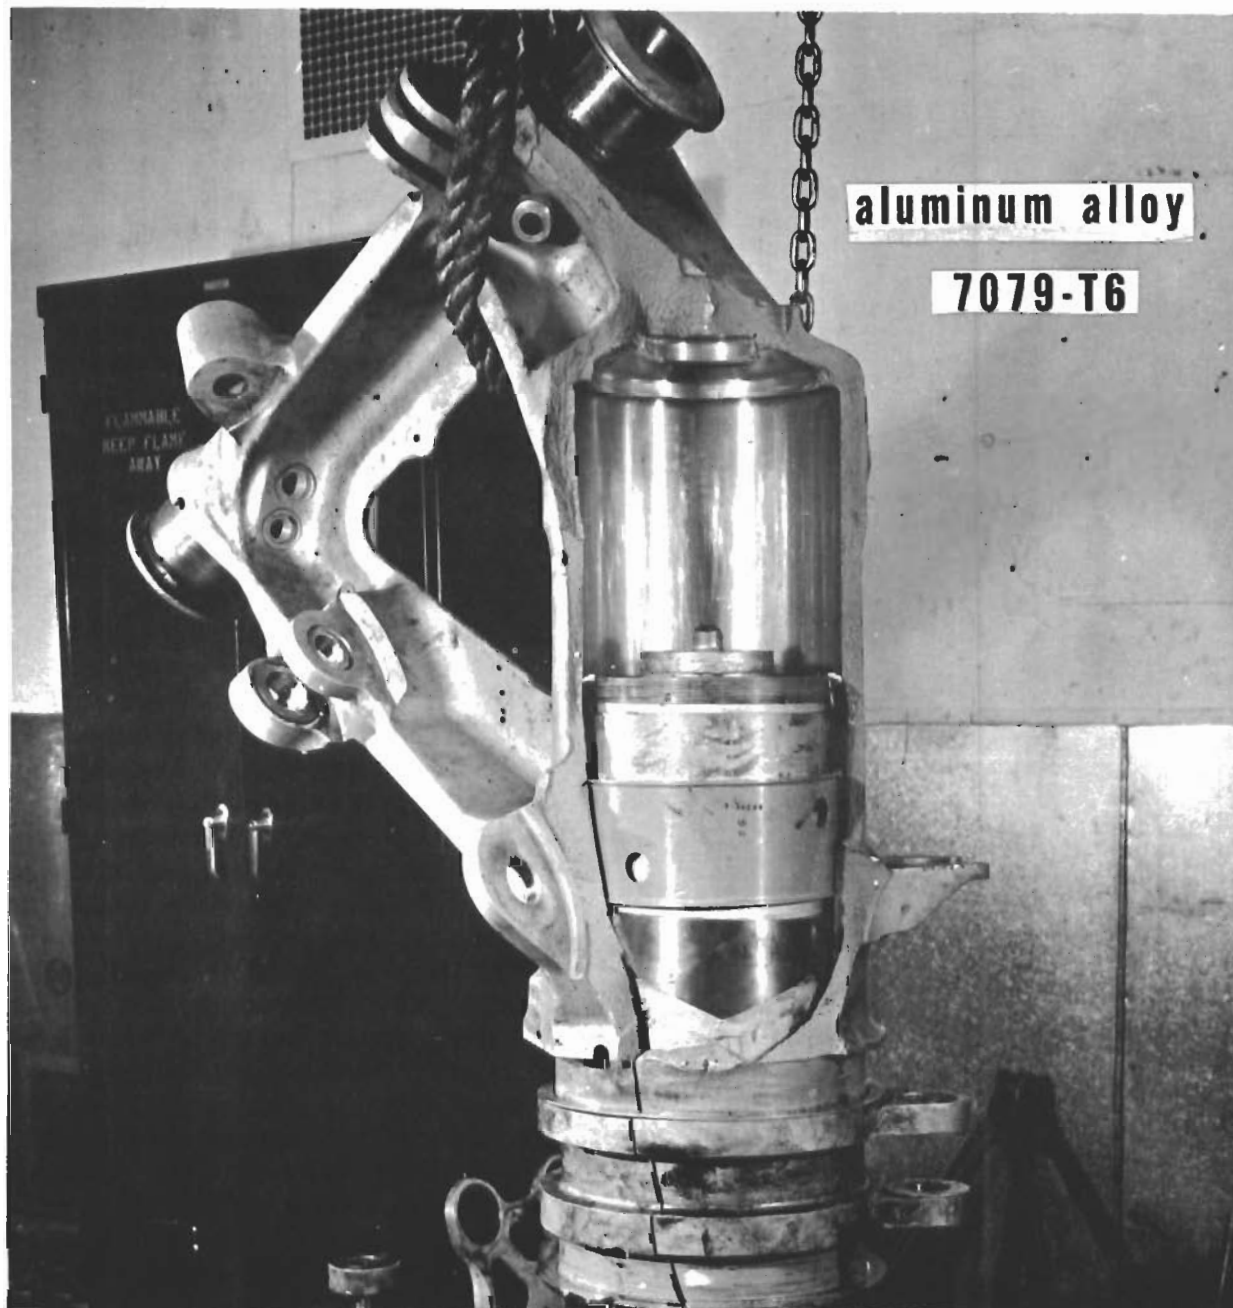
Figure 8. Stress Corrosion Cracking Landing Gear Cylinder

This type of corrosion involves a complex interaction of sustained tension stress and corrosive attack that results in rapid cracking and the premature brittle failure of a normally ductile material. As a general phenomena, many metallic systems (from pure metals to commercial alloys) can be susceptible to stress corrosion cracking under certain environmental conditions. For example, the chemical process industry, with the variety of acids, chlorides and other active chemicals, frequently in hot aqueous solutions, has a long history of stress corrosion cracking problems in metallic structures, as well as general corrosion deterioration. Casual awareness of these and similar industrial problems, and the observation that laboratory stress corrosion cracking investigations are performed in apparently very corrosive media (such as boiling salt solution, with questionable correlation with normal atmospheric service conditions) has apparently led designers and materials engineers to the belief that the environment associated with normal atmospheric flight conditions is simply not corrosive enough to induce stress corrosion cracking in structural metals. Nothing could be farther from the truth. This is due to the increased susceptibility of high strength alloys, and often to the occurrence of unexpectedly severe corrosive conditions, while processing chemicals during manufacture, or salt on wet runways during winter deicing. The continuing occurrence of stress corrosion failures in service has frequently affected the operational reliability of many important weapons systems. The appearance of educational features by Alcoa (2) in national engineering publications indicates the importance of the problem. An example of structural damage in the outer cylinder of a main landing gear shown in figure 8 is attributed to stress corrosion cracking.

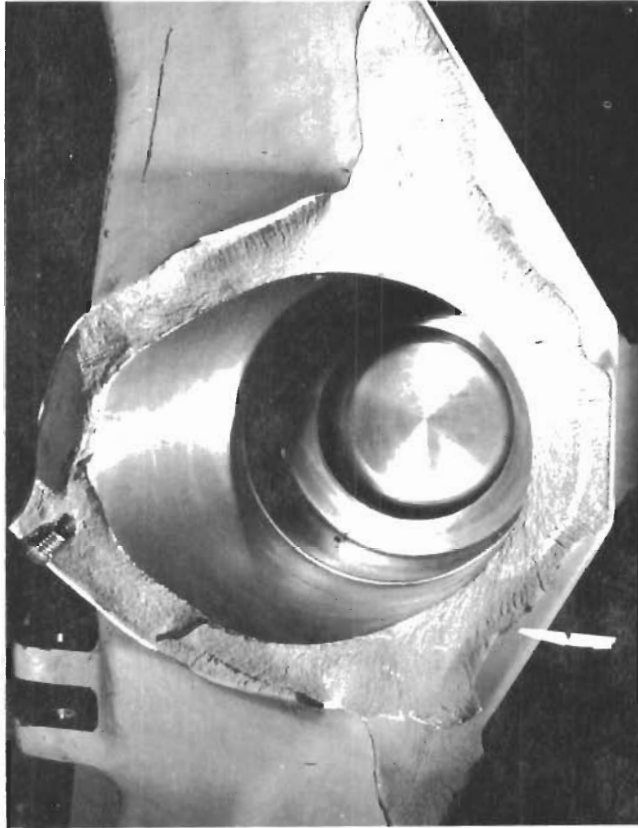
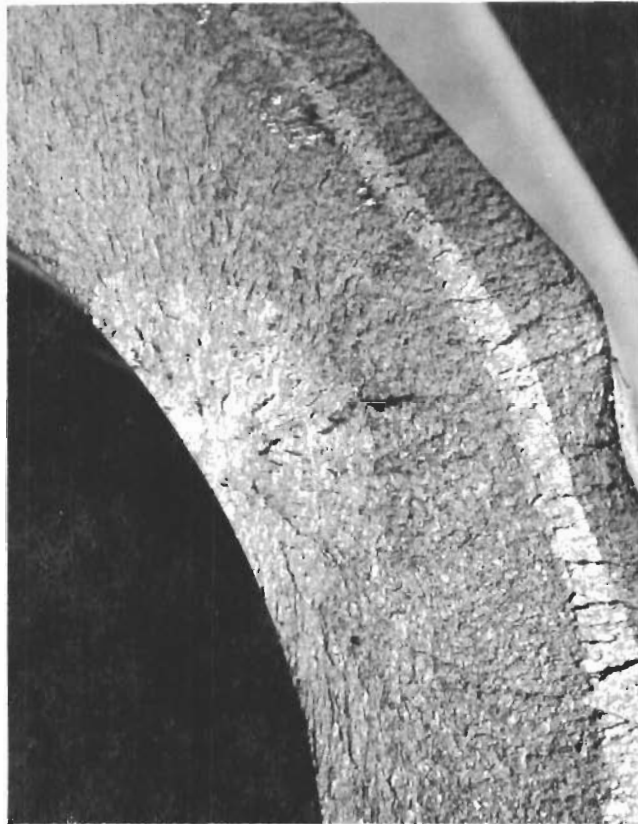
Figure 14. Stress Corrosion Cracking - Main Landing Gear

The fractural landing gear cylinder shown in figure 14 was presumably exposed only to hydraulic fluid, possibly containing slight water contamination. Note that two distinct stress cracking zones are evident, separated by a zone of overload crack propagation which apparently was halted by reduction of the load acting on the landing gear. Experience shows that internal surface cracks such as the first cracking stage can be caused by processing chemicals reacting with high residual stresses. However, in this case, certainly the second stress corrosion cracking zone must be attributed to the impure hydraulic fluid, and perhaps the fluid was the "corrosive media" for the entire fracture.

MULTIPLE CRACKING STAGES 7075 - T6

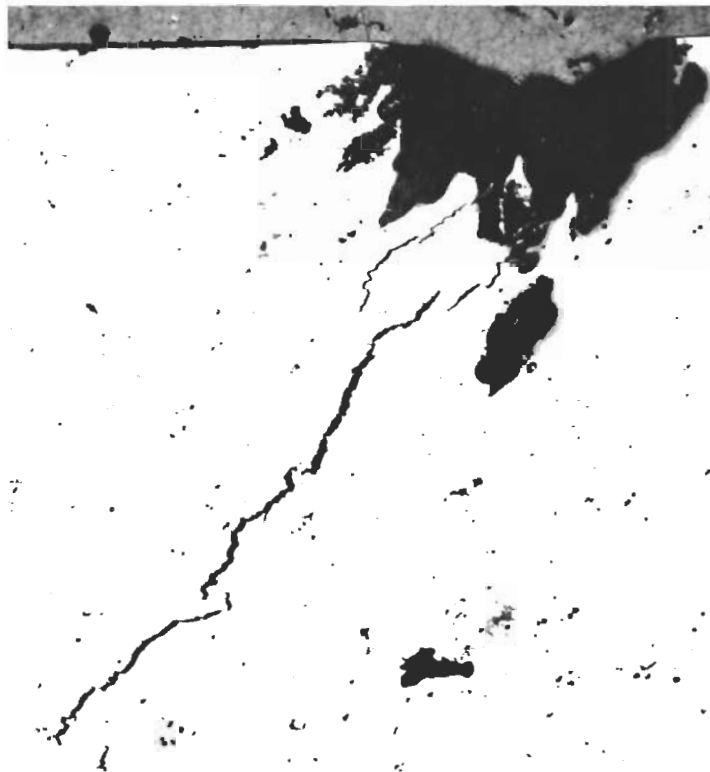
Figure 15. Interaction of Surface Pits With Stress Corrosion Cracking Mechanism (7079-T6 Aluminum Alloy)

The cracking shown in figure 15 demonstrates a frequently observed behavior in hardware failures - that conditions for stress corrosion cracking is actually associated with the existence of surface pits. Probably the stress concentration effects and altered (more severe) chemistry associated with a surface pit are the real cause for stress corrosion failures in many cases. Certainly, no stress corrosion susceptibility tests have been made in aluminum alloys that simulate this condition and this is an area where fundamental corrosion mechanism research is urgently needed.

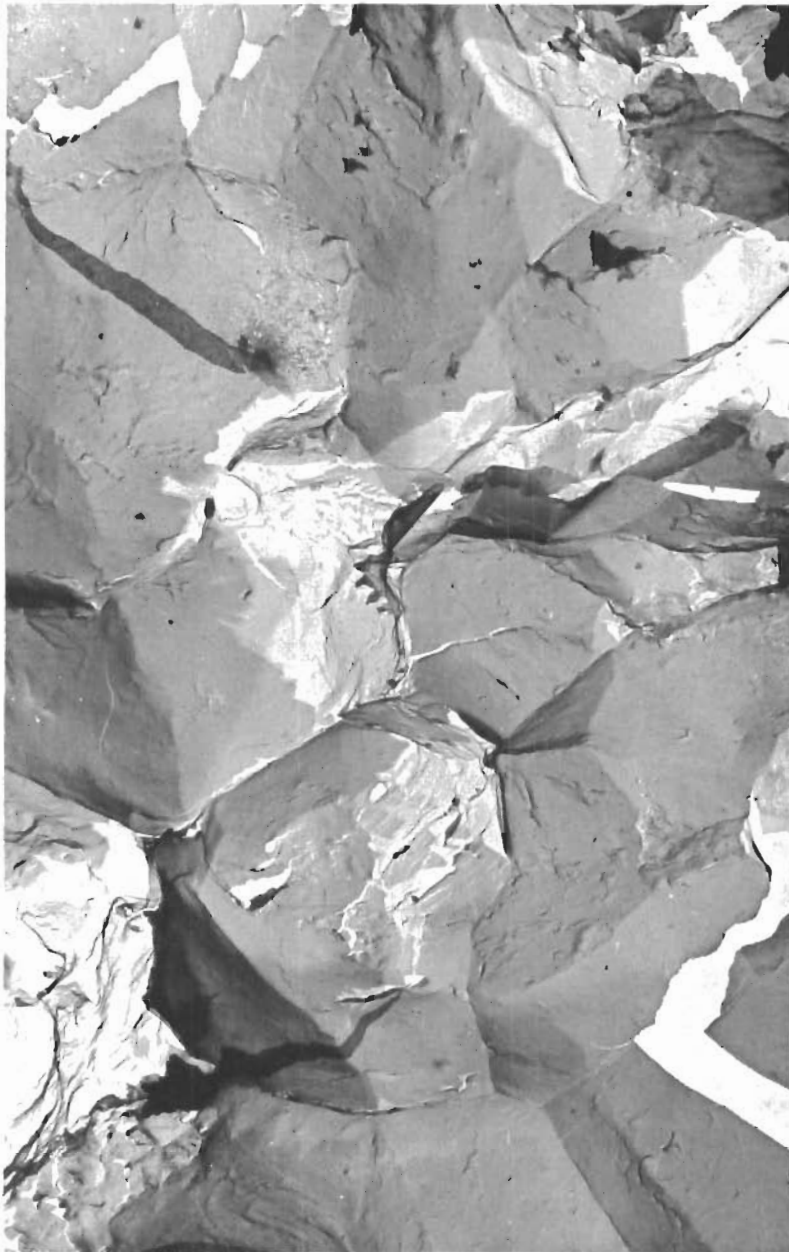
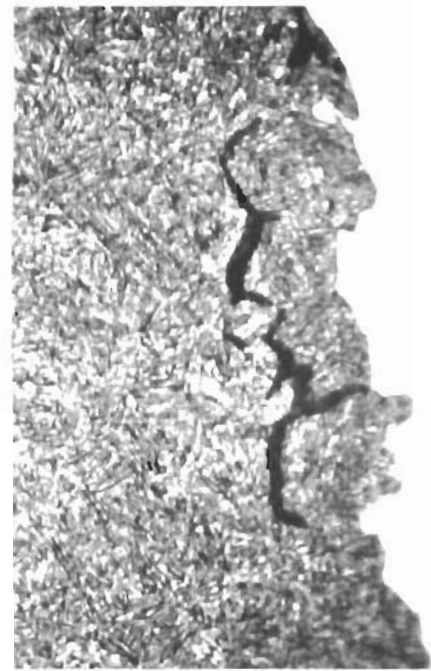
Figure 16. Stress Corrosion Fracture of Landing Gear Axle (AISI 4340 Heat Treated to 260-280 ksi UTS)

fractures in steel is more clearly shown in the electron microscope photograph of a fracture surface replica included as figure 16. Unfortunately, the relationship between the stress corrosion processes and the hydrogen embrittlement processes in low alloy steels is completely unresolved, and represents probably the most urgent area for additional corrosion research.

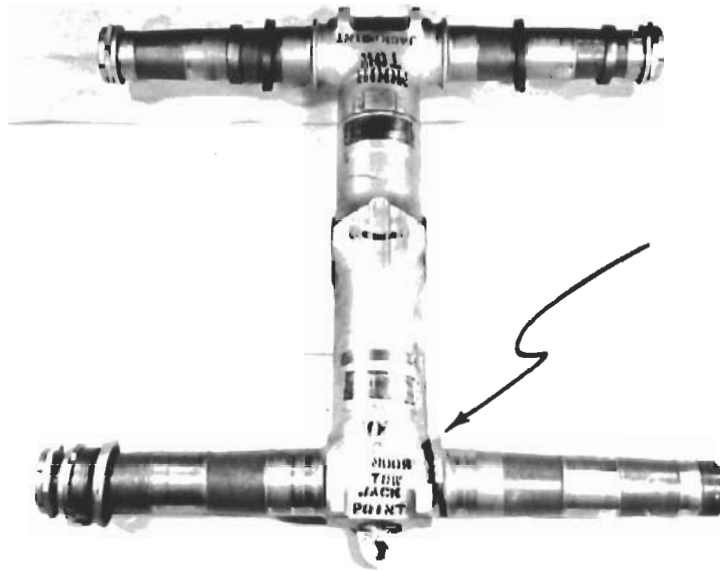
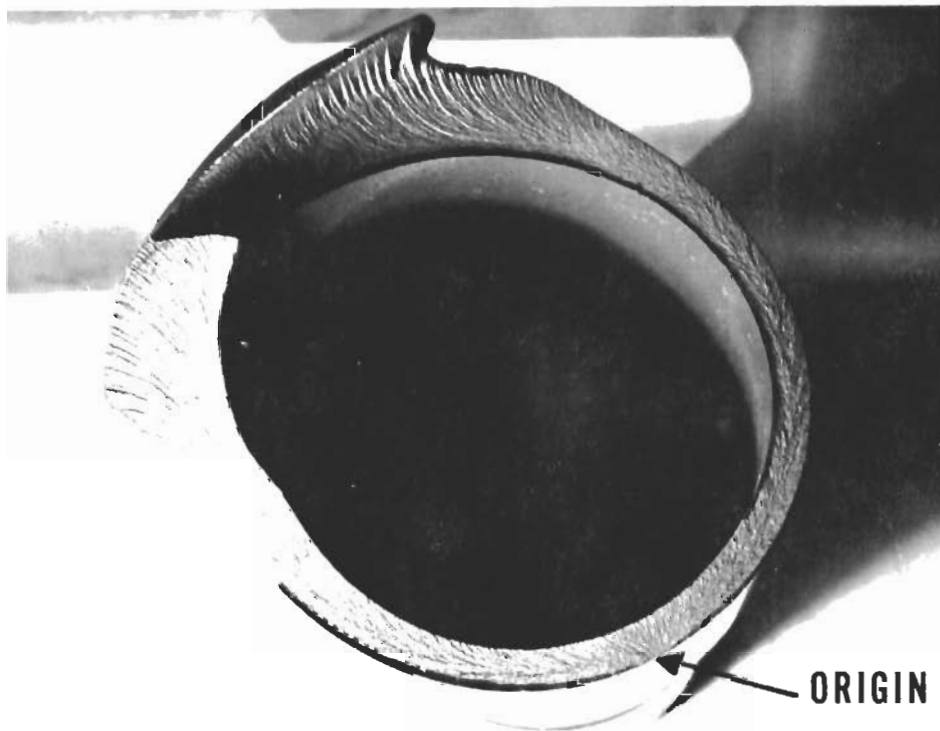
Figure 23. Axle Beam Failure

Then in 1961 a failure occurred during a jacking operation after only a dozen landings and a picture of the broken axle beam is shown in figure 23 (a). Figure 23 (b) shows a view of the fracture face and the point of origin that occurred in the radius of the lower fillet. The primary cause of the failure was overheating during grinding operations (grinding "burns") resulting in severe surface damage shown in figure 24. A surface layer of untempered martensite (Rc55) up to 0.001 inch deep was noted in several places, with a subsurface layer of overtempered martensite (Rc36 or 170 ksi tensile strength) several thousands of an inch in depth (up to 0.010 inches in places) the base metal hardness was Rc51. Thus, the surface damage was capable of initiating a surface crack large enough to cause complete fracture of a 0.23-inch thick forging at a stress well below the yield strength.

(a) View of Fractured Axle Beam 7/61 AISI 4340 (260-280 ksi UTS)

(b) Fracture Origin (Lower Radius) of Axle Beam 7/61

By this point, a general rework program had been initiated to remove the surface damage, and qualification tests on the reworked gears indicated at least a 100 percent improvement in life. Out of five gears tested, four gears lasted between 16,000 - 18,000 cycles and a fifth gear, lasted 33,000 cycles to failure. This last result is typical of the improvements obtained with proper control of grain flow (orientation of the longitudinal grain flow in the direction of maximum load or in this case parallel to axis of the axle). The grain flow of the majority of the gears was random in the critical fillet area, with a coarse dendritic structure, which is far from the optimum forged condition, particularly for good transverse ductility. Note, however, that the expected life time was experimentally determined based on gears with random grain flow and the safety factor for lifetime of the reworked gears was about five. The gears again appeared satisfactory from an engineering standpoint.

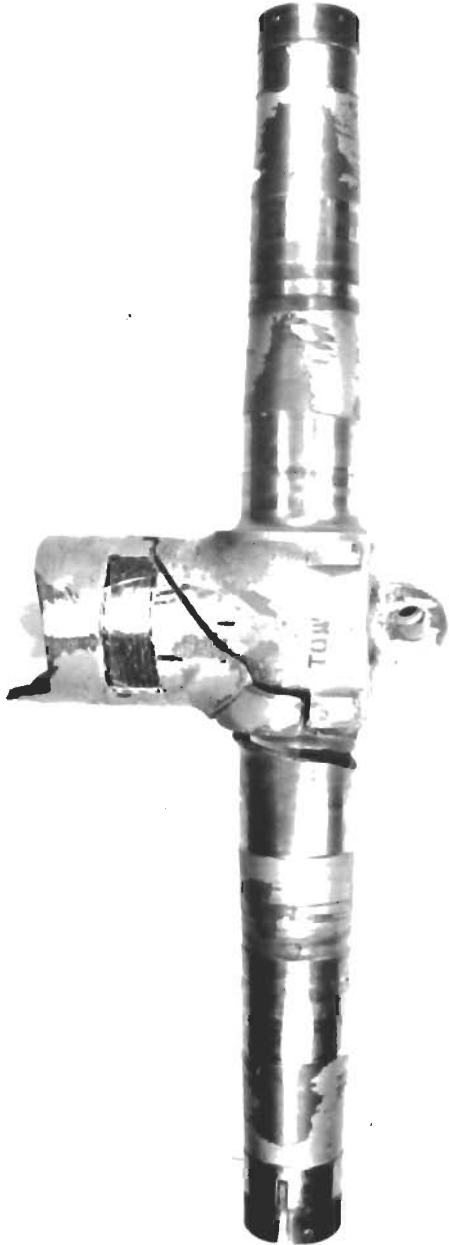
Figure 25. View of Fractured Axle Beam 9/61 AISI 4340 (260-280 ksi UTS)

In September, 1961, an axle fractured during normal take-off, but the fracture surfaces were damaged by impact and hindered the investigation. The fractured beam is shown in figure 25. Several intergranular cracks were noted near the fracture origin, up to .005 inches deep; see figure 26. Only one small area of surface damaged by grinding burns was found and this area was not associated with the failure. The intergranular cracking caused concern that stress corrosion cracking was present, which would indicate a fleet wide problem. The fillet surfaces had been thoroughly shot peened but were not coated and some minor surface pitting was evident with a 10X inspection. The possibility of hydrogen embrittlement, temper embrittlement from heat radiation effects during hard braking operations or corrosion fatigue were also suggested.

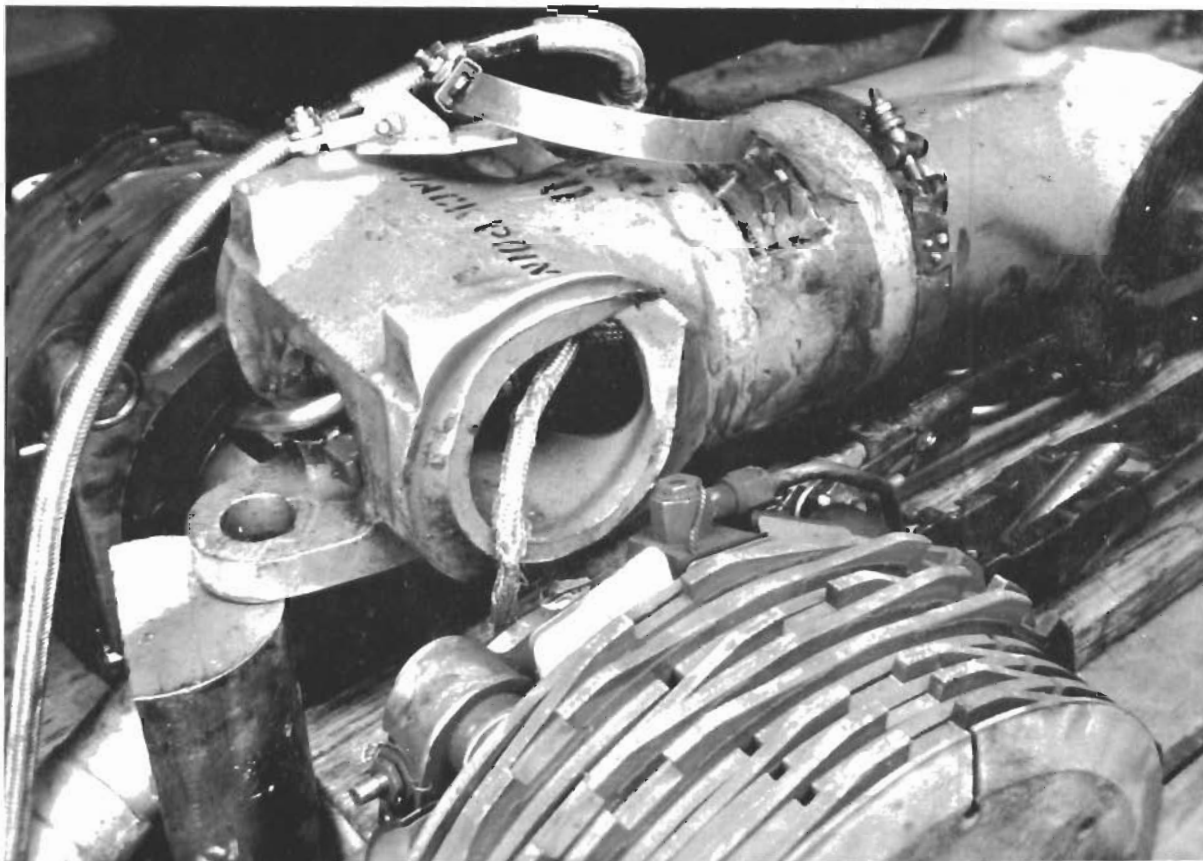
Figure 27. Axle Beam Failure 11/61 AISI 4340 (260-280 ksi UTS)

In November, 1961, both forward axles of one H beam catastrophically fractured one after the other while the crew was climbing into the aircraft (rather bad for the morale factor!) The estimated stress in the fillet was about 135 ksi at the time of initial failure. These gears had also been reworked to remove grinding burns and failure in both axles occurred in the high stress lower fillet area (see figure 27). The surface condition was uncoated shot peened steel but no serious rusting was evident. No evidence of grinding burns could be found in the primary failure and the secondary axle failure appeared to be a normal ductile failure caused by overload following the primary failure.

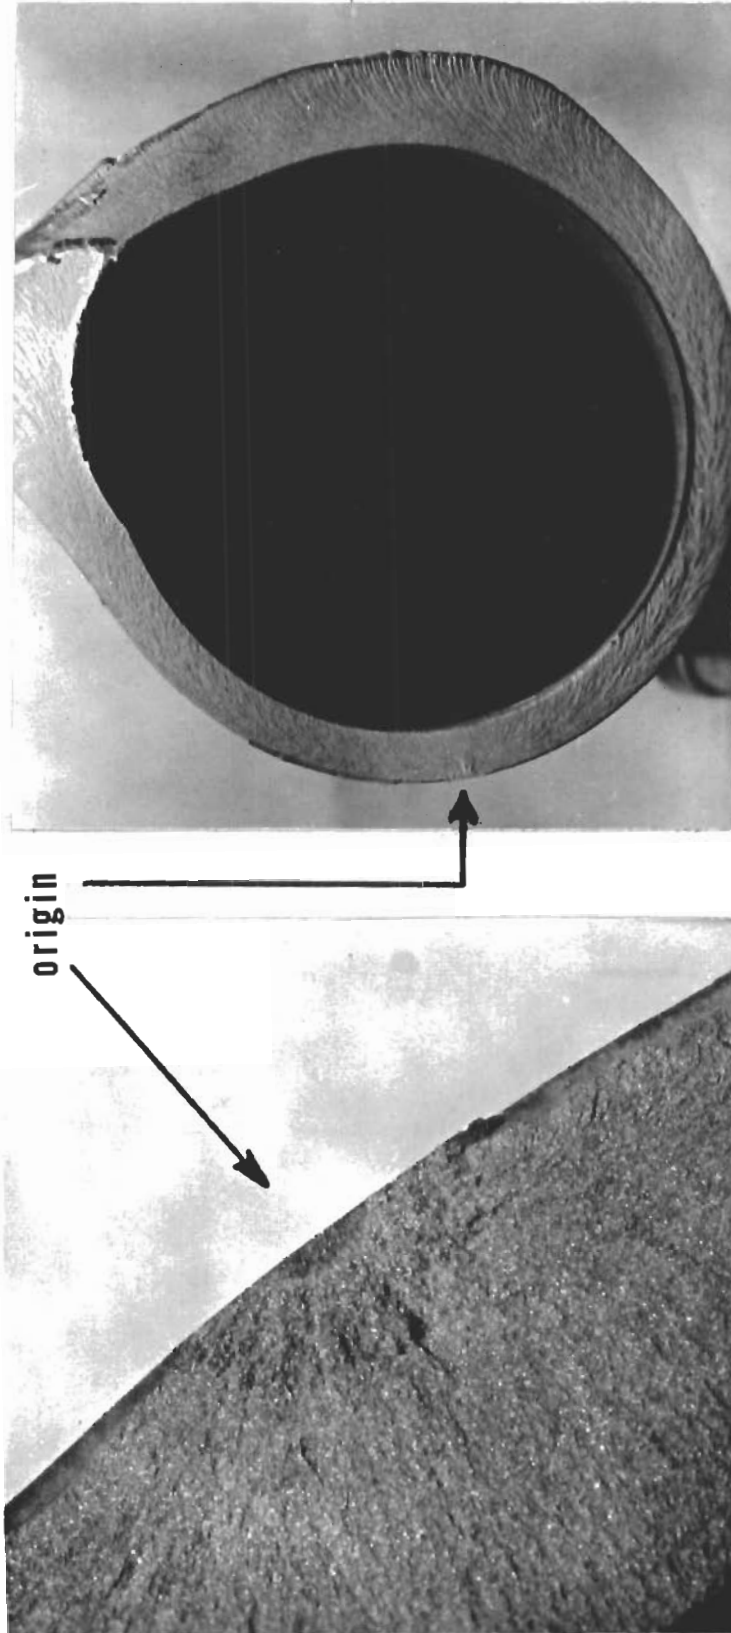
Figure 28. Fracture Origin - Axle Beam Failure 11/61

The fracture face of the primary failure is shown as figure 28 and close examination clearly shows the small origin capable of inducing catastrophic failure at this strength level. The close-up view of the origin shows a brittle surface crack about 1/64-inch deep by 1/16-inch long with a secondary progression ring roughly 3/32-inch deep by 11/64-inch long around the origin. The initial origin was initially interpreted as fatigue with the second stage progression probably due to crack growth under the sustained load of the fully fueled condition prior to anticipated take-off. In addition, small intergranular cracks were again noted in the primary fracture face and a secondary crack was detected at a point 1/8-inch apart from the primary crack (figure 29).

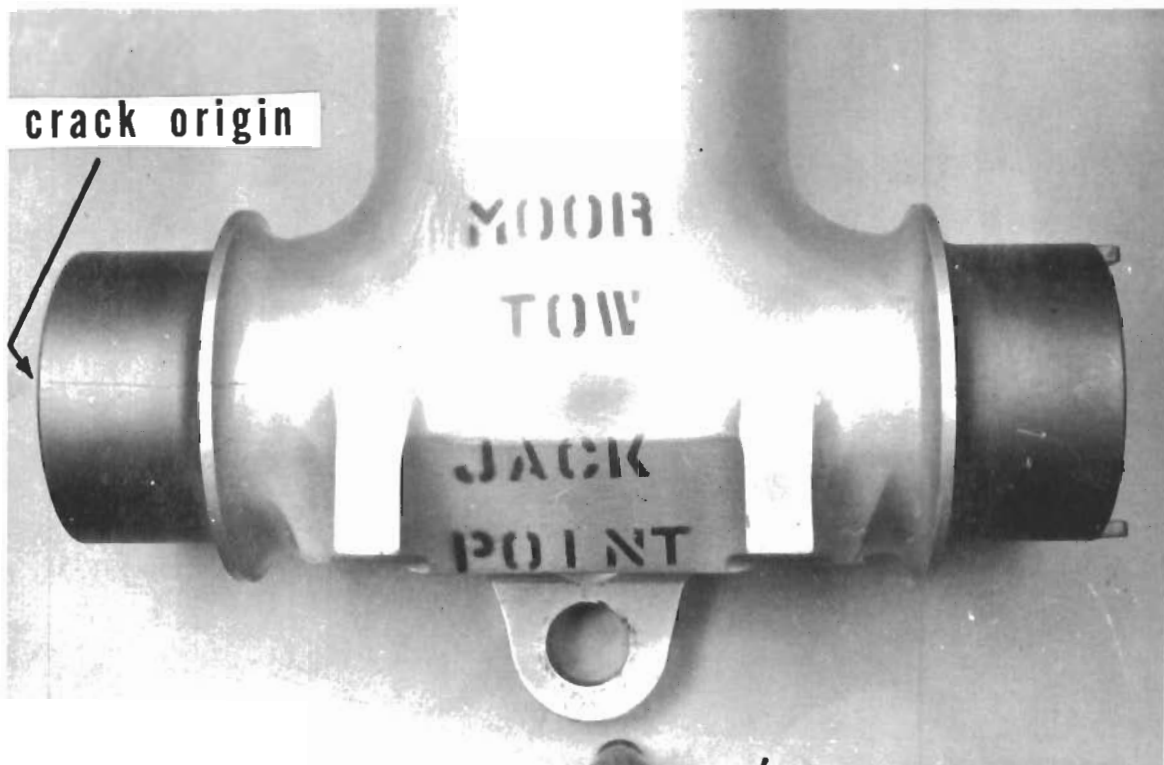
Figure 31. Axle Beam Failure Through Axle Design 1/62 AISI 4340 (260-280 ksi UTS)

One additional cracked axle was discovered during a jacking operation in January, 1962, where the original failures (in the highly stressed fillet area) were eliminated by removal of the integral axles and installation of separate "thru-axles" to carry the primary loads. (This modification increased over all gear weight by 100 percent and is a prohibitive weight penalty - a lighter weight more reliable design is being developed.) The cracked axle of the "thru-axle" design is shown in figure 31. The crack now occurred on the top side, in the forging parting line, but was not catastrophic as the cracking stopped when the low stress area was encountered. The modification has not eliminated the cracking but has served to prevent catastrophic failures by substitution of a moderate strength AISI 4340 axle (180-200 ksi UTS) as the critically loaded component. The fracture surface (figure 32) again shows an intergranular initiation zone. Note that over 50 percent of the fracture occurred by intergranular cracking and the axle assembly was still performing adequately under regular service conditions. The electron fractographs shown in figure 33 supposedly confirm the occurrence of hydrogen embrittlement.

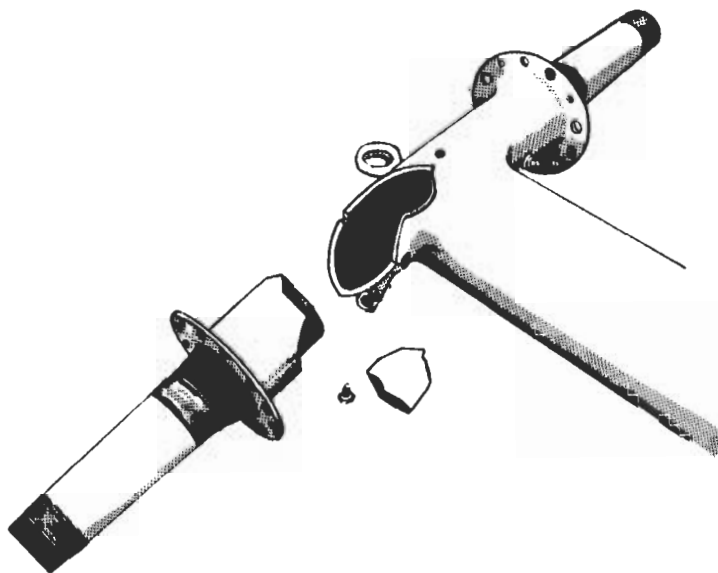
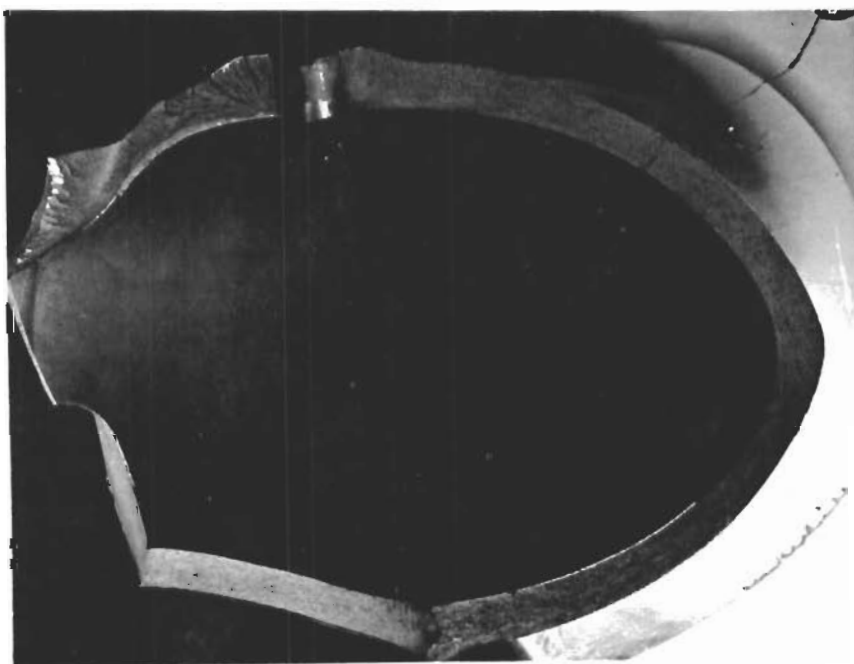
Figure 34. Landing Gear - Truck Beam Assembly Failure AISI 4340 (260-280 ksi UTS)  
100

The fractured truck beam of the main landing gear assembly shown in figure 34 is believed to be the first stress corrosion failure encountered in high strength low alloy steel axles (AISI 4340 heat treated to 260-280 ksi UTS). The failure occurred during a normal towing operation, September 1961. The general view of the assembly shows the through-axle design with the axle retaining bolt on each side; the gear is coated with an epoxy paint to protect against corrosion. A close-up of the fracture origin (figure 35) shows the cracking originated in the forward inboard bolt hole.

(a) Forward Gear Assembly  
Origin - Forward Bolt Line

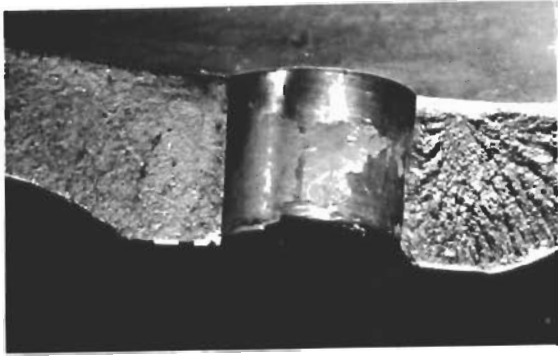
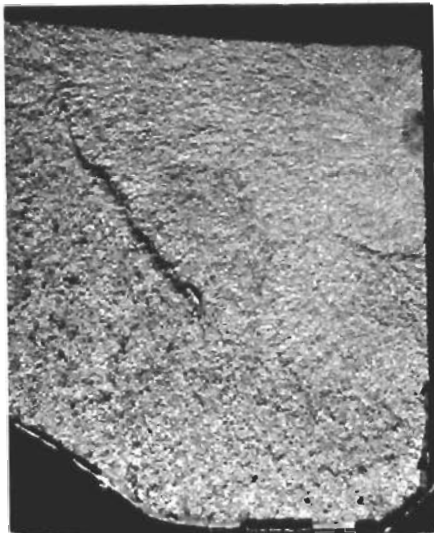
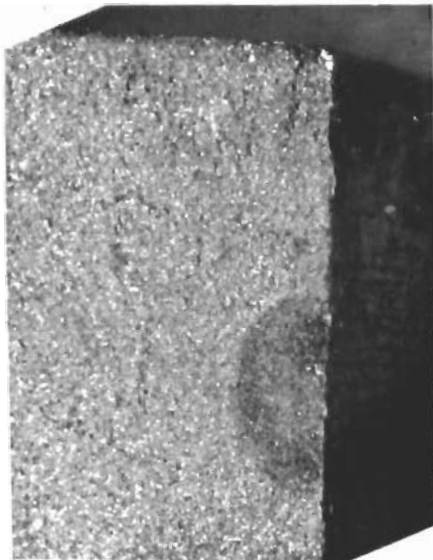
Figure 35. Landing Gear Truck Beam Failure AISI 4340 (260-280 ksi UTS)

Approaching the origin at higher magnifications, the origin is seen as a discolored semi-circle with faint concentric rings (not clearly evident in photographs). The discolored origin was approximately 0.03 by 0.05 inches and the largest concentric ring measured 0.40 inches; the entire origin exhibited "brittle" intergranular cracking which shows in the photomicrograph and electron microscope fractograph shown in figure 36.

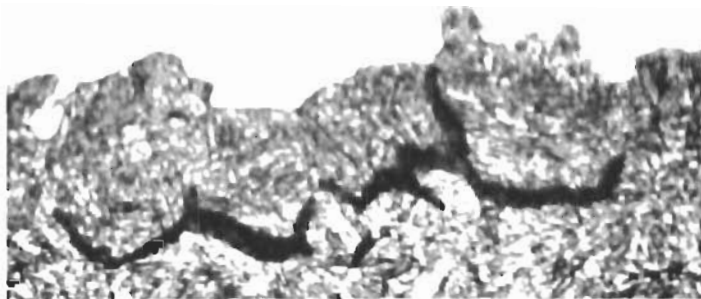
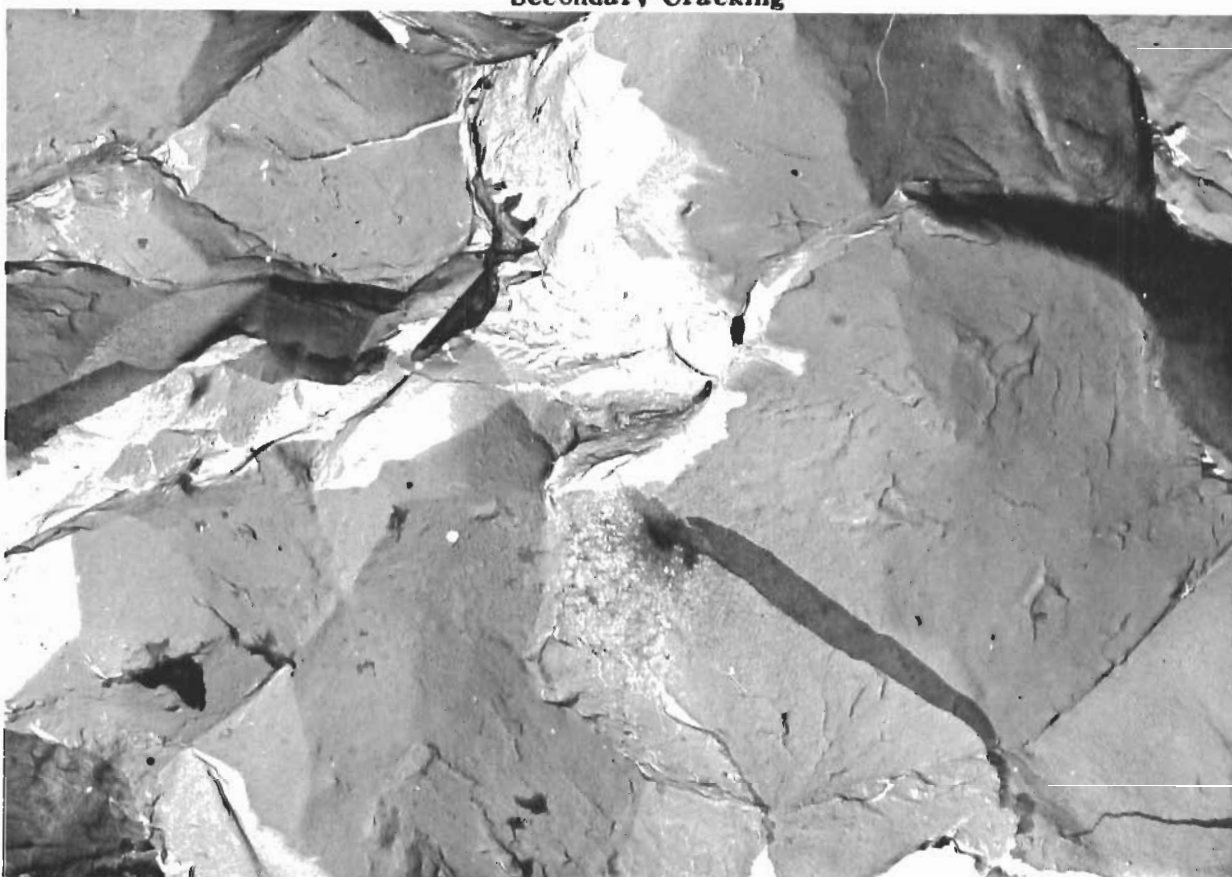
**Failure Origin - Microscopic Analysis**

The material quality was checked and found to be excellent, as indicated by the longitudinal tensile properties (percent reduction in area exceeding 30 percent and notched/unnotched strength ratio exceeding one). Examination of the fracture surface eliminated fatigue as the cracking mechanism, and hydrogen embrittlement seemed unlikely because of the lack of hydrogen-inducing conditions during processing. However, the conclusion that stress corrosion cracking was responsible was finally reached based primarily on the appearance of the electron microscope fracture-surface replicas, and the differences in appearance between hydrogen and stress corrosion failure.
