WADC TECHNICAL REPORT 59-87
PART II

**DETERMINATION OF FACTORS
GOVERNING SELECTION AND APPLICATION OF
MATERIALS FOR ABLATION COOLING
OF HYPERVELOCITY VEHICLES**

JULY 1959

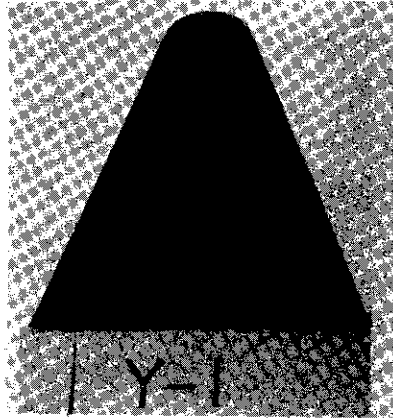
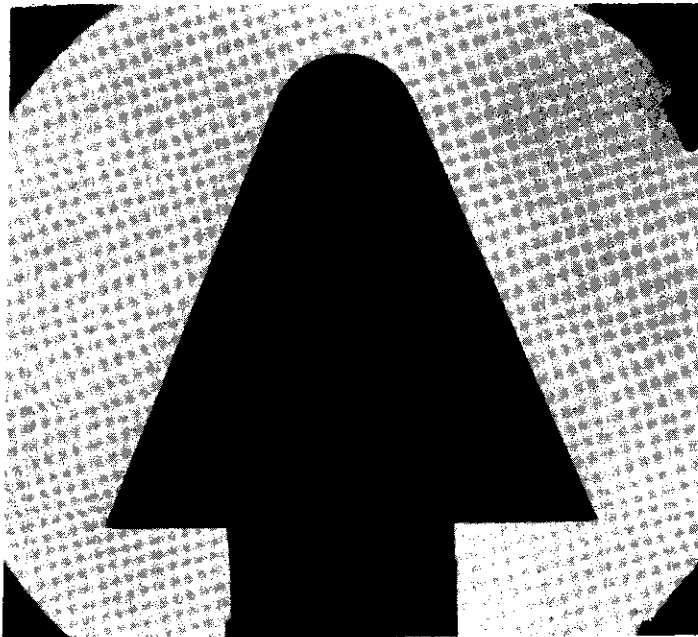
Remarks: Immediately after the start of heating, some liquid began to flow up the side of the sample. No cracking of the sample was observed.

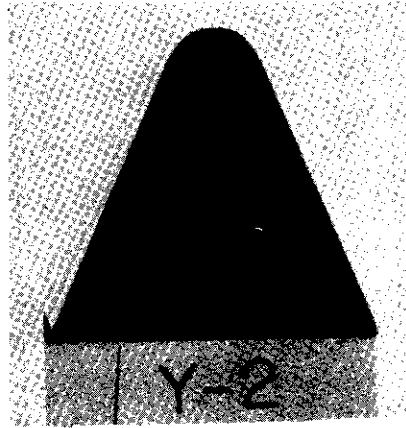
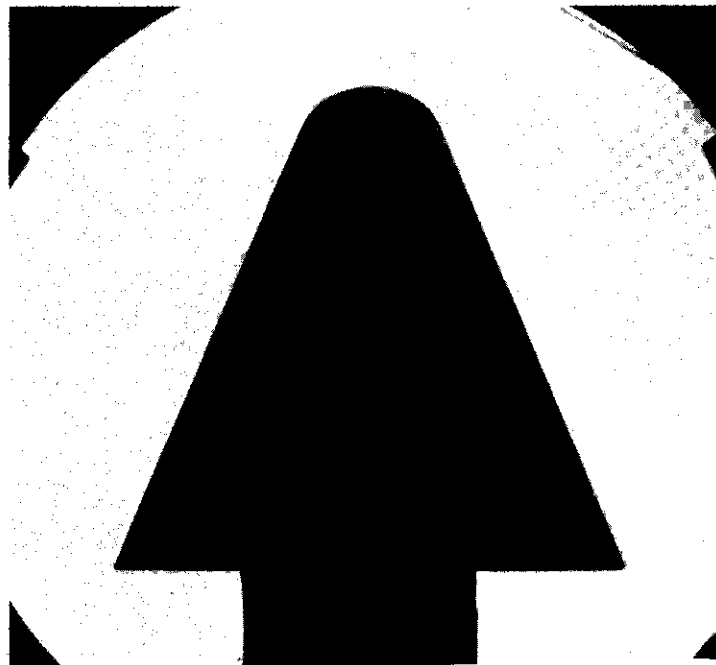
Remarks: Immediately after the start of heating, some liquid began to flow up the side of the sample. No cracking of the sample was observed.

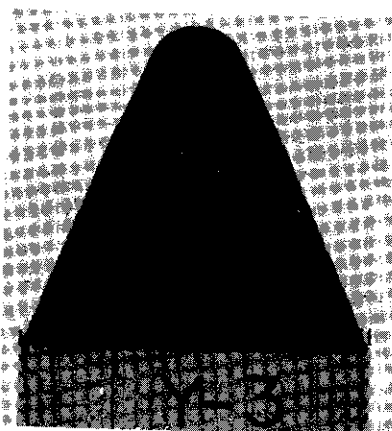
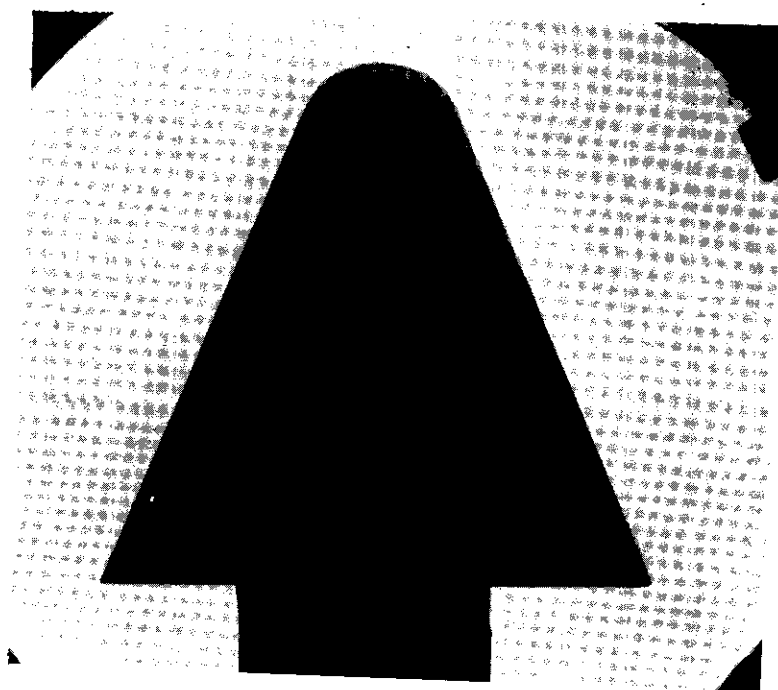
Remarks: The flow field is slightly asymmetrical although the condition is not serious. Again, liquid is seen leaving the hot nose zone. In addition, there are definite isotherms along the body, corresponding to possible phase changes. No cracking of the sample was observed.

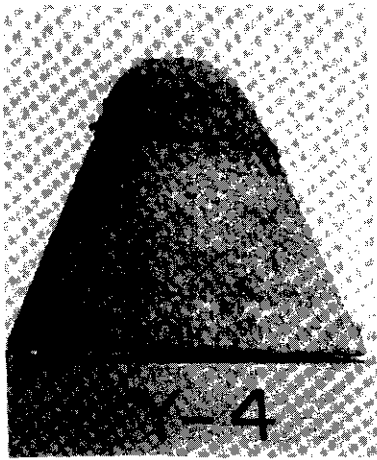
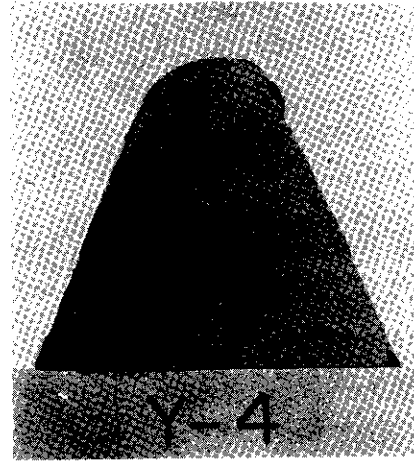
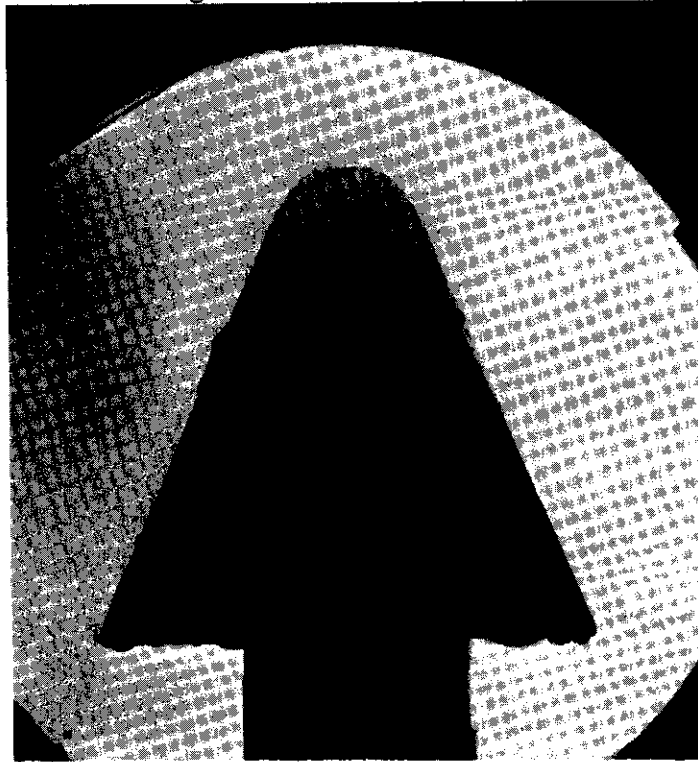
Remarks: Due to a malfunction of the arc, this sample was subjected to two stepwise heatings, of 10- and 26-second durations. Figure 18 shows the depths of penetration of the melted zone at the nose, and also indicates a probable thermal stress failure in the interior. During the early part of the test there was some spalling at the nose.

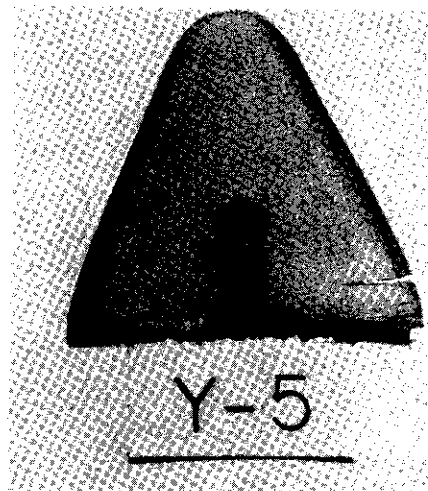
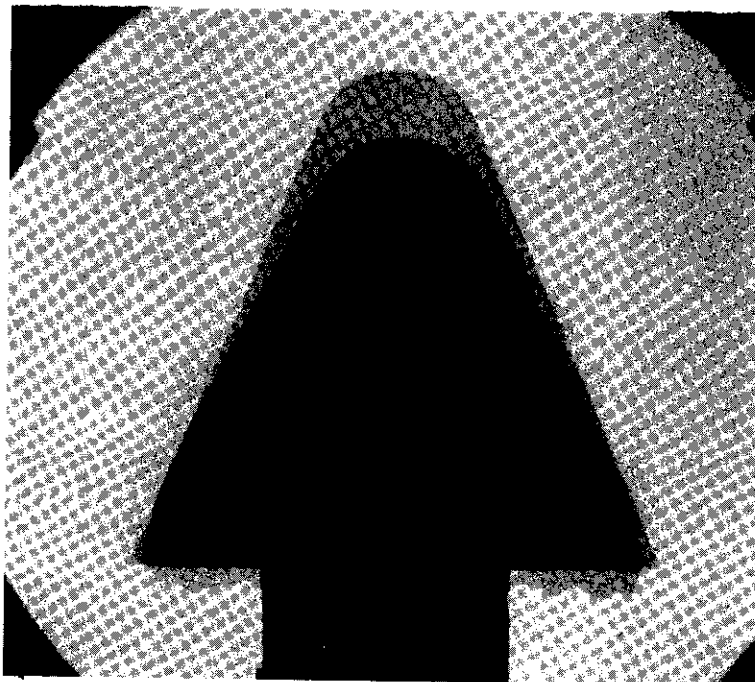
Remarks: During the run, much liquid was stripped away from the surface of the sample. The laminar failure near the base occurred during the latter portion of the test.

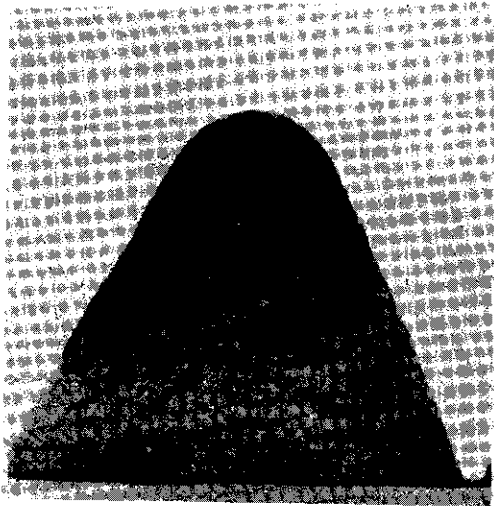
Remarks: The color motion pictures show little liquid leaving the surface of the sample. There is considerable roughening of the surface.

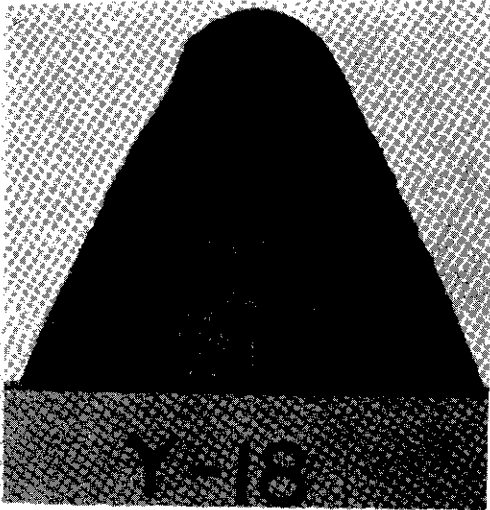
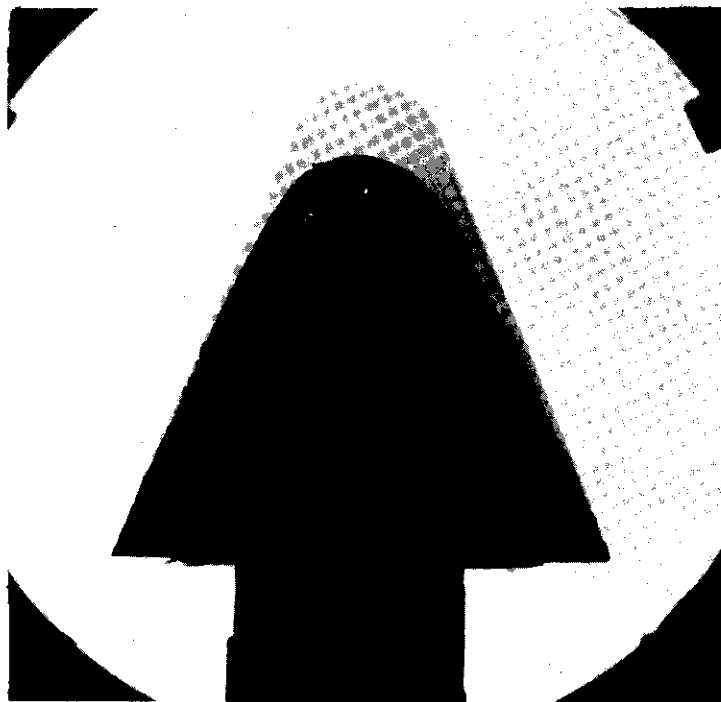
Remarks: This sample was identical to Y-17 except for a routed out section to relieve stresses which might cause delamination. It behaved similarly in all respects to Y-17. Neither sample cracked or delaminated. Although the weight loss percentage is somewhat higher, the actual loss of weight is comparable.

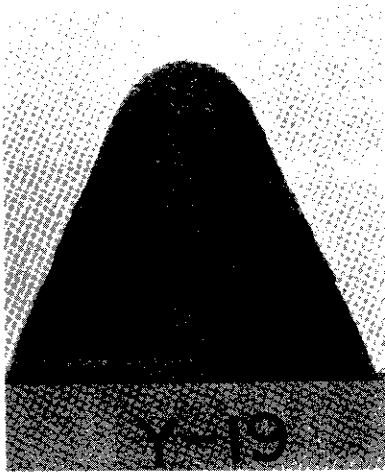
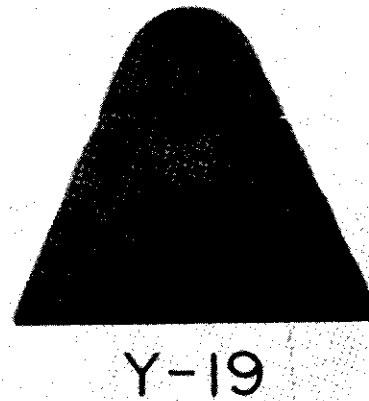
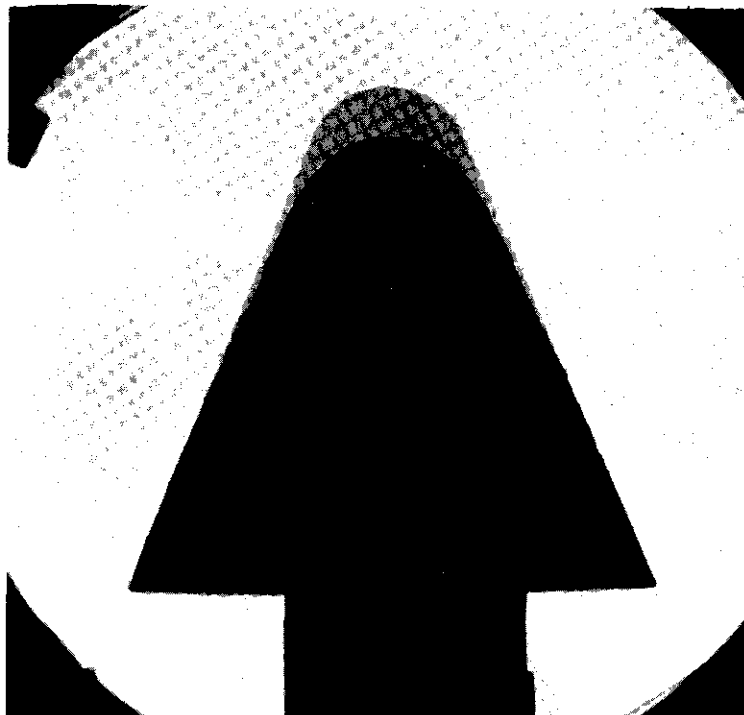
Remarks: This sample shows some degree of surface roughening. During the test a small amount of liquid could be seen leaving the base of the cone. This sample was of a laminar structure, but no delamination was noted during testing. However, a delamination was noticed 1-1/8 inches from the stagnation region upon sectioning of the sample, as shown in Fig. 37.

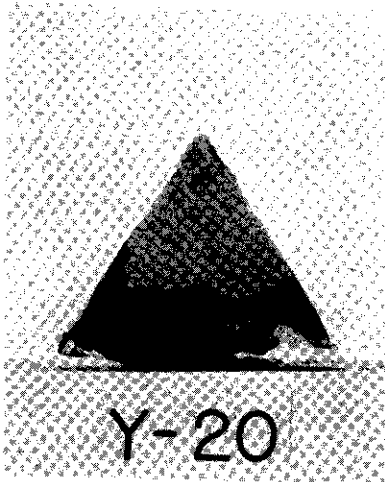
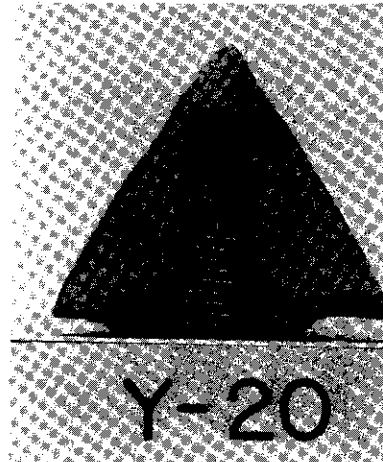
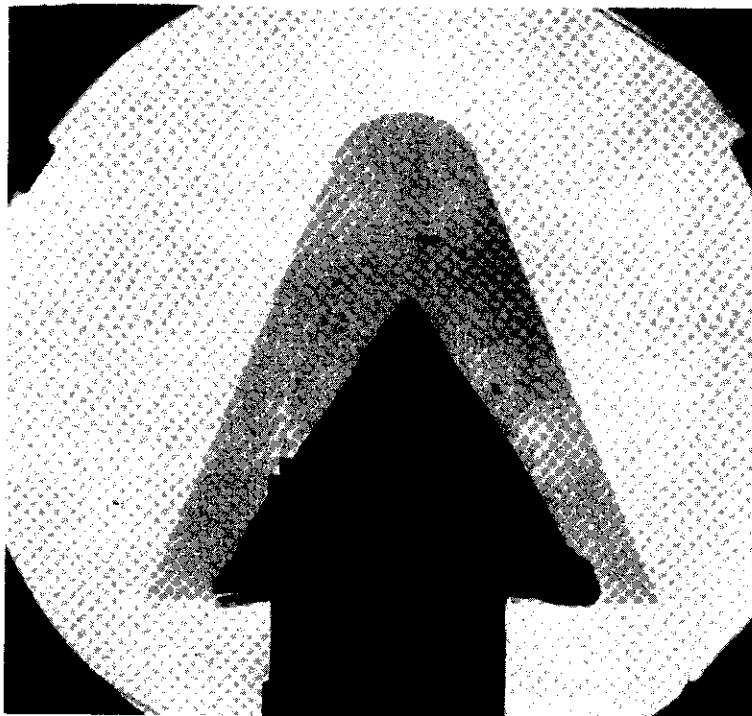
Remarks: Immediately after the start of heating of the sample thin sheets of material began flying off, and this phenomenon continued during the test. The sample very rapidly lost its hemispherical nose and assumed the pure conical shape illustrated by the after silhouette.

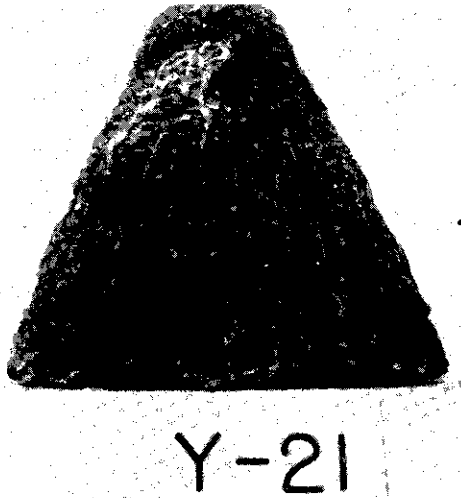
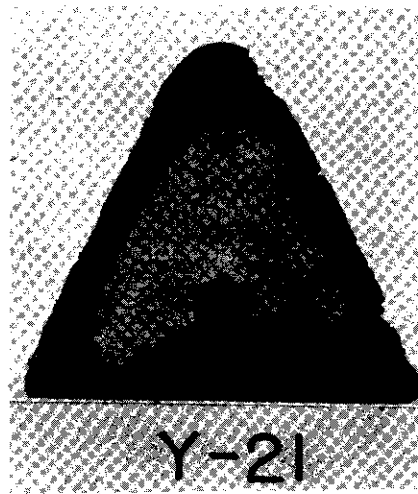
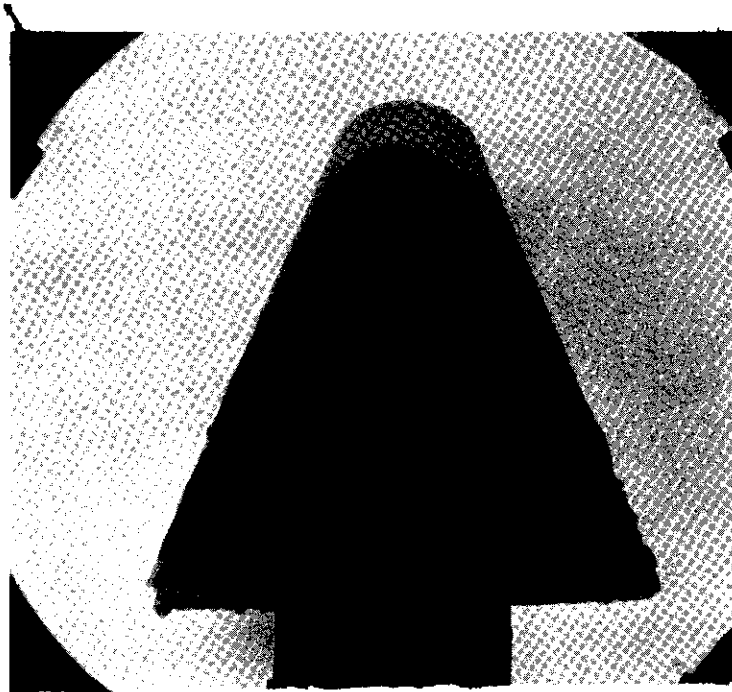
Remarks: The surface of this sample became pockmarked early in the test. Some liquid was noted leaving the base of the cone, and the surface of the sample was left in a considerably roughened condition after the heating.

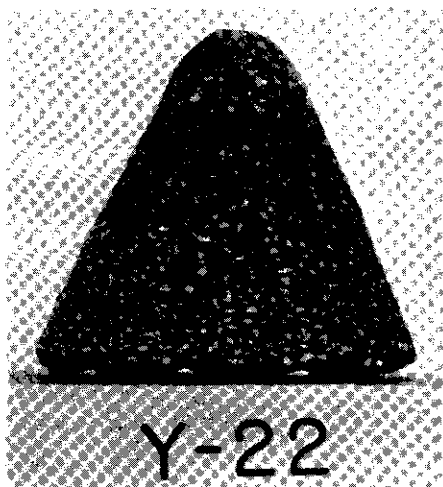
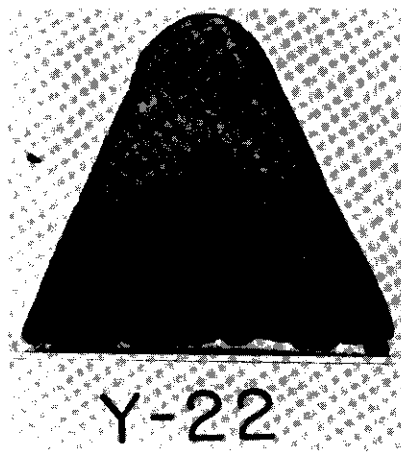
Remarks: A slight amount of pocking was noted early in the heating period, followed by considerable liquid loss from the base of the cone. The surface was left in slightly roughened condition.

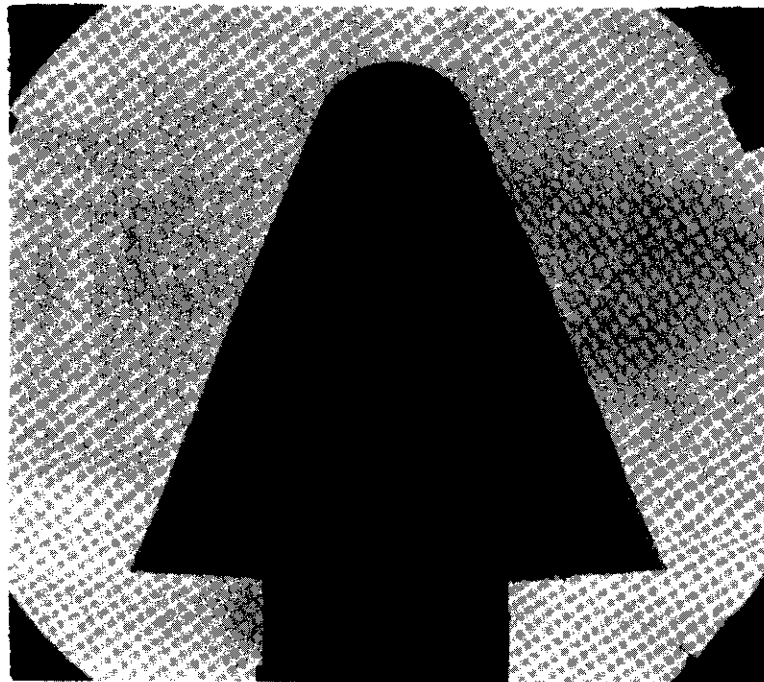
Remarks: This sample evidenced much more pocking, as though internal pressures were causing small pieces of the surface to be popped out. Little liquid was lost from the base of the cone, and the surface was left in somewhat better condition than that of the previous sample.

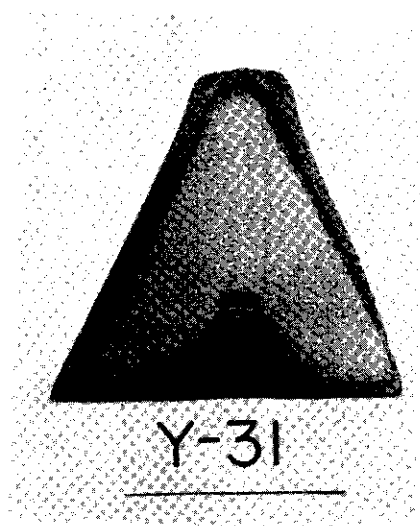
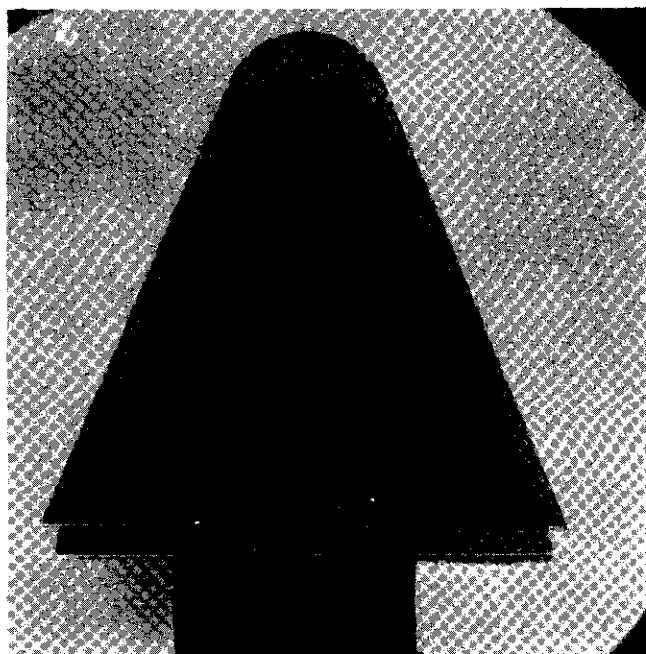
Remarks: Because this sample was laminated along the axis of the cone, it ablated asymmetrically. This fact is clearly shown in Fig. 51. The motion pictures show a rather thin boundary layer with evidence of surface carbonization and roughening. The heat transferred through the support rod charred the material and made accurate alignment of the silhouette almost impossible. The outer layer came off as a shell during handling for photographic purposes.

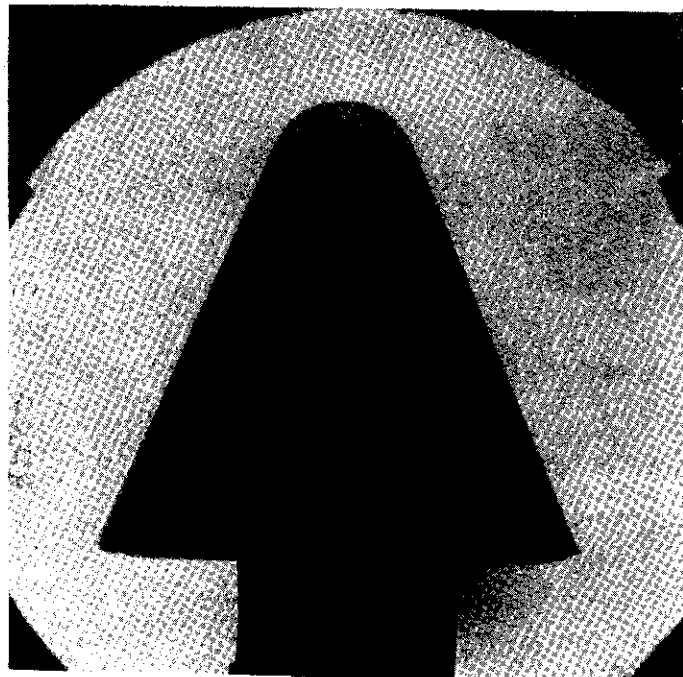
Remarks: Little information is available from the motion pictures because the film was inadvertently overexposed. The view of the sectioned sample shows that a relatively thin outer shell came loose during handling after the test.

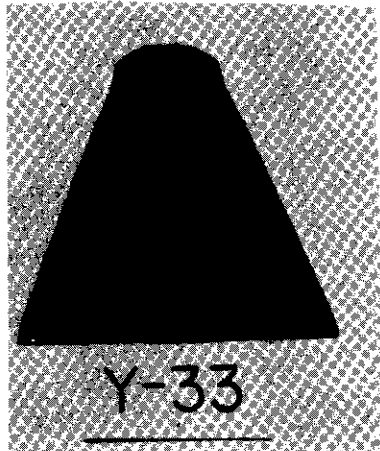
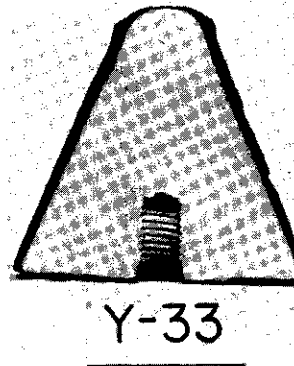
Remarks: The motion pictures show no liquid loss from the sample and evidence only a thin boundary layer. The view of the sectioned sample indicates a rather slight heat penetration from the surface.

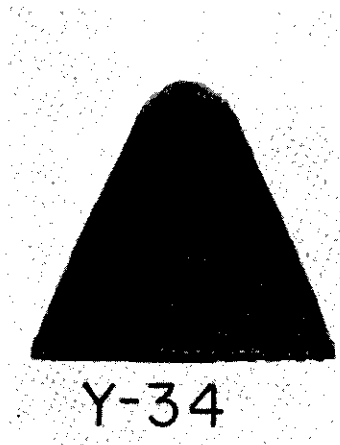
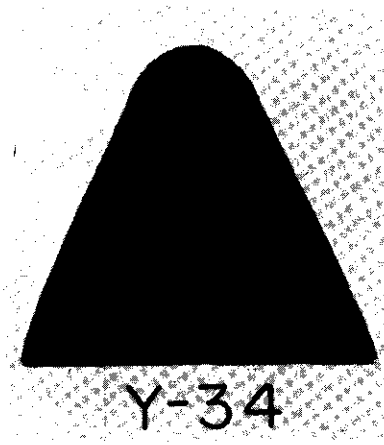
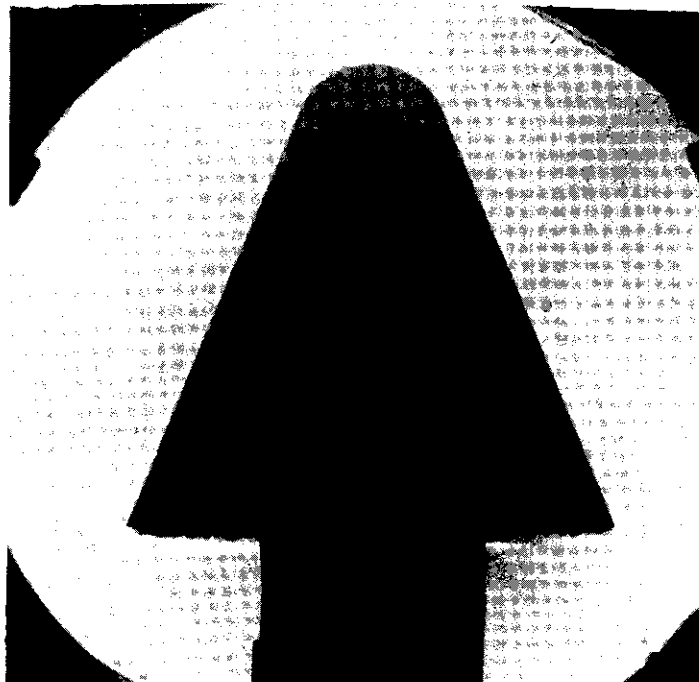
Remarks: The motion pictures show some early pocking of the surface and a fairly thick boundary layer. The surface of the sample remained in relatively good condition.

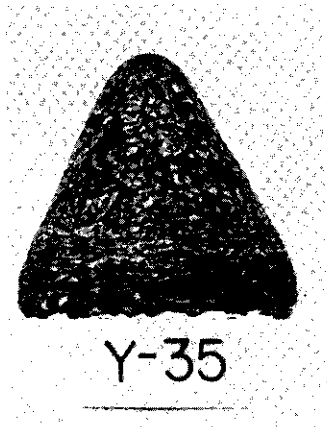
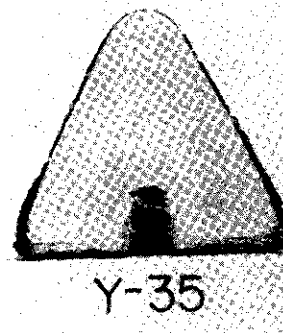
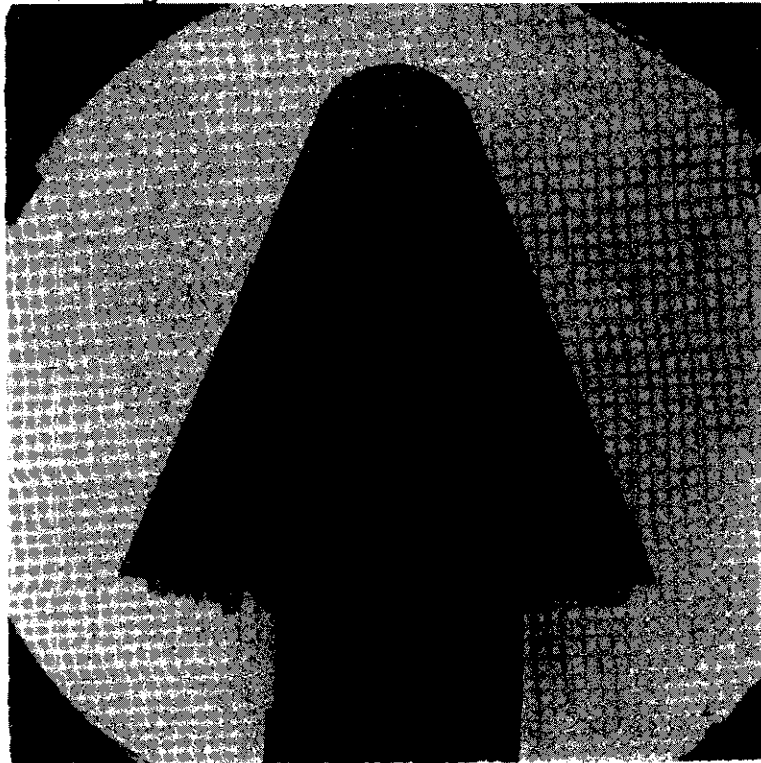
Remarks: The motion pictures show that some liquid was lost from the base of the cone and a relatively thin boundary layer. The surface shows considerable roughening.
