**AIRCRAFT GROUND-FLOTATION INVESTIGATION
PART VIII DATA REPORT ON TEST SECTION 7**

*W. BRABSTON and W. HILL, JR.
U. S. ARMY ENGINEER WATERWAYS EXPERIMENT STATION*

PART VIII DATA REPORT ON TEST SECTION 7

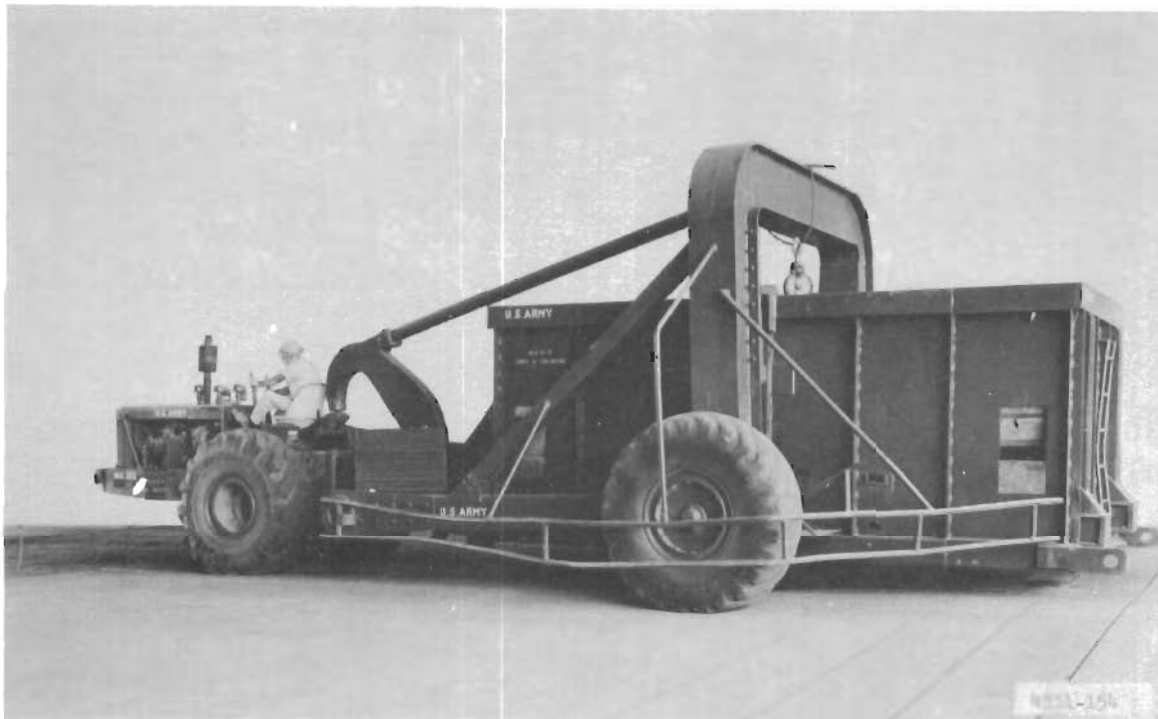
Figure 1. Load vehicle used on lanes 13 and 14

The load vehicle used for trafficking lanes 13 and 14 is shown in figure 1. Load cart construction, details of linkage between the load compartment and prime mover, and method of applying load are explained in Part I. For both lanes, a single-wheel assembly was used with a load of 25,000 lb and tire inflation pressure of 100 psi. The assemblies consisted of a 56x16, 32-ply aircraft tire and a 25.00-28, 30-ply aircraft tire for lanes 13 and 14, respectively.

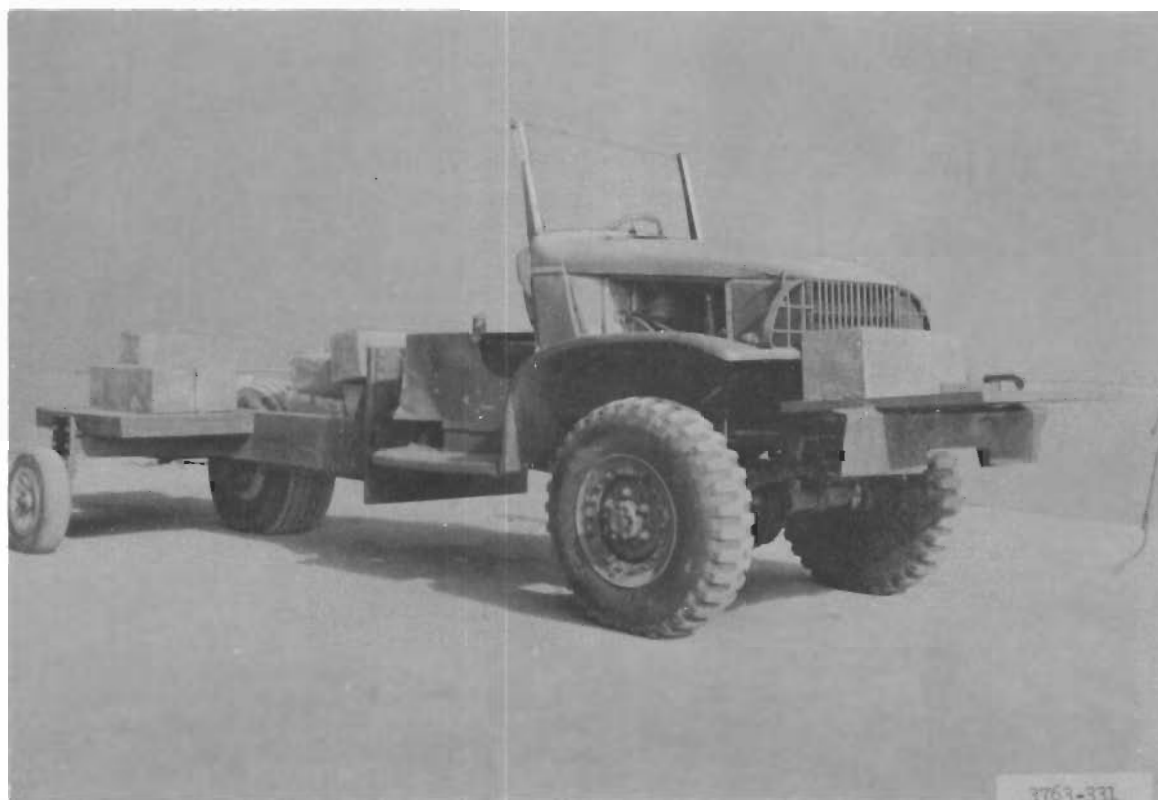
Figure 2. Load vehicle used on lanes 15 and 16

For trafficking lanes 15 and 16, the load vehicle shown in figure 2 was used with loads of 25,000 lb and 19,000 lb, respectively. For both lanes, a single-wheel assembly was used with tire inflation pressure of 100 psi. The assemblies consisted of a 17.00-16, 12-ply aircraft tire and a 34x9.9, 14-ply aircraft tire for lanes 15 and 16, respectively.

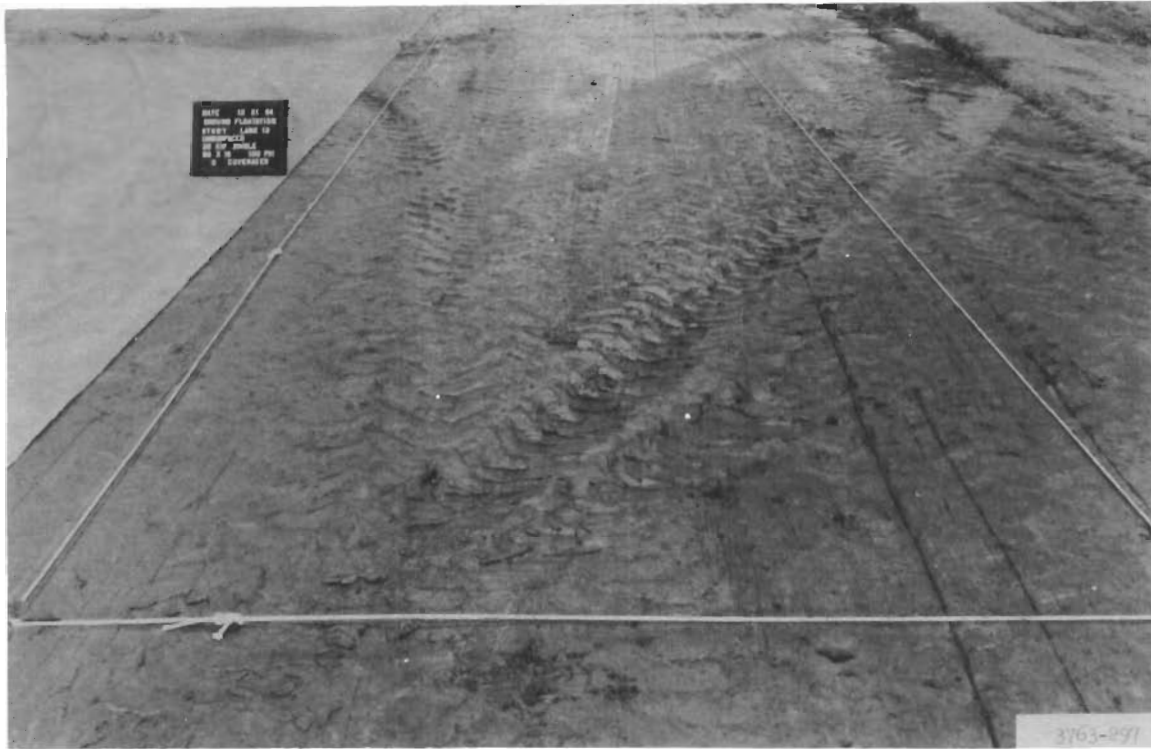
Figure 3. Lane 13 prior to traffic

Figure 3 shows lane 13 prior to traffic. The surface was moderately rutted at 20 coverages with rut depths averaging 1.5 in. Traffic was continued until the lane was considered failed due to rutting at 70 coverages (figure 4). The rated CBR of the lane was 9.2.

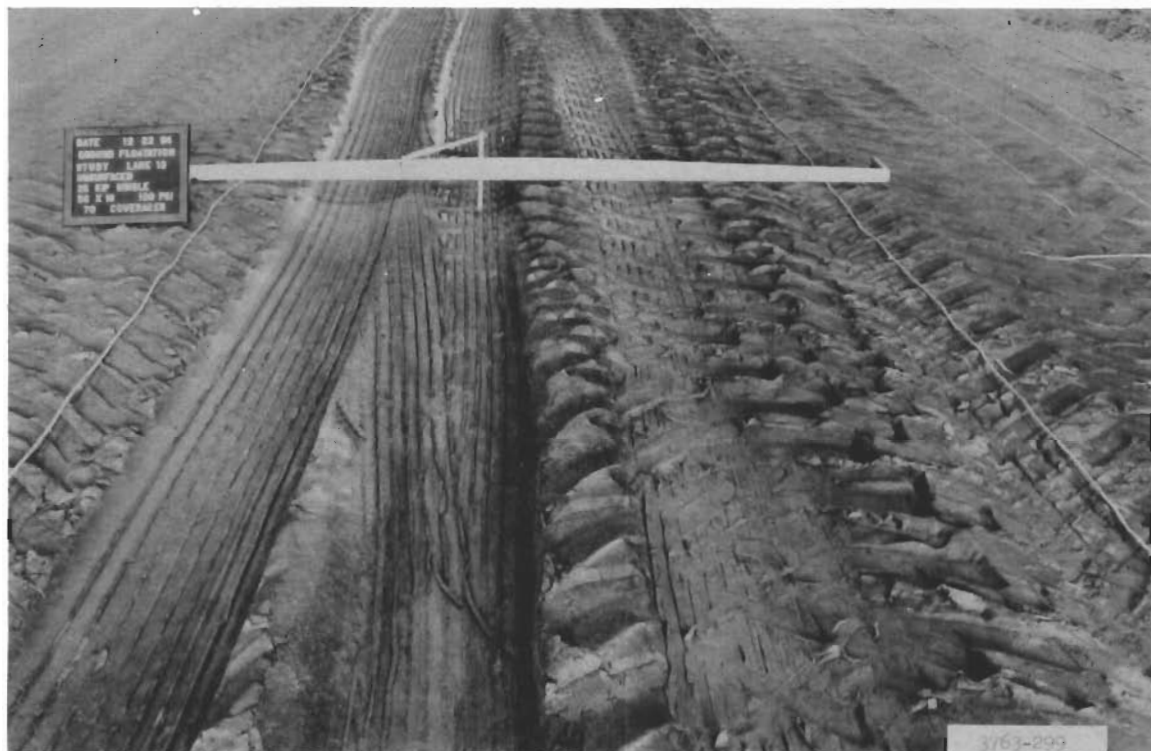
Figure 4. Lane 13; general view showing transverse straightedge measurement at 70 coverages (failure)

- a. Roughness. Table 1 shows the progressive development of differential deformations and rut depths with traffic. At failure, both transverse and diagonal differential deformations averaged 3.69 in. Longitudinal deformations were relatively small, averaging 0.69 in. Rut depths averaged 3.31 in. at failure.

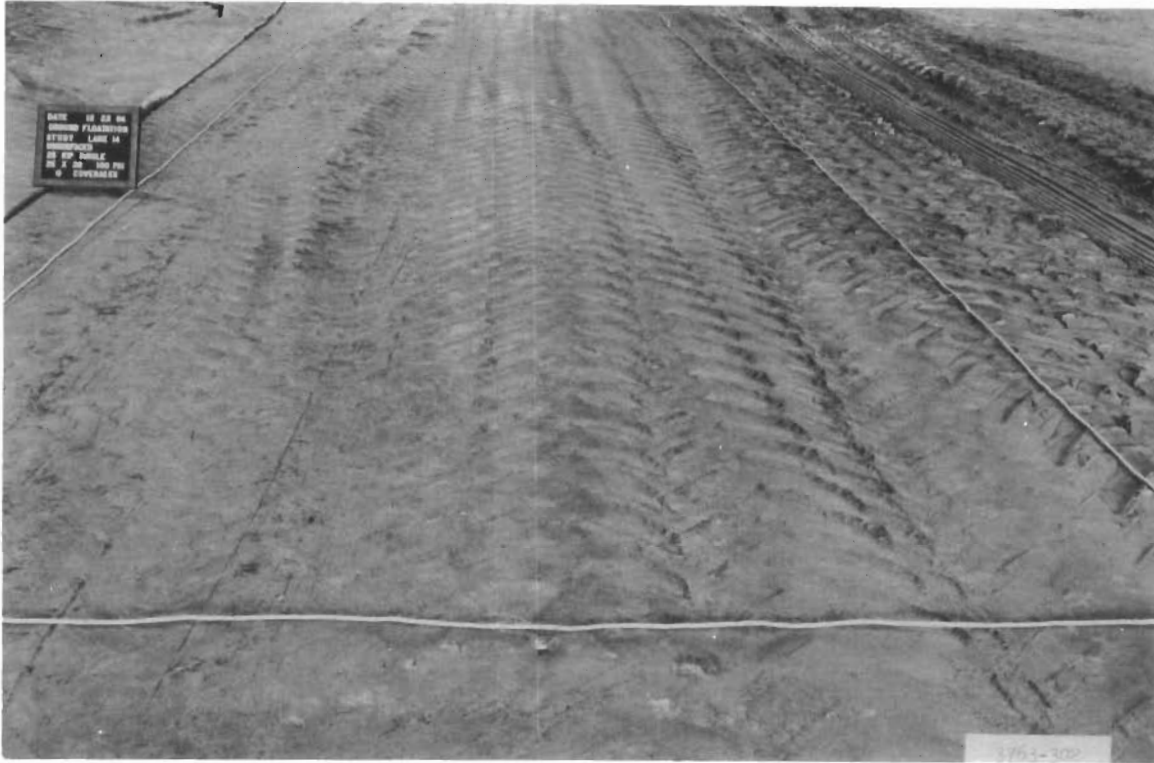
Figure 5. Lane 14 prior to traffic

Figure 5 shows lane 14 prior to traffic. The test surface held up well under testing and traffic was continued to 200 coverages at which time the lane was considered failed due to excessive transverse differential

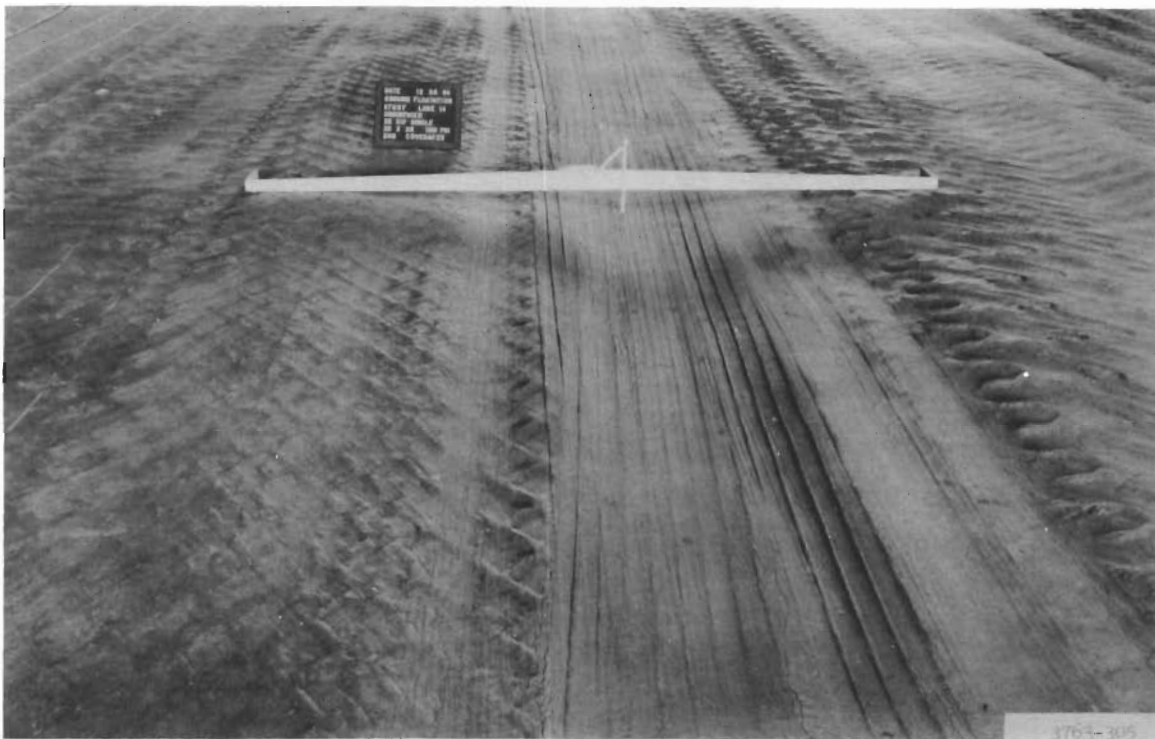
Figure 6. Lane 14; general view showing transverse straightedge measurement at 200 coverages (failure)

deformations (figure 6). The rated CBR of the lane was 7.8.

- a. Roughness. Table 1 shows the differential deformations and rut depths measured at intervals during testing. Transverse and diagonal differential deformations exceeded in magnitude other deformation measurements and averaged 3.50 and 3.56 in., respectively, at failure. Due to the uniform subsidence in the lane cross section, rut depths were not great and averaged only 1.16 in. at failure.

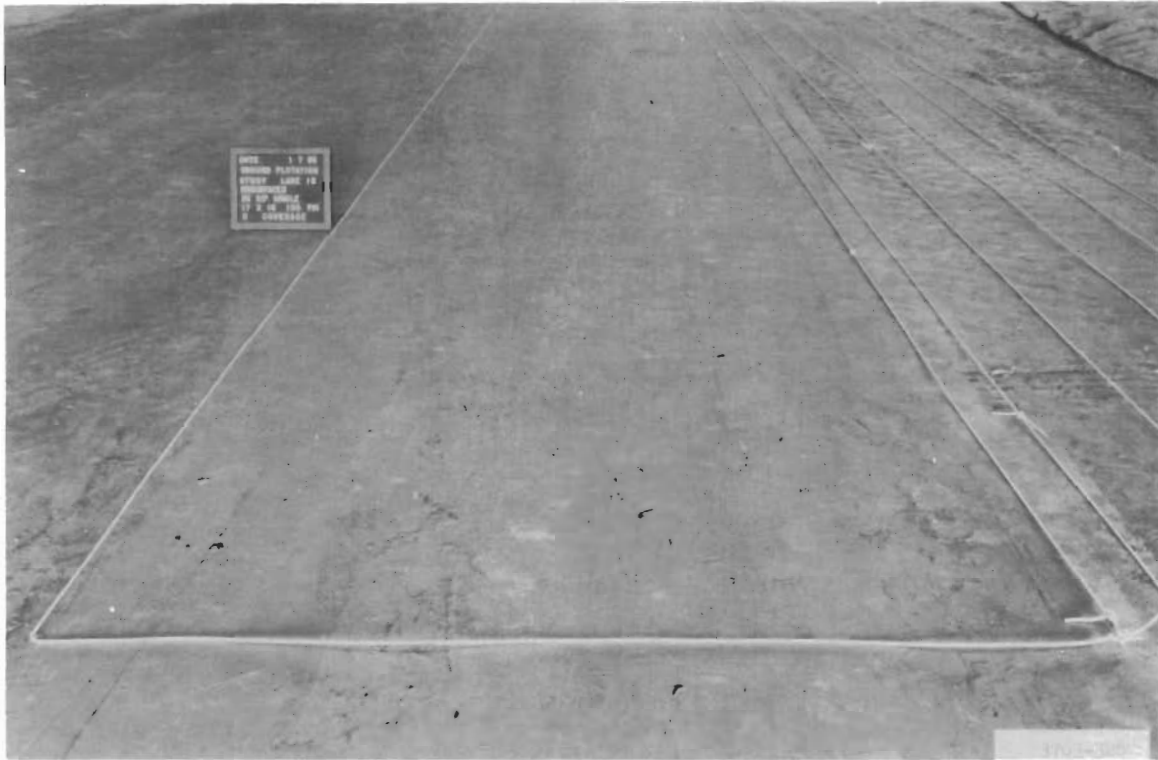
Figure 7. Lane 15 prior to traffic

Figure 7 shows lane 15 prior to traffic. The lane was considered failed at 100 coverages primarily due to excessive transverse differential deformations (figure 8). The rated CBR of the lane was 7.8.

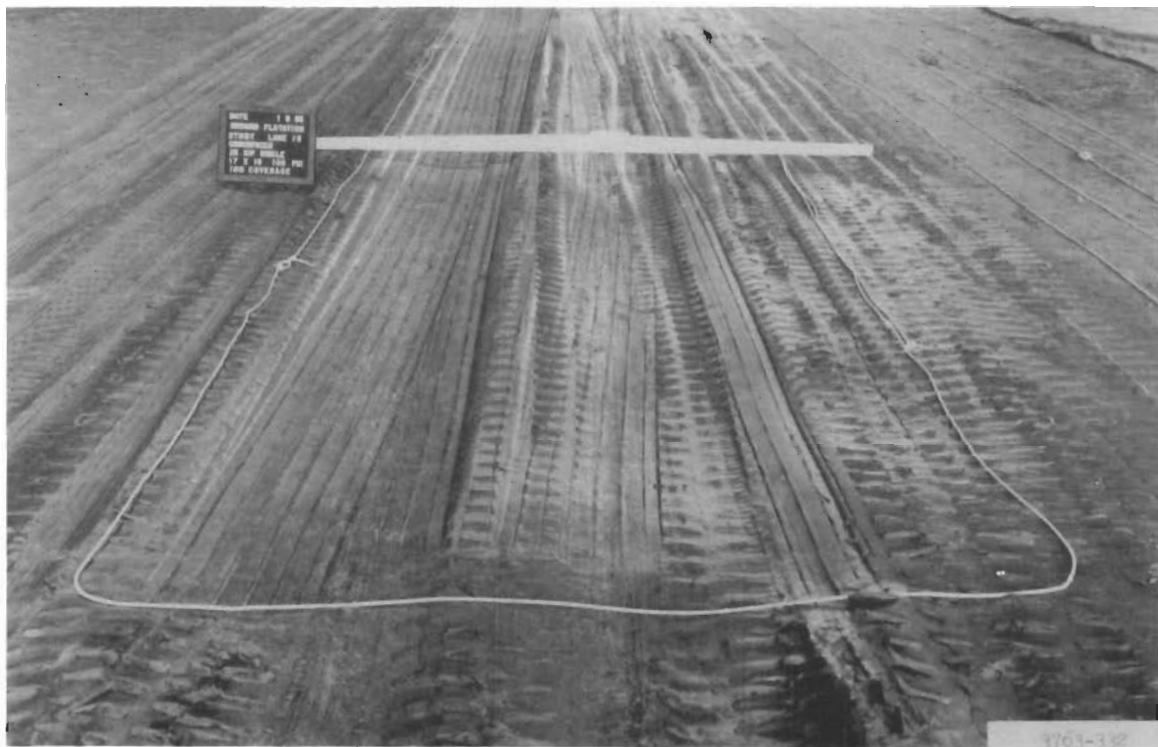
Figure 8. Lane 15; general view showing transverse straightedge measurement at 100 coverages (failure)

- a. Roughness. Table 1 shows differential deformations and rut depths measured at 20 and 100 coverages. Transverse and diagonal differential deformations were largest and averaged 3.62 and

3.83 in., respectively, at failure. Rutting was less severe, averaging 2.15 in. at failure.

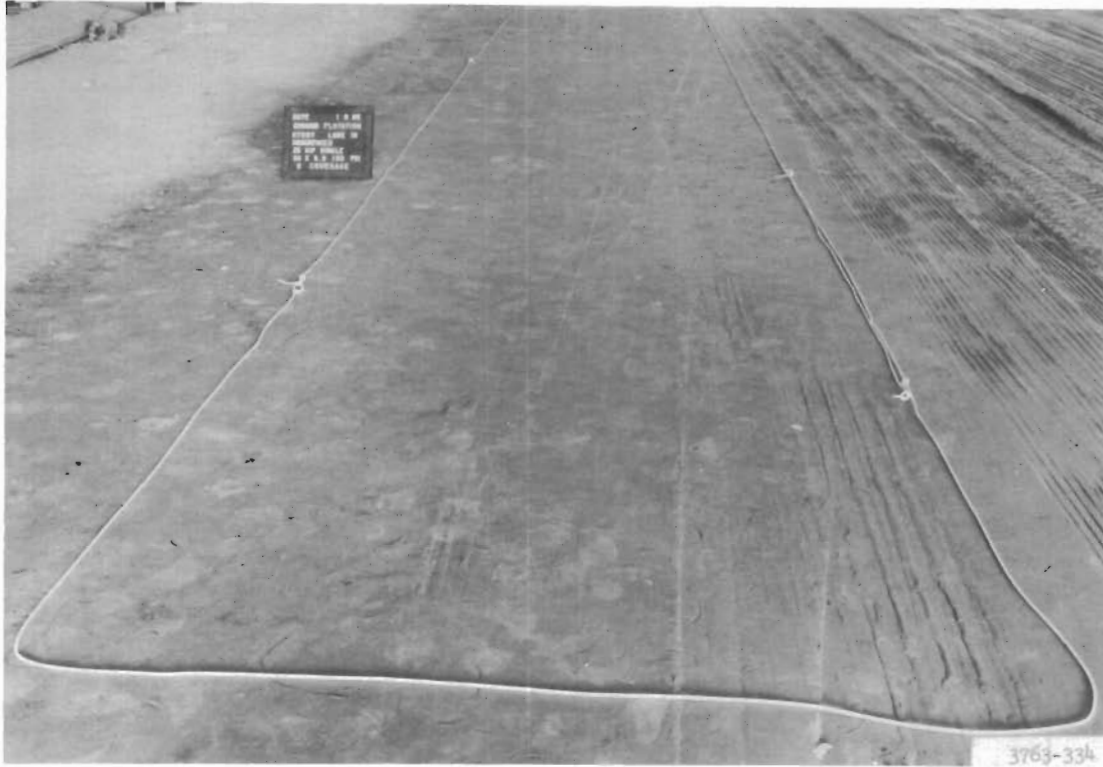
Figure 9. Lane 16 prior to traffic

Figure 9 shows lane 16 prior to traffic. Severe ruts developed early in testing with high ridges forming between the ruts. It became impossible beyond 14 coverages to track the ridged strips, as the load wheel continually slipped sideways into an adjacent rut. The relative heights of the ridges increased with continued trafficking due to soil upheaval from the rutted areas. To obtain more representative roughness data, the influence of the ridge areas was de-emphasized by cutting access notches across the ridges so that for differential deformation measurements the ends of the 10-ft straightedge rested on the undisturbed surfaces outside the tracking lane. Figure 10 shows the lane after it was judged failed at 32 coverages. The rated CBR of the lane was 8.4.

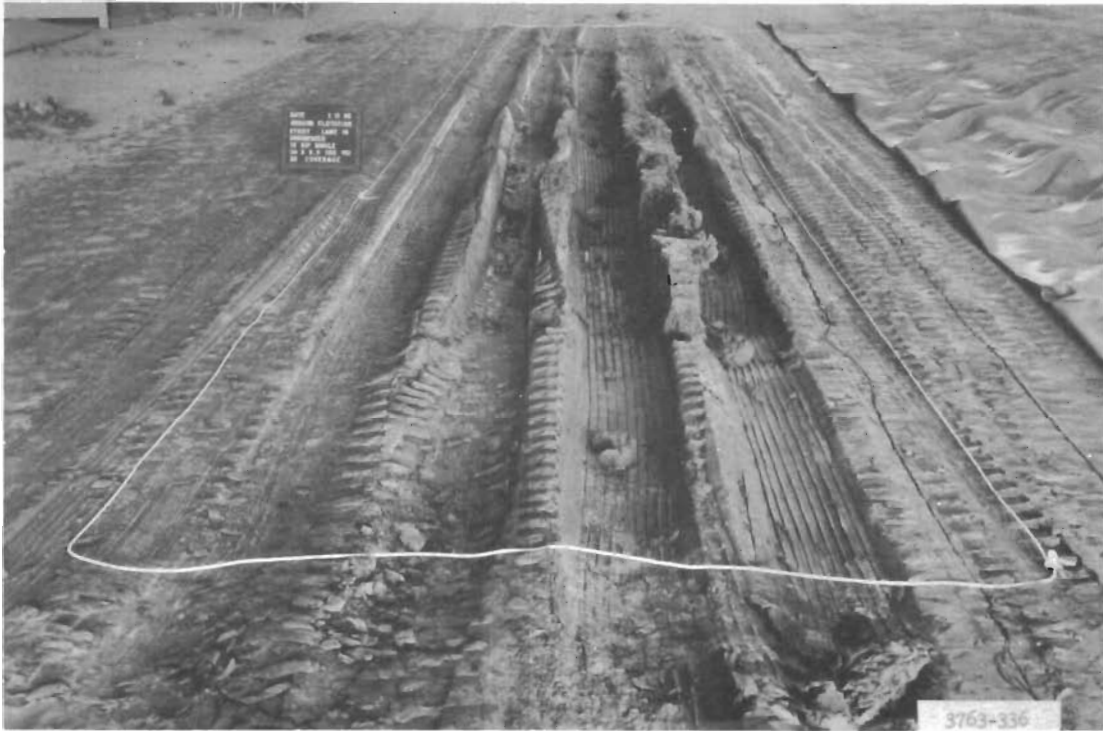
Figure 10. General view of lane 16 after 32 coverages (failure)
