STRESS CORROSION SUSCEPTIBILITY OF WELDED ALUMINUM ALLOYS

DOUGLAS AIRCRAFT COMPANY

TECHNICAL REPORT AFML-TR-67-291

AUGUST 1967

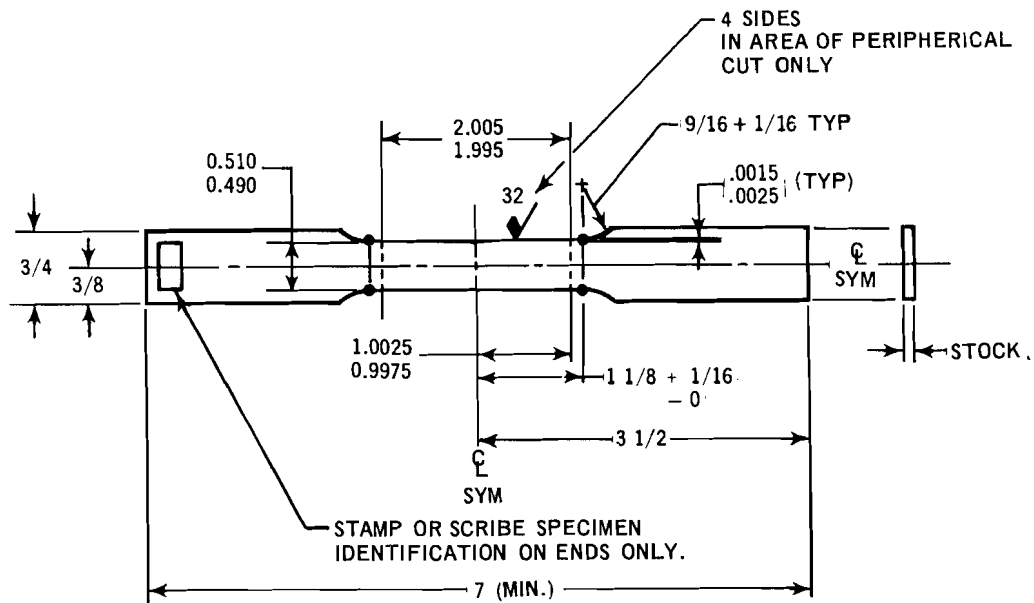
FIGURE 1. TENSILE SPECIMEN FOR BASIC TEMPER SHEET

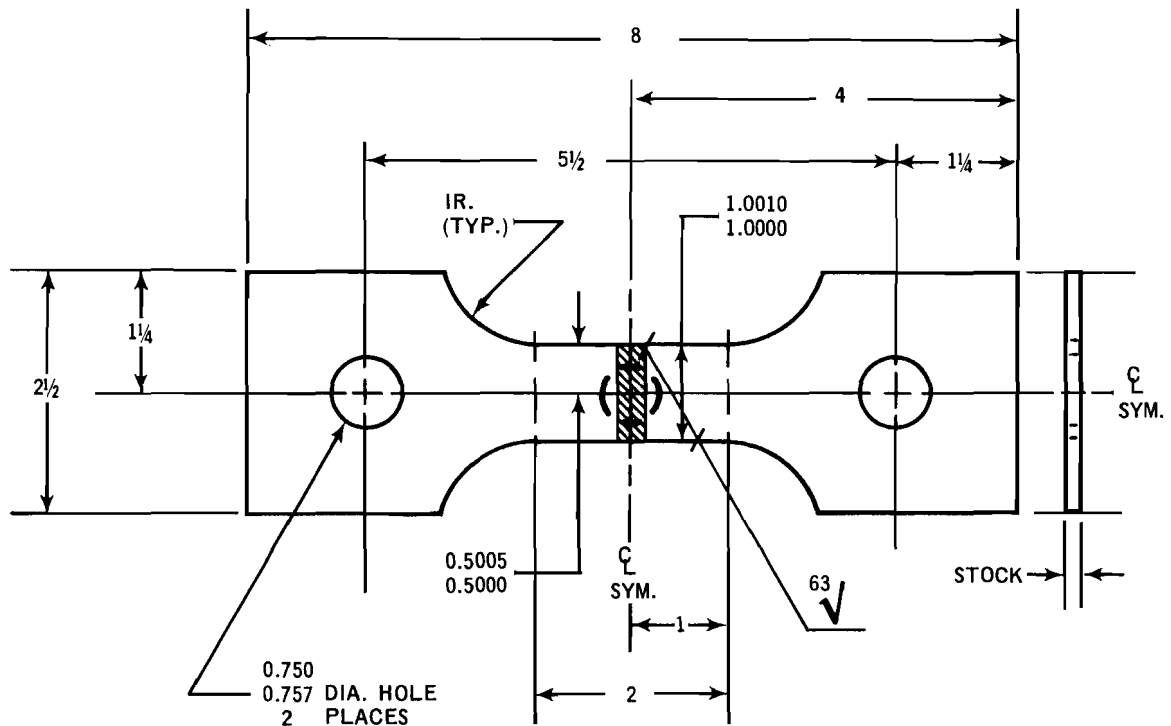
NOTES: STRESS CORROSION SPECIMEN FOR BASIC TEMPER SHEET IS THE SAME WITHOUT WELD BEAD AND CRACK.

FIGURE 2. STRESS CORROSION AND TENSILE SPECIMEN FOR WELDED AND CRACKED SHEET

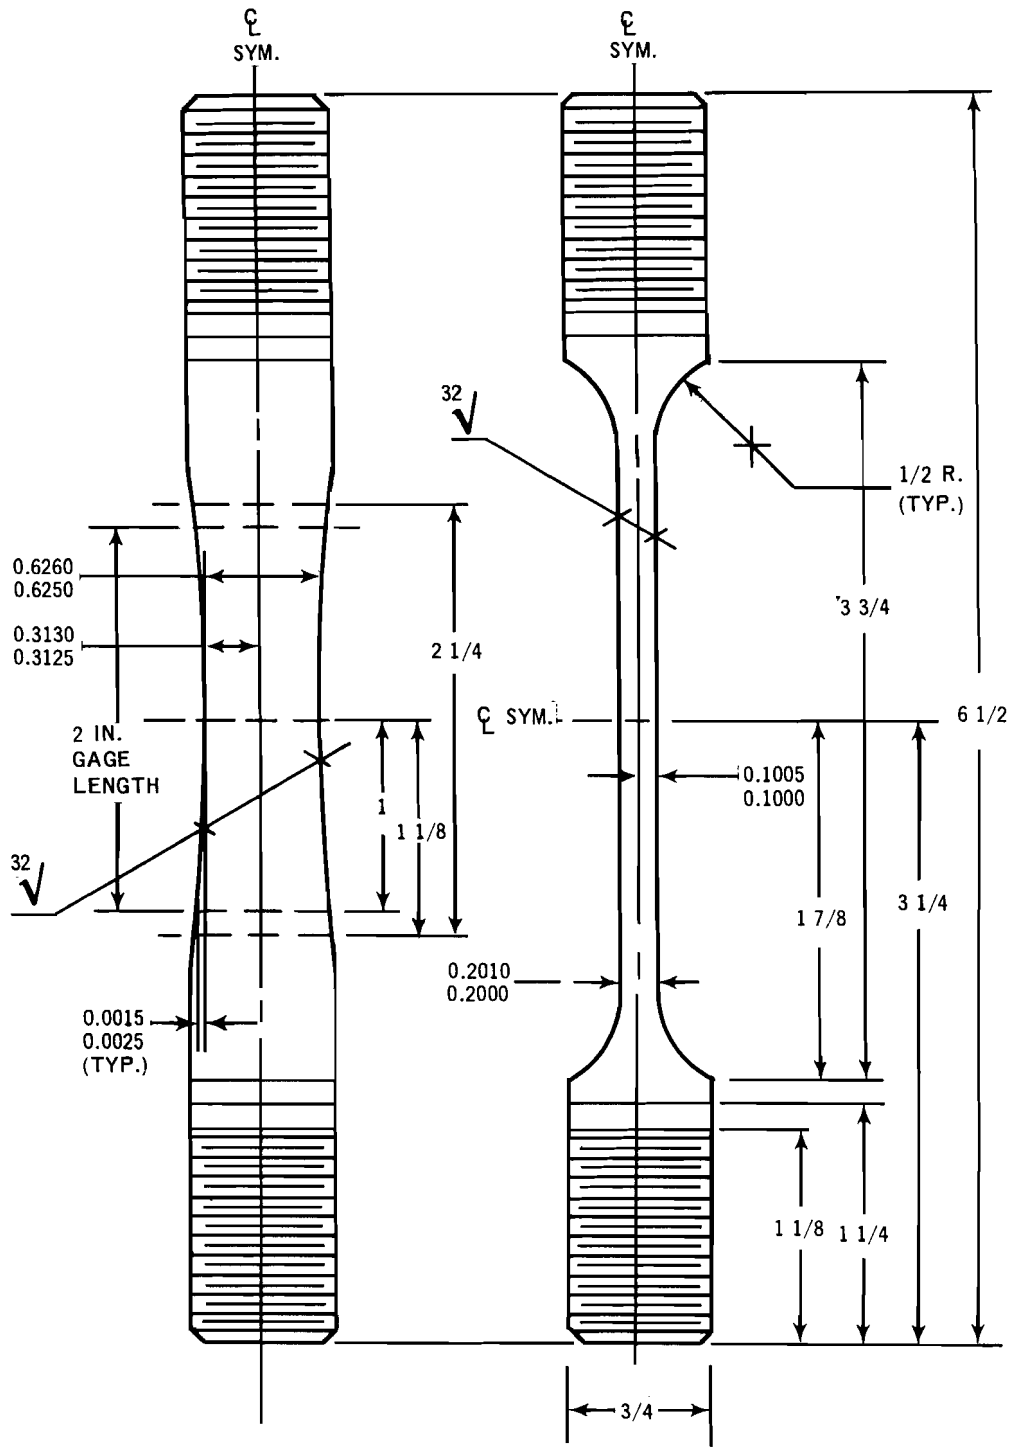
FIGURE 3. TENSILE SPECIMEN FOR BASIC 3/4" PLATE

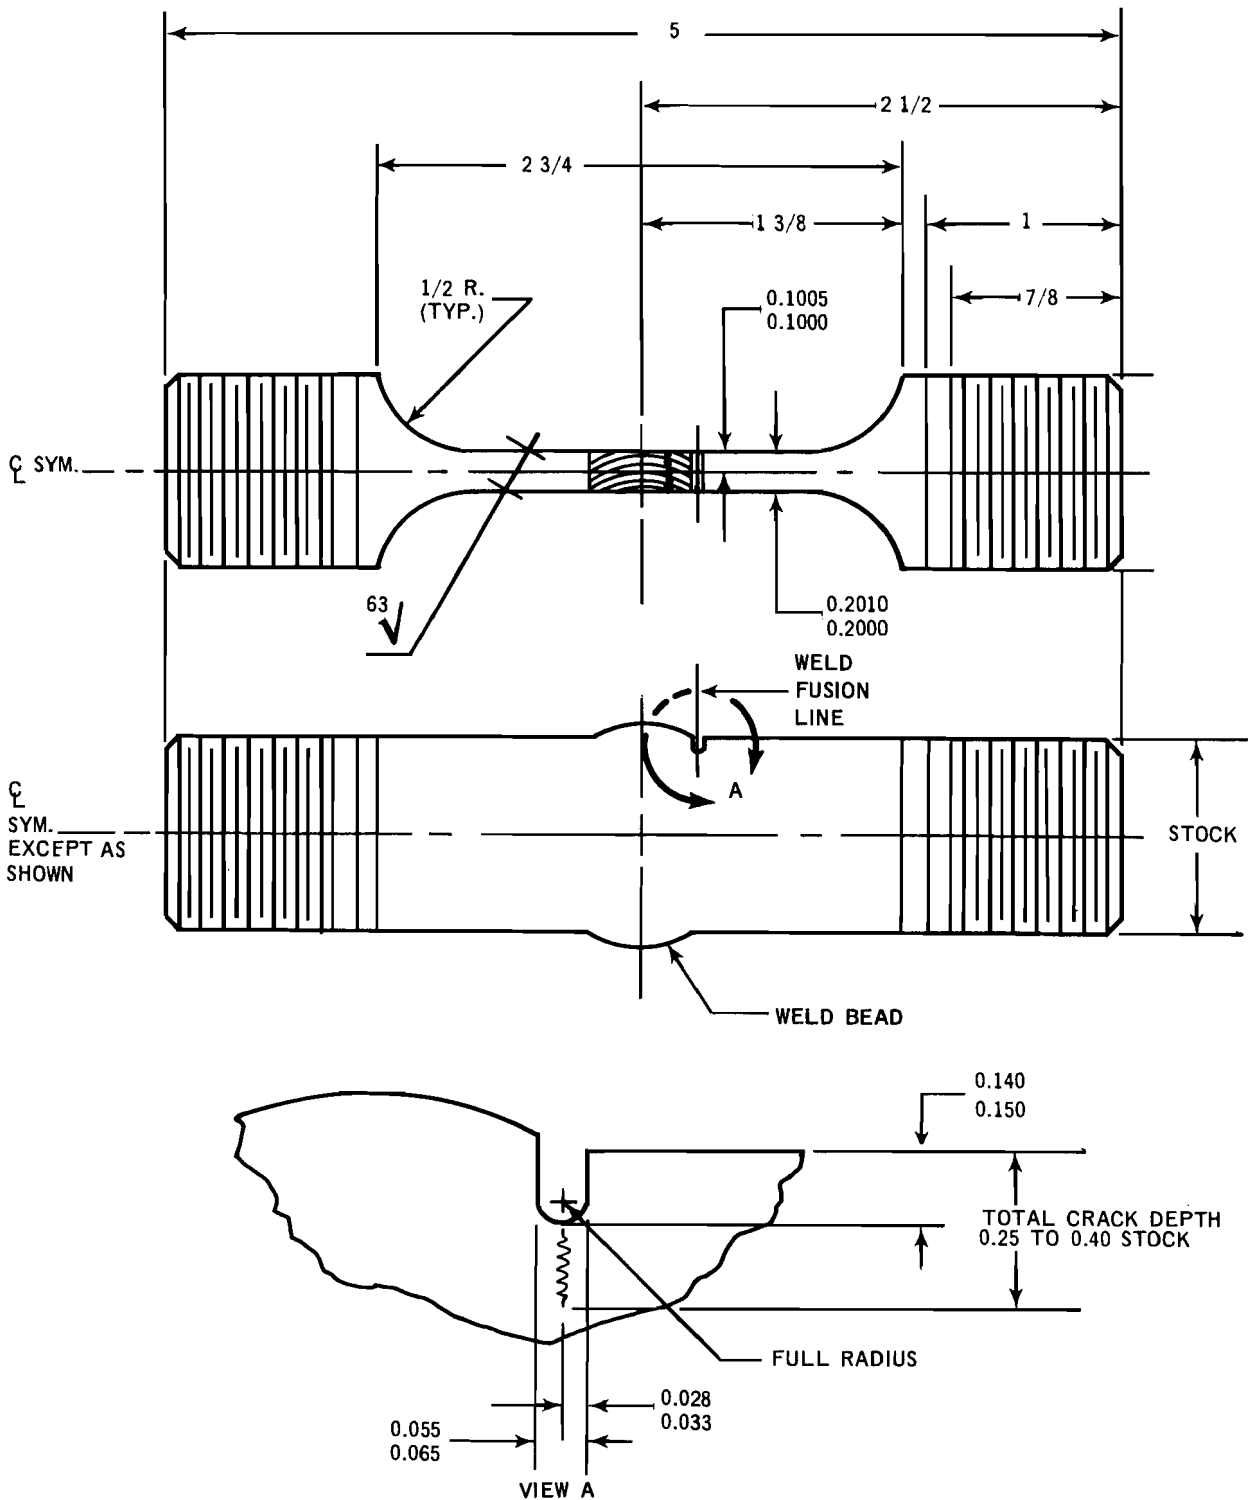
NOTE: STRESS CORROSION SPECIMEN FOR BASIC TEMPER 1" PLATE IS THE SAME WITHOUT WELD BEAD AND CRACK.
 STRESS CORROSION AND TENSILE SPECIMEN FOR WELDED UNNOTCHED 1" PLATE IS THE SAME WITHOUT CRACK AND TENSILE SPECIMEN HAS 2" GAGE LENGTH.

FIGURE 5. STRESS CORROSION AND TENSILE SPECIMEN FOR WELDED AND CRACKED 1" PLATE

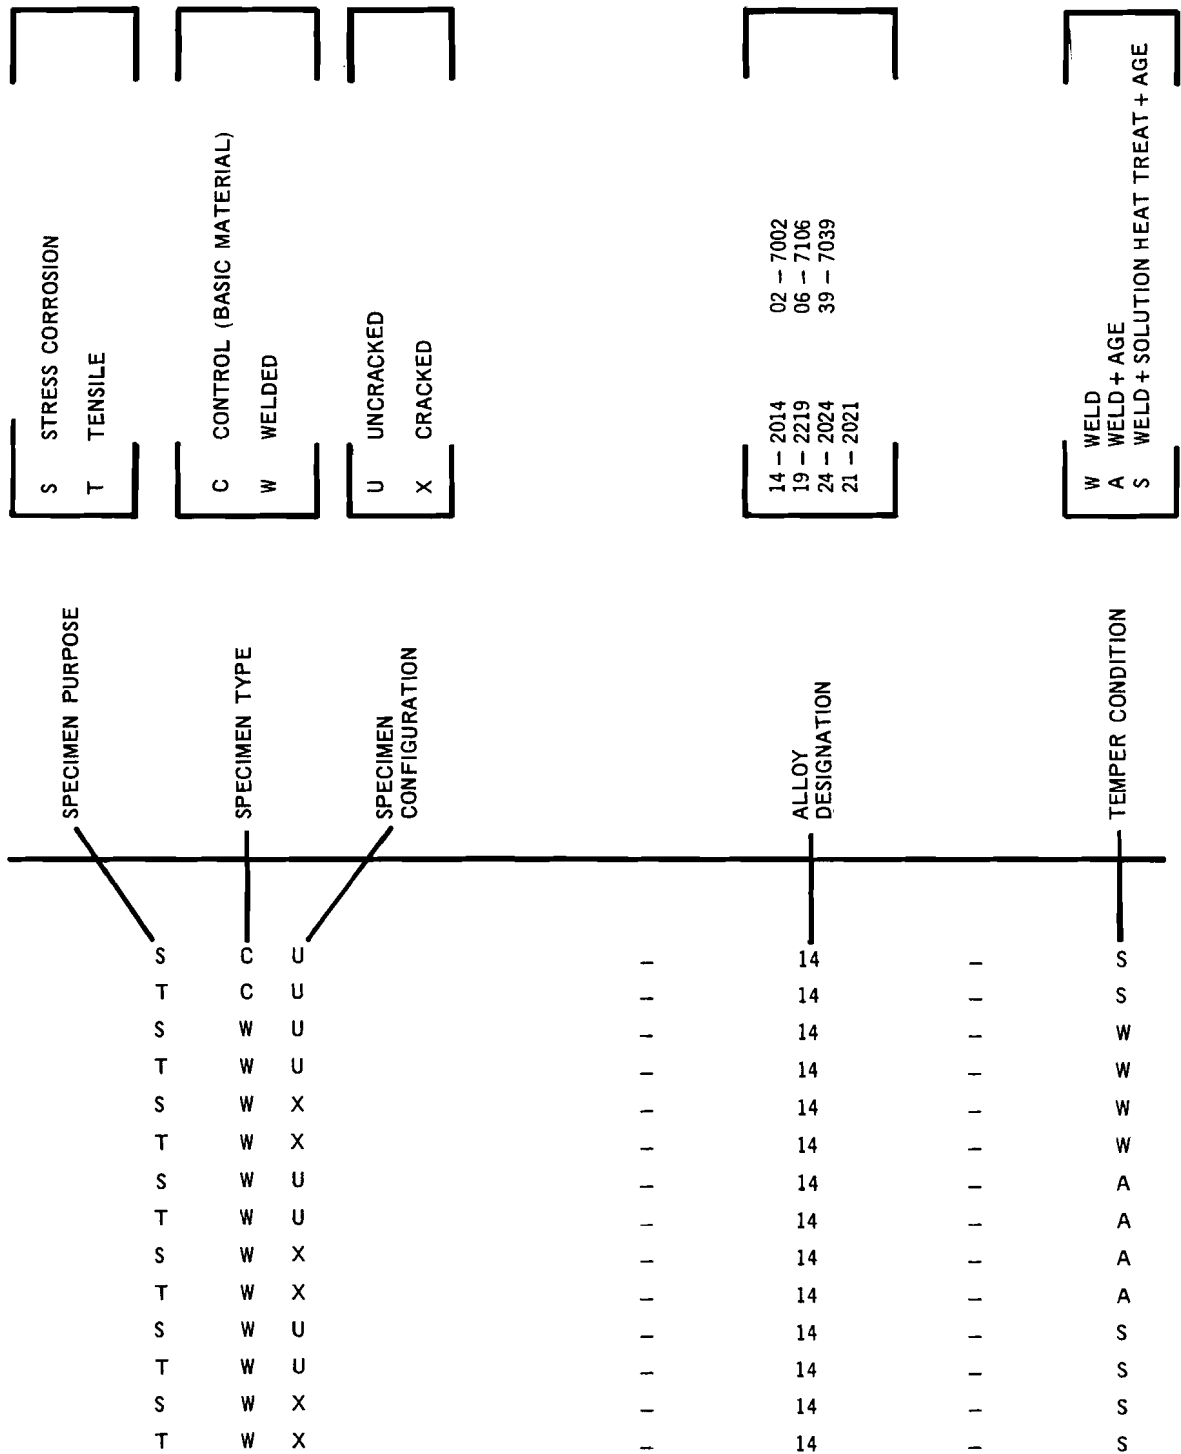
FIGURE 7. TYPICAL SPECIMEN IDENTIFICATION CODE

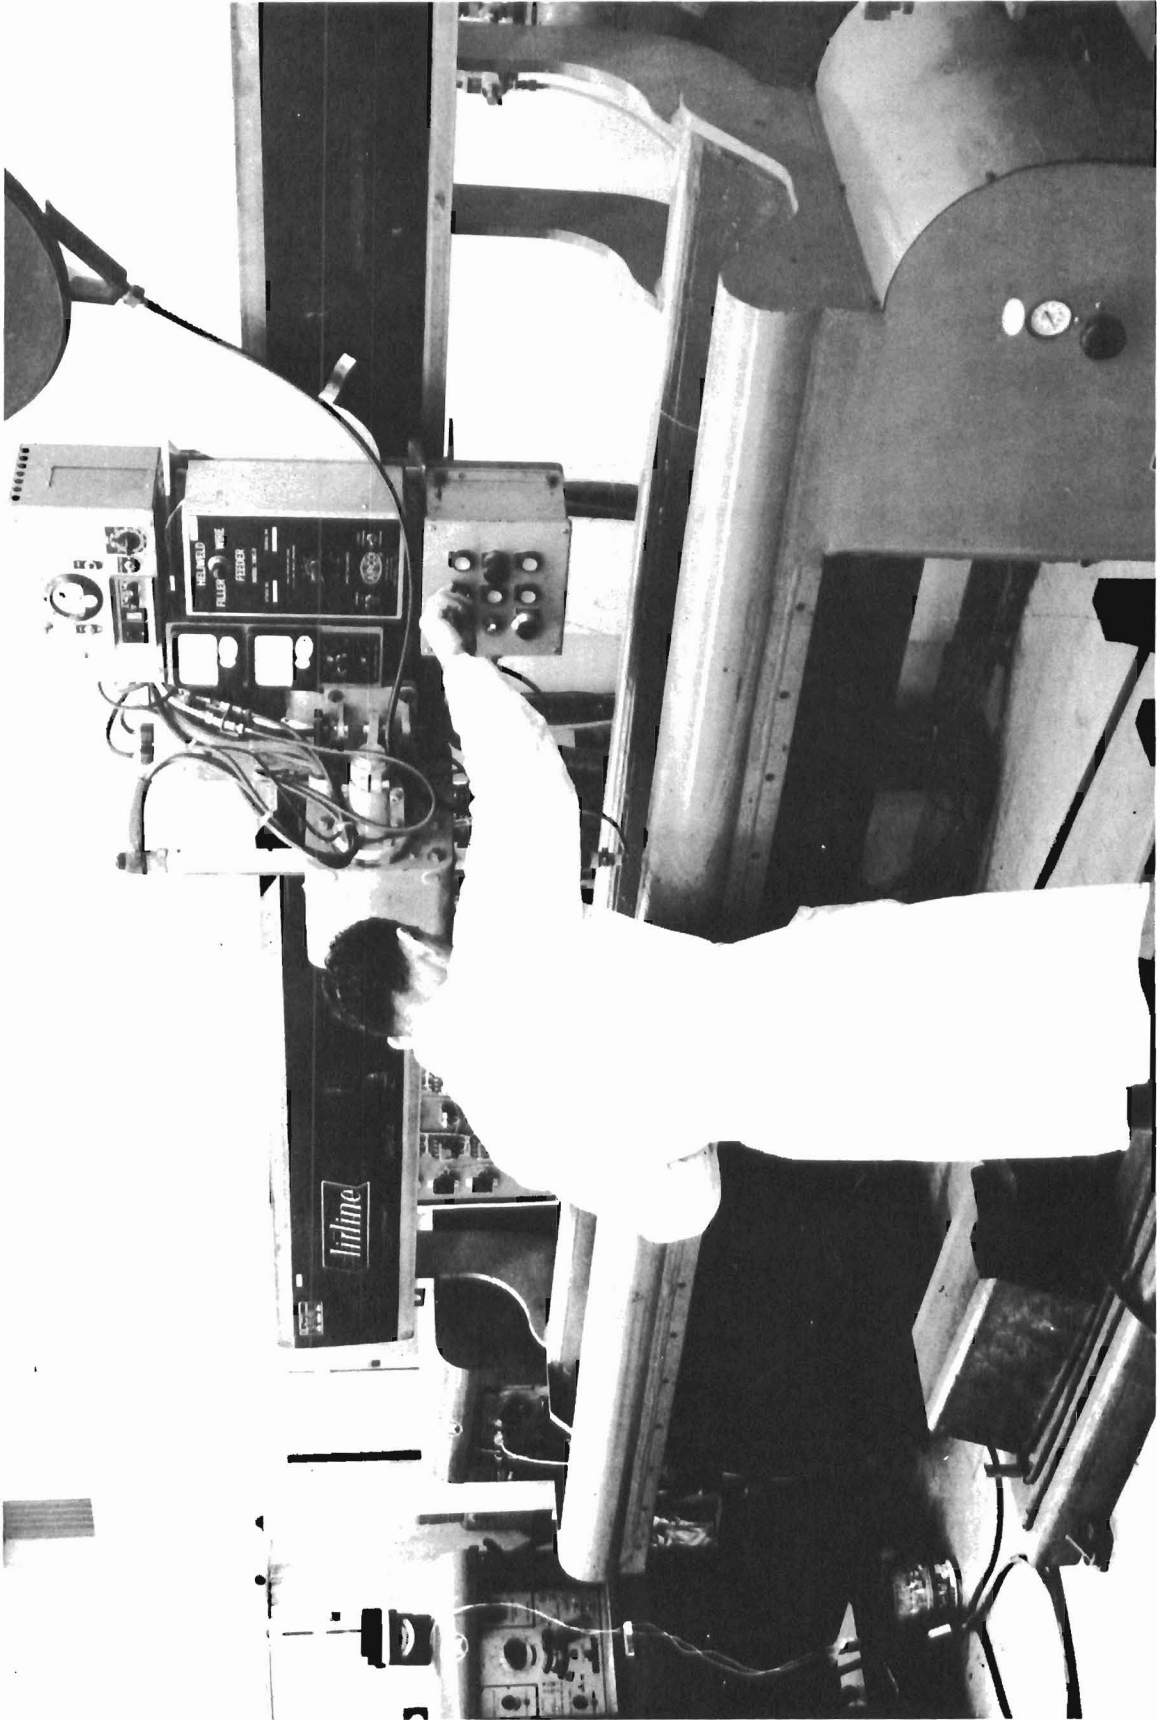
FIGURE 8. VIEW OF THE WELDING EQUIPMENT USED TO WELD SHEET PRODUCT

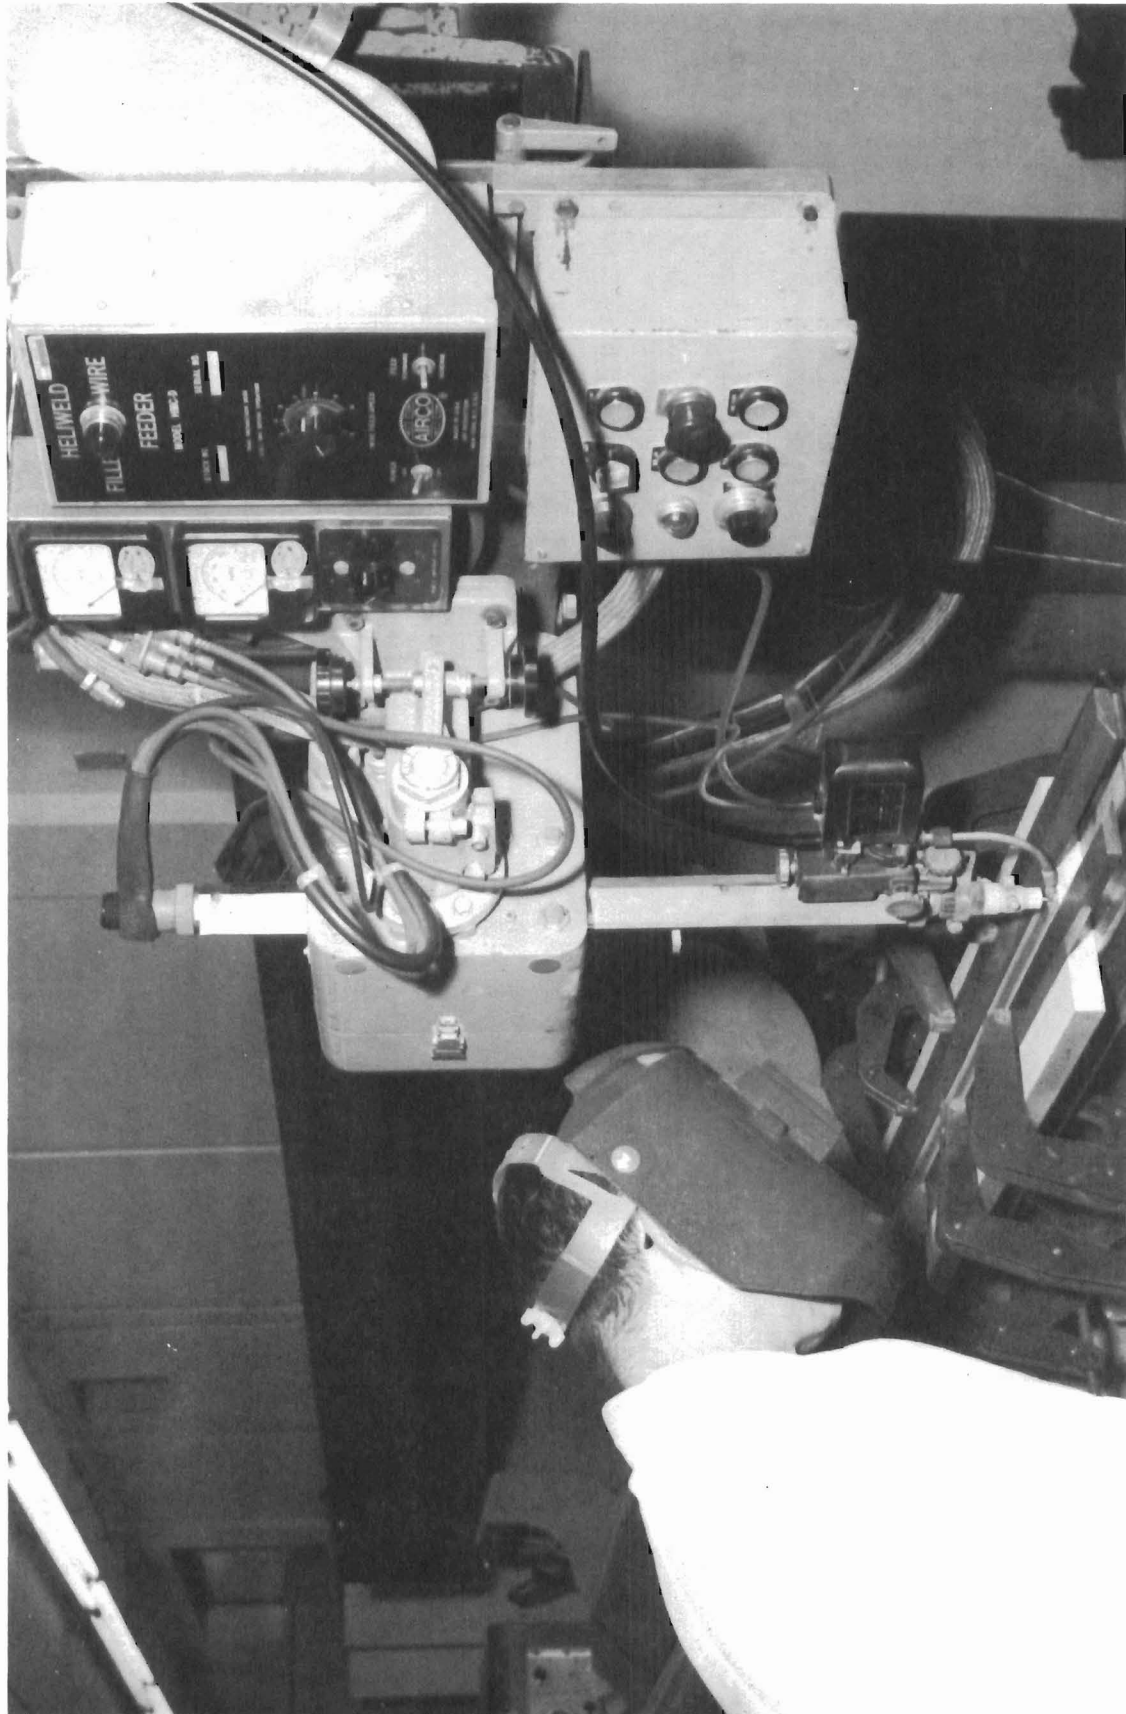
FIGURE 9. VIEW OF SET UP USED TO WELD PLATE PRODUCT

The welding equipment used in this program is shown in Figures 8 and 9 and is drawn schematically in Figure 10. Basic components of the equipment are described briefly as follows:

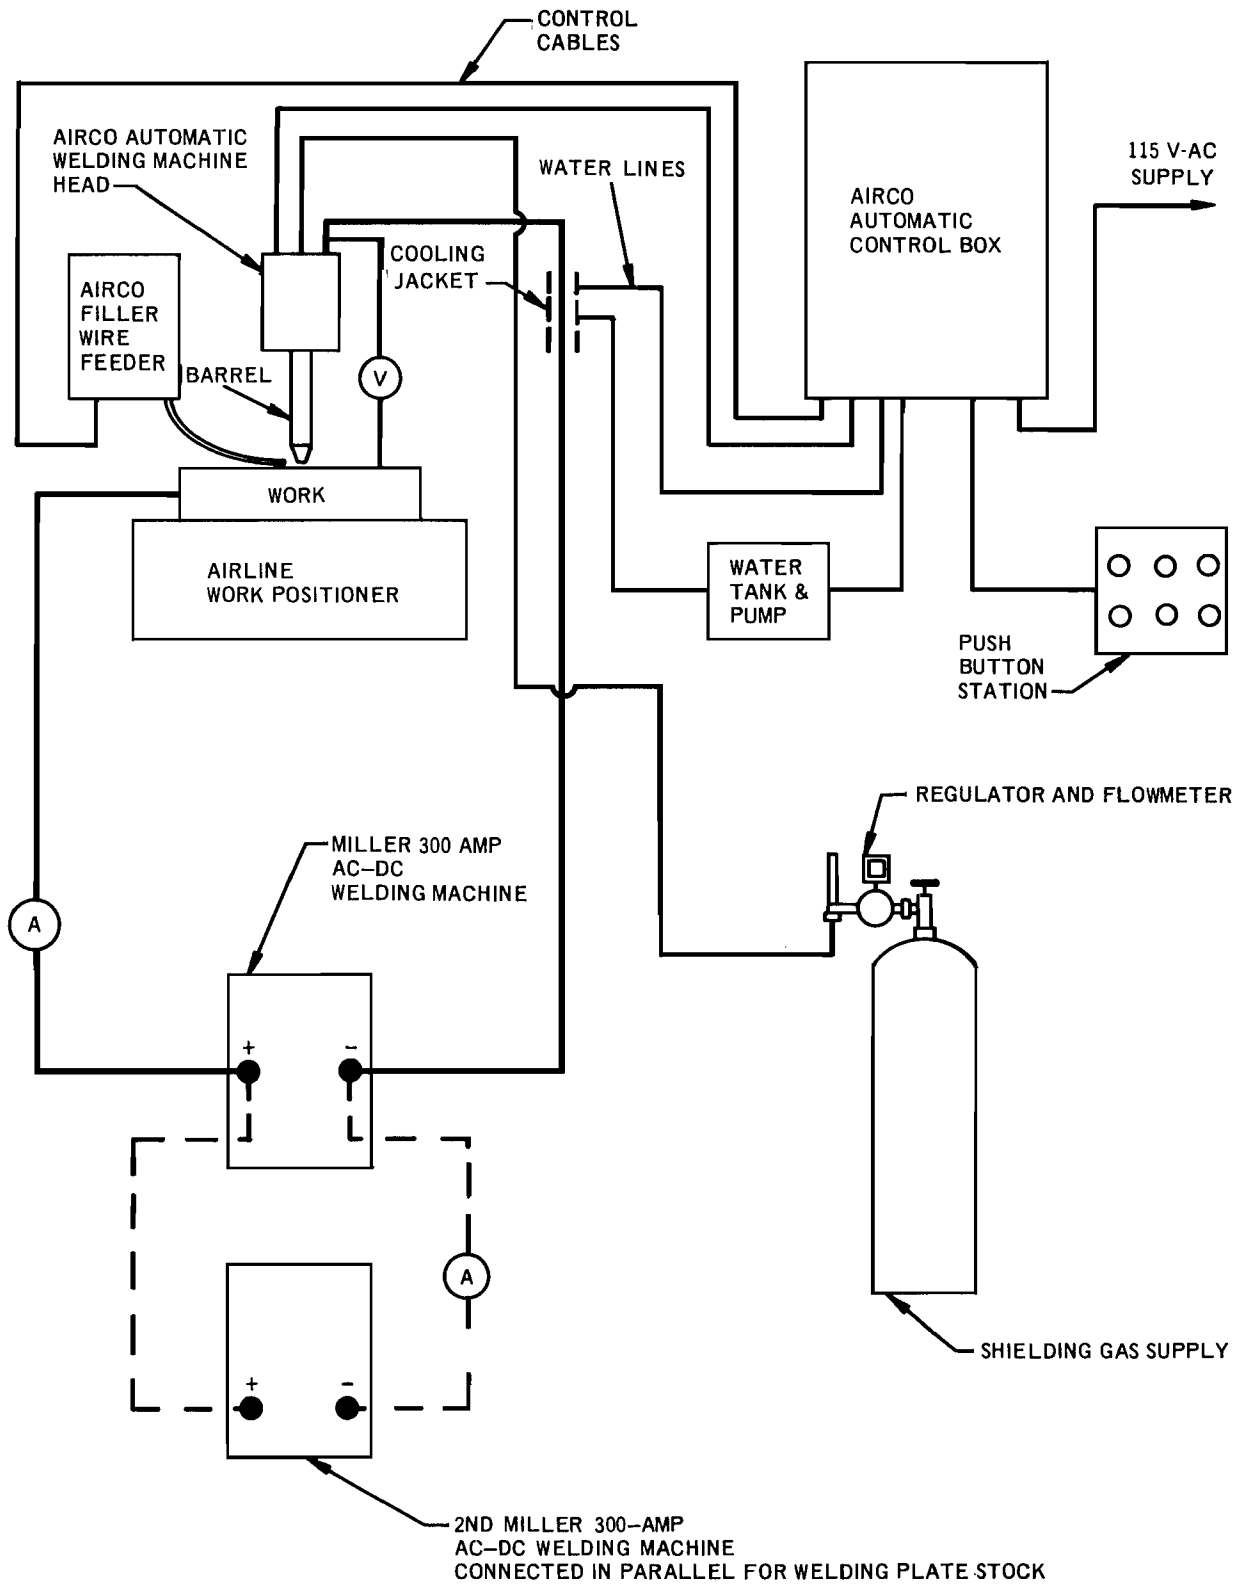
FIGURE 10. SCHEMATIC DRAWING OF WELDING EQUIPMENT SET-UP

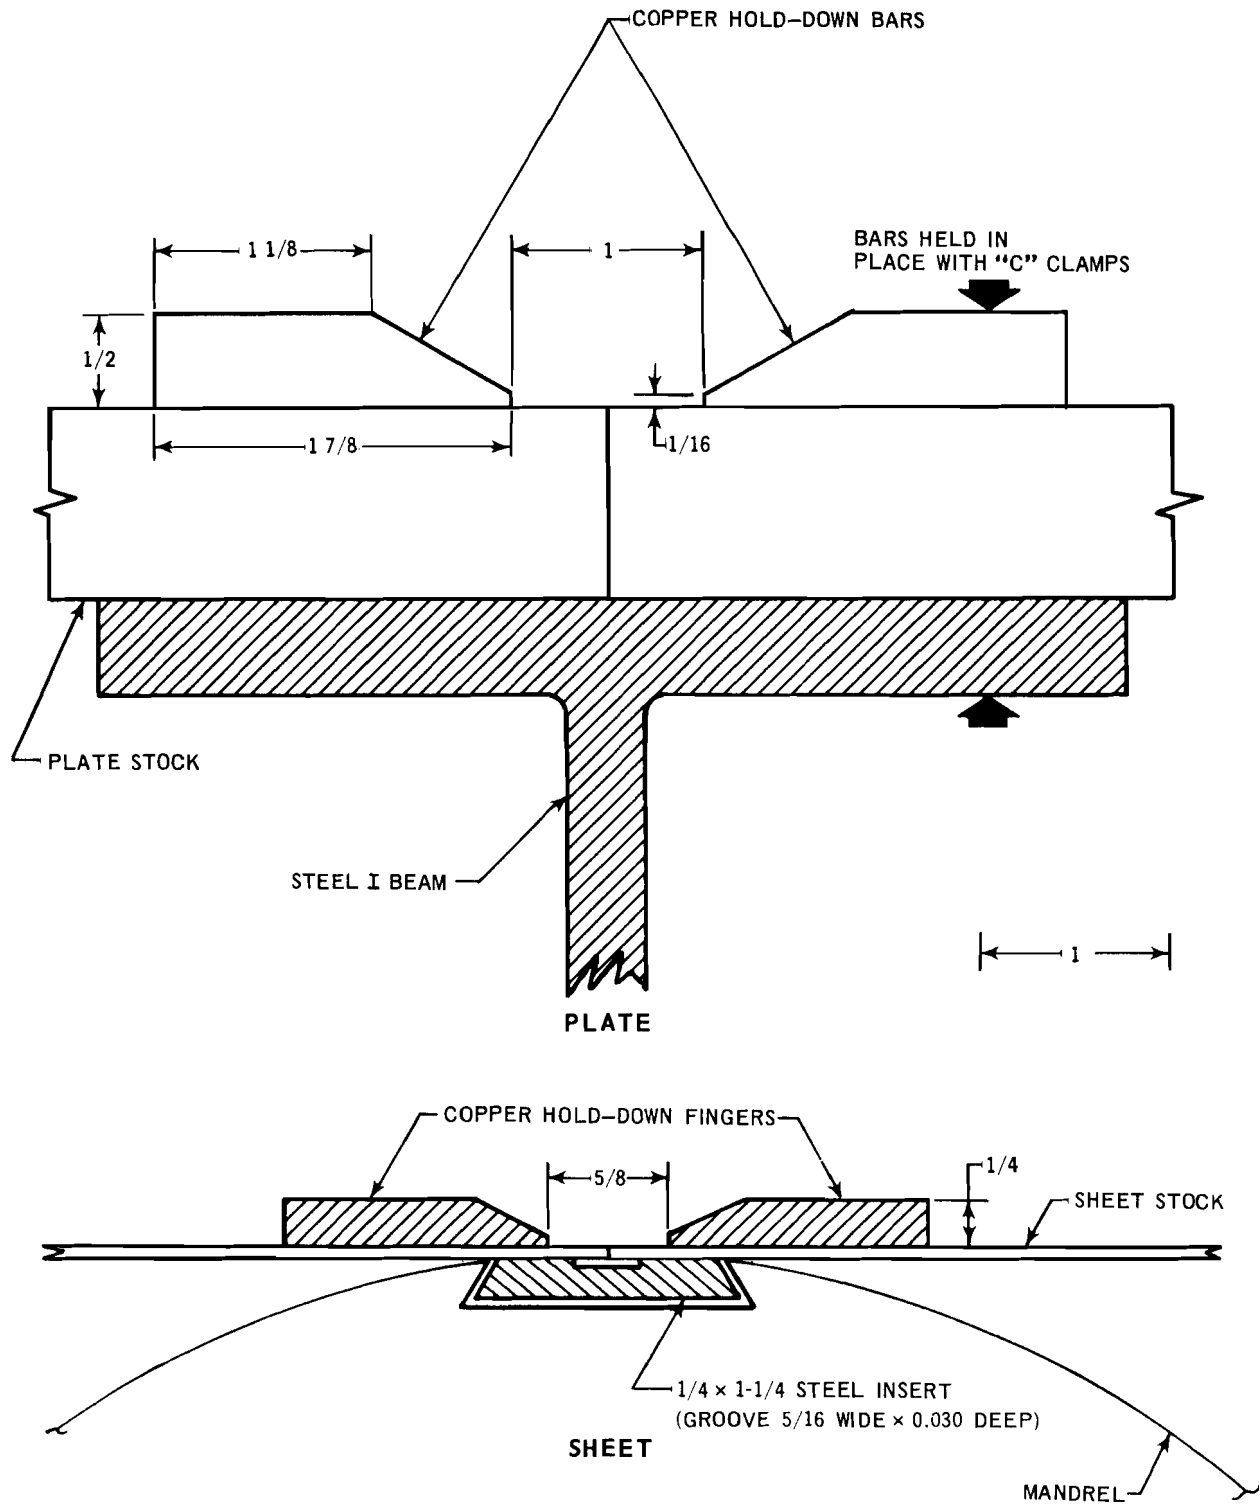
HOLD DOWN PRESSURE FOR ALL SHEET WELDS = 68 psi

FIGURE 11. WELDING FIXTURES

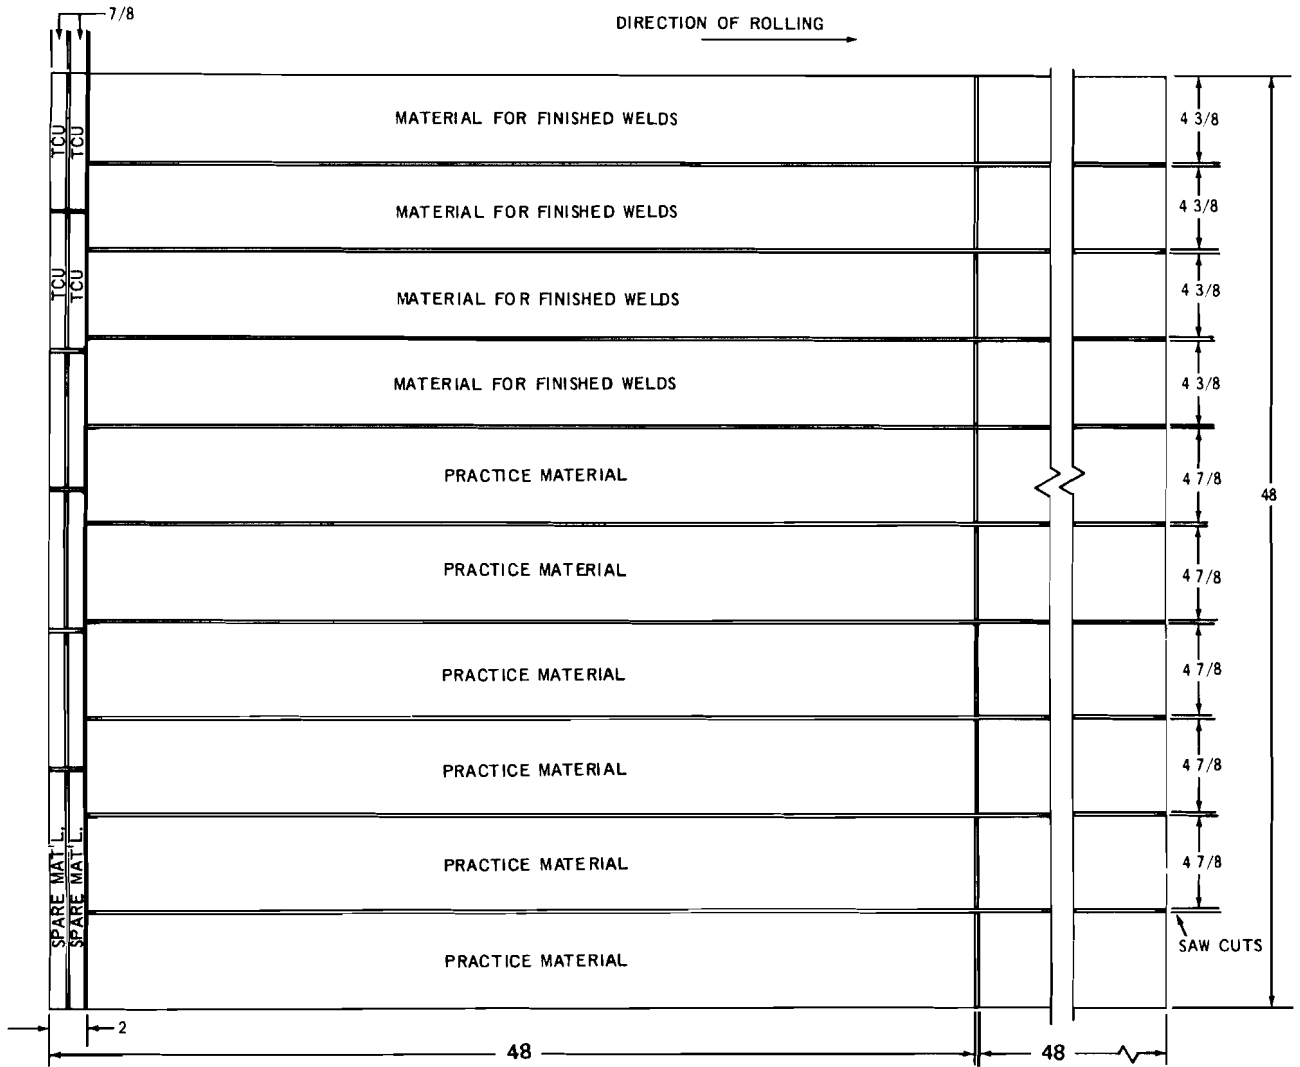
FIGURE 12. TYPICAL SECTIONING DIAGRAM FOR SHEET

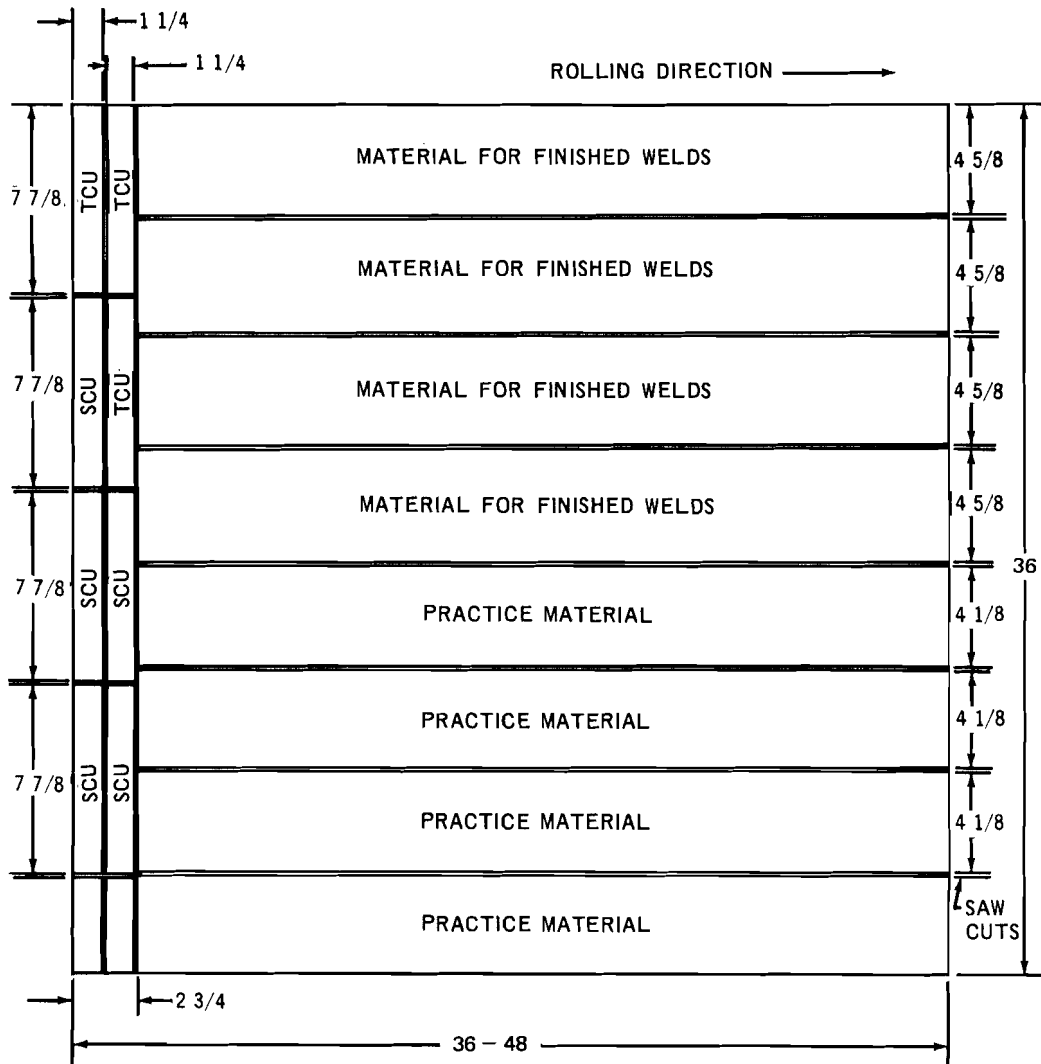
FIGURE 13. TYPICAL SECTIONING DIAGRAM FOR PLATE MATERIAL.

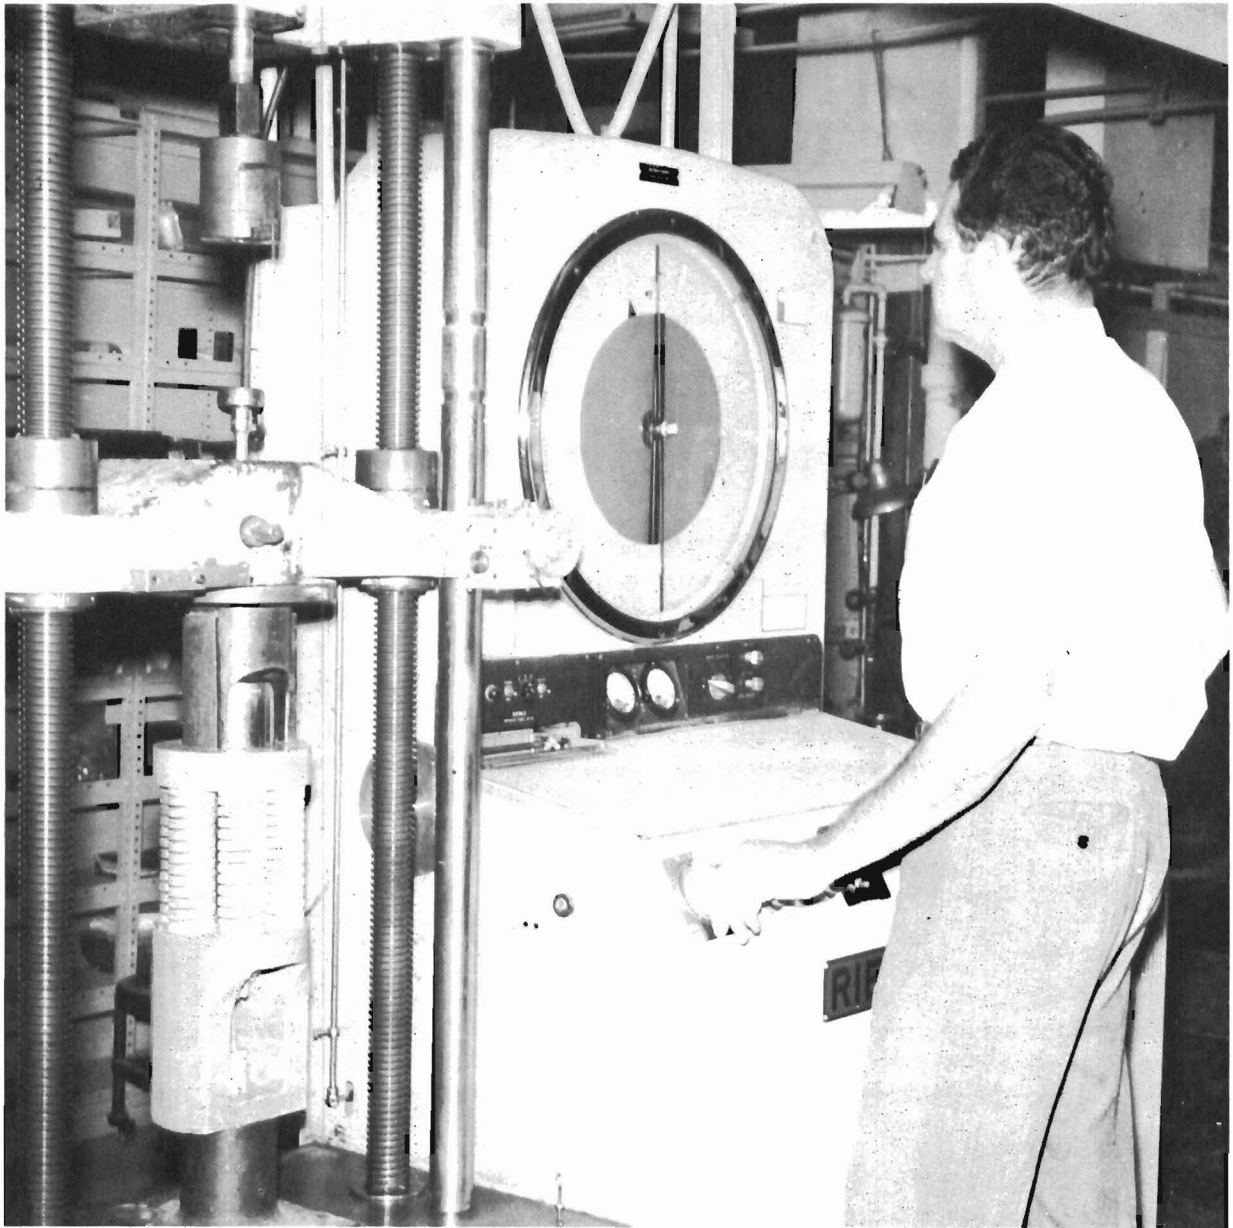
FIGURE 14. VIEW OF RIEHLE TEST MACHINE LOADING A SIX SPRING STRESS CORROSION JIG.

Sustained loading of plate specimens for environmental exposure was accomplished in three- and six-spring constant-load aluminum stress corrosion jigs capable of applying loads up to 6000 and 12,000 pounds, respectively (Figure 14). Sustained loading of sheet specimens was accomplished in two- and four-spring steel jigs capable of applying loads up to 4000 and 8000 pounds, respectively (Figure 15). Calibration testing using electrical strain-gaged load cells in place of specimens indicated accuracy of applied

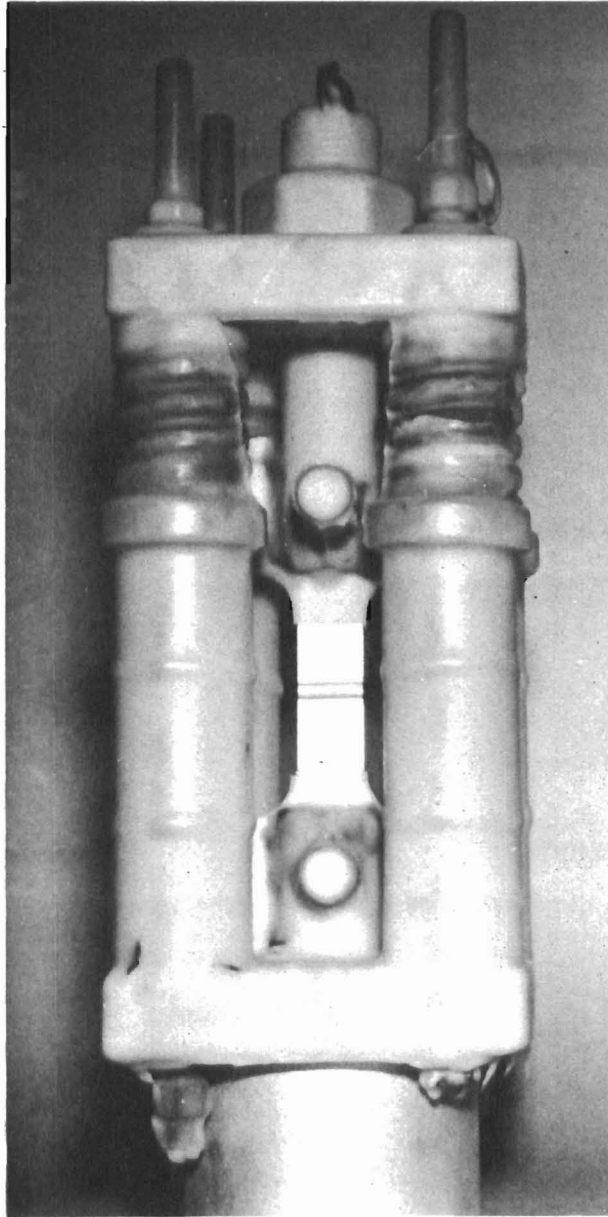
FIGURE 15. TYPICAL FOUR-SPRING LOADING JIG FOR STRESS CORROSION TESTING

After sustained loading specimens, each jig was coated with a warm dip polyethylene wax (Finch Paint Co. Coating CA-79) to prevent any galvanic action between specimen and jig--the specimen being protected during dipping. The machined edges of the SCC specimens were then coated with chem mill maskant (Organoceram 1-2020) so that only the mill surface was exposed to the alternate immersion environment.

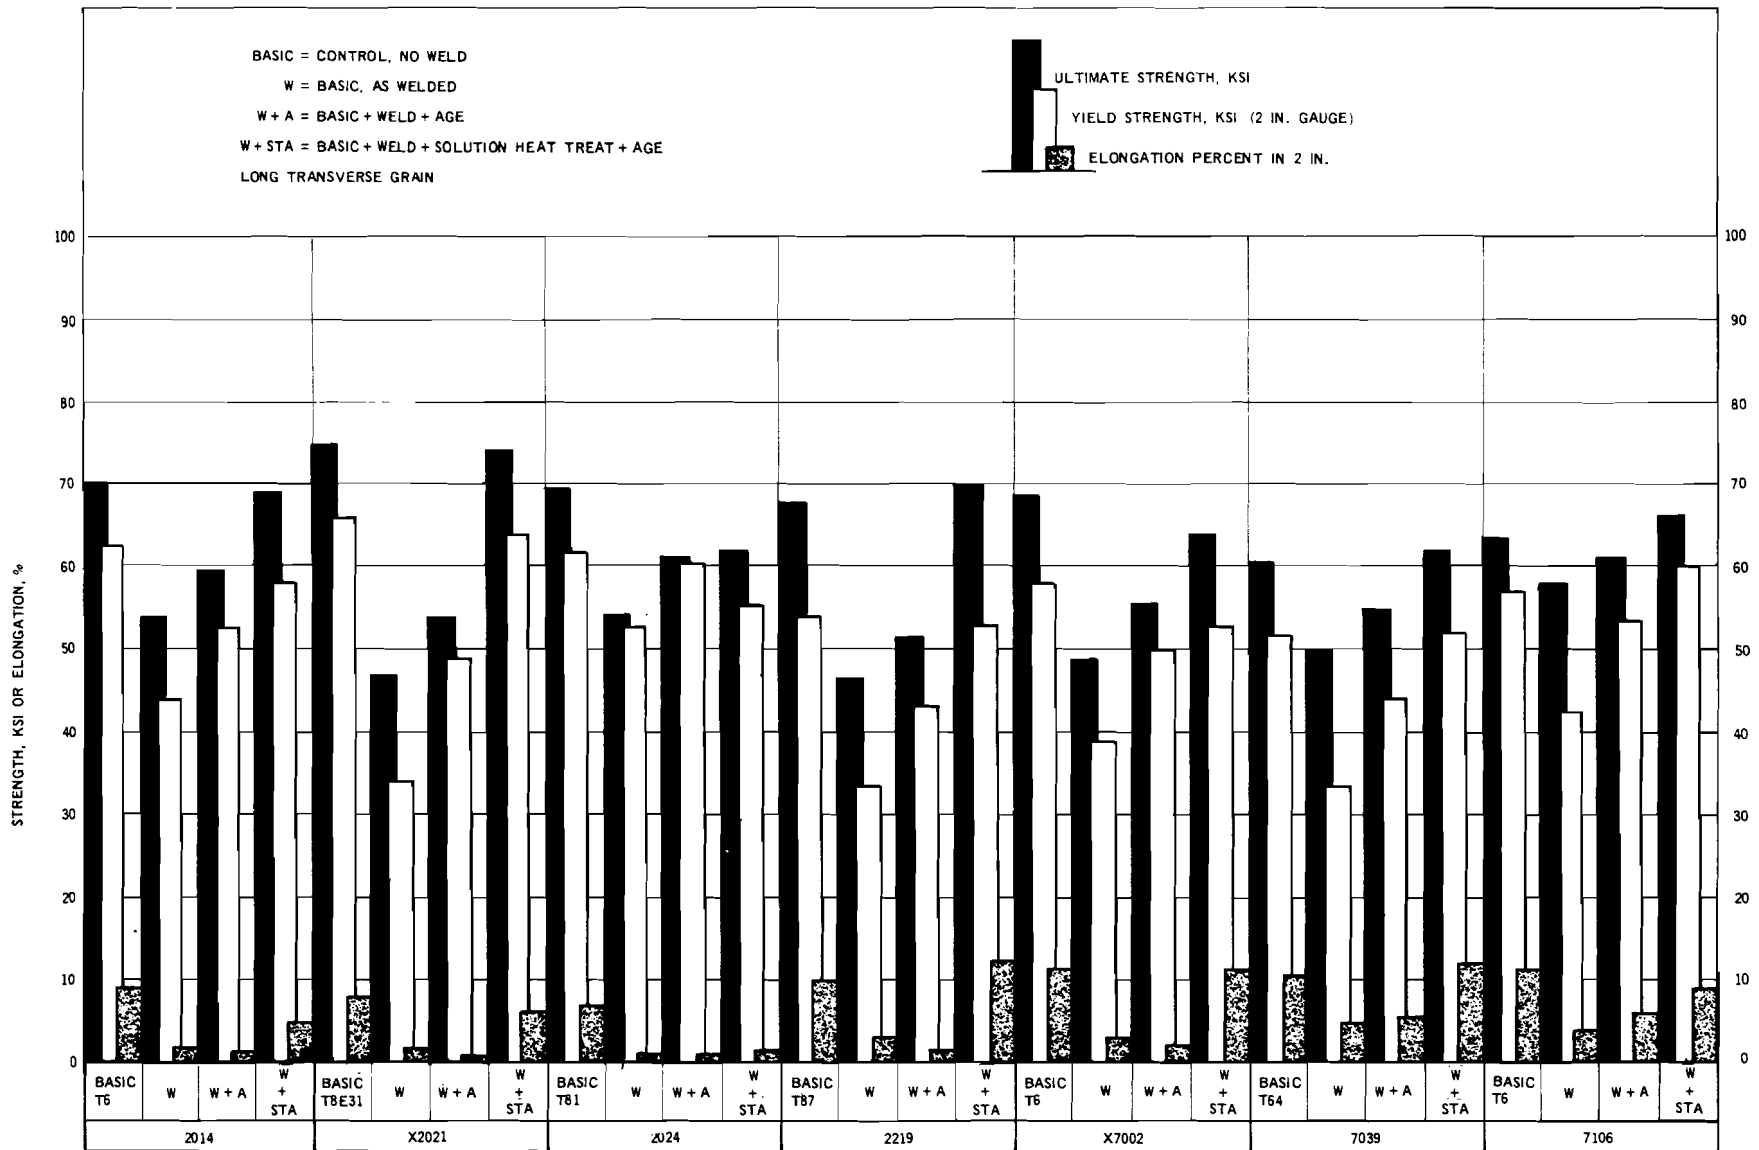
FIGURE 16. EFFECT OF WELDING AND POST WELD HEAT TREATMENT ON TENSILE PROPERTIES OF ALUMINUM SHEET ALLOYS

The ratio of net section notch strength to 0.2-percent offset yield strength for the sheet specimens was near to or greater than 1.00 for all alloys and tempers except for X2021-T8E31 weld plus age and weld plus solution heat treat plus age (0.75 to 0.80) and 2024-T81 as-welded (0.76 to 0.82), and weld plus age (0.40 to 0.44). Fracture surfaces beyond the fatigue
