STRESS CORROSION SUSCEPTIBILITY OF WELDED ALUMINUM ALLOYS

DOUGLAS AIRCRAFT COMPANY

TECHNICAL REPORT AFML-TR-67-291

AUGUST 1967

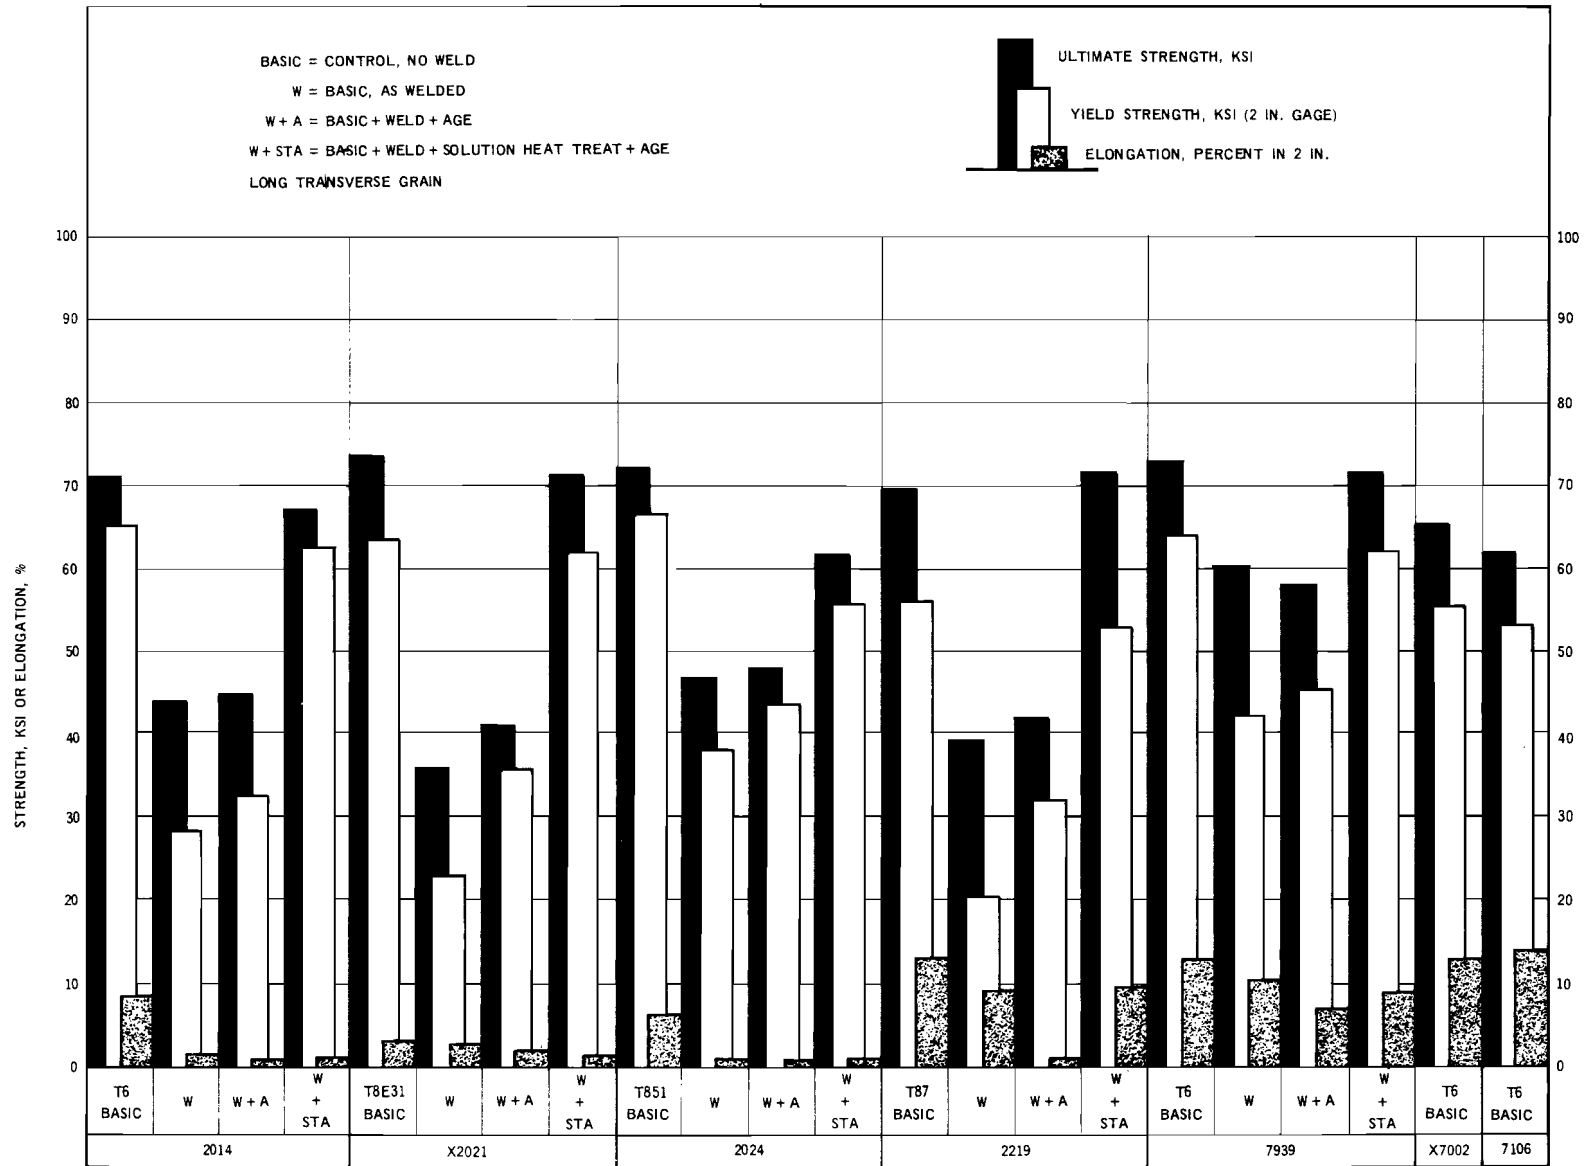
FIGURE 17. EFFECT OF WELDING AND POST WELD HEAT TREATMENT ON TENSILE PROPERTIES OF ALUMINUM PLATE ALLOYS

Mechanical properties are graphically presented for the sheet alloy-weld-temperers in Figure 16 and for the plate alloy-weld-temperers in Figure 17. These data are further shown as "efficiencies" in Tables IV and V.

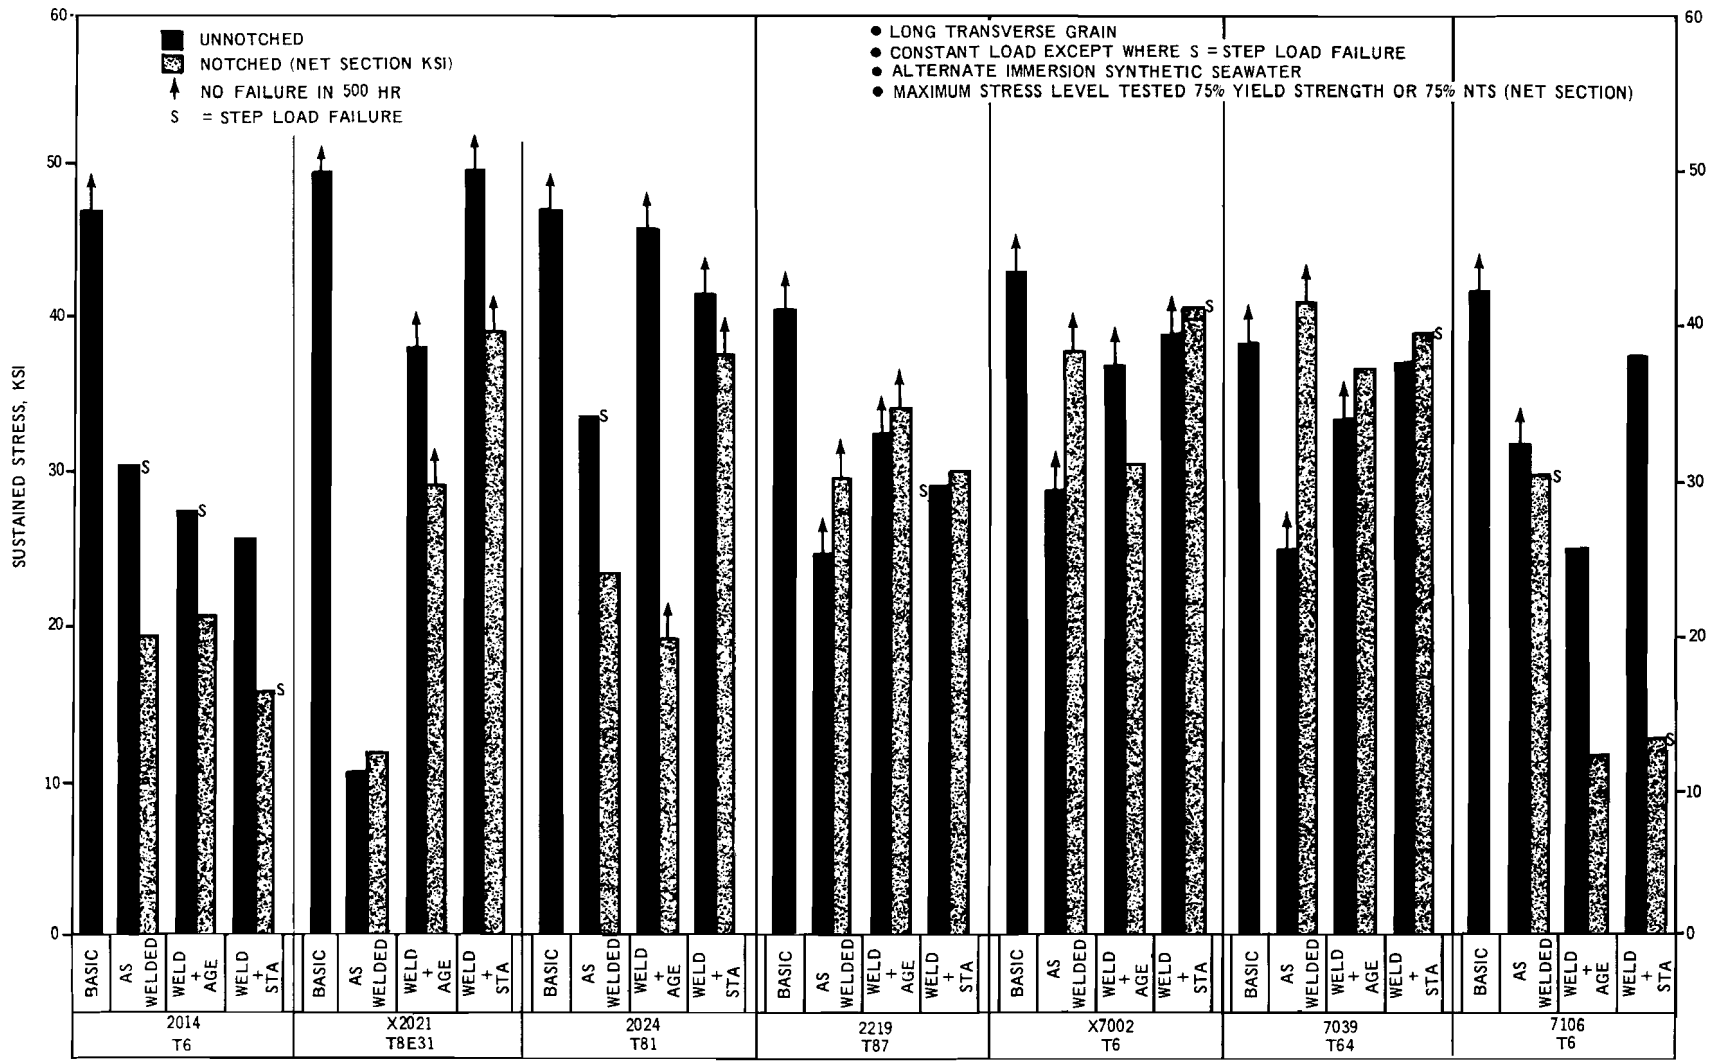
FIGURE 18. COMPARISON OF SCC THRESHOLD STRESS FOR NOTCHED AND UNNOTCHED, AS WELDED AND POST WELD HEAT TREATED ALUMINUM ALLOY SHEET.

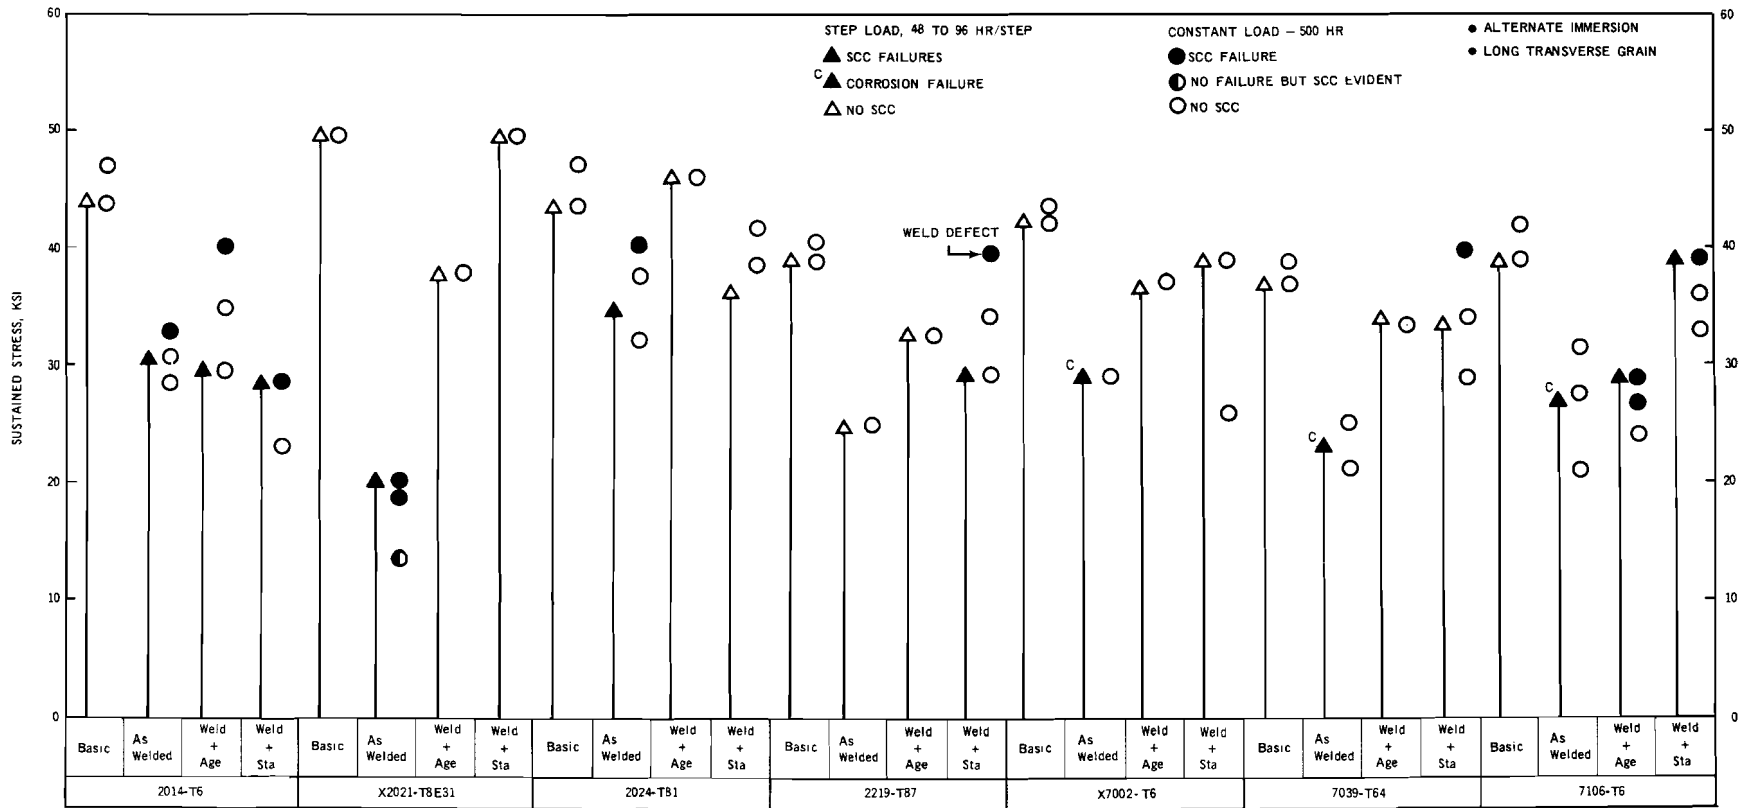
FIGURE 19. COMPARISON OF STEP LOAD AND CONSTANT LOAD SCC DATA FOR UNNOTCHED ALUMINUM ALLOY SHEET

The position of the constant-load threshold relative to step load, then, is inconsistent and may be either higher than or lower than step-load value. It is fitting, however, to refer to the step-load threshold as

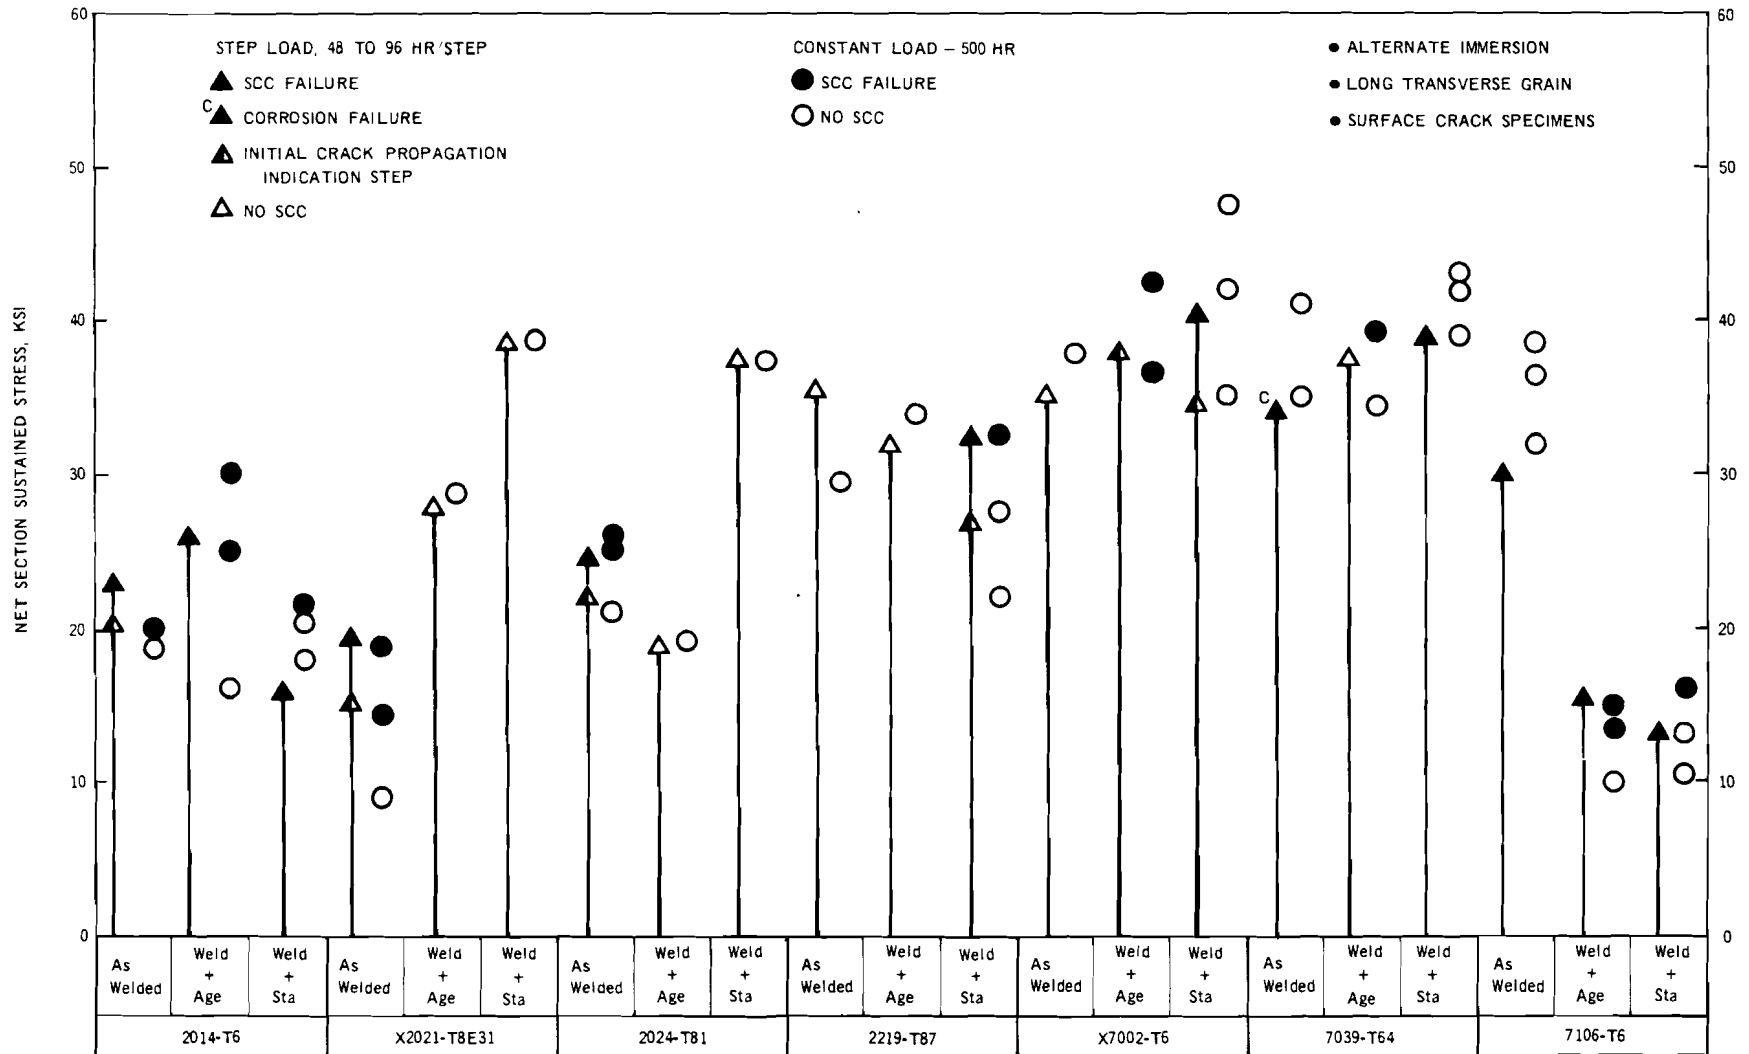
FIGURE 20. COMPARISON OF STEP LOAD AND CONSTANT LOAD SCC DATA FOR NOTCHED ALUMINUM ALLOY SHEET

The cases of step-load threshold above constant-load threshold may be attributed to inability to detect SCC initiation in the step-load test. Considering stress levels in which crack initiation was indicated prior to failure in Figure 20 reduces the Δ threshold for notched alloy-temper; 2014-T6 as-welded, X2021-T8E31 as-welded, 2024-T81 as-welded, and 2219-T87 weld plus STA.

The stress intensity data calculated from step-load and constant-load alternate immersion test data are graphically presented in Figure 21 in a manner similar to net section stress data previously presented in Figure 20, but are lacking sufficient data for defining a nominal $K_{I_{SCC}}$ threshold in a few alloy-weld-tempers. These data indicate a relationship of alloys, tempers, and testing similar to that previously discussed on the basis of net section stress.

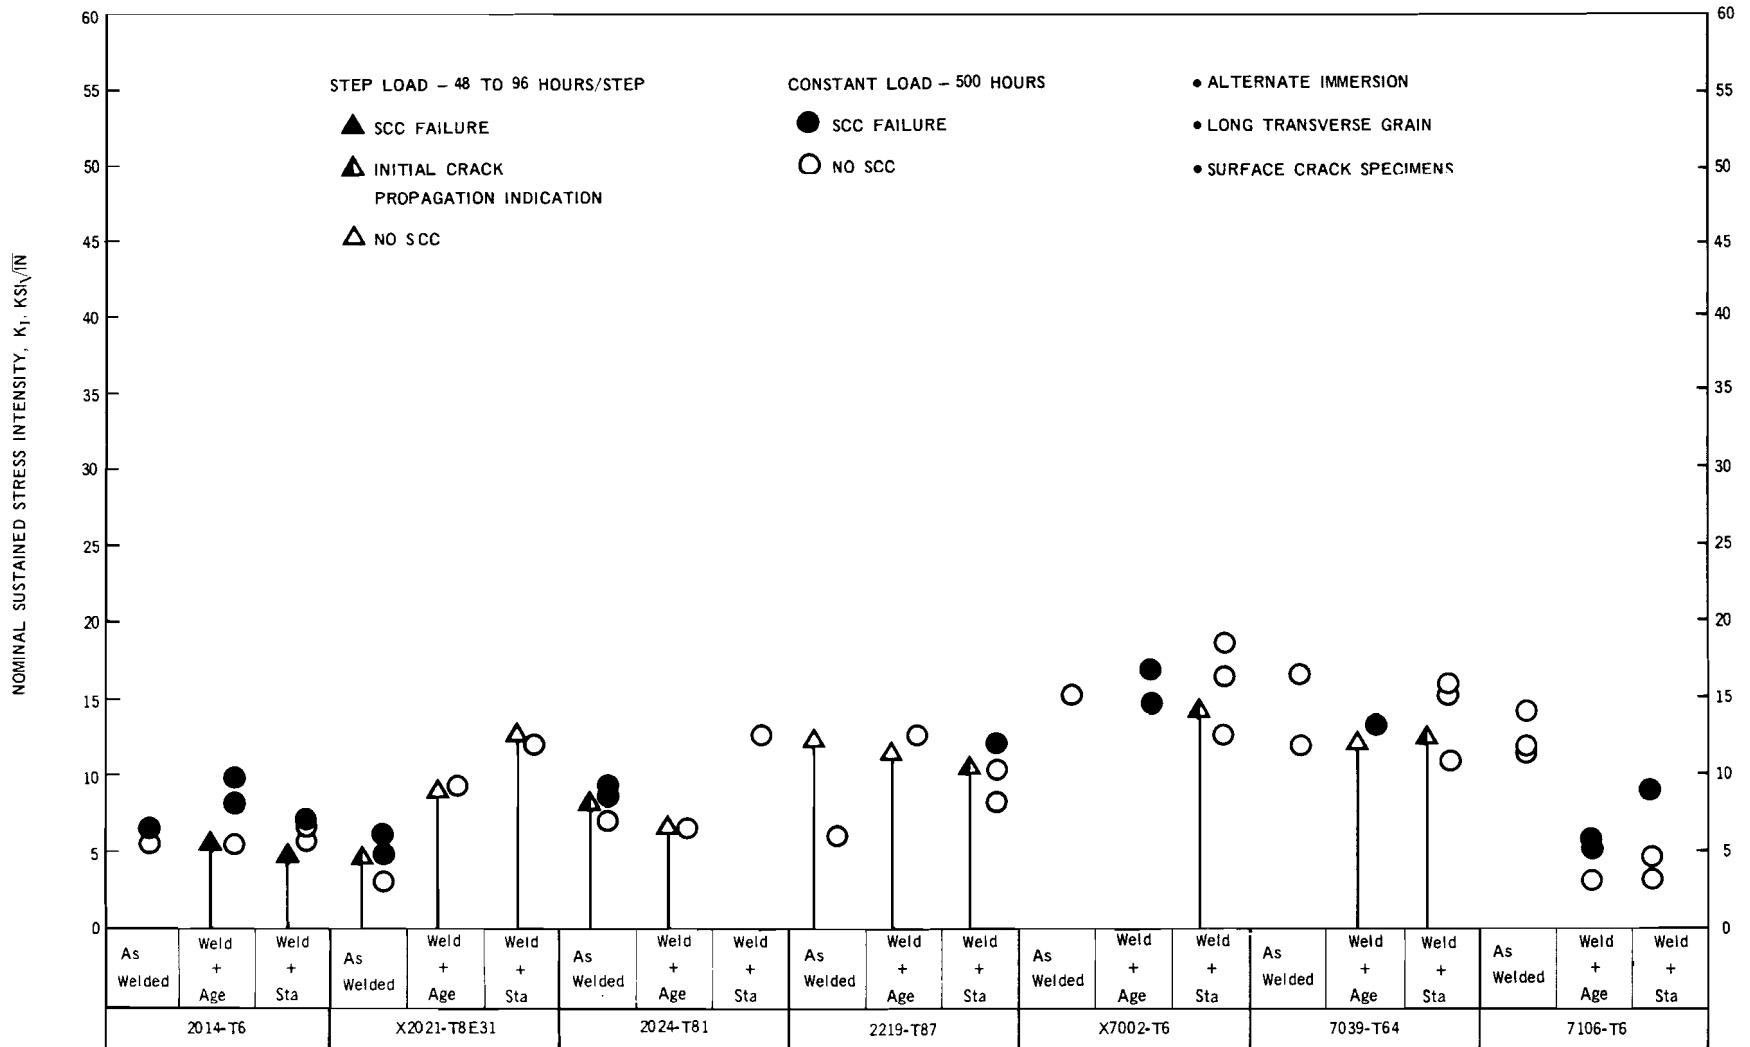
FIGURE 21. EFFECT OF STRESS INTENSITY ON STRESS CORROSION OF WELDED ALUMINUM ALLOY SHEET

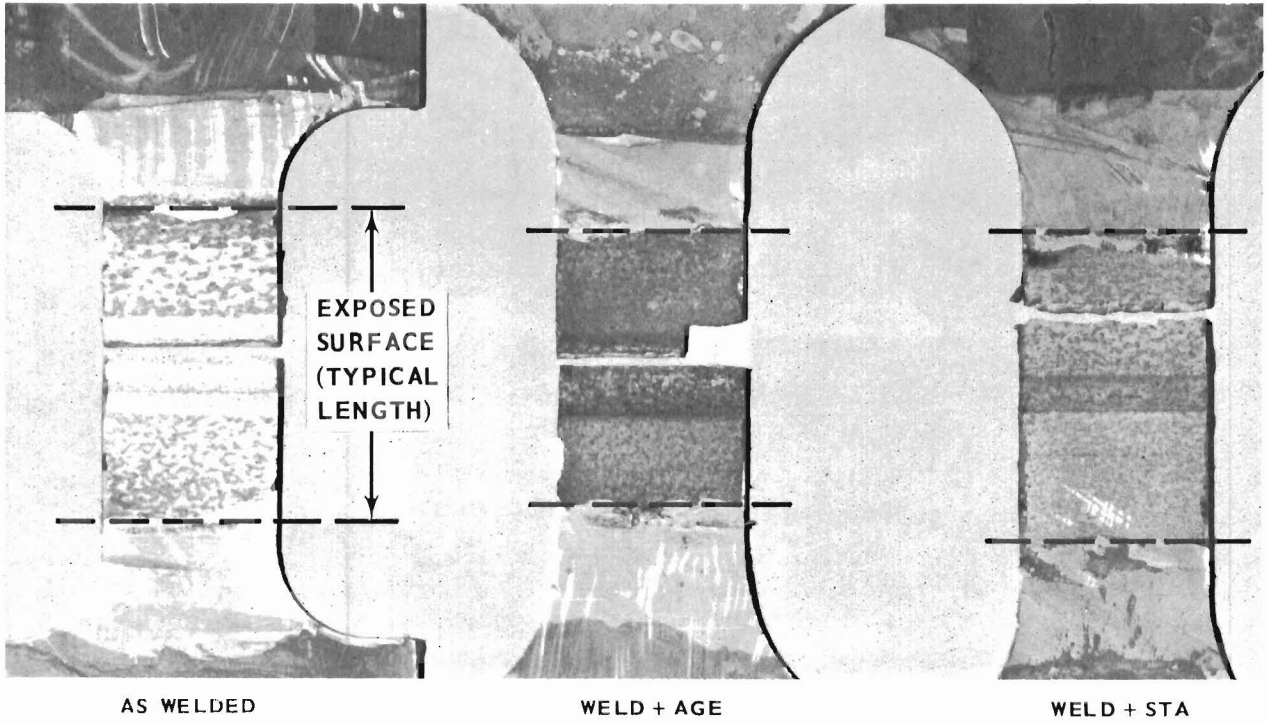
FIGURE 22. SURFACE CONDITION OF 2014-T6 WELDED SHEET AFTER 500-HOURS ALTERNATE IMMERSION. (TENSION TESTED AFTER EXPOSURE)

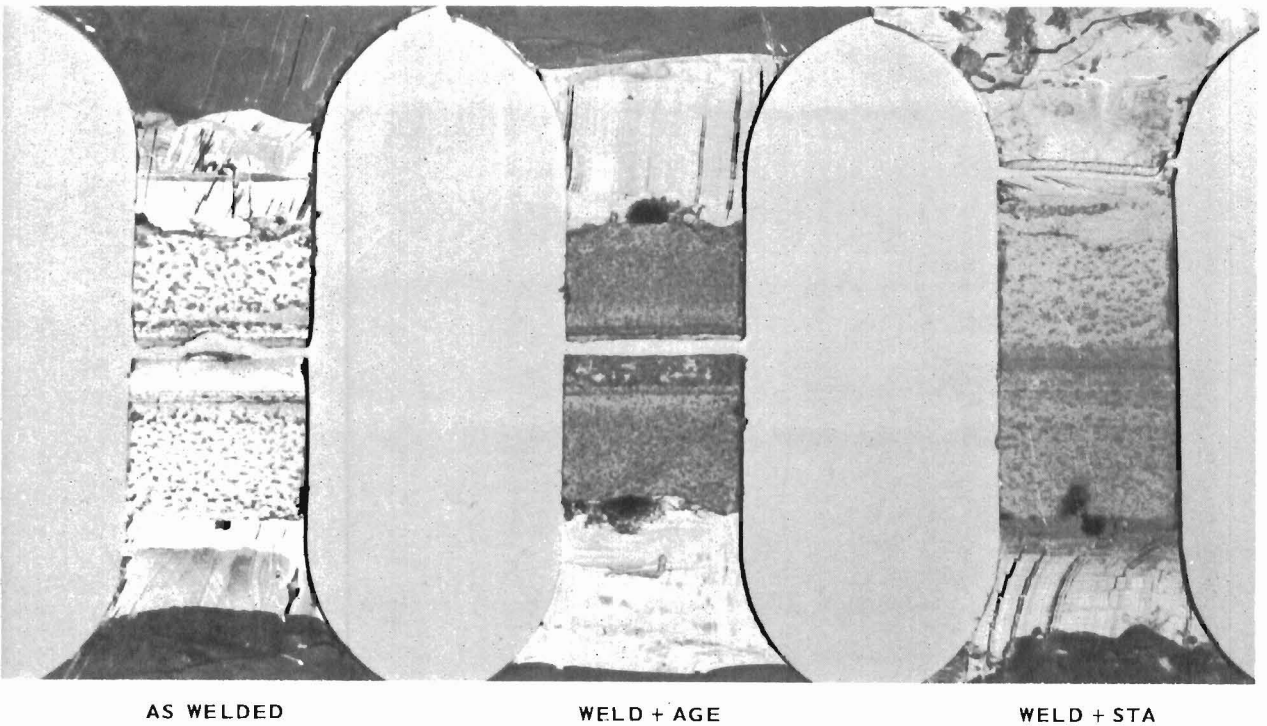
FIGURE 23. SURFACE CONDITION OF X2021-T8E31 WELDED SHEET AFTER 500-HOURS ALTERNATE IMMERSION. (TENSION TESTED AFTER EXPOSURE)

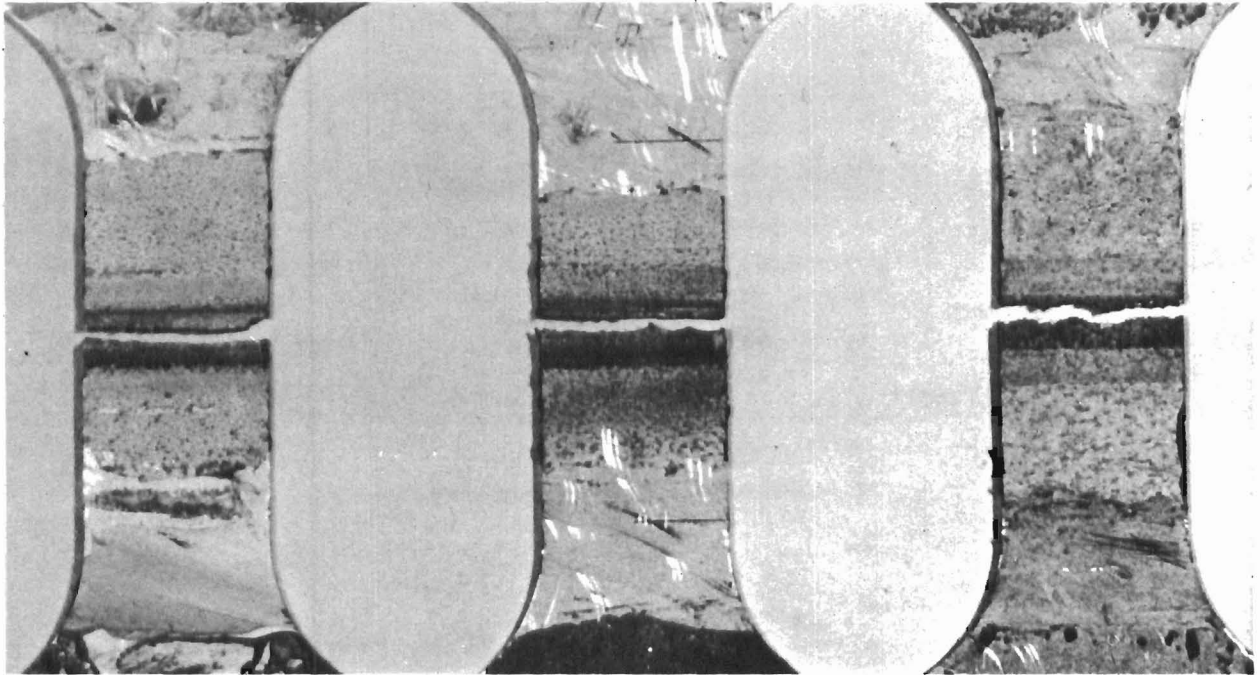
FIGURE 24. SURFACE CONDITION OF 2024-T81 WELDED SHEET AFTER 500-HOURS ALTERNATE IMMERSION. (TENSION TESTED AFTER EXPOSURE)

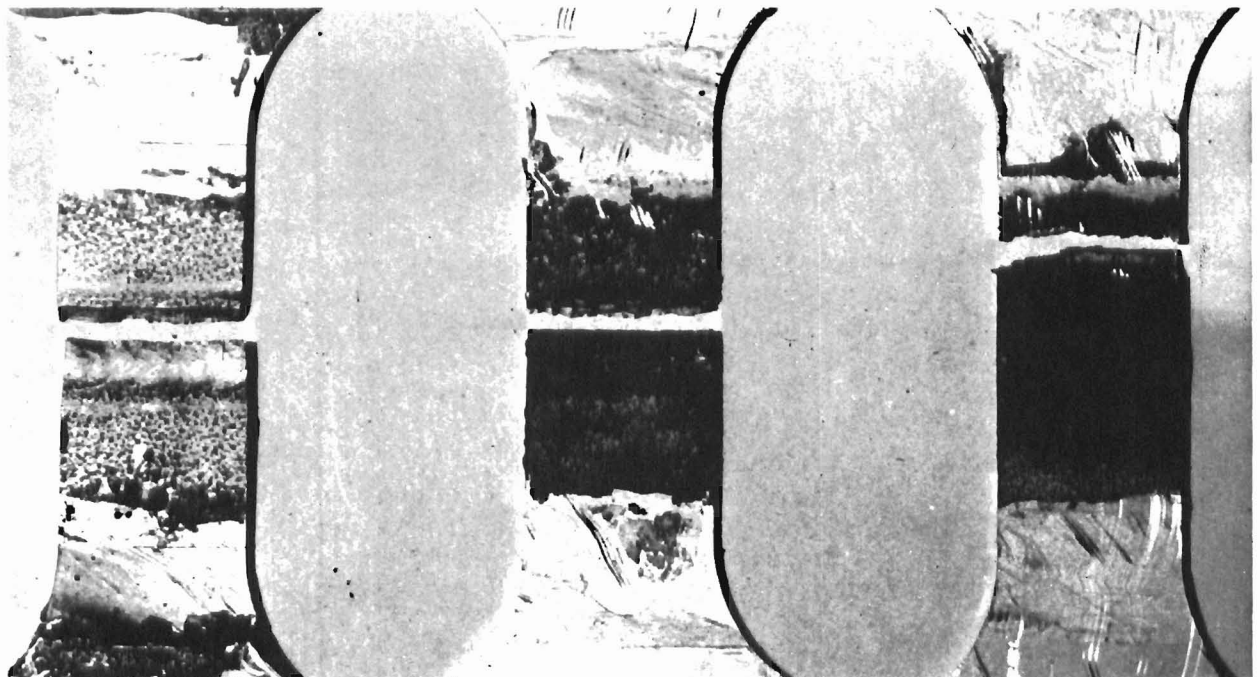
FIGURE 25. SURFACE CONDITION OF 2219-T87 WELDED SHEET AFTER 500-HOURS ALTERNATE IMMERSION. (TENSION TESTED AFTER EXPOSURE)

Little distinction for 2219-T87 (see Figure 25) could be made between the weld zone and parent metal except for the as-welded temper where the parent metal appeared more susceptible to corrosion than the weld zone. Considering all zones, the weld plus STA temper was most resistant to corrosion followed by as-welded temper and weld plus age temper. Note in Figure 25 two horizontal lines of selective corrosion approximately 5/8-inch apart and parallel to the weld bead. These lines were noted on a few of the specimens, independent of alloy, and are attributable to scuffing and copper contamination from the tips of the copper hold-down bars used in welding (see Figure 11 in Procedures Section). Although stress corrosion did not occur from these markings when present, selective corrosion was observed and demonstrates that although a standard welding setup was used improvement can be made to reduce contamination and lowering of corrosion resistance. In this case stainless steel hold down bars may have been a better selection than copper bars.

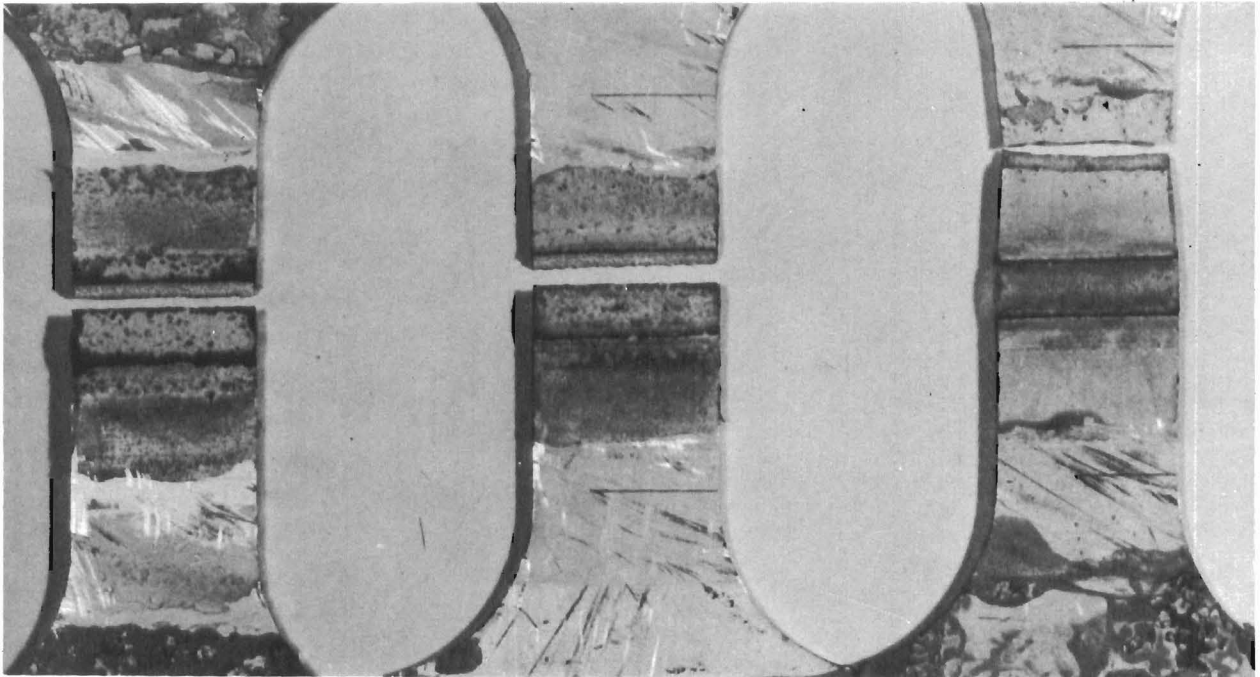
FIGURE 26. SURFACE CONDITION OF X7002-T6 WELDED SHEET AFTER 500-HOURS ALTERNATE IMMERSION. (TENSION TESTED AFTER EXPOSURE)

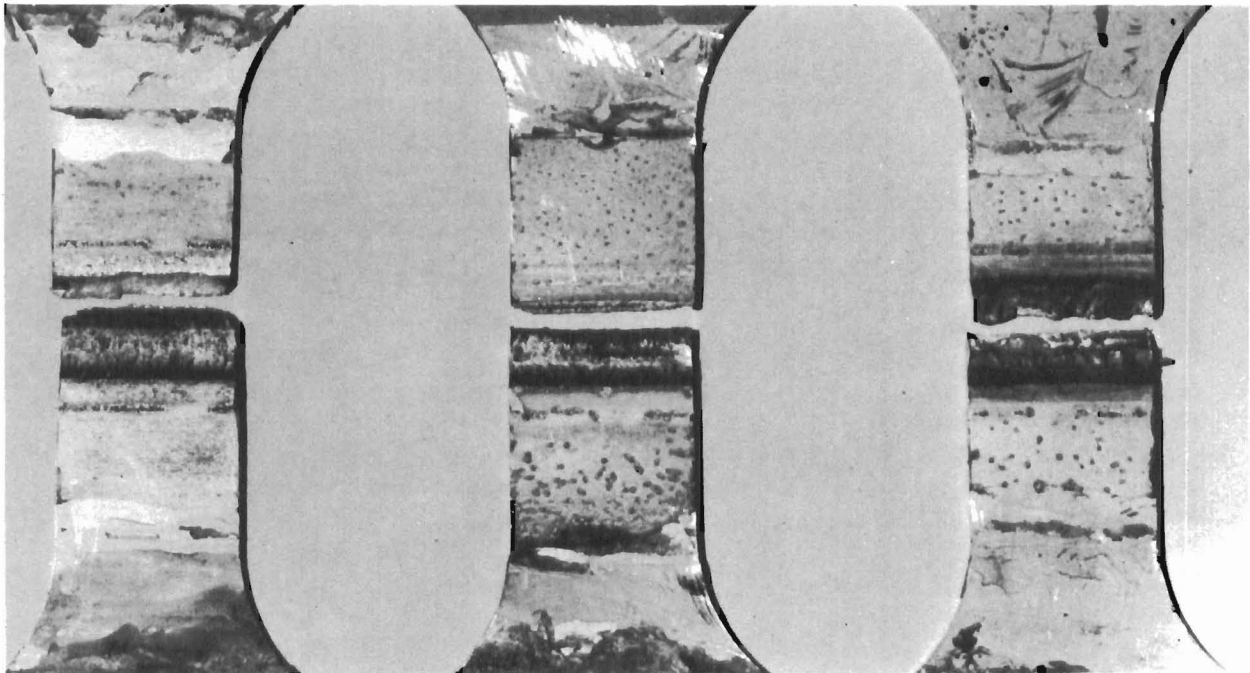
FIGURE 27. SURFACE CONDITION OF 7039-T64 WELDED SHEET AFTER 500-HOURS ALTERNATE IMMERSION. (TENSION TESTED AFTER EXPOSURE)

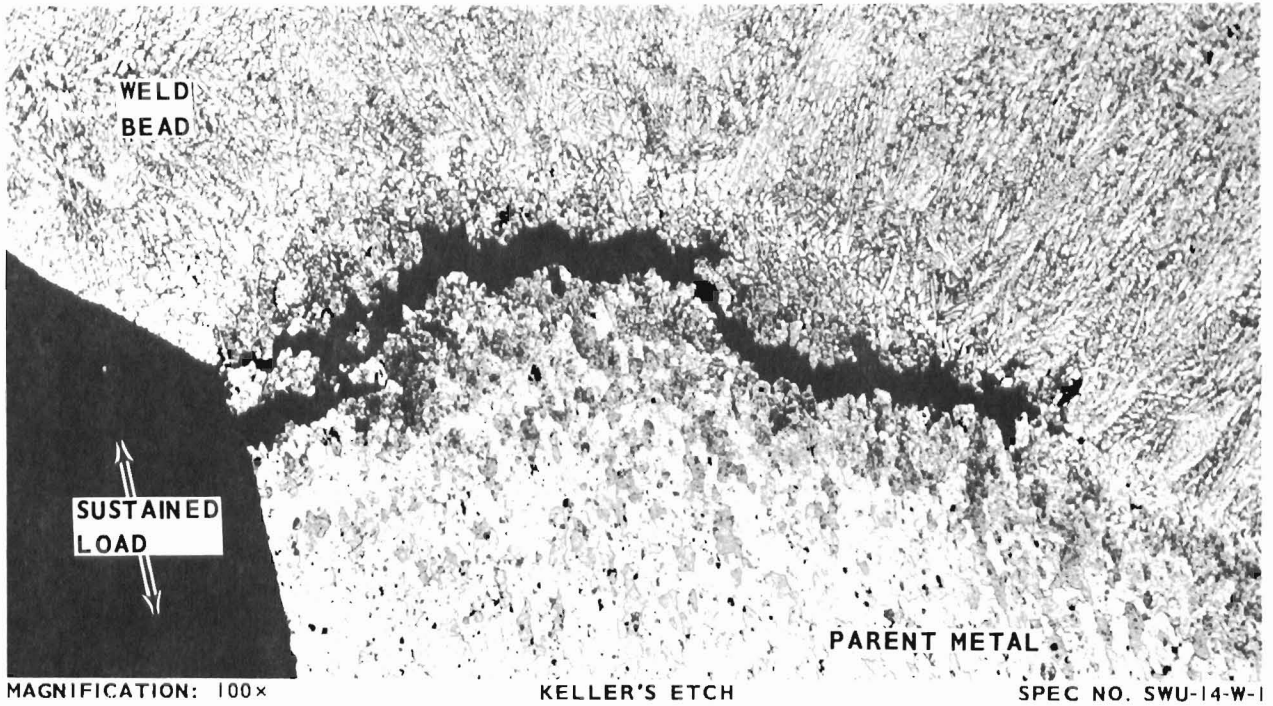
FIGURE 29. STRESS CORROSION CRACKING AT EDGE OF WELD BEAD IN 2014 -T6 SHEET, AS WELDED TEMPER.

In cases of notched as-welded specimens with a fatigue precrack at the edge of the weld bead, failure occurred during step-load testing at 19.6 ksi (net section) and was first observed at 15.7 ksi. Subsequent constant-load tests produced failures at 18.9 ksi in 80 hours, at 14.5 ksi in 34 hours, and one specimen at 9.1 ksi (7.74 ksi gross section) did not fail in 500 hours. No apparent SCC was noted on the unfailed specimen fracture surface after tension testing and residual net section strength was 95 percent of unexposed strength.

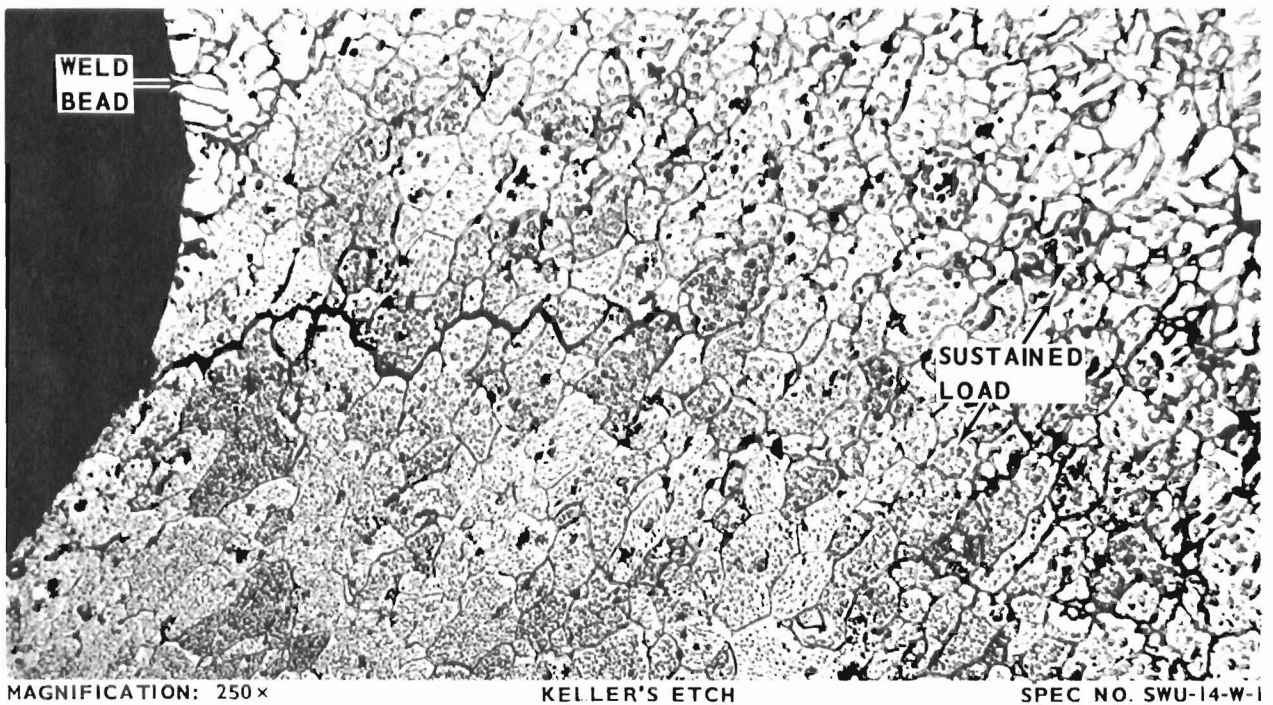
FIGURE 30. STRESS CORROSION CRACK AT EDGE OF WELD BEAD IN 2014-T6 SHEET, AS WELDED TEMPER.

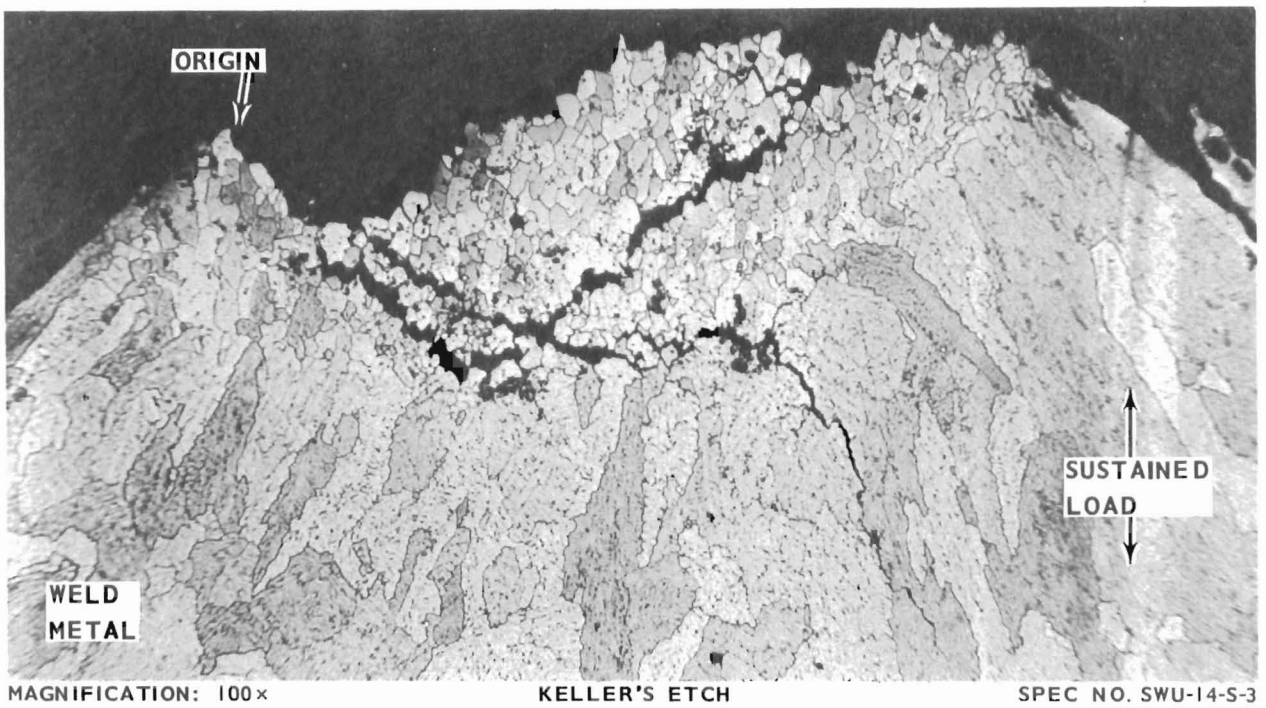
FIGURE 31. ORIGIN OF STRESS CORROSION FAILURE OF UNNOTCHED 2014-T6 SHEET, WELD AND STA TEMPER.

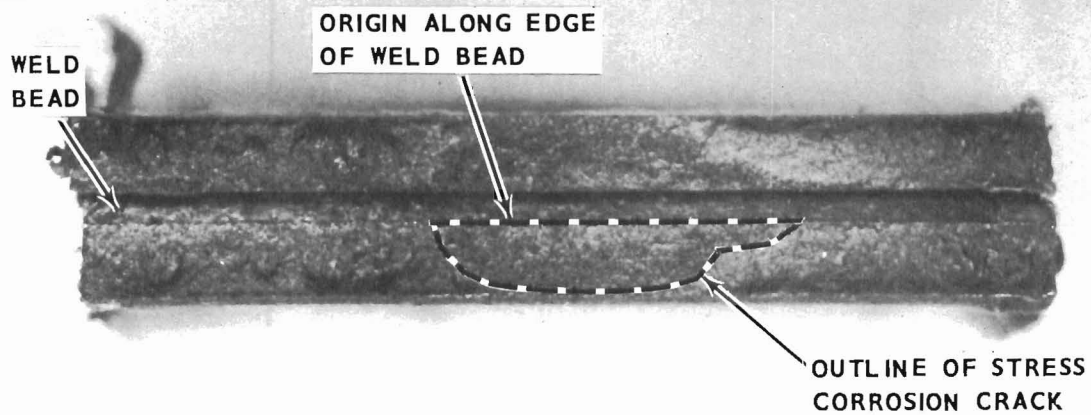
MAGNIFICATION: 5×

SPEC NO. SWU-14-W-1

FIGURE 32. FRACTURE SURFACE OF UNNOTCHED 2014-T6 SHEET, AS WELDED TEMPER, THAT FAILED, DURING SCC TESTING.

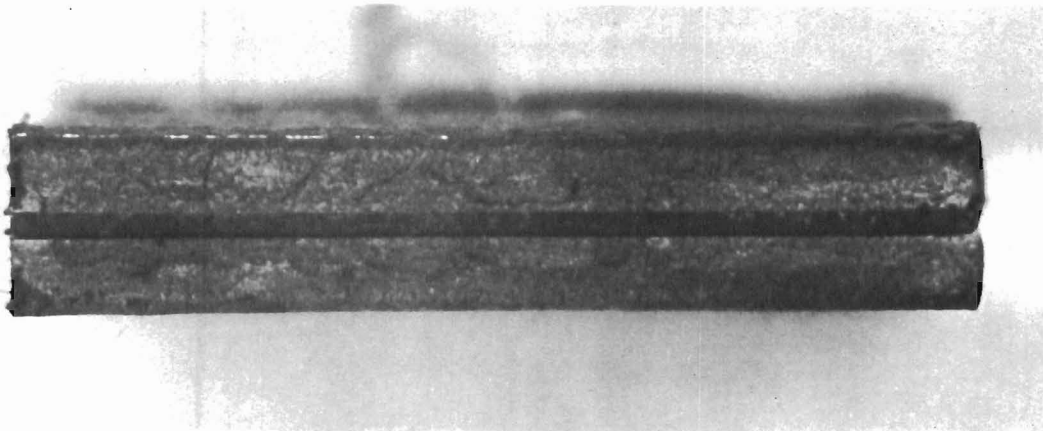
MAGNIFICATION: 5×

SPEC NO. SWU-14-A-5

FIGURE 33. FRACTURE SURFACE OF UNNOTCHED 2014-T6 SHEET, WELD AND AGE TEMPER, THAT FAILED DURING SCC TESTING.

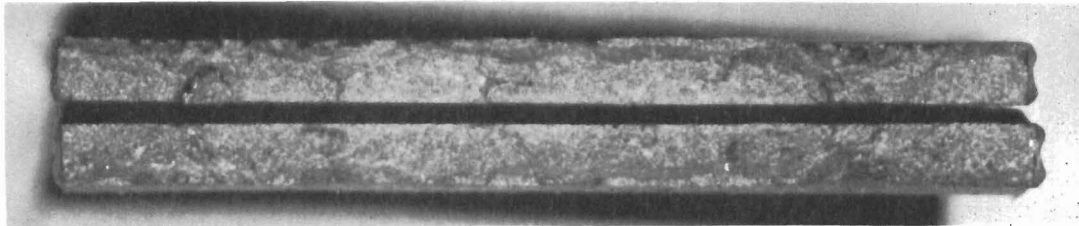
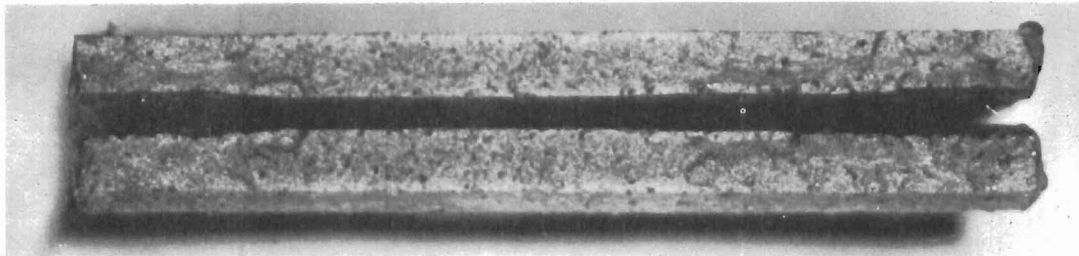
FIGURE 35. TYPICAL SCC FRACTURE SURFACES OF UNNOTCHED X2021 - T8E31 SHEETS, AS WELDED TEMPER.

Fracture surfaces of the susceptible as-welded temper are shown in Figure 35, and the typical line of failure in Figure 36. All failures occurred through the cold side of the heat-affected zone, including the precrack specimens. Although fatigue cracks at the edge of the weld bead and minor crack extension was observed, stress corrosion cracking occurred principally out of the fatigue crack plane, as indicated above, and joined the fatigue crack tips with through-the-thickness cracks parallel to the sustained load prior to sudden failure.

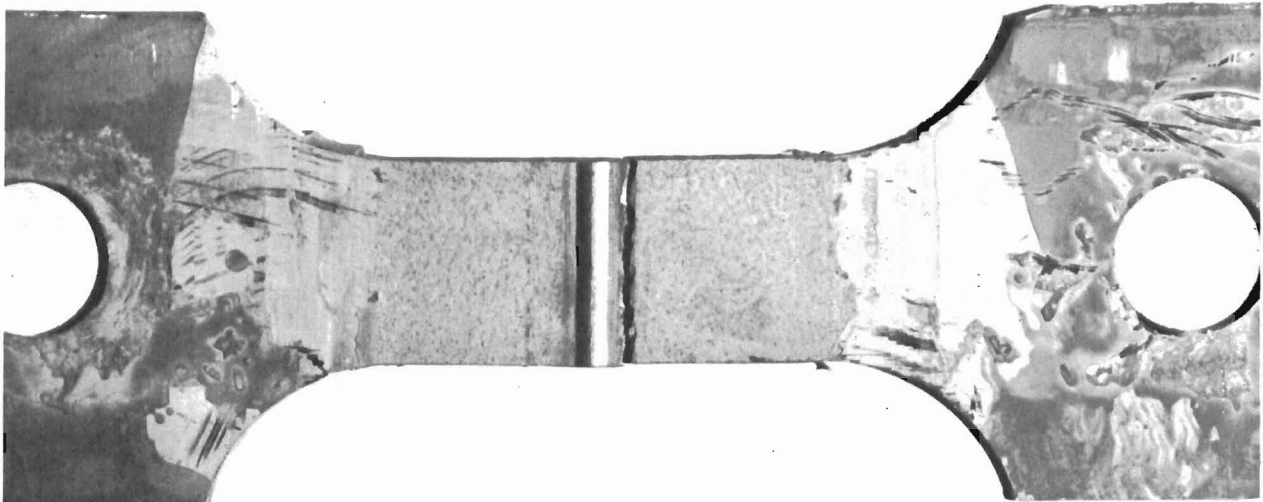
FIGURE 36. TYPICAL LINE OF SCC FAILURE THROUGH COLD SIDE OF HEAT AFFECTED ZONE OF X2021 - T8E31 SHEET, AS WELDED TEMPER.

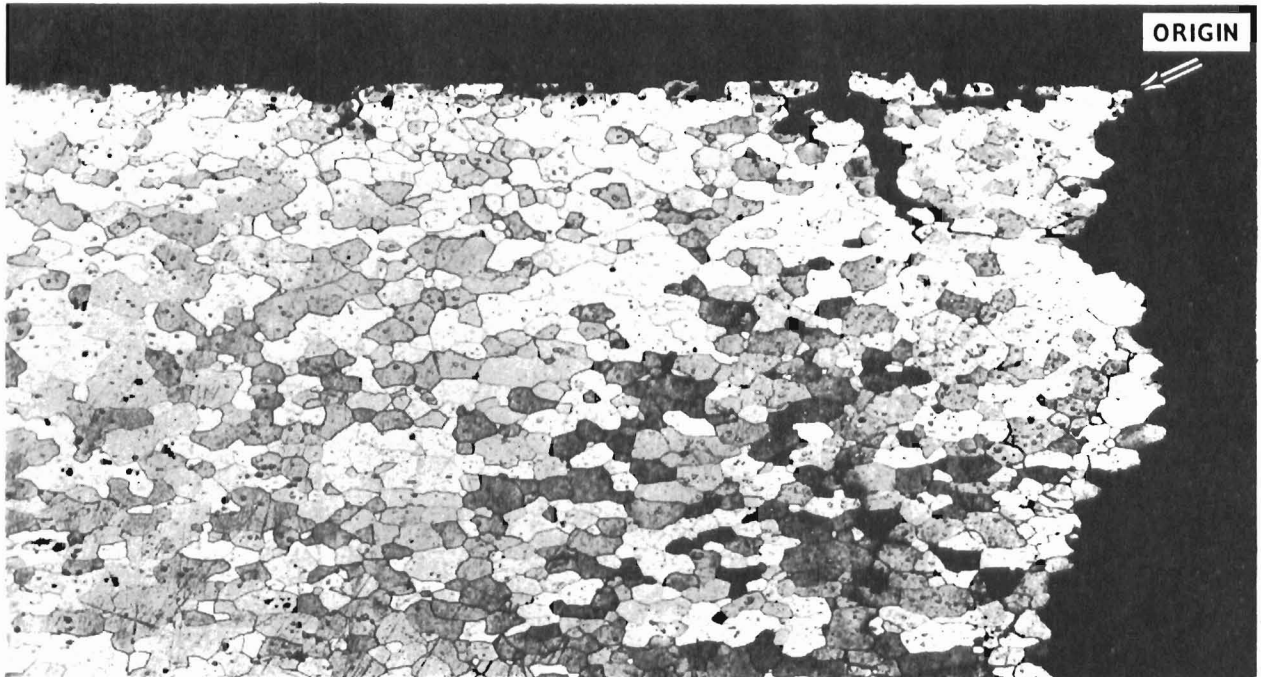
FIGURE 37. MICROSTRUCTURE AT SCC FRACTURE PROFILE OF X2021-T8E31 SHEET, AS WELDED TEMPER.

Cracking was predominately intergranular. However, there was evidence of transgranular cracking (see Figures 37 and 38). Because of the severe intergranular cracking observed, the transgranular cracking may be due to mechanical failure of metal posts left behind by a rapidly advancing intergranular network-type crack front.

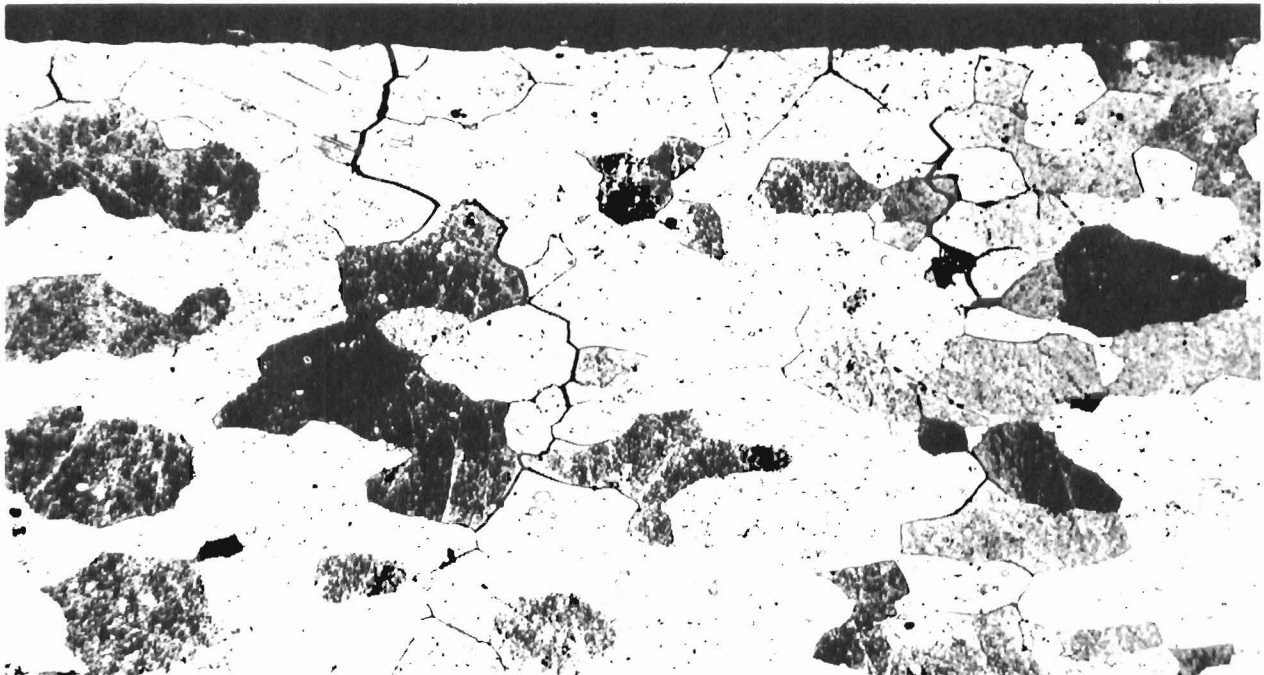
FIGURE 38. INTERGRANULAR AND TRANSGRANULAR CRACKING IN SCC SUSCEPTIBLE HEAT AFFECTED ZONE OF X2021-T8E31 SHEET, AS WELDED TEMPER.
