STRESS CORROSION SUSCEPTIBILITY OF WELDED ALUMINUM ALLOYS

DOUGLAS AIRCRAFT COMPANY

TECHNICAL REPORT AFML-TR-67-291

AUGUST 1967

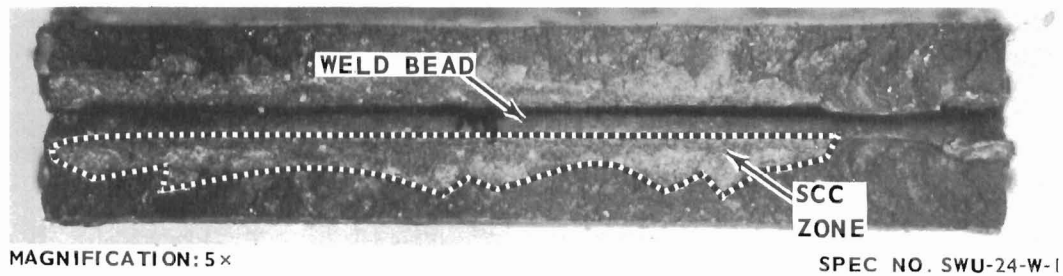
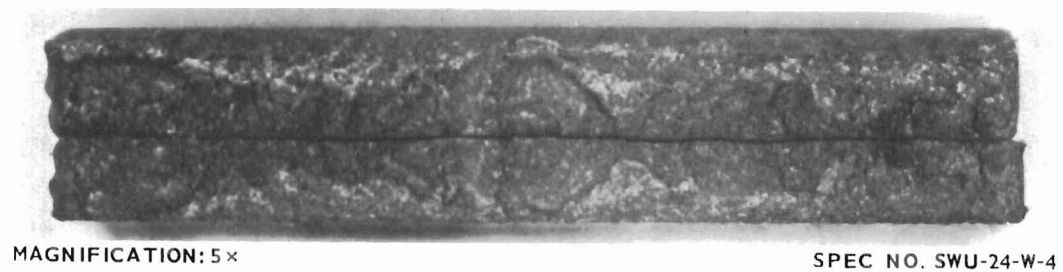
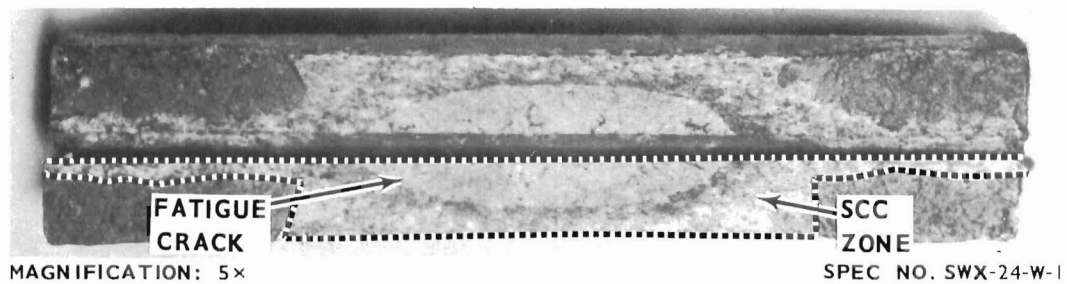
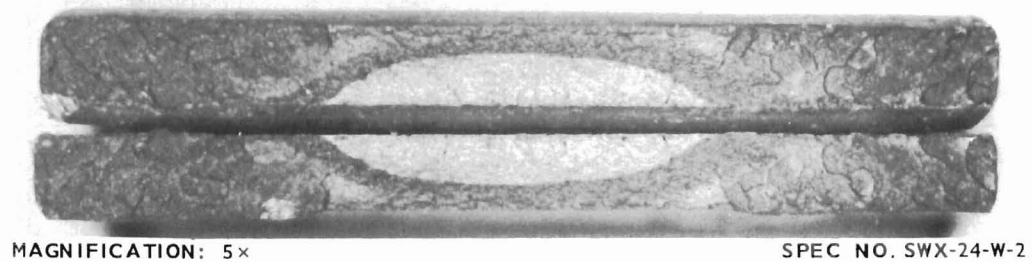
FIGURE 39. FRACTURE SURFACES OF NOTCHED AND UNNOTCHED 2024-T81 SHEET, AS WELDED TEMPER, THAT FAILED DURING SCC TESTING.

Typical fracture surfaces of failed specimens of the as-welded temper are shown in Figure 39. The SCC fracture zone was more easily distinguished on the fracture surface of this alloy compared to other alloys evaluated because of the characteristic gross, flat dimples of the sudden failure zone compared to the flatter featureless zone of SCC (see

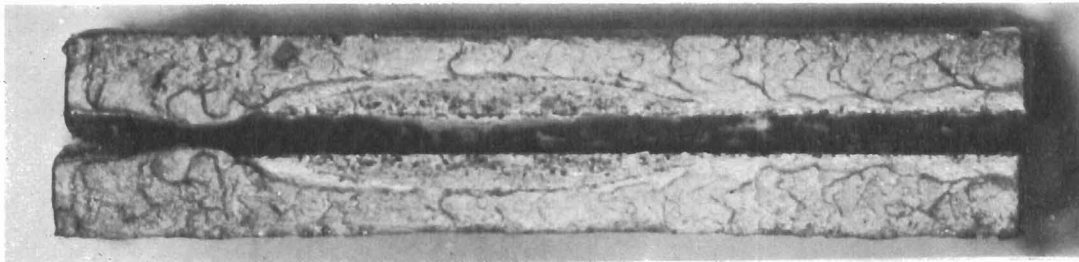
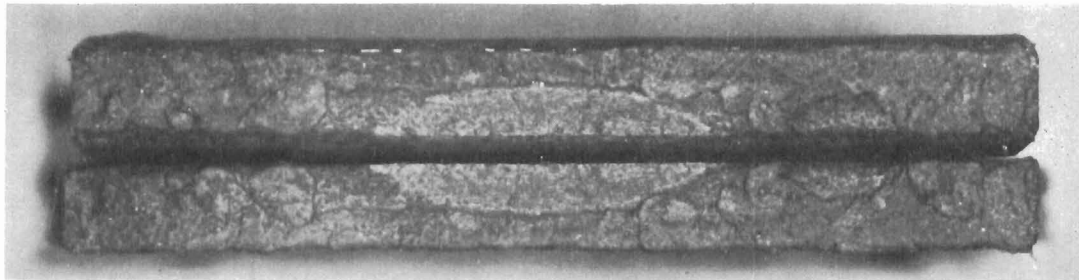
FIGURE 40. FRACTURE SURFACES OF NOTCHED 2024-T81 SHEET, TENSION TESTED AFTER ALTERNATE IMMERSION EXPOSURE.

Figure 40). The appearance of the instantaneous fracture appeared independent of post-weld heat treat or the presence of a stress corrosion crack or fatigue crack.

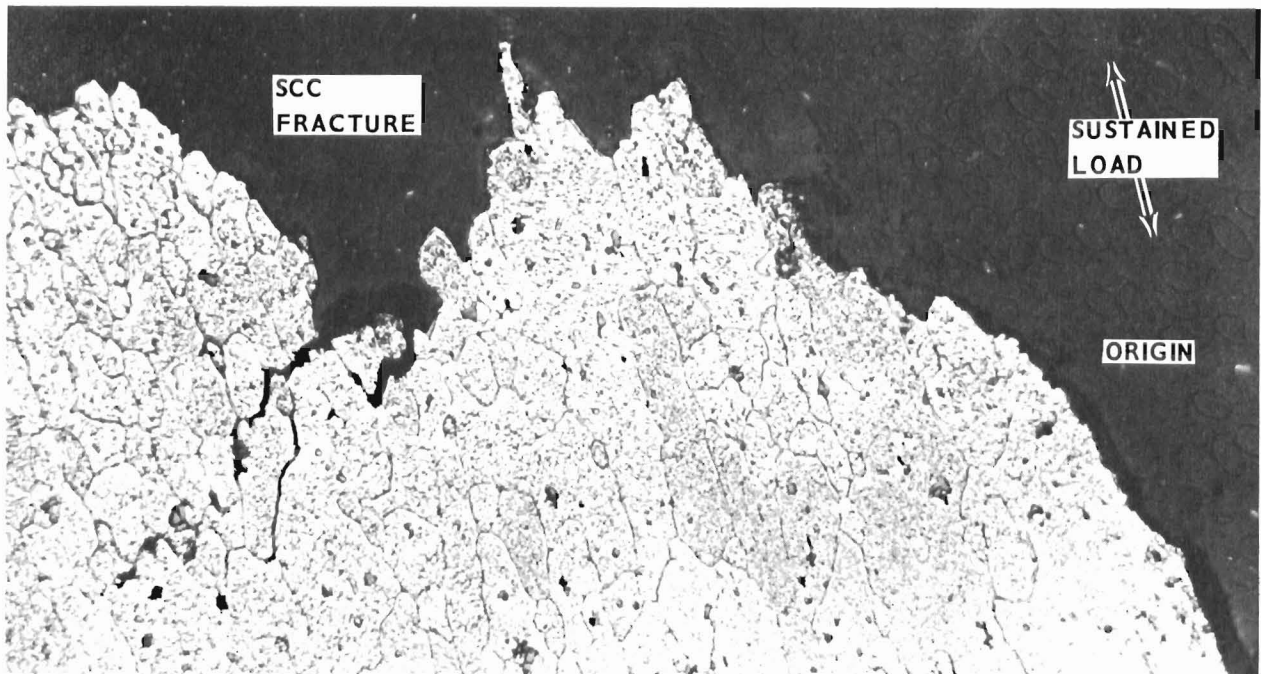
FIGURE 41. MICROSTRUCTURE AT ORIGIN OF SCC FAILURE OF UNNOTCHED 2024-T81 SHEET, AS WELDED TEMPER.

Microscopic examination of unnotched failed specimens indicated origins to be at the edge of the weld bead. Propagation in the flat featureless zone was intergranular into the weld bead or along the edge of the weld bead. The main line of failure exhibited very few branching cracks (see Figure 41).

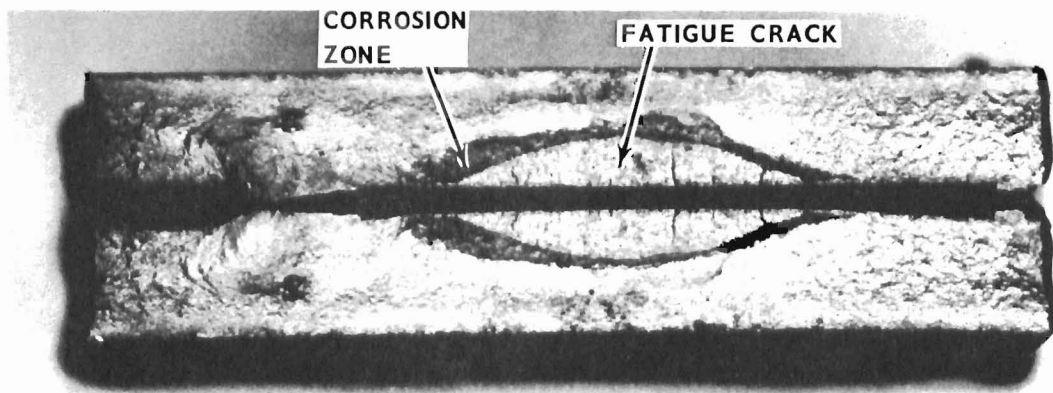
FIGURE 42. FRACTURE SURFACE OF NOTCHED 2219-T81 SHEET, WELD + AGE TEMPER, TENSION TESTED AFTER STEP LOAD ALTERNATE IMMERSION EXPOSURE.

Stress corrosion cracking was not observed for tempers: (1) basic unwelded unnotched, (2) as-welded, notched or unnotched, and (3) weld plus age, notched or unnotched. Crack extension was observed after 606 hours exposure for the step-loaded, notched as-welded temper but was examined microscopically and attributed to corrosion (see Figure 42).

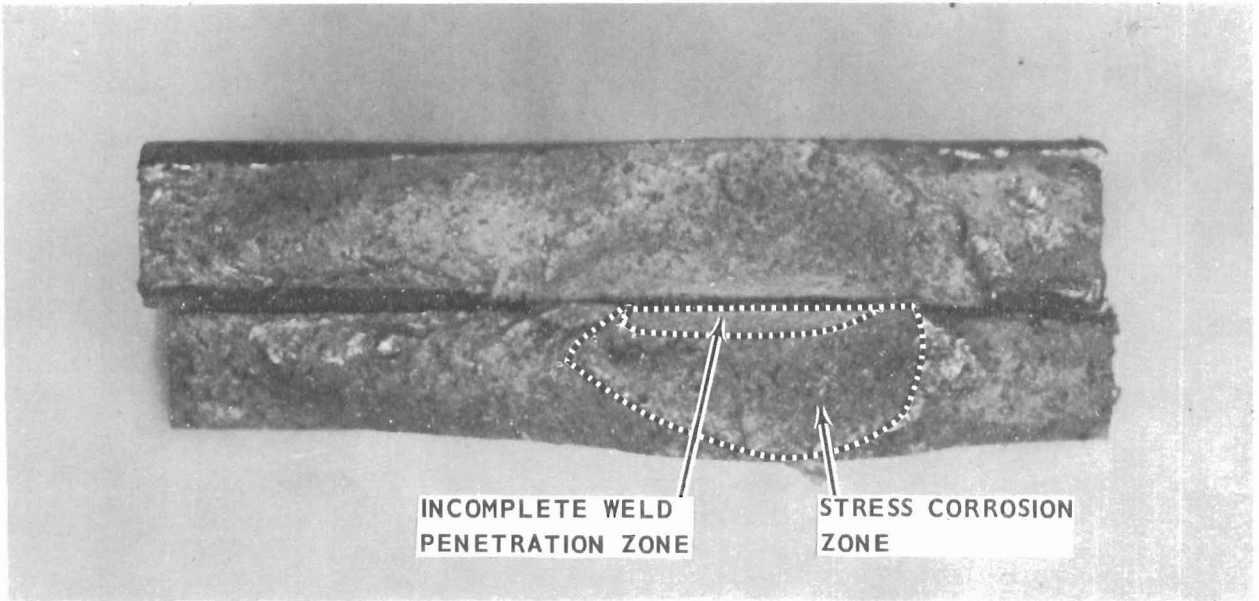
FIGURE 43. FRACTURE SURFACE OF 2219-T81 SHEET, WELD + STA TEMPER, THAT FAILED DURING ALTERNATE IMMERSION EXPOSURE AND EXHIBITED INCOMPLETE WELD.

Susceptibility to SCC was incurred with notched and unnotched weld plus STA temper. For the unnotched condition, step-load alternate immersion tests produced SCC failure at 29.0 ksi after accumulating 395 hours of alternate immersion and 30 hours in air between steps. Failure occurred in air prior to loading to next step. Subsequent constant load of 500 hours alternate immersion did not produce failures at 29.0 ksi or 34.2 ksi. The third constant-load specimen failed at 39.5 ksi through the weld bead. Examination of the fracture surface revealed incomplete weld penetration (0.27-inch long) on the bottom side of the weld bead from which the SCC initiated (see Figures 43 and 44).

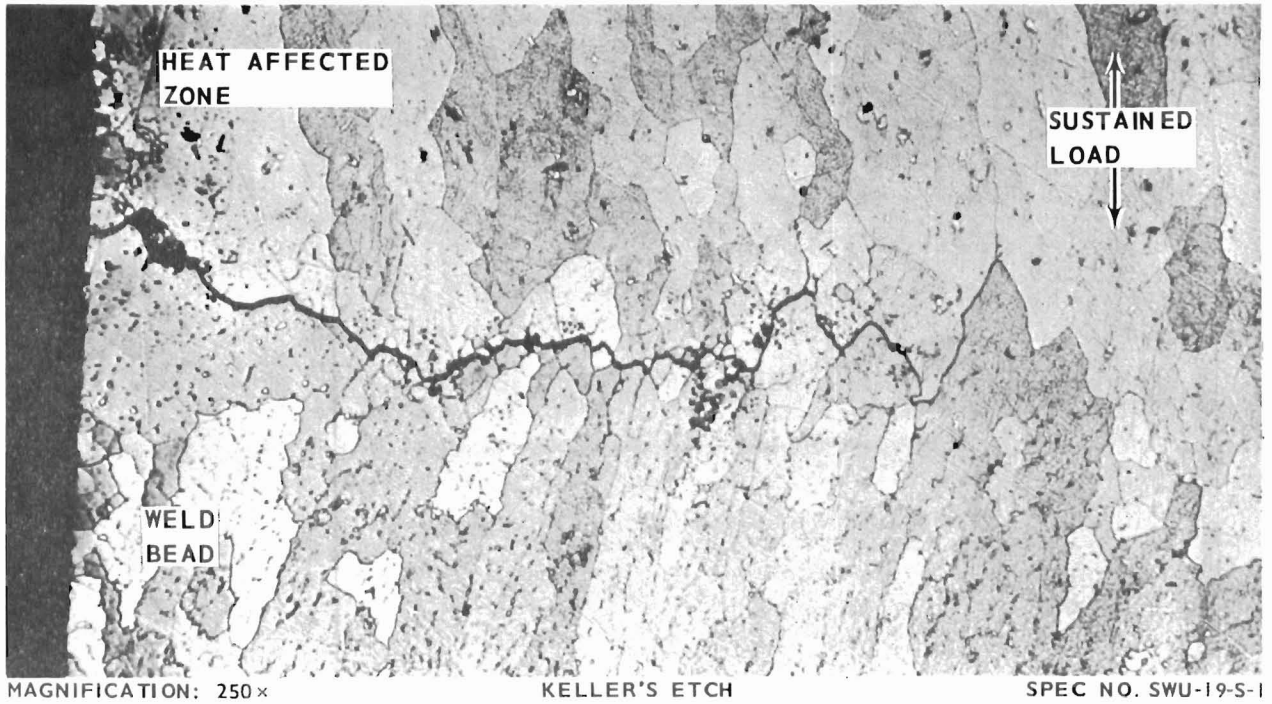
FIGURE 45. STRESS CORROSION CRACKING IN MICROSTRUCTURE AT EDGE OF WELD BEAD IN 2219-T81 SHEET, WELD + STA TEMPER, STEP LOAD ALTERNATE IMMERSION EXPOSURE.

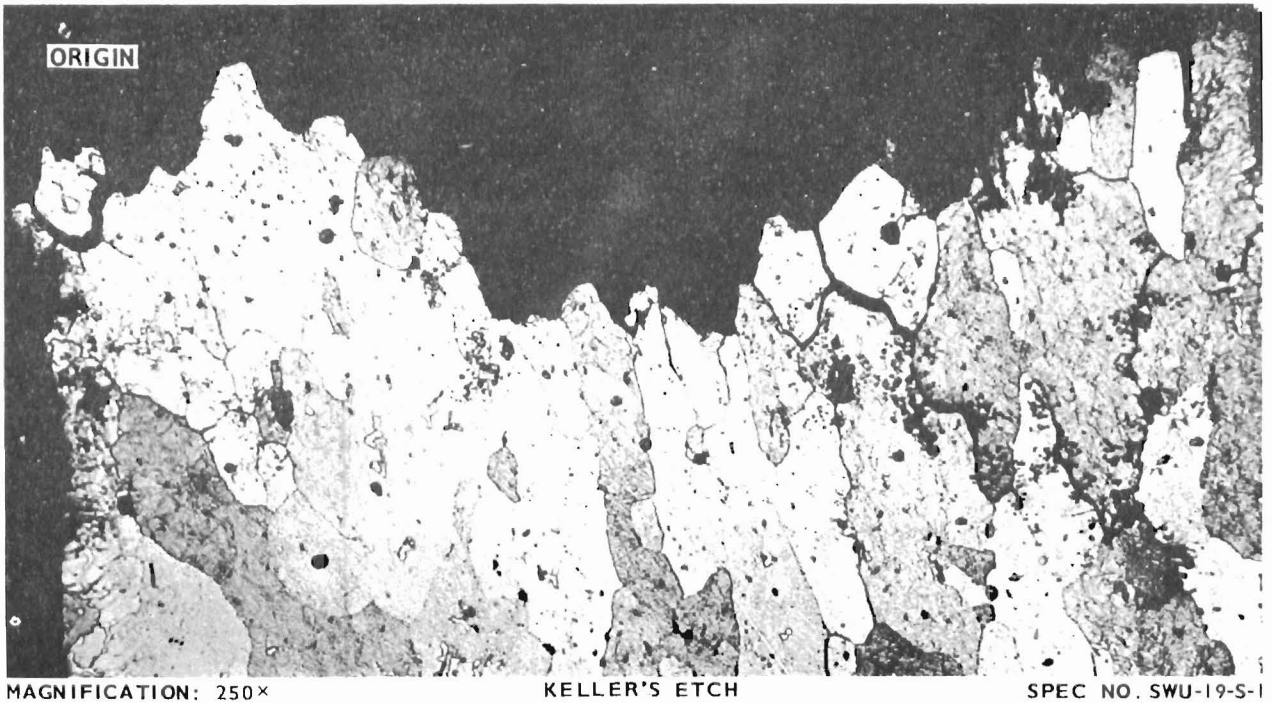
FIGURE 46. MICROSTRUCTURE AT ORIGIN OF FAILURE, EDGE OF WELD BEAD, IN 2219-T81 SHEET, WELD + STA TEMPER, STEP LOAD ALTERNATE IMMERSION EXPOSURE.

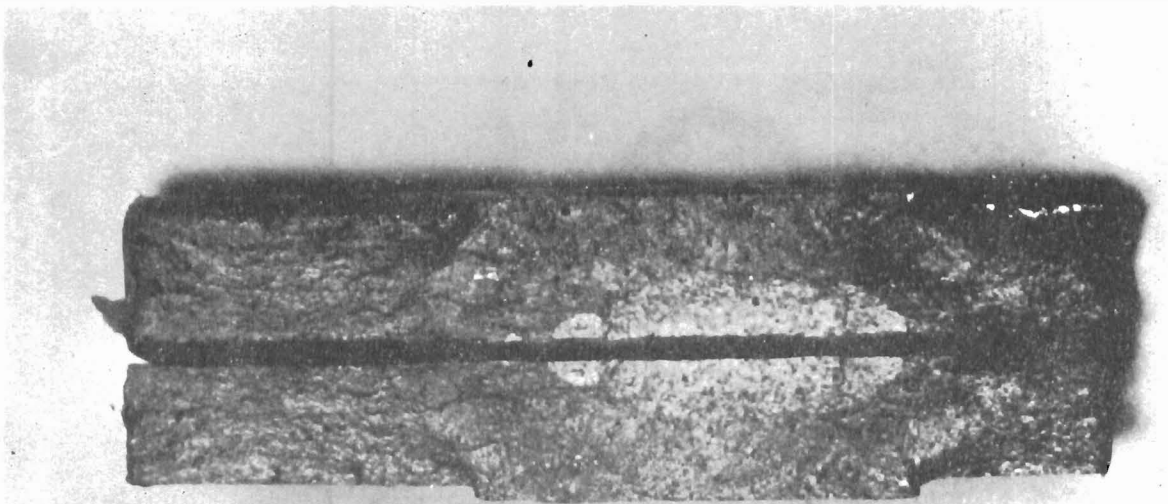
FIGURE 47. FRACTURE SURFACE OF NOTCHED 2219-T81 SHEET, WELD + STA TEMPER, THAT FAILED DURING STEP LOAD ALTERNATE IMMERSION EXPOSURE.

Typical SCC fracture of notched, weld plus STA temper is shown in Figure 47. Because fracture surface was similar to the stress corrosion fracture of the unnotched specimen SWU-19-S-4-4, which displayed intergranular cracking below the line of incomplete penetration, metallographic examination was not conducted on notched specimens. Fracture originated at and followed the edge of the weld bead.

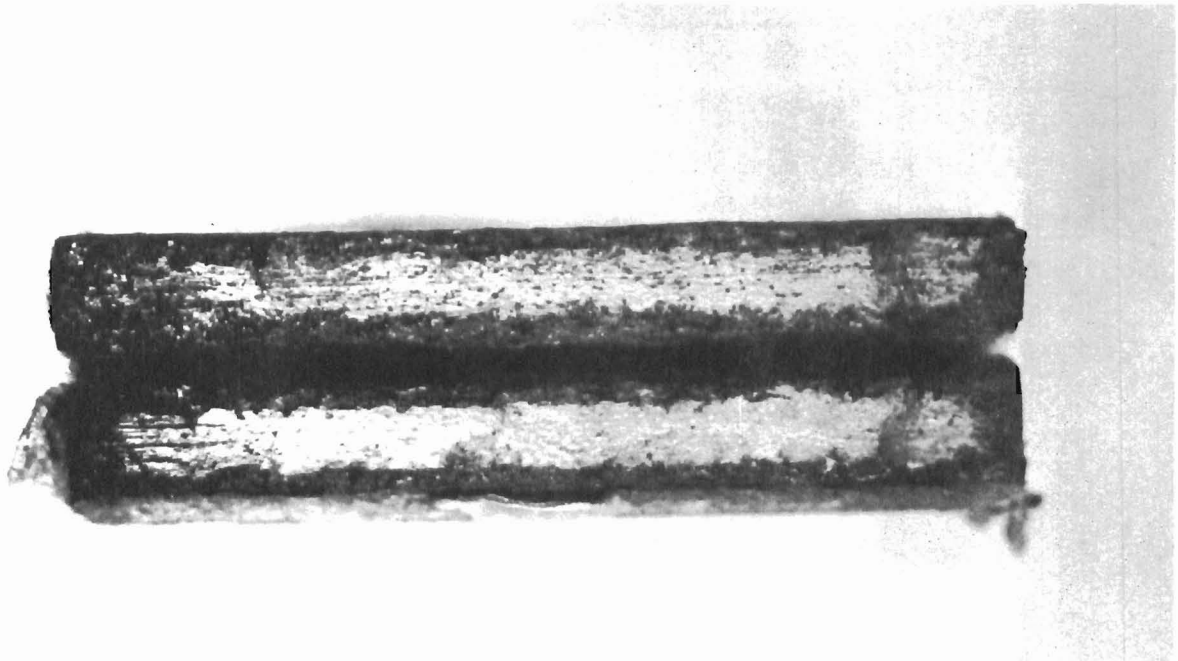
FIGURE 49. FRACTURE APPEARANCE OF 7039-T64 SHEET, AS WELDED TEMPER, EXHIBITING CORROSION-TENSILE FAILURE THROUGH HEAT AFFECTED ZONE.

Fracture and surface appearance of the corrosion-tensile failed step load, notched, as-welded temper are shown in Figures 49 and 50. Failure occurred out of the plane of the fatigue crack through the heat-affected zone. Metallographic examination confirmed pitting corrosion followed by tensile failure.

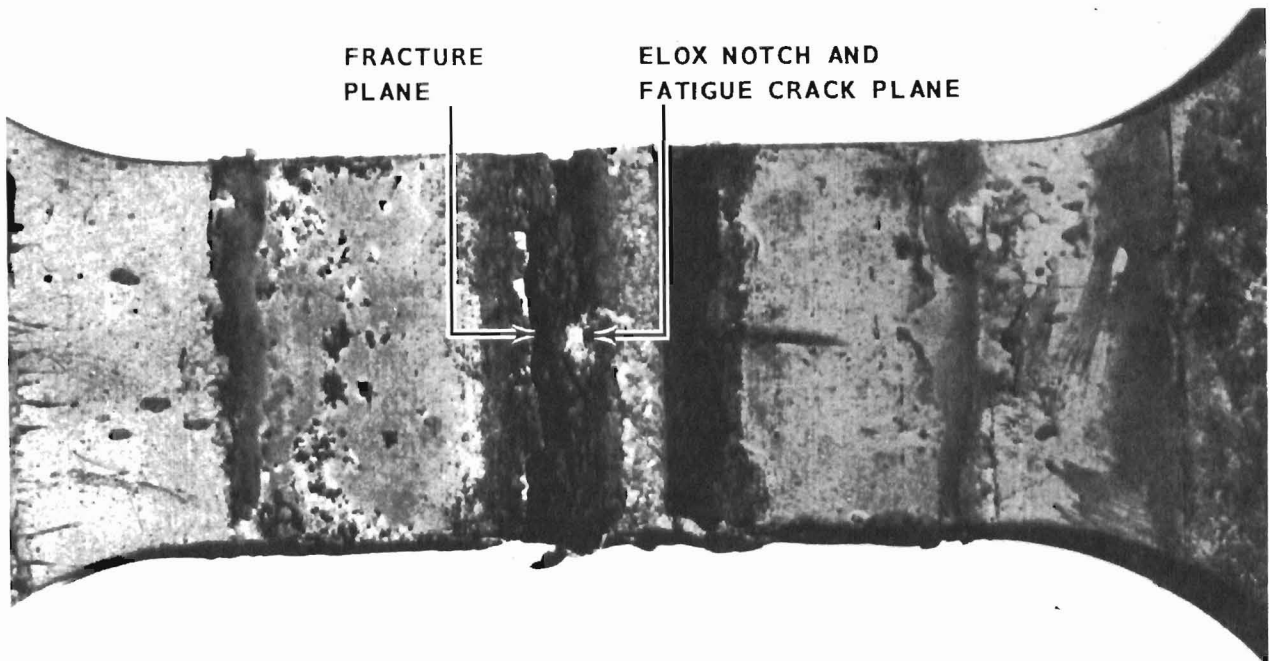
FIGURE 50. SURFACE APPEARANCE OF NOTCHED 7039-T64 SHEET, AS WELDED TEMPER, EXHIBITING CORROSION-TENSILE FAILURE THROUGH HEAT AFFECTED ZONE.

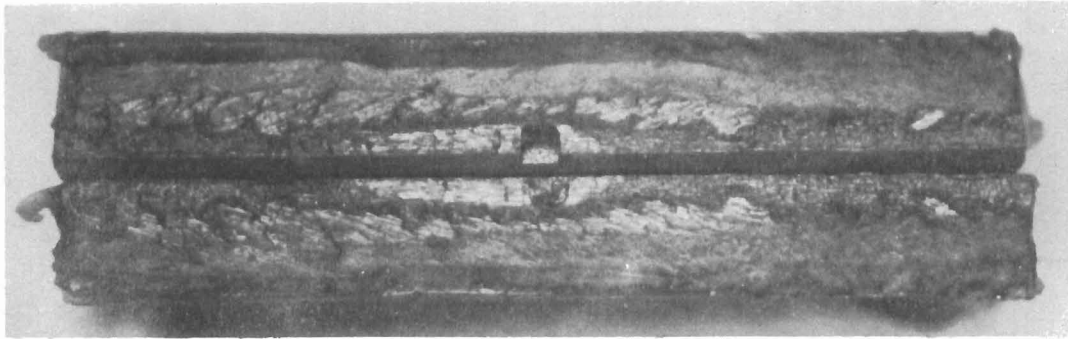
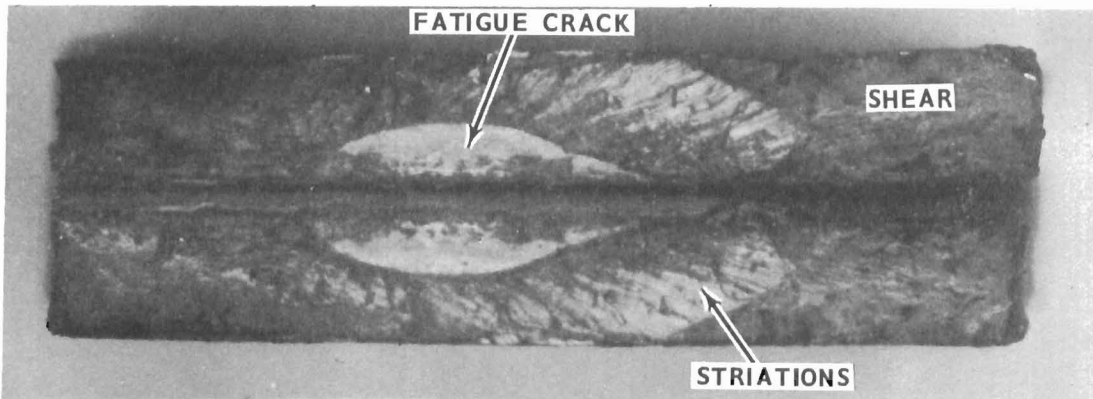
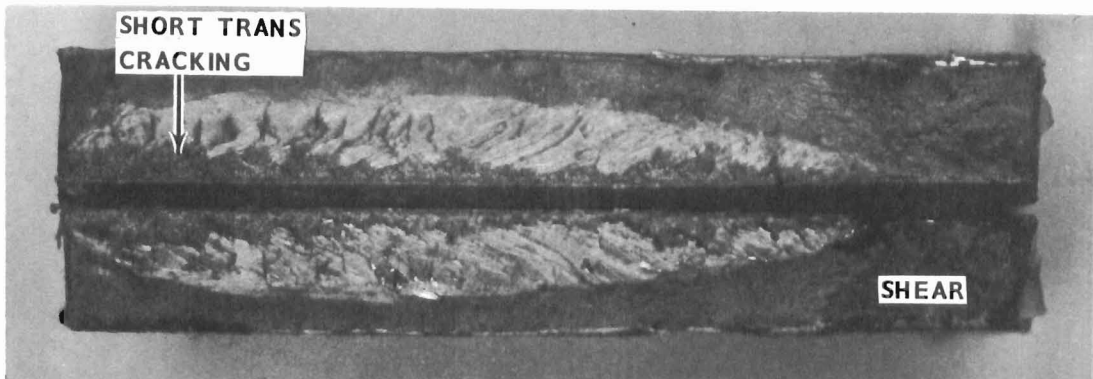
FIGURE 51. TYPICAL FRACTURE APPEARANCE OF 7039-T64 SHEET, WELD + POST WELD HEAT TREAT, FAILED DURING ALTERNATE IMMERSION EXPOSURES.

Typical fracture surfaces of specimens that failed during stress corrosion testing weld plus age, and weld plus STA are shown in Figure 51. Regardless of temper or notch stress, corrosion-failed specimens exhibited dark fracture at the edge of the weld bead which was followed by striations and terminated in shear. Fracture surface of a specimen tension-tested after 500 hours alternate immersion exposure is shown in Figure 52, illustrating a full shear failure which was typical of specimens that did not fail during SCC testing. Dark tears along the edge of and 90° to the fatigue

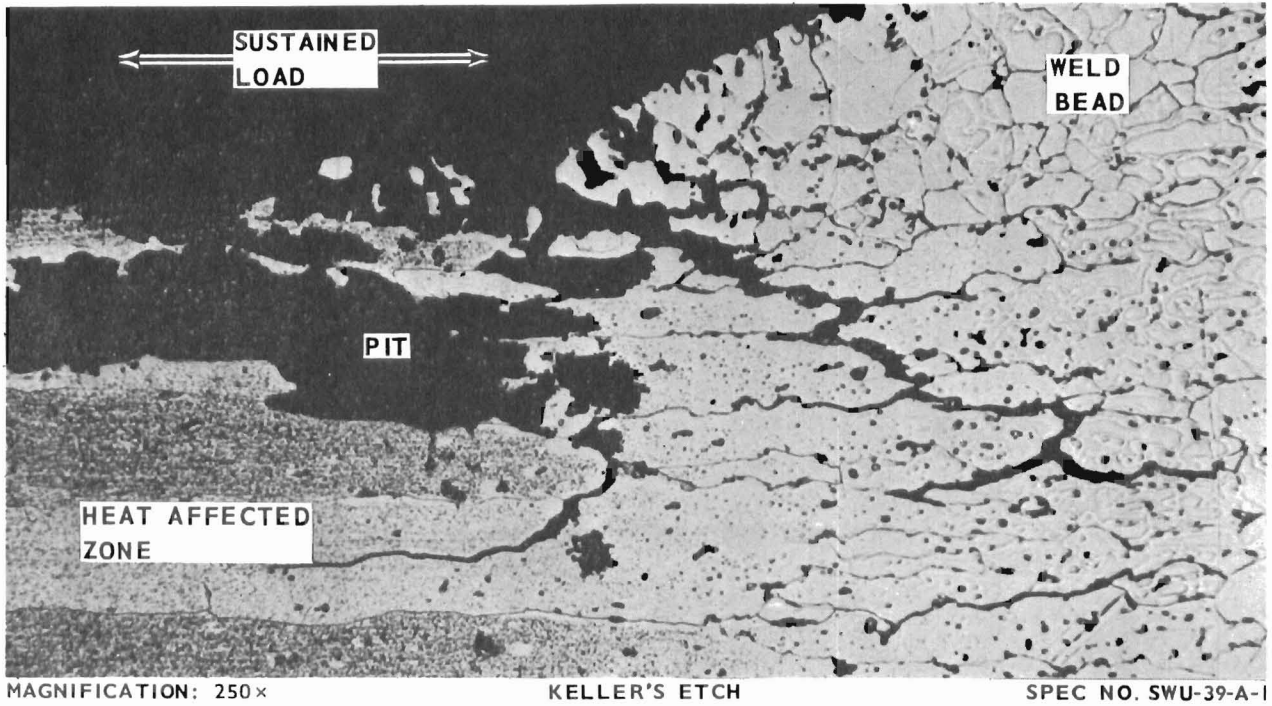
FIGURE 53. PITTING AT EDGE OF WELD BEAD IN 7039-T64 SHEET, WELD + AGE TEMPER, FAILED DURING STEP LOAD ALTERNATE IMMERSION EXPOSURE.

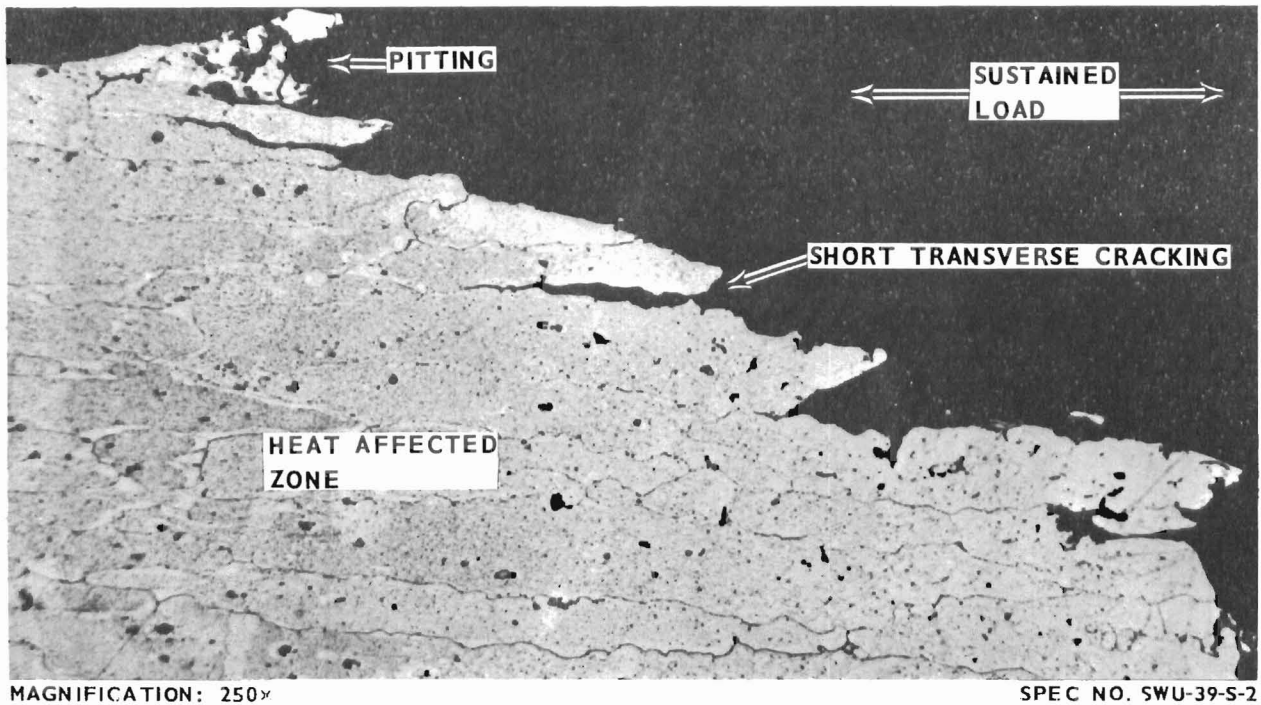
FIGURE 54. PITTING AND CRACKING AT SCC ORIGIN, EDGE OF WELD BEAD, IN 7039-T64 SHEET, WELD + STA TEMPER, FAILED DURING ALTERNATE IMMERSION EXPOSURE.

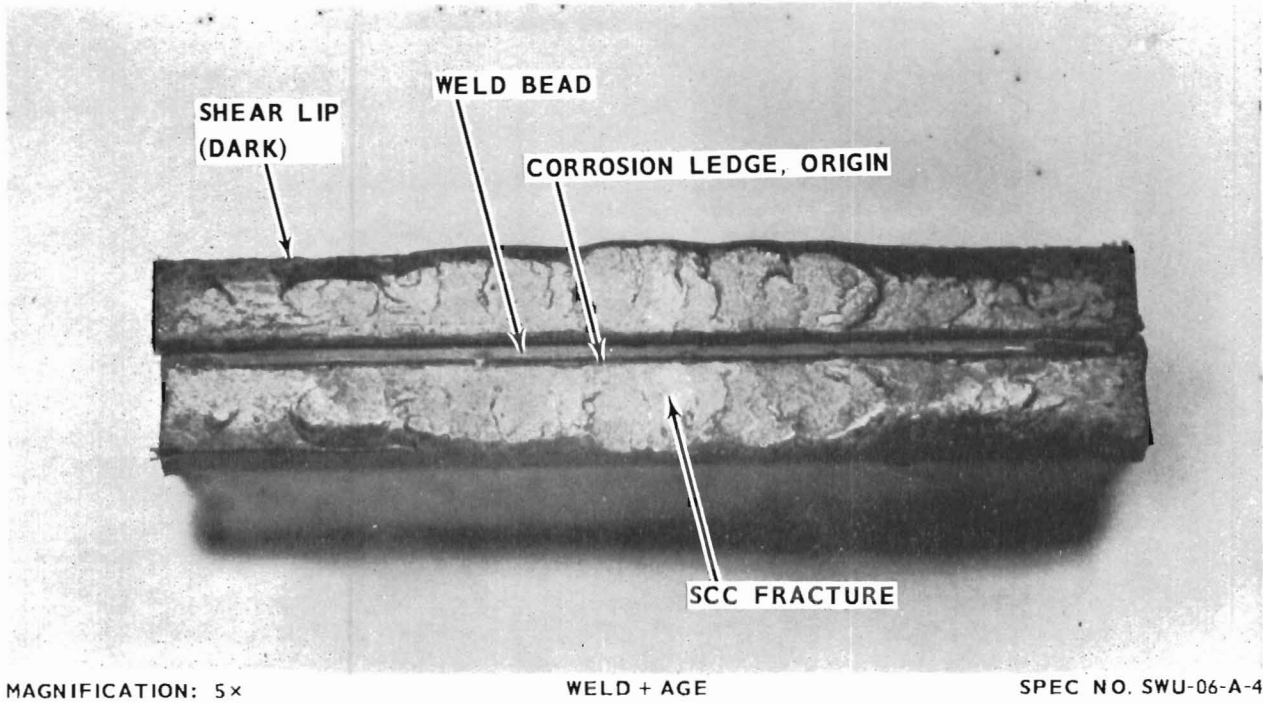
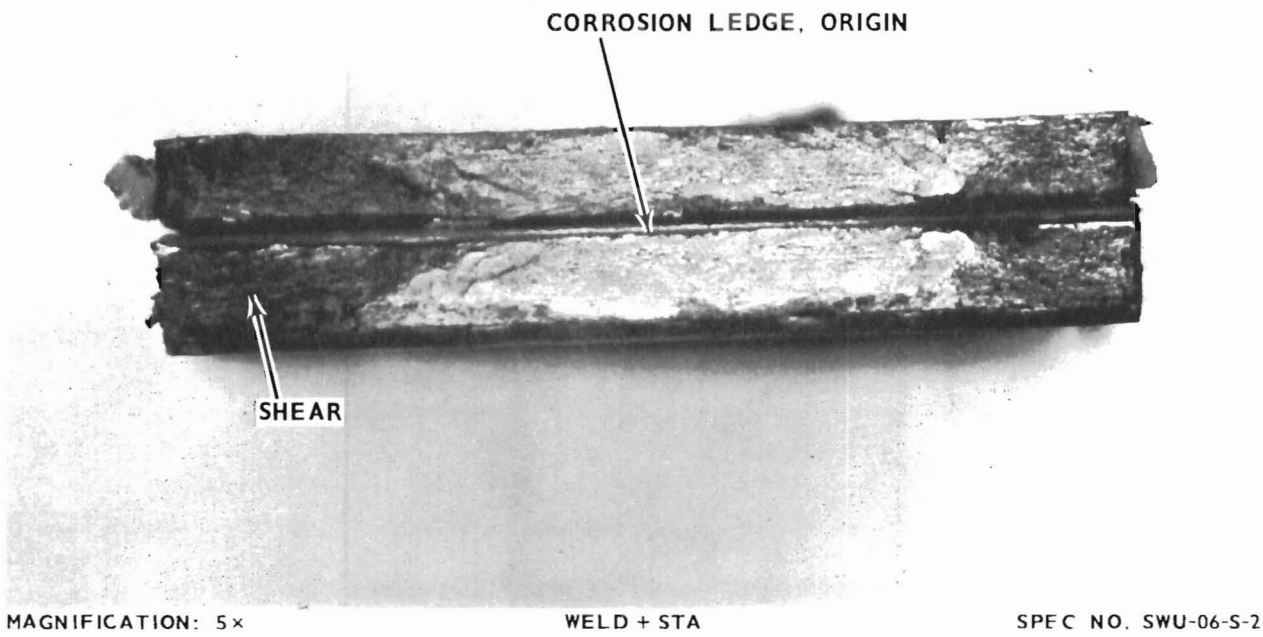
Fracture surfaces of unnotched weld plus age and weld plus STA specimens which failed during SCC testing are shown in Figure 56. The origin of failure appeared as a thin corroded ledge at the edge of the weld bead with the main fracture at 90° to and behind the ledge following the edge of the weld bead through the thickness as a curve-linear surface.

FIGURE 56. FRACTURE SURFACES OF UNNOTCHED 7106-T6 SHEET THAT FAILED DURING ALTERNATE IMMERSION EXPOSURE.

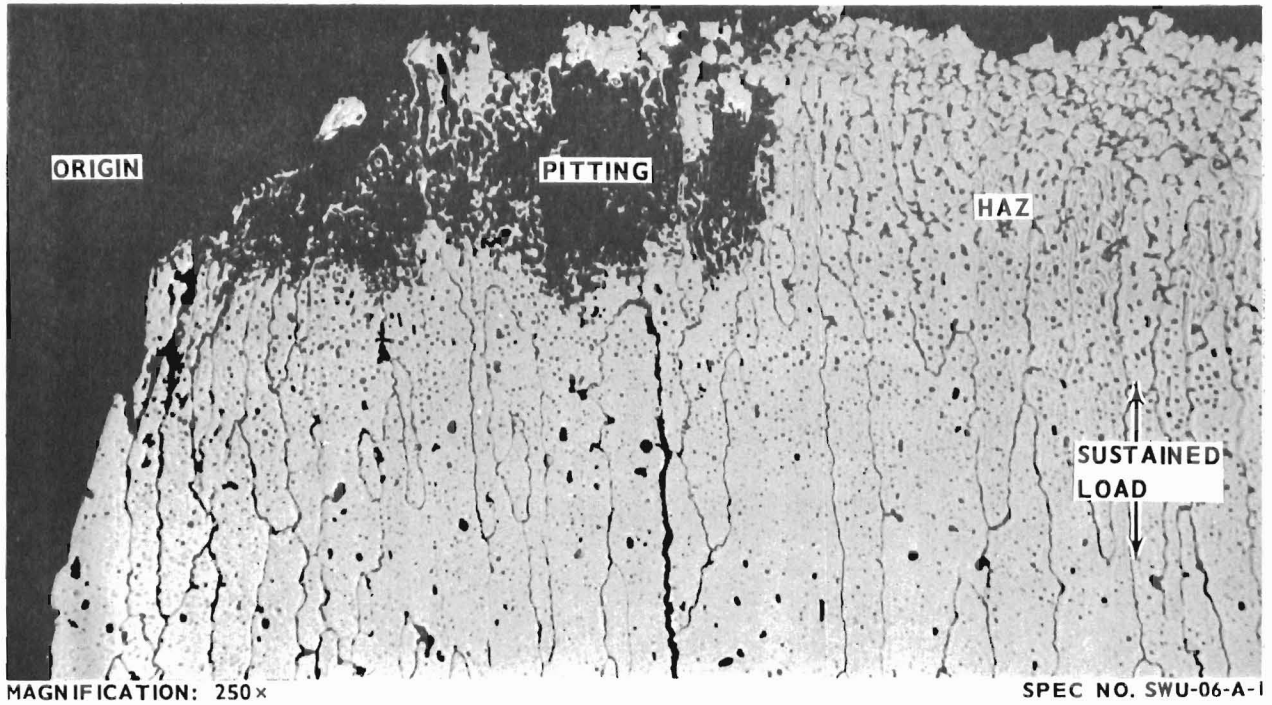
FIGURE 57. PITTING CORROSION AT ORIGIN OF FAILURE, UNNOTCHED 7106 - T6 SHEET, WELD + AGE TEMPER.

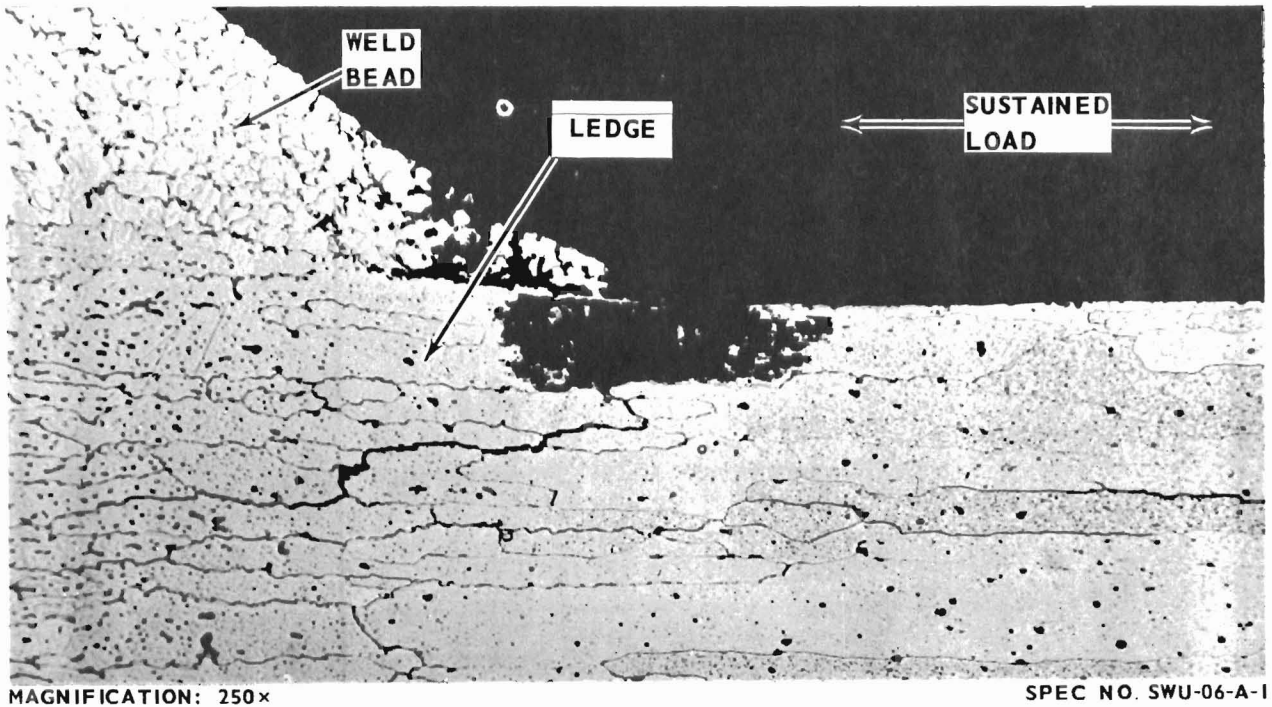
FIGURE 58. PITTING CORROSION AND STRESS CORROSION CRACKING AT EDGE OF WELD BEAD IN 7106 - T6 SHEET, WELD + AGE TEMPER.

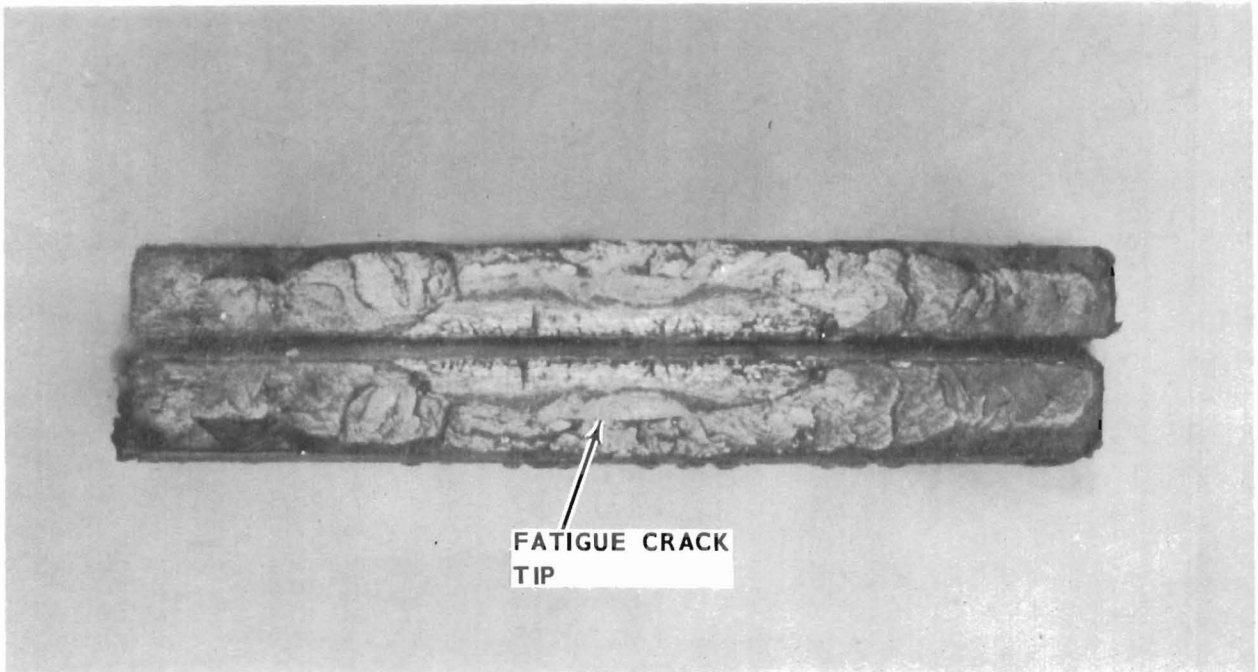
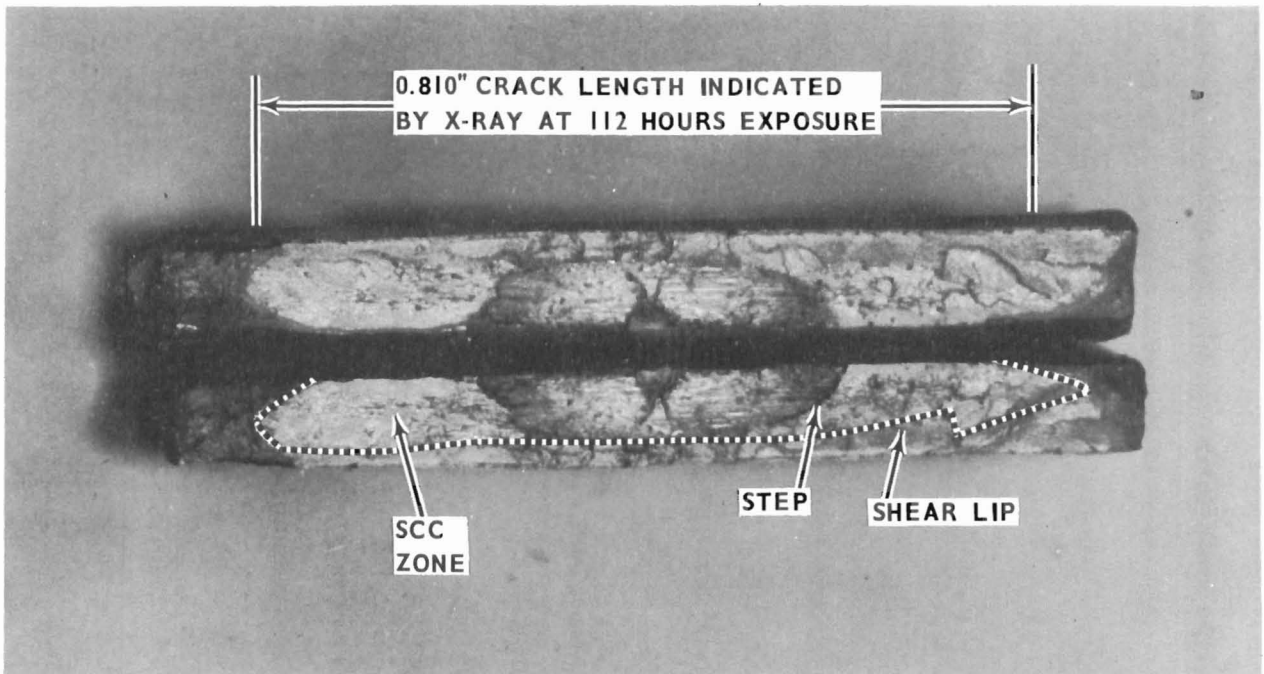
Typical fracture surfaces of notched specimens which failed during SCC testing are shown in Figure 59. Because fracture appearance was similar to unnotched stress-corrosion failed specimens and did not display the full shear fracture of notched, unfailed specimens tension-tested after exposure, failures were considered due to stress corrosion. It was observed that the fatigue crack did not extend in its plane but rather stepped out of the plane, parallel to sustained load, and then continued along the edge of the weld bead through the thickness. In some cases, the full fatigue crack was not visible on the fracture surface (see Figure 59). This may be due to susceptibility of the short transverse grain direction or a more susceptible region adjacent to the fatigue crack.

FATIGUE CRACK TIP

0.810" CRACK LENGTH INDICATED BY X-RAY AT 112 HOURS EXPOSURE

SCC ZONE

FIGURE 59. FRACTURE SURFACE APPEARANCE OF NOTCHED 7106-T6 SHEET THAT FAILED DURING STEP LOAD ALTERNATE EXPOSURE.

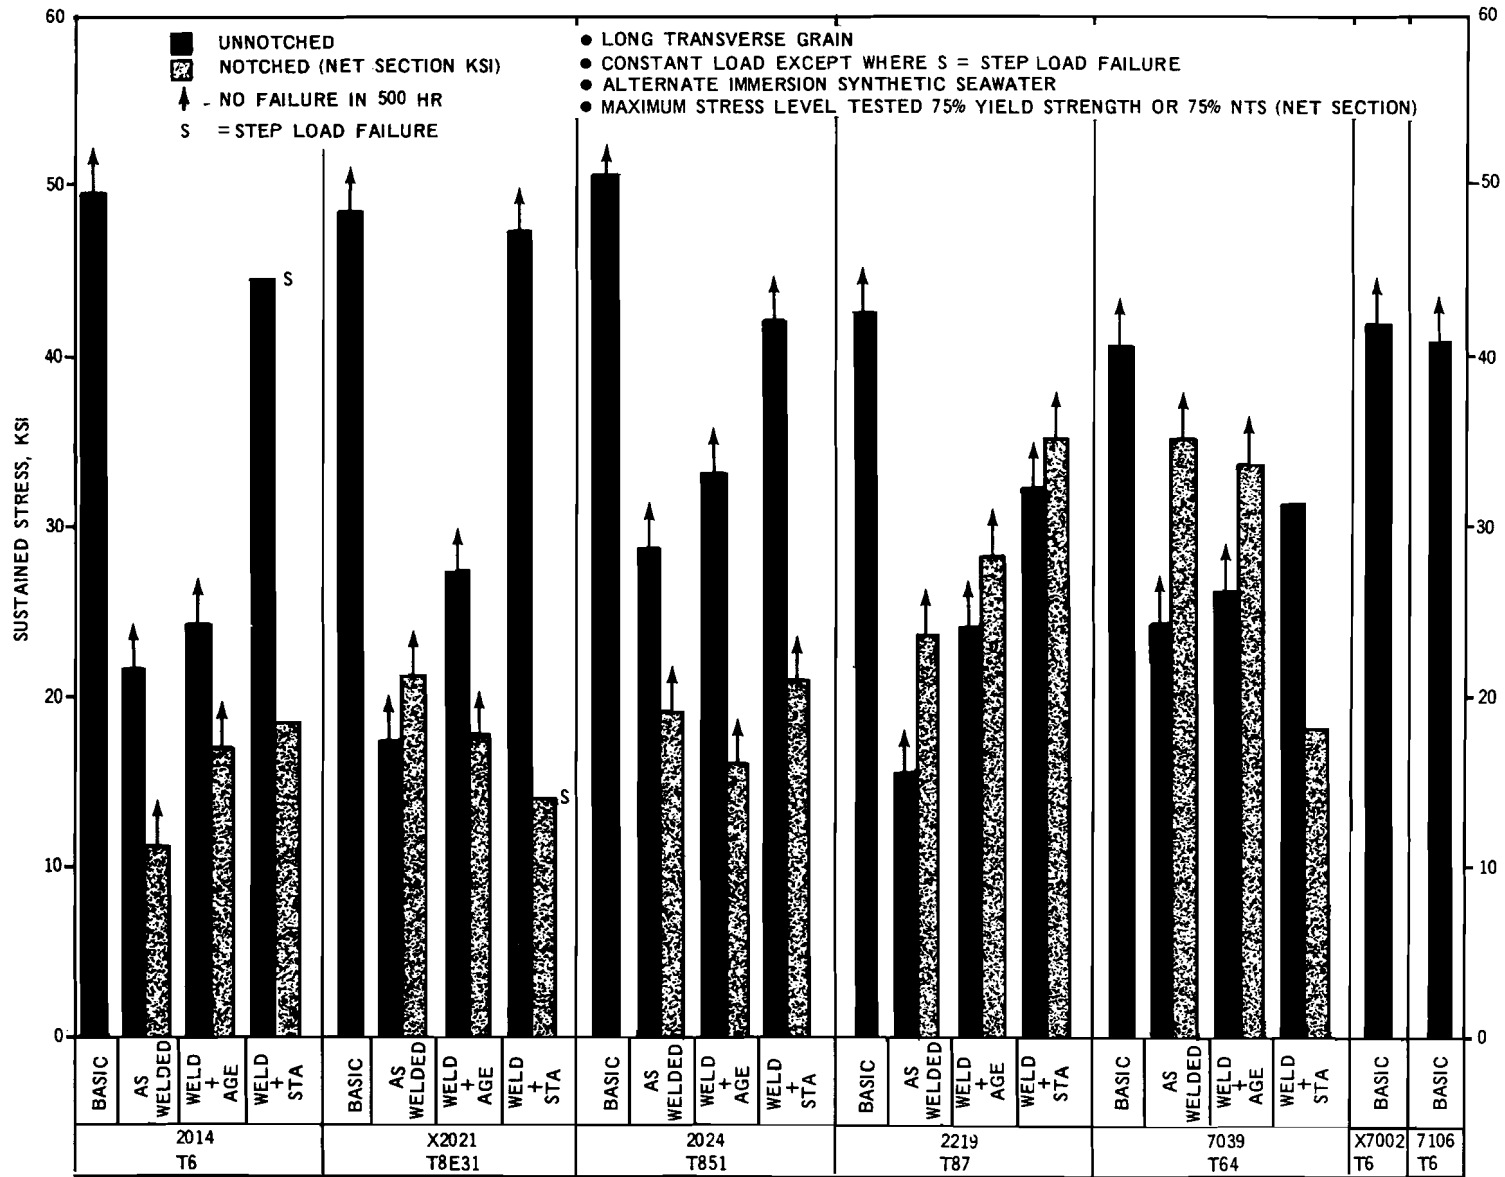
FIGURE 60. COMPARISON OF SCC THRESHOLD STRESS FOR NOTCHED AND UNNOTCHED, AS WELDED AND POST WELD HEAT TREATED ALUMINUM ALLOY PLATE.

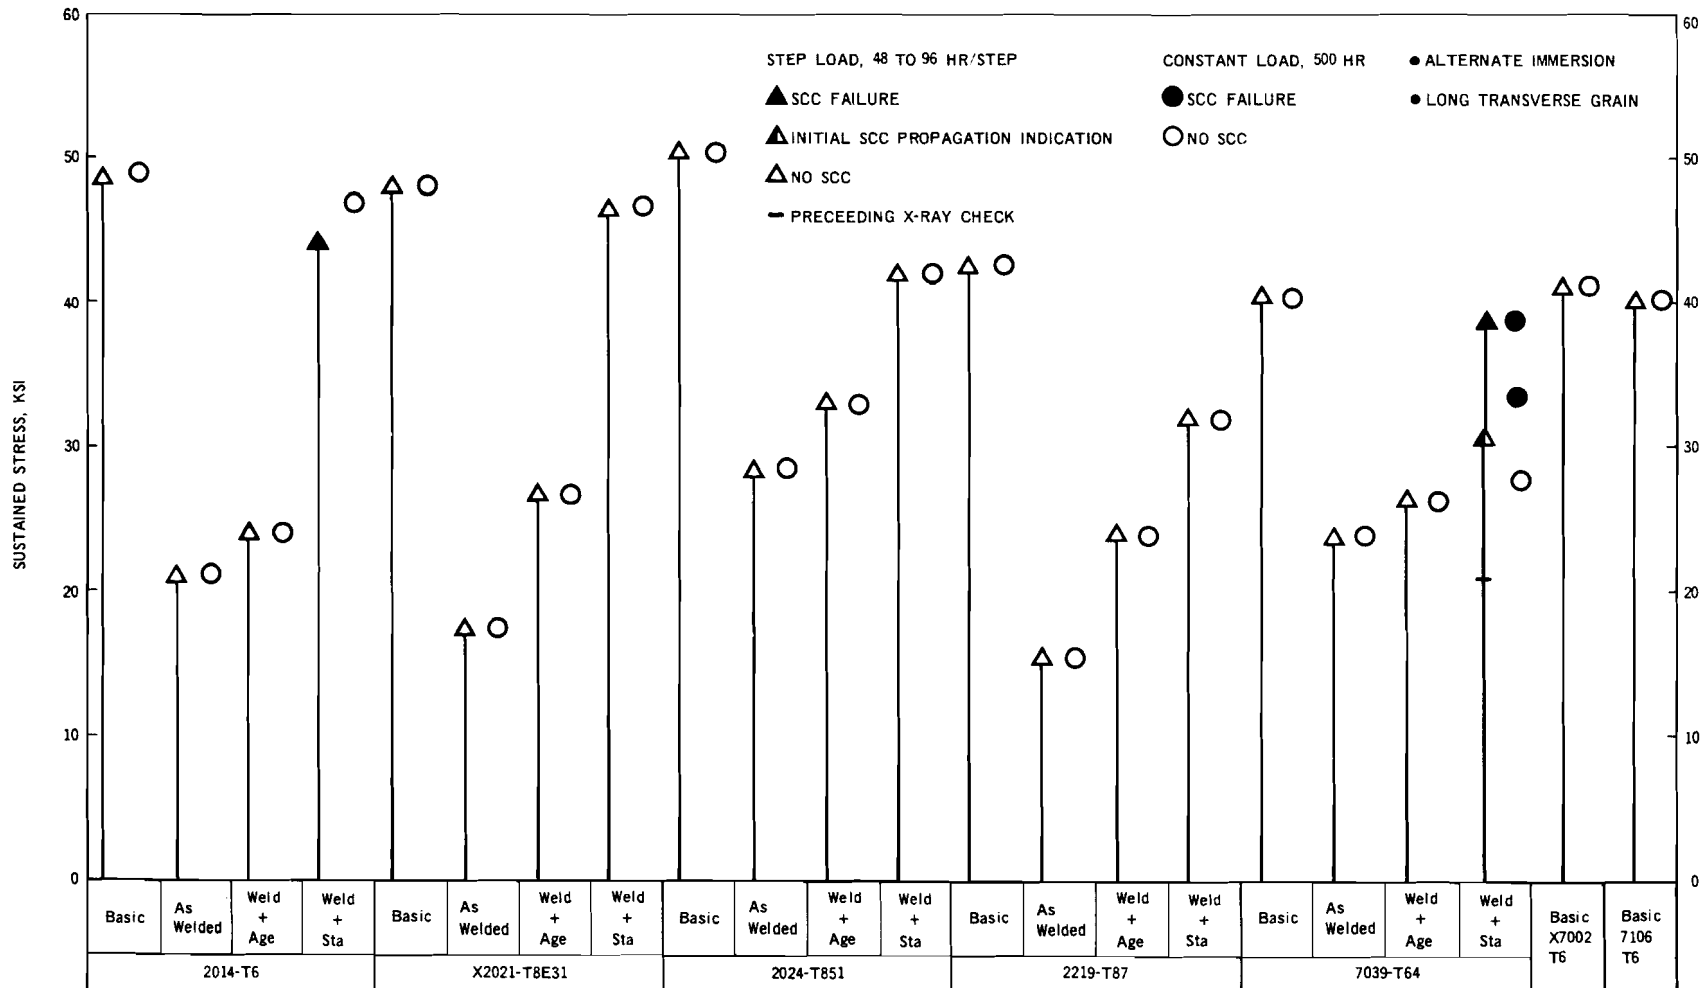
FIGURE 61. COMPARISON OF STEP LOAD AND CONSTANT LOAD SCC DATA FOR UNNOTCHED ALUMINUM ALLOY PLATE

These data are in general agreement with the results from the sheet step-load constant-load data. That is: (1) step-load specimens that failed above the constant-load threshold may have crack initiation at lower stresses which

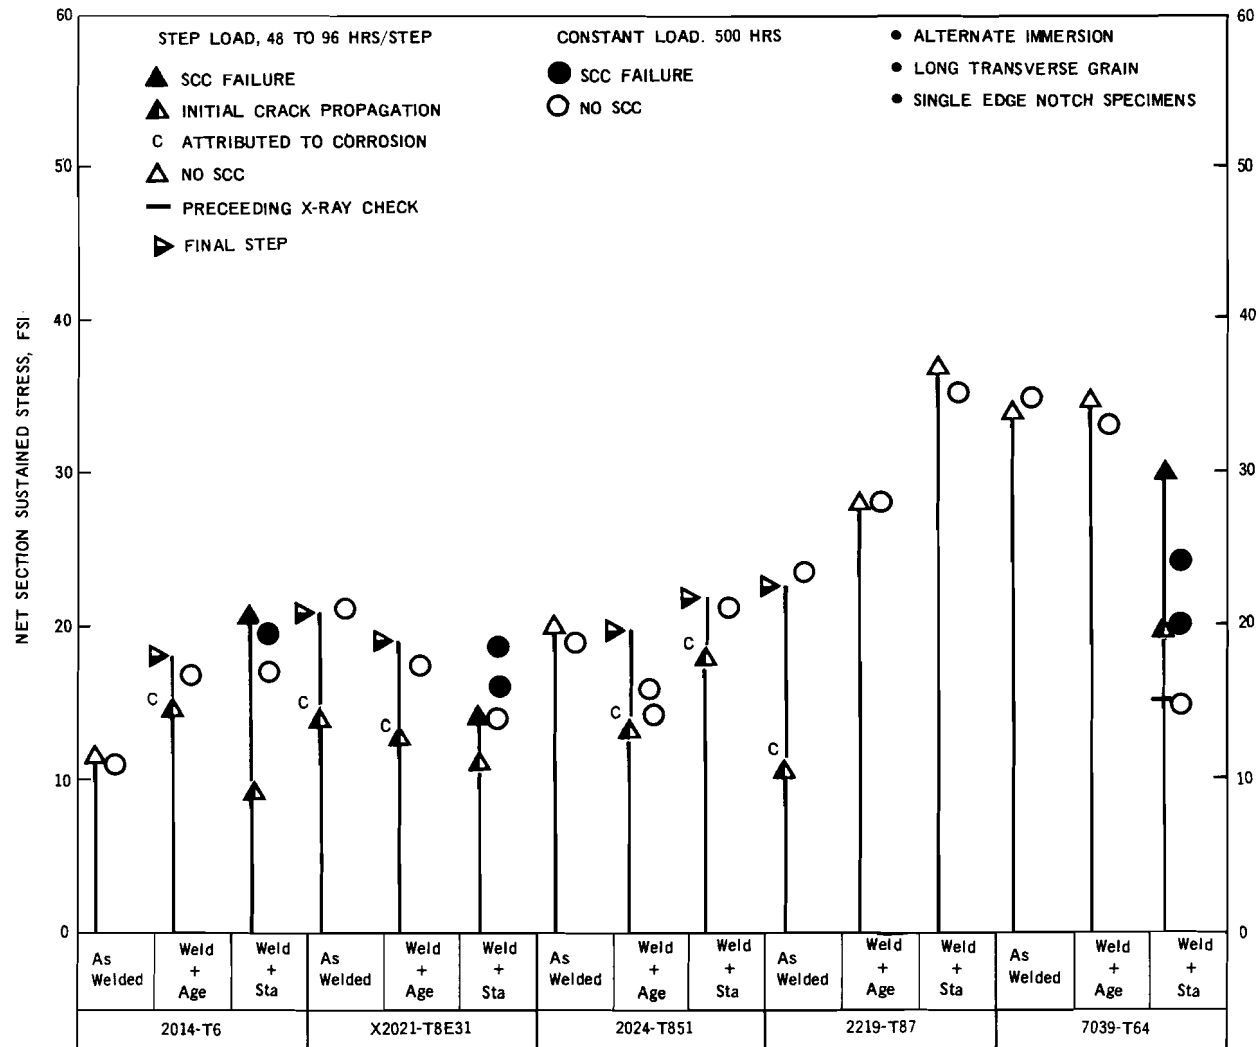
FIGURE 62. COMPARISON OF STEP LOAD AND CONSTANT LOAD SCC DATA FOR NOTCHED ALUMINUM ALLOY PLATE
