STRESS CORROSION SUSCEPTIBILITY OF WELDED ALUMINUM ALLOYS

DOUGLAS AIRCRAFT COMPANY

TECHNICAL REPORT AFML-TR-67-291

AUGUST 1967

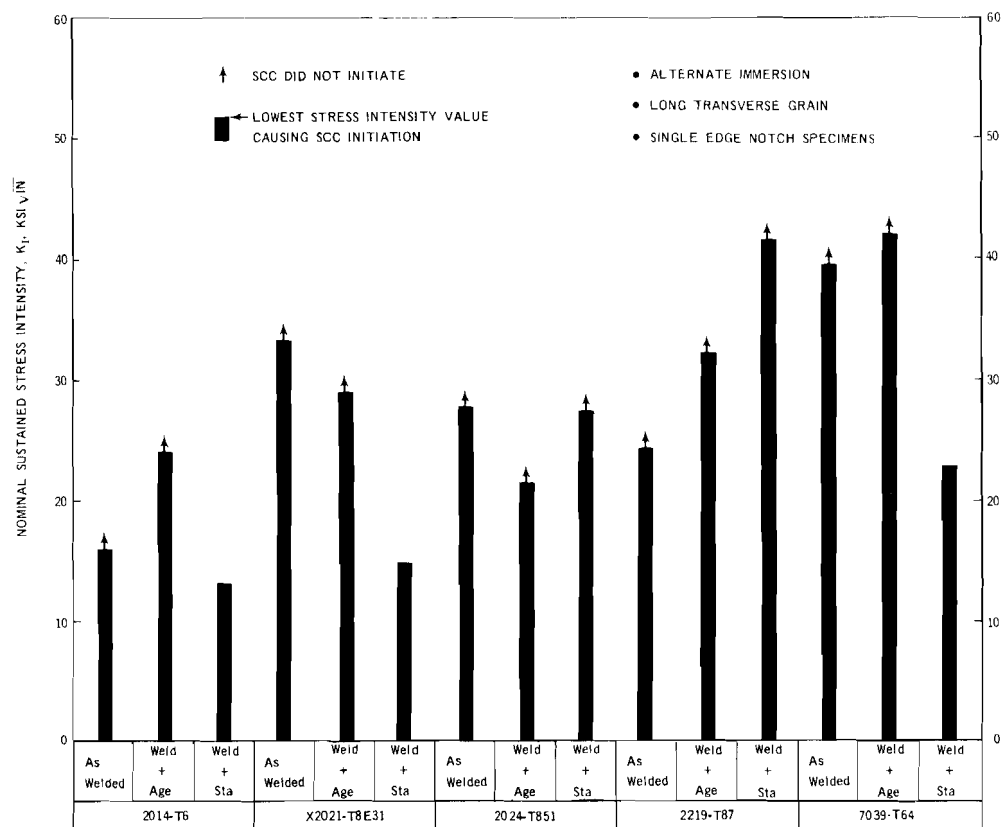
FIGURE 63. STRESS INTENSITY LEVELS REQUIRED TO INITIATE SCC IN NOTCHED ALUMINUM ALLOY PLATE.

Stress intensity levels at final stage of SCC failure are shown for the constant-load test specimens in Table A-27 and step-load specimens in Table A-26 and illustrate stress intensity increased as the crack propagated, reaching a critical value and sudden failure. Few specimens were satisfactory for these calculations because of wide divergence of the stress-corrosion crack from the fatigue crack plane and indistinguishable final stress-corrosion crack lengths. It was also noted that there was no solution to the K_{Ic} equation when net section sustained stress approached yield strength.

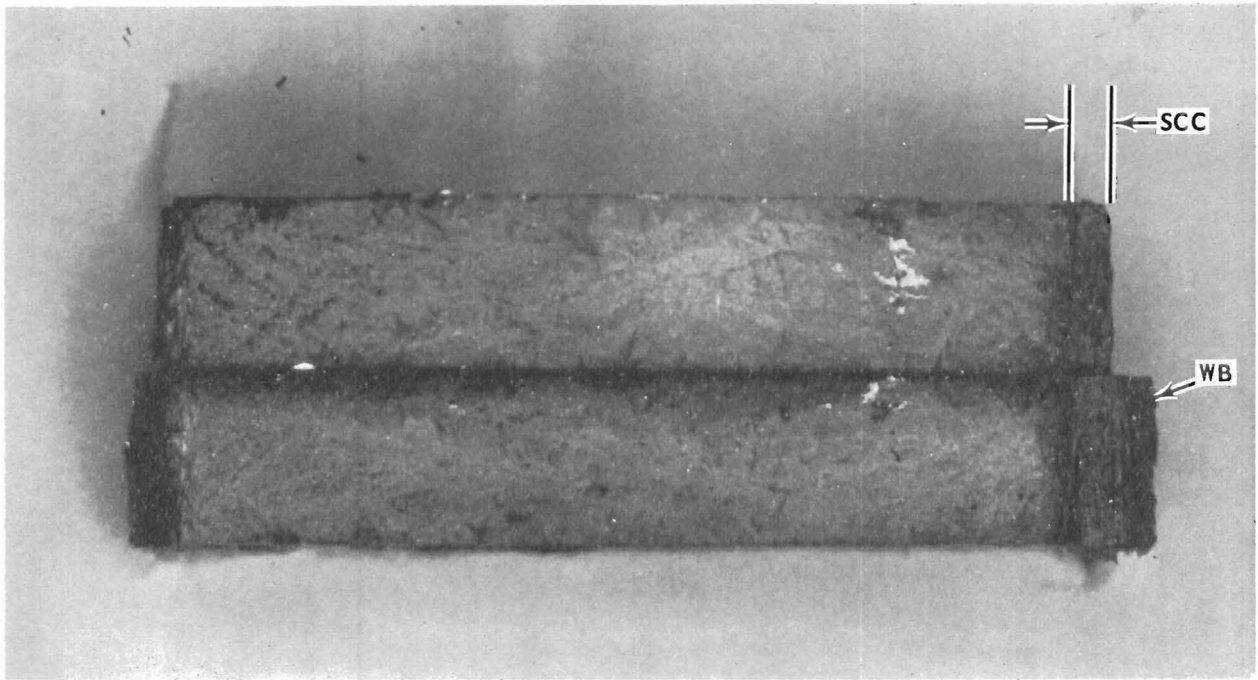
SPEC NO. SWU-14-S-5

The fracture surface of SWU-14-S-5 is shown in Figure 64, and the line of failure along the edge of the weld bead is shown in Figure 65. Metallographic examination at the origin in Figure 66 revealed intergranular cracking, typical of stress-corrosion cracking, and also micro-porosity. This porosity could have contributed to the failure, although cracks are not shown emitting from the porosity in the plane of the micro section.

FIGURE 64. FRACTURE SURFACE OF 2014-T6 PLATE, WELD + STA TEMPER, FAILED DURING SCC TESTING

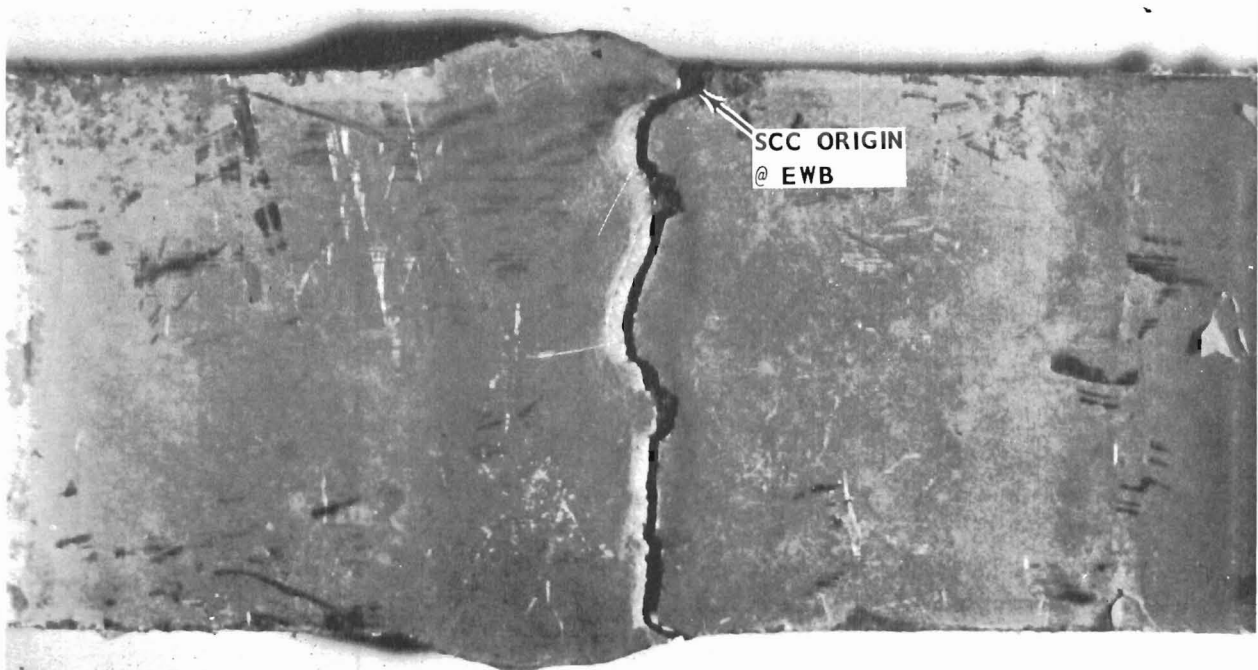
SPEC NO. SWU-14-S-5

FIGURE 65. LINE OF FAILURE OF 2014-T6 PLATE, WELD + STA TEMPER, FAILED DURING SCC TESTING

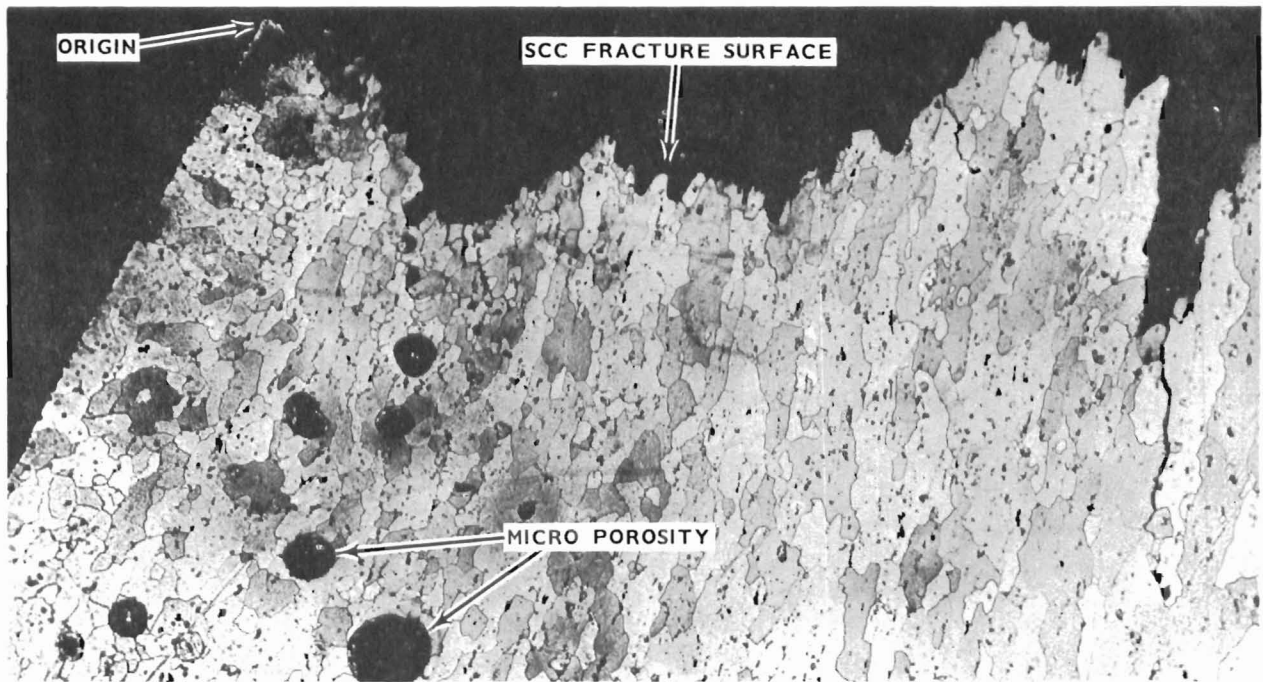
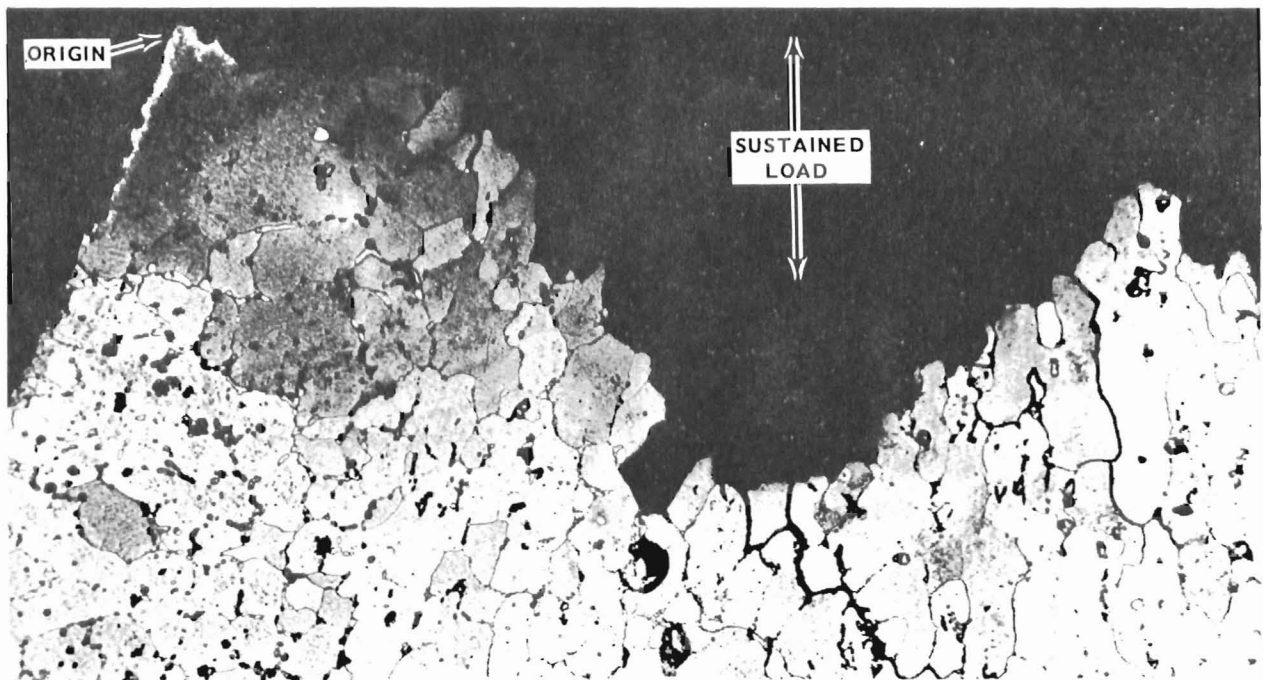
FIGURE 66. MICROSTRUCTURE AT ORIGIN OF FAILURE OF 2014-T6 PLATE, WELD + STA TEMPER, FAILED DURING SCC TESTING.

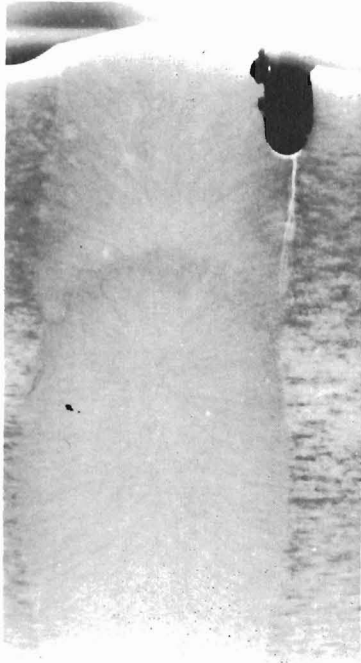
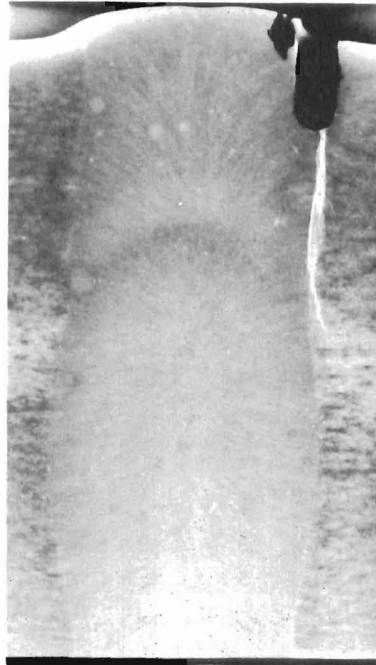
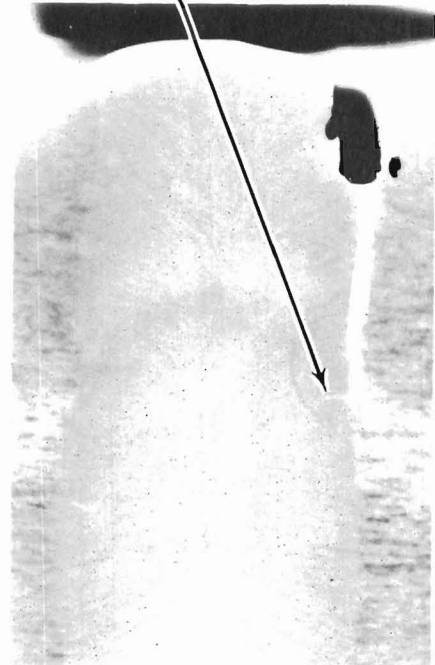
SPEC NO. SWX-14-S-5

A series of pictures made directly from the X-ray negatives from the step-load specimen illustrating the stages of crack propagation are shown in Figure 68. The crack appears to have several fronts, branching into the heat-affected zone initially and finally turning 90° into the weld bead just prior to final failure.

STEP 1	STEP 2	STEP 5
SUSTAINED STRESS (KSI)	5.93	8.90	17.81
HOURS AT STEP	90	41	113
ACCUM. HOURS ALTERNATE IMMERSION	90	131	394
ACCUM. HOURS, AIR (BETWEEN STEPS)	0	6	31
NOTCH + CRACK DEPTH (INCH)	0.393	0.503	0.518

FIGURE 68. STAGES OF STRESS CORROSION CRACK PROPAGATION IN PRE-CRACKED 2014-T6 PLATE, WELD + STA TEMPER, AS VIEWED BY X-RAY.

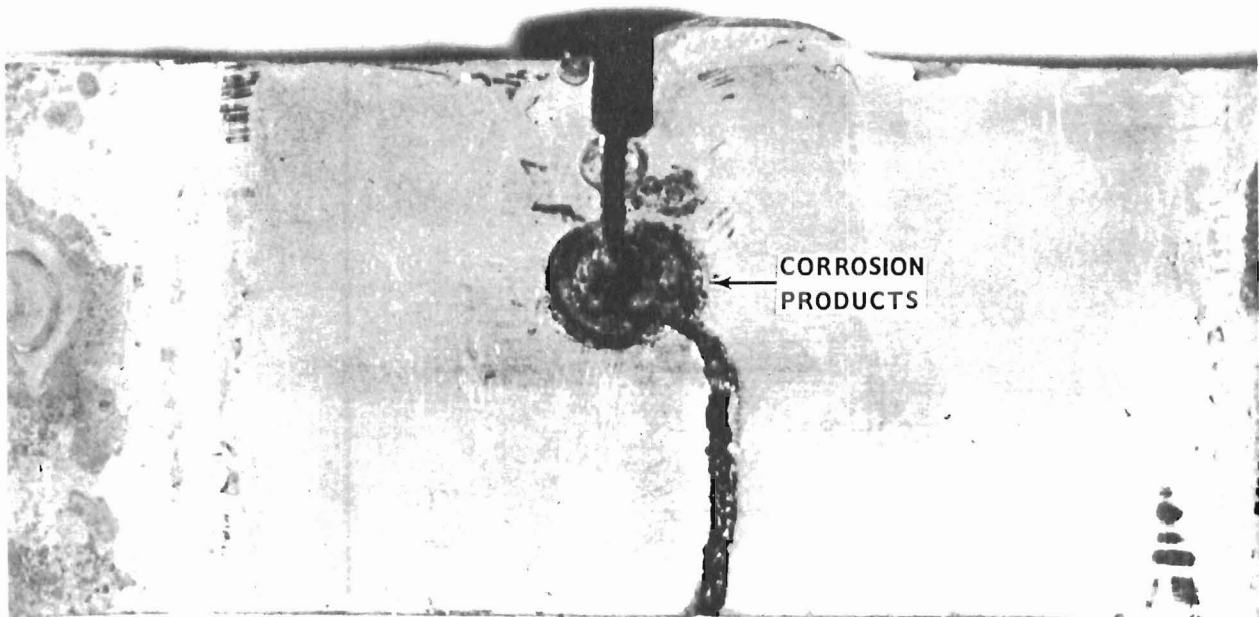
SPEC NO. SWX-14-S-5

The fracture surface and line of failure are shown in Figures 69, and displaying an erratic dog-leg that terminated in final failure through the weld bead. Corrosion products on the side of the specimen at the SCC area in Figure 70 confirm the corrodent was transported through the notch and fatigue crack to the crack tip. Sides of all plate specimens were masked to prevent SCC away from the fatigue crack tip.

FIGURE 70. LINE OF FAILURE OF 2014-T6 PLATE, WELD + STA TEMPER, THAT FAILED DURING SCC TESTING.

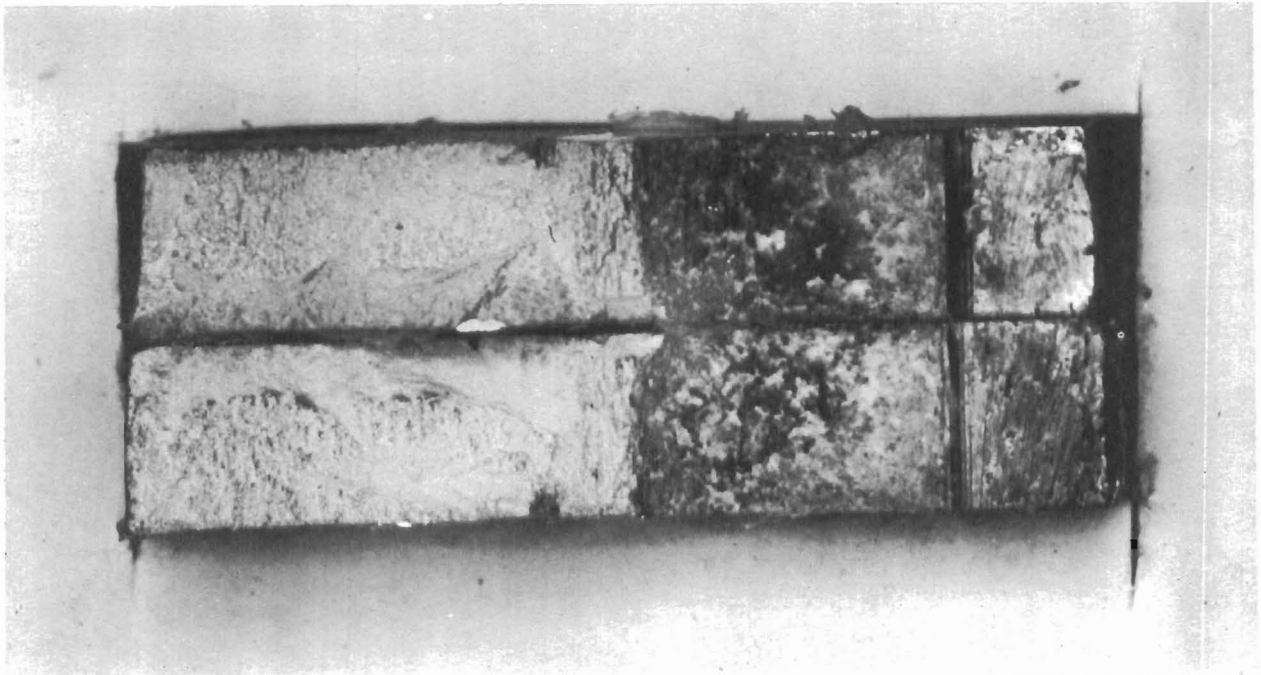
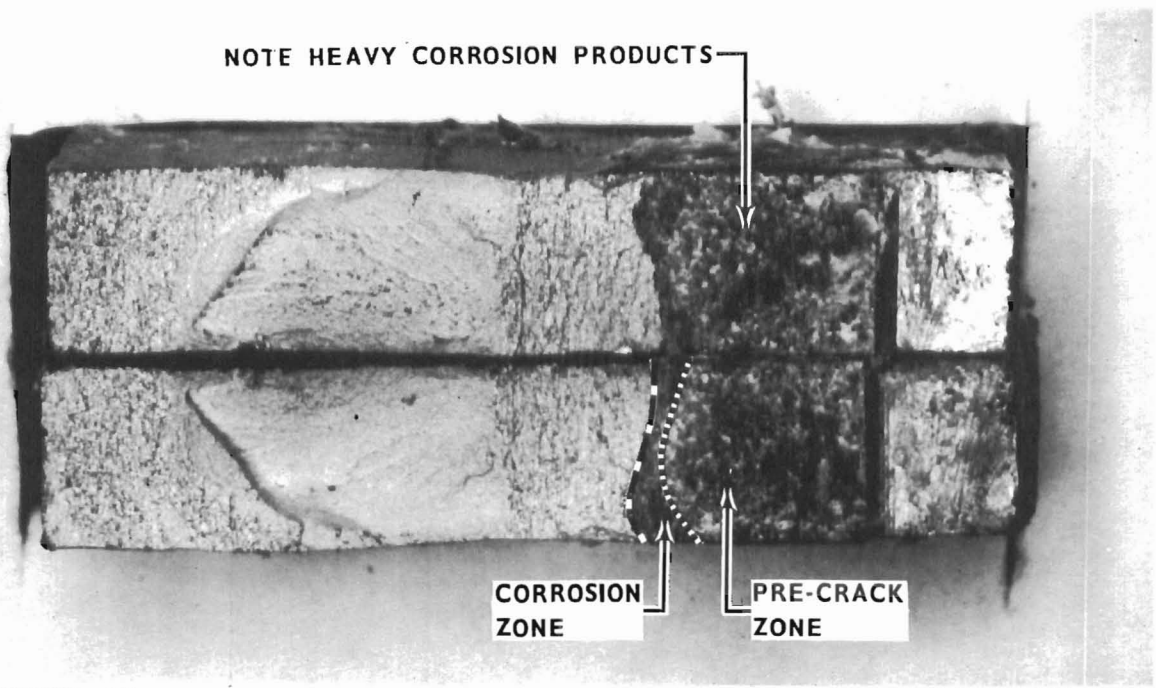
It was difficult to verify mode of crack extension for the step-loaded, as-welded and weld plus age tempers because of short crack extension lengths for viewing. Considerable corrosion products were observed on fracture surfaces of these two specimens, SWX-21-W-5 and SWX-21-A-5, as illustrated in Figure 71, and wide grain boundary corrosion was observed microscopically at the fatigue crack tip on SWX-21-W-5. It is considered likely that both crack extensions were due to corrosion.

FIGURE 71. FRACTURE SURFACES OF PRE-CRACKED X2021-T8E31 PLATE THAT DID NOT FAIL DURING SCC TESTING BUT DISPLAYED CRACK EXTENSION ATTRIBUTED TO CORROSION.

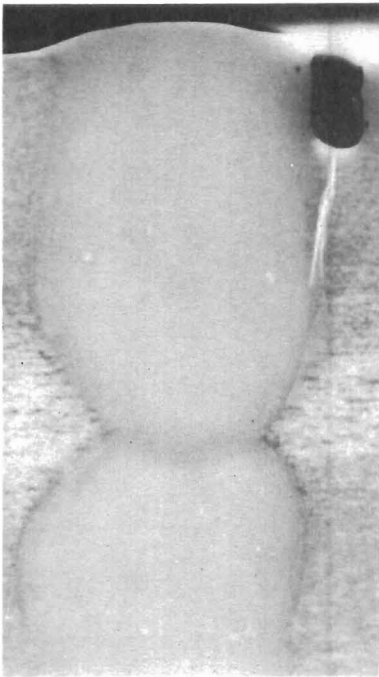
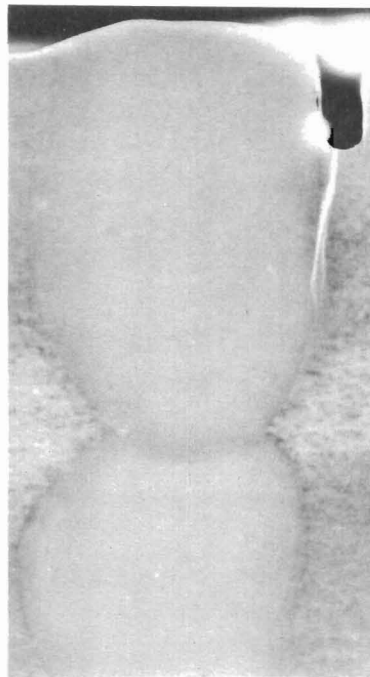
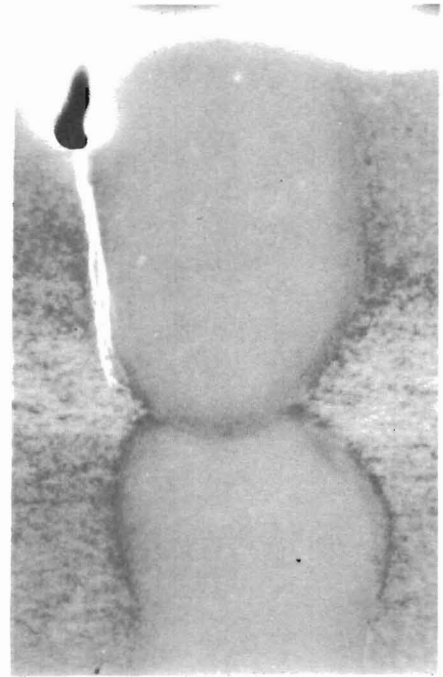
SPEC NO. SWX-21-S-5

The nature of crack extension for the weld plus STA temper was also difficult to verify with microscopic examination. Branching or distinct intergranular cracks were not observed along the fracture surface. Since the fracture surfaces displayed fewer corrosion products than the former two tempers, failure times were a function of sustained stress (lower stress – longer times) and a significant degree of rapid crack extension was observed, the failures of the weld plus STA temper are considered attributable to SCC. The stages of crack propagation as viewed by X-ray are shown for SWX-21-S-5 in Figure 72, and the relatively clean surface of the crack-extended area in Figure 73.

STEP 2	STEP 3	STEP 4
SUSTAINED STRESS (KSI)	8.3	11.0	13.7
HOURS AT STEP	88	41	41
ACCUM. HOURS ALTERNATE IMMERSION	129	170	211
ACCUM. HOURS AIR (BETWEEN STEPS)	8	15	22
NOTCH + CRACK DEPTH (INCH)	0.348	0.373	0.558

FIGURE 72. STAGES OF STRESS CORROSION CRACK PROPAGATION IN PRE-CRACKED X2021-T8E31 PLATE, WELD + STA TEMPER, AS VIEWED BY X-RAY.

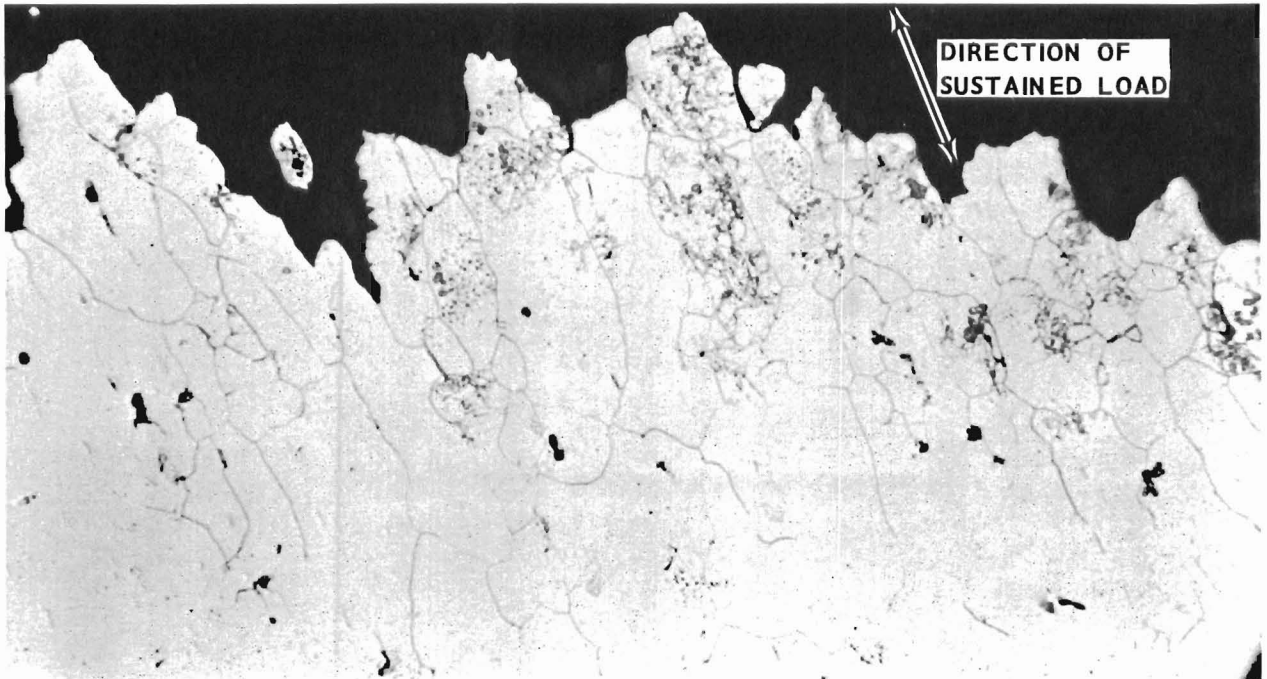
SPEC NO. SWX-19-W-6

Microscopic examination was conducted on the constant-load specimen to determine nature of cracking. Random intergranular cracking, associated with the eutectic melt zone, was observed along the edge of the fatigue crack and along the fork leg, as shown in Figures 75 through 77. Similar cracking was observed along the crack formed on the unnotched side of the specimen.

FIGURE 75. INTERGRANULAR CORROSION AND EUTECTIC MELTING ALONG FRACTURE SURFACE IN HEAT AFFECTED ZONE OF 2219-T87 PLATE, AS WELDED TEMPER, TESTED IN ALTERNATE IMMERSION.

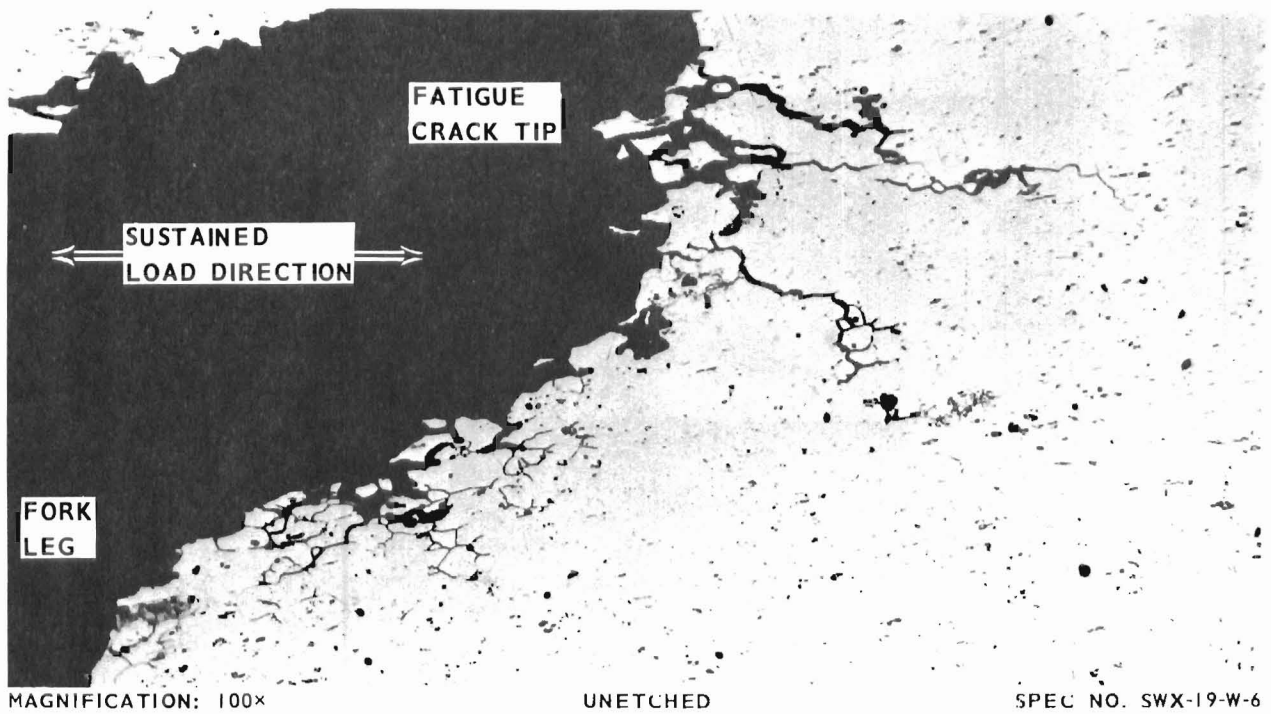
FIGURE 77. INTERGRANULAR CORROSION AT TIP OF FATIGUE CRACK IN 2219 - T87 PLATE, AS WELDED TEMPER, TESTED IN ALTERNATE IMMERSION.

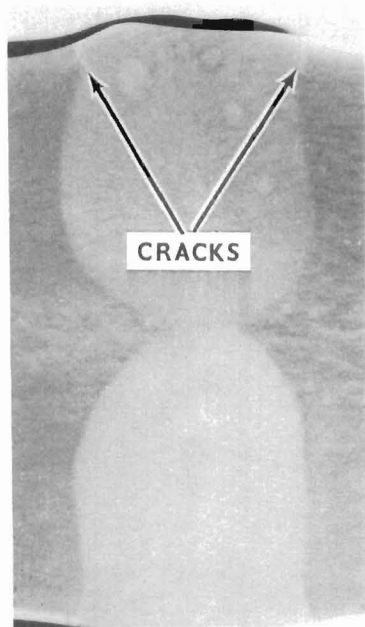
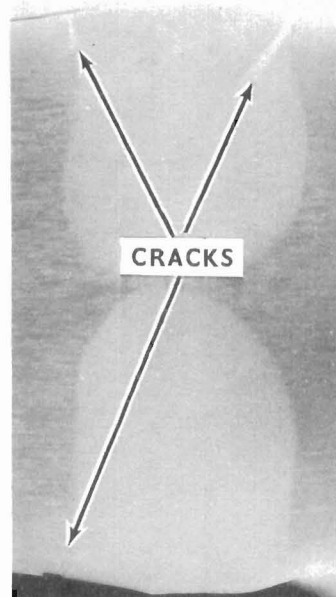
For the unnotched weld plus STA temper, SCC occurred at the edge of the weld bead in three locations prior to failure with the step-load specimen SWU-39-S-5 as illustrated in Figure 78, with final failure occurring through the weld bead, Figure 79. First cracks were observed at 31.3 ksi sustained stress. The fracture surface is shown in Figure 80. Microscopic examination along the line of and at the origin of failure, Figure 81, revealed intergranular cracking typical of SCC.

STEPLOAD 5	STEPLOAD 6
SUSTAINED STRESS (KSI)	31.3	36.5
HOURS AT STEP	113	24
ACCUM. HOURS ALTERNATE IMMERSION	394	436
ACCUM. HOURS AIR (BETWEEN STEPS)	31	55
CRACK DEPTH (INCH)	0.75 0.75	0.150 0.100 0.075

FIGURE 78. STAGES OF SCC PROPAGATION IN 7039-T64 PLATE, WELD + STA TEMPER, AS VIEWED BY X-RAY.

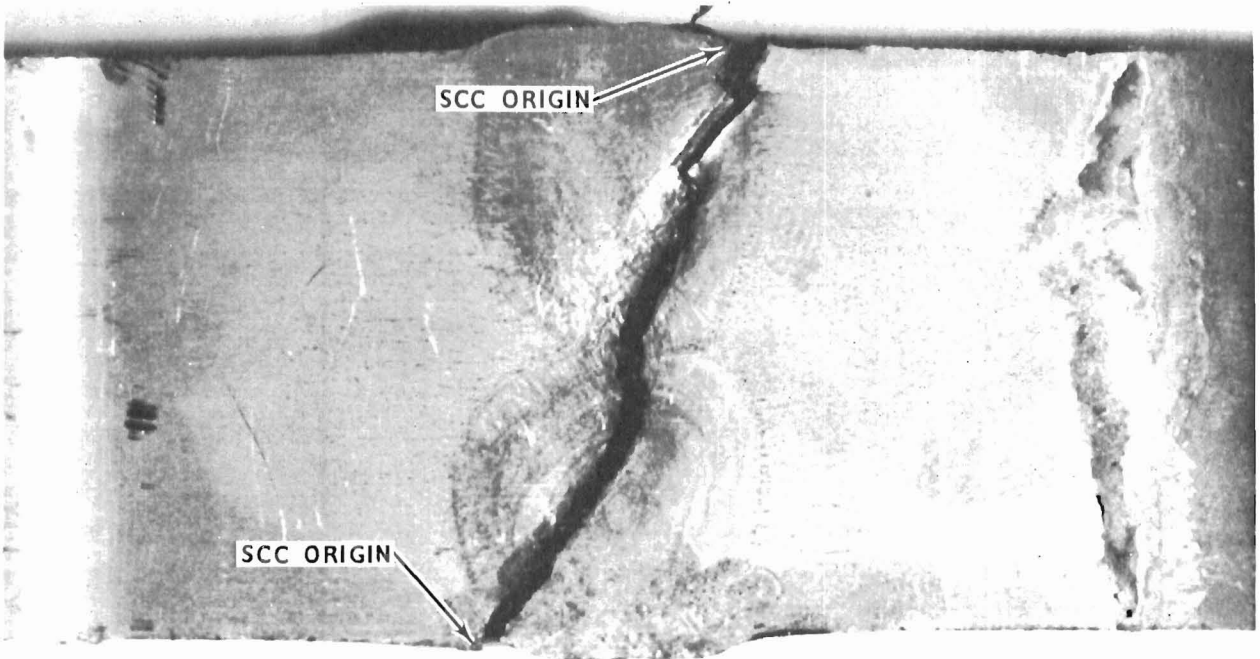
SPEC NO. SWU-39-S-5

FIGURE 79. LINE OF FAILURE OF 7039-T64 PLATE, WELD + STA TEMPER, THAT FAILED DURING STEP LOAD SCC TESTING.

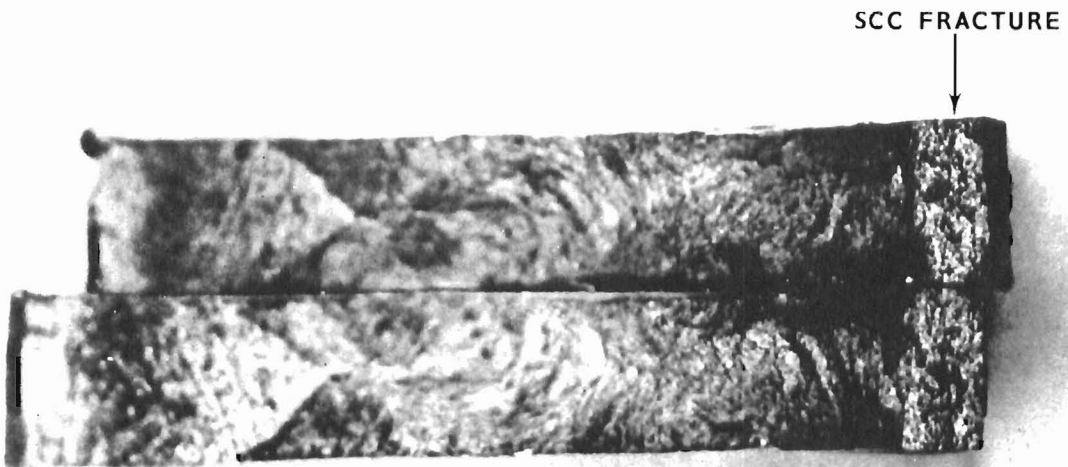
SPEC NO. SWU-39-S-5

FIGURE 80. FRACTURE SURFACE OF 7039-T64 PLATE, WELD + STA TEMPER, THAT FAILED DURING STEP LOAD SCC TESTING.

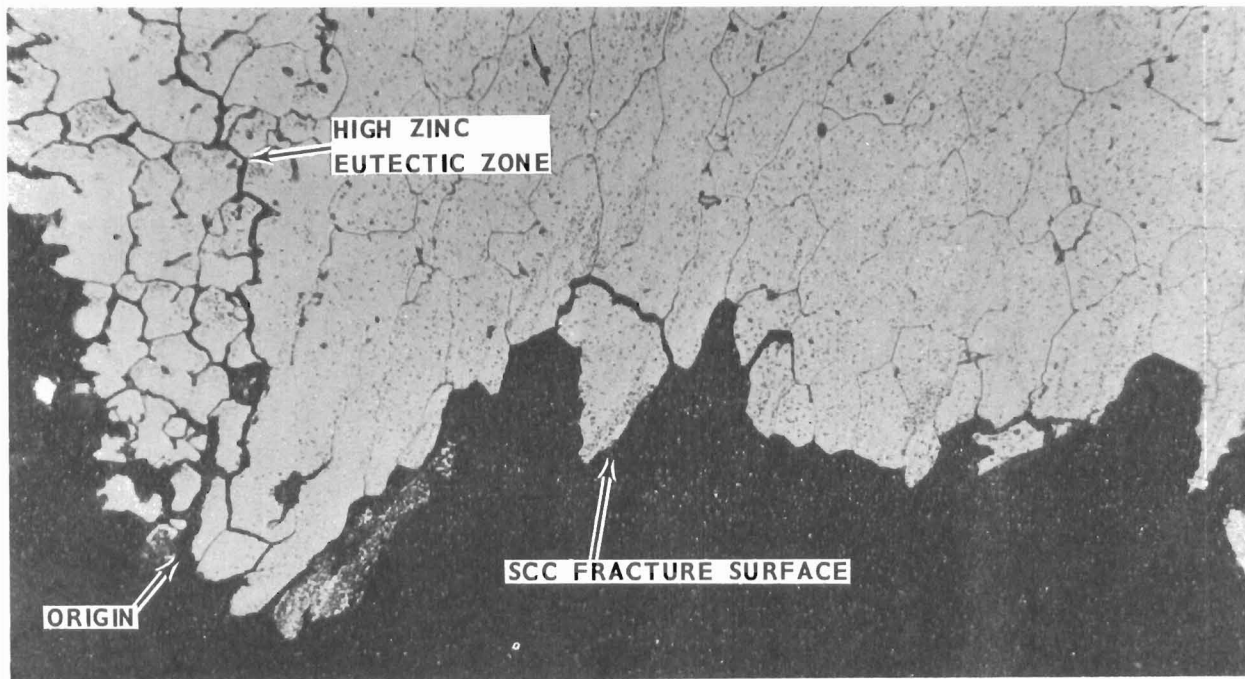
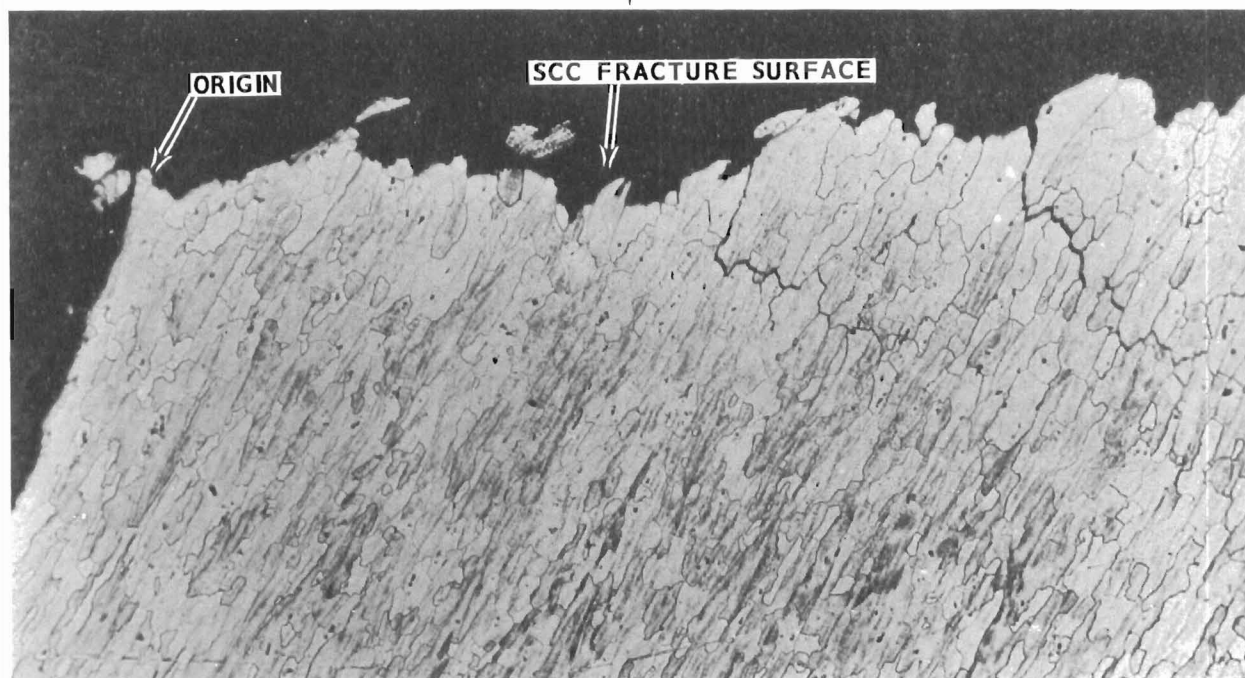
FIGURE 81. MICROSTRUCTURE AT ORIGIN OF FAILURE (EDGE OF WELD BEAD) OF 7039-T64 PLATE, WELD + STA TEMPER, FAILED DURING STEP LOAD SCC TESTING.

The microstructure at the origin, as shown in Figures 81 and 82, includes what is considered the high-zinc eutectic formed during welding. It does not appear that the eutectic contributed a significant part to SCC because (1) it was present on as-welded and weld plus age tempers that did not fail, and (2) notched specimens of the weld plus STA temper (the notch removing the eutectic area) still were susceptible, as discussed in the following paragraphs.

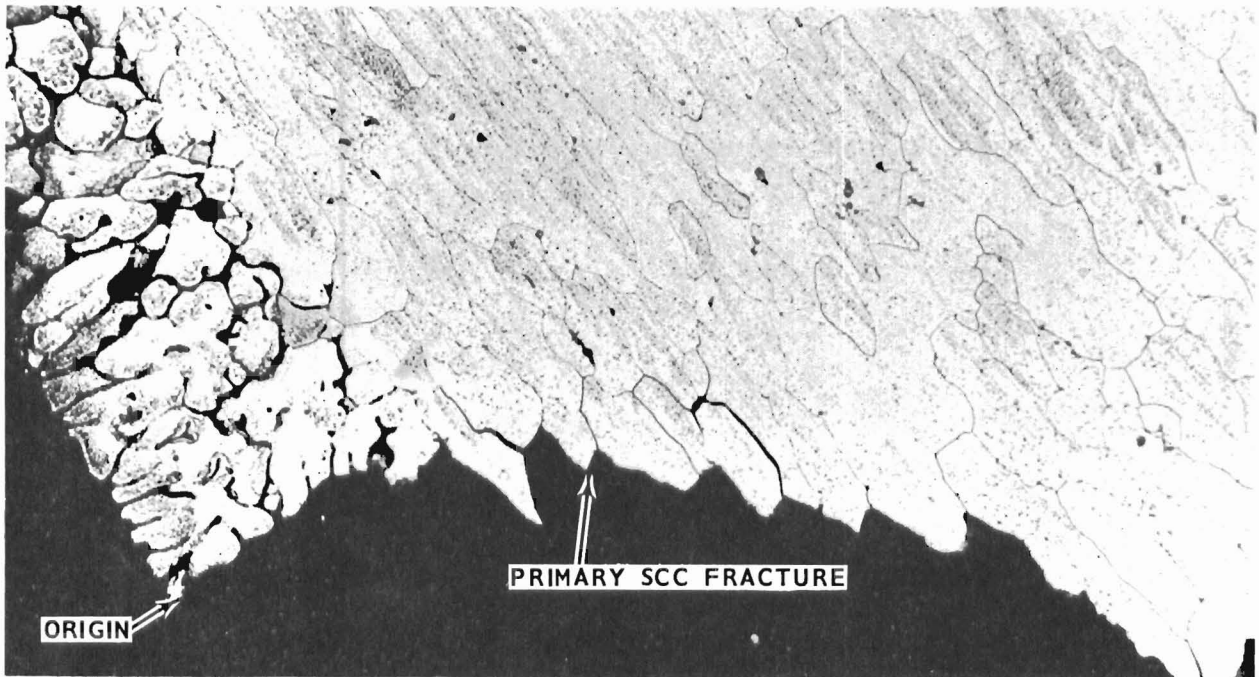
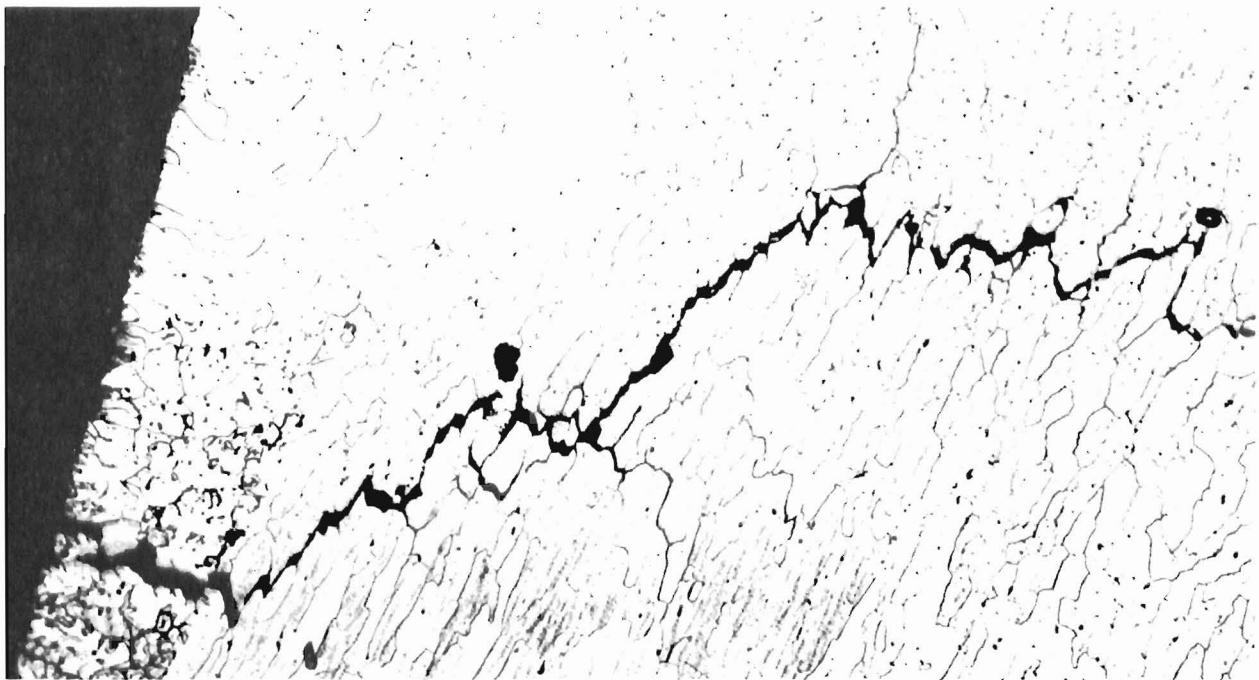
Replicate constant-load weld plus STA specimens exposed at stress levels in the region of step-load SCC failure failed under 39.1 ksi sustained stress (249 hours) and 33.9 ksi (416 hours) and the third did not have evidence of SCC at 28.7 ksi in 500 hours alternate immersion. Microscopic examination of failed constant-load specimen SWU-39-S-6 revealed intergranular cracking at the origin of failure, edge of weld bead, as shown in Figure 82.

FIGURE 82. MICROSTRUCTURE AT ORIGIN OF PRIMARY AND SECONDARY CRACK IN 7039 -T64 PLATE, WELD + STA TEMPER, FAILED DURING CONSTANT LOAD SCC TESTING.

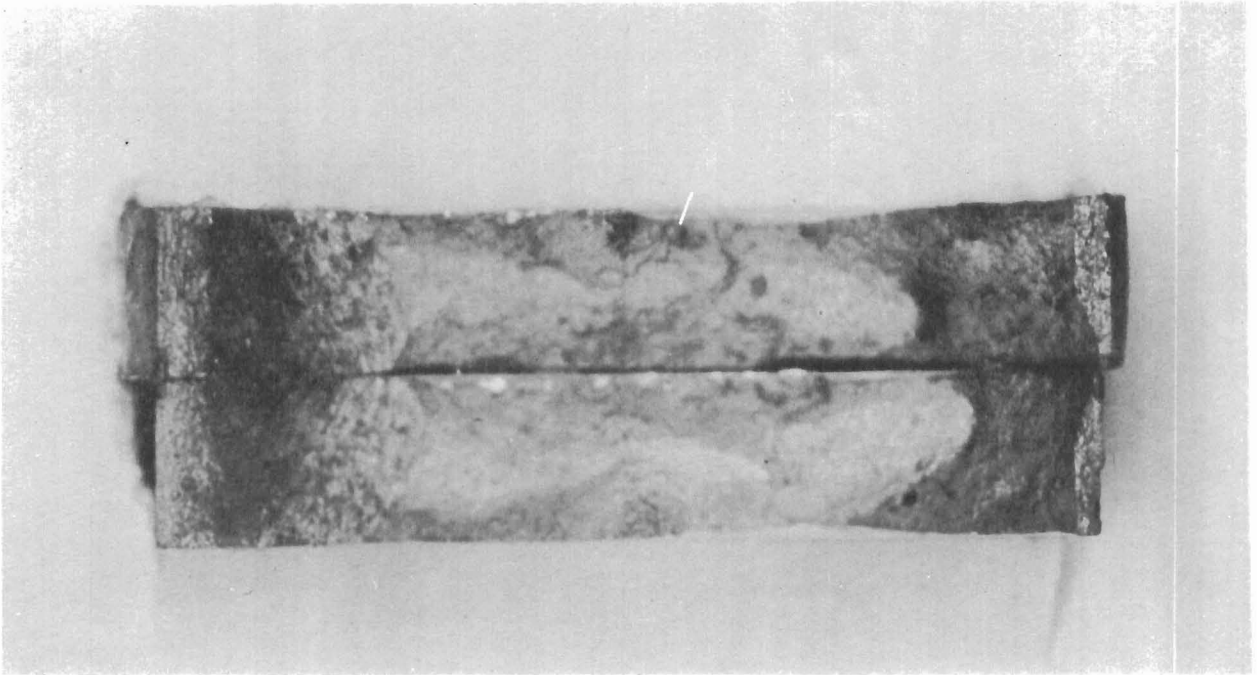
SPEC NO. SWU-39-S-6

Fracture surface and line of failure through the weld bead are shown in Figures 83 and 84.

FIGURE 83. FRACTURE SURFACE OF 7039 - T64 PLATE, WELD + STA TEMPER, THAT FAILED DURING CONSTANT LOAD SCC TESTING.

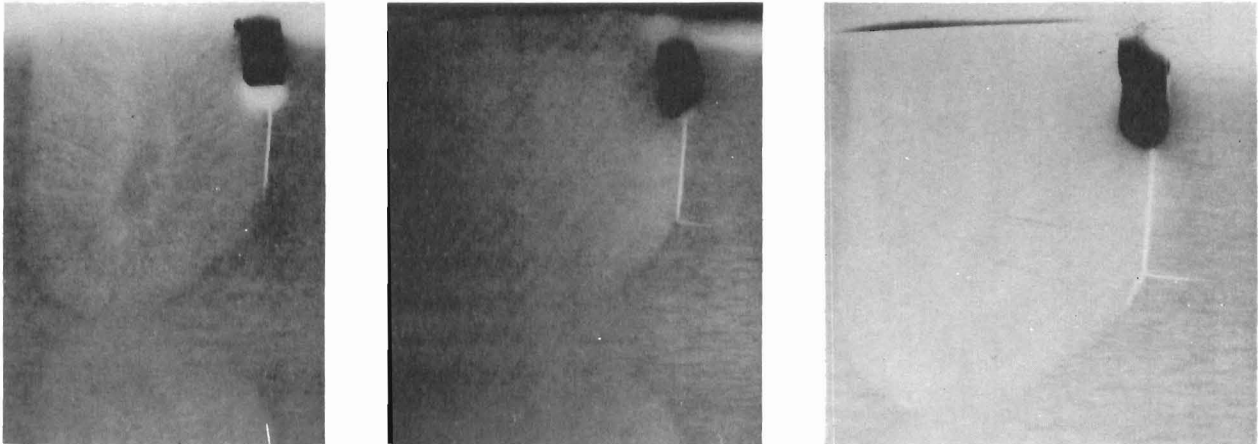
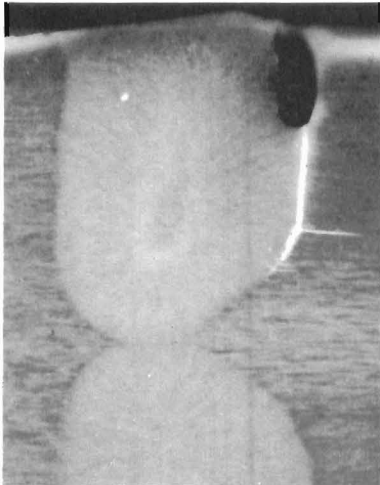
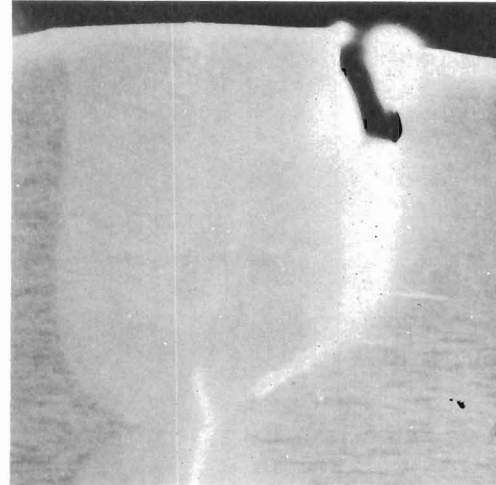
The stages of stress-corrosion crack propagation in the step-load specimen, as viewed by X-ray, are shown in Figure 85. Initially, short cracks extended from and 90° to the precrack tip (short transverse grain direction). This was followed by extension of the main fatigue crack front along the edge of the weld bead confined to the fusion line. Branching cracks, short transverse grain direction, accompanied this progression along the edge of the weld bead. In the final stage, a mechanical crack formed on the centerline of the weld bead, disjointed from the stress-corrosion crack, and the specimen subsequently failed. Short transverse grain direction cracks are considered indicative of susceptibility in that direction and residual stress.

STEP LOAD	1	2	3
SUSTAINED STRESS (KSI)	10.1	15.1	20.1
HOURS AT STEP	41	88	41
ACCUM. HOURS ALTERNATE IMMERSION	41	129	170
ACCUM. HOURS AIR (BETWEEN STEPS)	0	8	15
CRACK DEPTH (INCH)	0.340	0.340	0.375

STEP LOAD	4	5
SUSTAINED STRESS (KSI)	25.2	30.2
HOURS AT STEP	41	89
ACCUM. HOURS ALTERNATE IMMERSION	211	300
ACCUM. HOURS AIR (BETWEEN STEPS)	21	27
CRACK DEPTH (INCHES)	0.415	0.510 (0.600 LINEAR)

FIGURE 85. STAGES OF SCC PROPAGATION IN 7039-T64 PLATE, WELD + STA TEMPER, AS VIEWED BY X-RAY.

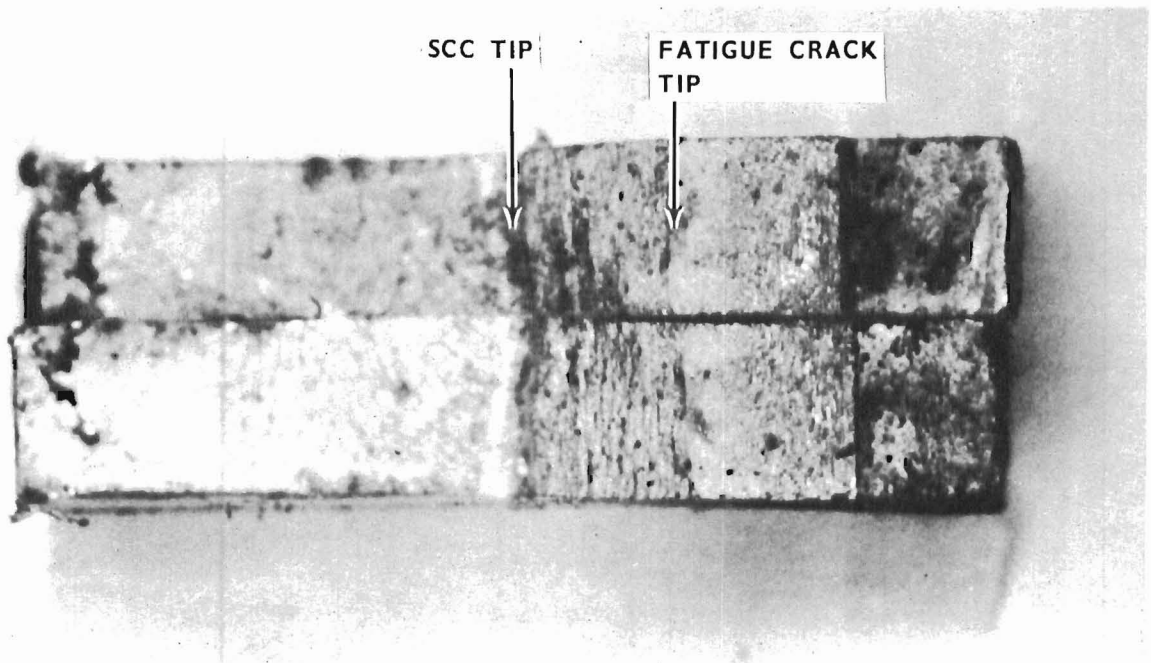
SPEC NO. SWX-39-S-5

The fracture surface of the step-load specimen is shown in Figure 86 and is typical of the failures of the constant-load specimens.

FIGURE 86. FRACTURE SURFACE OF PRE-CRACKED 7039-T64 PLATE, WELD + STA TEMPER, THAT FAILED DURING STEP LOAD SCC TESTING.

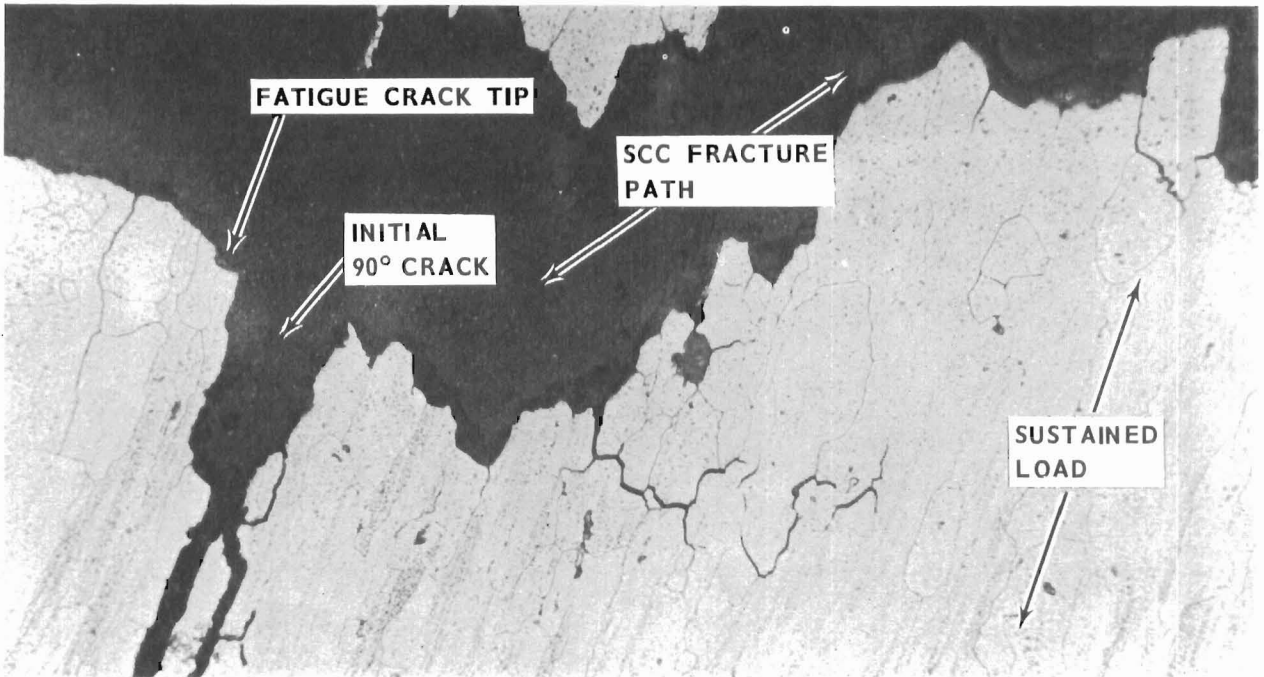
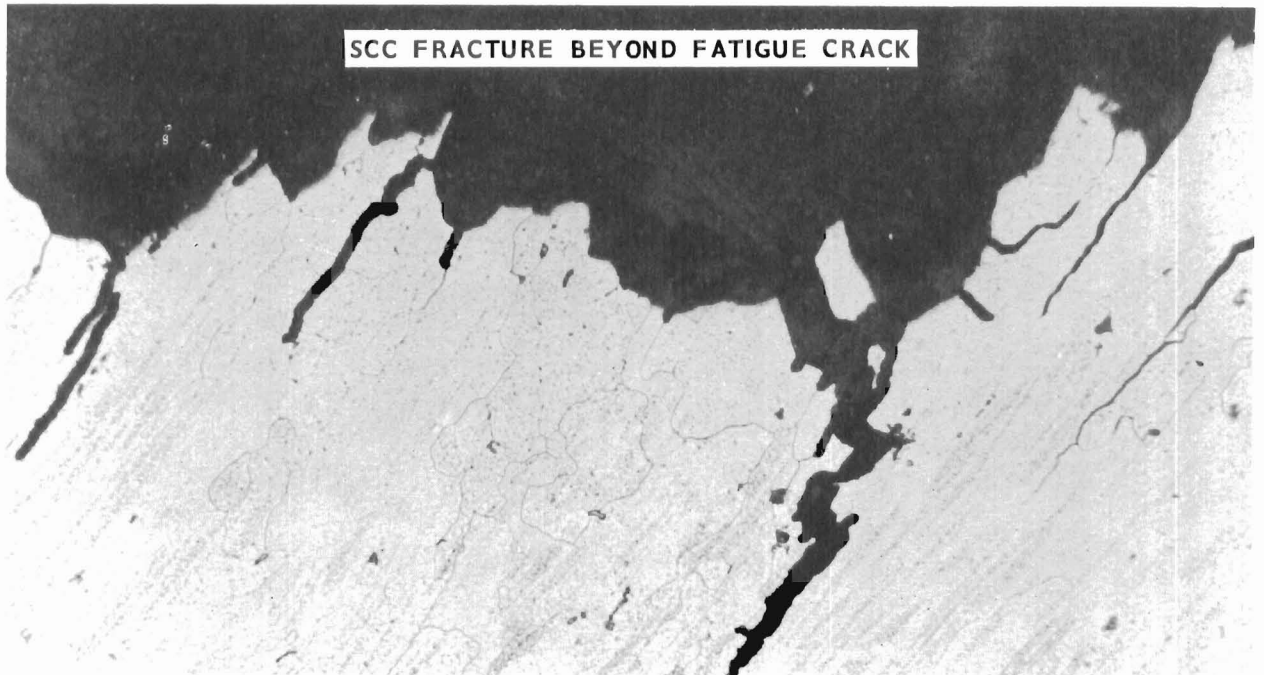
Microstructure studies along the fracture profile revealed intergranular cracking typical of SCC which terminated as transgranular tearing at the base of the weld bead. Microstructure at the tip of the fatigue crack is shown in Figure 87. Both rounded and sharp tip cracks were noted indicating corrosion and stress corrosion as operating modes.

FIGURE 87. MICROSTRUCTURE AT TIP OF FATIGUE CRACK OF 7039-T64 PLATE, WELD + STA TEMPER, THAT FAILED DURING STEP LOAD SCC TESTING.
