AN INVESTIGATION OF ADD-ON DAMPING TREATMENT FOR LIFE EXTENSION
OF THE F-15 UPPER OUTER WING SKIN

M. Parin, V. Levraea, A. Pacia, and L. Rogers

Flight Dynamics Directorate
Wright Laboratory
Wright-Patterson AFB, OH

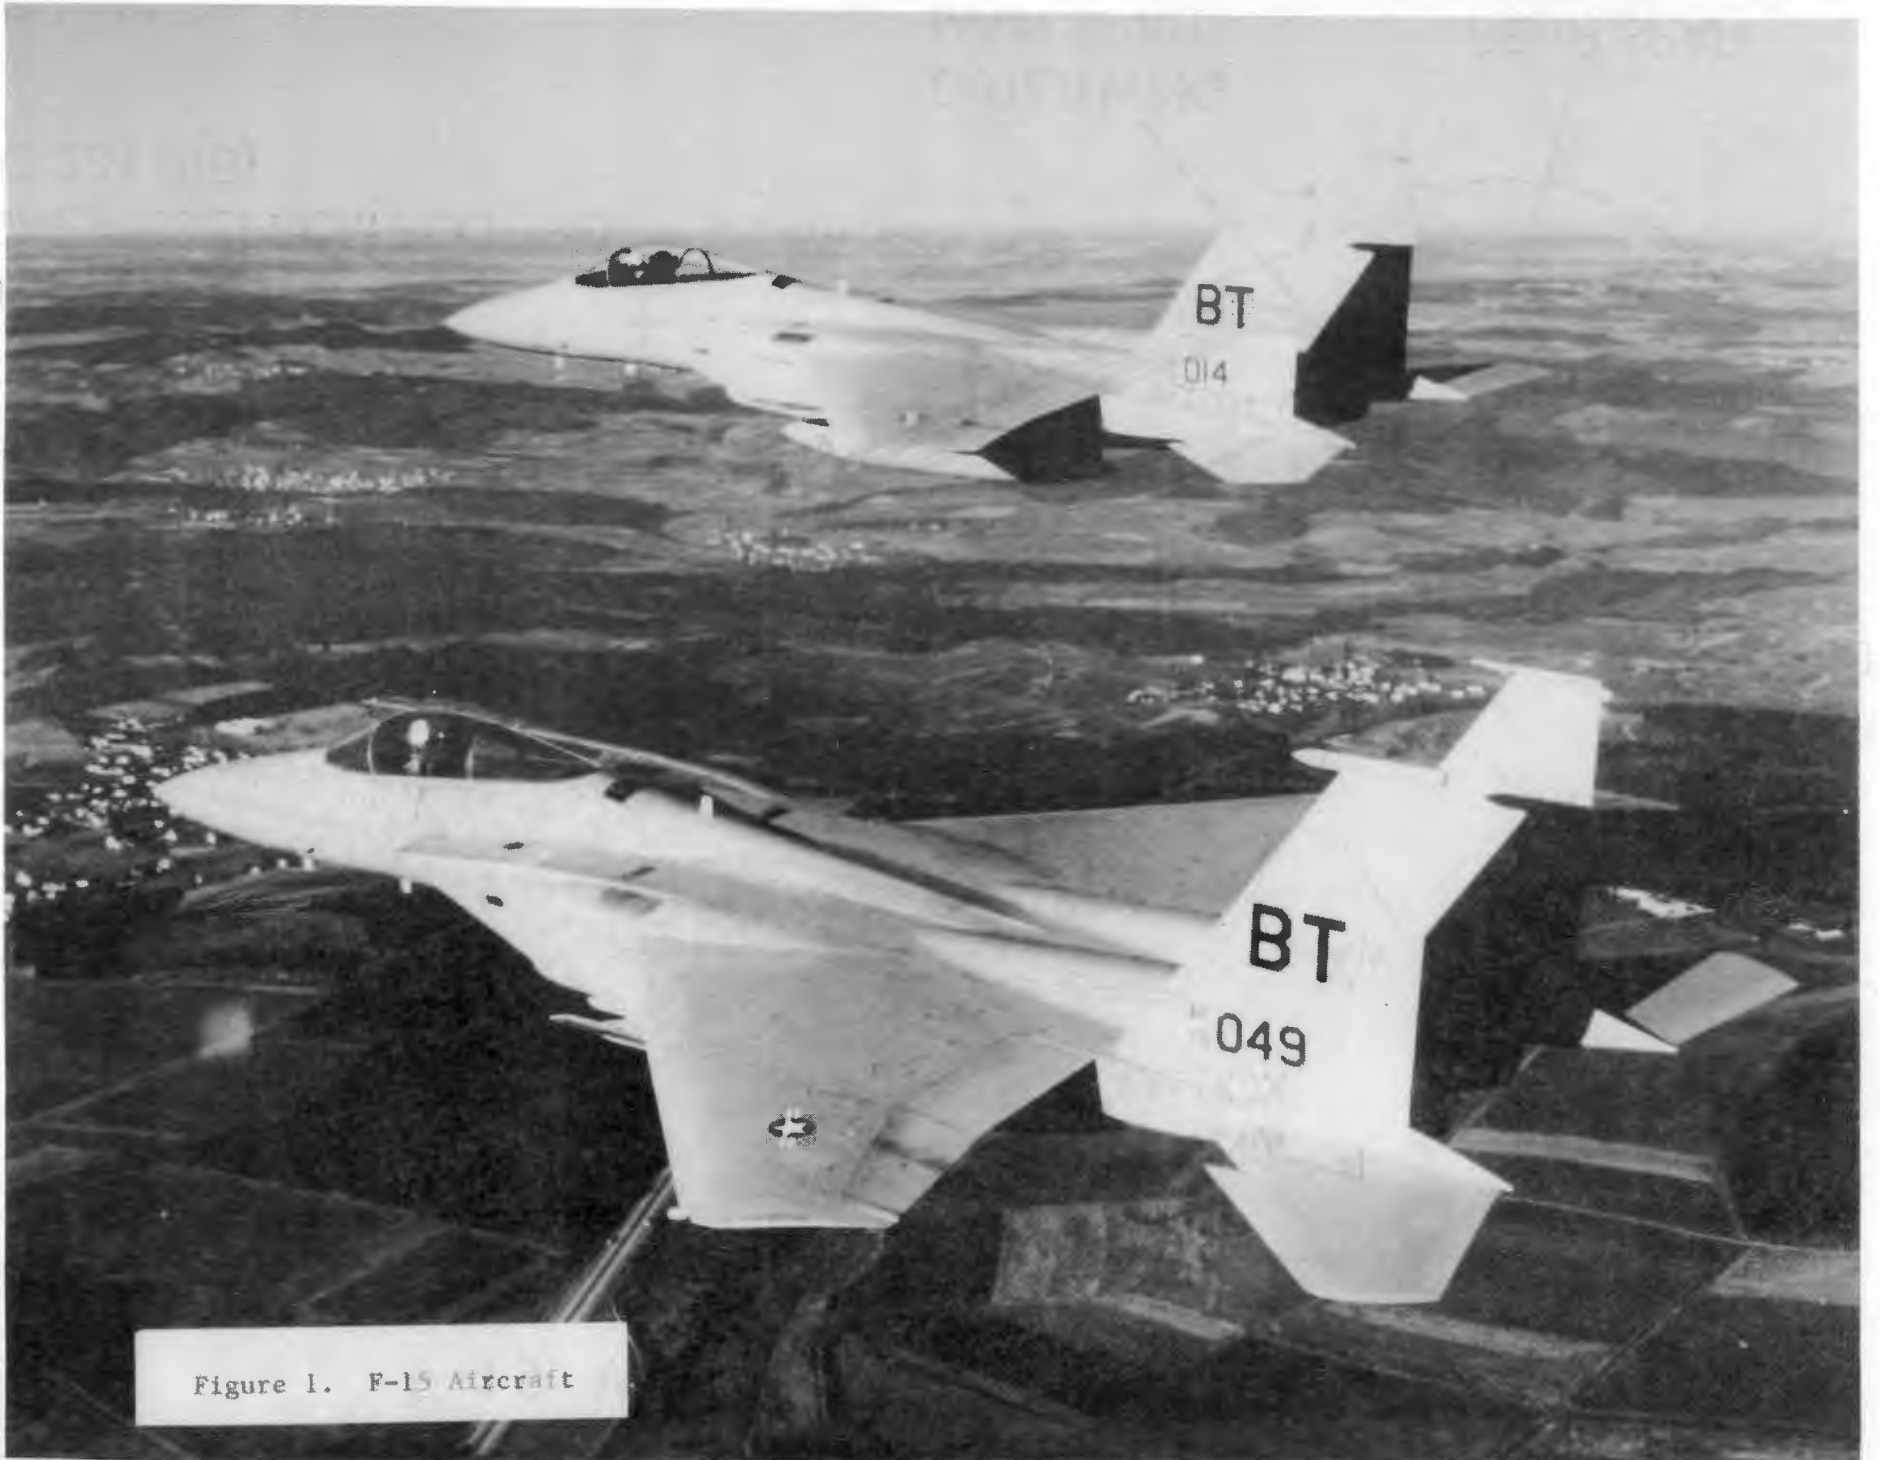
Figure 1. F-15 Aircraft

The F-15 upper-outer wing skin (UOWS) panel has experienced cracks resulting from high cycle fatigue. The F-15 aircraft, shown in Figure 1, has sufficient thrust to perform sustained, high load factor maneuvers. Consequent separated flow over the wing panel contains high-level broad band random pressure fluctuations and induces large vibratory response in the UOWS panel and associated wing substructure. The resulting elevated stresses over time cause high cycle fatigue cracks to form in the wing skin. Historically, UOWS cracking dates to the late 1970's and early 1980's. At that time, the cracks were considered to occur only over a small portion of the skin closest to the wing tip. Subsequent findings show that the entire UOWS is prone to cracking.

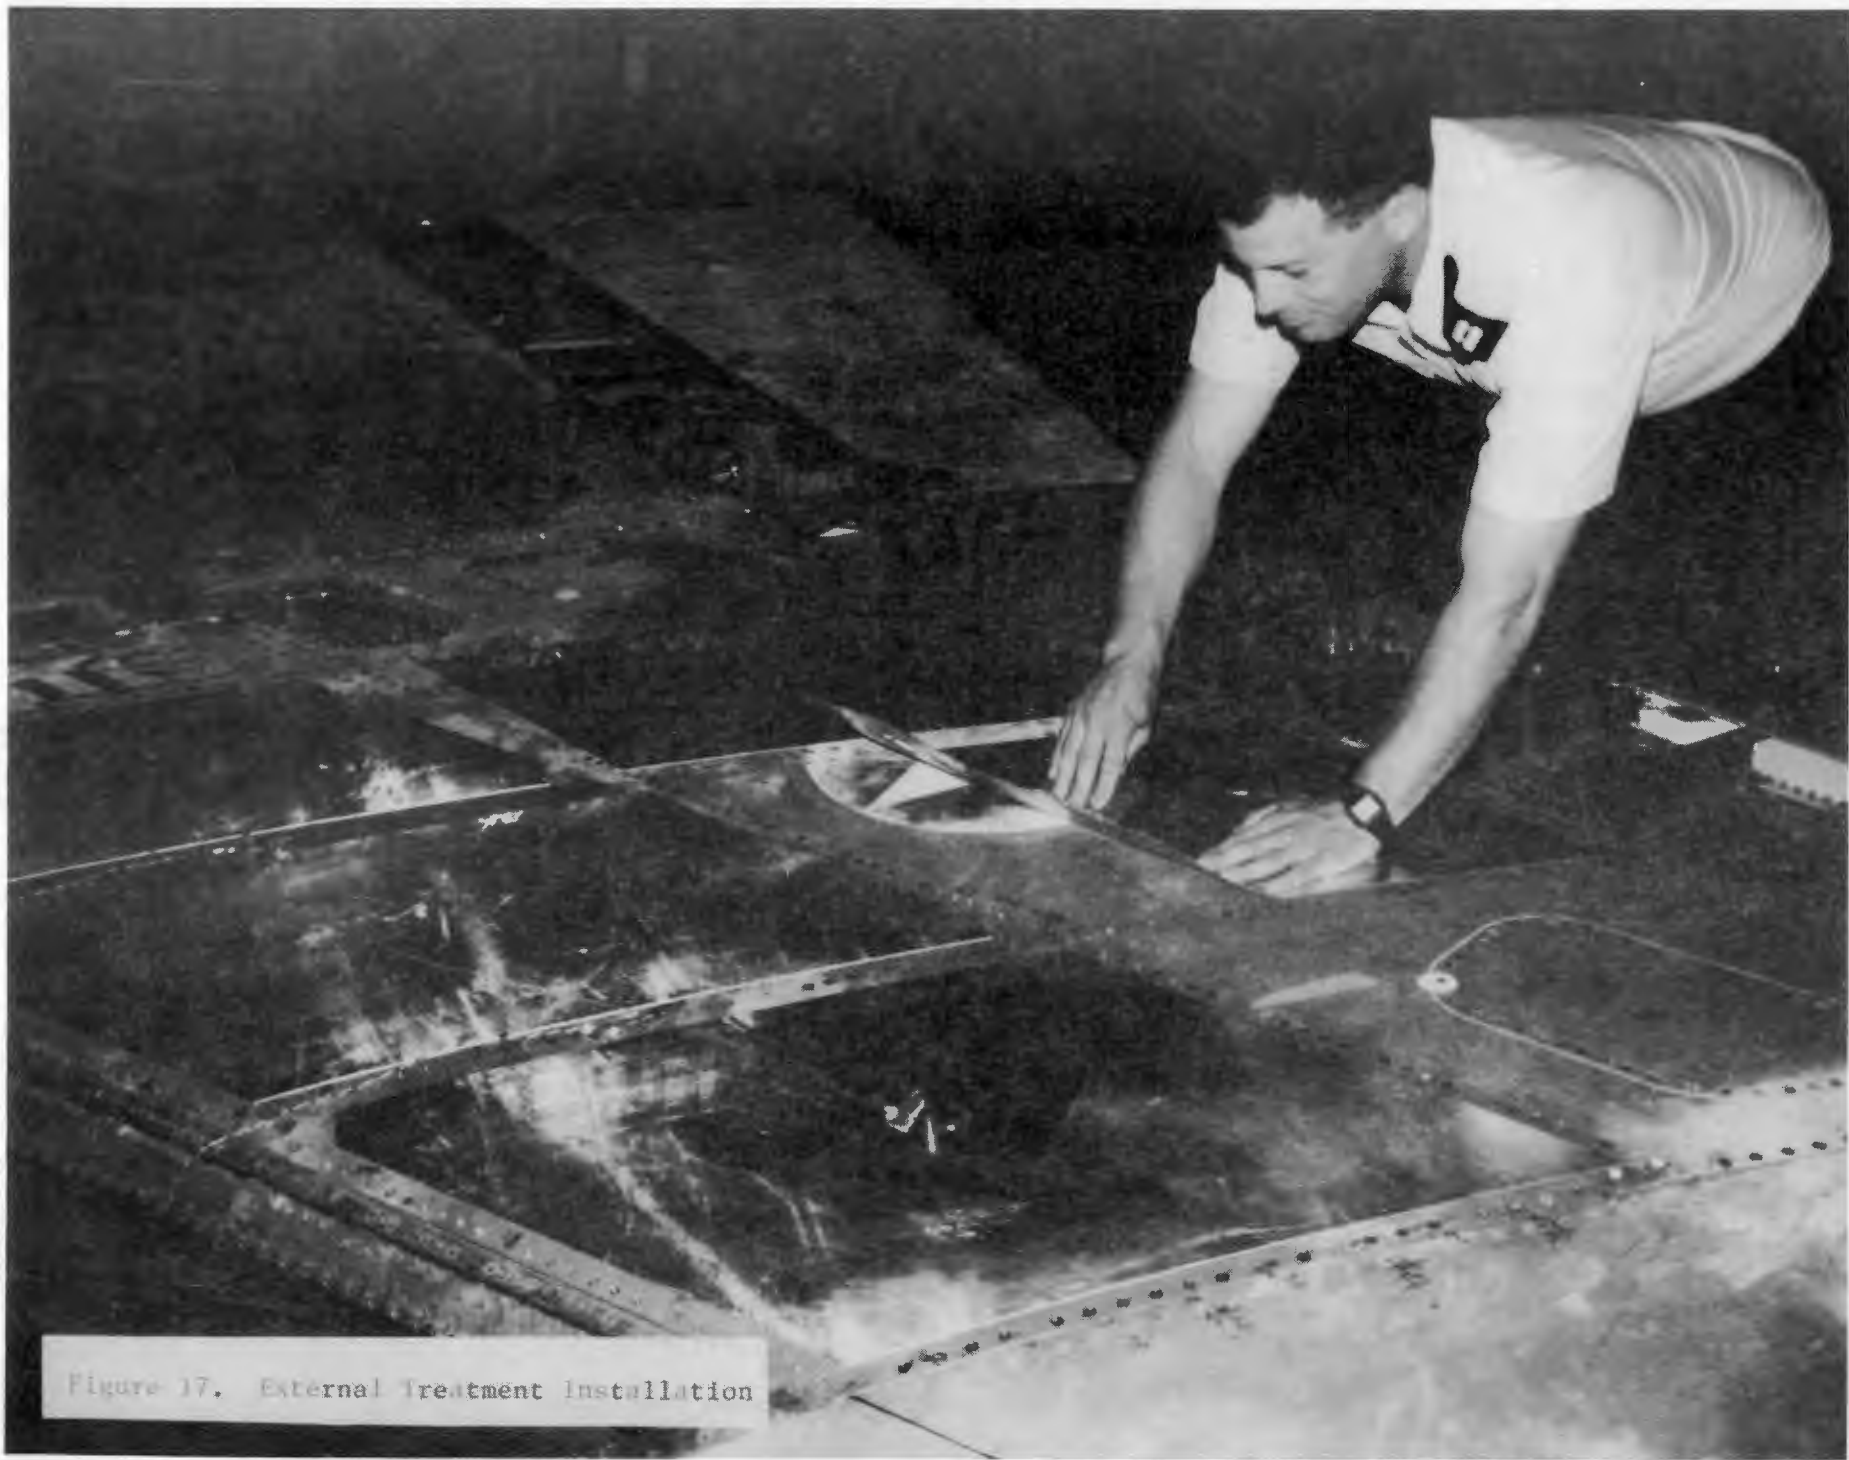
Figure 17. External Treatment Installation

The installation of the damping treatments was simple and straight forward. First the UOWS was cleaned to remove all oil and dirt. Next, the external damping treatment was pre-cut to fit between the fastener rows for each spar-rib bay. The treatment was cut to insure that access to the fasteners was not impaired. A small amount of split peel ply or release paper was removed from the bottom of the damping treatment, exposing the first layer of VEM. The damping treatment was then carefully centered onto the appropriate spar-rib bay. Finally, the procedure was to gradually remove the release paper from under the damping treatment while simultaneously adhering the treatment. Special care was necessary to minimize entrapped air bubbles. A small, flat plastic scraper was rubbed over the surface of the external treatment as it was applied to squeegee out as much air as possible. This step is illustrated in Figure 17. A nice feature of the external damping treatment was that small amounts of compound curvature could be accommodated without
