**AIRCRAFT GROUND-FLOTATION INVESTIGATION**  
**PART X — DATA REPORT ON TEST SECTION 9**

*W. BRABSTON and W. HILL, JR.*

Tests on Section 9 are one phase of a comprehensive research program to develop ground-flotation criteria for heavy cargo-type aircraft. Section 9 consisted of two similar lanes, lanes 21 and 22, each of which was divided into three items (figure 15). Each item was constructed to a different subgrade CBR value and had a different traffic surface. Item 1 was surfaced with modified T11 aluminum landing mat, item 2 with M8 steel landing mat, and item 3 remained unsurfaced.

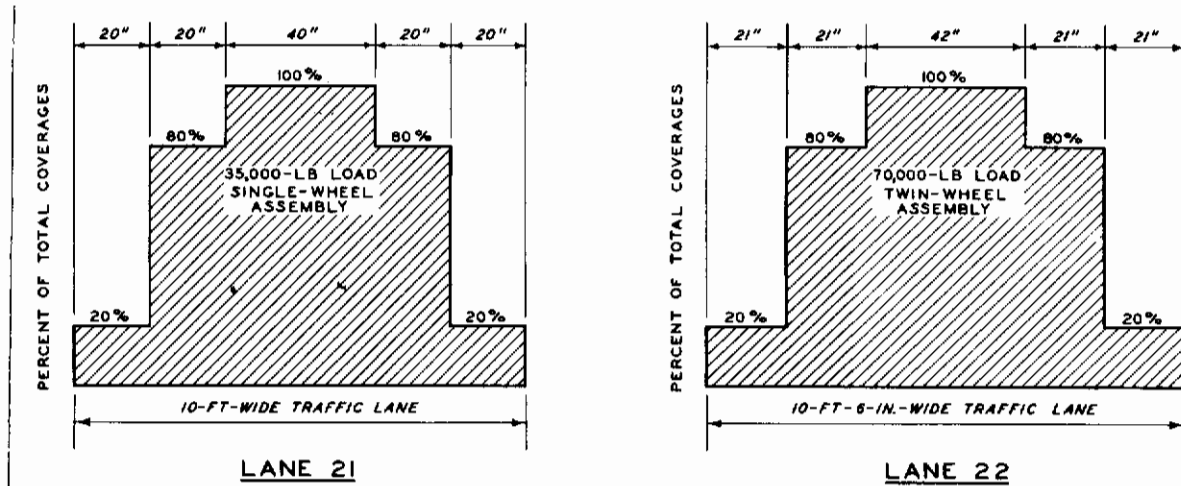
Figure 1. Traffic distribution patterns, Test Section 9

Traffic was applied to the test lanes in a nonuniform pattern with intensity of traffic being varied within each lane to produce three zones of approximately 100, 80, and 20 percent traffic coverage. Traffic so distributed within a traffic lane simulates as nearly as possible the bell-shaped traffic distribution curve which results from the wander of aircraft from the lane center line. The coverage levels referred to in the tables and text herein are the total number of coverages applied to the 100 percent coverage zone. The corresponding number of coverages applied to the outer traffic zones is proportional to the percentage factor for the respective zones as shown in figure 1.

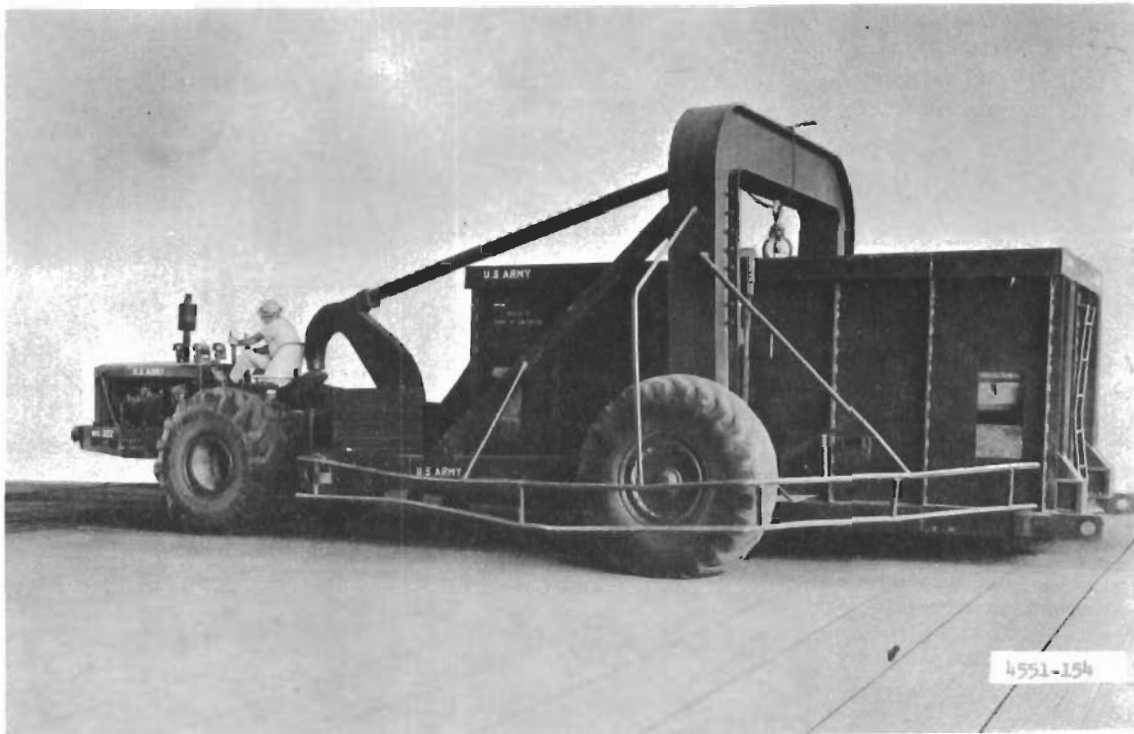
Figure 2. Test load vehicle

The load vehicle is shown in figure 2. Load cart construction, details of linkage between the load compartment and prime mover, and method of applying load are explained in Part I. A 35,000-lb load on a single-wheel assembly and a 70,000-lb load on a twin-wheel assembly were used for trafficking lanes 21 and 22, respectively. Wheel spacing was 42 in. c-c on the twin-wheel assembly. Tires used on both assemblies were 25.00-28, 30 ply with inflation pressure of 50 psi. Tire-print dimensions and tire characteristics are shown in figure 17.

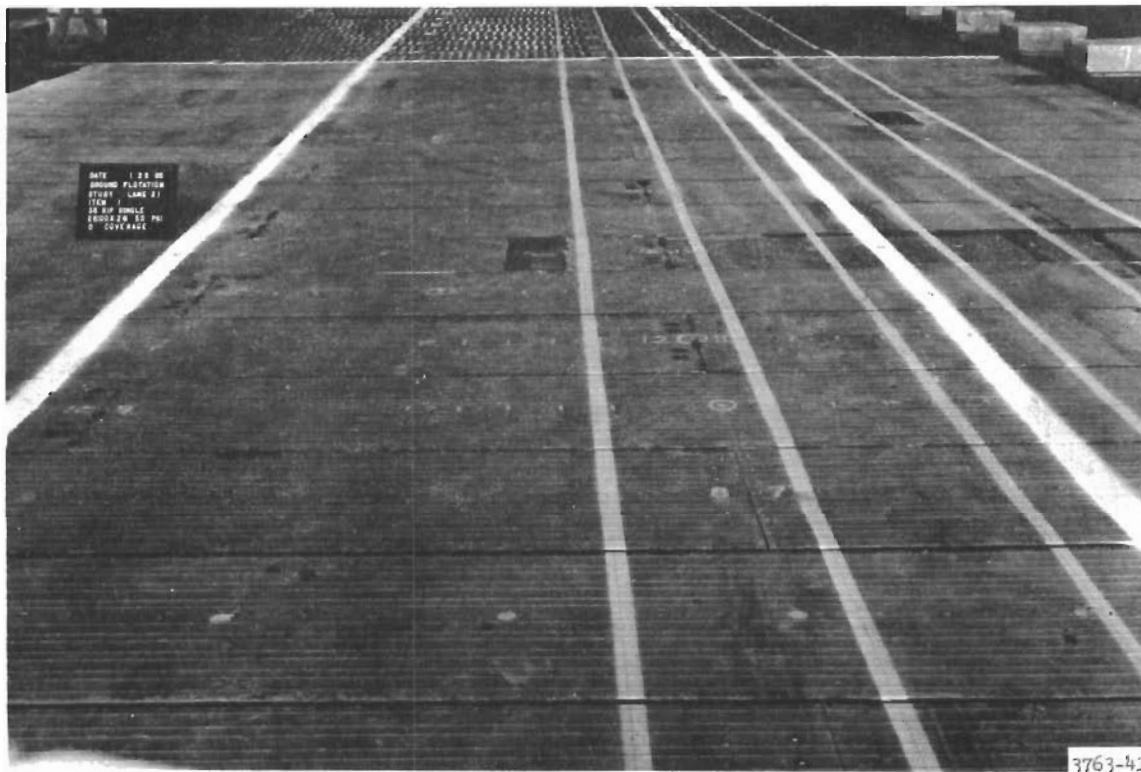
Figure 3. Lane 21, item 1, prior to traffic

Item 1. Figure 3 shows item 1 prior to traffic. The item sustained 600 traffic coverages without developing appreciable roughness or mat breakage. Traffic was suspended at 600 coverages with the item surface remaining in good condition (figure 4). The rated CBR of the item was 1.5.

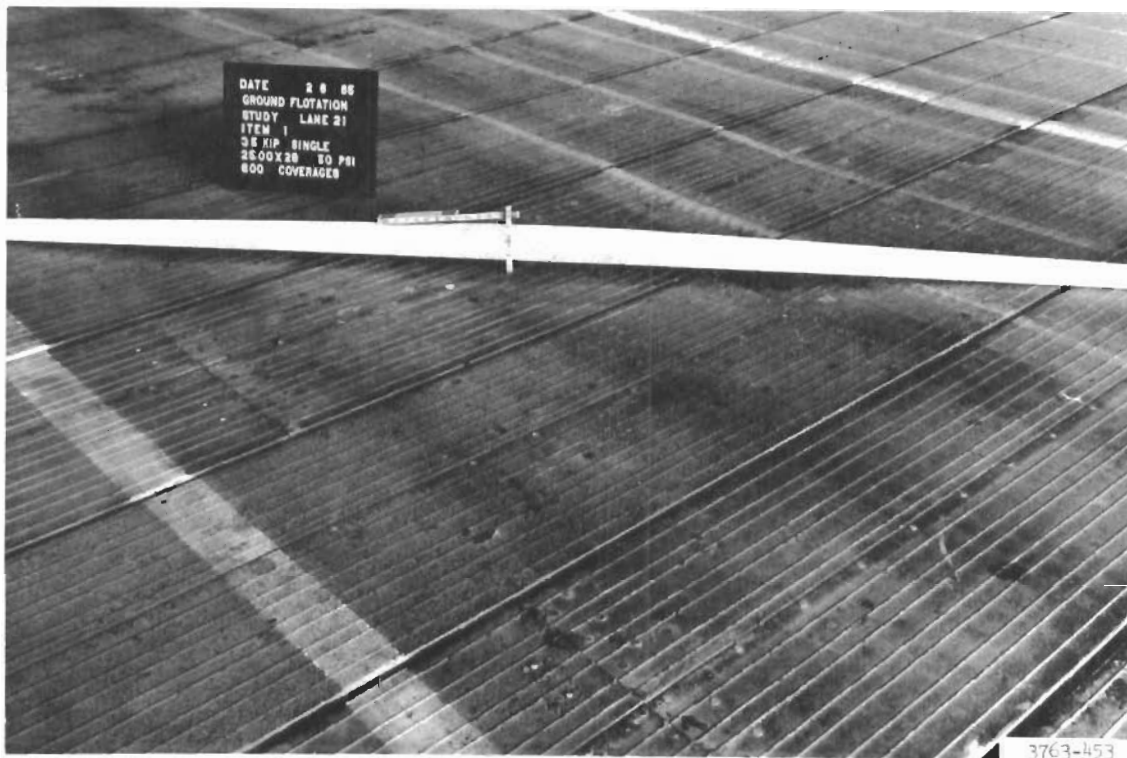
Figure 4. Lane 21, item 1. Diagonal straightedge shows small deformations existing at 600 coverages (traffic suspended)

- a. Roughness. Differential deformations that developed with trafficking are recorded in table 1. At 600 coverages (suspension of traffic), the item was still in good condition with average transverse and diagonal differential deformations of 0.97 and 1.10 in., respectively. Average dishing measurement (table 1) was 0.50 in.

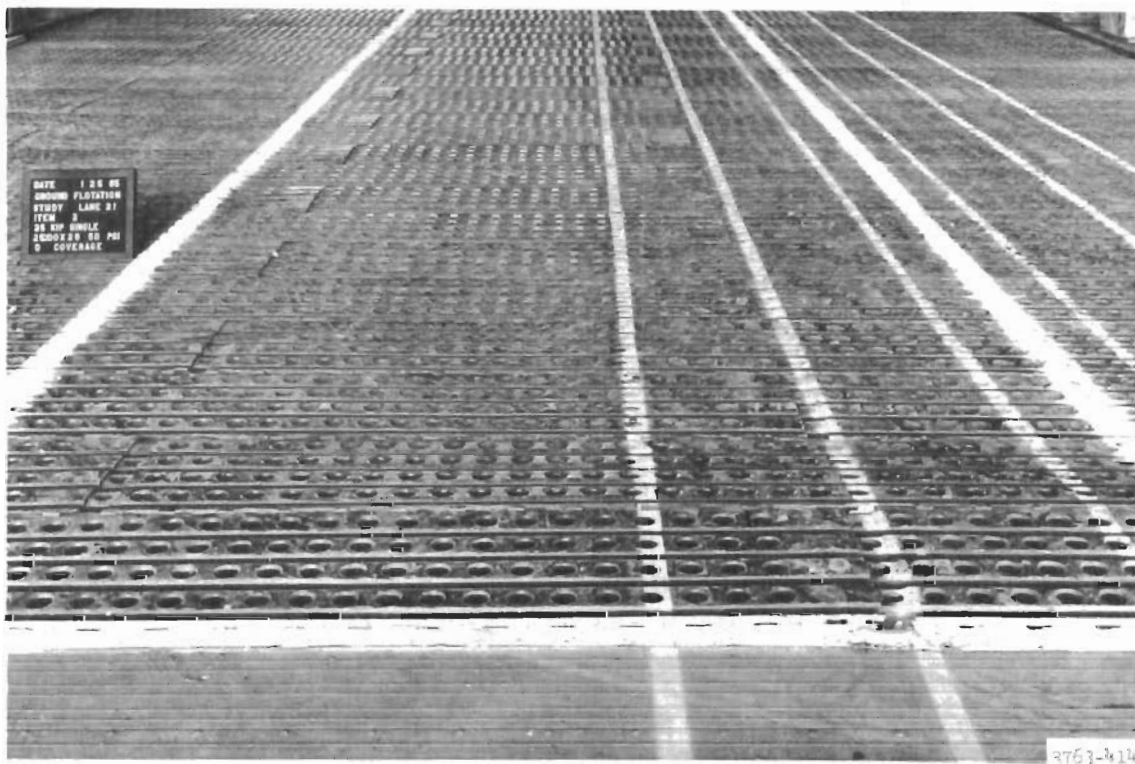
Figure 5. Lane 21, item 2, prior to traffic

Item 2. Figure 5 shows item 2 prior to traffic. At 20 coverages the item evidenced average transverse and diagonal differential deformations of about 1 in. The item held up well under continued trafficking until 300 coverages when it was considered failed due to roughness (figure 6). The rated CBR for the item was 1.9.

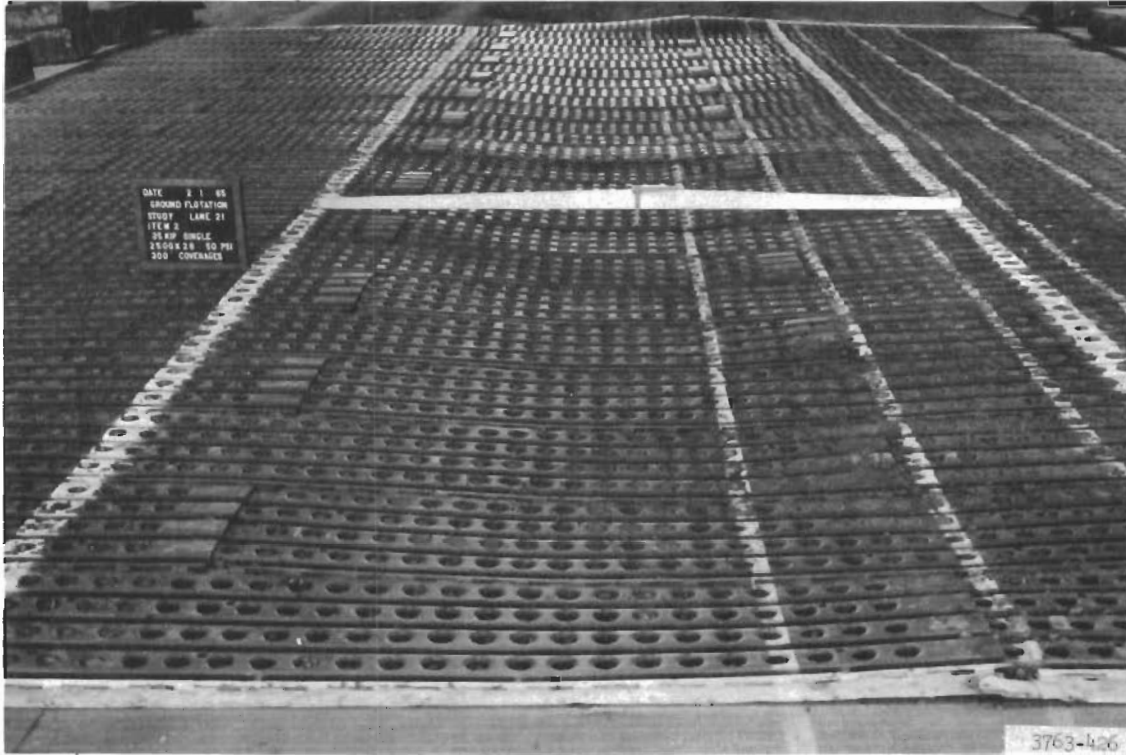
Figure 6. Lane 21, item 2. Transverse straightedge shows roughness at 300 coverages (failure)

a. Roughness. Differential deformations shown in table 1 indicate a steady increase with number of traffic coverages. At failure the average transverse and diagonal differential deformations were 2.97 and 3.03 in., respectively. Dishing measurements were small, averaging 0.19 in. at failure.

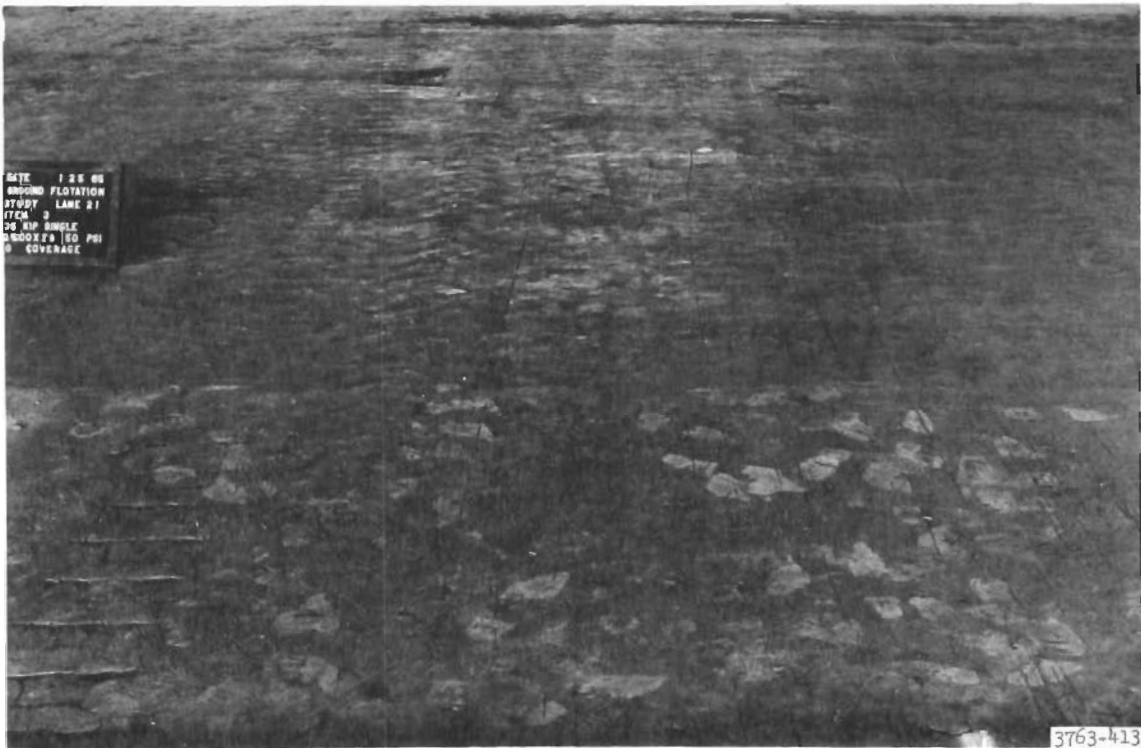
Figure 7. Lane 21, item 3, prior to traffic

Item 3. Figure 7 shows item 3 prior to traffic. The item resisted rutting throughout trafficking. At 300 coverages the item was considered failed due to roughness (figure 8). The rated CBR for the item was 4.7.

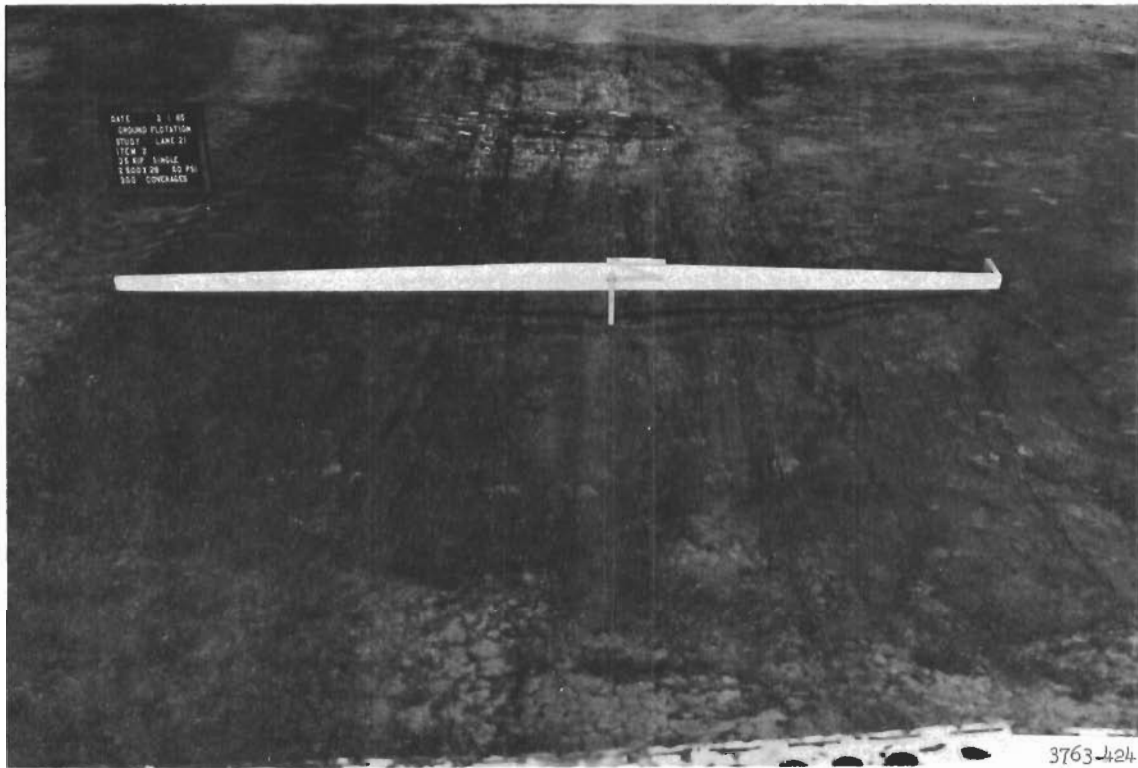
Figure 8. Lane 21, item 3. Transverse straightedge shows roughness at 300 coverages (failure)

a. Roughness. Differential deformations and rut depths measured at intervals throughout trafficking are shown in table 1. Rut depths did not reach serious proportions at any time, but transverse and diagonal differential deformation showed steady increases with trafficking. At 300 coverages both the transverse and diagonal differential deformations averaged 3.50 in. Average rut depth was 0.91 in.

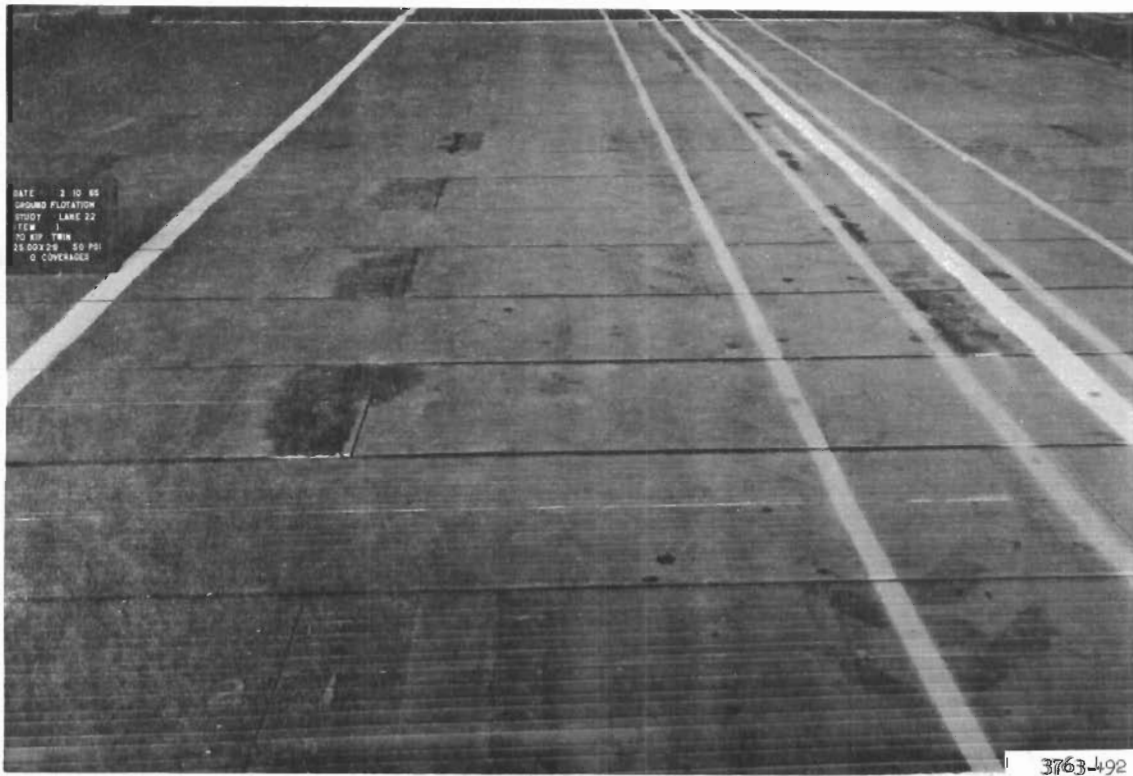
Figure 9. Lane 22, item 1, prior to traffic

Item 1. Figure 9 shows item 1 prior to traffic. The item was considered failed due to roughness at 400 coverages (figure 10). The mat surface was not severely damaged at failure. The rated CBR was 1.8.

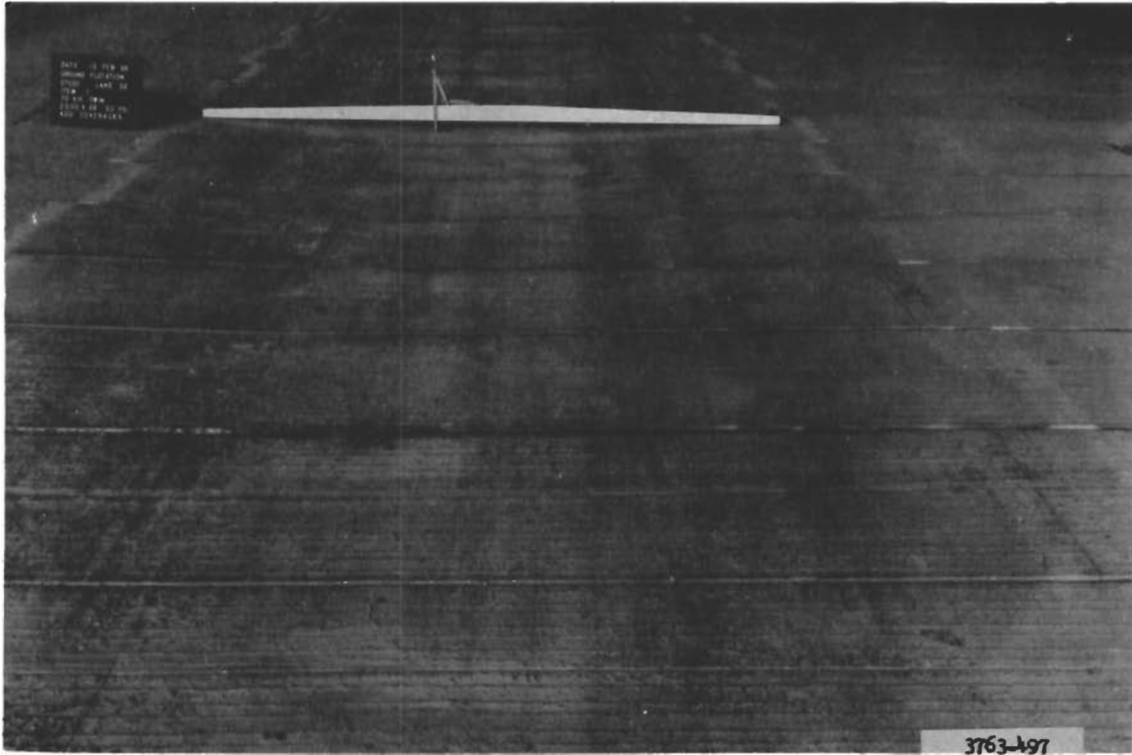
Figure 10. Lane 22, item 1. Transverse straightedge shows roughness at 400 coverages (failure)

- a. Roughness. Differential deformations, shown in table 1, increased steadily with traffic coverages throughout testing. At failure the average transverse and diagonal differential deformations were both 2.63 in. Average longitudinal differential deformation was 1.38 in. Table 1 shows an average dishing measurement of 0.60 in. at failure.

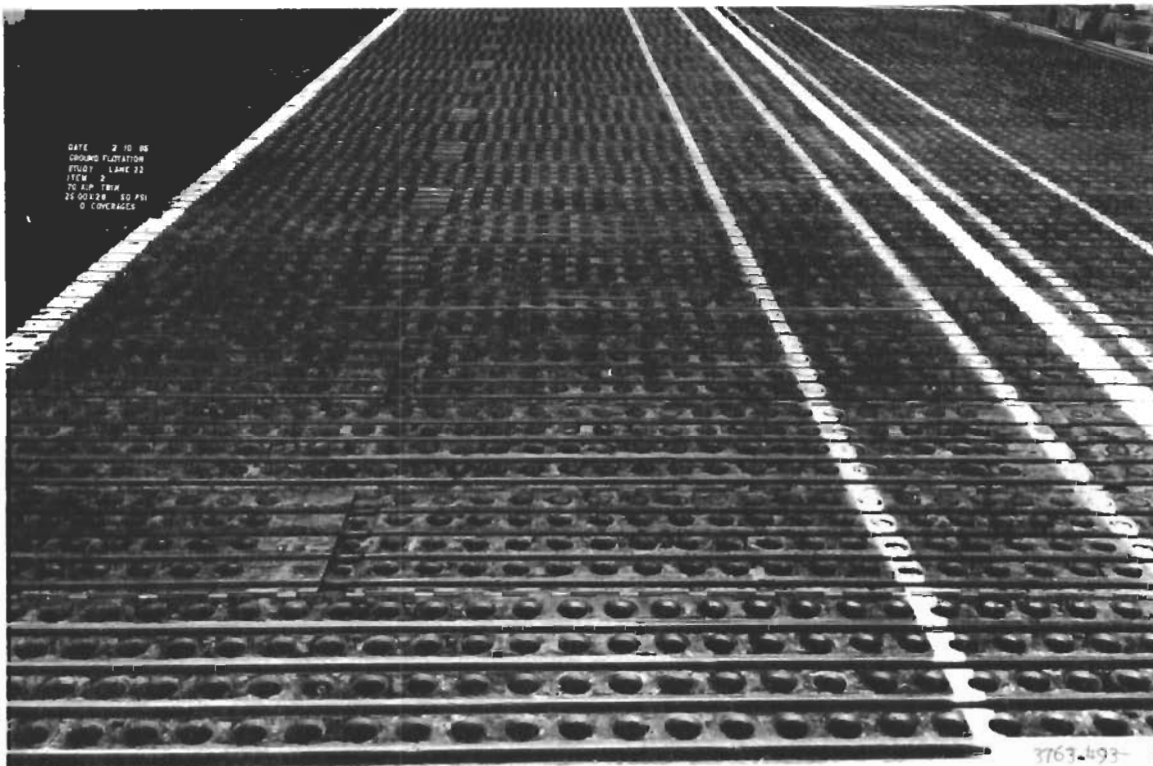
Figure 11. Lane 22, item 2, prior to traffic

Item 2. Figure 11 shows item 2 prior to traffic. The item settled along the center line with trafficking and was considered failed due to roughness at 100 coverages (figure 12). The rated CBR was 1.9.

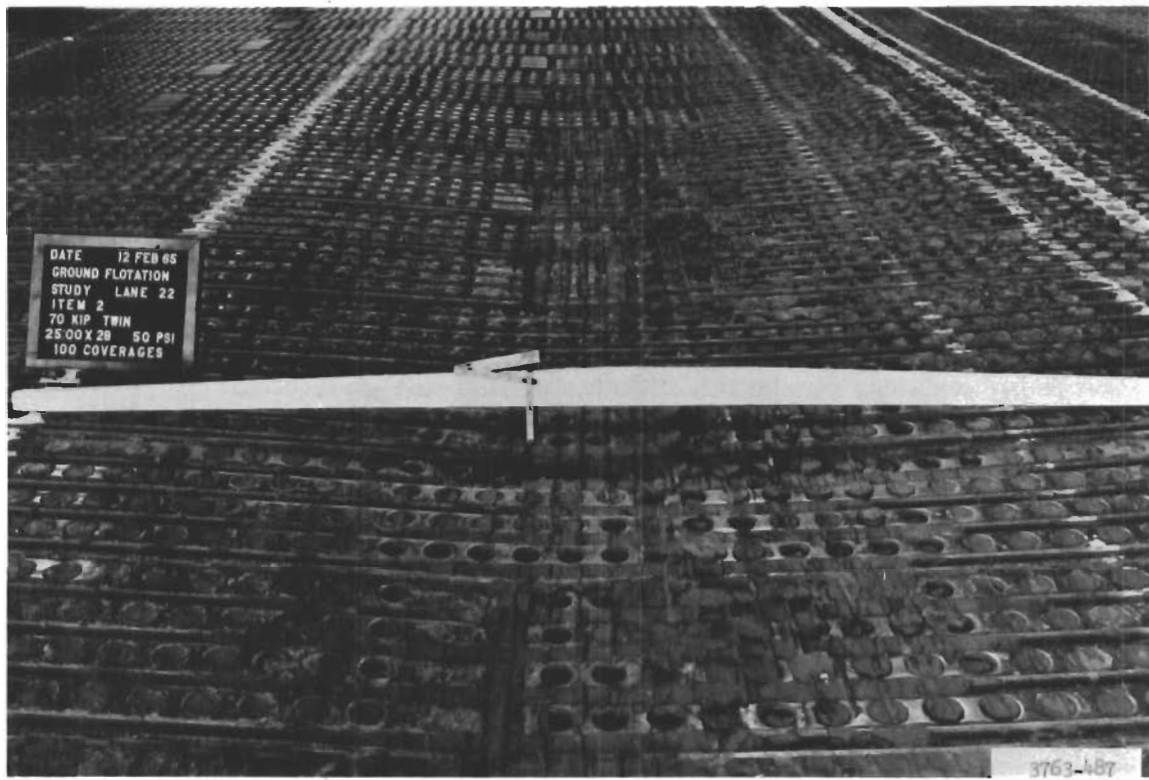
Figure 12. Lane 22, item 2. Transverse straightedge shows roughness at 100 coverages (failure)

- a. Roughness. Differential deformations that developed with trafficking are recorded in table 1. At 100 coverages the average transverse and diagonal differential deformations were 4.19 and 3.88 in., respectively. Dishing of individual mat panels averaged 0.25 in. at 100 coverages.

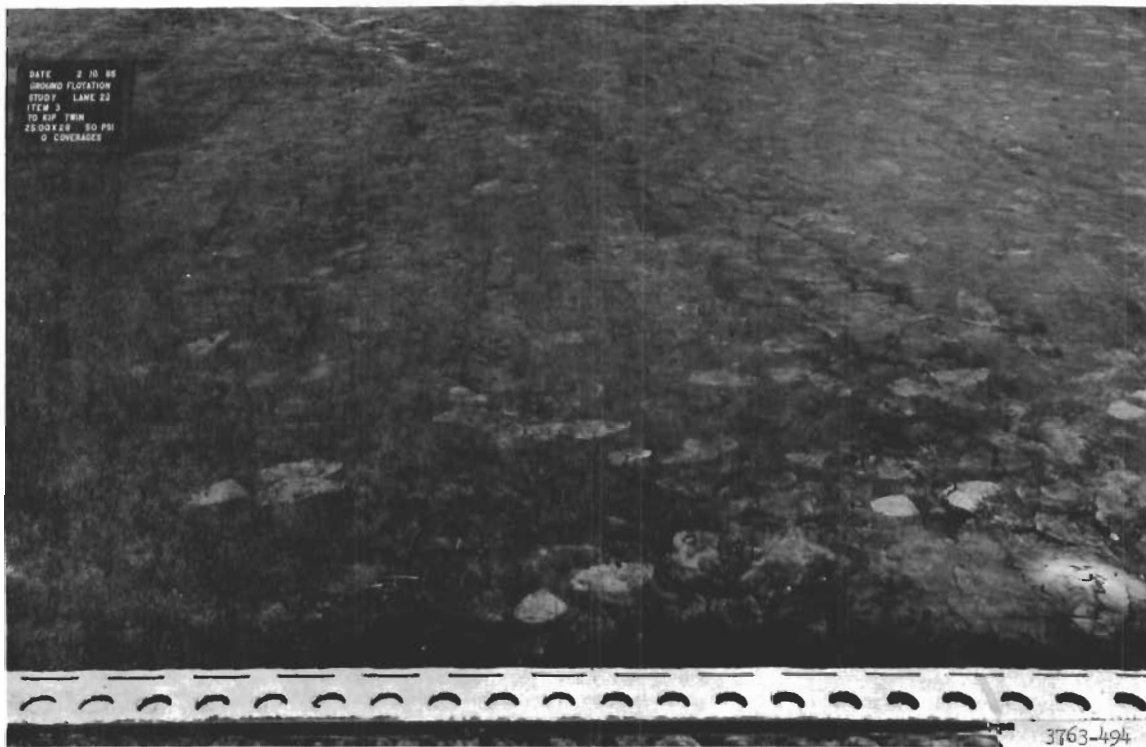
Figure 13. Lane 22, item 3, prior to traffic

Item 3. Figure 13 shows item 3 prior to traffic. The item was considered failed due to roughness at 100 coverages (figure 14). The rated CBR was 4.8.

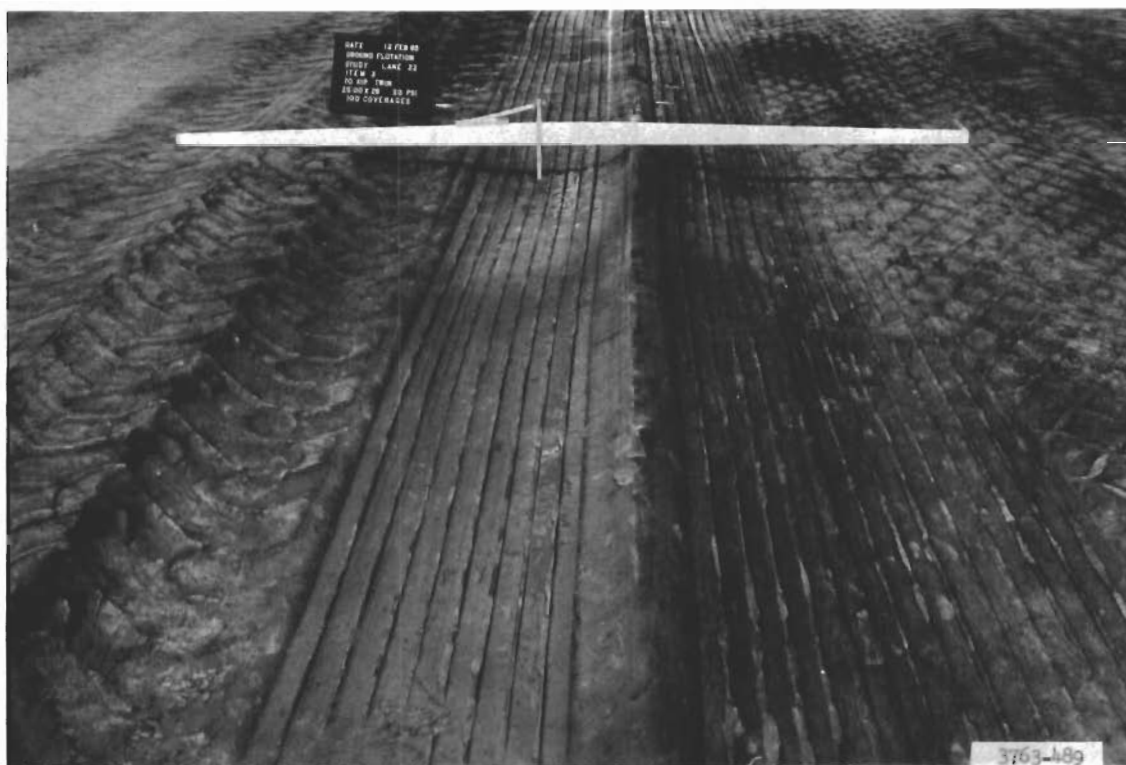
Figure 14. Lane 22, item 3. Transverse straightedge shows roughness at 100 coverages (failure)

- a. Roughness. Differential deformations and rut depths measured at intervals throughout trafficking are shown in table 1. Transverse and diagonal differential deformations were most severe with average readings of 4.07 and 4.10 in., respectively, at 100 coverages. Rut depths averaged 3.62 in. at 100 coverages.

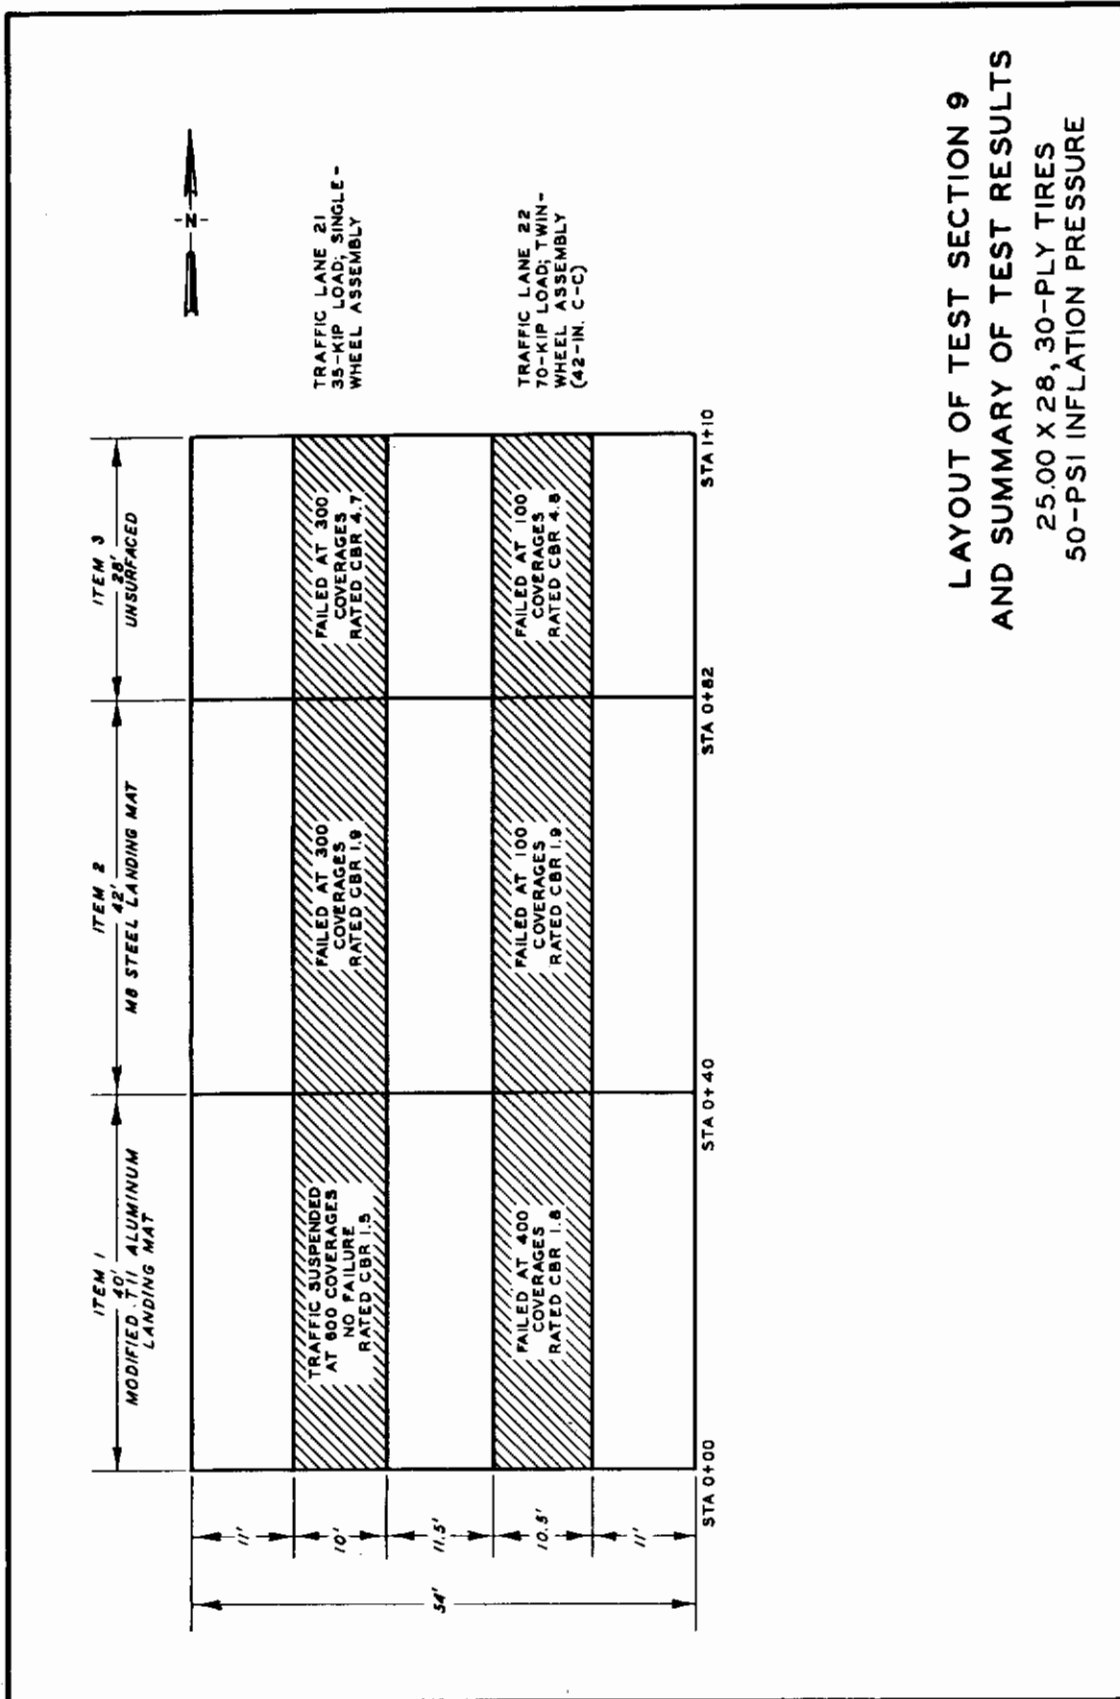
Figure 15

The test section (figure 15) was located within a roofed area in order to allow control of the subgrade CBR (California Bearing Ratio) in the test items. Section 9 was located on the same site as prior Test Sections 6, 4, and 2. The construction of Test Section 2 is described in Part III. The underlying subgrade was undisturbed by prior tests on the site so that in construction of Test Section 9 only the upper 24 in. of soil was excavated. The excavated area was backfilled to the original grade level in compacted lifts with a heavy clay soil (buckshot; classified as CH according to the Unified Soil Classification System, MIL-STD-619). Gradation and classification data for the subgrade material are given in Part I.

LAYOUT OF TEST SECTION 9  
AND SUMMARY OF TEST RESULTS  
25.00 X 28, 30-PLY TIRES  
50-PSI INFLATION PRESSURE

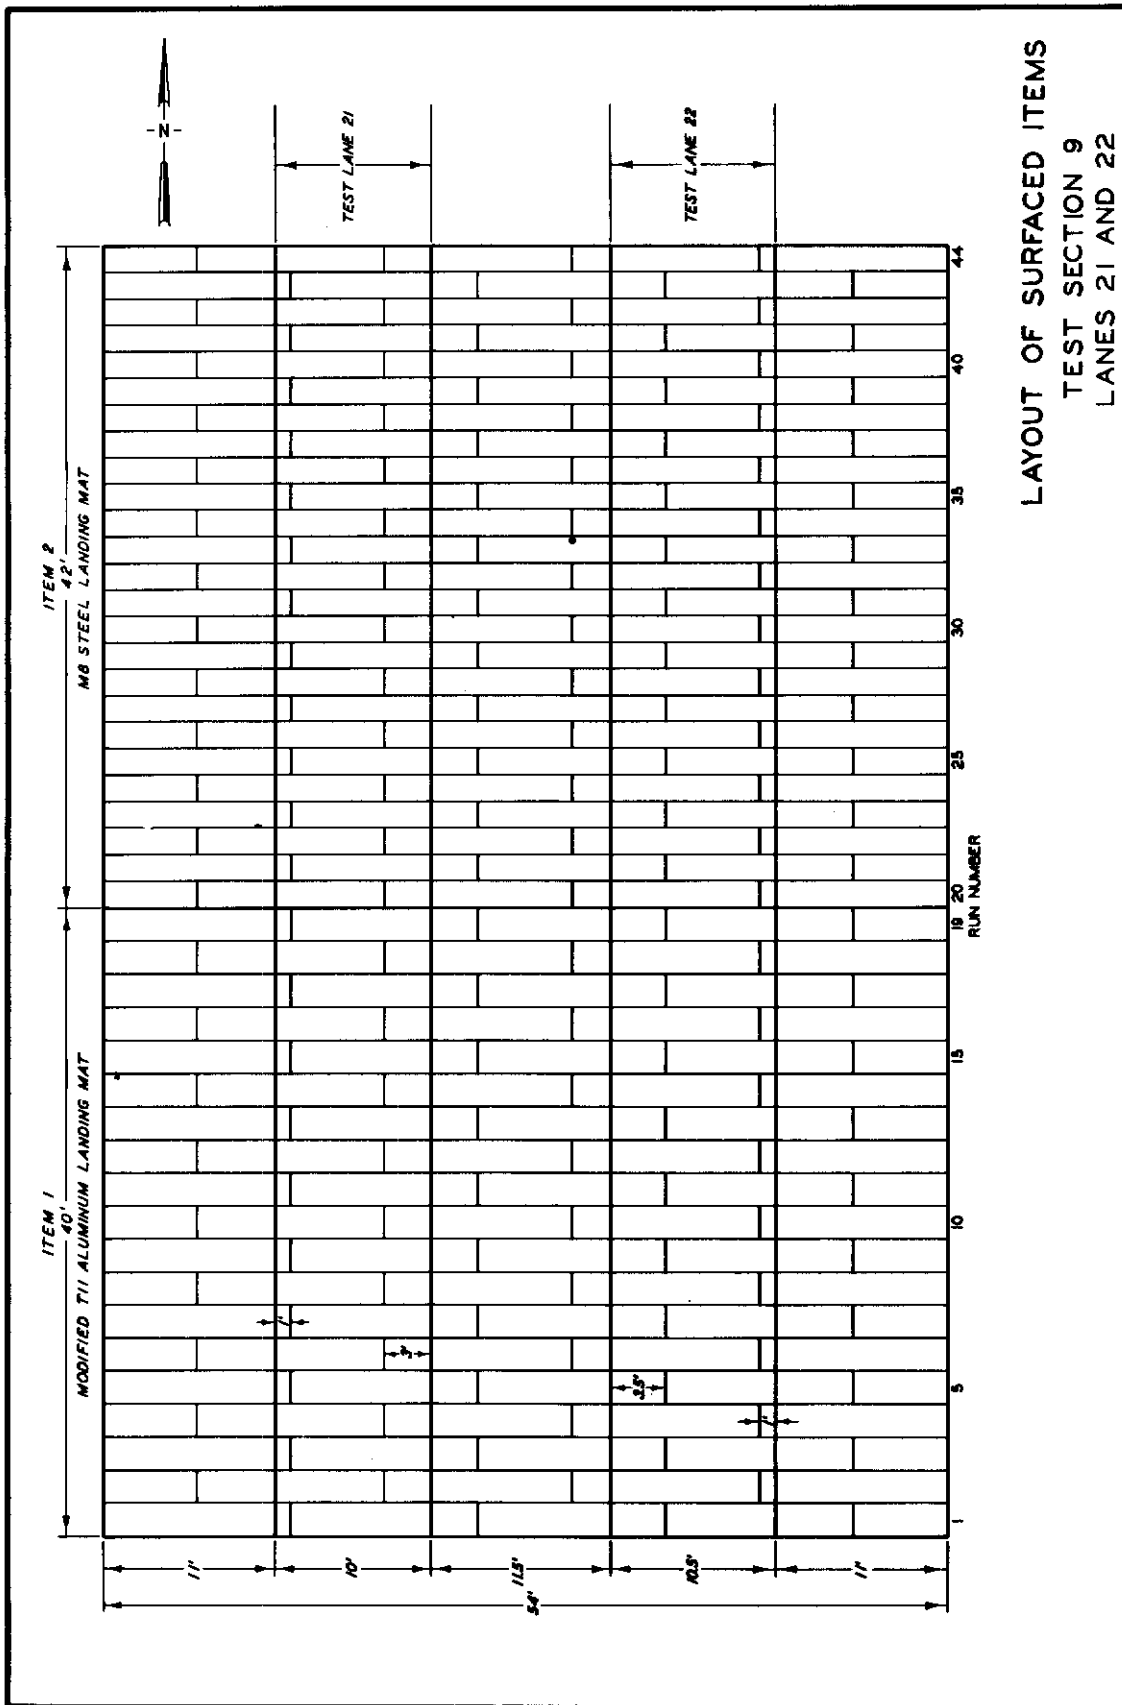
Figure 16

Two traffic lanes divided into three items each were constructed in the test section. Different subgrade strengths were obtained in the items by controlling water content and compaction effort (figure 15). Items 1 and 2 were surfaced with modified T11 aluminum landing mat and M8 steel landing mat, respectively (figure 16), and item 3 remained un-surfaced. The landing mats used are described and illustrated in Part I.

LAYOUT OF SURFACED ITEMS  
TEST SECTION 9  
LANES 21 AND 22

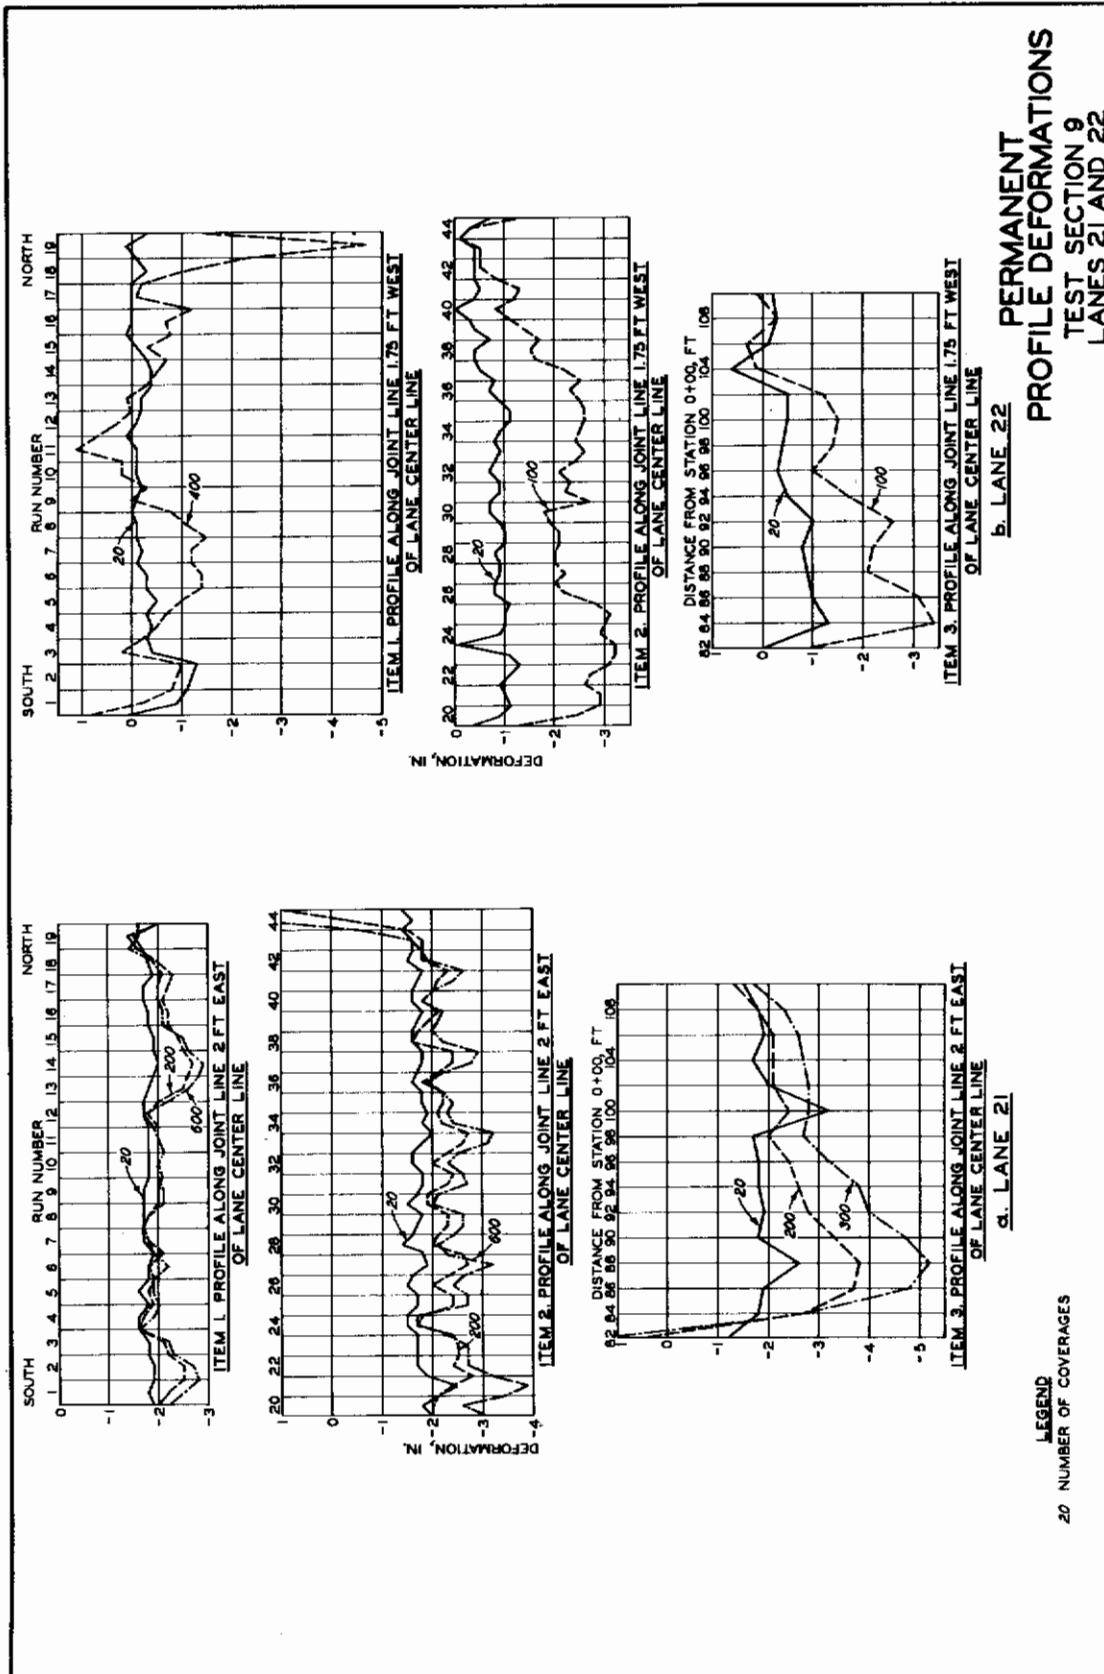
Figure 19

- b. Deformation. Figure 18 shows average cross-section deformations at 20, 200, and 600 coverages for each of two typical mat runs. Cross-section deformations remained small throughout trafficking, although there was considerable general subgrade subsidence. Profile deformations along the mat end-joint line nearest the lane center line are shown in figure 19.

b. Deformation. Figure 18 shows average cross-section deformations at 20, 200, and 300 coverages for each of two typical mat runs. The greatest deformation is seen to occur at the lane center line. Profile deformations along the mat end-joint line nearest the lane center line are shown in figure 19. General subgrade subsidence along the length of the lane is evident as well as surface irregularities in the mat.

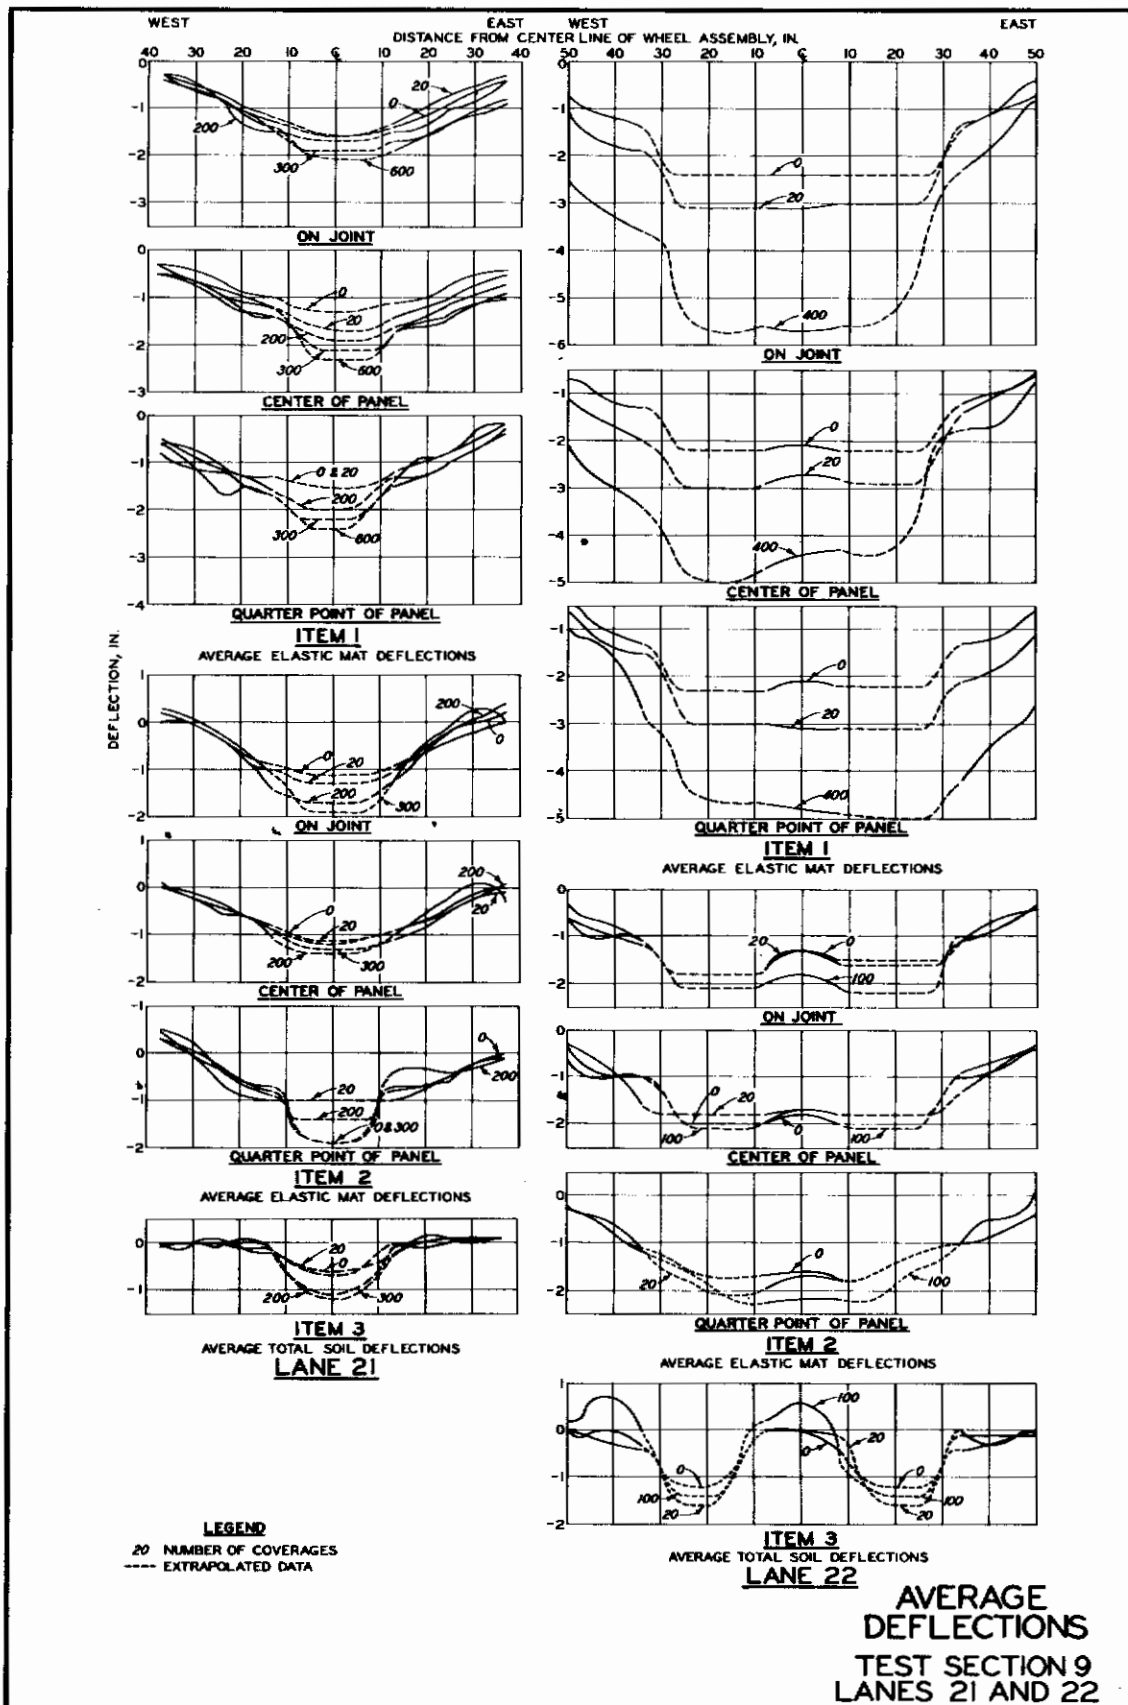
Figure 20

- c. Deflection. Average elastic mat deflections shown in figure 20 for three positions of the wheel assembly relative to mat end joints show a steady increase at measurement intervals ranging from 0 to 600 coverages.

c. Deflection. Average elastic mat deflections are shown in figure 20 for three positions of wheel assembly relative to mat end joints. The increasing magnitude of deflections was consistent with increasing number of coverage levels when the mat joint was at center line of the wheel assembly. Plots shown for other positions of the load wheel on the mat surface indicated variable results with no consistent pattern.

- c. Deflection. Average elastic mat deflections under static load of the load-wheel assembly are shown in figure 20 for three positions of the assembly relative to mat end joints. Deflections measured at 0, 20, and 400 coverages increased steadily throughout testing. Elastic soil deflection at 400 coverages was 1.0 in.

- c. Deflection. Average elastic mat deflections under static load of the load-wheel assembly are shown in figure 20 for three positions of the assembly relative to mat end joints. Elastic subgrade deflections are shown in table 1 for several coverage

- c. Deflection. Average total soil deflections measured at 0, 20, and 100 coverages are shown in figure 20. Total soil deflection was greater at 20 coverages than at 100 coverages. Elastic soil deflections shown in table 1 follow a similar pattern with the maximum value occurring at 20 coverages.
