# **AIRCRAFT GROUND-FLOTATION INVESTIGATION**

## **PART XIV — DATA REPORT ON TEST SECTION 14**

*J. WATKINS and G. HAMMITT II*

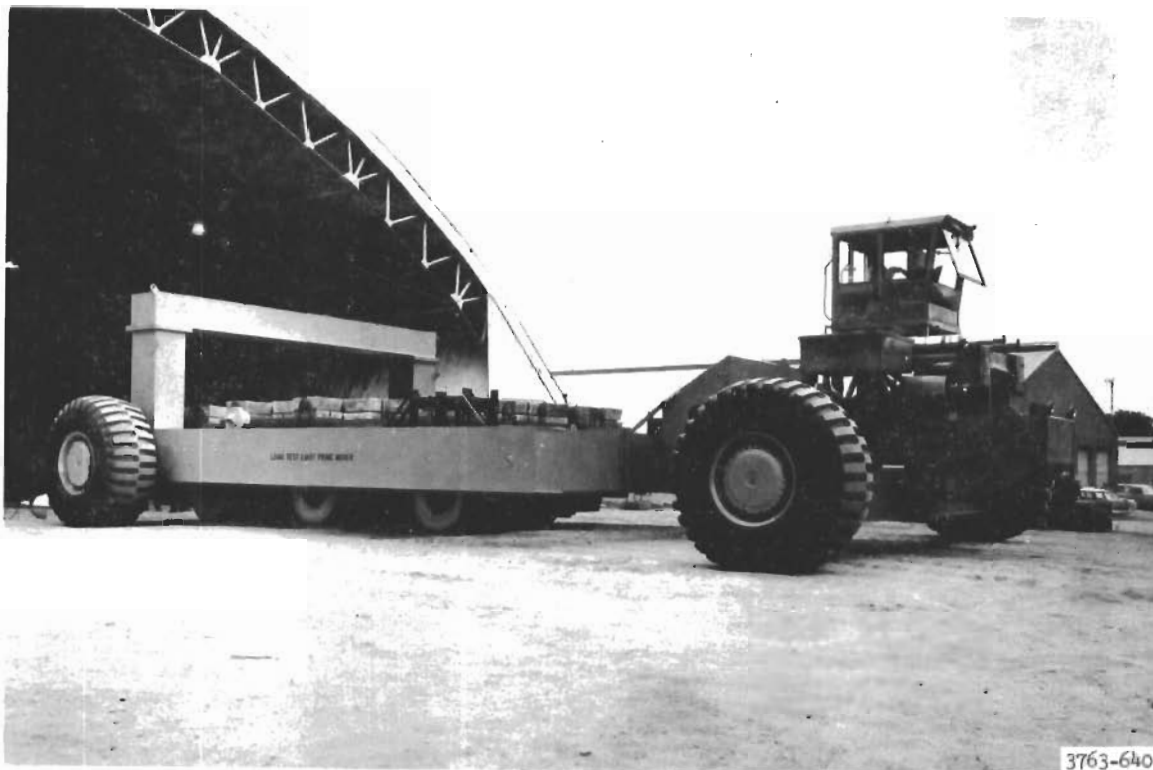
Figure 2. Test load vehicle used in trafficking lane 30

The multiwheel load vehicle used in trafficking lane 30 is shown in figure 2. This vehicle consists of an electrically powered prime mover with three load carts. The load carts are attached to the prime mover by a torsion bar, and to each other by parallel bars that maintain horizontal stability while allowing the load carts to oscillate vertically. The test load was 21,000 lb per wheel (a total load of 252,000 lb). The wheel assembly consisted of twelve 20.00-20, 22-ply aircraft tires inflated to a pressure of 100 psi. Typical tire-contact-area dimensions, overall assembly dimensions, and pertinent tire characteristics are shown in figure 14.

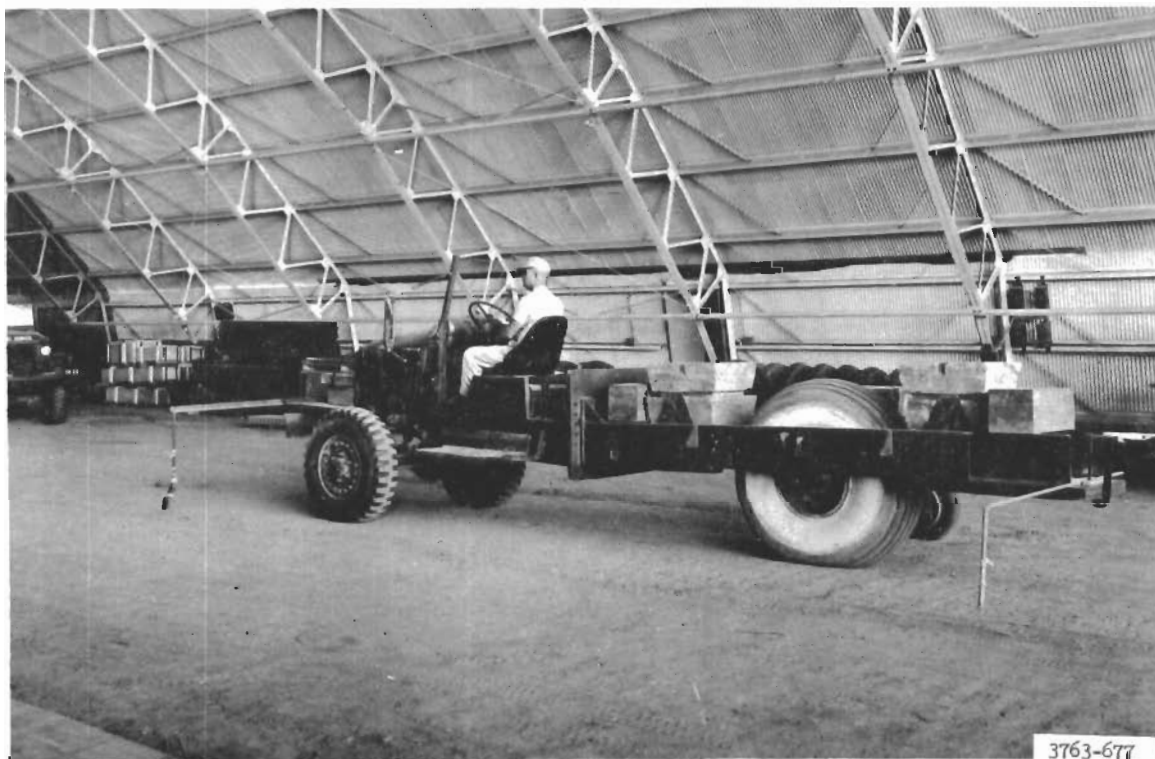
Figure 3. Test load vehicle used in trafficking lane 31

The total test load designated for lane 31 was 21,000 lb. The wheel assembly (figure 3) consisted of a 20.00-20, 22-ply aircraft tire with 100-psi inflation pressure. Tire-print data and pertinent tire characteristics are shown in figure 14.

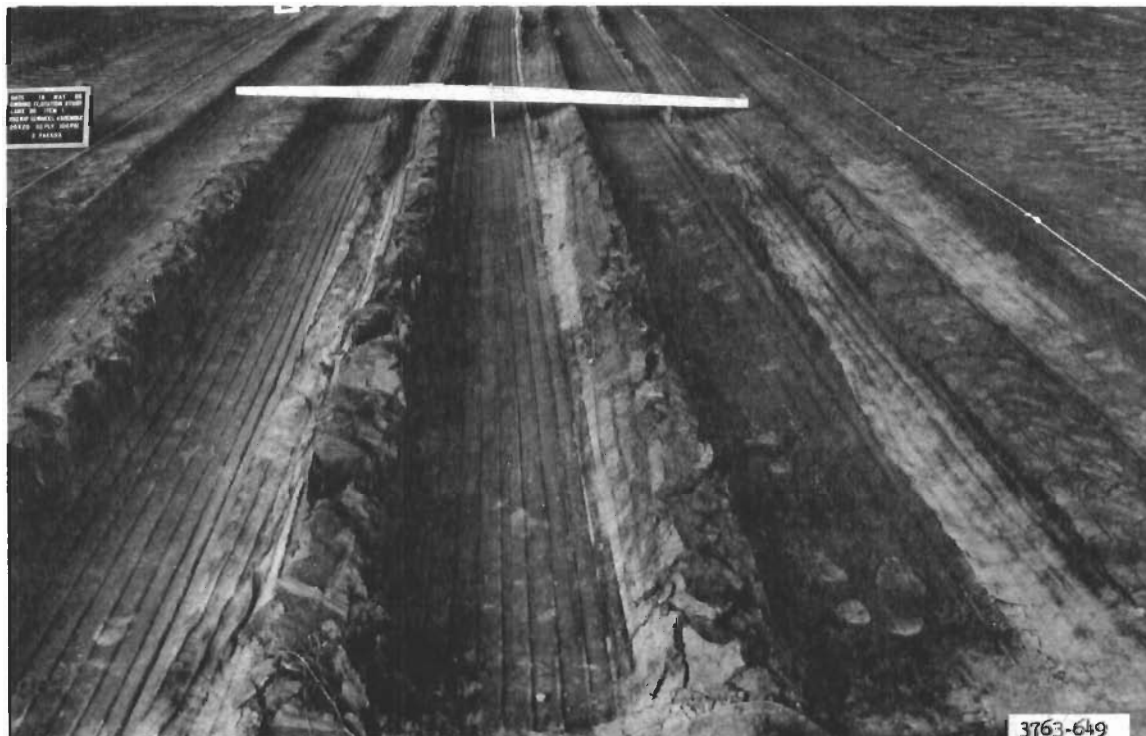
Item 1. Figure 4 shows item 1 prior to traffic. After 2.4 coverages (2 passes) the item was severely rutted and considered failed (figure 5). After failure the item was leveled and surfaced with M9 landing mat in order to continue trafficking the remaining items in the test lane. The rated CBR of the item was 3.8.

Figure 5. Lane 30, item 1. Transverse straightedge shows rutting at 2.4 coverages (2 passes) (failure)

- a. Roughness. Differential deformations and rutting were very severe after 2 passes of the load vehicle (table 1). Average transverse and diagonal differential deformations were 7.87 and 8.72 in., respectively. The average rut depth at failure was 7.85 in.
- b. Deformations. Cross-sectional deformations at 2 passes are shown in figure 15 for four locations along the item. The severity of rutting is evident in the plots with some ridges of soil from 4 to 6 in. high. A profile along the item at 2 passes (figure 17) shows greatest settlement in the first 25 ft of the item.
- c. Deflection. Average total subgrade deflection and average elastic subgrade deflection under a single pass of the load cart were unchanged with traffic, measuring 2.40 in. and 0.50 in., respectively (table 1).
- d. Rolling resistance. Peak and rolling drawbar pull values were

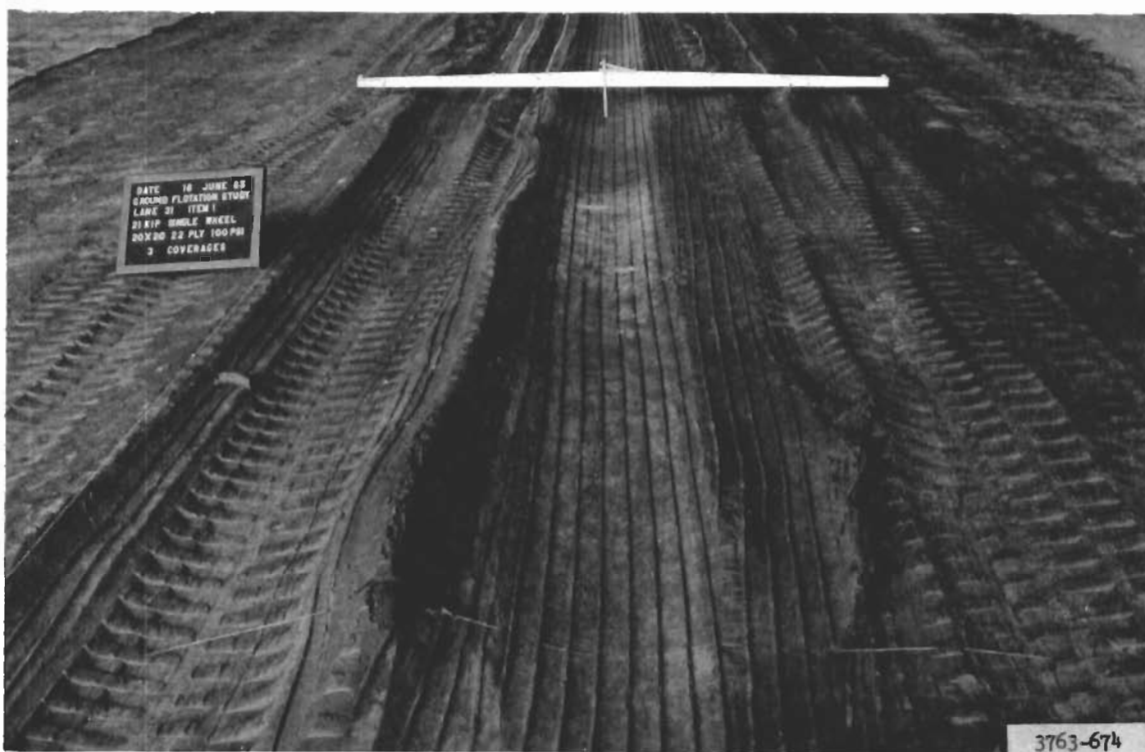
Item 1. Item 1 prior to traffic was similar in appearance to the item shown in figure 4. The item rutted severely under traffic and at 3 coverages was considered failed (figure 10). The rated CBR for the item was 4.2.

Figure 10. Lane 31, item 1. Transverse straightedge shows roughness at 3 coverages (failure)

- a. Roughness. Differential deformations and rutting measurements (table 1) indicate the severe roughness of the item surface at 3 coverages. Average transverse and diagonal differential deformations were 4.90 and 5.10 in., respectively, at failure, while average rut depth was 4.37 in.
- b. Deformations. Cross-section deformations (figure 16) show the severely rutted surface at 3 coverages. Figure 17, showing profile deformations at 3 coverages, further illustrates the general settlement that occurred along the item.
- c. Deflection. Average total and average elastic subgrade deflections under a single pass of the load cart showed decreases with traffic (table 1). Average total deflection was 2.7 in. and 1.2 in. at 0 and 3 coverages, respectively, while average elastic deflection decreased slightly from 0.9 to 0.7 in.

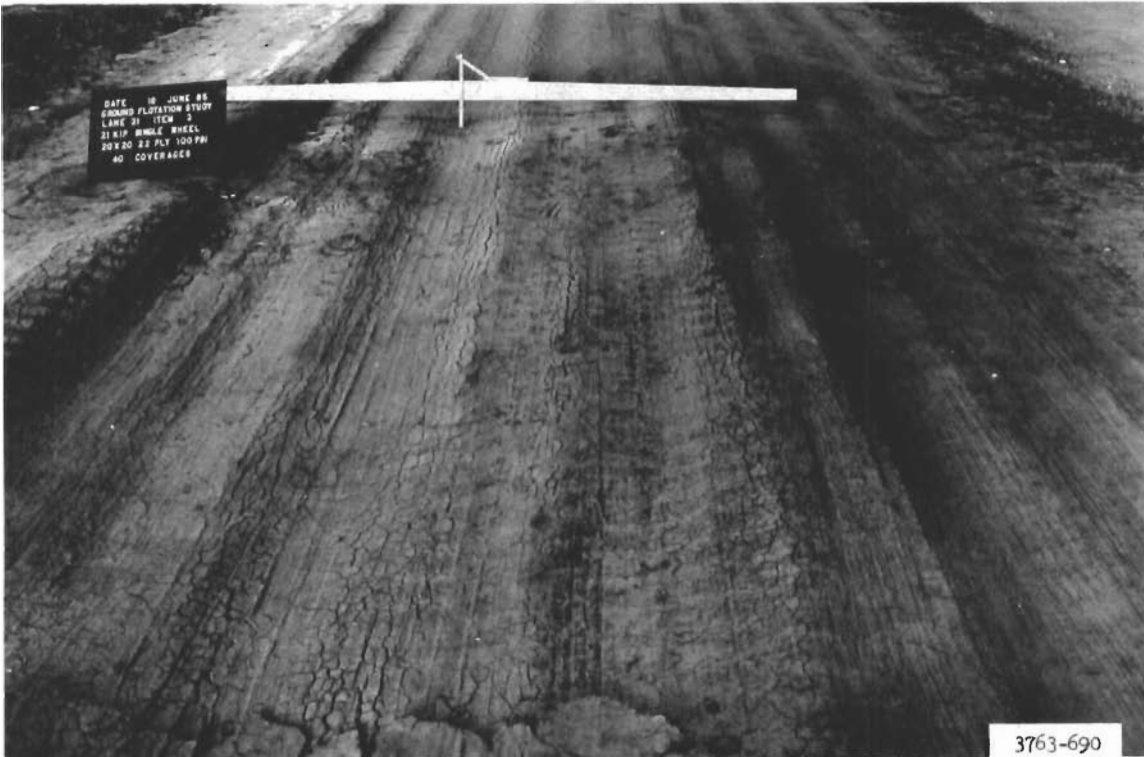
Item 3. Item 3 prior to traffic was similar in appearance to the item shown in figure 8. When data were recorded at 26 coverages, the item surface was considerably rutted and had prominent surface cracks. At 40 coverages the item was considered failed due to roughness (figure 12). The rated CBR for the item was 7.5.

Figure 12. Lane 31, item 3. Transverse straightedge shows roughness at 40 coverages (failure)

- a. Roughness. Differential deformations and rut depths, shown in table 1, increased steadily with traffic. Average transverse and diagonal differential deformations of 5.44 and 4.72 in., respectively, exceeded average rut depth of 2.38 in. at 40 coverages.
