**SONIC FATIGUE TOLERANCE OF GLASS  
FILAMENT STRUCTURE:  
EXPERIMENTAL RESULTS**

*J. A. HAYES*

Sonic Fatigue experimental test results on a series of sixty flat rectangular glass fiber sandwich test panels are presented and discussed. The panels were of the fluted core (corrugated) type, had nominal overall dimensions of 24" x 30" x 0.45", and a nominal surface weight of one pound per square foot. The fluted core glass fabric (181 and 151 S glass) was of the integrally woven variety. A vacuum process was employed to impregnate the glass cloth with resin. Twenty each of three types of panel were sonic fatigue tested using a discrete frequency siren, five identical panels at four different sound pressure levels, to provide three S-N (Sound Pressure Level Vs. Cycles to Failure) plots. Twenty aluminum skin-stringer panels of the same overall dimensions and surface weight were similarly tested for control.

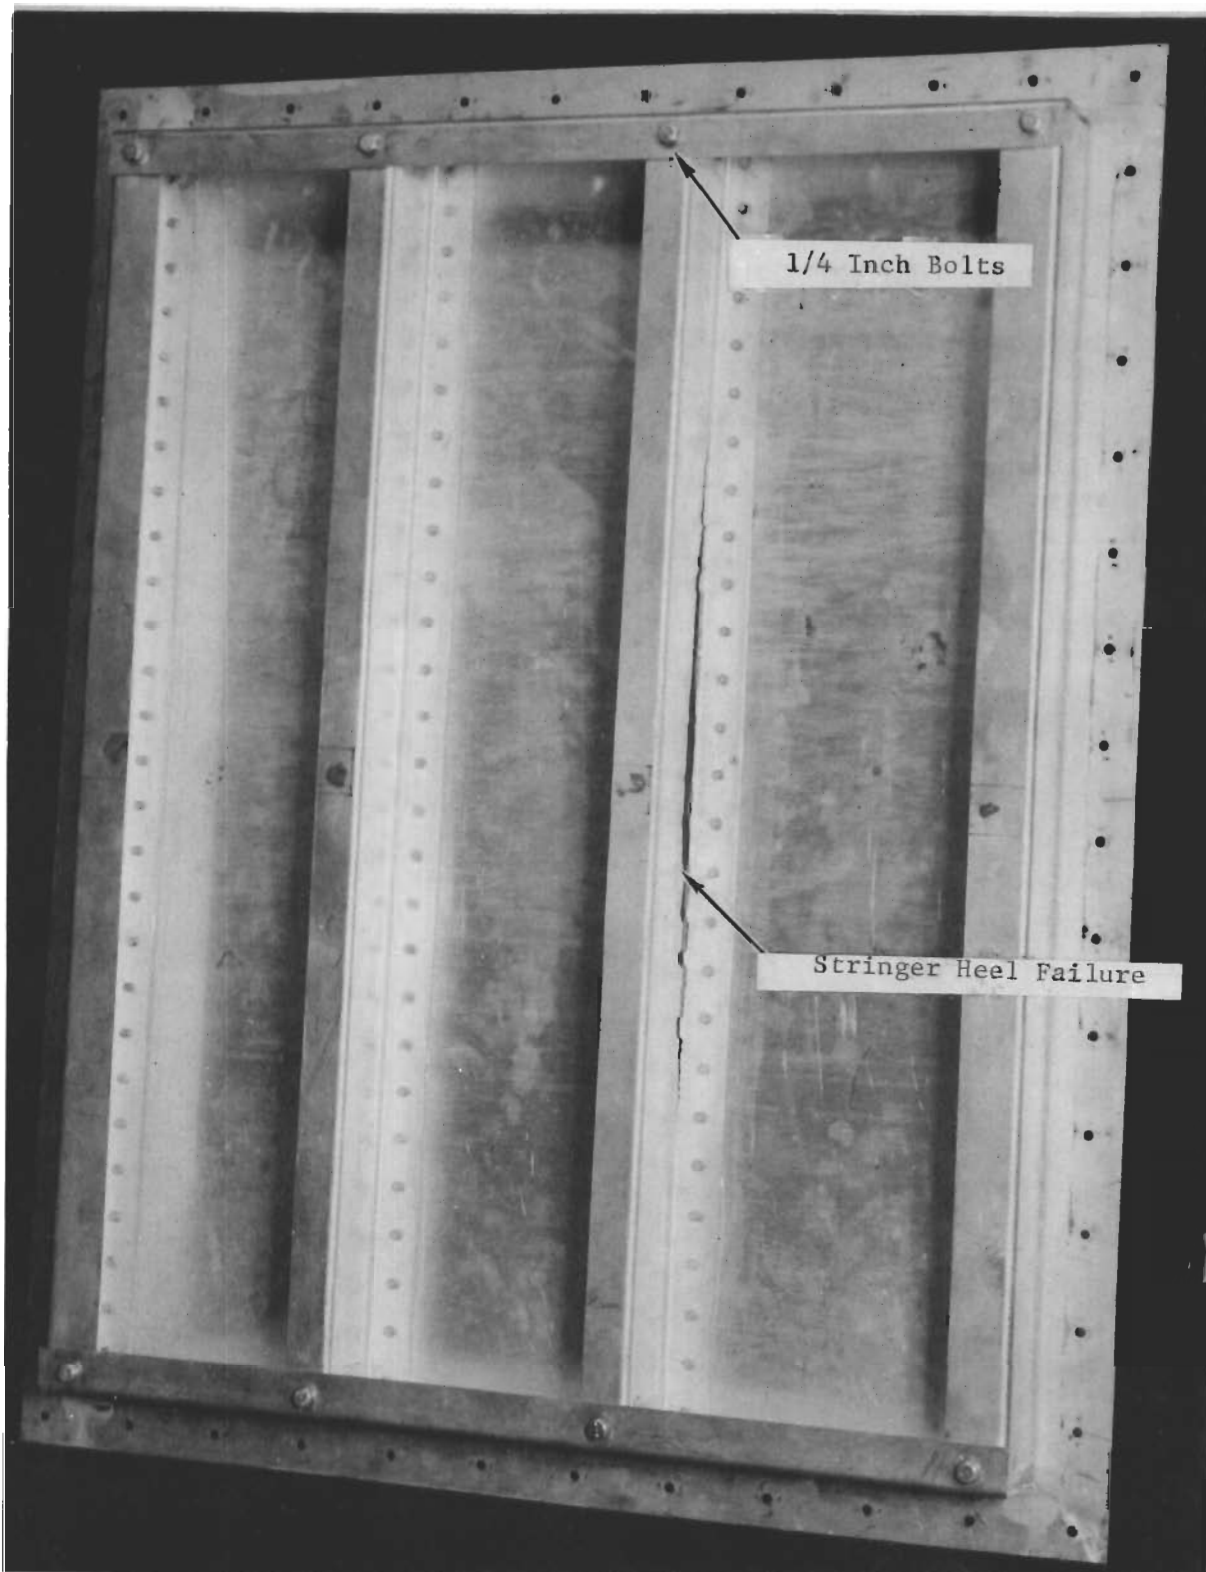
Figure 1. Aluminum Control Panel Original Design

The general arrangement of this panel is shown on Figure 1. The design is typical of most current conventional aircraft structures, the aspect ratio of the bays being quite commonly found in fuselage, flap, aileron and empennage trailing edge structures. The 0.040" Z stiffeners are bonded and riveted to the 0.032" skins. All materials are 7075 T-6 Alclad. Overall dimensions are 24" x 30" and the weight is 5 lb. The 1/4 inch stringer tie-in bolts were used to replace the rivets originally specified when the latter worked loose after a few preliminary frequency sweeps at low SPL's. Further frequency sweeps at higher sound pressure levels showed that stringer rotation was excessive and further modifications were necessary.

Upon completion of the stress frequency response tests, the panel was subjected to a discrete frequency SPL of 160 db at 155 Hz. Failure occurred at a stringer heel, Figure 1, after some ten minutes running i.e.,  $9.28 \times 10^4$  cycles. Torsional rotation of the stringer was the primary cause of failure.

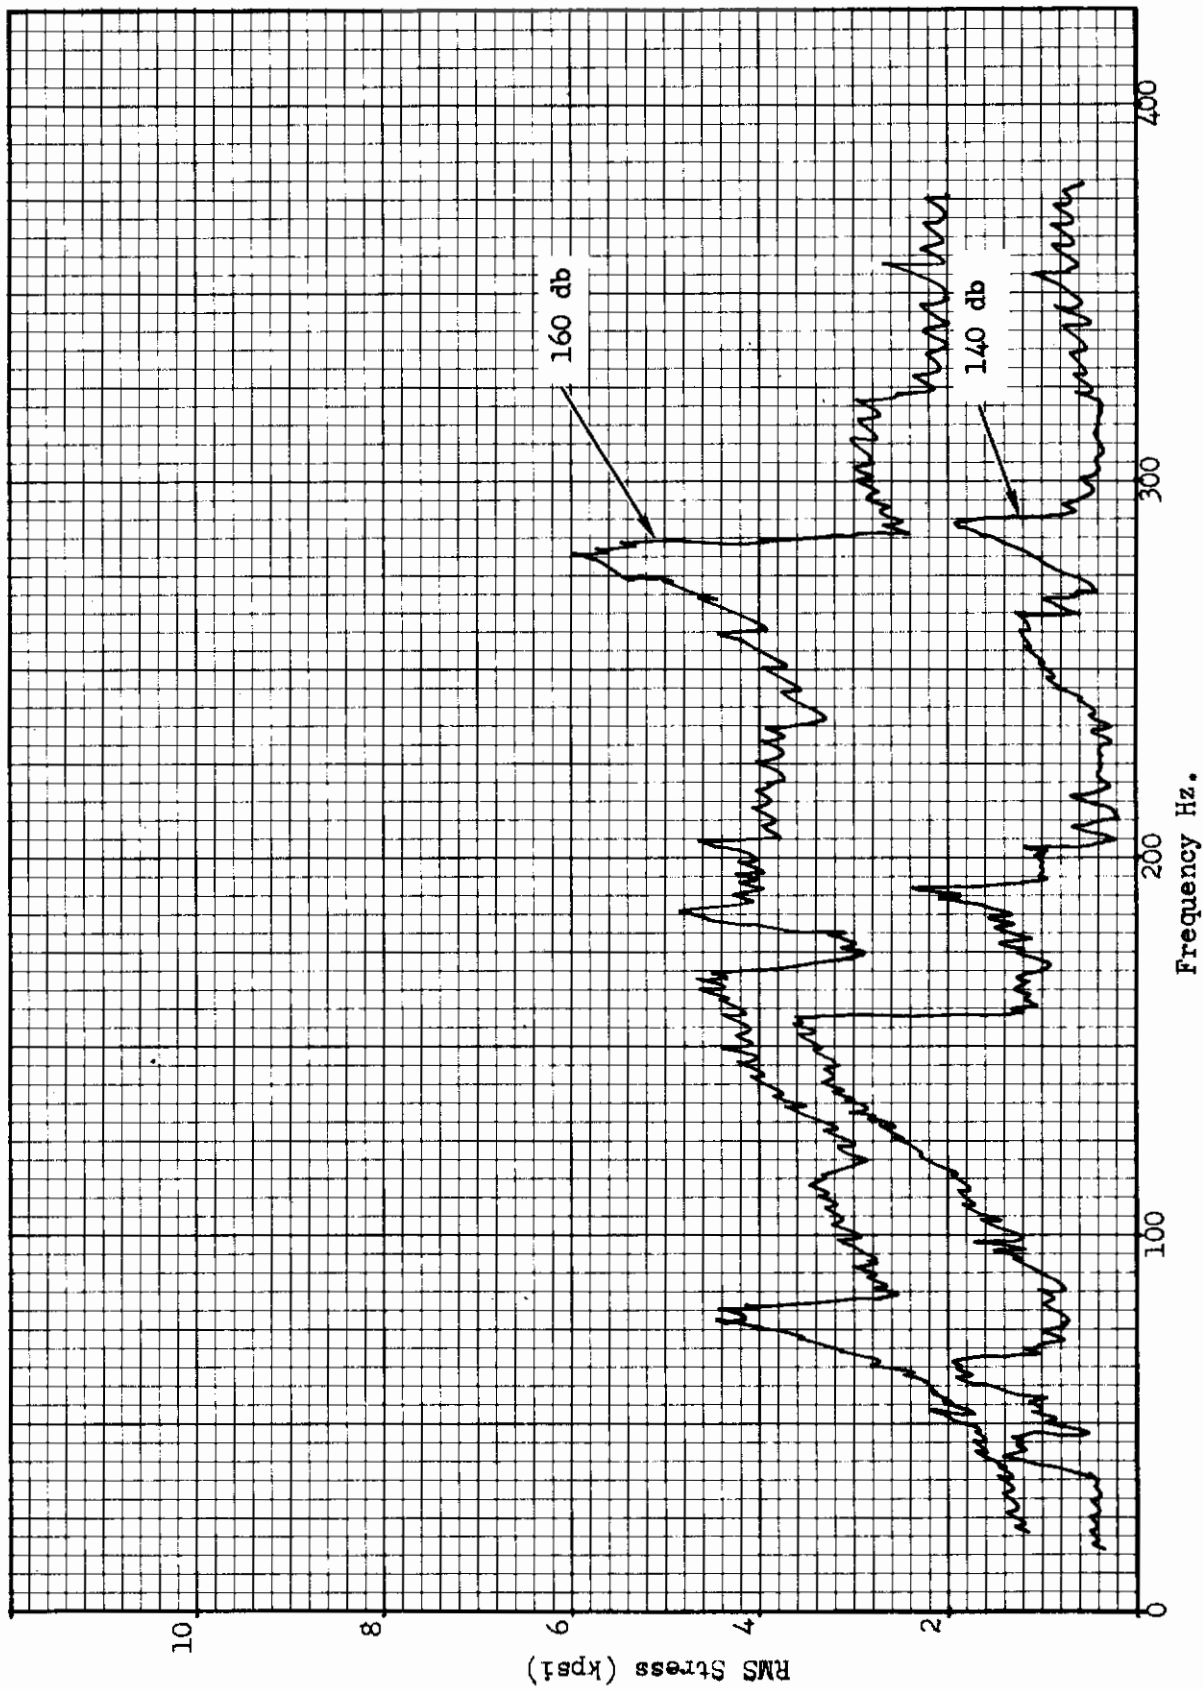
Figure 10. Panel C-1X No. 2 Strain Gage Response at 140 db and 160 db SPL

A total of six Budd type C12-121 strain gages were affixed to panel No. C-1-X as shown on Figure 9. Typical stress vs. frequency response data for strain gage #2 (mid-panel position) are shown for 140 db and 160 db on Figure 10. A large number of stress-frequency sweeps were performed on this panel and the stress response data showed multimodal response characteristics typical of this construction. During the latter part of the frequency sweep tests the 1/4 inch bolts periodically worked loose and had to be re-tightened. This was no doubt due to the large stringer rotation.

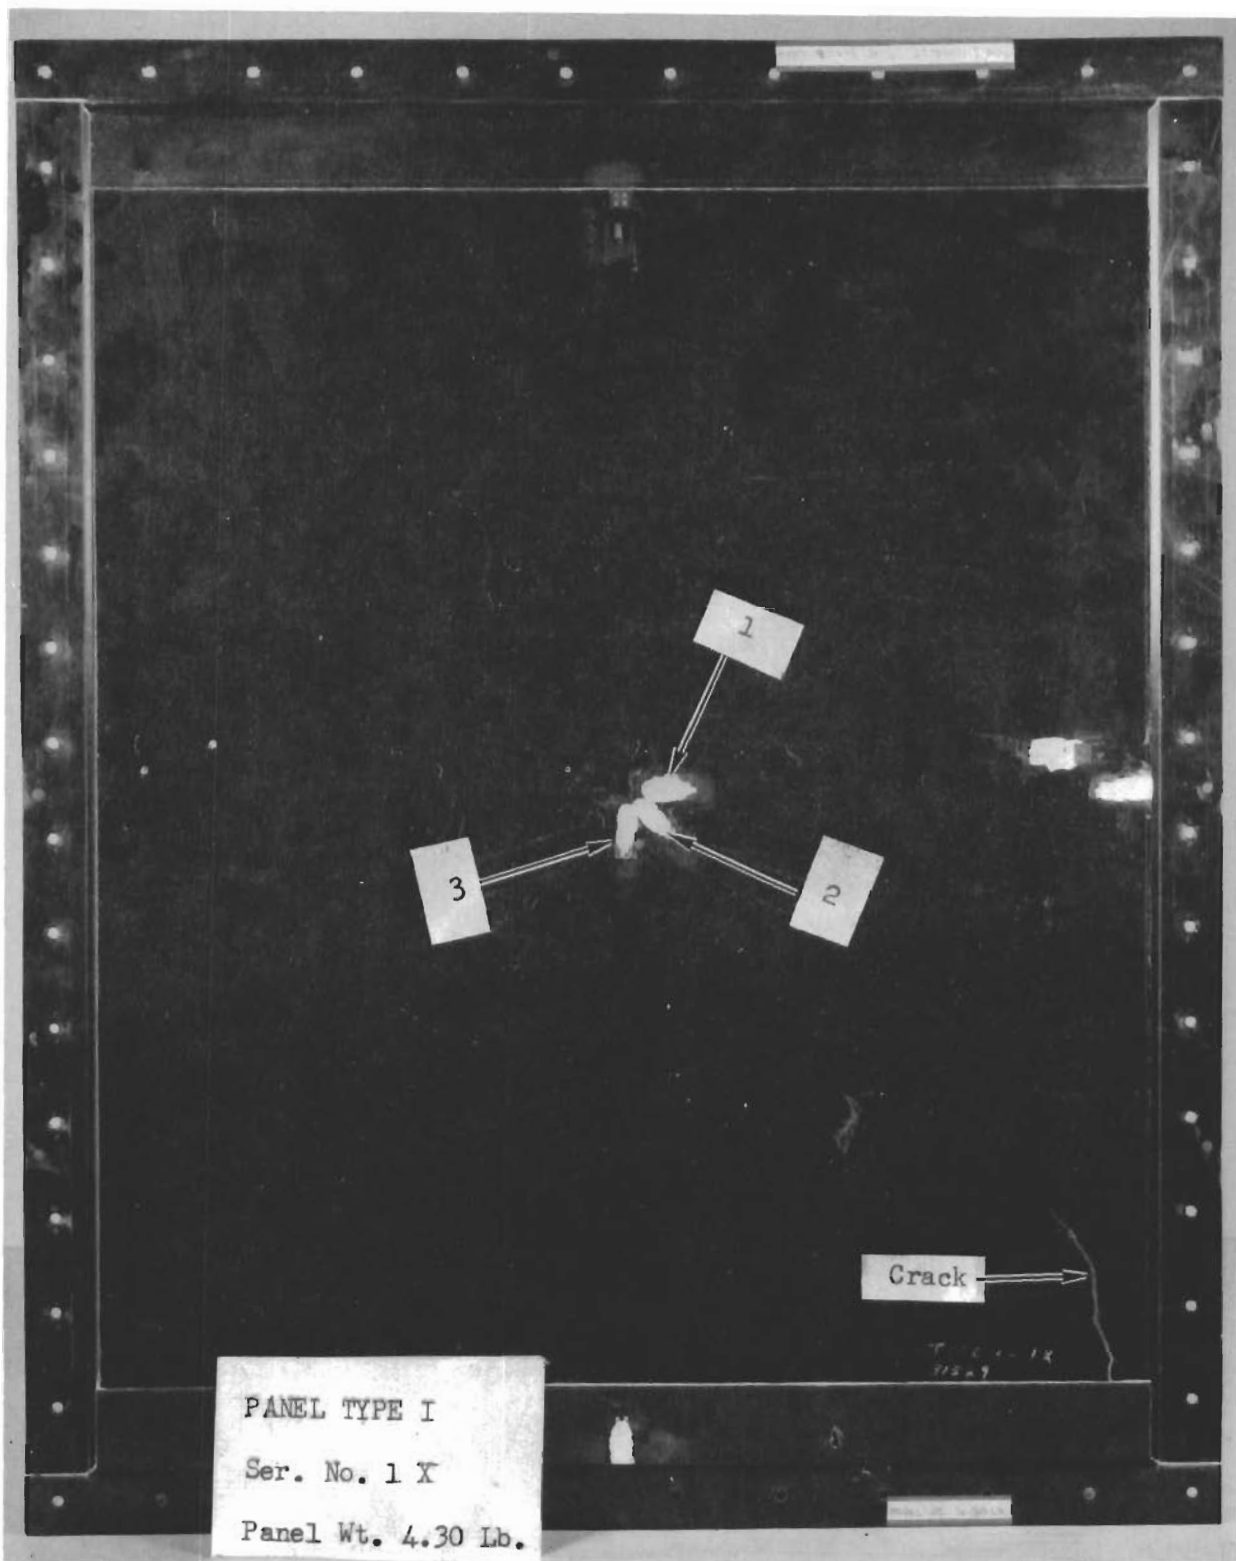
Figure 17. Type I Glass Fiber Panel - Strain Gage Locations

A number of strain gages were affixed to this panel at locations shown on Figure 17. The panel was then subjected to constant SPL vs. frequency sweeps from 0 to 500 Hz at SPL's of 140 db, 145 db, 150 db, 155 db and 160 db. However, because of the fact that most of the gages failed during preliminary sweeps, it was not possible to obtain a complete set of data from all gages. The premature failure of the gages was found to be due to excessive strains in the glass fiber resulting from the relatively low tensile modulus ( $E \approx 3 \times 10^6$  psi) for this material. This was incompatible with the 5% elongation of the Budd Type C-12-141 gages, which were used successfully on the aluminum panels. Budd Type HE-141 gages (15% elongation) were substituted for all further glass fiber panels.

This panel was tested for 32 minutes and 24 seconds at SPL of 160 db, when failure occurred on the skin at the lower right hand corner, Figure 17. Failure was readily detected by a sudden drop out of resonance when the panel could not be retuned.

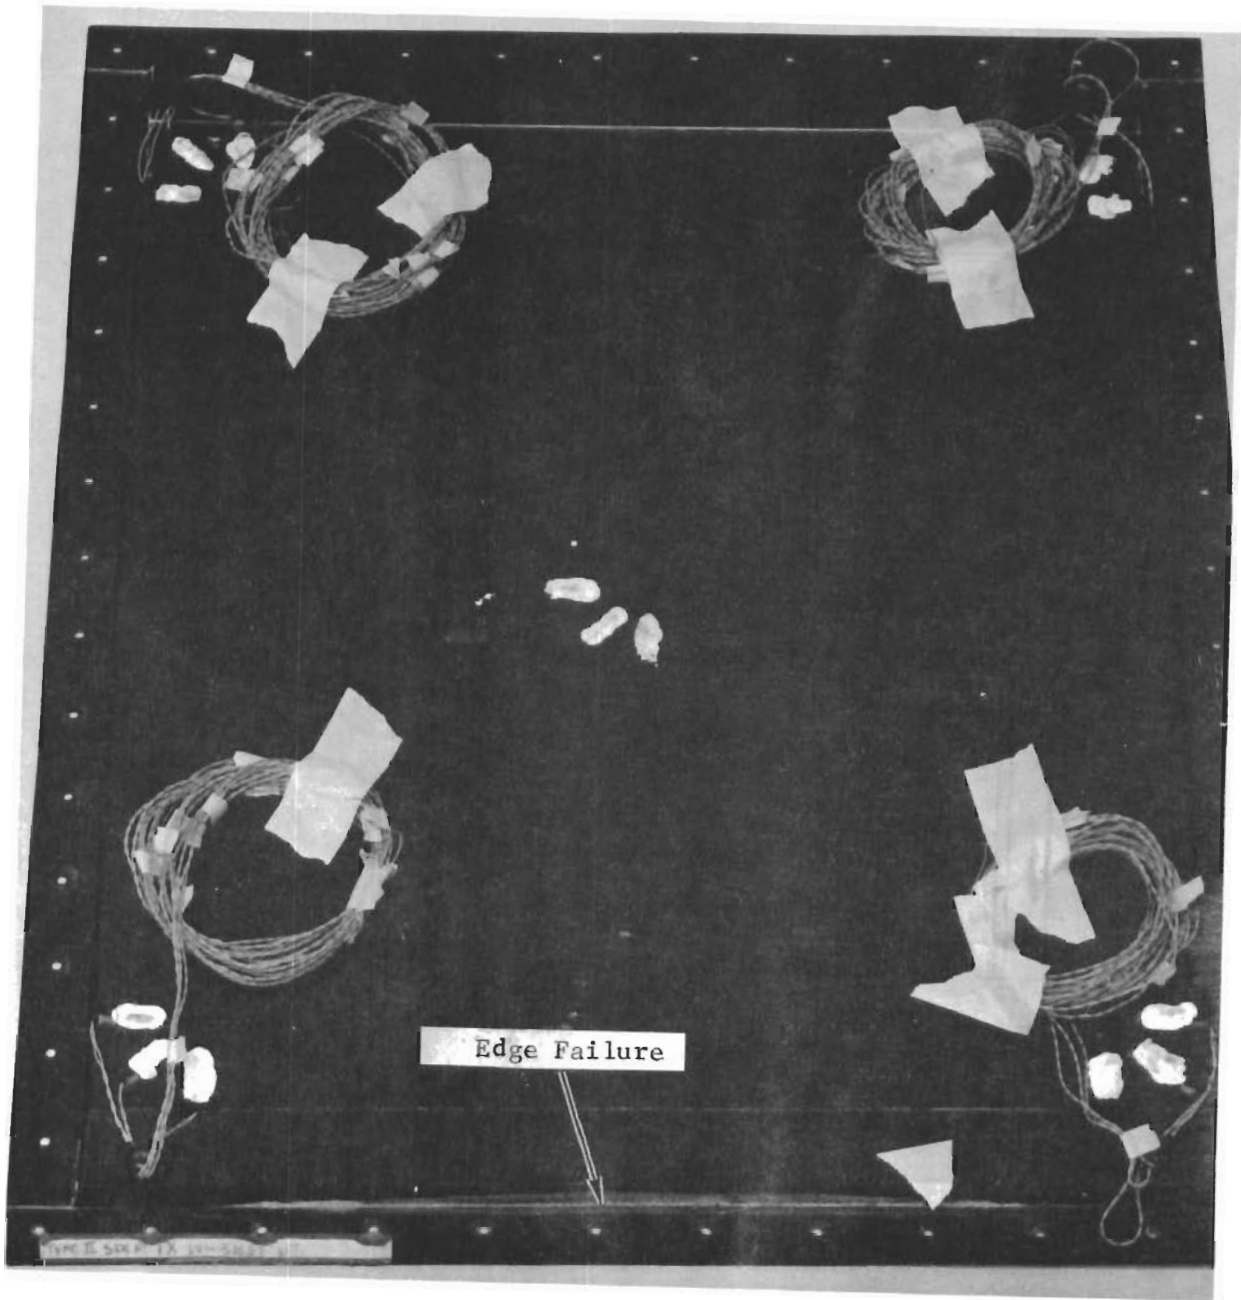
Figure 28. Type II Glass Fiber Panel after Failure

The Type II panel was tested to failure at 160 db SPL at its first mode. There was a sharp drop in resonant frequency after some 4 minutes and 10 seconds of running. The panel suffered delamination along its lower edge originating at the edge radius, Figure 28.

This design was clearly not satisfactory. The lower edge failure was due to insufficient edge thickness resulting from the trading of two edge plies of glass fabric for foam stabilizer. The effect of the sharp edge radius was also detrimental. The finished weight of 4.2 lb. (1,906 grams), was well below specified design weight.

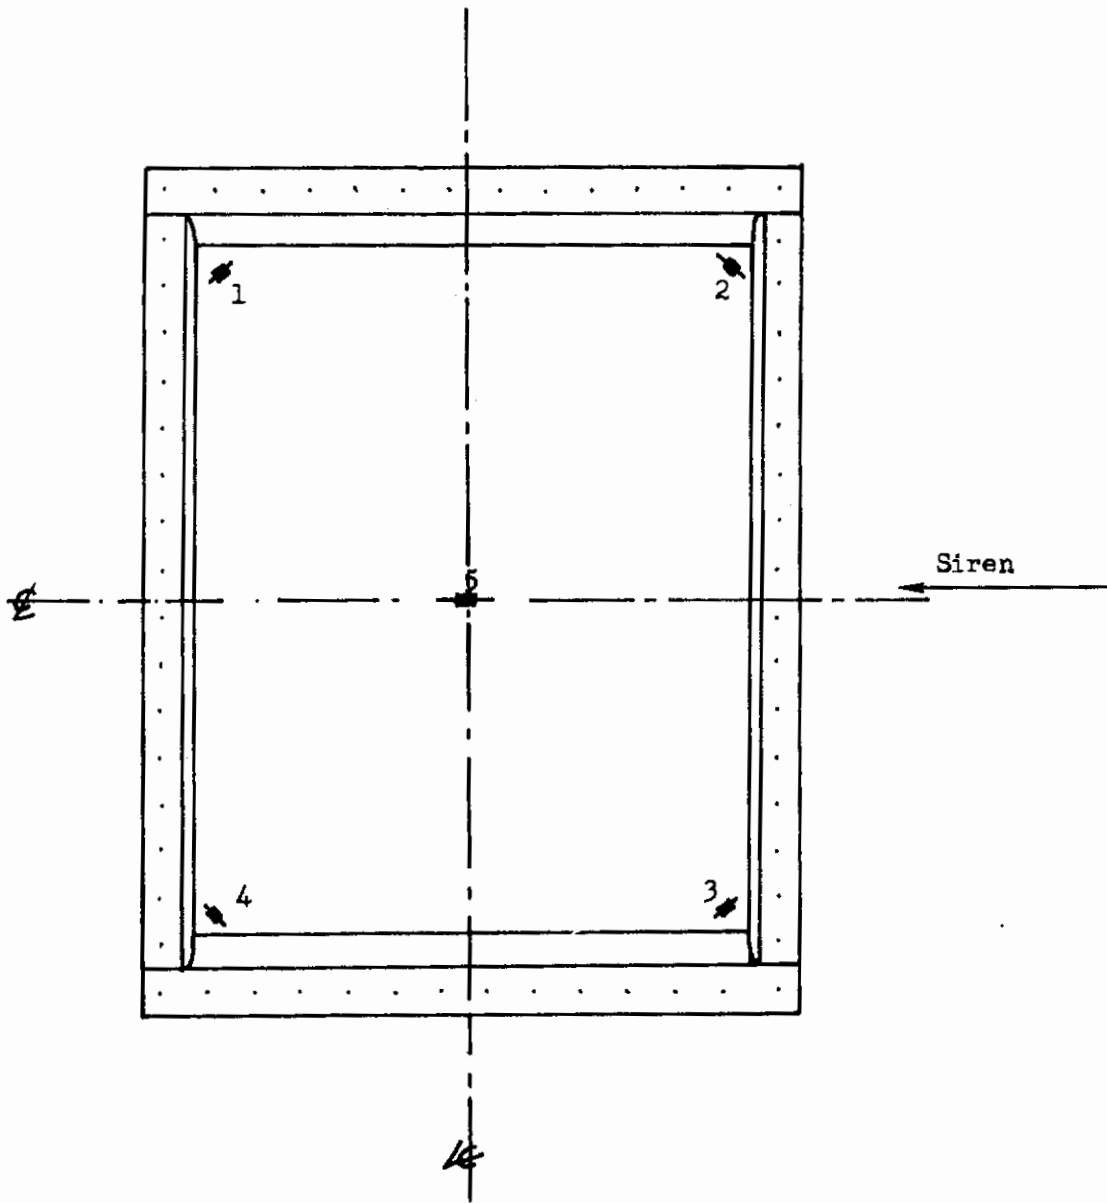
Figure 29. Glass Fiber Panel Type III Strain Gage Location

Strain gages were located on this panel at locations shown on Figure 29. The panel was subjected to constant SPL vs. frequency sweeps at 145 db, 150 db, 155 db, 160 db and 165 db. A typical stress vs. frequency plot for a 165 db sweep is shown on Figure 30. This panel suffered premature flute failure during a second sweep at 165 db. Examination of the failed flute showed that the finished skin to flute thickness ratio was approximately 3.5 to 1. It was clear that the flutes in this design required foam stabilization.

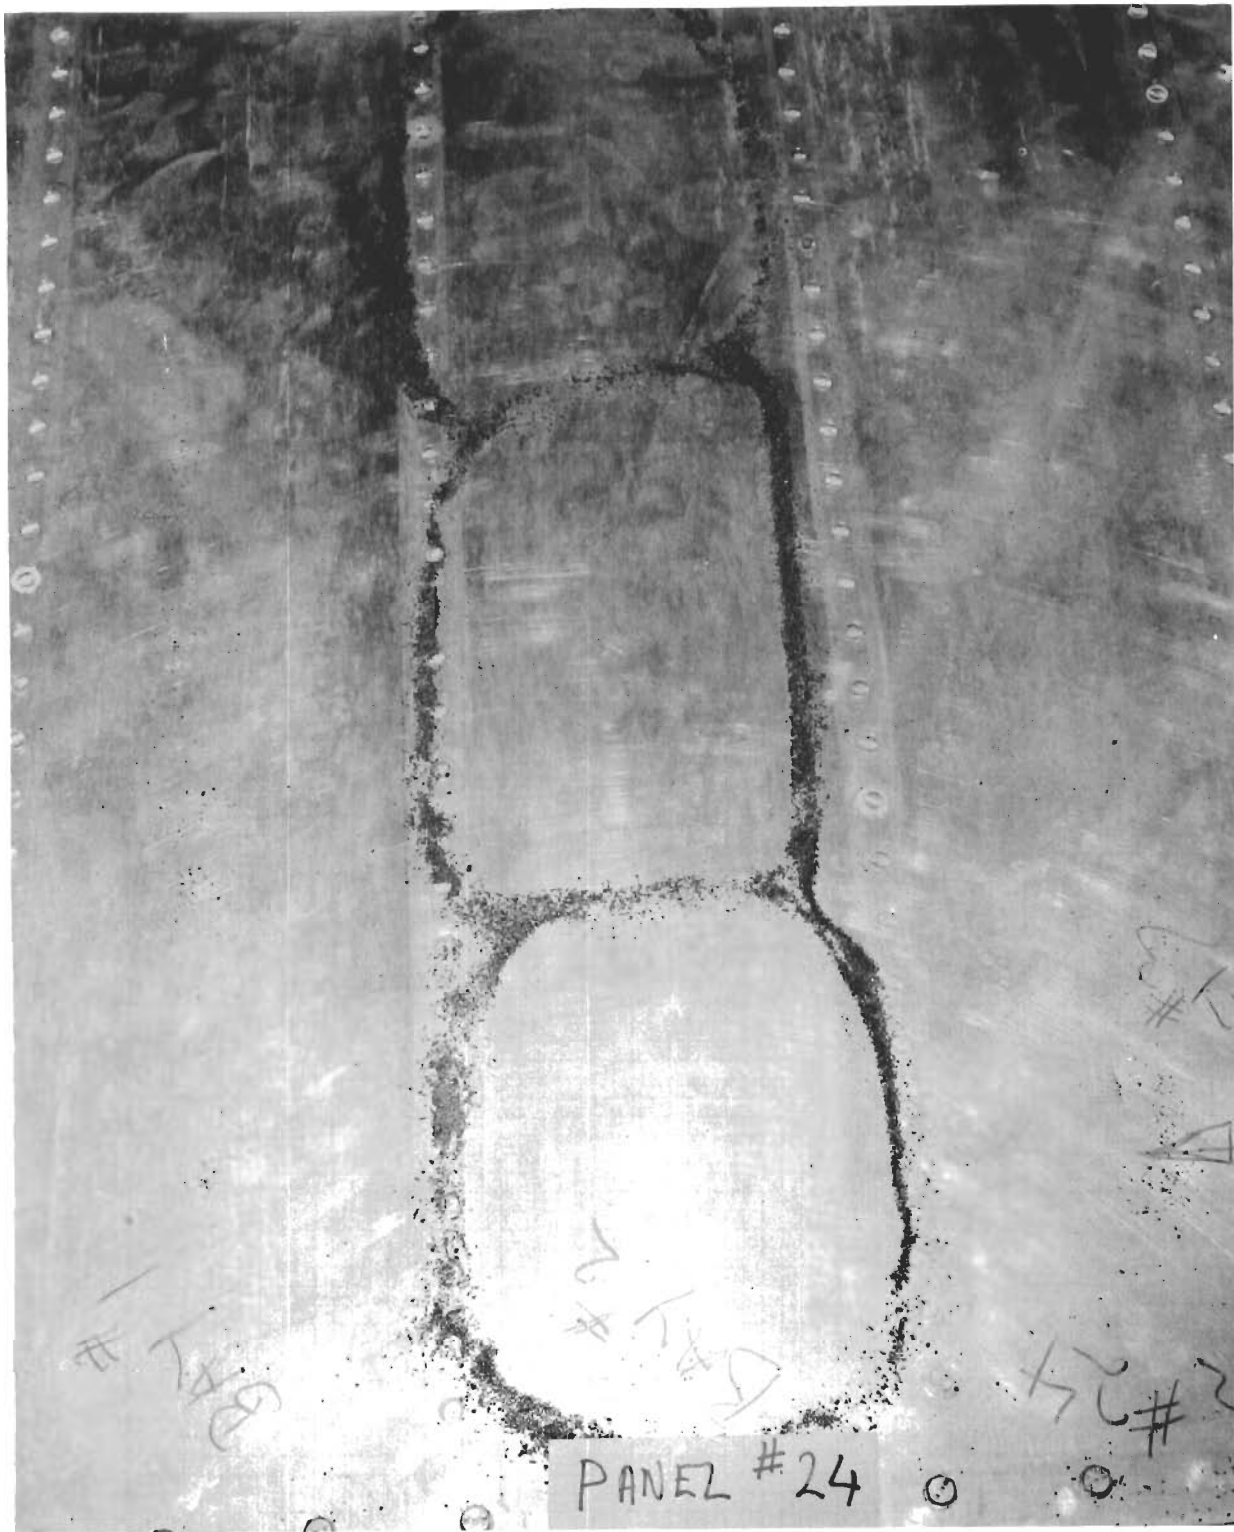
Figure 34. Control Panel No. 24 Mid-Pay Third Mode (189 Hz.)

The sub-panel in-phase mode was isolated during panel shake tests with a panel mounted on a stiff frame suspended from bungee cord, and driven by a pair of 50 lb. shakers, Figure 33. The sub-panel third mode for similar conditions is shown on Figure 34. Many other higher modes were identified during the shake tests, however, isolation of these modes was difficult. Modal frequencies for specific modes were in general somewhat lower in the shake test fixture than in the siren test fixture. This is accounted for by

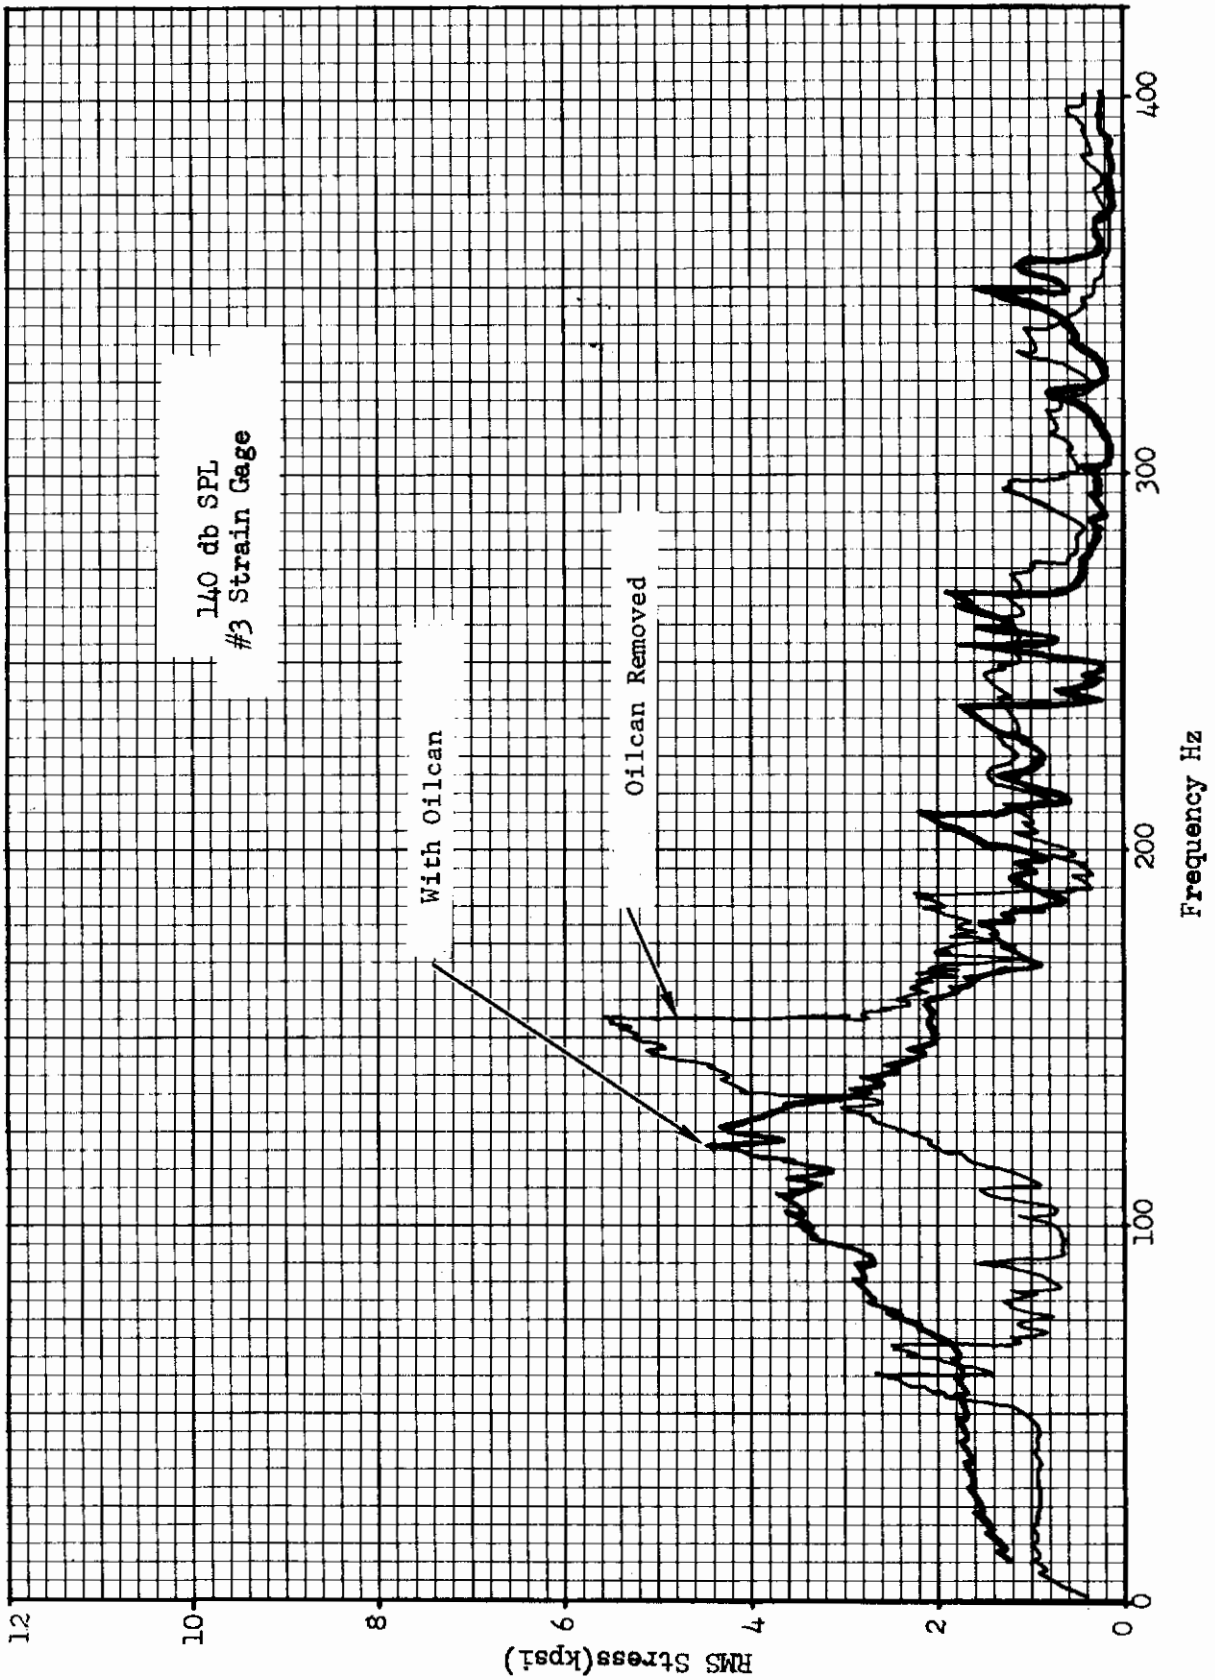
Figure 39. Stress Response Data Control Panel No. 25 - Effects of "Oilcan"

The effects of "oilcan" on stress response are illustrated on Figure 39. The response with "oilcan" present shows a significant lowering of the critical resonant frequencies and the corresponding panel stresses at those frequencies. The degree of "oilcan" present in a given panel could be determined by running a frequency sweep at the test SPL, and comparing it with the original data obtained before commencement of the fatigue test. The primary cause of "oilcan" was found to be differential expansion or contraction of the test fixture relative to the test panel.

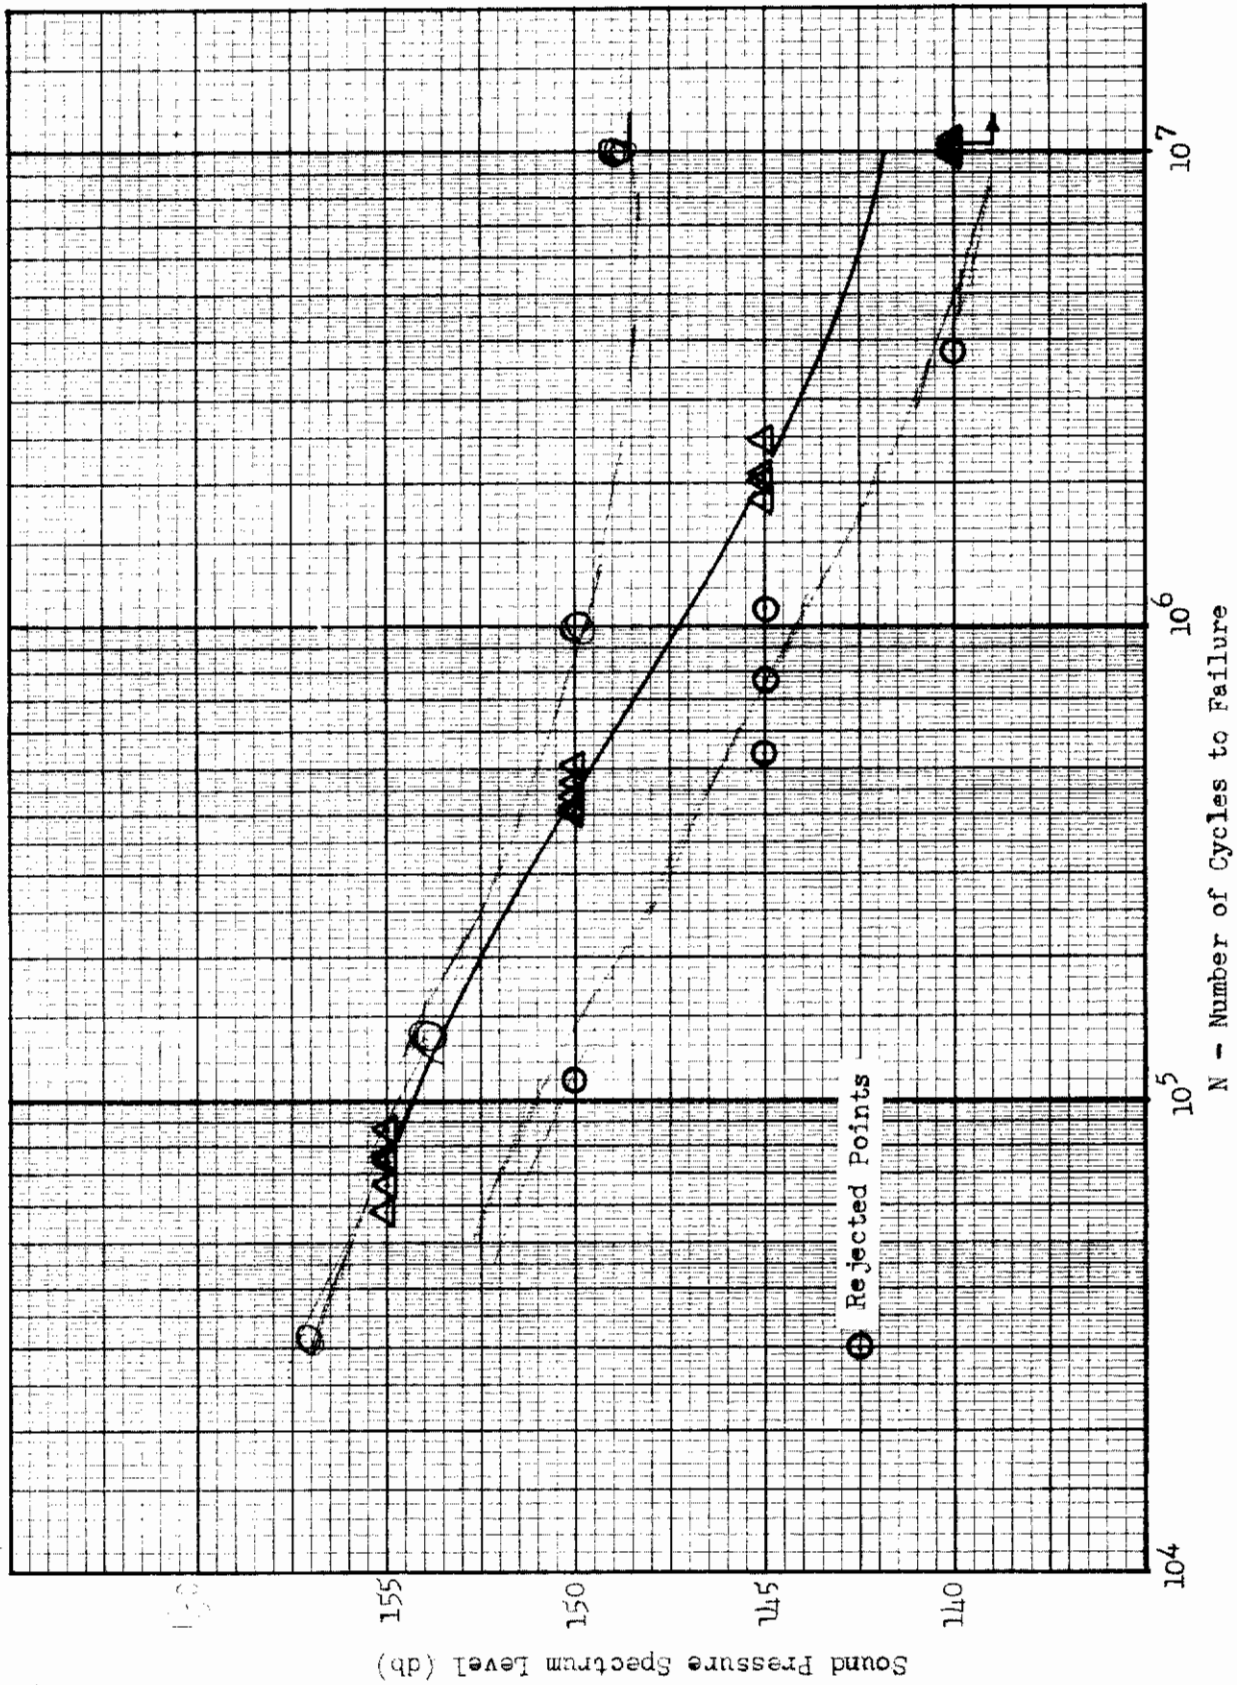
Figure 42. Aluminum Control Panels SPL vs. Cycles to Failure Plot

Table I shows sonic fatigue test results on all twenty-five production control panels. These results are plotted on an SPL vs. Cycles to Failure curve on Figure 42. The mean failing stresses shown, Table I, are those measured at gage positions #2 or #3, Figure 31, during failure tests. Most panels exhibited a gradual drop in resonant frequency and/or stress during test. The test frequency shown on Table I was that prevailing for the greater part of the test run. It should be noted that many frequency vs. stress sweeps were made on most panels at various SPL's, before and during fatigue testing.

The 140 db test level was selected on the basis of panel #5 data. This panel was later rejected after other panels showed no failure at 20 hours of test at this level. The control panels appear to approach infinite life at 140 db. Panel #12 which showed no failures after twenty hours testing at 140 db, SPL was retested at 155 db SPL and failed after 14 minutes testing at this level. All panels failed on the skin at a stringer heel location.

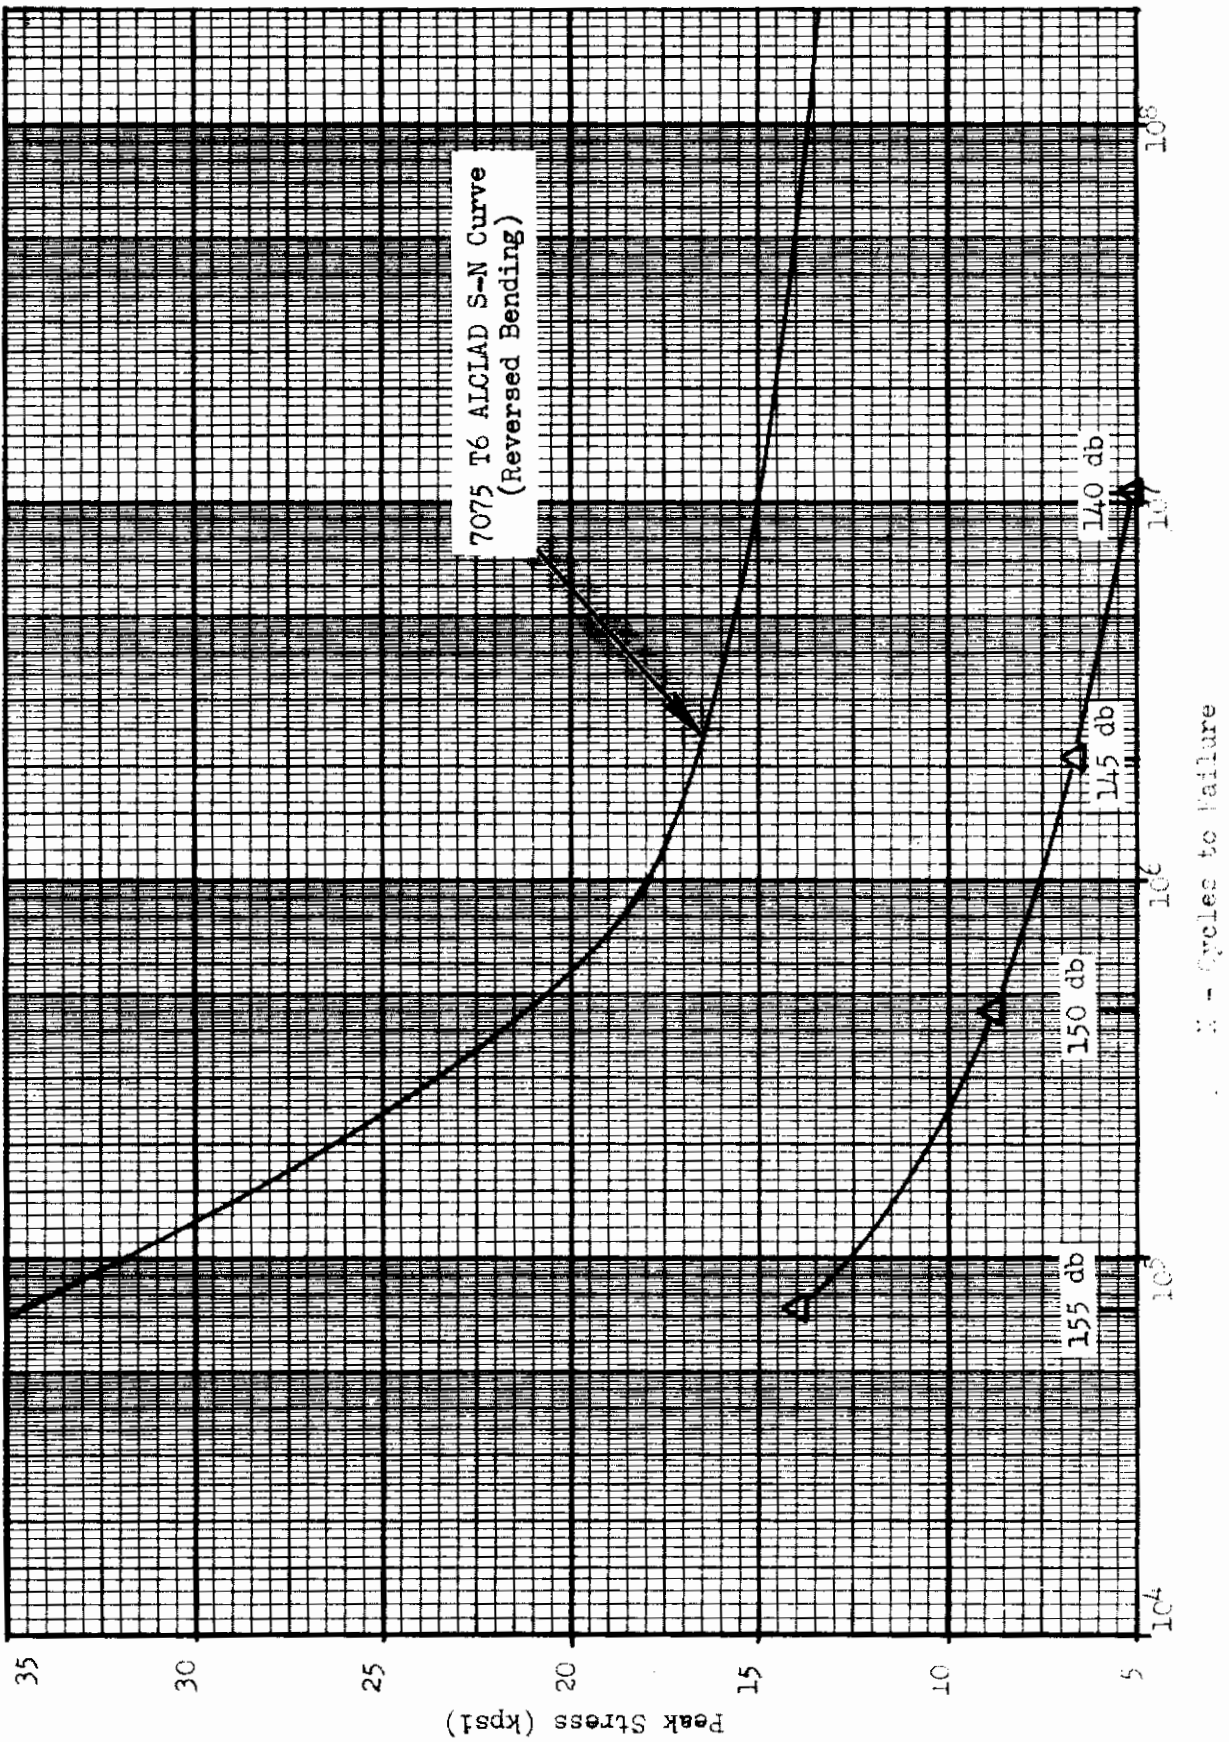
Figure 43. Control Panel Failing Stress vs. Cycles to Failure

Figure 43 shows a reverse bending S-N curve for 7075-T-6 Alclad. The average of the peak values of failing stress, and cycles to failure (excluding rejected panels) from Table I for 140 db, 145 db, 150 db and 155 db SPL are also plotted on Figure 43.

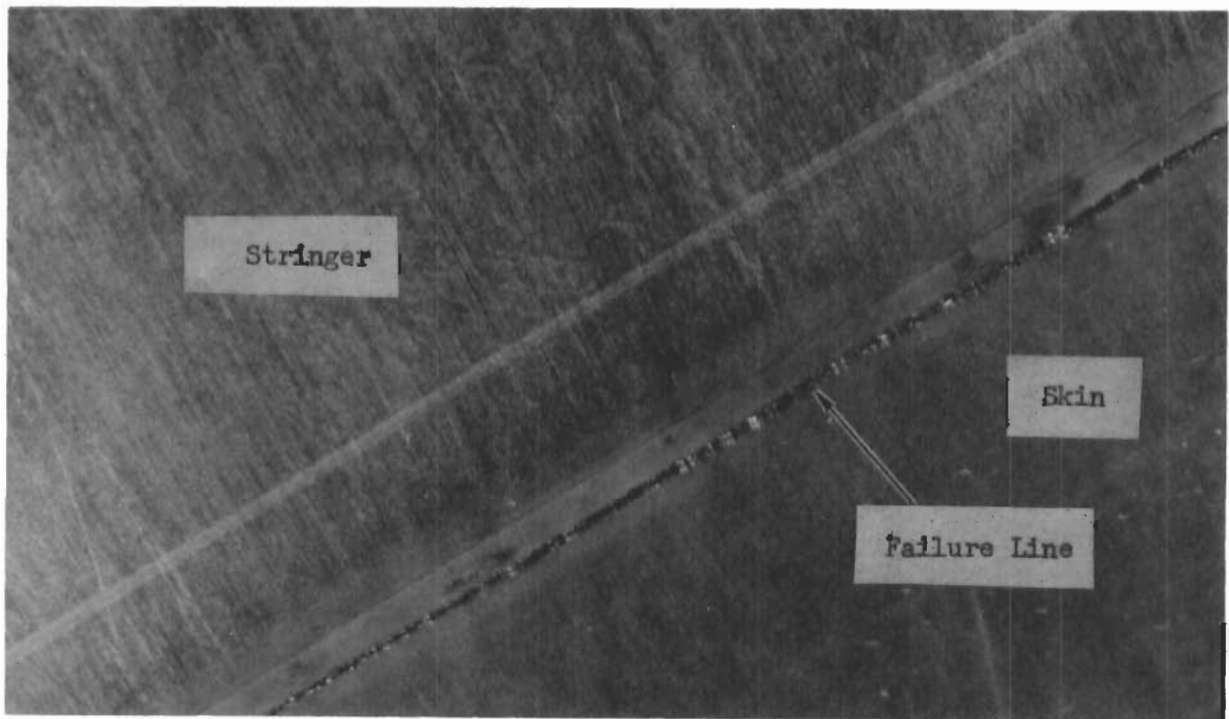
**Figure 51. Control Panel Typical Skin Failures**

shown on Figure 50 (b). The failure line generally followed that of the AF-111 adhesive\* and was initiated at the sharp edge of the adhesive bead, where there was an obvious line of stress concentration, Figure 51.

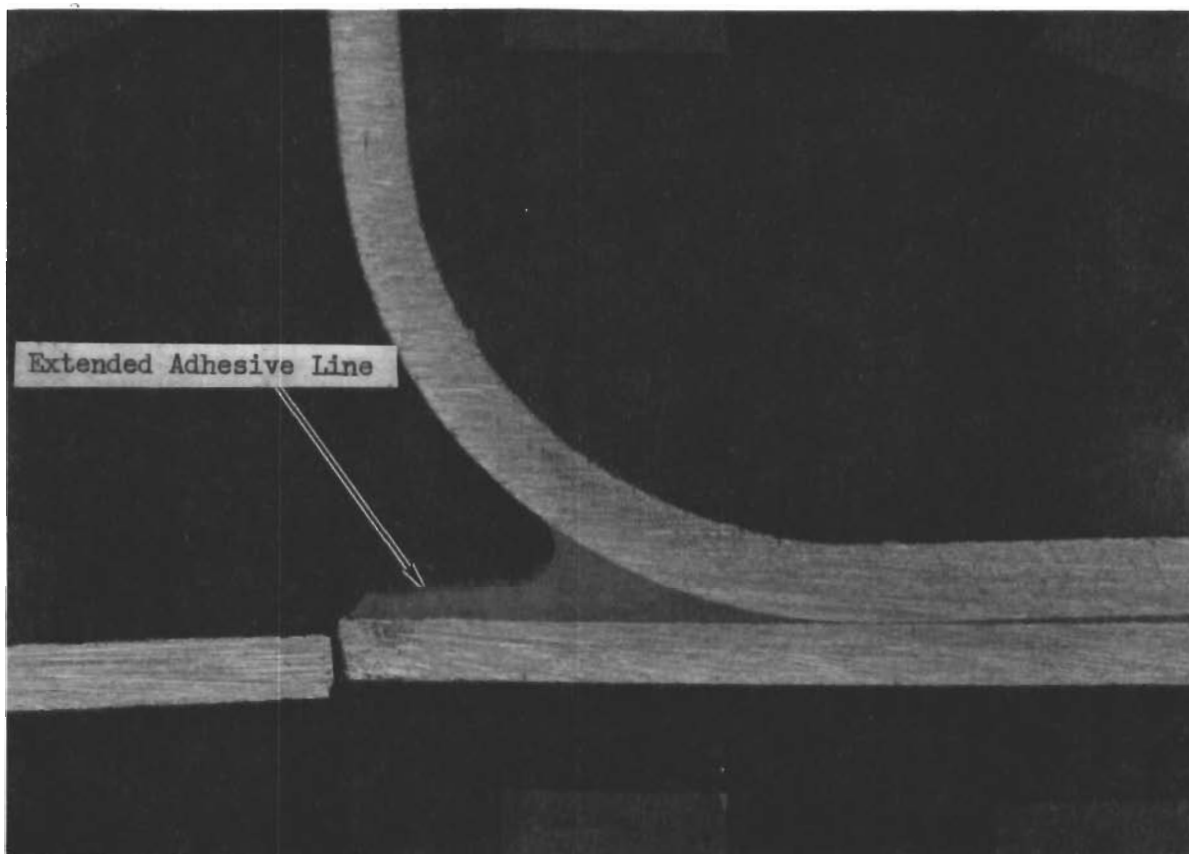
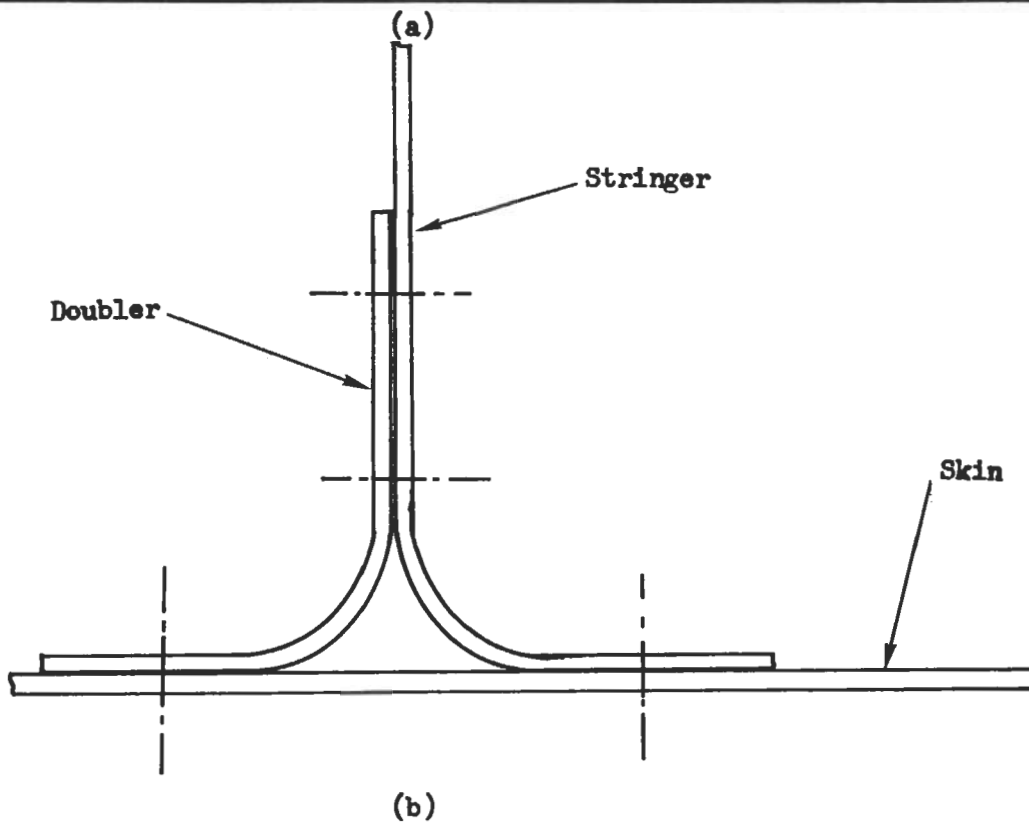
Figure 52. Skin-Stringer Attachment - Improved Design

Table II shows Rockwell hardness readings taken on "good" and rejected panels. Table III shows results of a dimensional survey taken of the four panels sectioned. Lap shear tests of sample test pieces for "good" and rejected panels showed that adhesive shear stress failure values were well within AF-111 specification limits. This also applied to panel #9 which suffered a premature bond failure between skin and stringer resulting in a rivet line failure. Examination of the failed panel showed evidence of insufficient clamping pressure during adhesive cure. However, the lap shear control specimen for this panel was adequately clamped and gave good results. It was later established that a switch of operators was made during manufacture of panel #9, and that the new operator had not followed correct clamping procedure during adhesive cure. It was noted that in the initial series of production panels, the AF-111 adhesive did not extend much beyond the heel-skin junction leaving a significant stress concentration at this point. Accordingly, it was decided to extend the adhesive beyond this junction in all subsequent panels. A section through panel #20 with extended adhesive line is shown on Figure 52(a). The line of failure is still on the adhesive edge, however, the stress concentration factor is probably reduced. The fatigue life of these panels could be significantly improved by use of an additional doubler, Figure 52(b).
