**SONIC FATIGUE TOLERANCE OF GLASS  
FILAMENT STRUCTURE:  
EXPERIMENTAL RESULTS**

*J. A. HAYES*

Sonic Fatigue experimental test results on a series of sixty flat rectangular glass fiber sandwich test panels are presented and discussed. The panels were of the fluted core (corrugated) type, had nominal overall dimensions of 24" x 30" x 0.45", and a nominal surface weight of one pound per square foot. The fluted core glass fabric (181 and 151 S glass) was of the integrally woven variety. A vacuum process was employed to impregnate the glass cloth with resin. Twenty each of three types of panel were sonic fatigue tested using a discrete frequency siren, five identical panels at four different sound pressure levels, to provide three S-N (Sound Pressure Level Vs. Cycles to Failure) plots. Twenty aluminum skin-stringer panels of the same overall dimensions and surface weight were similarly tested for control.

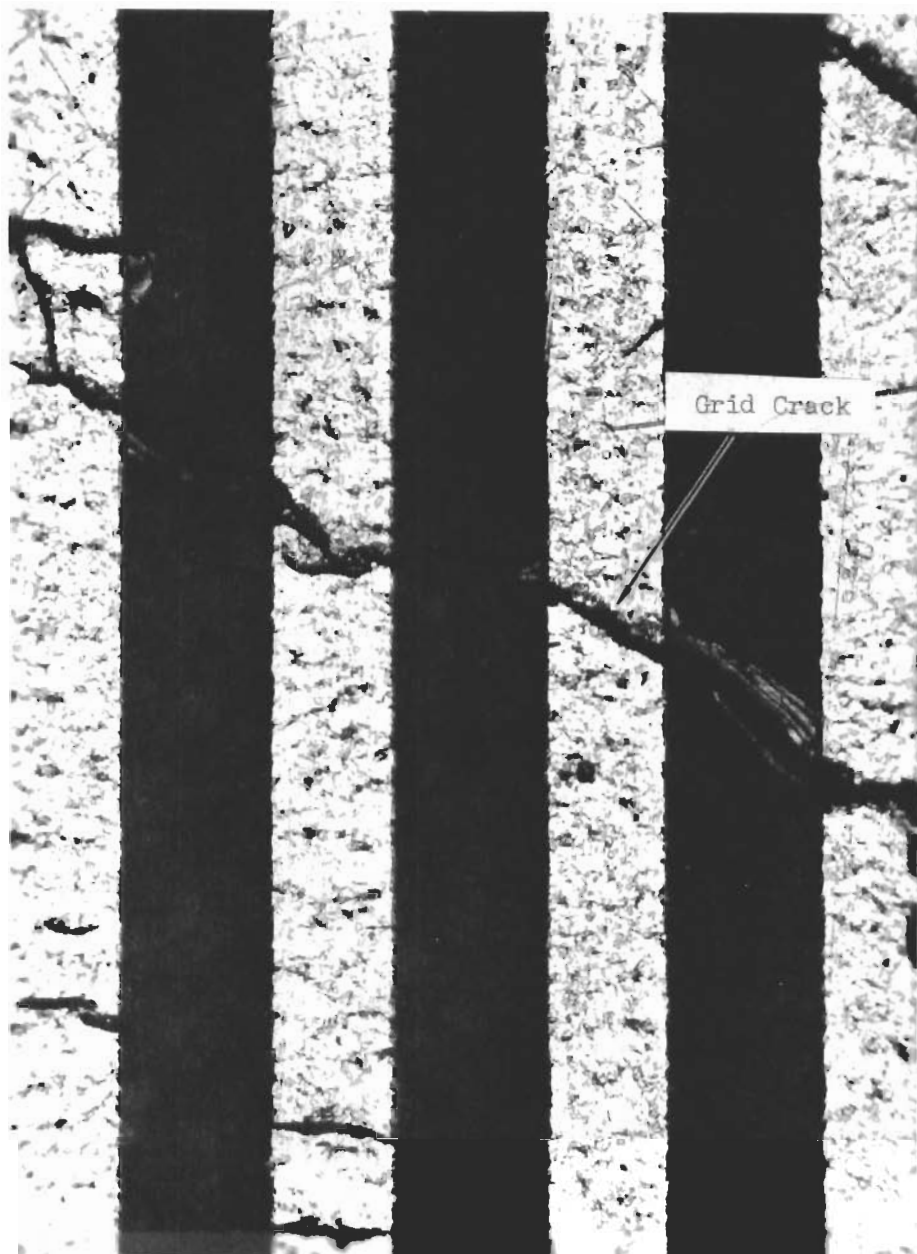
Figure 83. Typical HE-141 Strain Gage Grid Failure

The high strains in the glass fiber panels (over 20 percent for 5000 psi stress level) resulted in premature failures of the Budd C-12-141 5% elongation strain gages, which were employed for the aluminum panels. The Budd Type HE-141 high elongation strain gages (15% elongation) were a considerable improvement, however, they could only be considered marginal for the glass fiber panels in this program, since many premature gage failures were encountered, particularly at the higher sound pressure levels. A close-up view of a typical HE-141 gage failure is shown on Figure 83. It should be noted that the cracks through the grid of this gage are not visible to the naked eye.

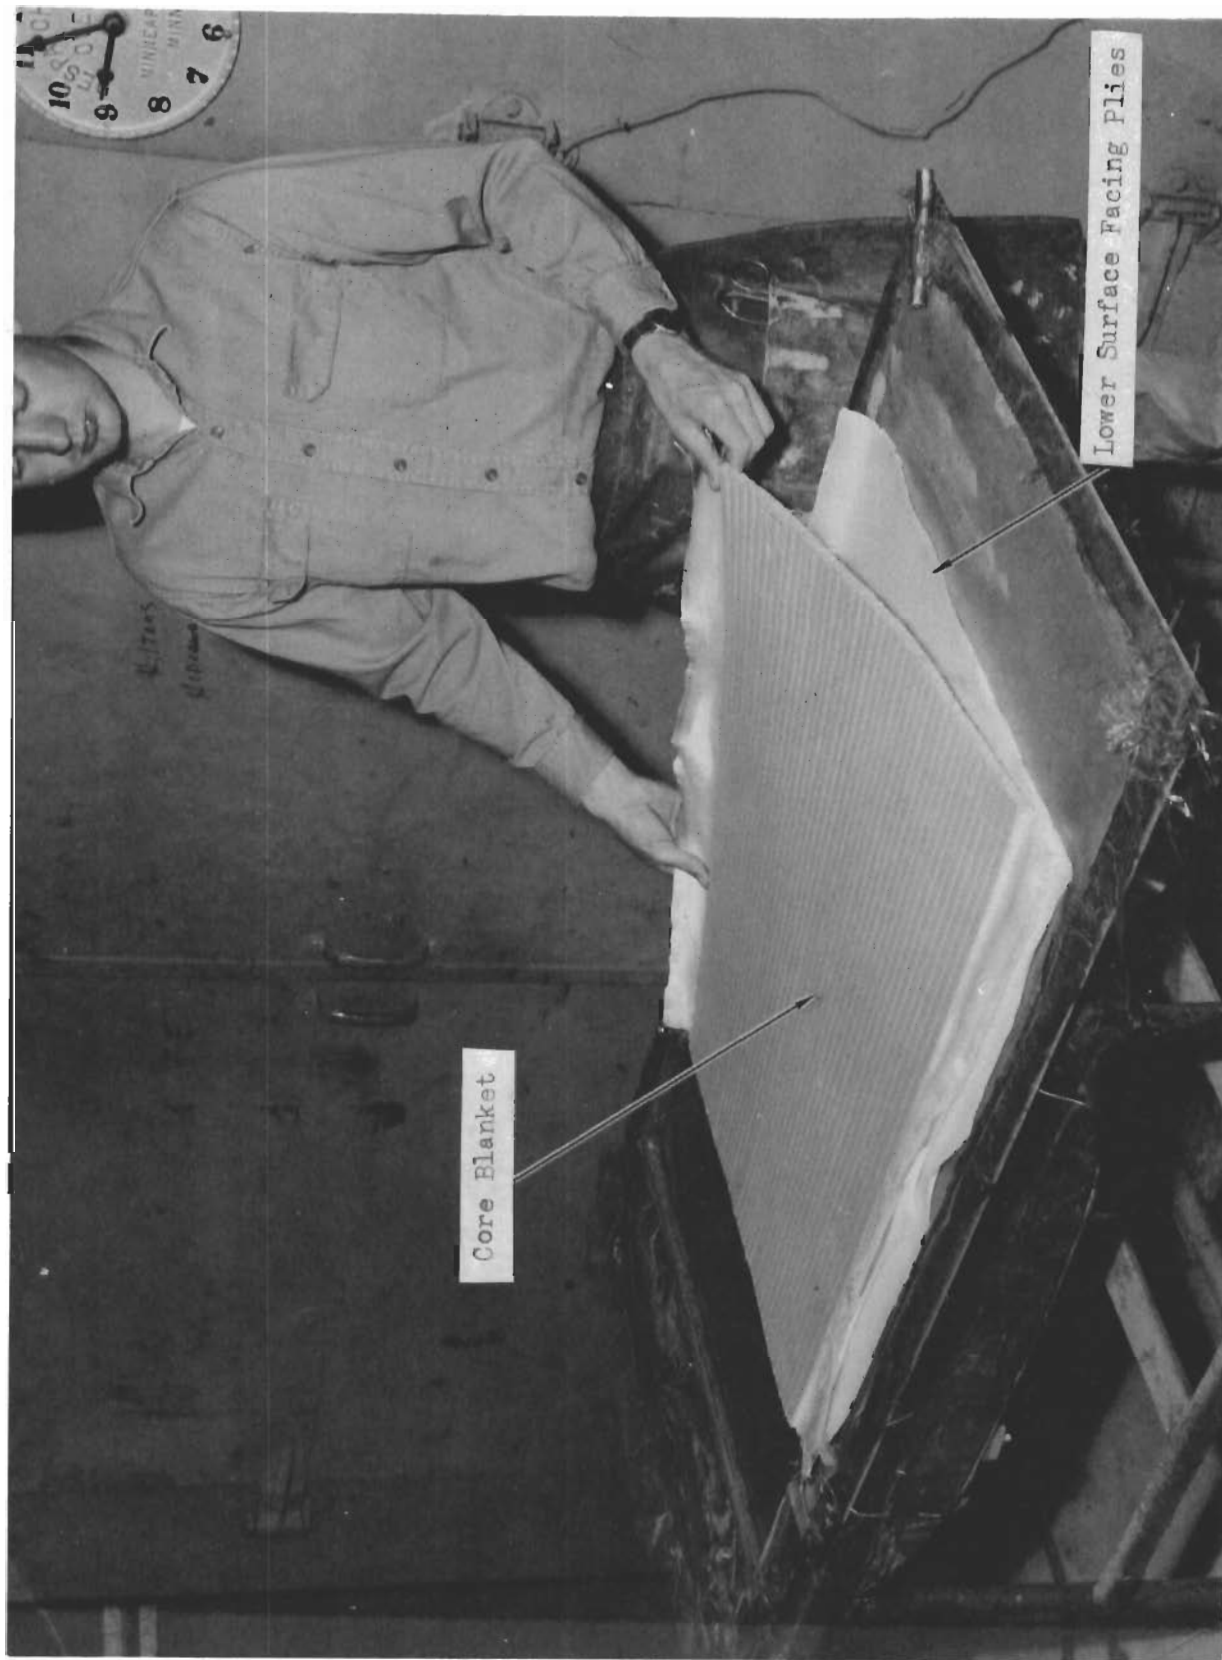
Figure 88. Glass Fiber Panel - Lower Surface and Core Dry Fabric Lay-up

The process begins by laying the cut and trimmed glass fabric plies on the mould surface, and positioning the core material on top, Figure 88. The top plies are now positioned, Figure 89, ready for the caul tool, Figure 90. When the caul tool is in place, a polyvinyl alcohol sheet is placed over the entire mould, and the edges are sealed with a putty-like sealant, Figure 91. The resin-catalyst mixture is now poured on the mould surface at the end of the panel and the polyvinyl alcohol vacuum bag sheet extended to cover resin mixture and panel. A vacuum is now applied at the opposite end of the panel and the entire assembly is placed in an oven for the pre-cure cycle at approximately 170°F. for 60 minutes. The resin viscosity is lowered by this heating enabling the resin to flow through the core more easily. Excess resin is absorbed by hair felt placed around the panel edges. For the cure phase, the temperature is raised to 260°F. for a further 30 minutes, when post curing for 120 minutes at 325°F is commenced. The finished core is now removed and the polypropylene mandrels extracted (in the Type I, hollow flute panels). The polyurethane foam mandrels are retained in the Type II and III panels. The core ends are now trimmed and cut off at a 60° angle ready for bonding the end close out doublers.

The principal steps in manufacturing the glass fiber fluted core panels for sonic fatigue testing are illustrated on Figures 88 through 92.
