AIRCRAFT GROUND-FLOTATION INVESTIGATION
PART XII — DATA REPORT ON TEST SECTION 12

W. BRABSTON and G. HAMMITT II

PART XII DATA REPORT ON TEST SECTION 12

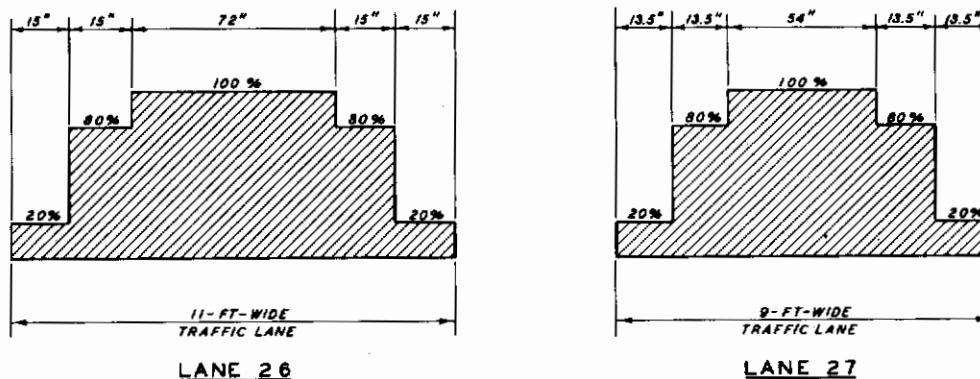
NOTE: PERCENTAGE FIGURES SHOW PERCENT
OF TOTAL COVERAGES.

Figure 1. Traffic distribution patterns, Test Section 12

Traffic was applied to the test lanes in a nonuniform pattern with intensity of traffic being varied within each lane to produce three zones of approximately 100, 80, and 20 percent traffic coverage. Traffic so distributed within a traffic lane simulates as nearly as possible the bell-shaped traffic distribution curve which results from the wander of aircraft from the lane center line. The coverage levels referred to in the tables and text of this part are the total number of coverages applied to the 100 percent coverage zone. The corresponding number of coverages applied to the outer traffic zones is proportional to the percentage factor for the respective zones, as shown in figure 1. In lane 26 the lane width was not an exact multiple of the tracking-tire widths and spacings so that it was necessary to determine a coverage factor to compensate for small gaps in the traffic pattern.

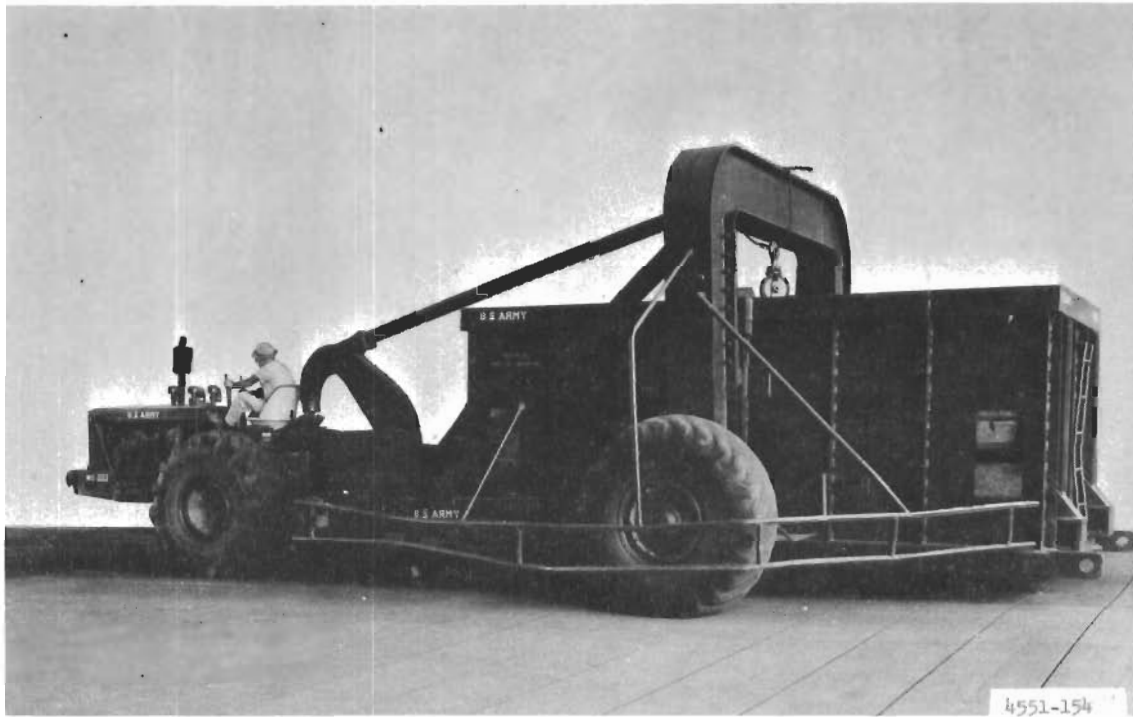
Figure 2. Test load vehicle

The load vehicle used in trafficking lanes in Section 12 is shown in figure 2. Load cart construction, details of linkage between the load compartment and prime mover, and method of applying load are explained in Part I. For trafficking lanes 26 and 27, the load compartment was weighted to produce a load of 105,000 lb on a three-wheel-abreast tracking assembly. For trafficking, the load wheels were spaced 33 and 27 in. c-c for lanes 26 and 27, respectively. Three 56x16, 24-ply aircraft tires with inflation pressure of 100 psi were used and the three wheels were on a single axle. Tire-print data and pertinent tire characteristics are given in figure 17.

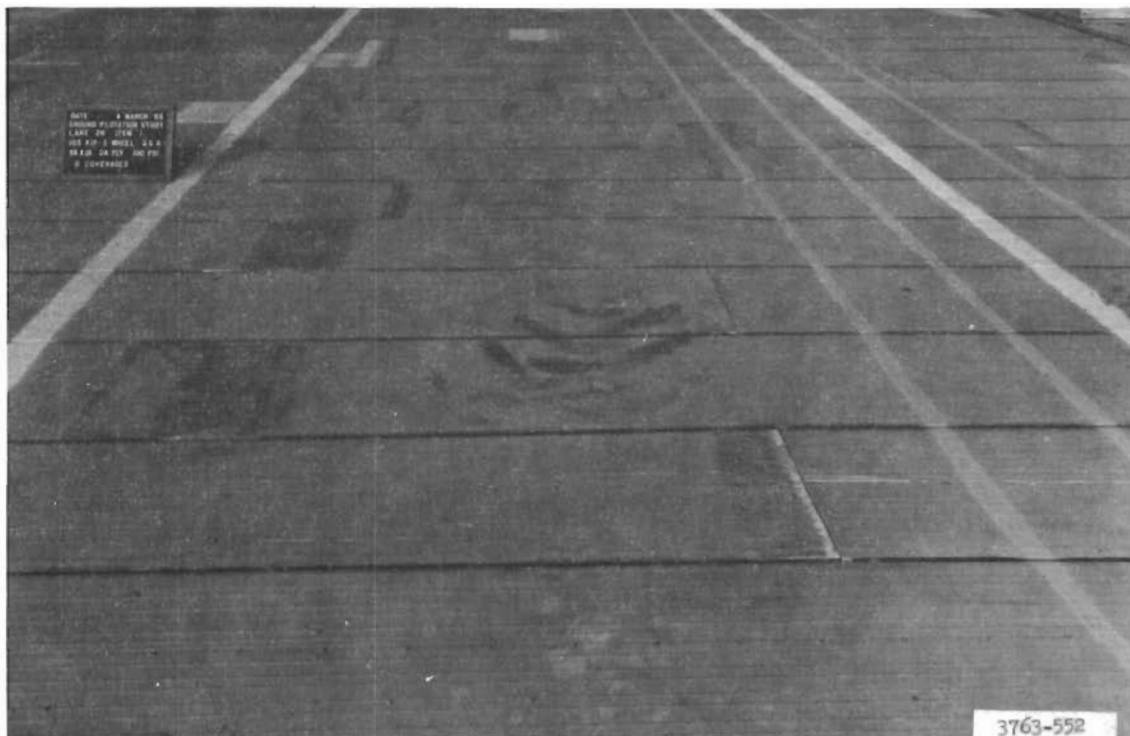
Figure 3. Lane 26, item 1, prior to traffic

Item 1. Item 1 prior to traffic is shown in figure 3. After 20 coverages, mat deformations measured about 1 in. and there were no mat breaks. Traffic was continued to 150 coverages at which time item 1 was considered failed due to roughness (figure 4). The rated CBR of the item was 2.2.

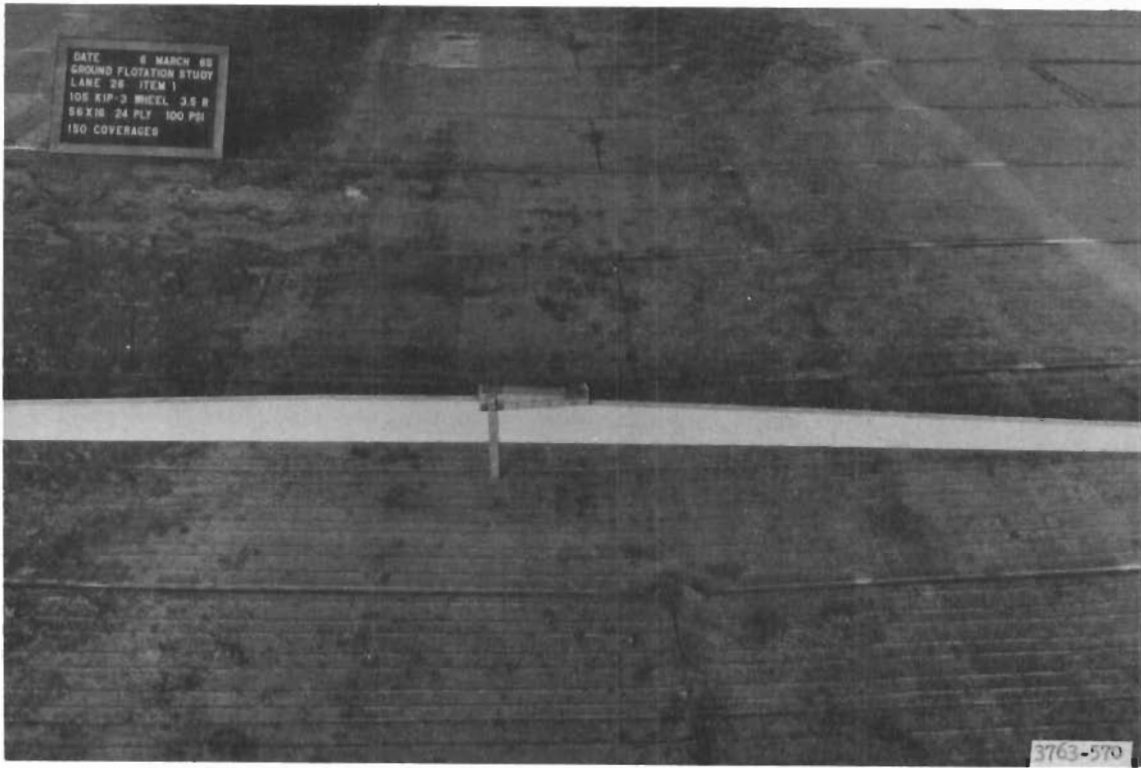
Figure 4. Lane 26, item 1. Transverse straightedge shows roughness at 150 coverages (failure)

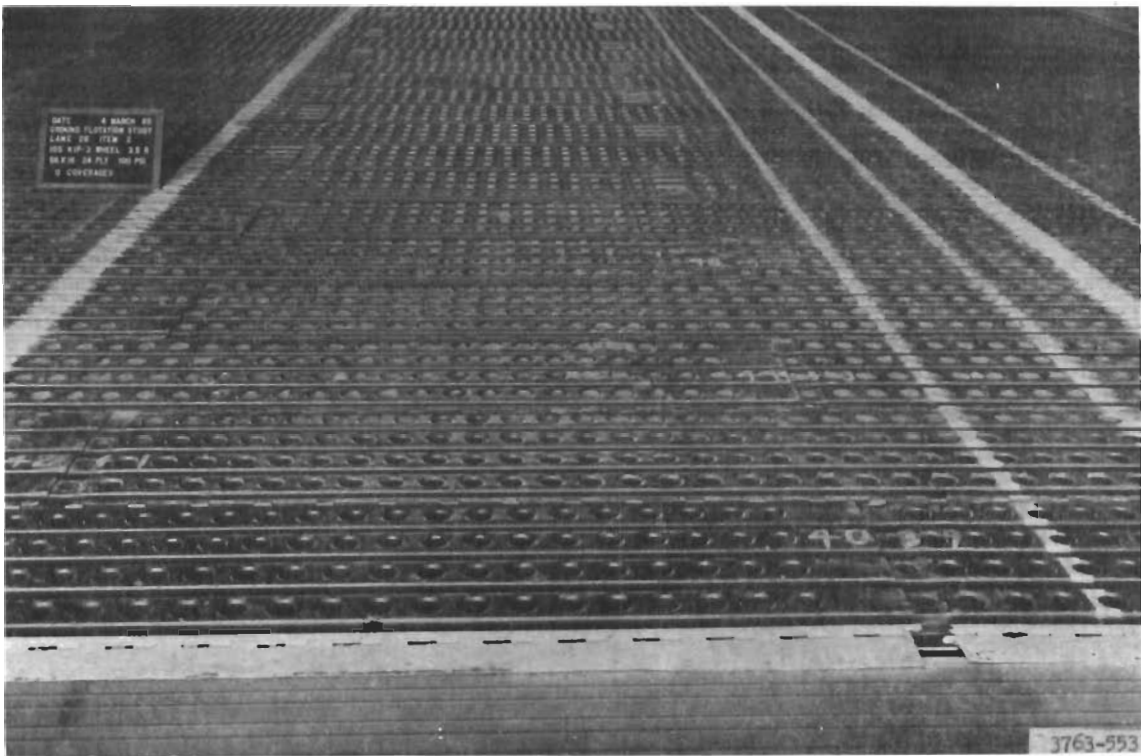
Figure 5. Lane 26, item 2, prior to traffic

Item 2. Item 2 prior to traffic is shown in figure 5. After 20 coverages, average mat deformation measured slightly less than 1 in. Traffic was continued to 150 coverages at which time item 2 was considered failed due to roughness. At failure, there was a considerable amount of subgrade extruded through the tubulated holes in the mat (figure 6). There were no mat breaks at failure. The rated CBR of the item was 3.7.

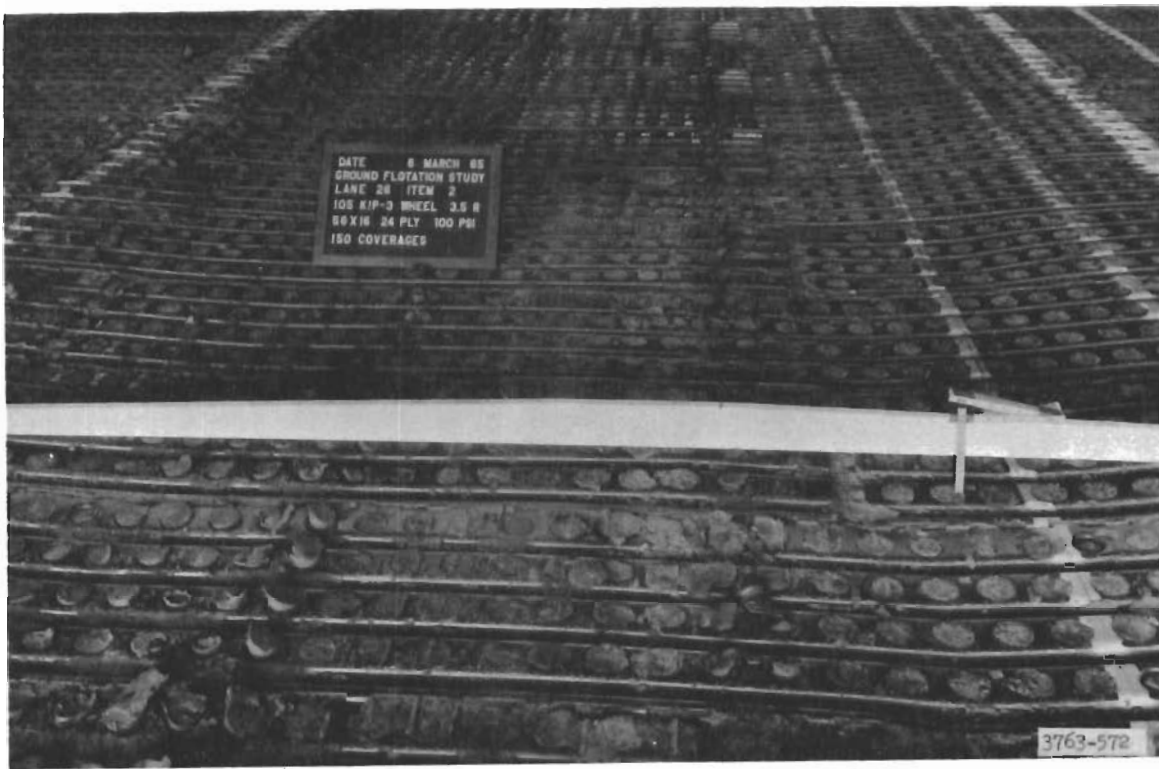
Figure 6. Lane 26, item 2. Transverse straightedge shows roughness at 150 coverages (failure)

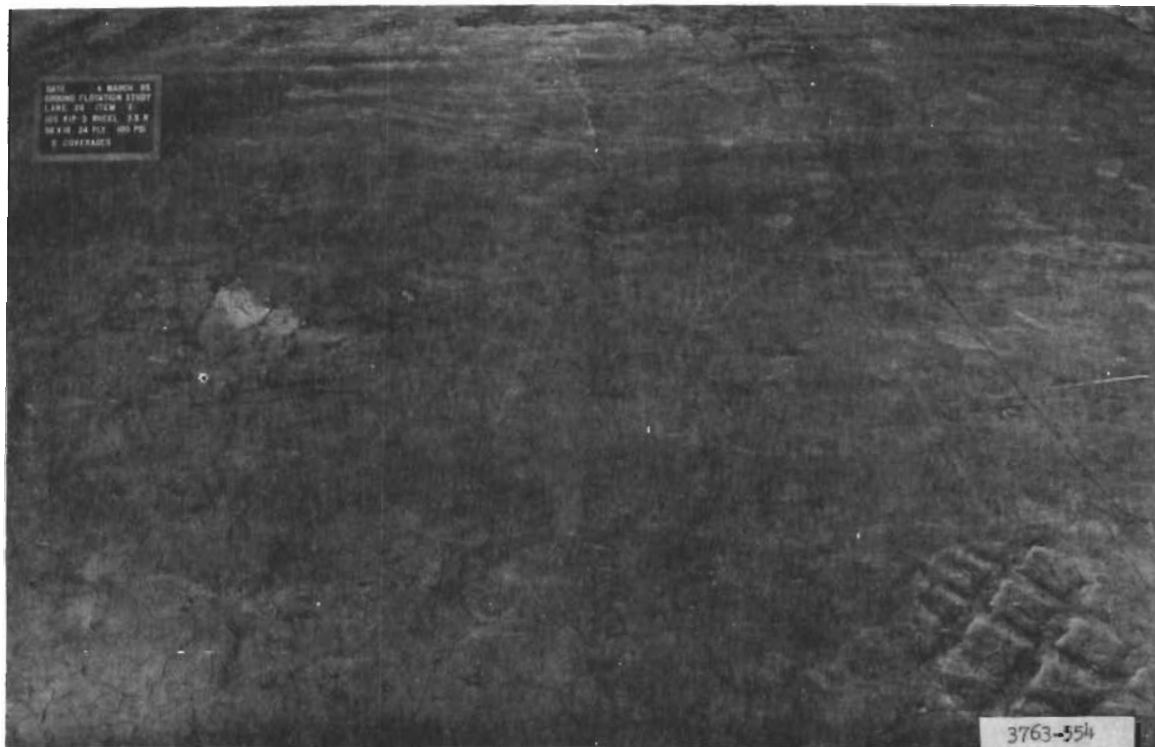
Figure 7. Lane 26, item 3, prior to traffic

Item 3. Item 3 prior to traffic is shown in figure 7. After 20 coverages, there was moderate soil deformation with an average rut depth of 0.78 in. At 72 coverages, the item was considered failed due to roughness (figure 8). The rated subgrade CBR was 11.0.

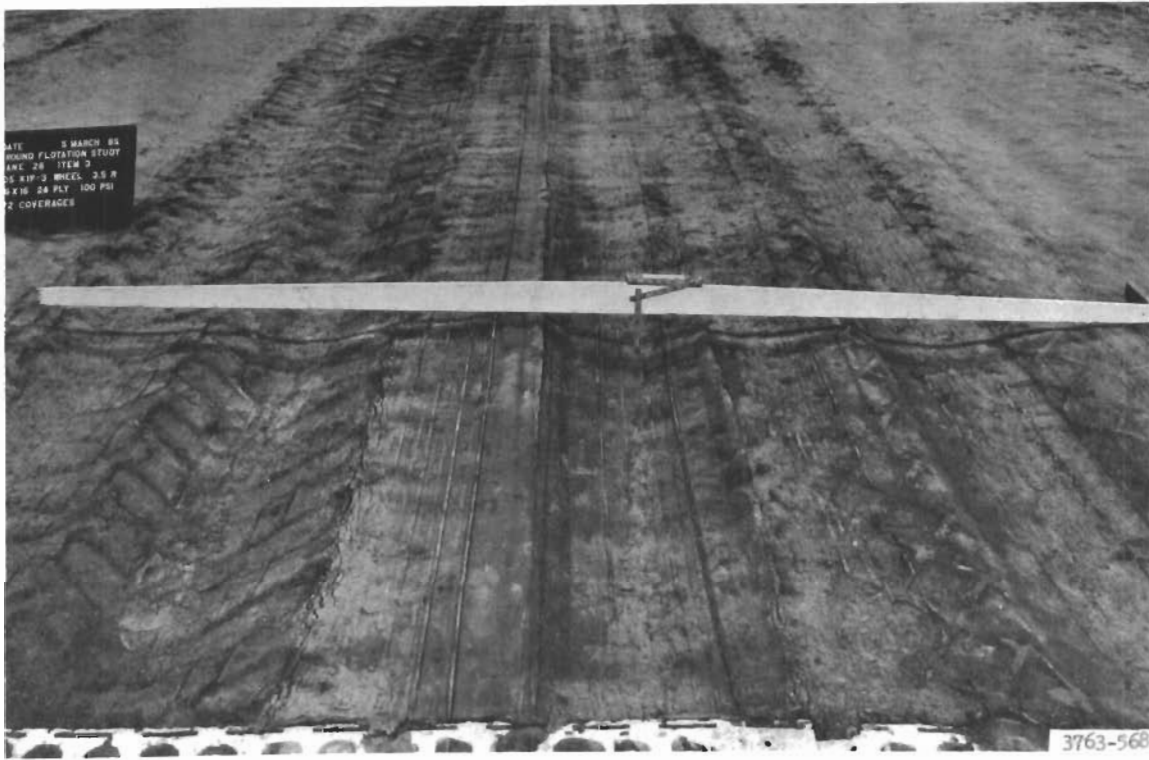
Figure 8. Lane 26, item 3. Transverse straightedge shows roughness at 72 coverages (failure)

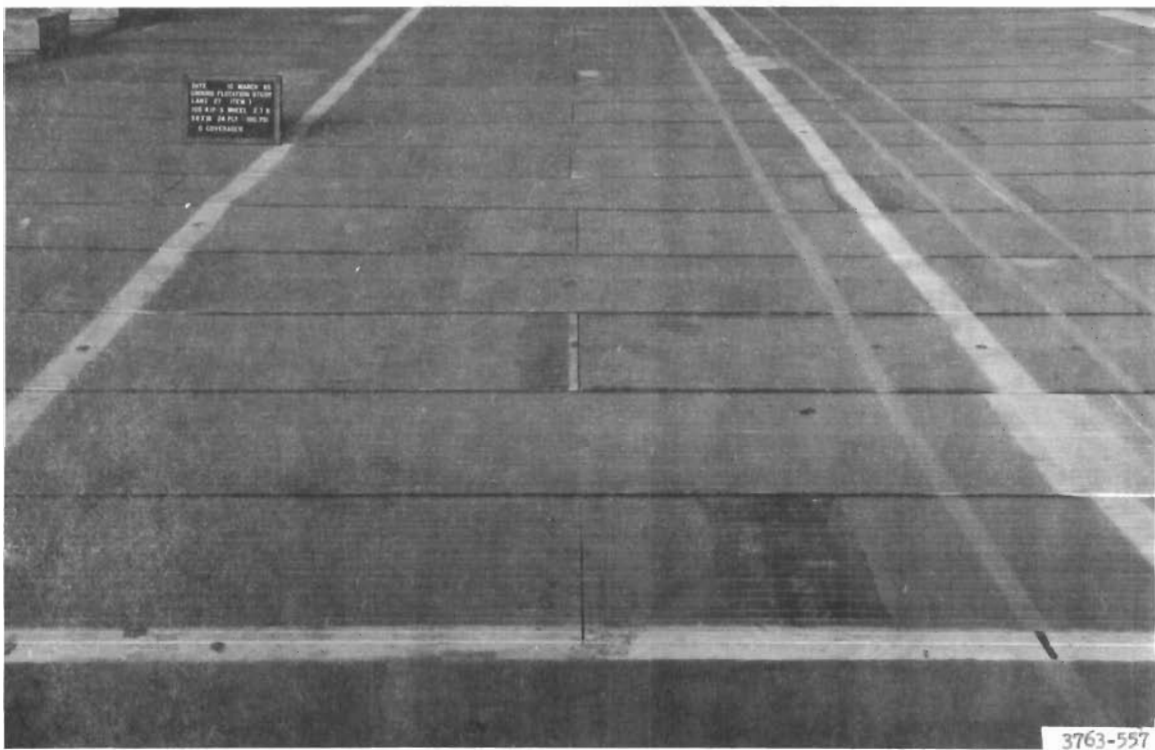
Figure 9. Lane 27, item 1, prior to traffic

Item 1. Item 1 prior to traffic is shown in figure 9. At 30 coverages, most of the center-line rivets in the panel in run 6 had sheared and the panel separated. At this time, mat runs 1-9 were eliminated from further consideration in testing. With continued traffic, additional panel center-line rivets failed and at 68 coverages the item was considered failed due to roughness and mat deterioration (figure 10). The rated CBR of the item was 2.4.

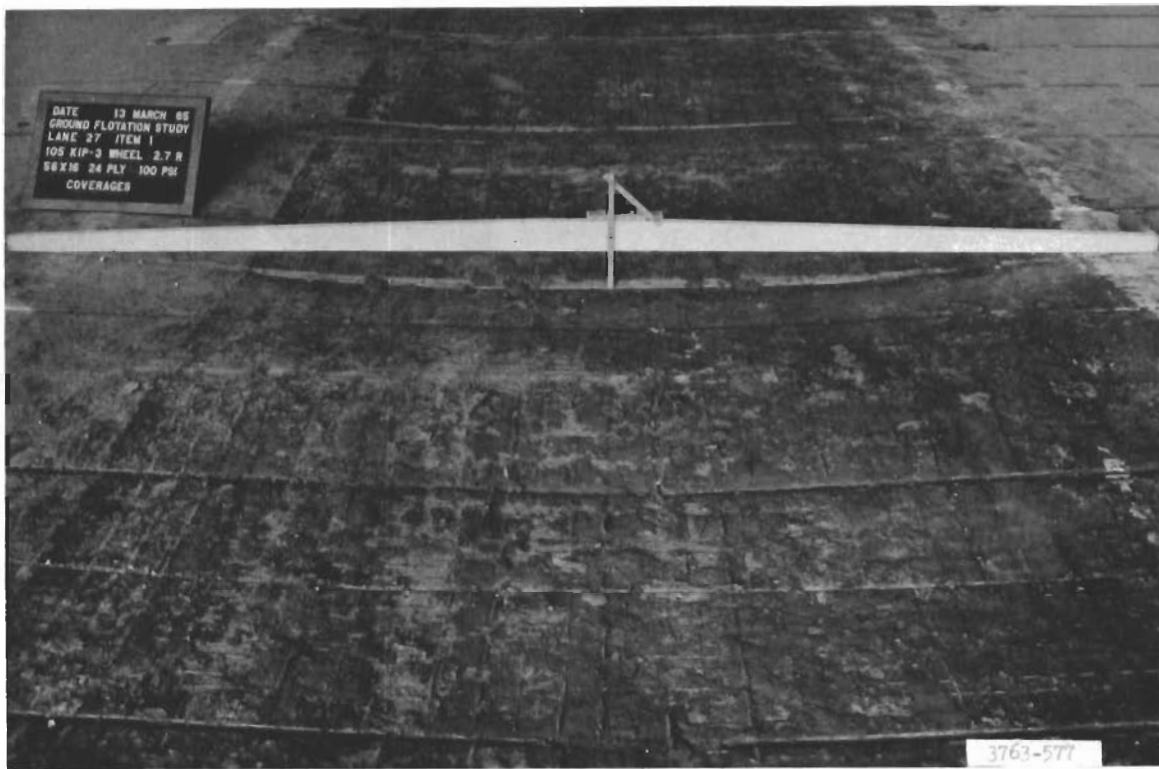
Figure 10. Lane 27, item 1. Transverse straightedge shows roughness at 68 coverages (failure)

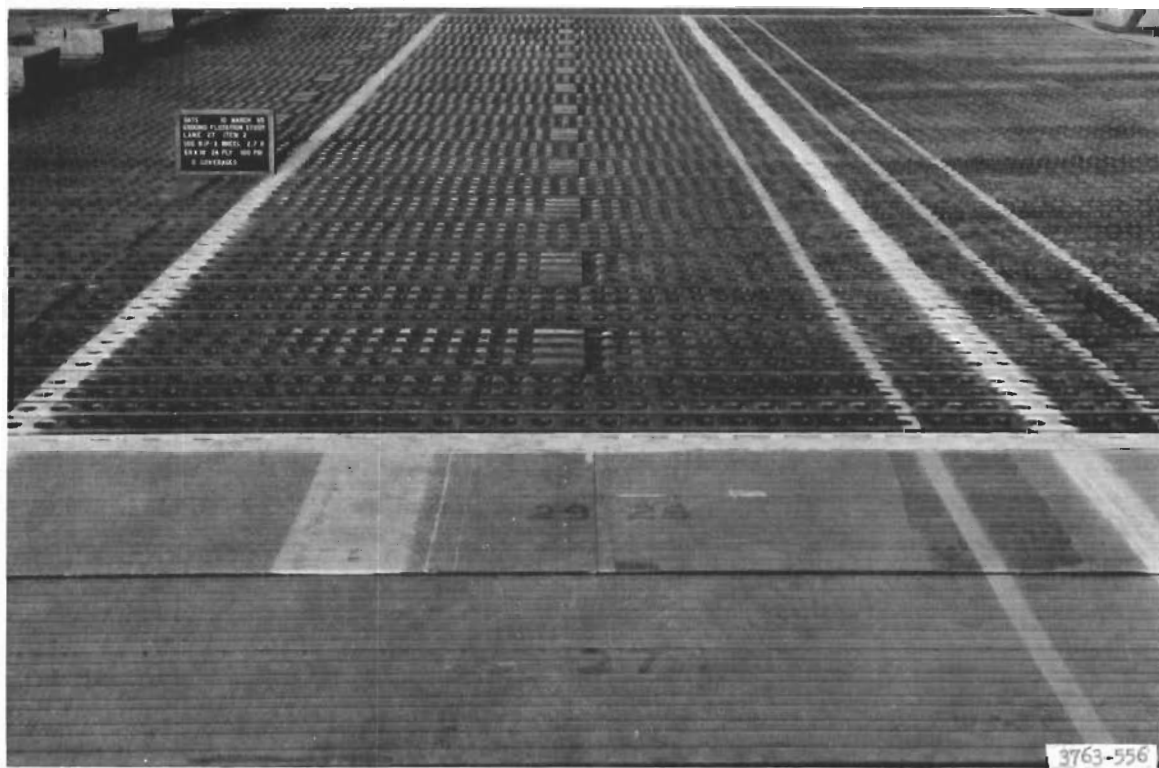
Figure 11. Lane 27, item 2, prior to traffic

Item 2. Item 2 prior to traffic is shown in figure 11. With continued traffic there was a considerable amount of subgrade extruded through the tubular holes in the mat. At 68 coverages the item was considered failed due to roughness (figure 12). The rated CBR of the item was 3.7.

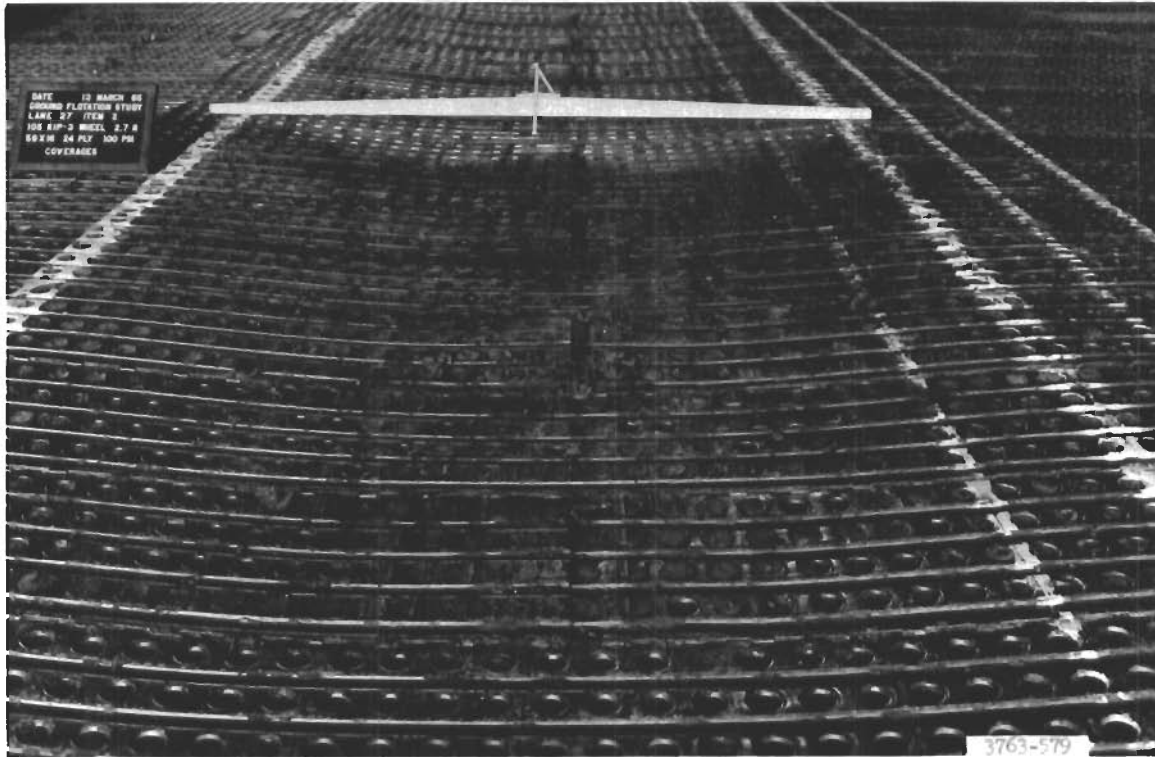
Figure 12. Lane 27, item 2. Transverse straightedge shows roughness at 68 coverages (failure)

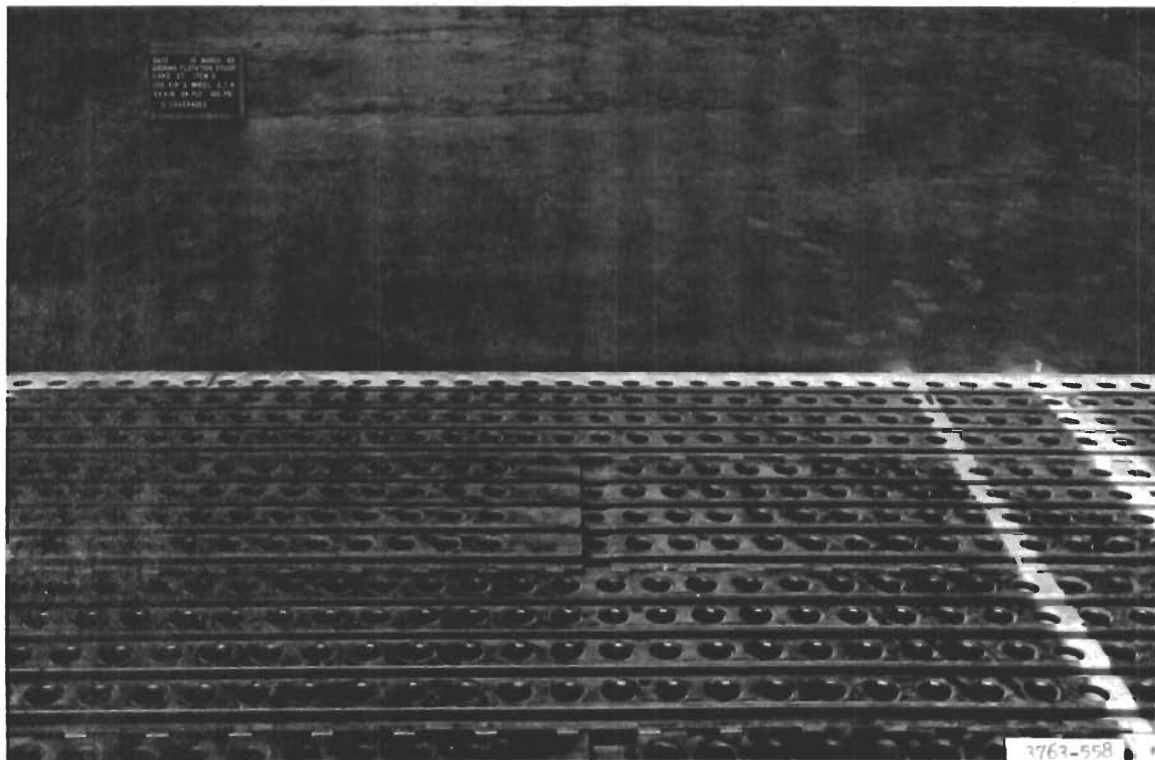
Figure 13. Lane 27, item 3, prior to traffic

Item 3. Item 3 prior to traffic is shown in figure 13. The item deformed rather easily under traffic and at 30 coverages was considered failed due to roughness (figure 14). The rated CBR of the item was 10.

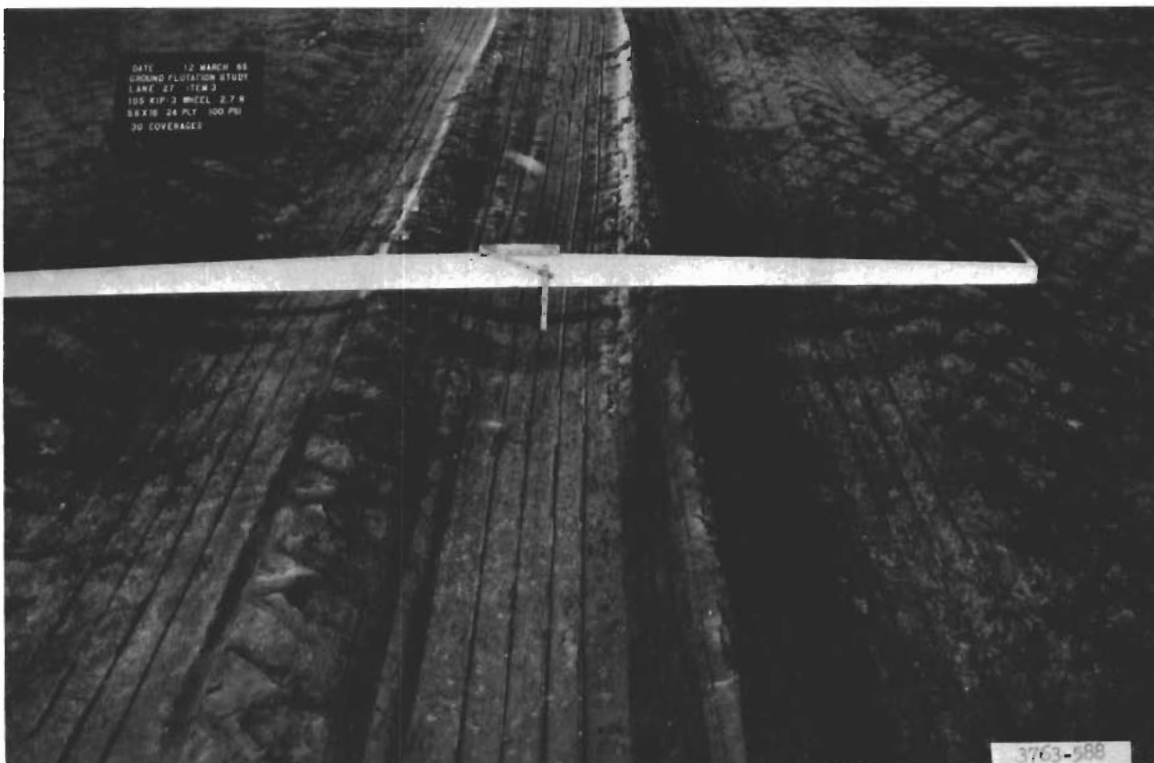
Figure 14. Lane 27, item 3. Transverse straightedge shows roughness at 30 coverages (failure)

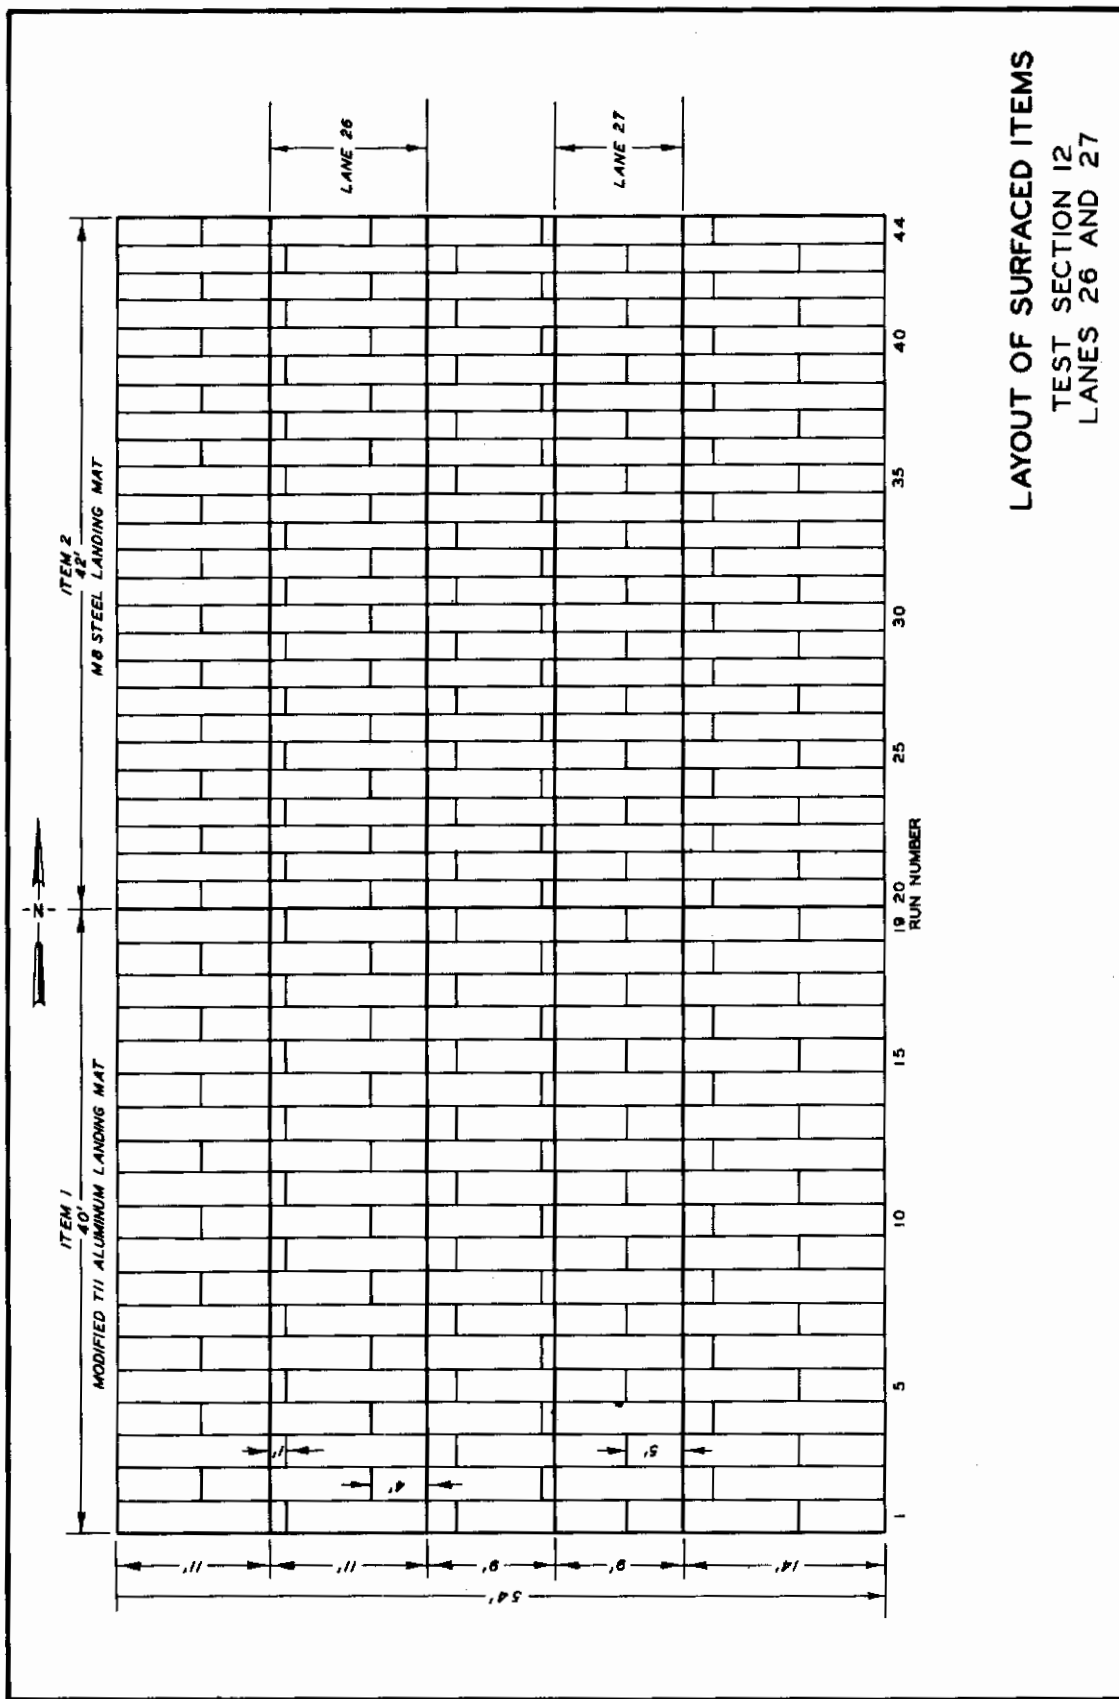
LAYOUT OF SURFACED ITEMS
TEST SECTION 12
LANES 26 AND 27

Tests on Section 12 are one phase of a comprehensive research program to develop ground-flotation criteria for heavy cargo-type aircraft. Section 12 consisted of two similar traffic lanes, lanes 26 and 27, each of which was divided into three items having different traffic surfaces and different subgrade CBR values (figure 15). Items 1 and 2 were surfaced with T11 aluminum and M8 steel landing mat, respectively (figure 16), and item 3 remained unsurfaced.

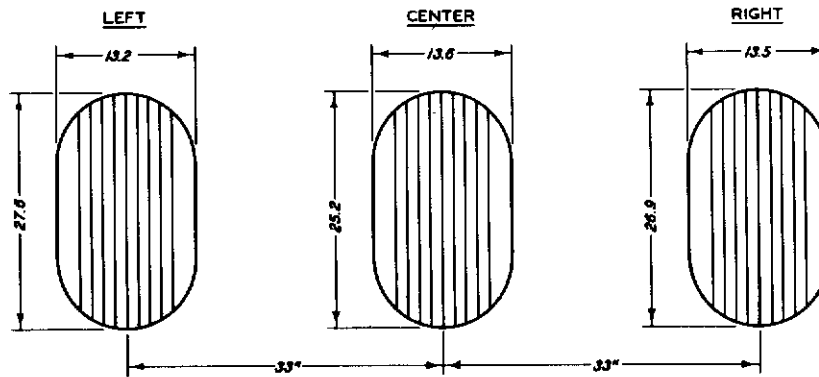
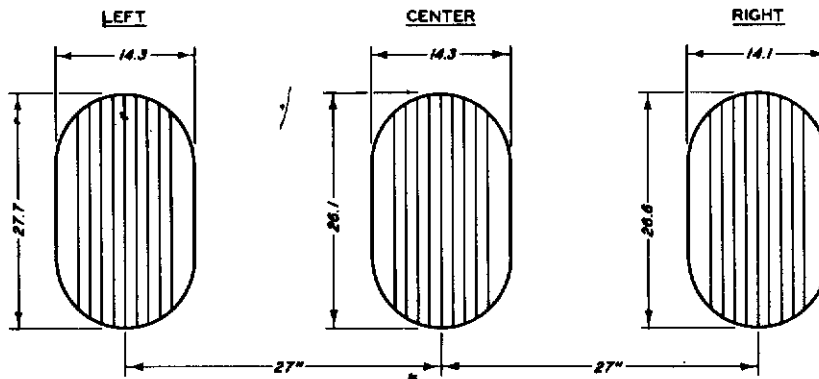
Figure 17

LEFT TIRE	CENTER TIRE	RIGHT TIRE
CONTACT AREA, SQ IN.	330	333	335
CONTACT PRESSURE, PSI	108	105	105
INFLATION PRESSURE, PSI	100	100	100
DEFLECTION, %	47	48	44
GROSS ASSEMBLY LOAD = 105,000 LB

LEFT TIRE	CENTER TIRE	RIGHT TIRE
CONTACT AREA, SQ IN.	346	334	333
CONTACT PRESSURE, PSI	101	105	105
INFLATION PRESSURE, PSI	100	100	100
DEFLECTION, %	51	45	44
GROSS ASSEMBLY LOAD = 105,000 LB

**TIRE-PRINT DIMENSIONS AND
TIRE CHARACTERISTICS**

TEST SECTION 12
LANES 26 AND 27
56X16, 24-PLY TIRES

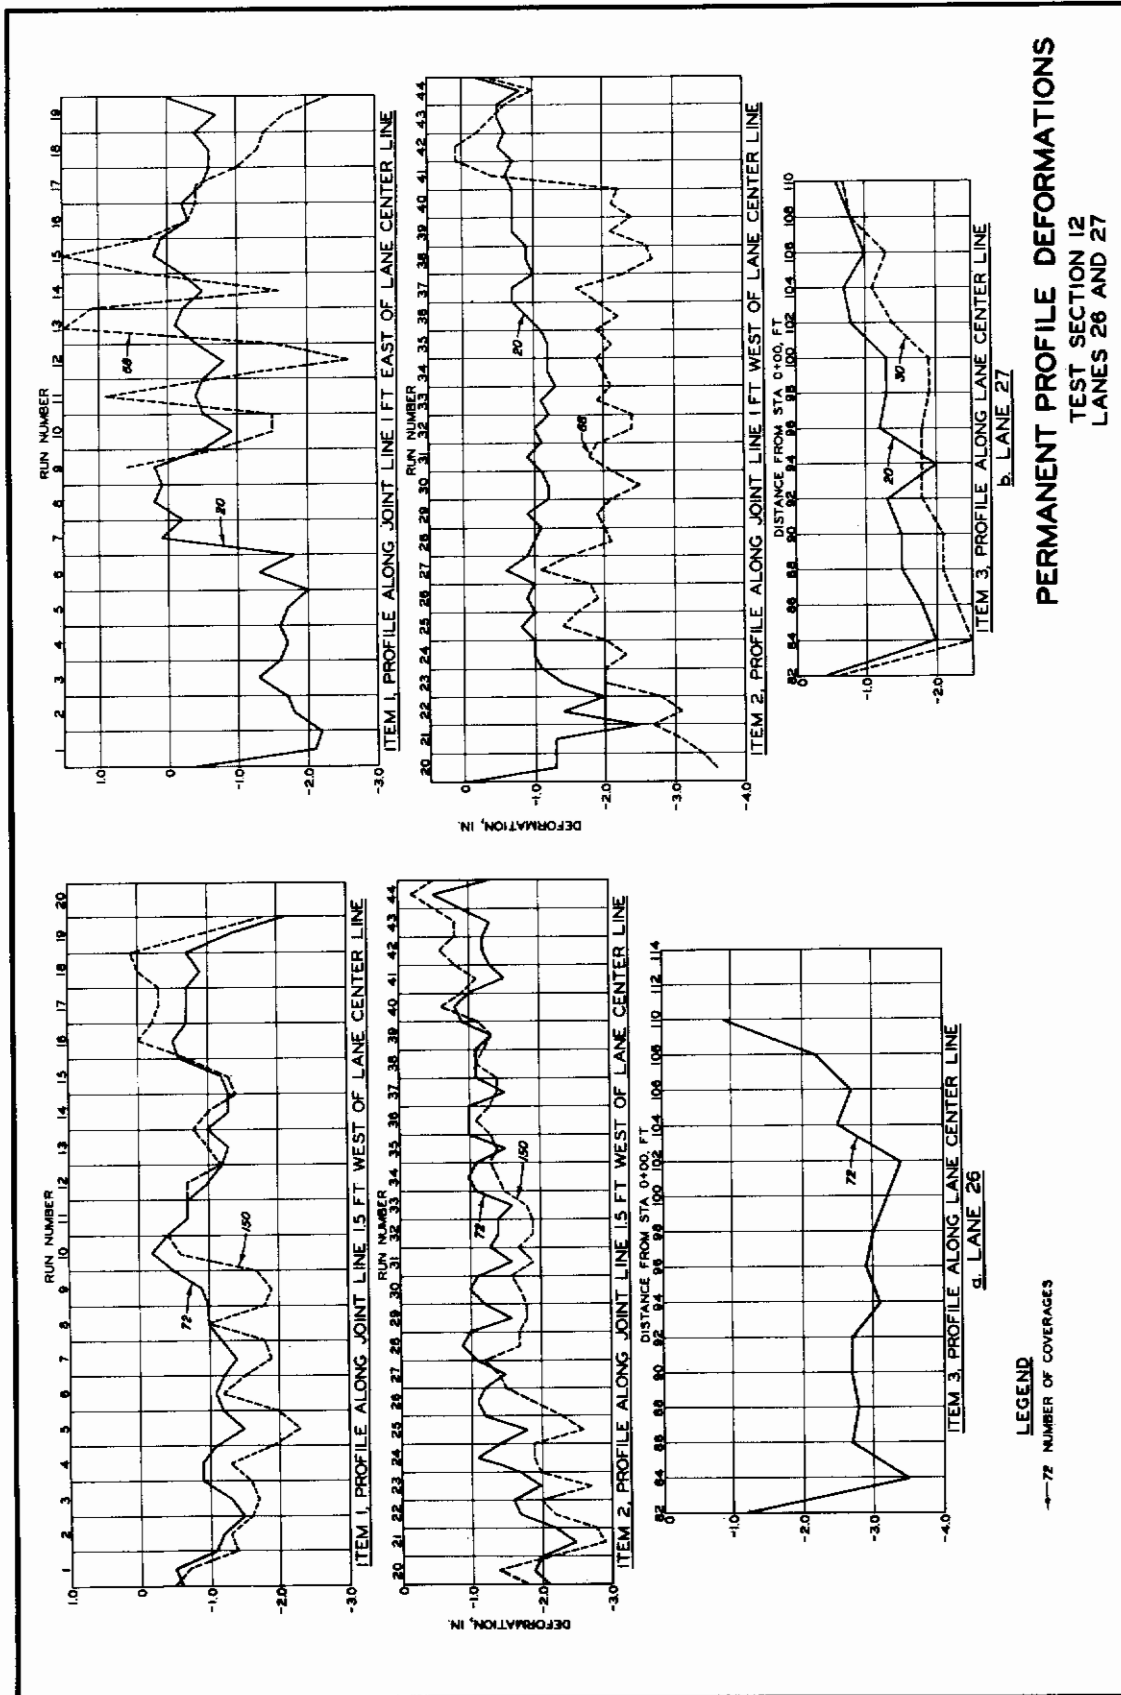
PERMANENT PROFILE DEFORMATIONS
 TEST SECTION 12
 LANES 26 AND 27

- b. Deformation. Average cross-section deformations for the two typical mat runs are shown in figure 18 for 72 and 150 coverages. Figure 19 shows profile deformations for the same coverage levels.

consideration, the cross-section plots do not represent averages but only single measurements at mat runs 13 and 16 as indicated. The elevated position of the mat surface at run 13 for 68 coverages was due to the extreme longitudinal deformations which resulted in transverse humps in the traffic lane. The very severe profile deformations that existed at failure are evident in figure 19.

- b. Deformation. Average cross-section and profile deformations at 20 and 30 coverages are shown in figures 18 and 19, respectively. Both figures indicate progressive deterioration under traffic with figure 19 showing settlement along the length of the item.
