PROBLEMS IN USING METALLIC MATERIALS
AT ELEVATED TEMPERATURESA. M. Hall
Battelle Memorial Institute

ASD TDR 62-396

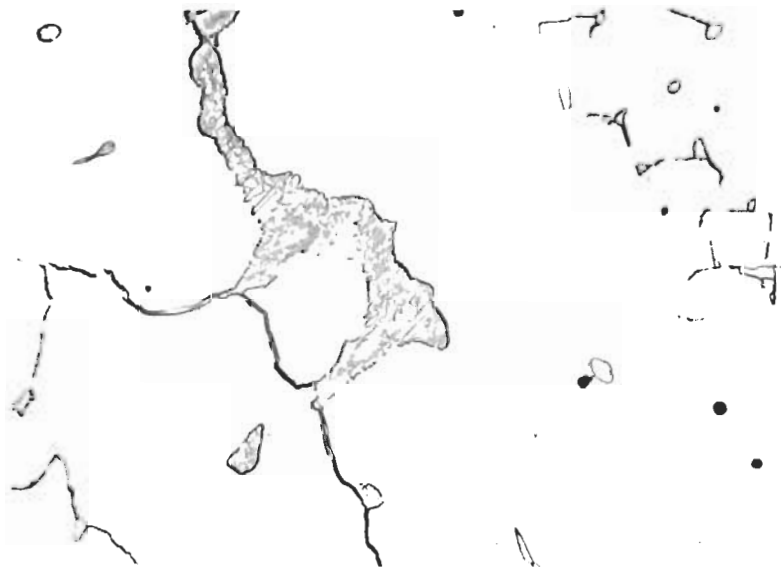
Figure 4. A 20 Cr-9 Ni Alloy as Cast. Eutectic Carbides, Some Intergranular Carbides and Occasional Islands of Delta Ferrite are Present

Sometimes ignorance of the degree of stability of the material of construction, as a function of time at elevated temperatures, can lead to unexpected failures. The precipitation of carbides (figures 4 and 5), or the gradual formation of the sigma phase (figure 6), in certain stainless steels can convert what started out as a ductile alloy into a brittle material. Because the design concept was based on ductility and toughness in the material, the structure eventually failed. It had been considered that little attention need be paid to the presence of designed-in notches or adventitious stress raisers. Had it been known that the alloy would become brittle and notch sensitive, a different material might have been selected, the design might have been changed, and the quality control standards used in manufacture might have been raised.

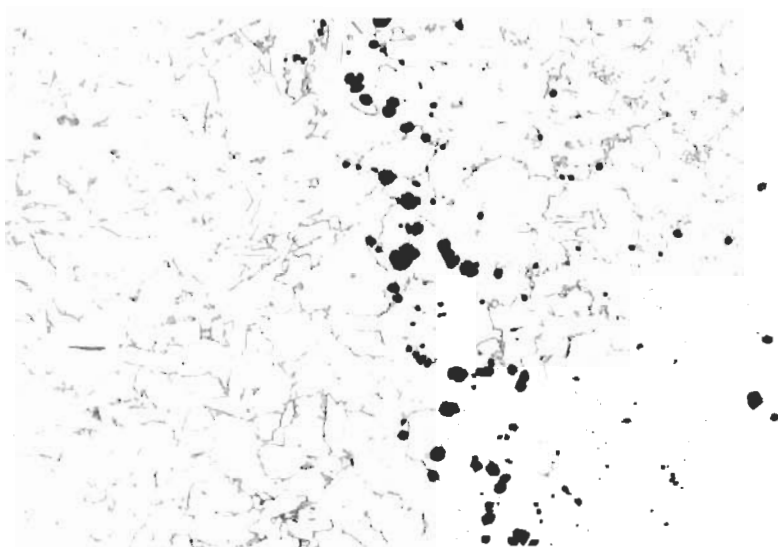
Figure 8. An Example of Moderate Graphitization at the Low-Temperature Edge of a Weld-Heat-Affected Zone

The history of steam piping affords a classical example of a failure due to the unexpected influence of long times at elevated temperatures on the microstructure of steel. Until 1945, it was not thoroughly appreciated that the normally observed microstructure of plain and low-alloy steels, that is, a mixture of ferrite and pearlite, is actually metastable, even through thermodynamic calculations had shown that such is the case. Then, a steam line leading from one of the boilers at the Springdale Station of the West Penn Power Company came apart near a welded joint. The fact that the boiler was going off the line averted what would otherwise have been a catastrophe. During the years, the microstructure of the steel changed from ferrite and pearlite to the stable state of ferrite and graphite. The latter had concentrated along the low-temperature edge of the weld-heat-affected zone to the point that a narrow section of the pipe had become converted essentially to graphite. Examples of graphitization are shown in figures 7, 8 and 9. Through research it was established that the addition of a small amount of chromium to the steel would stabilize the ferrite-plus-pearlite structure.
