**WADC TECHNICAL REPORT 54-492
PART III**

**OXIDATION-RESISTANT COATINGS
FOR MOLYBDENUM**

Climax Molybdenum Company of Michigan

April 1957

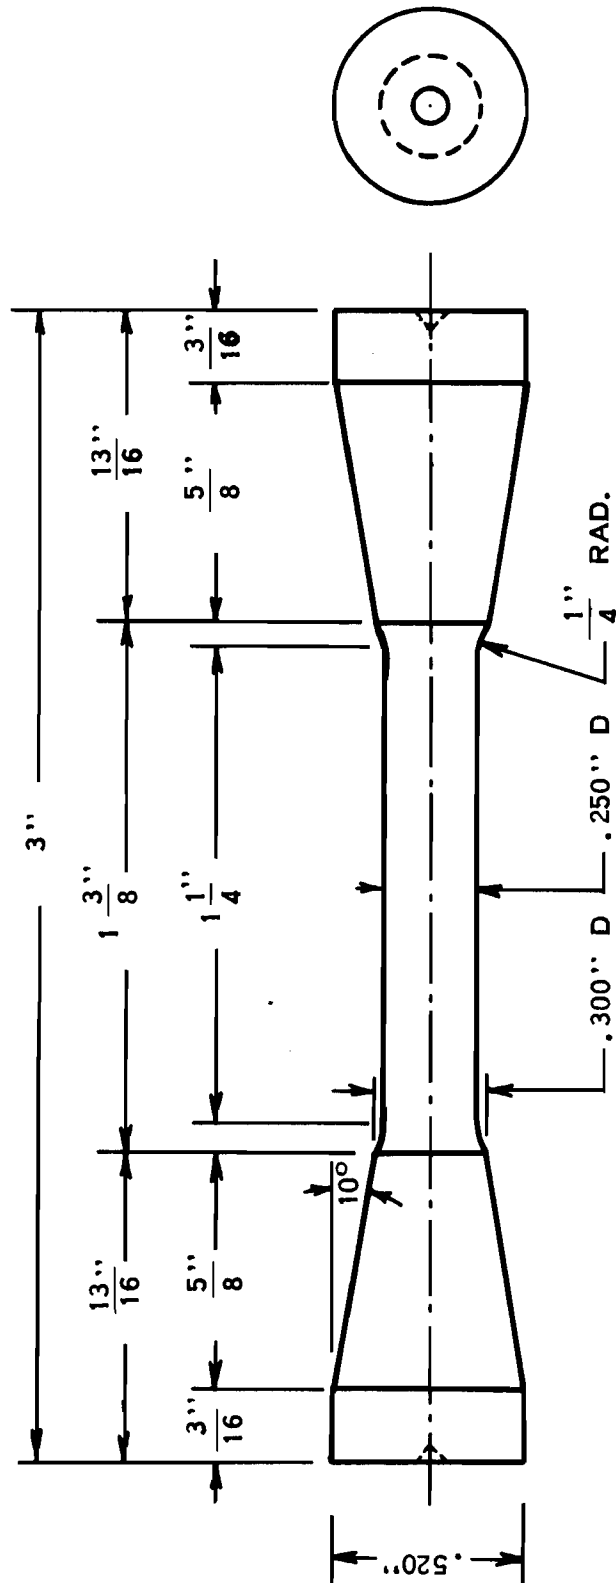
FIGURE 1 (917) - DUCTILITY TEST SPECIMEN WITH TAPERED ENDS

Coated molybdenum is subjected to the ductility test to determine whether the coating has the capacity to sustain a small amount of plastic deformation and still provide protection of the molybdenum against oxidation at 1800°F. In the ductility test formerly employed, plastic deformation amounting to 2-5% elongation was produced in creep-rupture testing equipment during 100 or 500 hours of testing. This test was tedious and expensive to perform. Inasmuch as a precise measurement of the elongation of the specimen was not required, a simpler test was adopted. In this test a cylindrical specimen with tapered ends for gripping is employed. A sketch of the specimen is shown in Figure 1. Electroplated specimens are tested without further finishing of the specimen. Spray-coated specimens are coated on all surfaces. After the diffusion treatment, the coating is machine ground to a smooth finish. The flat ends of the specimen are ground parallel. The distance between the ends is measured. The specimen is then subjected to an oxidation test in air for 4 to 8 hours at 1800°F to expose gross flaws in the coating.

The rate of elongation is estimated by measuring the movement of the cross-head with a dial gage during testing. After approximately 4% elongation is observed on the dial gage, the specimen is removed from the tensile machine, and the distance between the flat surfaces on the ends of the specimen is measured with a micrometer to determine the exact amount of elongation. Due to slippage in the grips, 4% elongation measured by the dial gage actually produces approximately 2% elongation in the specimen. The elongated specimen is subjected to the standard oxidation test at 1800°F, to determine if the plastic deformation of the coated specimen has caused ruptures in the coating sufficient to expose the underlying molybdenum to oxidation.

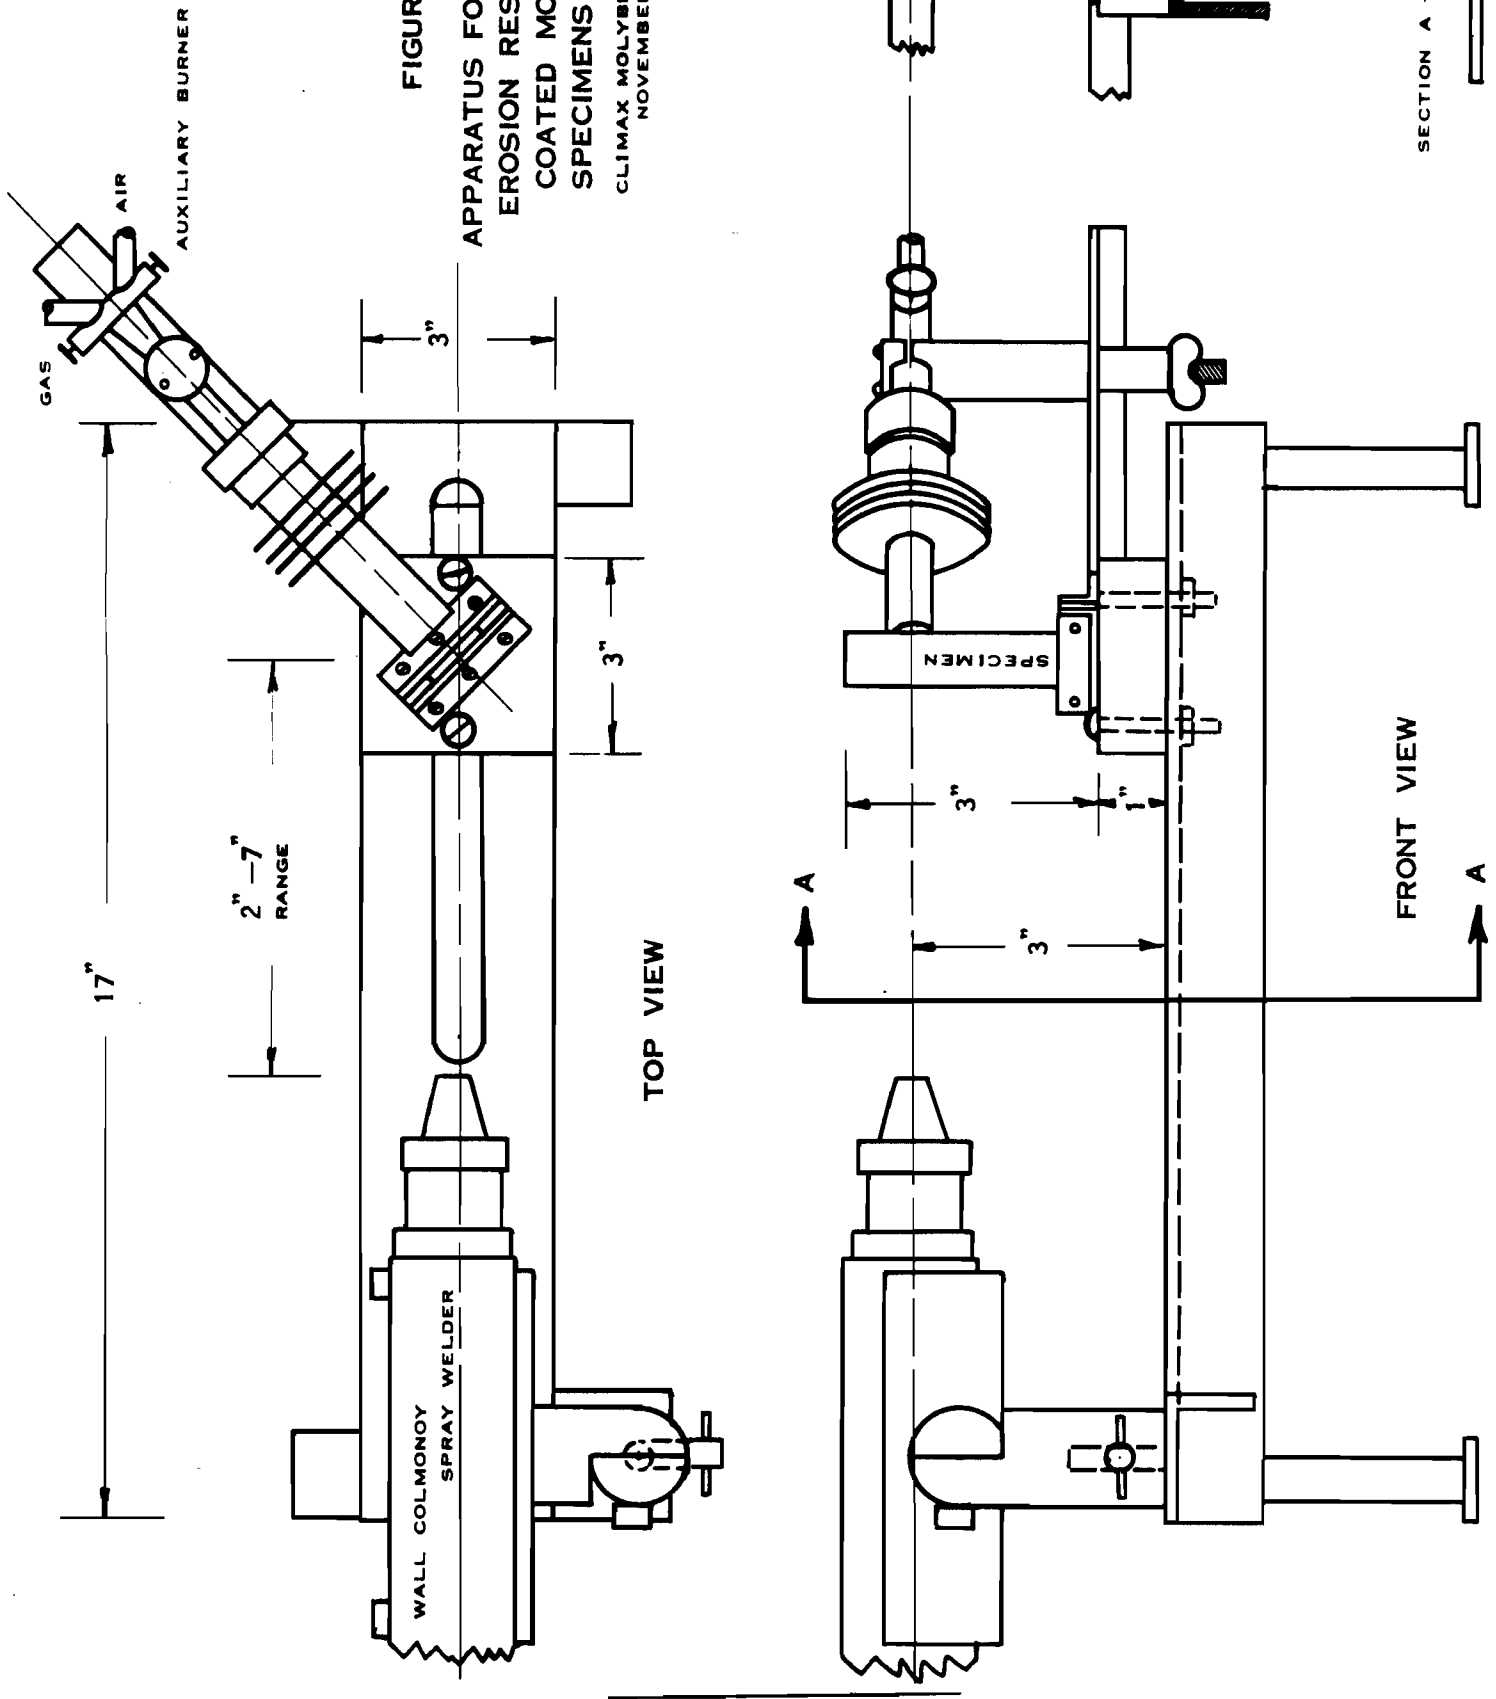
FIGURE 2
APPARATUS FOR EVALUATING
EROSION RESISTANCE OF
COATED MOLYBDENUM
SPECIMENS AT 1800 F
 CLIMAX MOLYBDENUM CO. 972
 NOVEMBER 9, 1955

The specimen is clamped in the vise shown in Figure 2 at a distance of four inches from the nozzle of the Spraywelder. The auxiliary burner is ignited and the gas-air ratio is adjusted to obtain an oxidizing flame at an air pressure of 24-25 psi.

The flame from the auxiliary burner is adjusted again so that the specimen is heated by the two heat sources to about 1780°F , as measured with an optical pyrometer.

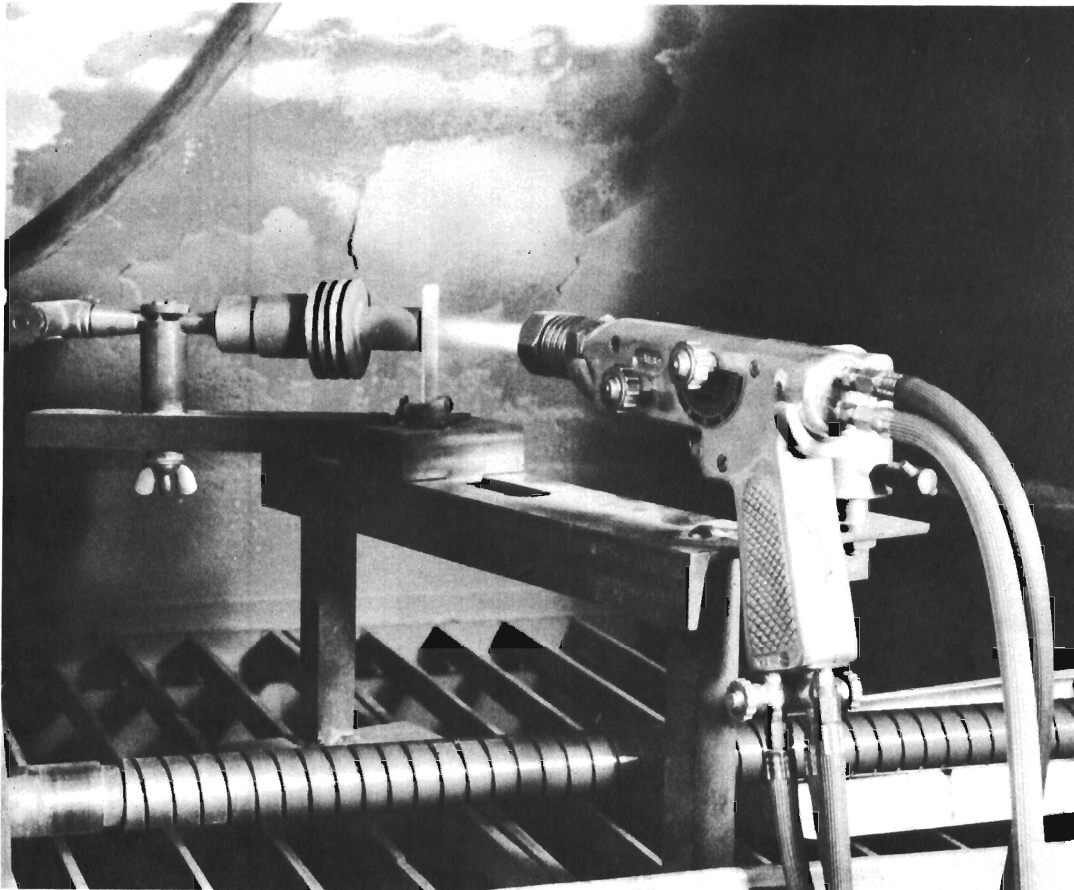
**FIGURE 3 (P1267) - HOT GRIT BLASTING OF COATED MOLYBDENUM SPECIMEN
USING EROSION TEST APPARATUS**

The temperature of the specimen is measured with an optical pyrometer after the specimen has been blasted with grit for a few minutes. It has been found that the hot, impinging grit raises the temperature of the specimen about 30 to 40°F . The auxiliary burner is adjusted, if necessary, so as to maintain the specimen at a temperature in the range $1800\text{-}1820^{\circ}\text{F}$. A specimen being hot-grit blasted is shown in Figure 3.

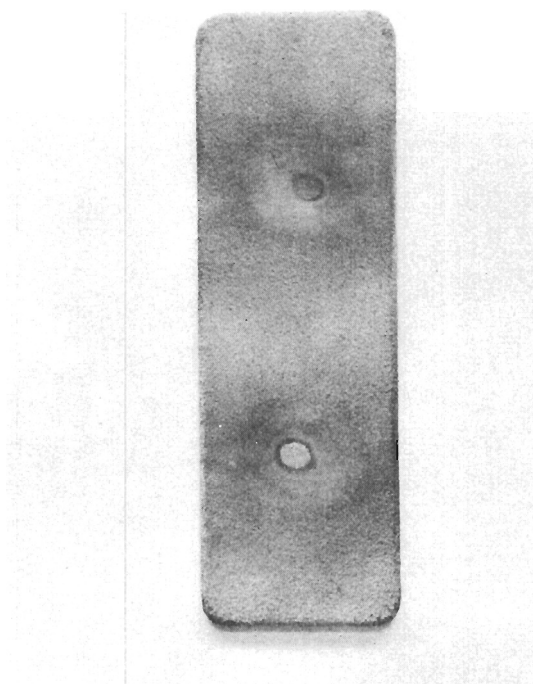
FIGURE 4 (P1325) FULL SIZE

COATED MOLYBDENUM SPECIMEN SHOWING THE TWO
ERODED AREAS OBTAINED IN TWO EROSION TESTS
AT 1800⁰F (Al-Cr-Si Coating)

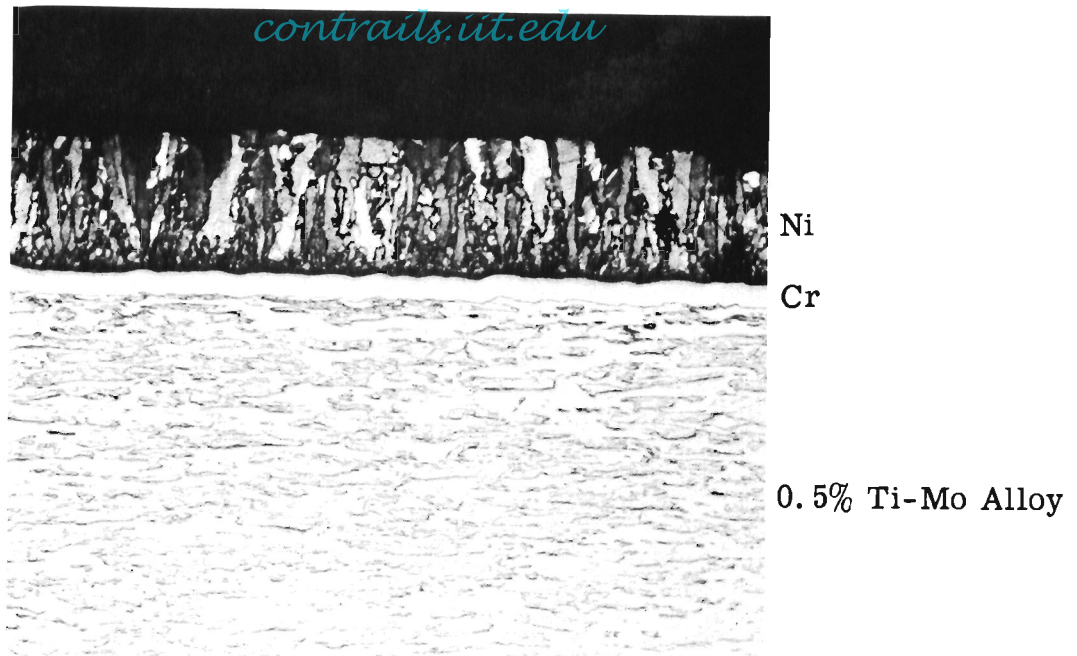
FIGURE 5 (M6091) X100
 Etchants: (1) Polish-Etch-Buff
 (2) Carapella's Reagent
 (3) NaOH + $K_3Fe(CN)_6$

CHROMIUM-NICKEL PLATING ON 0.5% Ti-Mo ALLOY IN
 AS-RECEIVED CONDITION

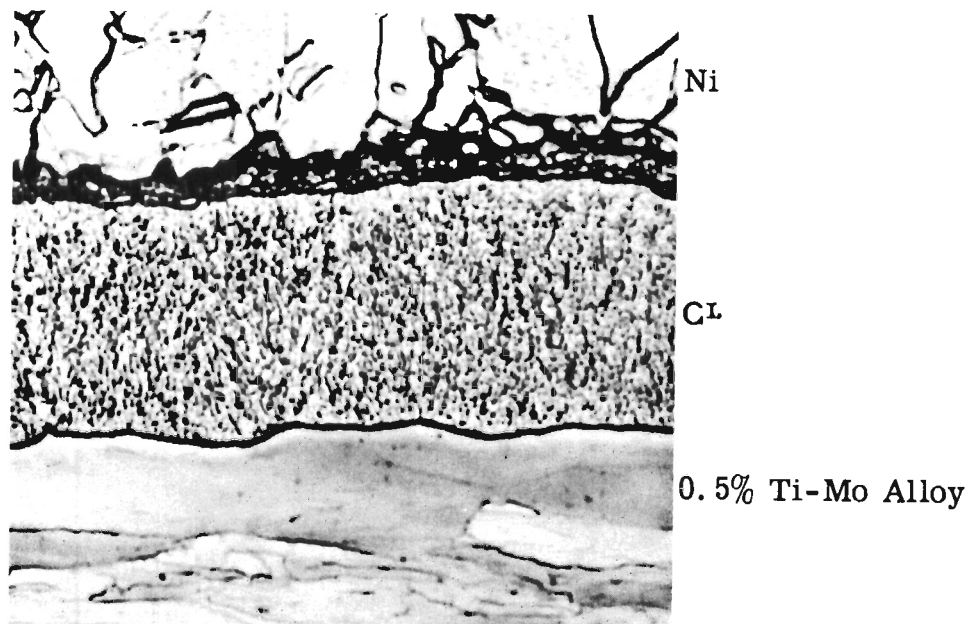
FIGURE 6 (M5940) X750
 Etchants: (1) Polish-Etch-Buff
 (2) Electrolytic Polish
 (3) Carapella's Reagent
 (4) NaOH + $K_3Fe(CN)_6$

CHROMIUM-NICKEL PLATING ON 0.5% Ti-Mo ALLOY
 IN AS-RECEIVED CONDITION

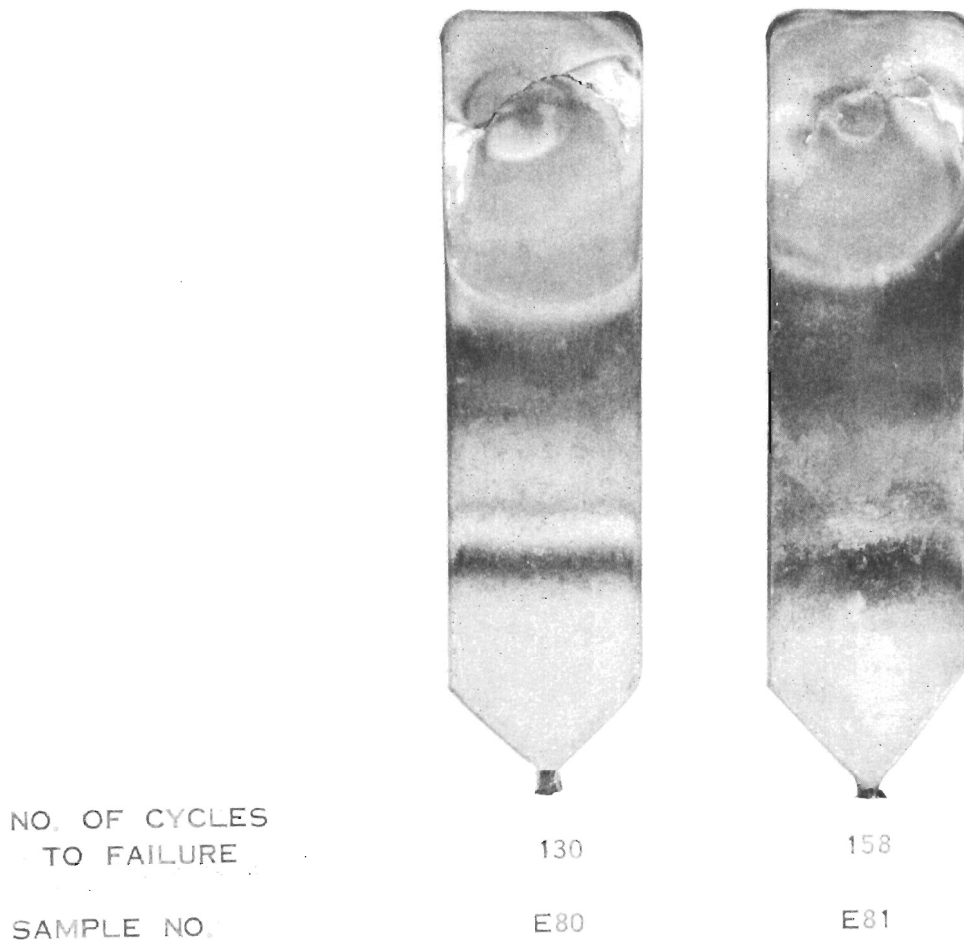
FIGURE 7 (P1411)

APPEARANCE OF CHROMIUM-NICKEL PLATED SPECIMENS AFTER THERMAL SHOCK TEST (TESTED IN AS-RECEIVED CONDITION)

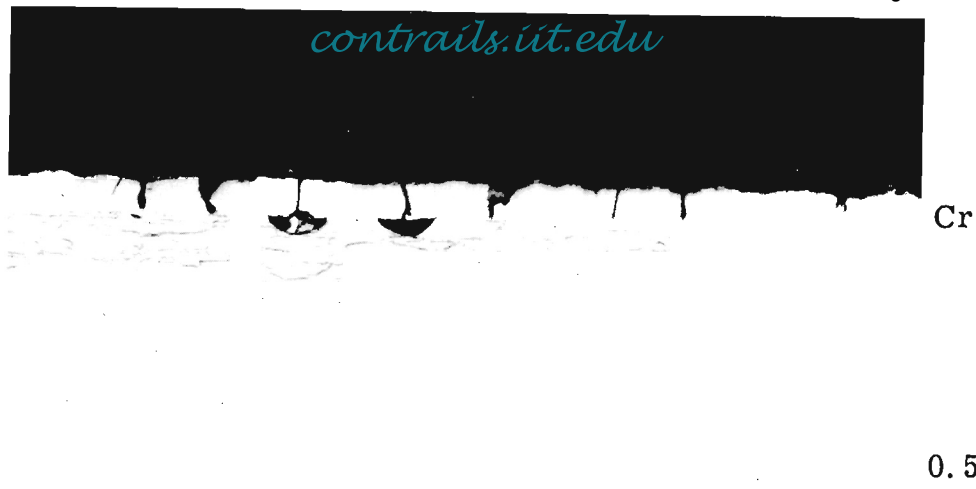
FIGURE 8 (M6102) Polish-Etch-Buffer

SECTION THROUGH BLISTER IN PLATING OF THERMAL SHOCK SPECIMEN E81 TESTED IN AS-RECEIVED CONDITION SHOWING CHROMIUM PLATE ADHERING TO MOLYBDENUM

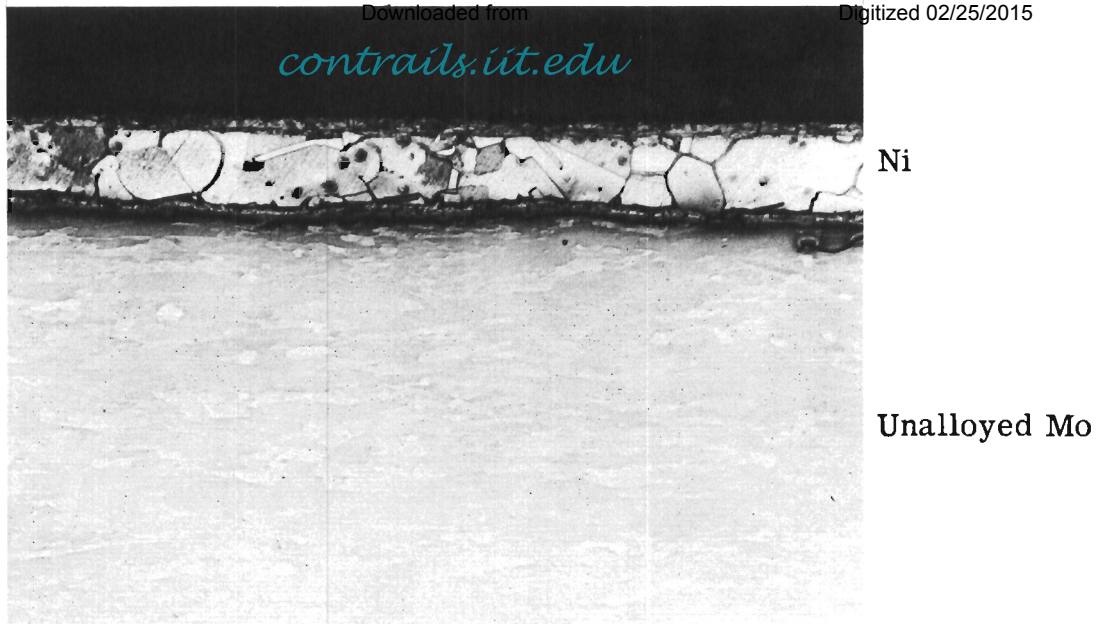
FIGURE 11 (M6084)

STRUCTURE OF 0.096 IN. THICK Ni-CLAD MOLYBDENUM STOCK
AS-RECEIVED. NICKEL LAYER IS 0.005 IN. THICK.

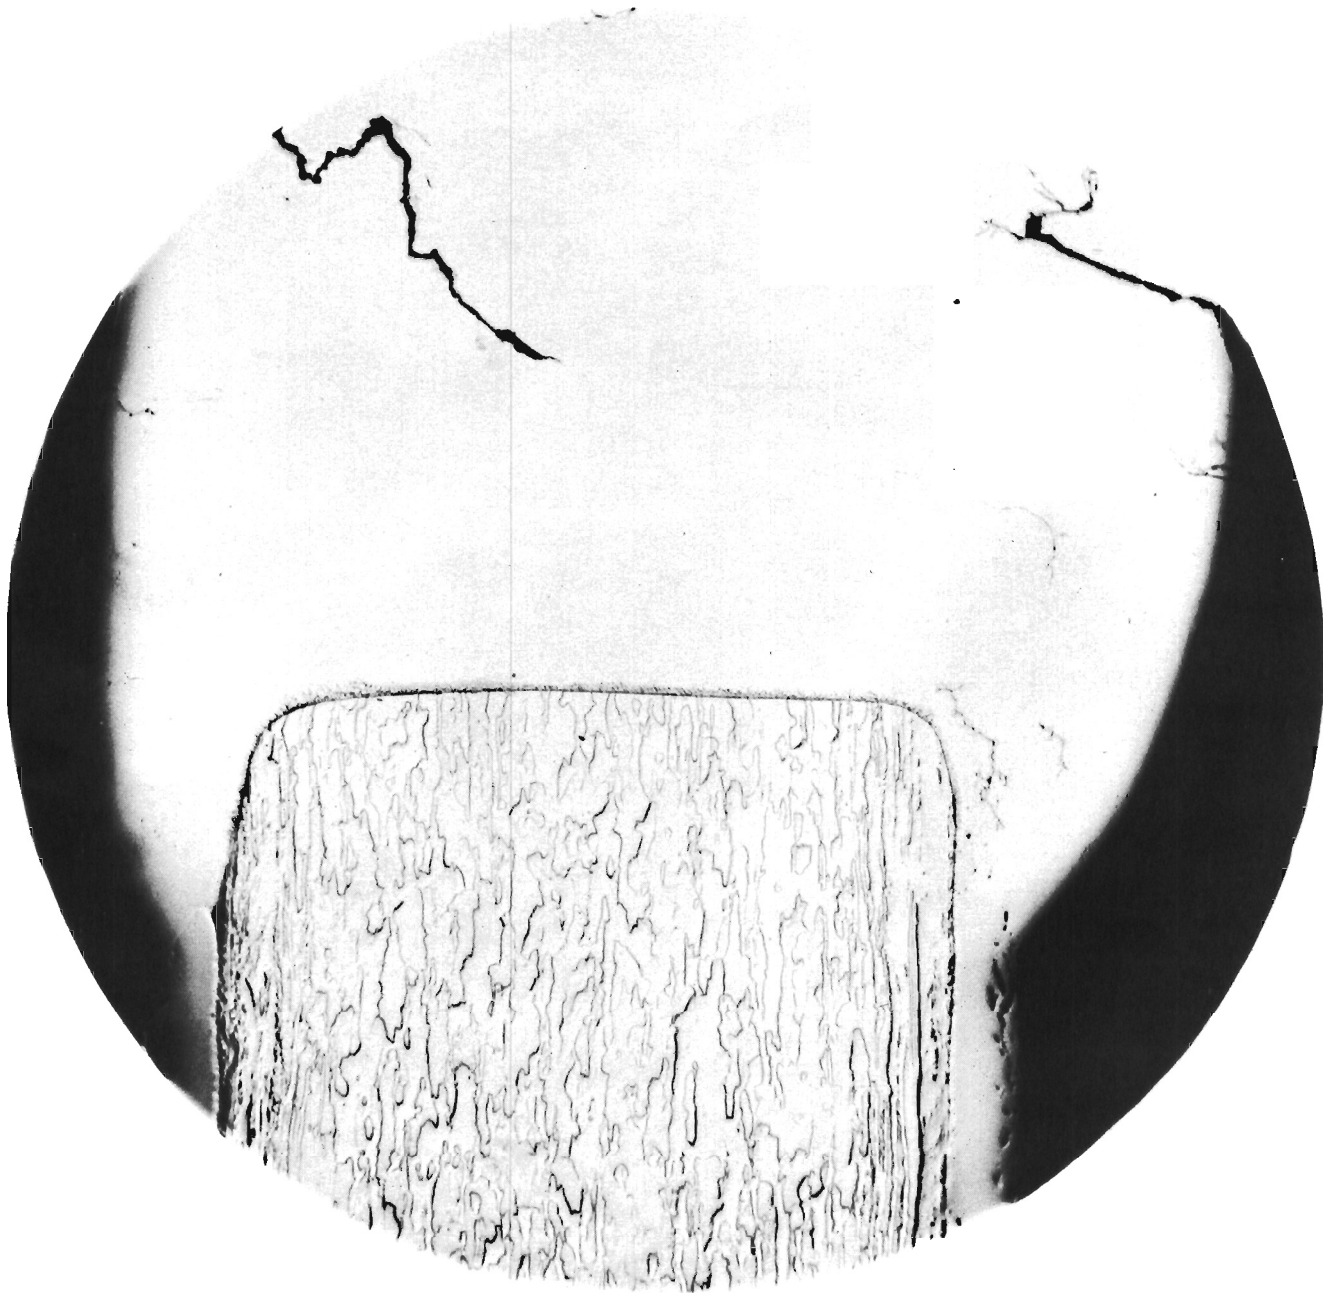
FIGURE 14 (M6127) Polish-Etch-Buff X100

SECTION THROUGH WELD BEAD OF Ni-CLAD THERMAL SHOCK
SPECIMEN AFTER TESTING

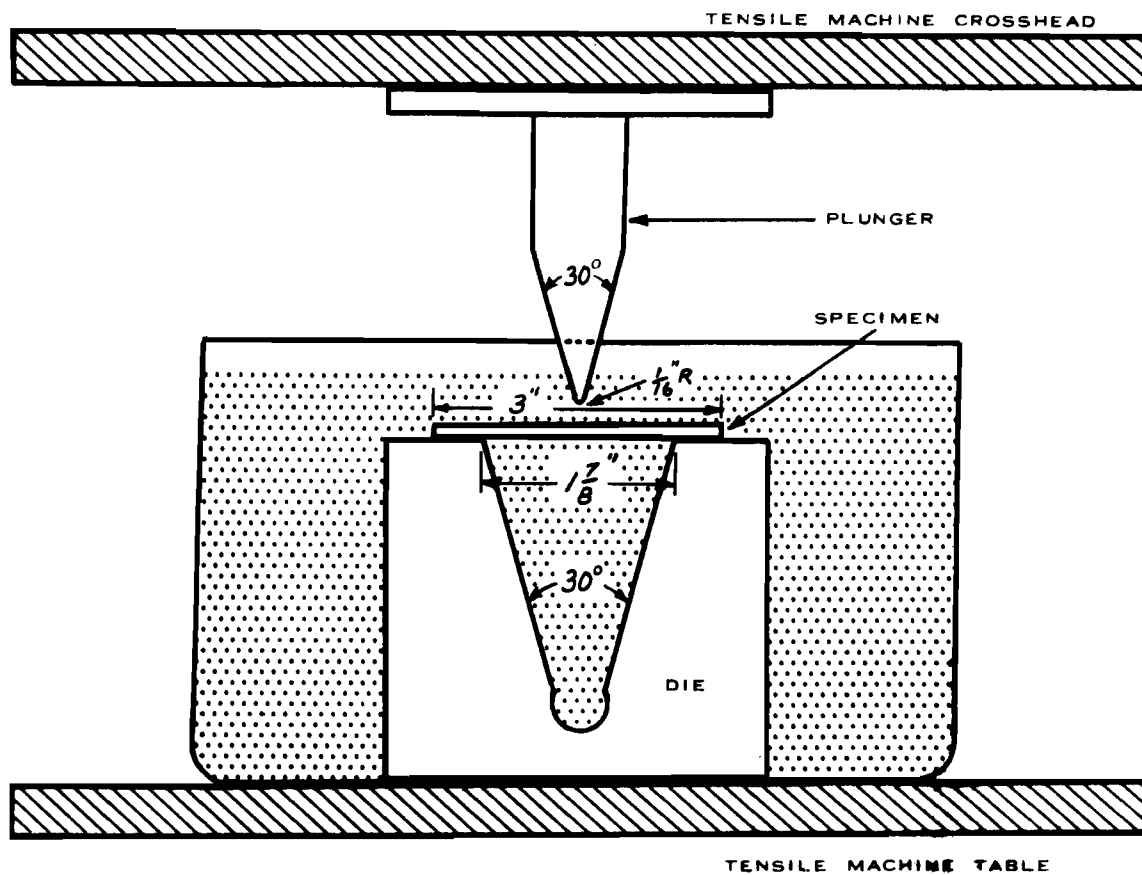
FIGURE 16 - SKETCH OF BEND TEST JIG

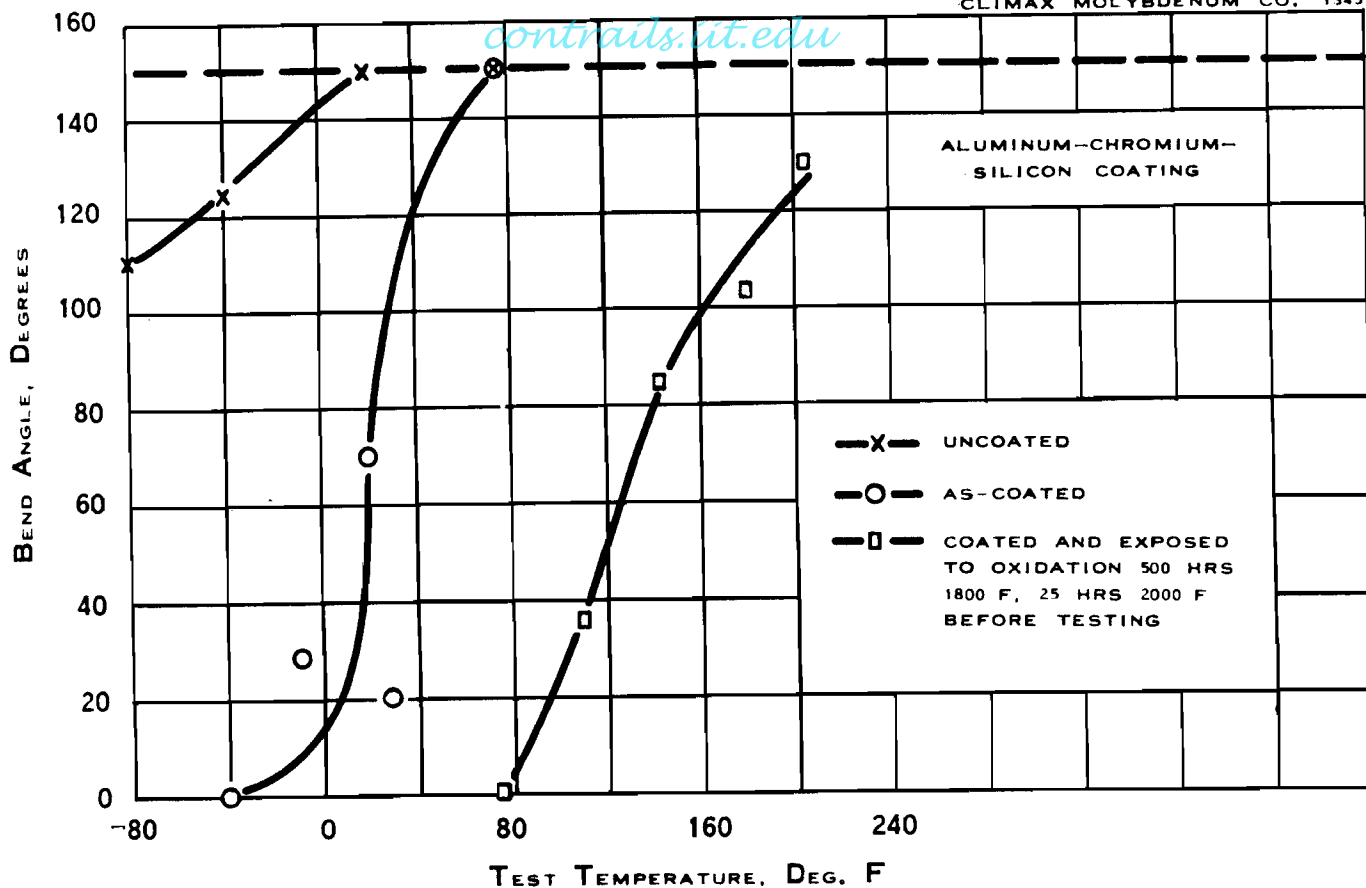
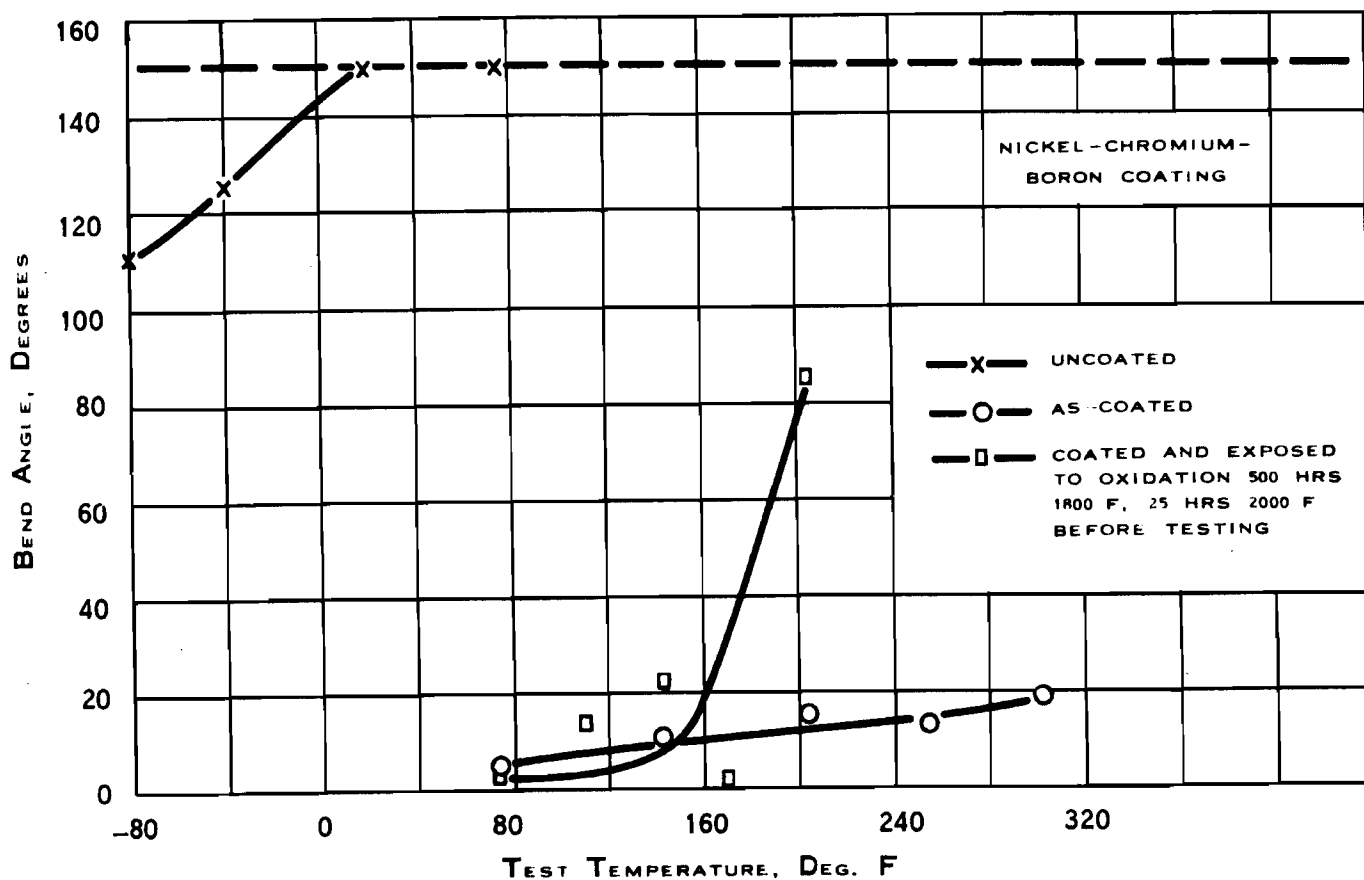
FIGURE 17 - RESULTS OF BEND TESTS

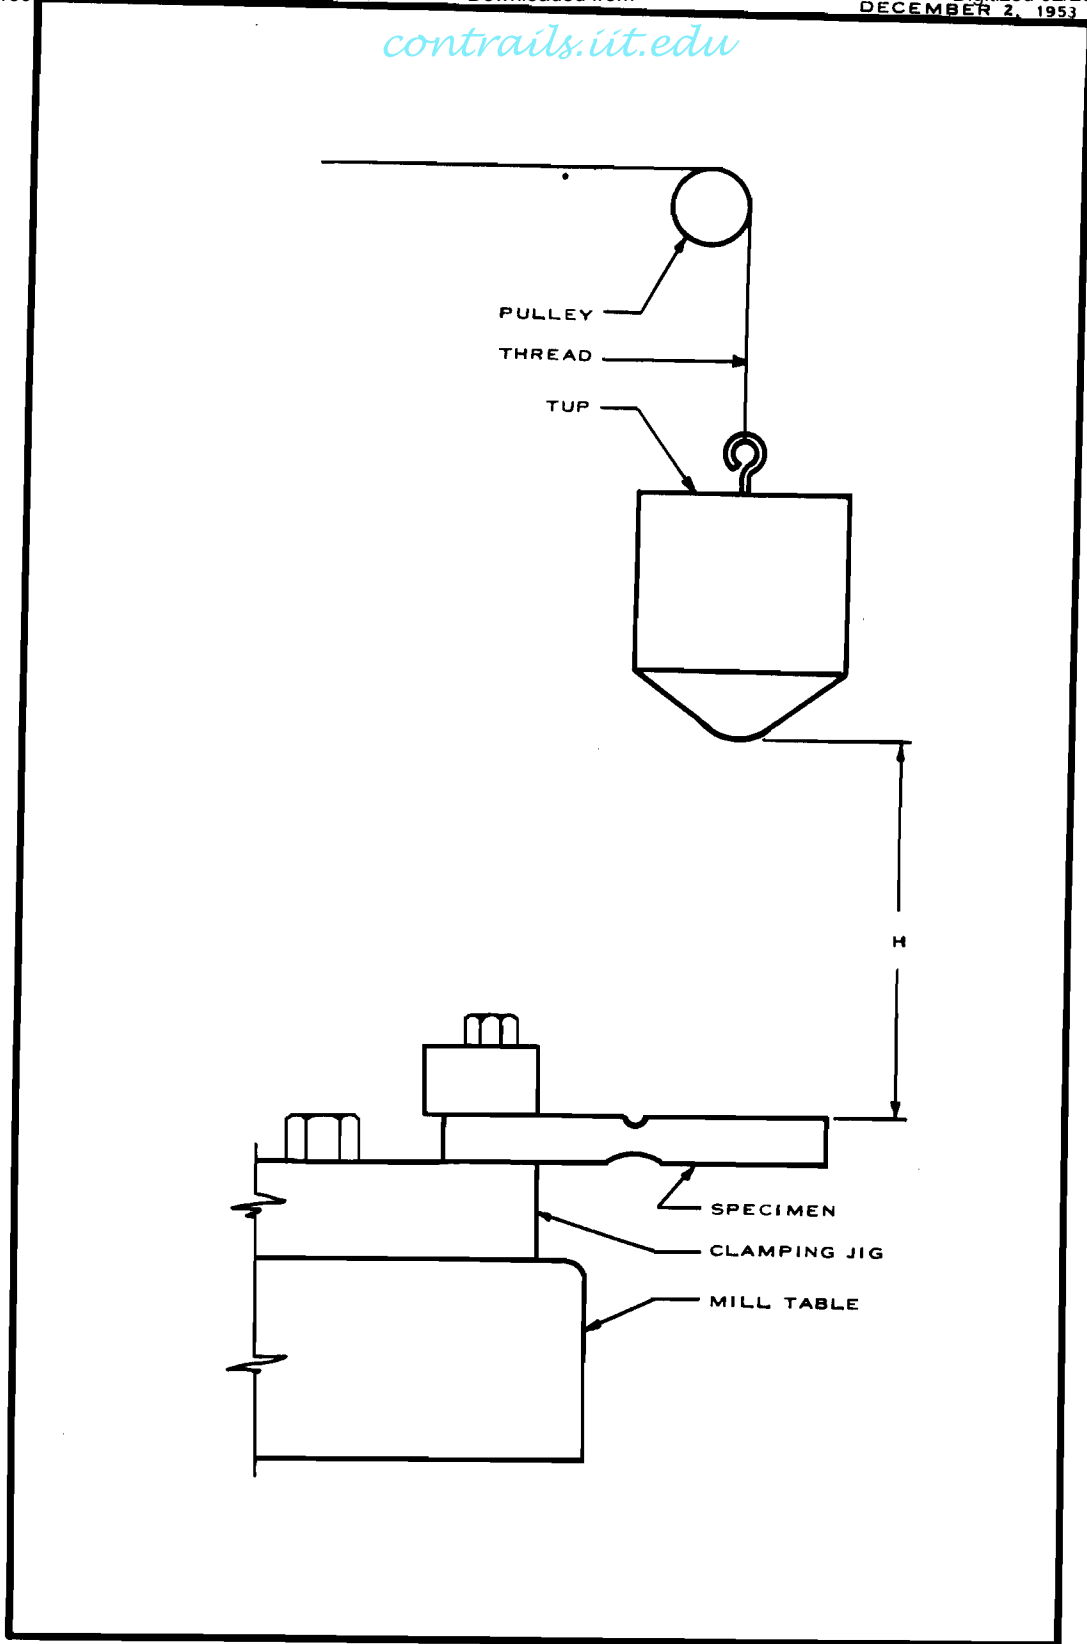
FIGURE 18 (482) - SCHEMATIC REPRESENTATION OF SPECIAL IMPACT TEST ASSEMBLY

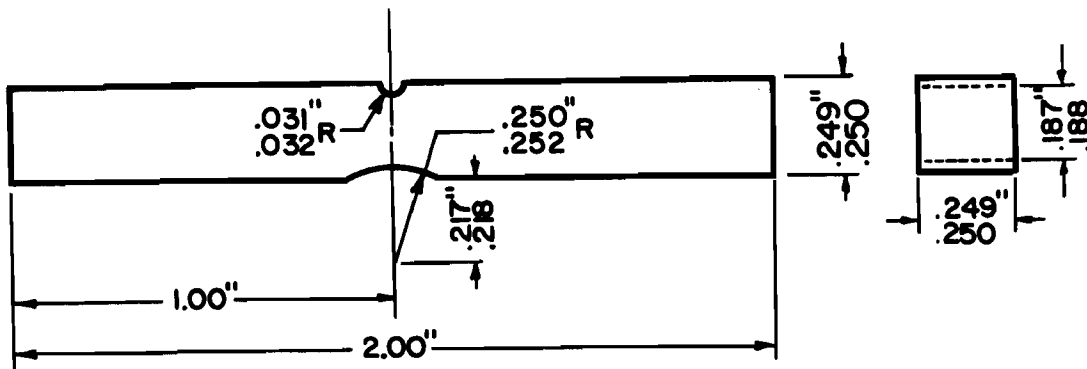
FIGURE 19 (481) - SPECIAL IMPACT SPECIMEN

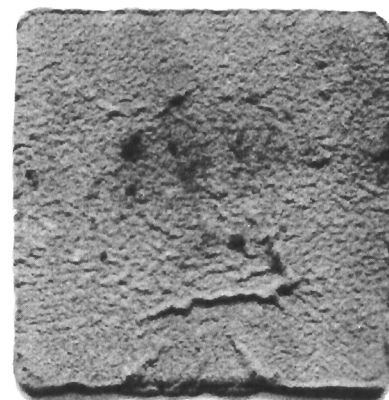
Specimen E149

8 hr at 1800°F
 1-1/2 hr at 2800°F
 Failed

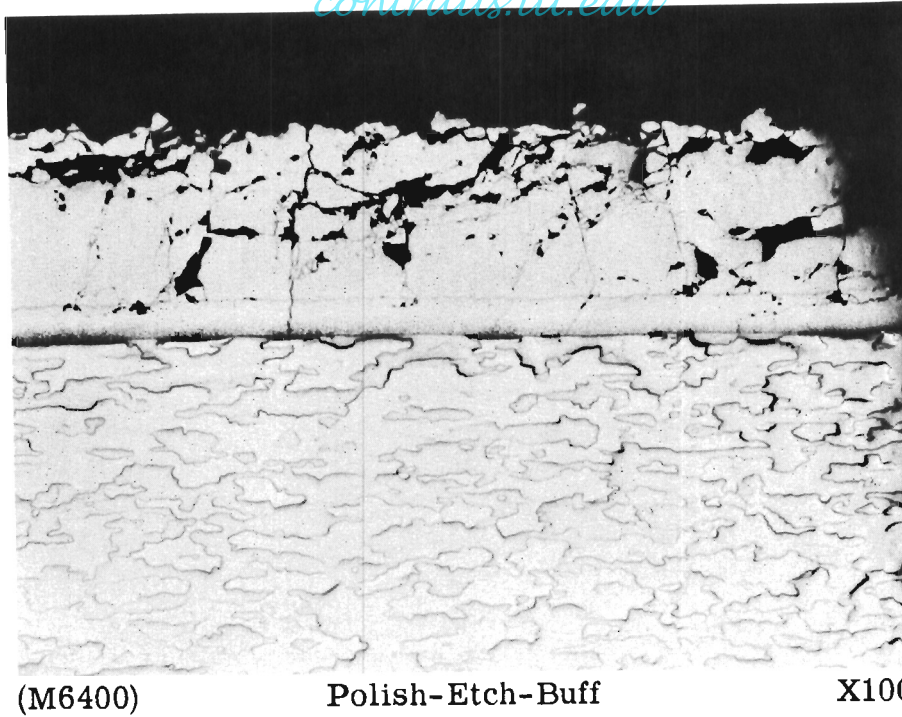
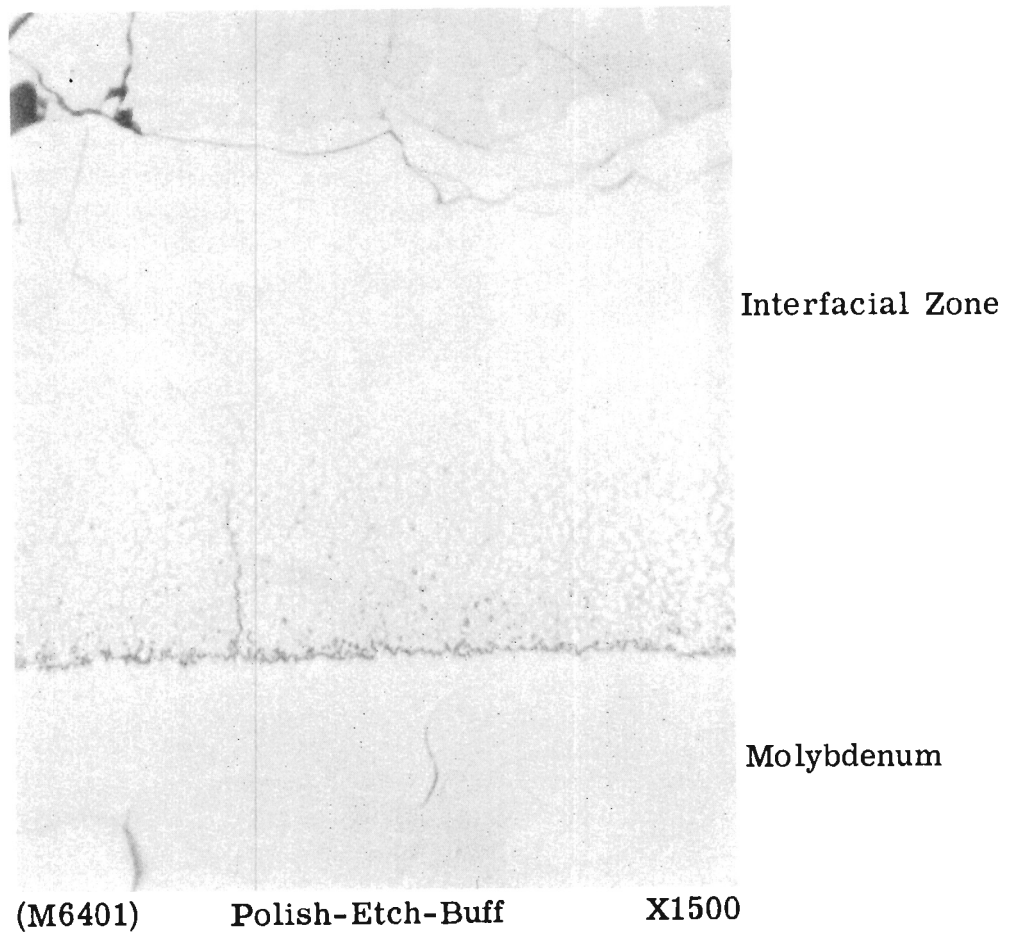
FIGURE 22 - Specimen E144. Al-Cr-Si on 0.5% Ti-Mo alloy. Diffusion treated 2 hours 2000^oF in dry argon. Oxidation tested 4 hours 1800^oF, 4 hours 2000^oF, 4 hours 2400^oF.

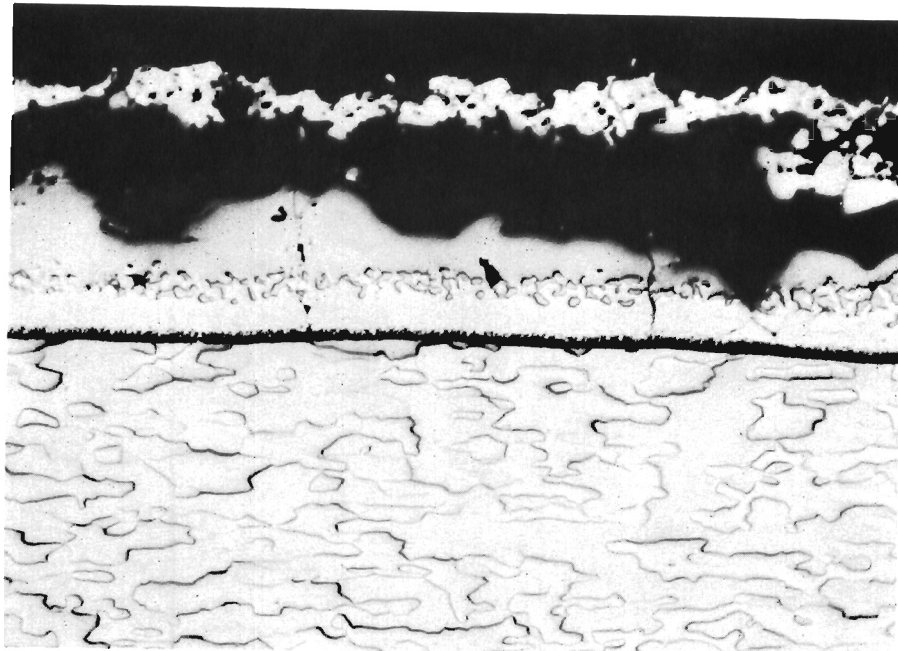
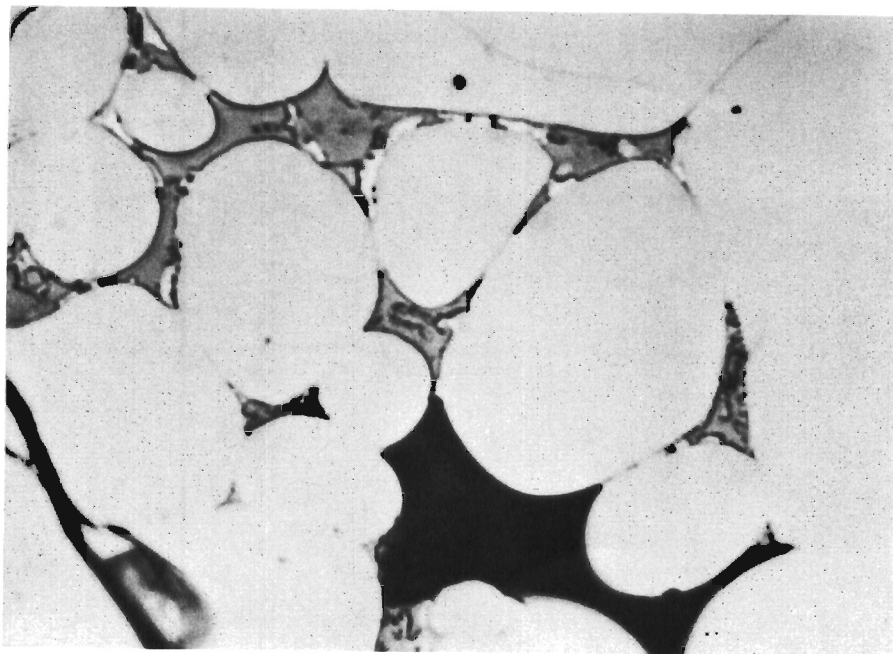
FIGURE 23 - Specimen E141. Al-Cr-Si on 0.5% Ti-Mo alloy. Diffusion treated 2 hours 2000^oF in dry argon. Oxidation tested 4 hours 1800^oF, 4 hours 2000^oF, 4 hours 2400^oF, 4 hours 2600^oF. Evidence of eutectic phase in coating.

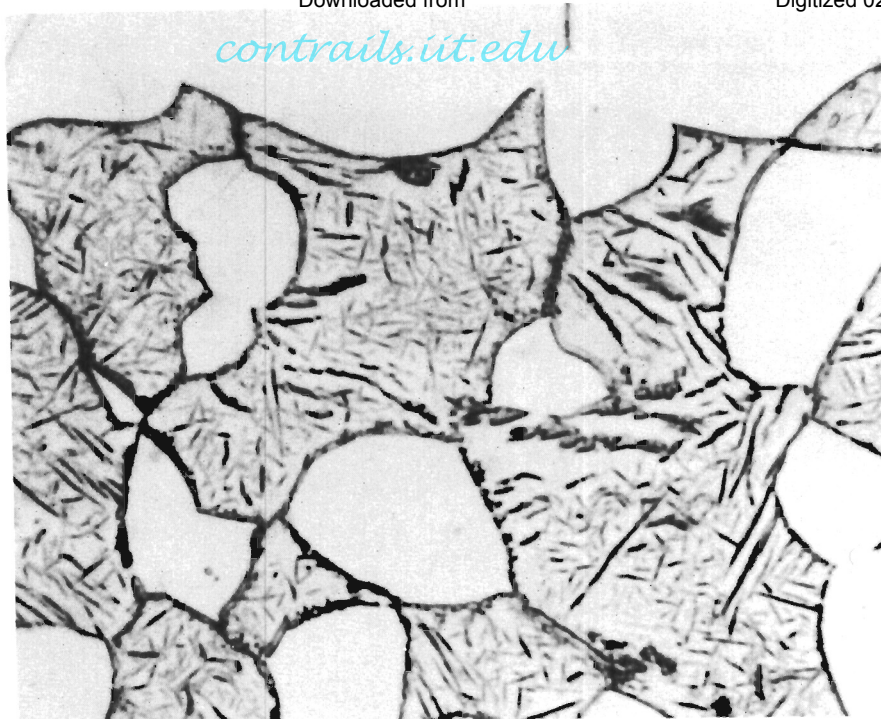
FIGURE 24 - Specimen E141. Additional evidence of eutectic phase in coating.

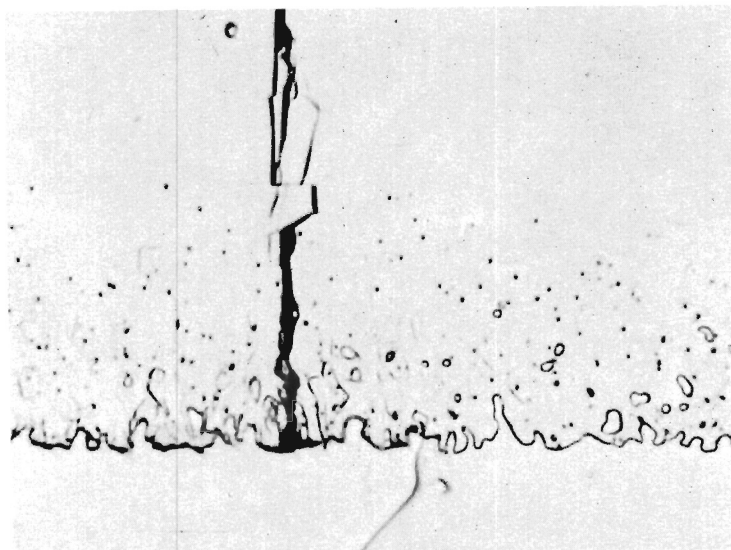
FIGURE 25 - Specimen E141. Indication of globules of undissolved molybdenum in interfacial zone of coating after 2600^oF exposure.

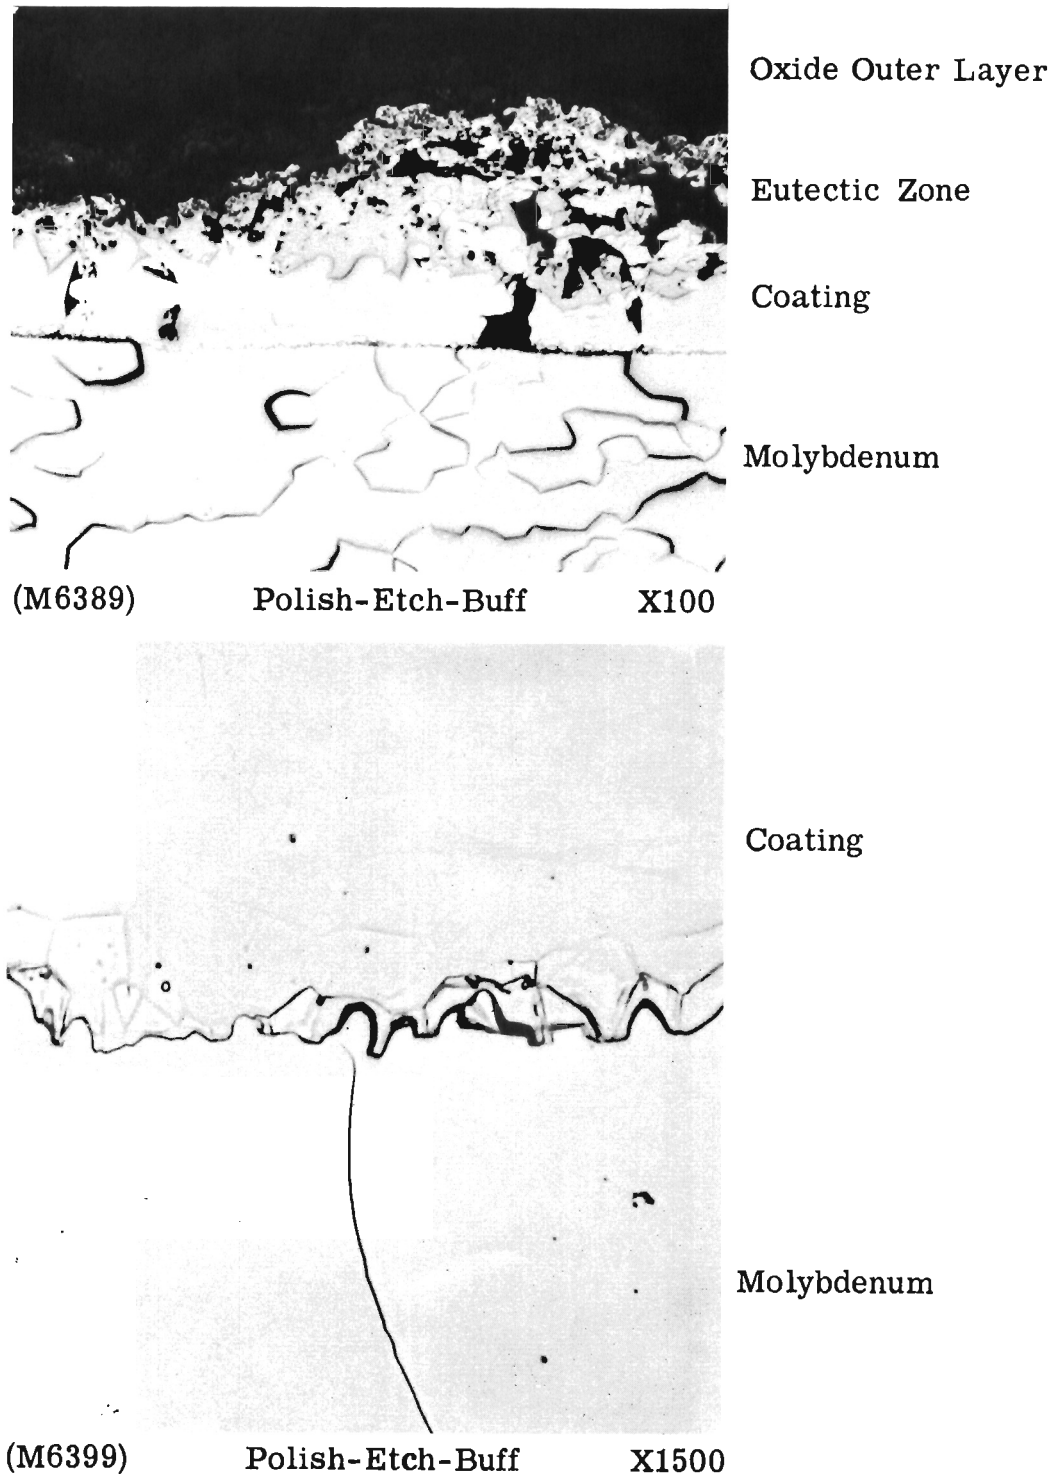
FIGURE 26 - Specimen E139. Al-Cr-Si on 0.5% Ti-Mo alloy. Diffusion treated 2 hours 2000^oF in dry argon. Oxidation tested 4 hours 1800^oF, 4 hours 2000^oF, 4 hours 2400^oF, 5-1/2 hours 2600^oF, 4 hours 2800^oF.
