**WADC TECHNICAL REPORT 54-492
PART III**

**OXIDATION-RESISTANT COATINGS
FOR MOLYBDENUM**

Climax Molybdenum Company of Michigan

April 1957

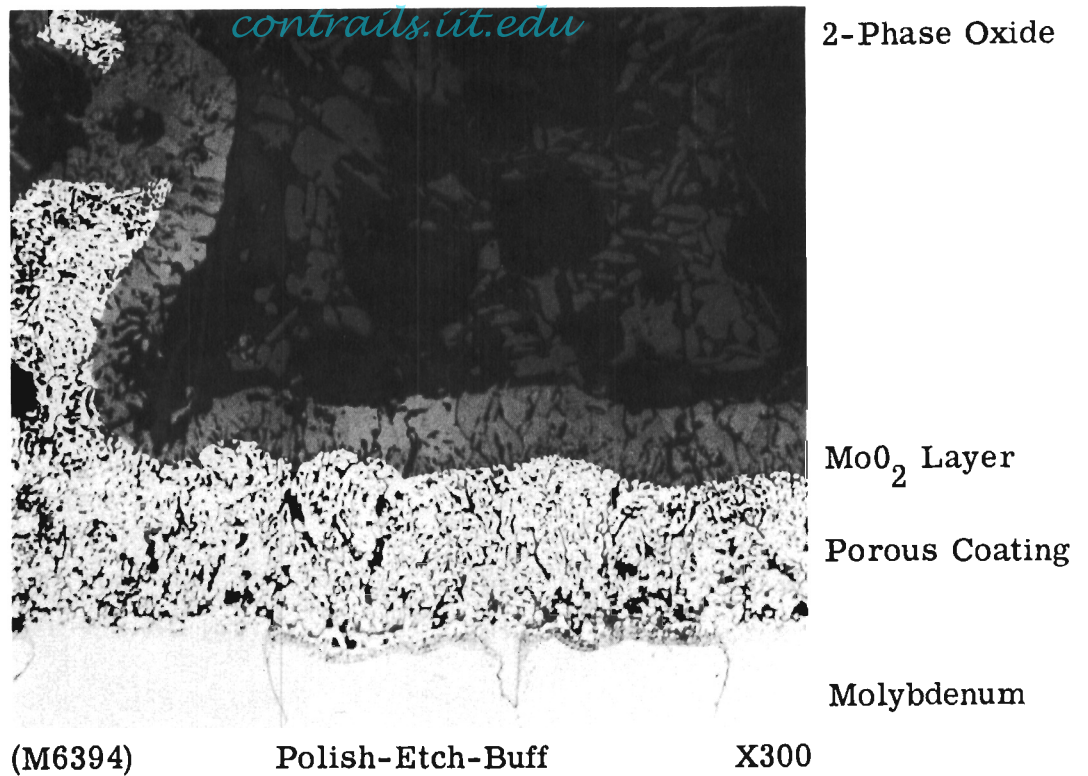
FIGURE 27 - Specimen E137. Al-Cr-Si coating on 0.5% Ti-Mo alloy. Diffusion treated 2 hours 2000°F in dry argon. Oxidation tested 4 hours 1800°F, 4 hours 2000°F, 4 hours 2400°F, 6 hours 2600°F, 4 hours 3000°F.

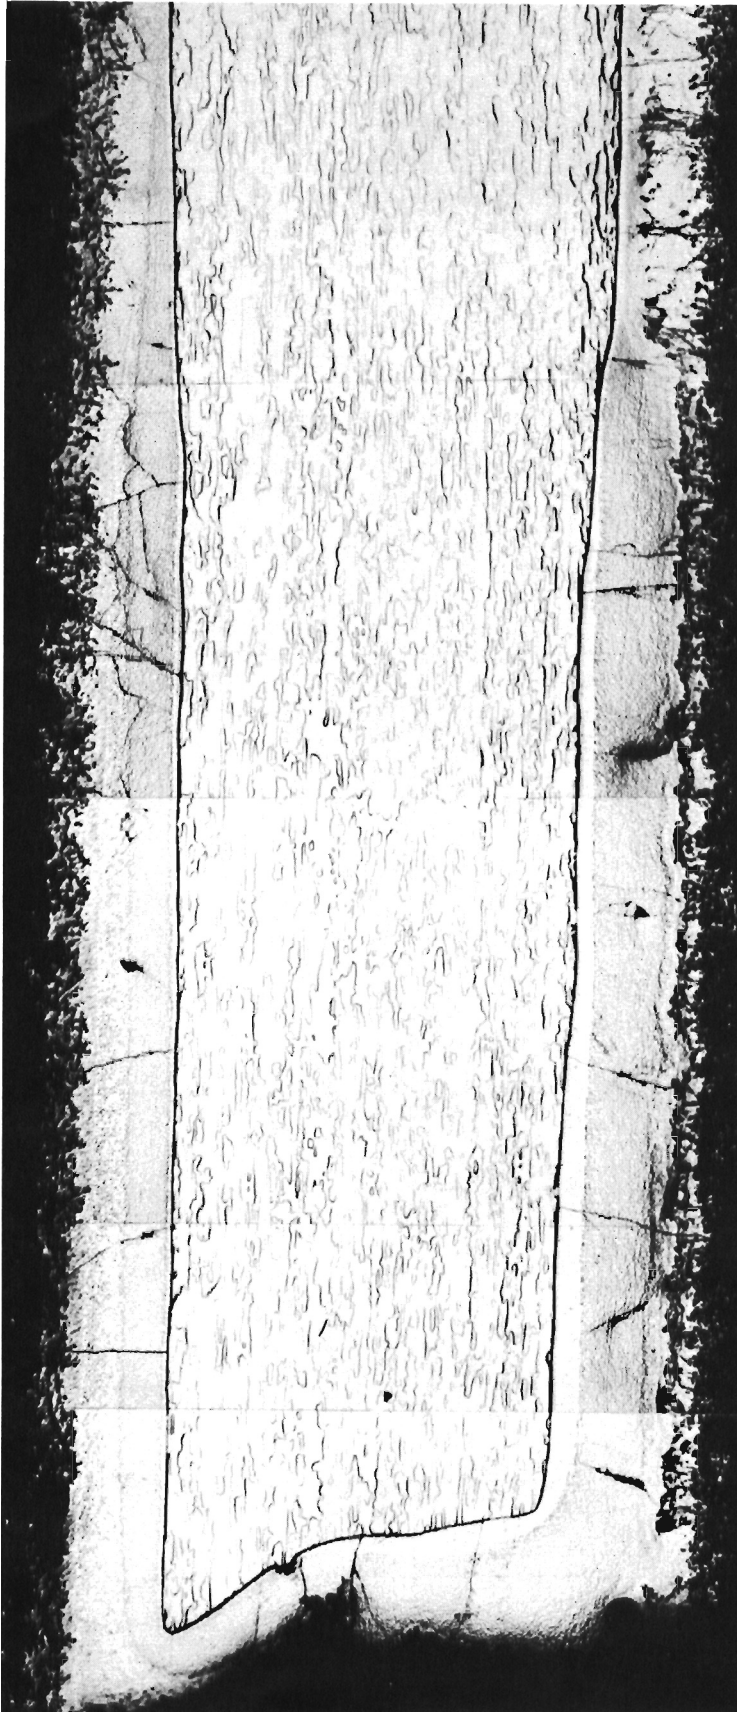
FIGURE 29 (P1629)

Al-Cr-Si COATING ON 0.5% Ti-Mo ALLOY. DIFFUSION TREATED 2 HOURS AT 2000°F IN DRY ARGON. OXIDATION TESTED 500 HOURS AT 1800°F. CORNER REMOVED FROM SPECIMEN BY SAWING. EXPOSED CORNER HEATED FOR 15 MINUTES IN THE TEMPERATURE RANGE 2450-2550°F USING AN OXY-ACETYLENE TORCH. COMPOSITE MICROGRAPH SHOWING FORMATION OF COATING OVER EXPOSED EDGE OF PANEL.

10. The results of experiments conducted to evaluate the "self-healing" of Al-Cr-Si coatings indicate that under some test conditions the flow of a eutectic phase from the coating can re-establish a coating where mechanical damage exposes small areas of molybdenum.

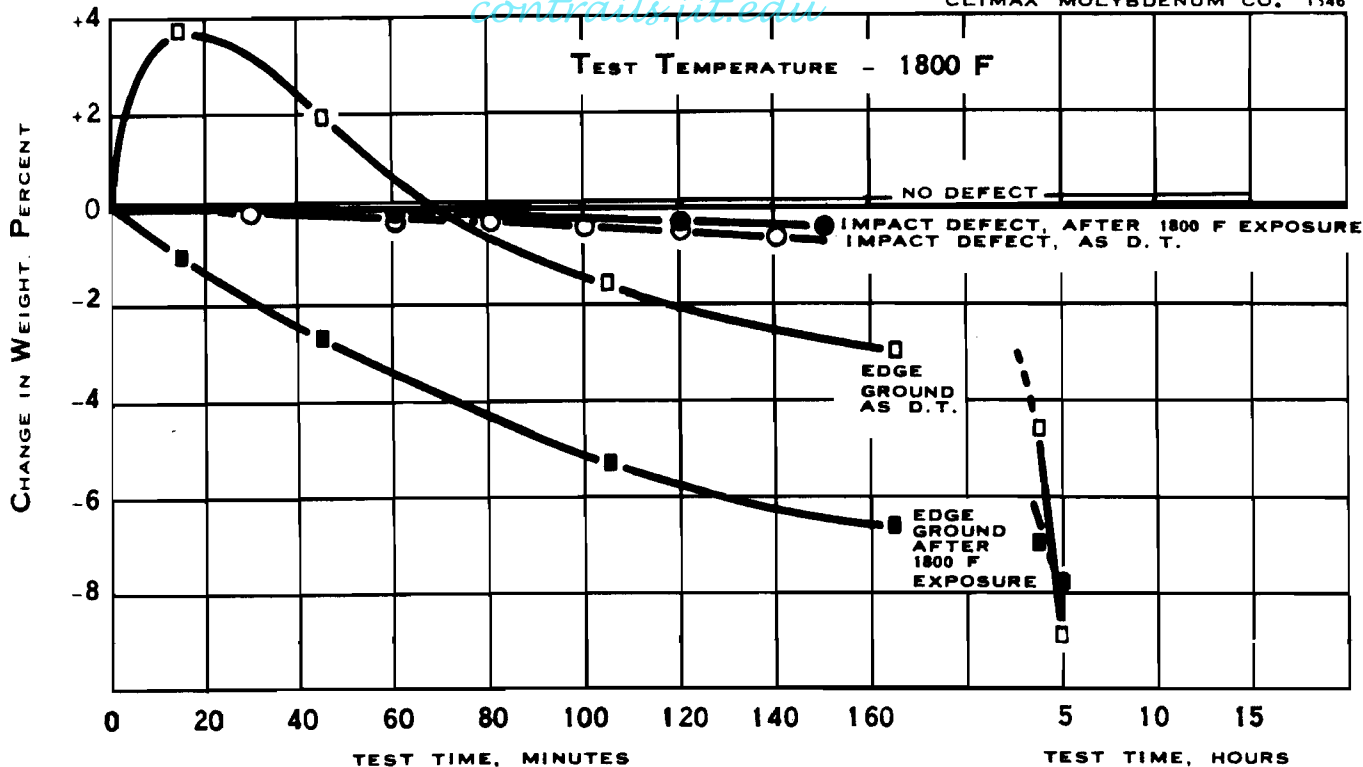
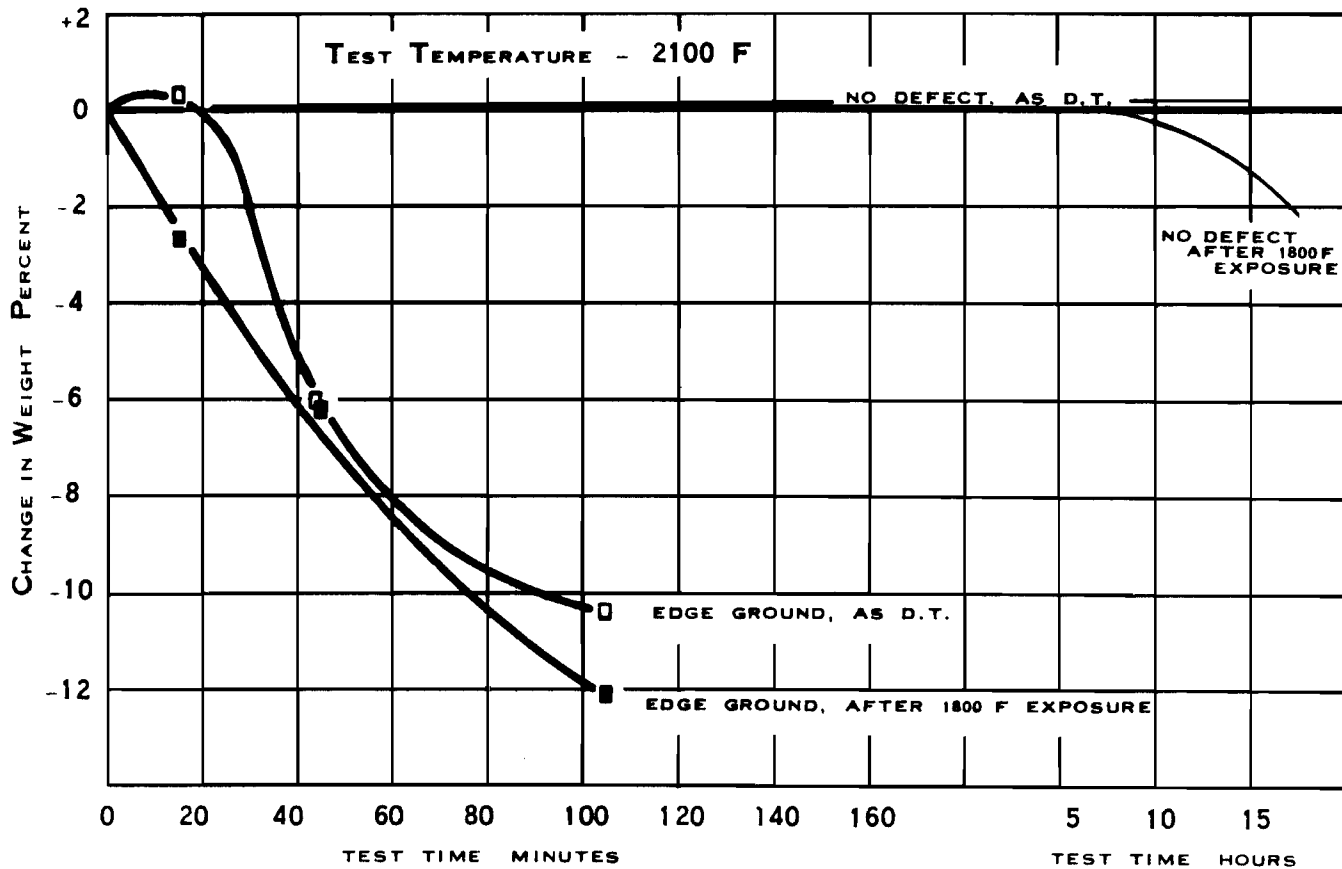
FIGURE 30 -WEIGHT CHANGES IN COATED MOLYBDENUM CONTAINING CONTROLLED DEFECTS

(AL-CR-SI COATING, OXIDATION TESTED AT 1800 AND 2100 F)

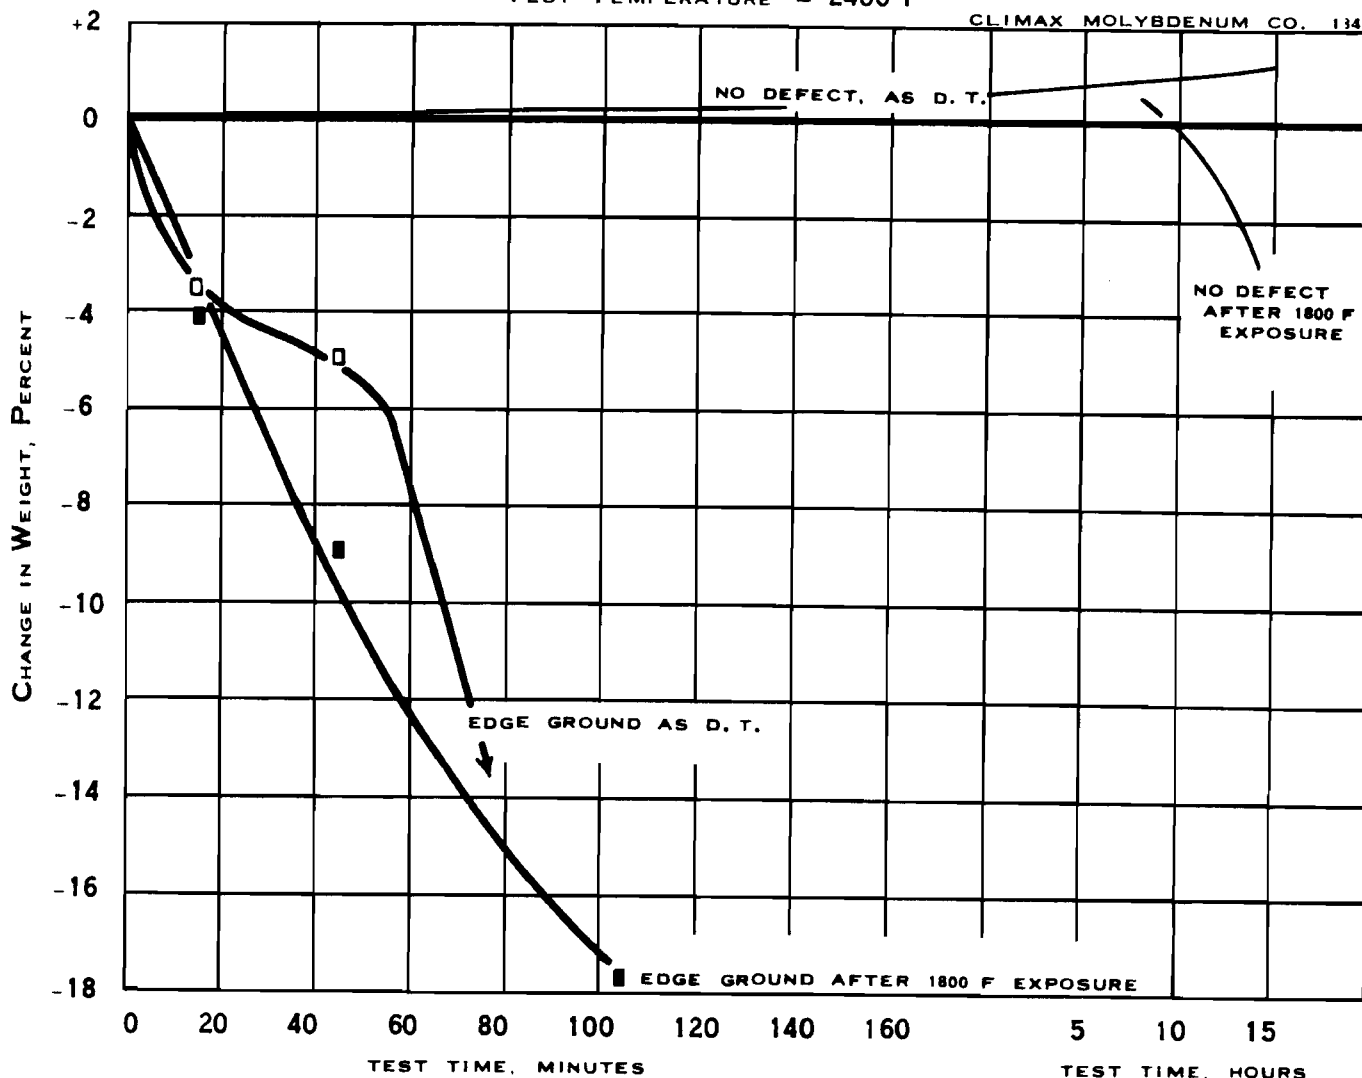
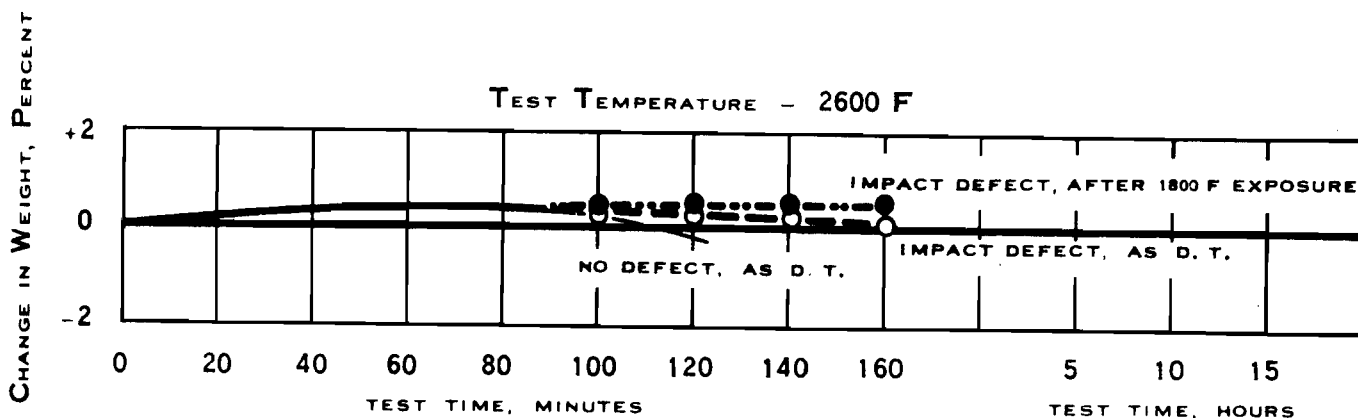
FIGURE 31 - WEIGHT CHANGES IN COATED MOLYBDENUM CONTAINING CONTROLLED DEFECTS

(AL-CR-SI COATING, OXIDATION TESTED AT 2400 AND 2600 F)

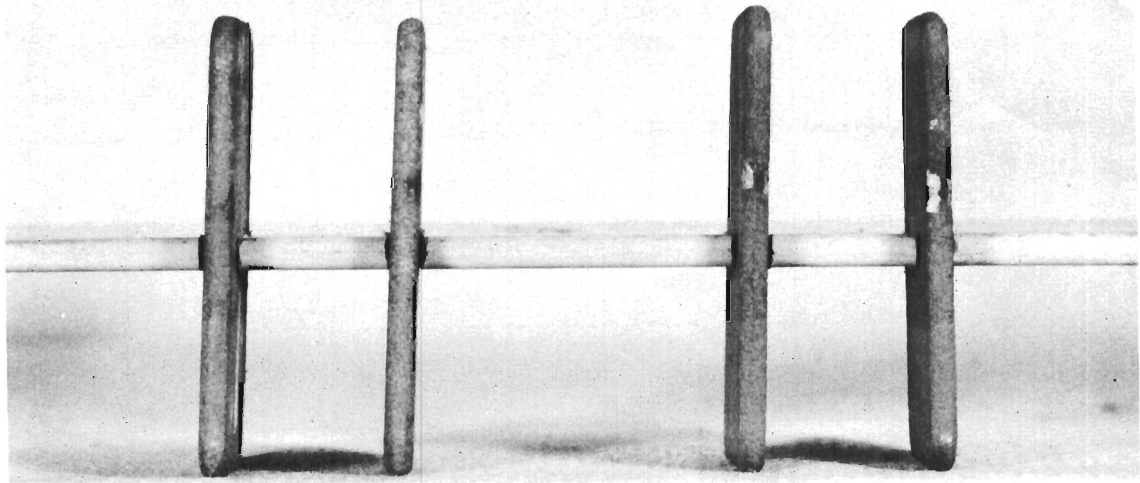
FIGURE 32 - PHOTOGRAPH OF BALLISTIC-IMPACT SPECIMENS BEFORE OXIDATION TEST. UNALLOYED MOLYBDENUM, COATED WITH Al-Cr-Si, DIFFUSION TREATED TWO HOURS AT 2000° F IN PURIFIED HYDROGEN

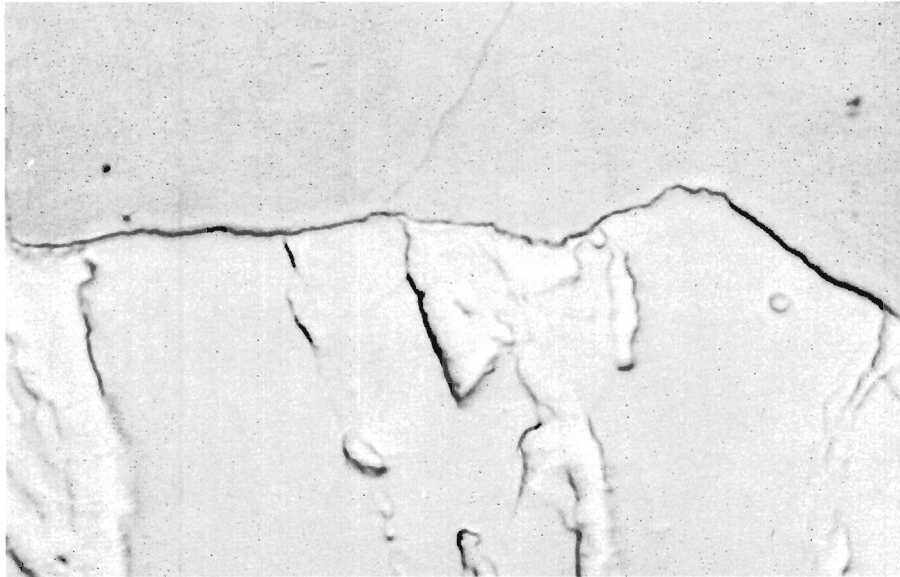
FIGURE 34 (M4244) Polish-Etch-Buff X2000

Specimen C93. Al-Cr-Si on unalloyed molybdenum. Diffusion treated two hours at 1800^oF in purified hydrogen. Note absence of interfacial zone.

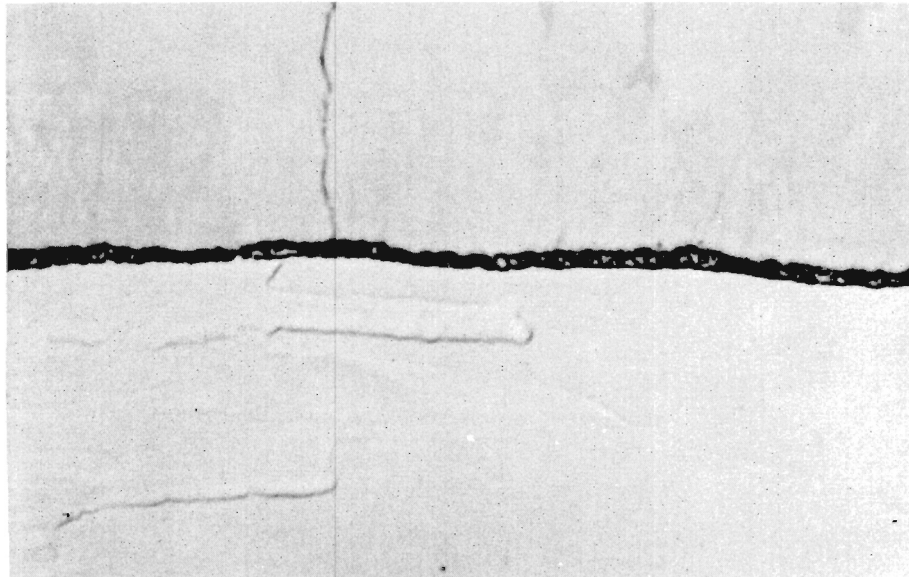
FIGURE 37 (M5157) Polish-Etch-Buff X2000

Specimen D296. Al-Cr-Si on 0.5% Ti-Mo alloy. Diffusion treated two hours at 2000^oF in dried argon. Note more continuous interfacial zone.

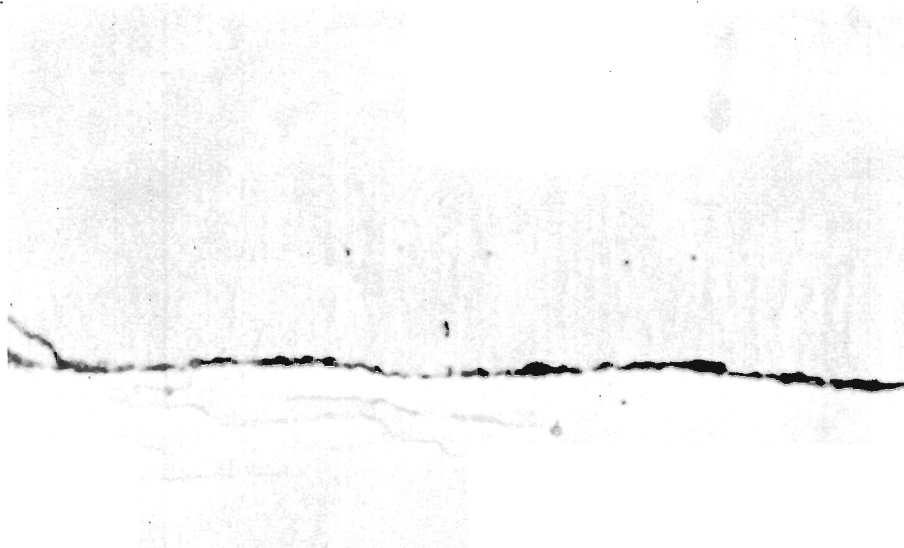
FIGURE 38 (M6257) Polish-Etch-Buff X2000

Specimen E321. Al-Cr-Si on 0.5% Ti-Mo alloy. Diffusion treated two hours at 2000^oF in dried argon. Thin, somewhat discontinuous interfacial zone.

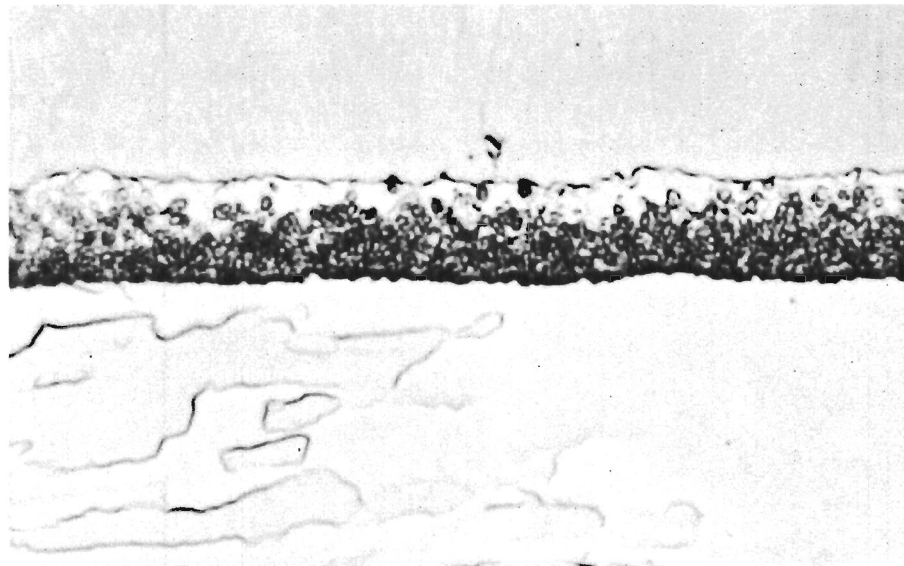
FIGURE 39 (M6436) Polish-Etch-Buff X2000

Specimen E396-B. Al-Cr-Si on 0.5% Ti-Mo alloy. Diffusion treated two hours at 2200^oF in tank argon. Note wide interfacial zone.

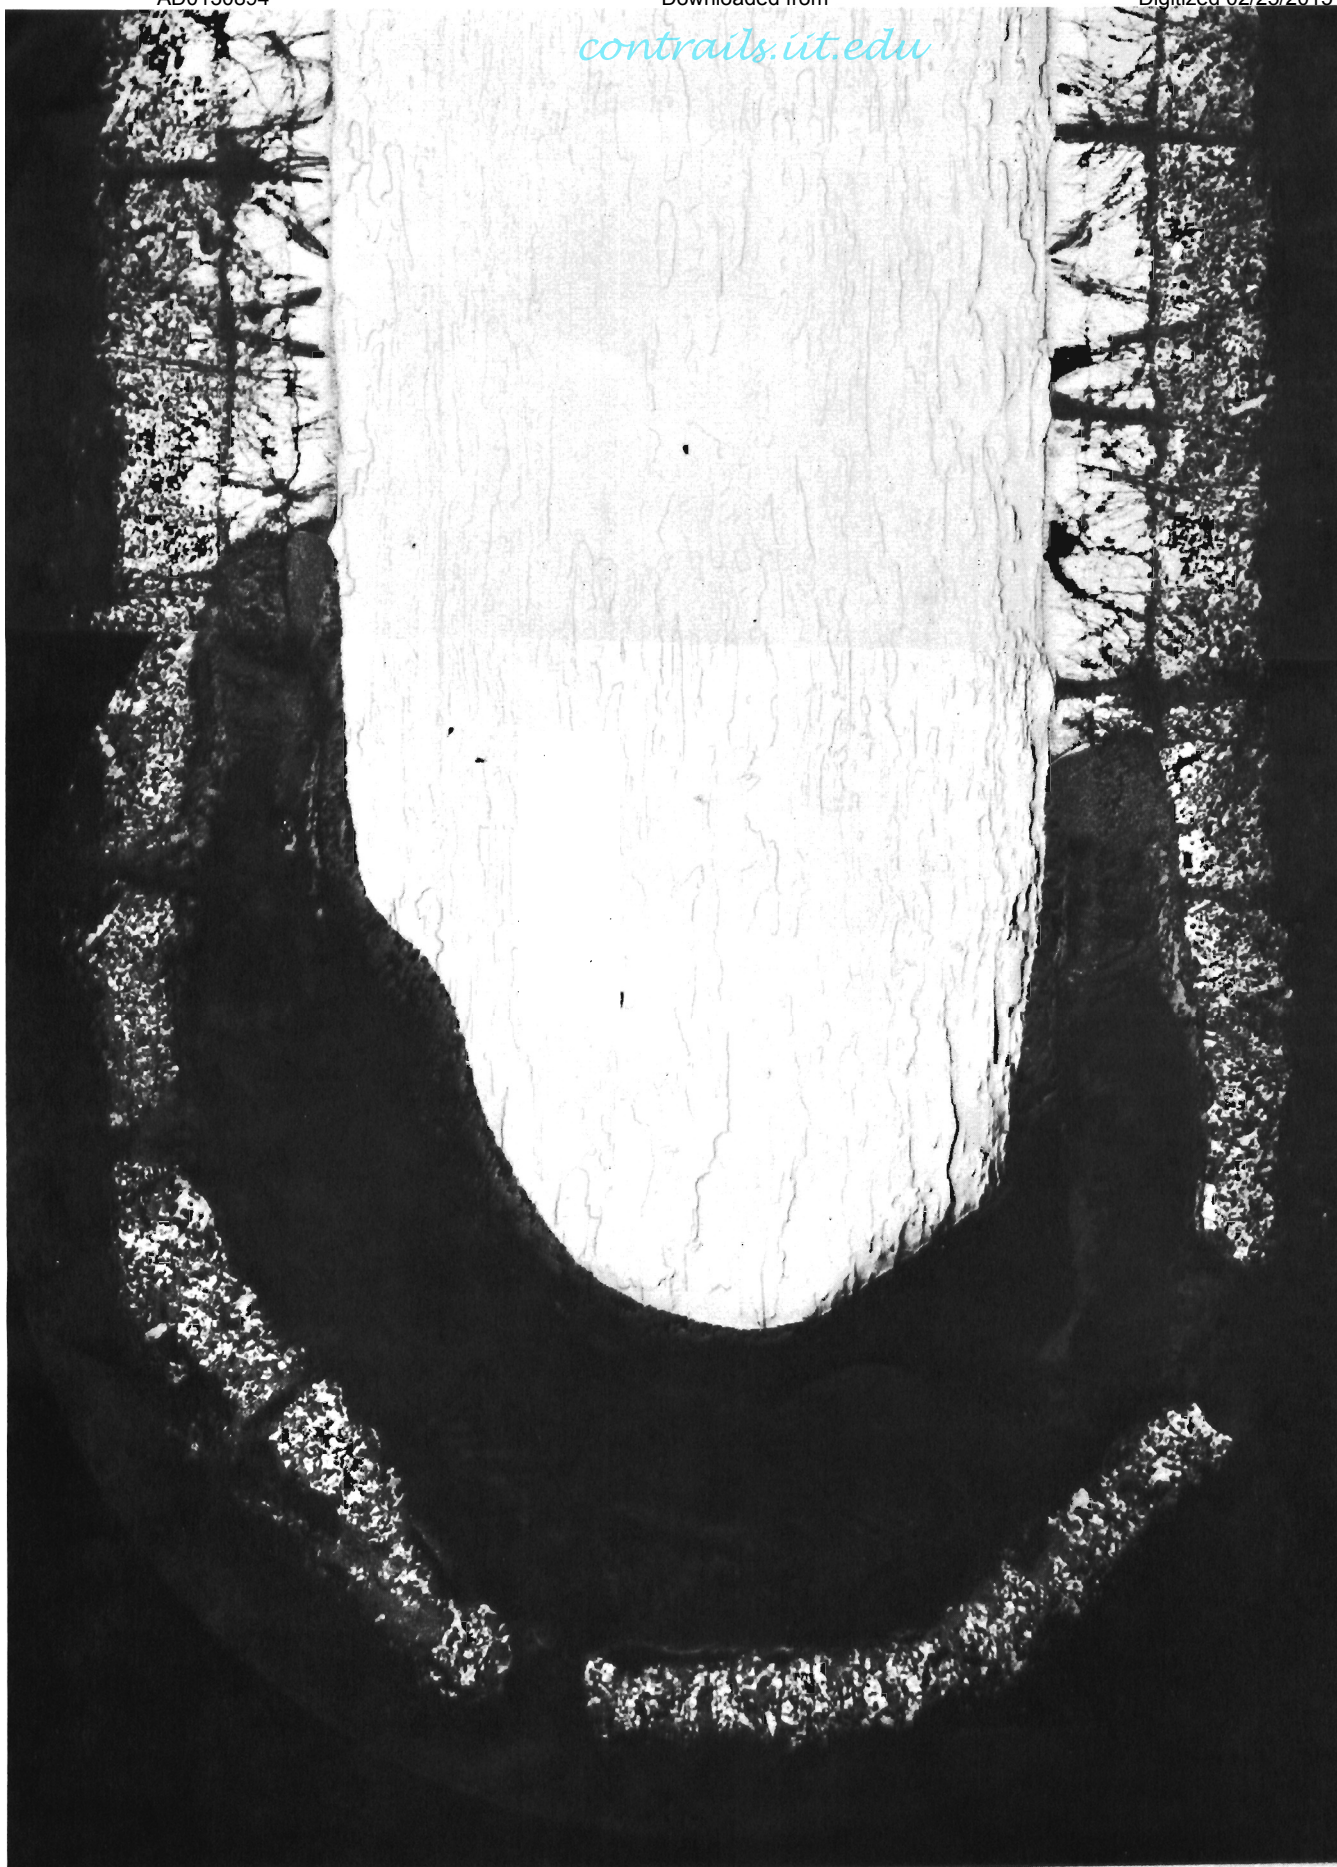
FIGURE 41 (M5266, M5267) Polish-Etch-Buffer
SPECIMEN D289. MICROSTRUCTURE OF CROSS SECTION AT FAILED EDGE OF TEST PANEL, SHOWING PROGRESS OF OXIDATION.

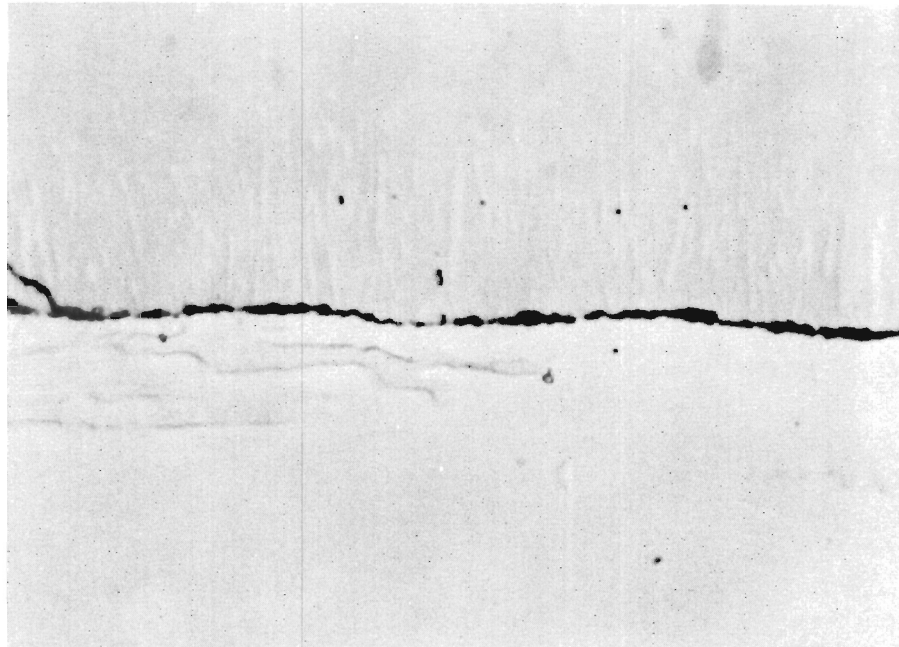
FIGURE 42 (M6257) Polish-Etch-Buff X2000

Microstructure at interface

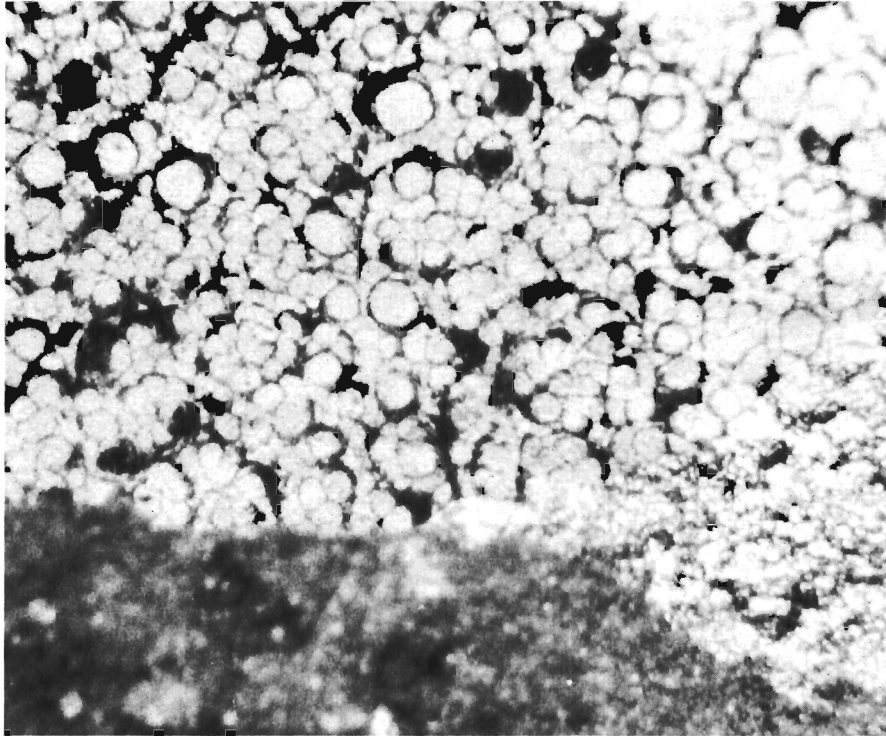
FIGURE 44 (35-11)

Specimen E321. Macrostructure of Mo surface at coating interface after chipping coating off. After 50 cycles from 1800⁰F in thermal cycling apparatus. Note dark molybdenum oxide in circular pattern.

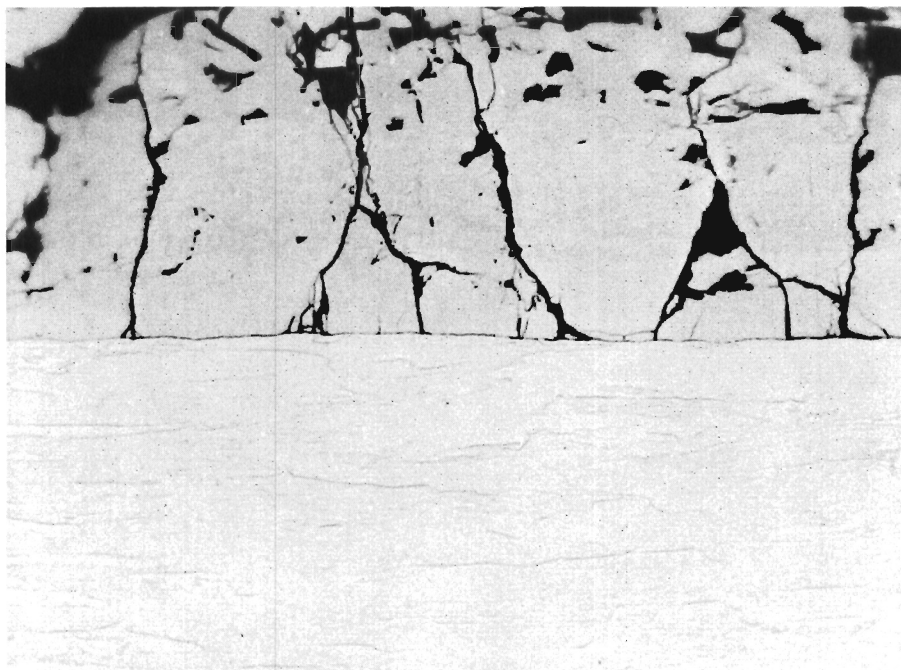
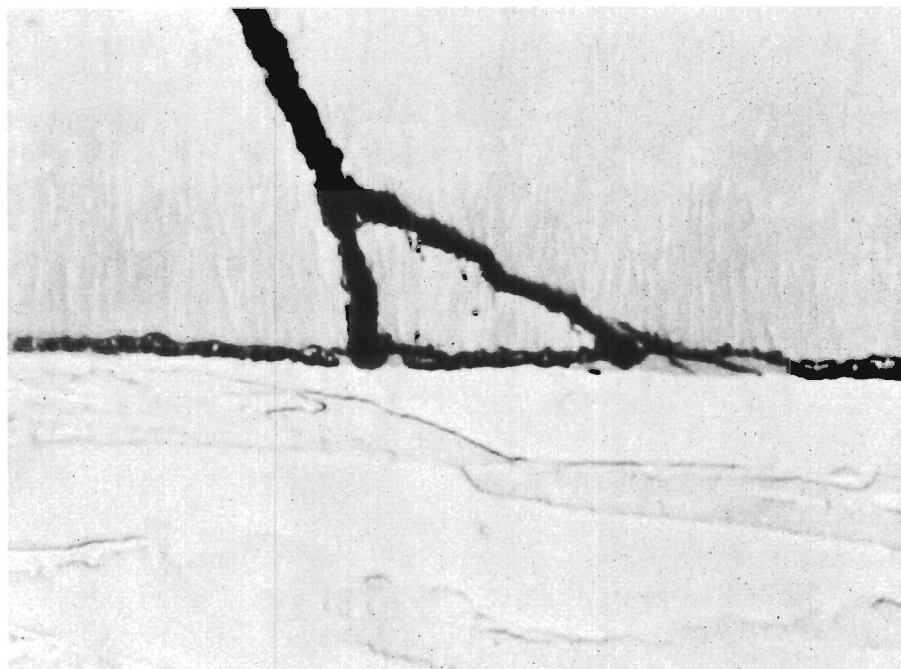
FIGURE 45 - SPECIMEN E321. Al-Cr-Si ON 0.5% Ti-Mo ALLOY. AFTER 50 CYCLES FROM 1800°F IN THERMAL CYCLING APPARATUS. NOTE OXIDATION OF INTERFACIAL ZONE.

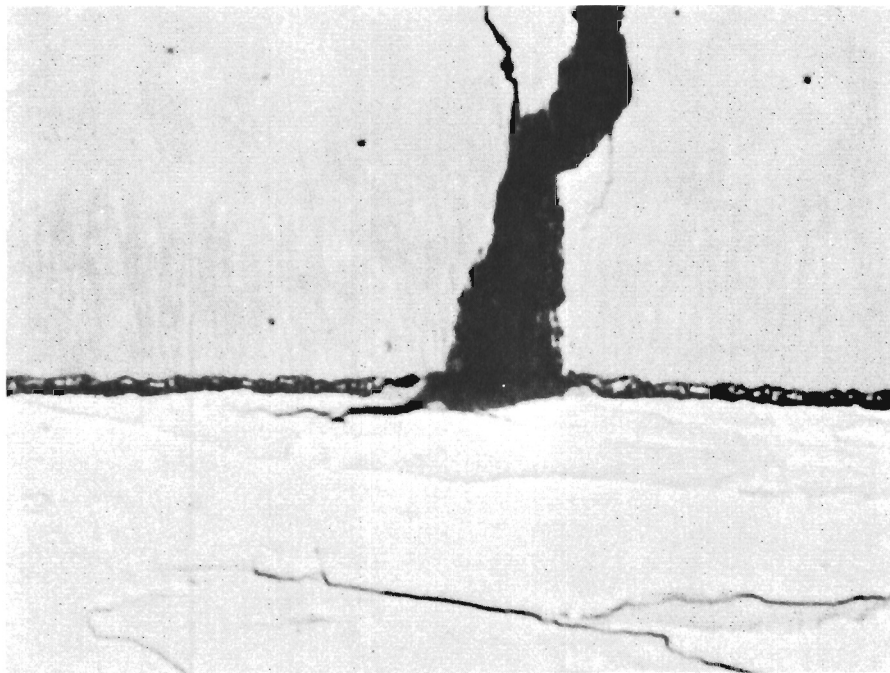
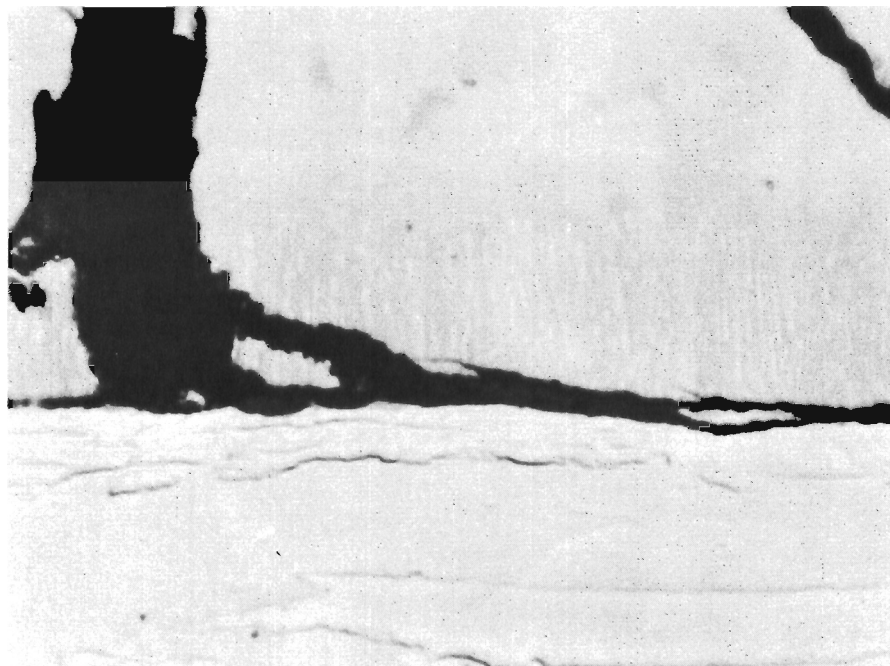
FIGURE 46 - SPECIMEN E321. Al-Cr-Si ON 0.5% Ti-Mo ALLOY. AFTER 50 CYCLES FROM 1800⁰F IN THERMAL CYCLING APPARATUS. ADDITIONAL EVIDENCE OF OXIDATION AND CRACKING ALONG INTERFACIAL ZONE.

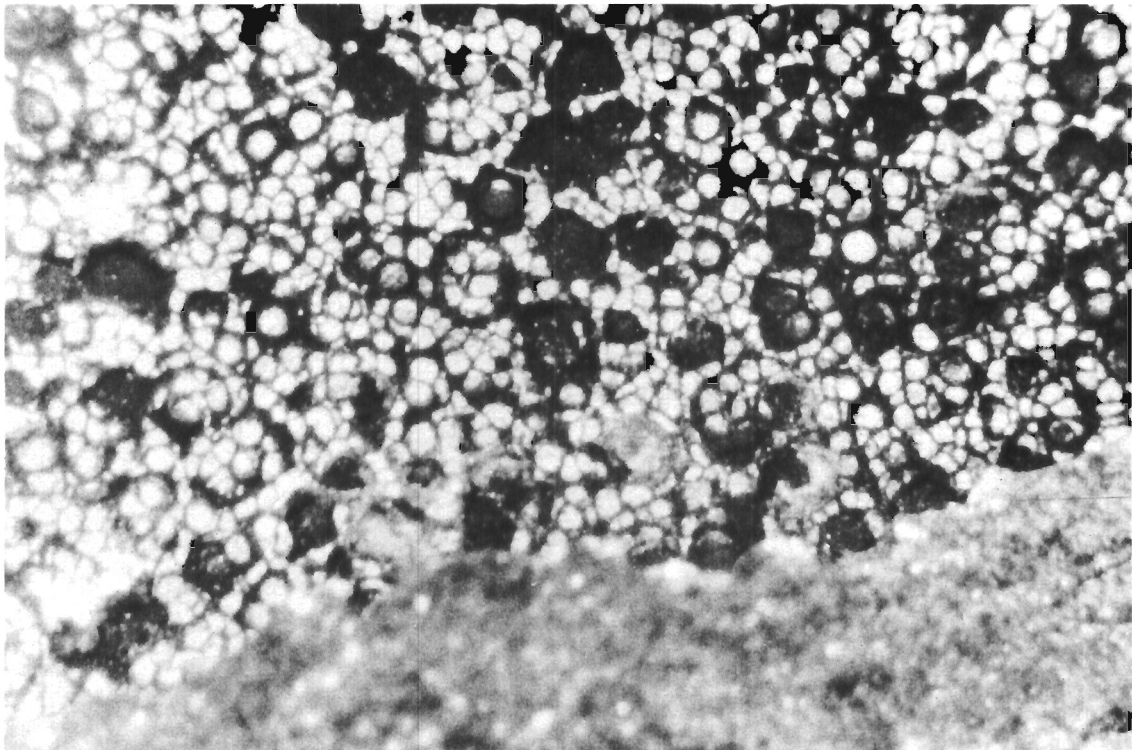
FIGURE 47 (35-13)

Specimen E322. Al-Cr-Si on 0.5% Ti-Mo alloy. After 200 cycles from 1800°F in thermal cycling apparatus. Appearance of molybdenum surface at interface.

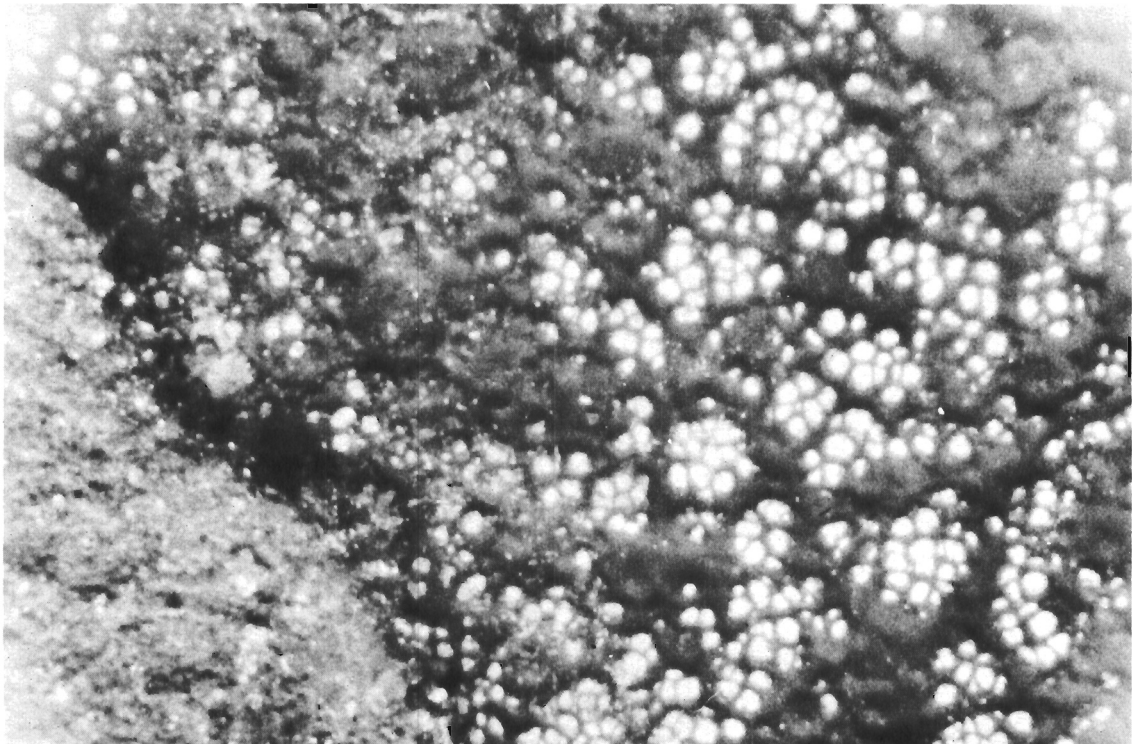
FIGURE 48 (35-14)

Specimen E323. Al-Cr-Si on 0.5% Ti-Mo alloy. After 390 cycles from 1800°F in thermal cycling apparatus. Appearance of molybdenum surface at interface.

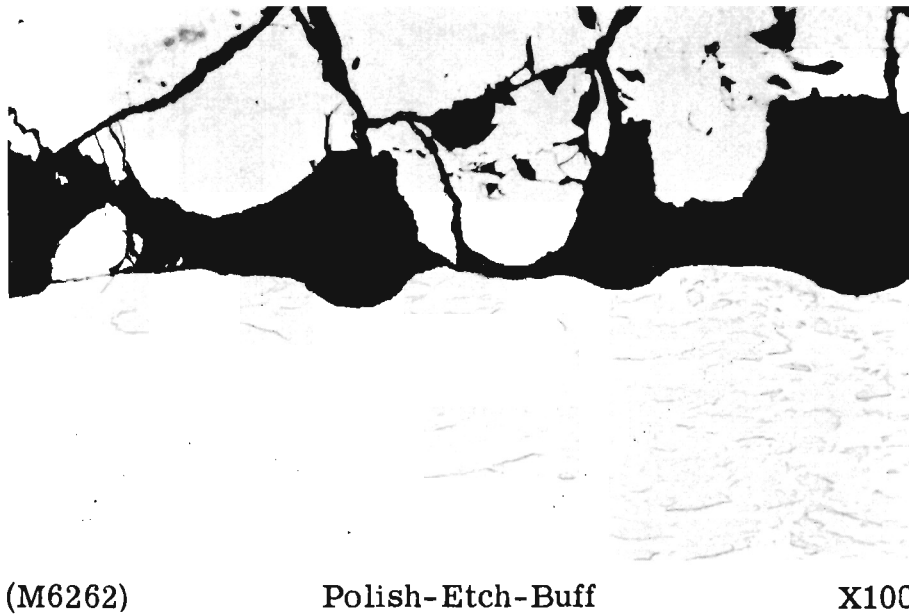
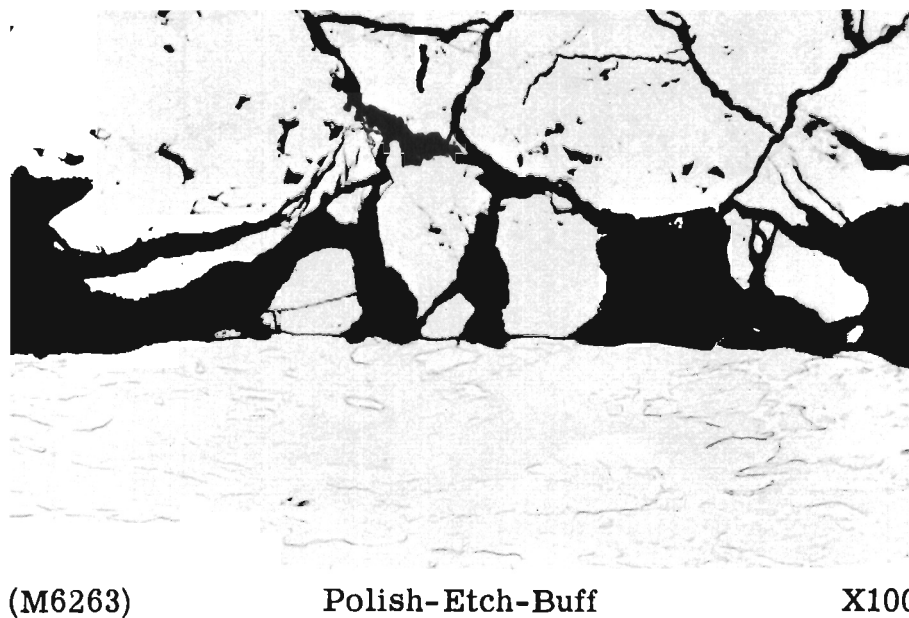
FIGURE 49 - SPECIMEN E323. MICROSTRUCTURE AT INTERFACE SHOWING ATTACK ON THE BASE MOLYBDENUM AFTER 390 CYCLES FROM 1800°F IN THERMAL CYCLING APPARATUS.

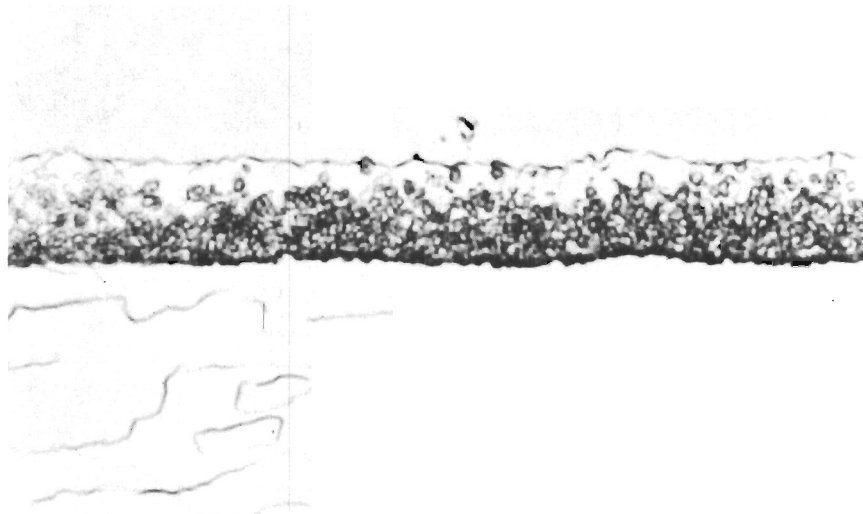
FIGURE 50 (M6436) Polish-Etch-Buff X2000

Specimen E396-B. Al-Cr-Si on 0.5% Ti-Mo alloy. Diffusion treated two hours at 2200^oF in tank argon. Note wide interfacial zone.

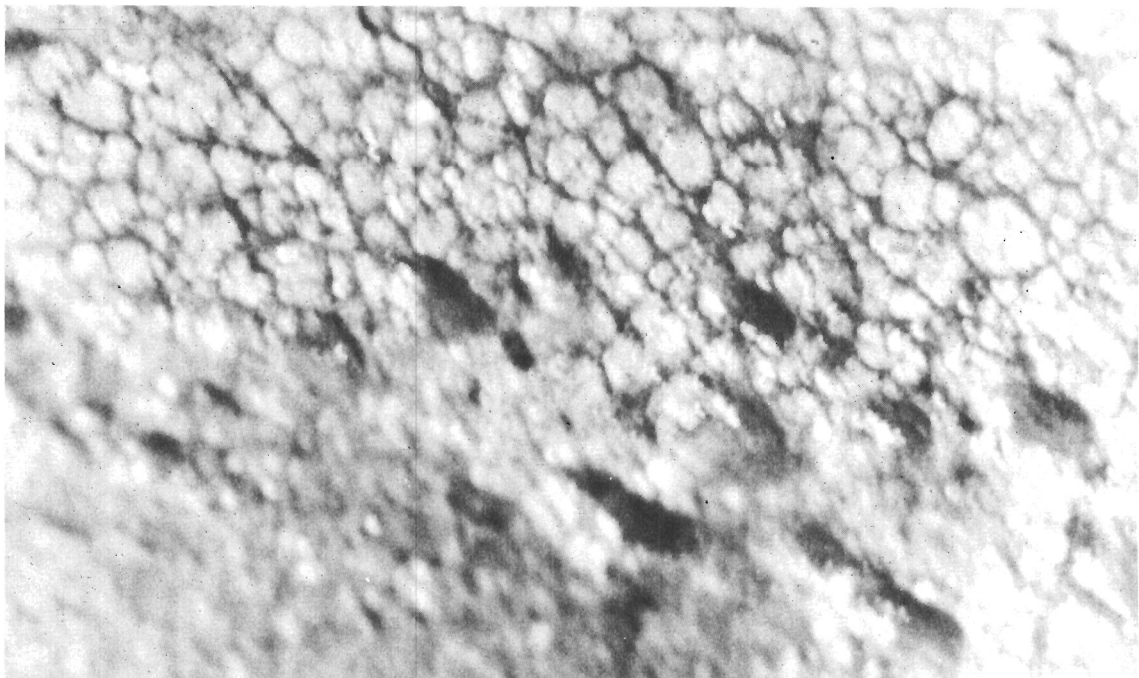
FIGURE 51 (35-24)

Specimen E396. Al-Cr-Si on 0.5% Ti-Mo alloy. Diffusion treated two hours at 2200^oF in tank argon. After 429 cycles from 1800^oF in thermal cycling apparatus. Appearance of molybdenum surface at interface.

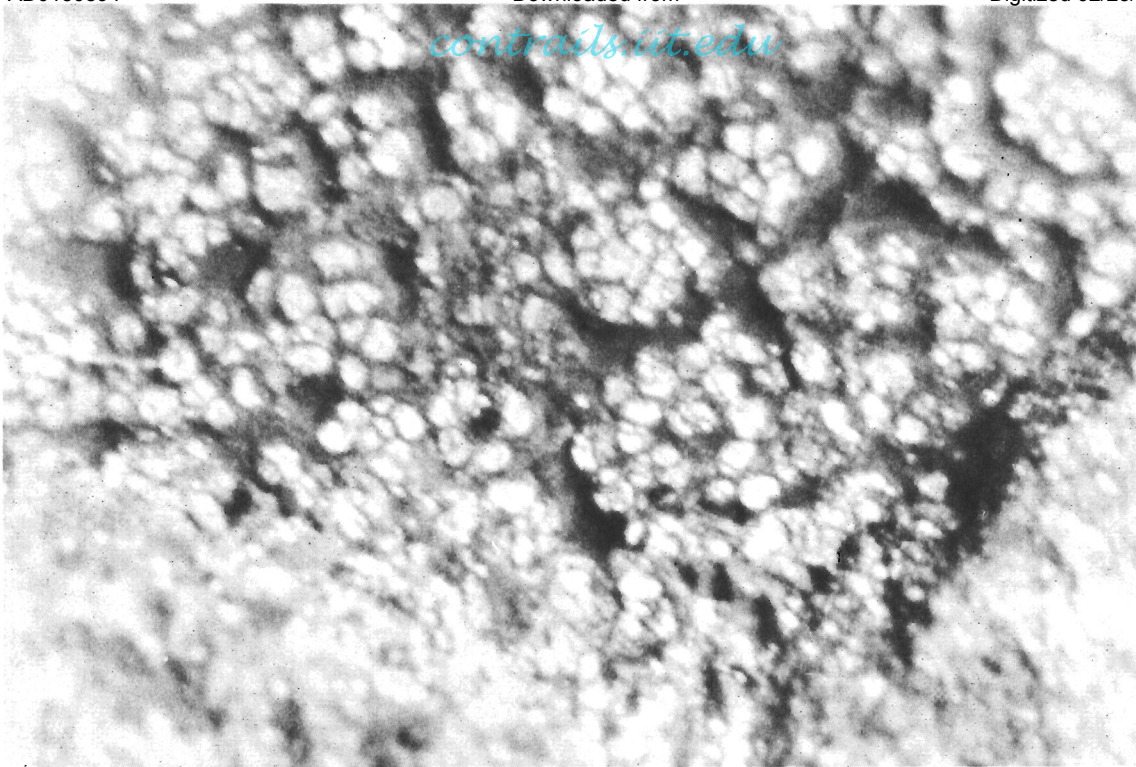
FIGURE 52 (35-23)

Specimen E394. Al-Cr-Si on 0.5% Ti-Mo alloy. Diffusion treated two hours at 2200°F in tank argon. After 1,361 thermal cycles from 1800°F in thermal cycling apparatus. Appearance of molybdenum surface at interface.

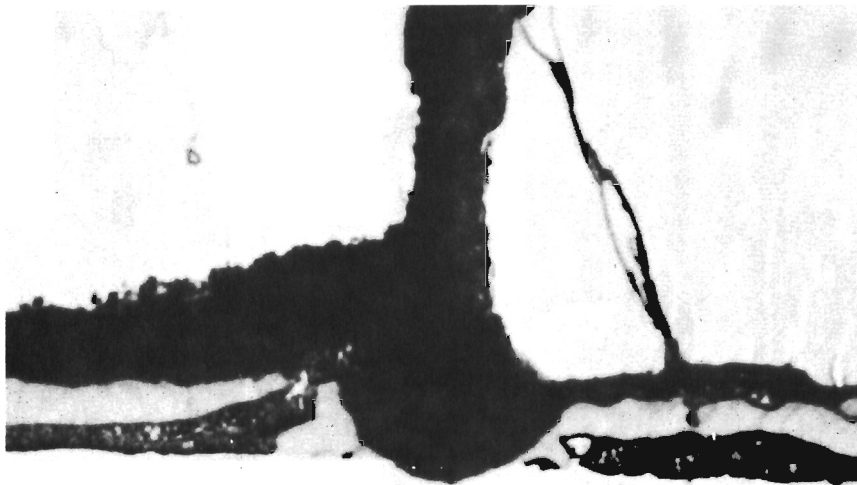
FIGURE 53 (M6944)

Specimen E394. Microstructure at interface, showing oxidation of wide interfacial zone before oxidation of base molybdenum.

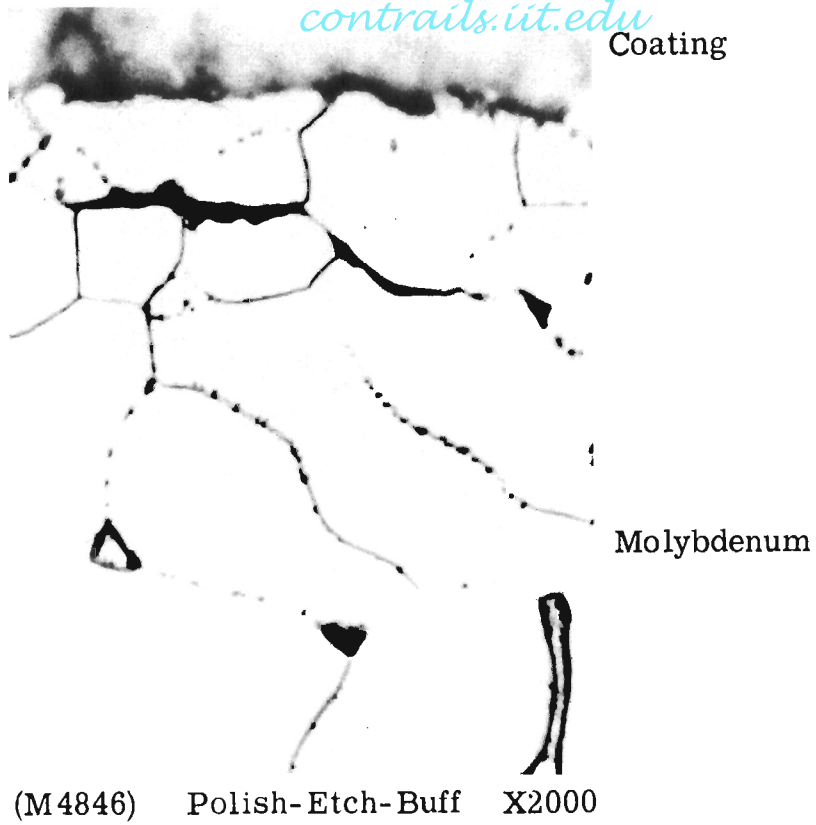
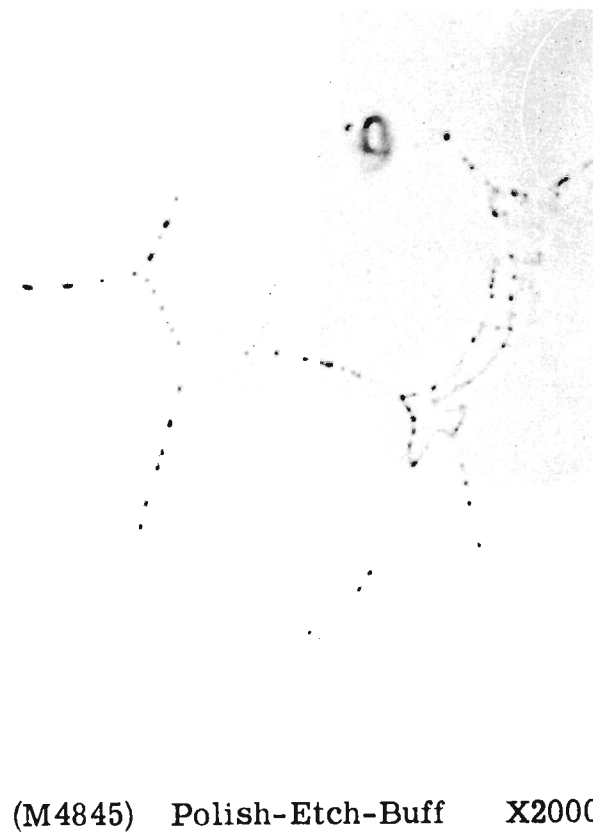
FIGURE 55 - SPECIMEN C422. SHOWING OXIDATION AT MOLYBDENUM GRAIN BOUNDARIES IN RECRYSTALLIZED LAYER BENEATH THE COATING.
