**WADC TECHNICAL REPORT 54-492
PART III**

**OXIDATION-RESISTANT COATINGS
FOR MOLYBDENUM**

Climax Molybdenum Company of Michigan

April 1957

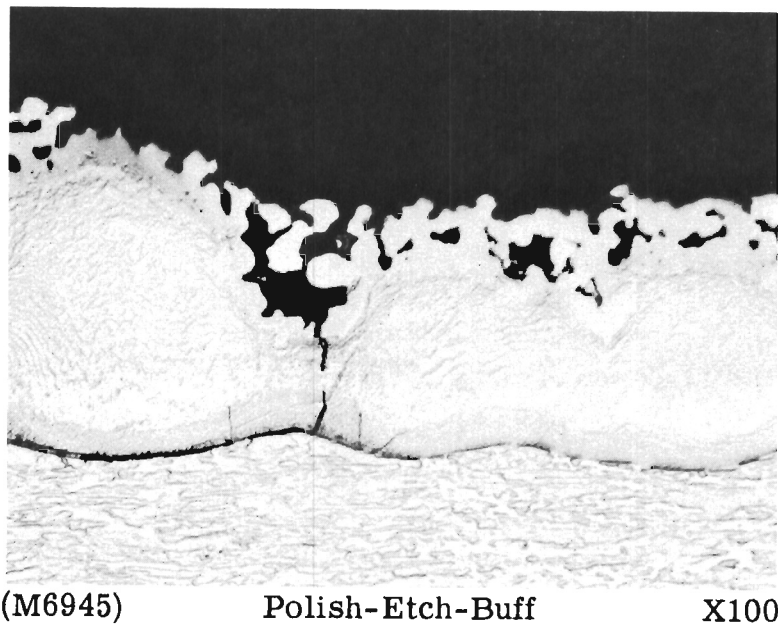
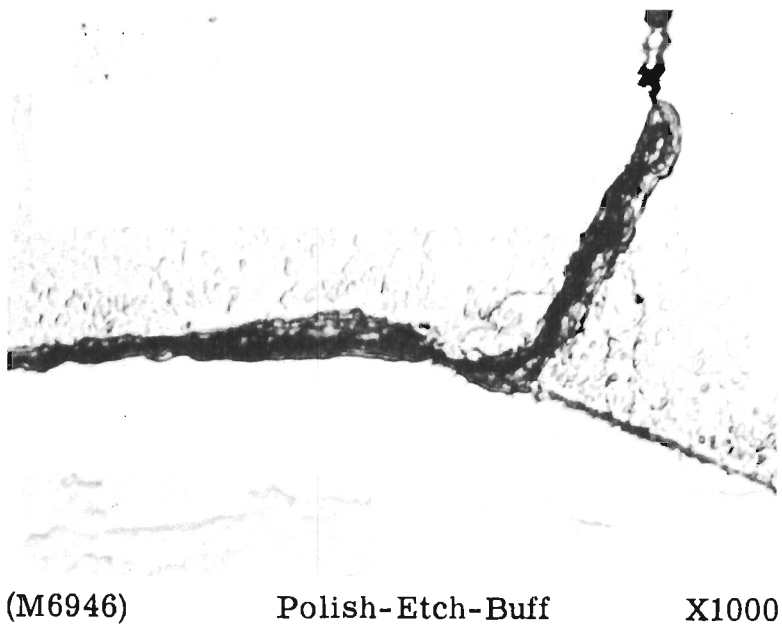
FIGURE 56 - SPECIMEN E324. COLMONOY NO. 5 ON 0.5% Ti-Mo ALLOY. DIFFUSION TREATED TWO HOURS AT 2000°F IN DRY ARGON. SUBJECTED TO 20 THERMAL CYCLES FROM 1800°F. NOTE OXIDATION AT INTERFACE ADJACENT TO CRACK ON COATING.
