# Improvements in Corrosion Resistance of Adhesive Bonded Structure

Daniel B. Arnold

Boeing Commercial Airplane Company

Tri-service Conference on Corrosion ■ United States Air Force Academy, Colorado

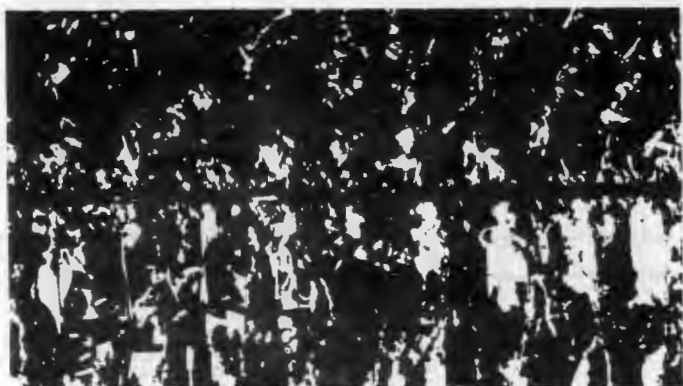
## EXAMPLES OF HONEYCOMB SERVICE FAILURES

Extensive usage of adhesive-bonded structure on the 747, as well as on other aircraft that were emerging in the late 1960s, was not without problems. Specifically, there were delamination and corrosion on a large variety of components, including both metal-to-metal and honeycomb types of structure. The experience in the commercial industry was similar to the experience with military aircraft. The following four photographs detail the types of problems that were typical of service failures.

This photograph shows the delamination of an inner skin of a honeycomb panel. Notice that there is lifting of this skin along the edges of the honeycomb. In addition, there is both doubler and skin separation on the external surface.

Slide 8 shows the delamination area along the edge of a honeycomb panel in which the face sheet has been peeled off, revealing the areas of corrosion and delamination. Notice that the delamination starts from the edge of the panel as well as from the fastener holes and radiates away from those exposed edges into the center of the bonded area.

This slide shows a delaminated body skin doubler leaving behind the external skin on the surface of the airplane. Notice again that the delamination initiates at the fastener holes and propagates radially from these holes. This is due to the ingress of moisture through the fastener holes.

This slide shows a severe case of corrosion in which the waffle pattern doubler has completely peeled away from the external skin, leaving behind serious corrosion. Notice also that the delamination occurs from both the doubler and the external skin, indicating that the problem exists with both of these pieces of the bonded assembly. Also, this type of delamination was accelerated by the environment. In this case, the panel was exposed in the bilge of an aircraft, and the fluids that existed in the area accelerated the corrosion.

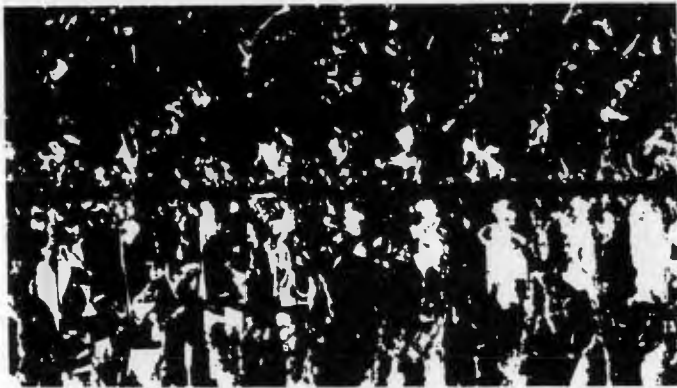
# WATER INGESTION

A second classical type of failure is shown here. Once water has progressed into the honeycomb area, the honeycomb foil itself is corroded and separation of the adhesive occurs from the foil itself. Thus, we have a lifting of the face sheet from the core, leaving behind a corroded surface of the cells. For this mechanism to occur, there must be water and relatively low stresses present. The water ingresses either through fasteners or through the hydroscopic adhesive that bonds the face sheet to the honeycomb core. The stresses exist due to air loads or fitup stresses.

HONEYCOMB  
FOIL AND ADHESION  
SEPARATION

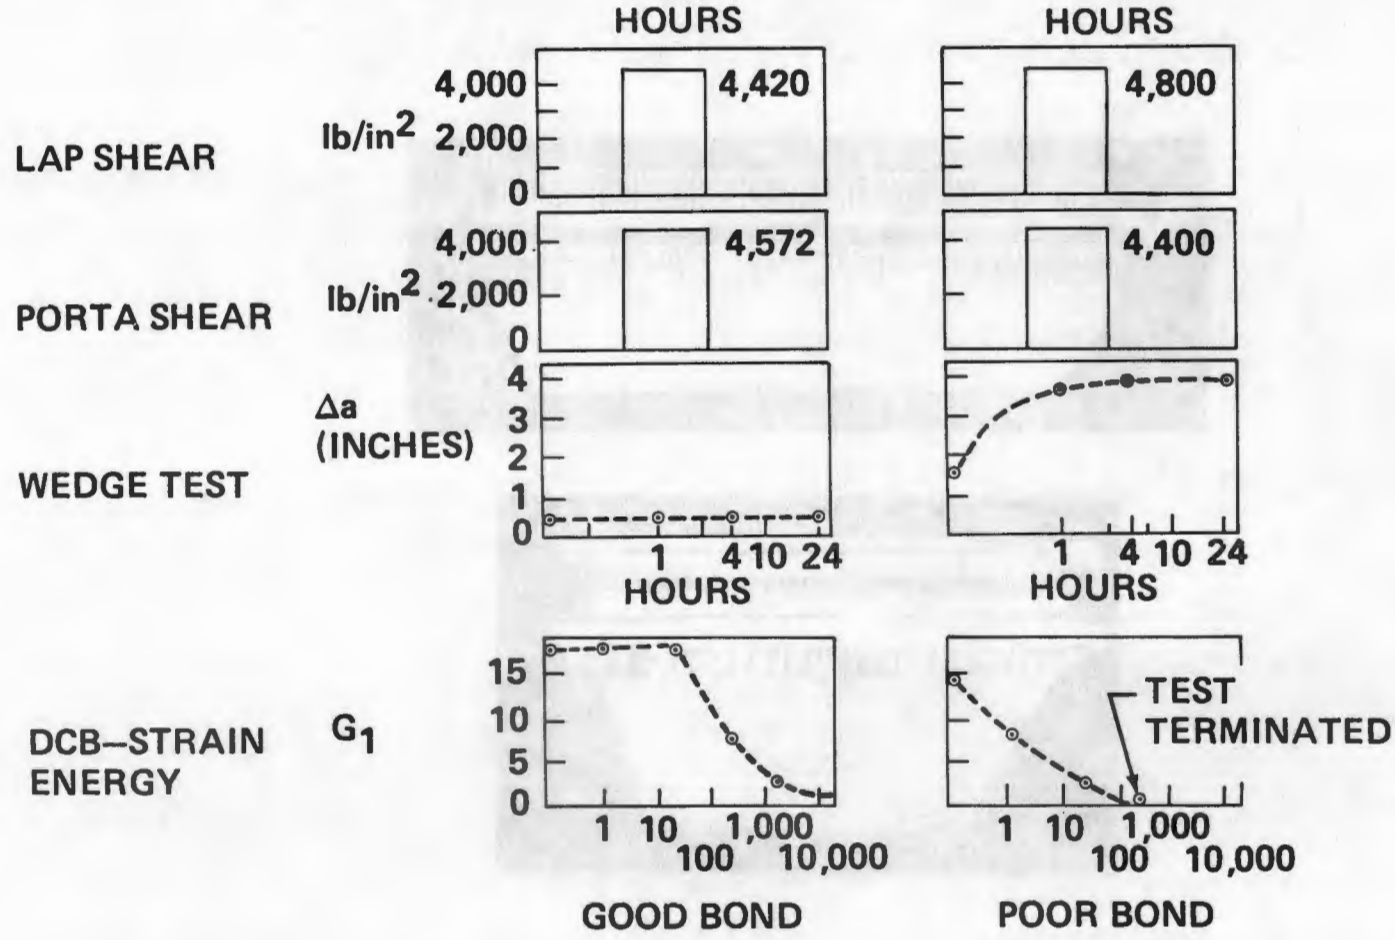
# EVALUATION OF SERVICE PARTS

If we now compare a good panel with a poor panel (i.e., a panel that has gone through service and not delaminated versus a panel that has gone through service and delaminated), we can see in the upper two comparisons of lap-shear portashear that there is no difference in the shear strength of the good and the bad panel. However, in the third comparison, the wedge test shows that the good panel had essentially no crack growth, whereas the delaminated panel had a precipitous crack growth that occurred in a matter of hours. In the fourth comparison, the toughness of the adhesives was measured; the good adhesive maintained its toughness until it was plasticized by the moisture, and then the toughness dropped off. With the poor adhesive that delaminated in service, the toughness dropped off quite rapidly and, in fact, we were not even measuring the toughness of the adhesive, but instead were seeing an interfacial failure, again typical of the type of failure seen in the panel.

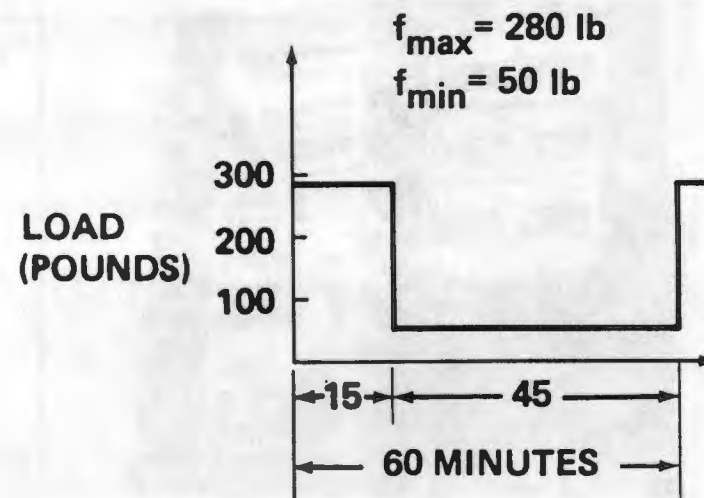
# CYCLIC LOAD

This slide shows the same type of specimen, only instead of a static load, it has been fitted with a bellows and the same fulcrum arrangement and cyclic stress can be applied. A 1-hour cure cycle was chosen because it represents the Webber chamber simulation of a ground-air-ground airplane flight cycle.

**CYCLIC LOAD ARRANGEMENT**

**CYCLIC LOAD CYCLE**

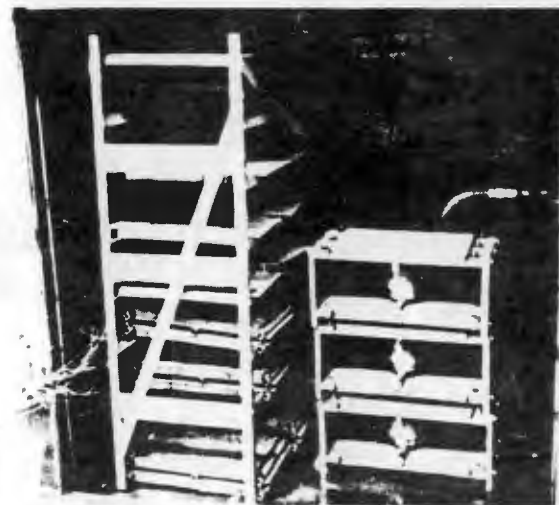
# GROUND—AIR—GROUND ENVIRONMENT

This slide shows the ground-air-ground environmental cycle. In the upper left, the humidity is varied from 100% to 0% and back to 100%, while at the same time the temperature is cycled from 140°F to -60°F and back to 140°F. The pressure in the chamber is also changed from sea level to a simulated altitude of 40,000 feet. In the right center, you can see a photograph of the inside of the chamber with a number of these different types of coupons sitting on the racks. The lower part of the slide shows a comparison of old and new-technology adhesive-bonded structure. Reading across, we can see that with no stress there were approximately 100 cells filled with water after 4000 cycles with the old-technology alkaline system, and no water was absorbed even up to 8000 cycles with the newer technology. If a static stress was applied, 50 or more cells filled with water after 700 cycles, whereas there was no water absorbed up to 8000 cycles with the new technology. If a cyclic load and environmental cycle were applied, it is seen that the old technology failed relatively quickly in 250 to 300 cycles, whereas the new technology endured over 8000 cycles without an ingestion of moisture or any propagation of failure.

BONDING TECHNOLOGY	NO STRESS	STATIC STRESS	CYCLIC STRESS
OLD	100 CELLS, WATER, 4,000 CYCLES	50 CELLS, WATER, 760 CYCLES	FAILED, 260 CYCLES
NEW	NO WATER, 8,000 CYCLES	NO WATER 8,000 CYCLES	NO FAILURE, 3,000 CYCLES

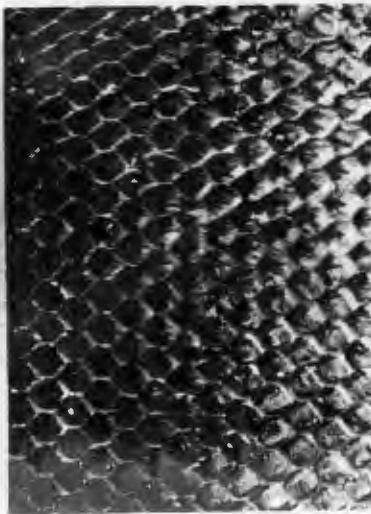
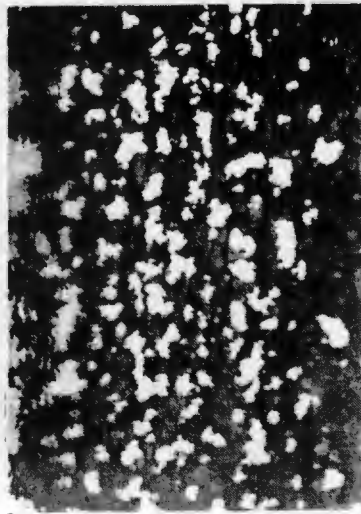
Perhaps one of the most dramatic changes that has taken place in adhesive-bonded structure has been the incorporation of corrosion-resistant honeycomb core. On the left is shown the older, uncoated honeycomb; on the right, the metal, organic-coated, corrosion-resistant honeycomb core. These particular specimens have been exposed to a salt spray environment for 25 days. On the left, the honeycomb core specimens, as well as the foil itself, are severely pitted; whereas on the right, there is no corrosion attack on the edges of the honeycomb foil or on the foil. In addition to the two changes that we have discussed here (phosphoric acid anodize and corrosion-resistant core), there have been a number of other changes to improve the corrosion resistance of bonded honeycomb structure. Specifically, the clad adherends have been changed to bare adherends to eliminate the problem of clad dissolution. Corrosion-resistant primers have been implemented. In the past, either no primers, or primers that were susceptible to moisture degradation, were used. Lastly, toughened epoxy adhesives have been used; not only do they have better toughness and resistance to peeling, but they also have higher resistance to moisture ingress. Thus, the amount of moisture that reaches the interface of the bond has been decreased.

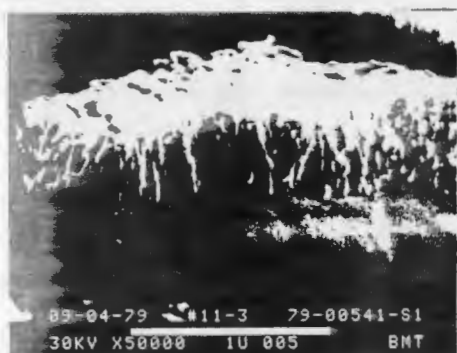
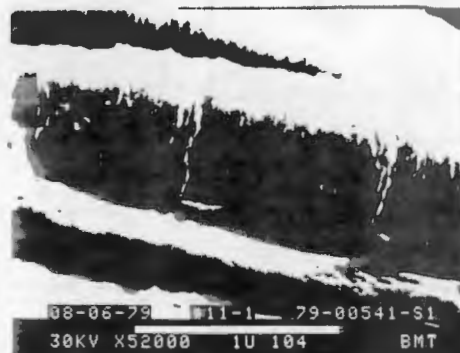
## COMPARISON OF PRIMERS ON PHOSPHORIC ACID

This slide shows a family of micrographs with three different types of adhesive primers applied over the surface of the oxide itself. On the left photograph, there is partial primer penetration into the oxide pores; in the center photograph, there is complete penetration; and in the right photograph, there is an excessive amount of primer built up on the oxide surface. A thicker rubber coating can be seen on the surface of this particular specimen.

**PARTIAL PENETRATION  
(THIN RUBBER CONTAINING  
PRIMER ON 2024-T3 CLAD)**

**COMPLETE PENETRATION  
(THIN RUBBER CONTAINING  
PRIMER ON 2024-T3 CLAD)**

**EXCESSIVELY THICK PRIMER  
(THICK RUBBER CONTAINING  
PRIMER ON 2024-T3 BARE)**
