**STRESS CORROSION CRACKING IN DEPLETED URANIUM -2 W/O**

**MOLYBDENUM ALLOY PENETRATORS**

By C. R. Crowe\*

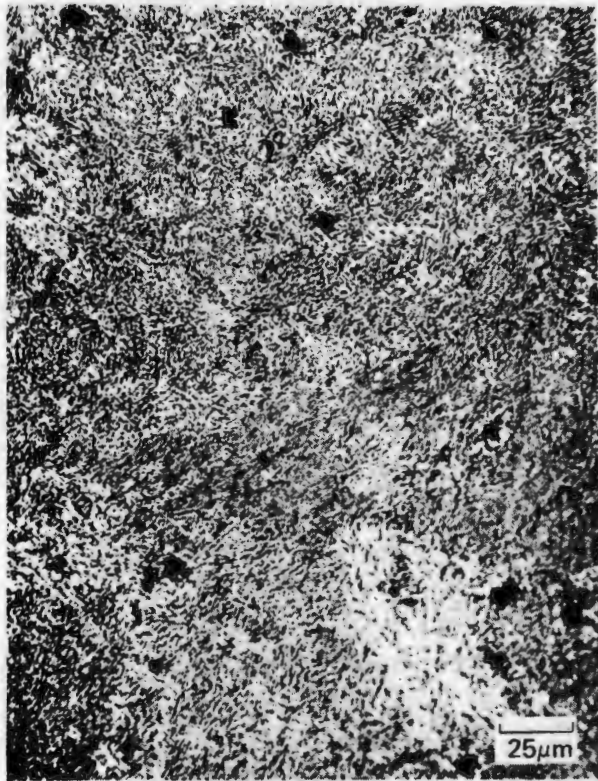
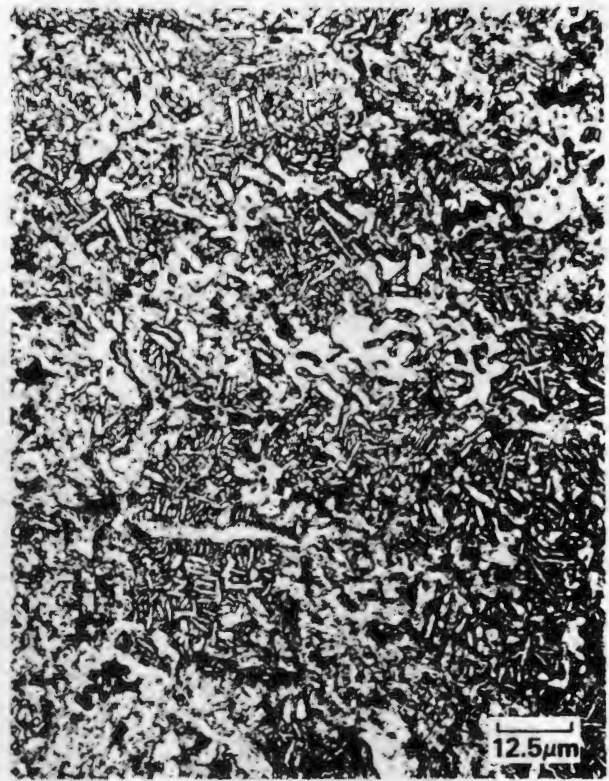
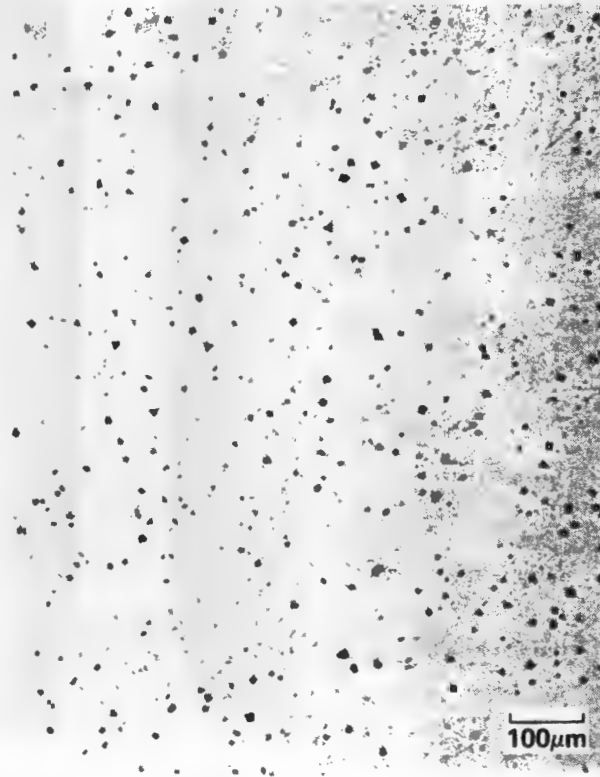
FIGURE 2 INCLUSIONS OBSERVED IN PENETRATORS

A round from each batch was cut lengthwise, mounted, polished, and etched for metallographic examination. The etchant which produced the best results was one part each of nitric acid, acetic acid, and water, adding a few drops of hydrofluoric acid. Illustrative microstructures are shown in Figure 2.

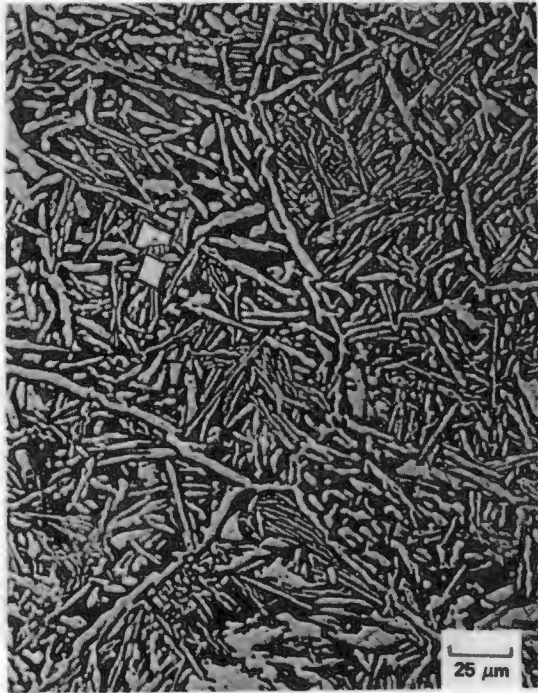
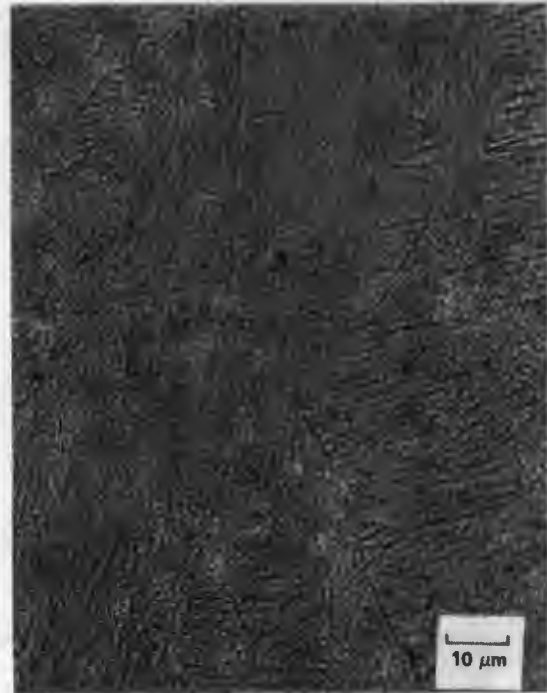
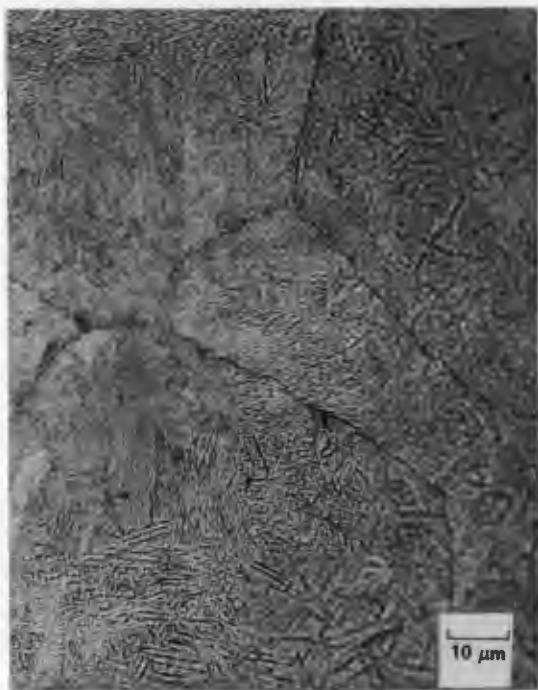
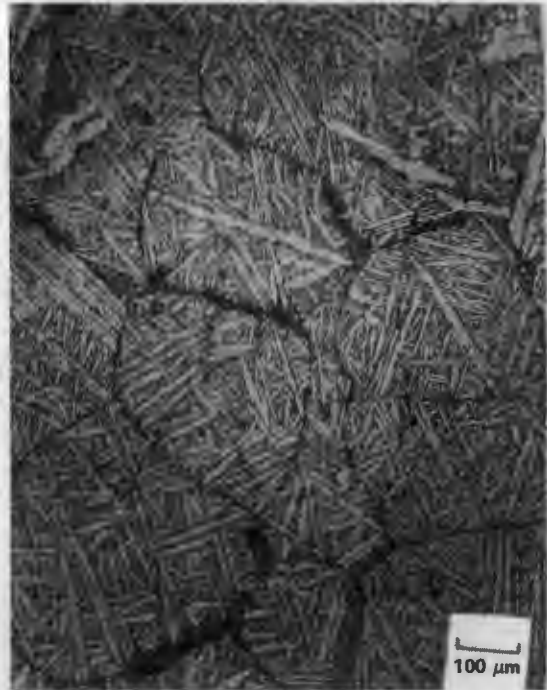
Some specimens of the U-2Mo QOA were reheat treated to form a two phase structure by quenching from the  $\alpha + \gamma$  phase field. The resulting microstructure is shown in Figure 3(a). The morphology consists of a dispersion of retained  $\gamma$ , rich in molybdenum, imbedded in a low molybdenum  $\alpha$  matrix. There is no optical evidence in the micrographs that the banded martensitic variant of the  $\alpha$  phase,  $\alpha_b'$ , was formed during the quench. The prior  $\gamma$  ASTM grain size is 2 to 3. Large rectangular precipitates, which presumably are carboxynitrides, are also found in the fracture topology.

The quenched and overaged U-2Mo QOA microstructure is seen in Figure 3(b). It consists of small precipitates of  $\delta$  along prior  $\gamma$  grain boundaries and pseudo-lamellar ( $\alpha + \delta$ ) in the grain interior. The prior  $\gamma$  grain size is ASTM 2 to 3. Again, there are some small blocky carboxynitride inclusions dispersed throughout the microstructure.

In Figure 3(c), the microstructure for the uranium -3/4 Quint (U-3/4 Quint) is given. The structure is similar to the quenched and overaged U-2Mo. In this case, however, the ASTM grain size number is 3 to 4.

The microstructure of the as extruded uranium -3/4 w/o titanium (U-3/4 Ti) material is presented in Figure 3(d). The structure is the acicular form of martensitic  $\alpha_2'$ , and is very similar to what one would expect for a  $\gamma$  quenched and overaged material. The morphology shows some decomposition at the prior  $\gamma$  grain boundaries and inside the martensitic needles. Some inclusions are also observed. The prior  $\gamma$  average grain diameter is 300  $\mu\text{m}$ .

- (a) U-2Mo quenched from the  $\alpha + \gamma$  phase field
  - (b) U-2Mo QOA
  - (c) U-3/4 Quint
  - (d) U-3/4 Titanium
- FIGURE 4 Charpy V-Notch impact data

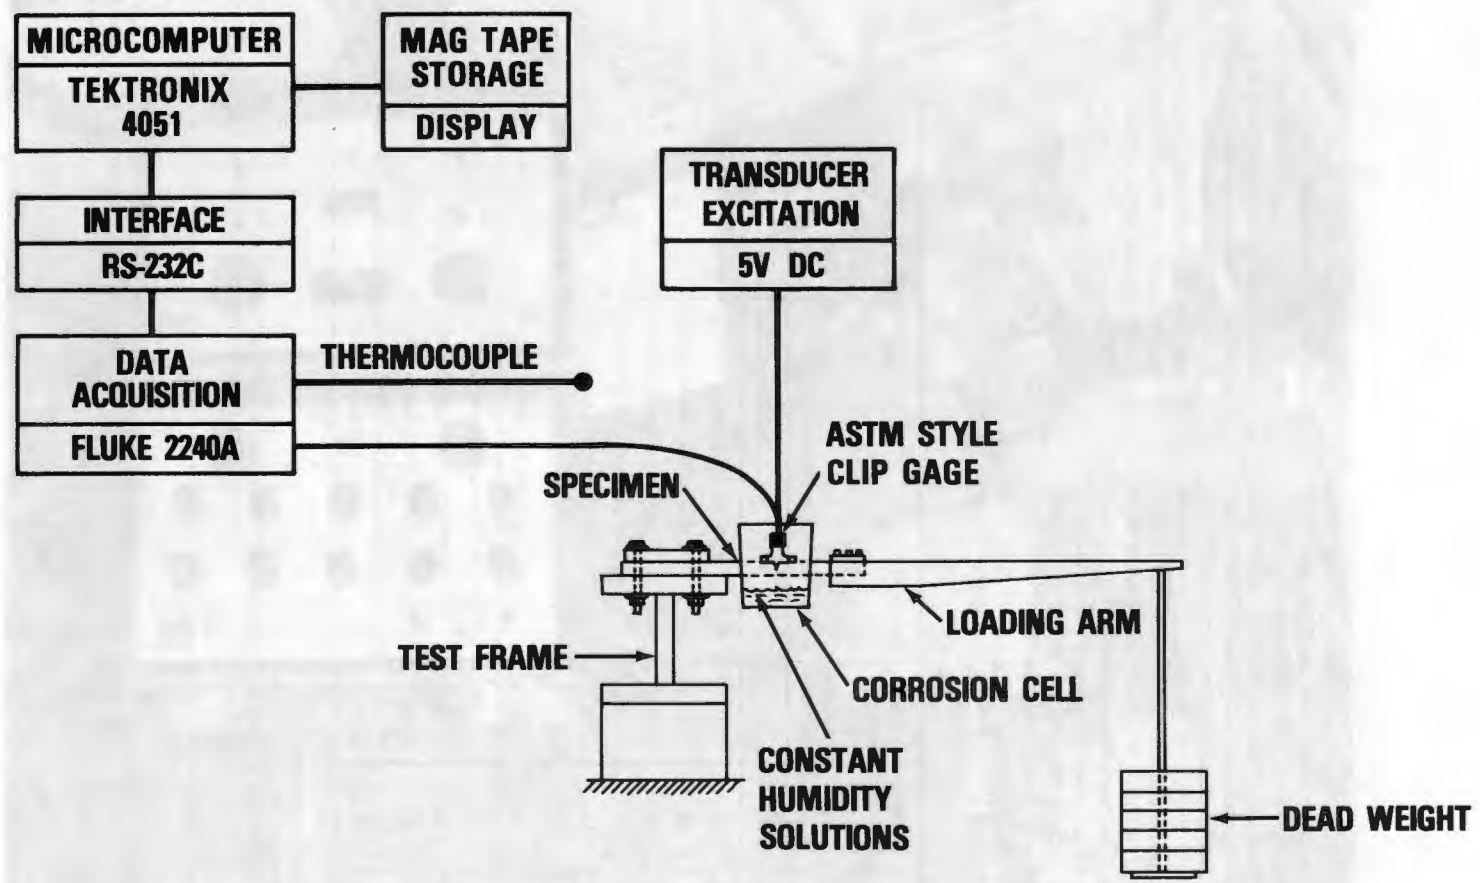
Stress corrosion testing was performed on the depleted uranium alloys to obtain crack growth kinetics. The test apparatus was a cantilever beam fixture similar to that proposed by Brown and Beachem<sup>4</sup>. Cantilever beam specimens were instrumented with a crack-opening-displacement gage to continuously monitor crack growth rate. A schematic of the test arrangement is shown in Figure 6. The system is capable of distinguishing crack opening displacement changes of  $1 \times 10^{-3}$  mm which gives a system resolution of 0.5 mm for a period of one month. Crack growth rates of  $3.5 \times 10^{-4}$  mm/hr can be detected in less than seven days.

Prior to testing, the specimens were fatigue precracked to insure a sharp notch. Crack orientation was TS. Fatigue precracking was performed in a cantilever configuration for the 12.7 mm x 12.7 mm x 152.4 mm samples on a constant deflection Krauss-Tatnal machine and in three point bending for the 25.4 mm x 25.4 mm x 152.4 mm samples on a closed-loop machine. The fatigue schedule was well within the criteria established in ASTM E399-74 with the ratio of the maximum stress intensity of the fatigue cycle,  $K_f$  (max) to the Young's modulus  $E$ , equal to  $8.01 \times 10^{-5} \text{ m}^{1/2}$  for the final 1.5% overall length of notch plus crack. The ratio of  $K_f$  (max) to  $K_{IC}$  was at most 0.3; and the plastic zone radius, using Irwin's approximation, at the beginning of the SCC test was  $1.38 \times 10^{-5}$  to  $1.76 \times 10^{-5}$  m.

The specimens were dipped in a 3.5 percent salt distilled water solution. The specimens were allowed to dry in laboratory air. The specimens were then installed in the cantilever beam test apparatus with zero applied load for one hour in a closed container designed to maintain 98 percent relative humidity. The solution in the container was a super-saturated solution of  $\text{CaSO}_4 \cdot 5\text{H}_2\text{O}$  in distilled water as specified by ASTM E104-51 (Reapproved 1971), located about 35 mm below the specimen. After the one hour necessary for the atmosphere to equilibrate around the specimen, the test load was applied. Room temperature and room relative humidity were continuously monitored. Additional details of this test procedure are given in reference 10.
