FATIGUE TESTS AND CRACK DETECTION
ON SOME TYPES
OF AXIAL-FLOW COMPRESSOR ROTOR BLADES

R. E. Thomas

von Kármán Gas Dynamics Facility

October 1962

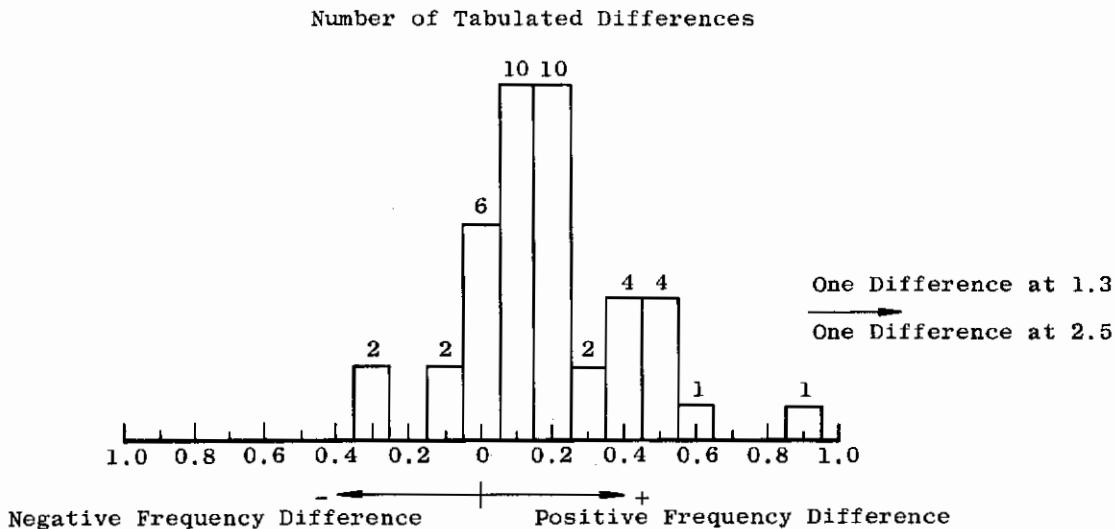
This graph represents only 44 blades because six of the blades had recently been changed to type-403 steel for reasons not connected to this illustration. The grouping of this range of differences is between -0.1 cps and $+0.6$ cps, and since the grouping is not concentrated about 0 cps, we assume that some or all reasons that may cause the natural frequency of a blade to change have influenced a general increase in frequency. This assumption includes a shift of instrumentation zero as well as natural changes to the blade. The three frequencies to the right of the grouping probably can be explained as an error in determining or recording the frequencies; it is discussed under section 4.5 of this report how these errors are eliminated by successive frequency determinations. In any event we have no basis for suspecting a defective blade by the indication of an increasing (positive) frequency change, and the 1.3-cps and 2.5-cps differences were ignored until future determinations could locate the error.

The two blade frequencies shown on the graph at -0.3 cps apparently exhibit decreasing frequencies outside the normal grouping, so we assume that the decreasing frequency change greater than all others in the row being considered may represent a cracked blade. Or in fact, these two blades should be inspected with all means available such as the MPT to determine if crack indications or other detrimental factors are present. In this actual case the two blades were pulled and subjected to MPT, X-ray inspection, and fatigue test in an attempt to locate cracks. One of the two blades was determined to be defective by fatigue tests, the

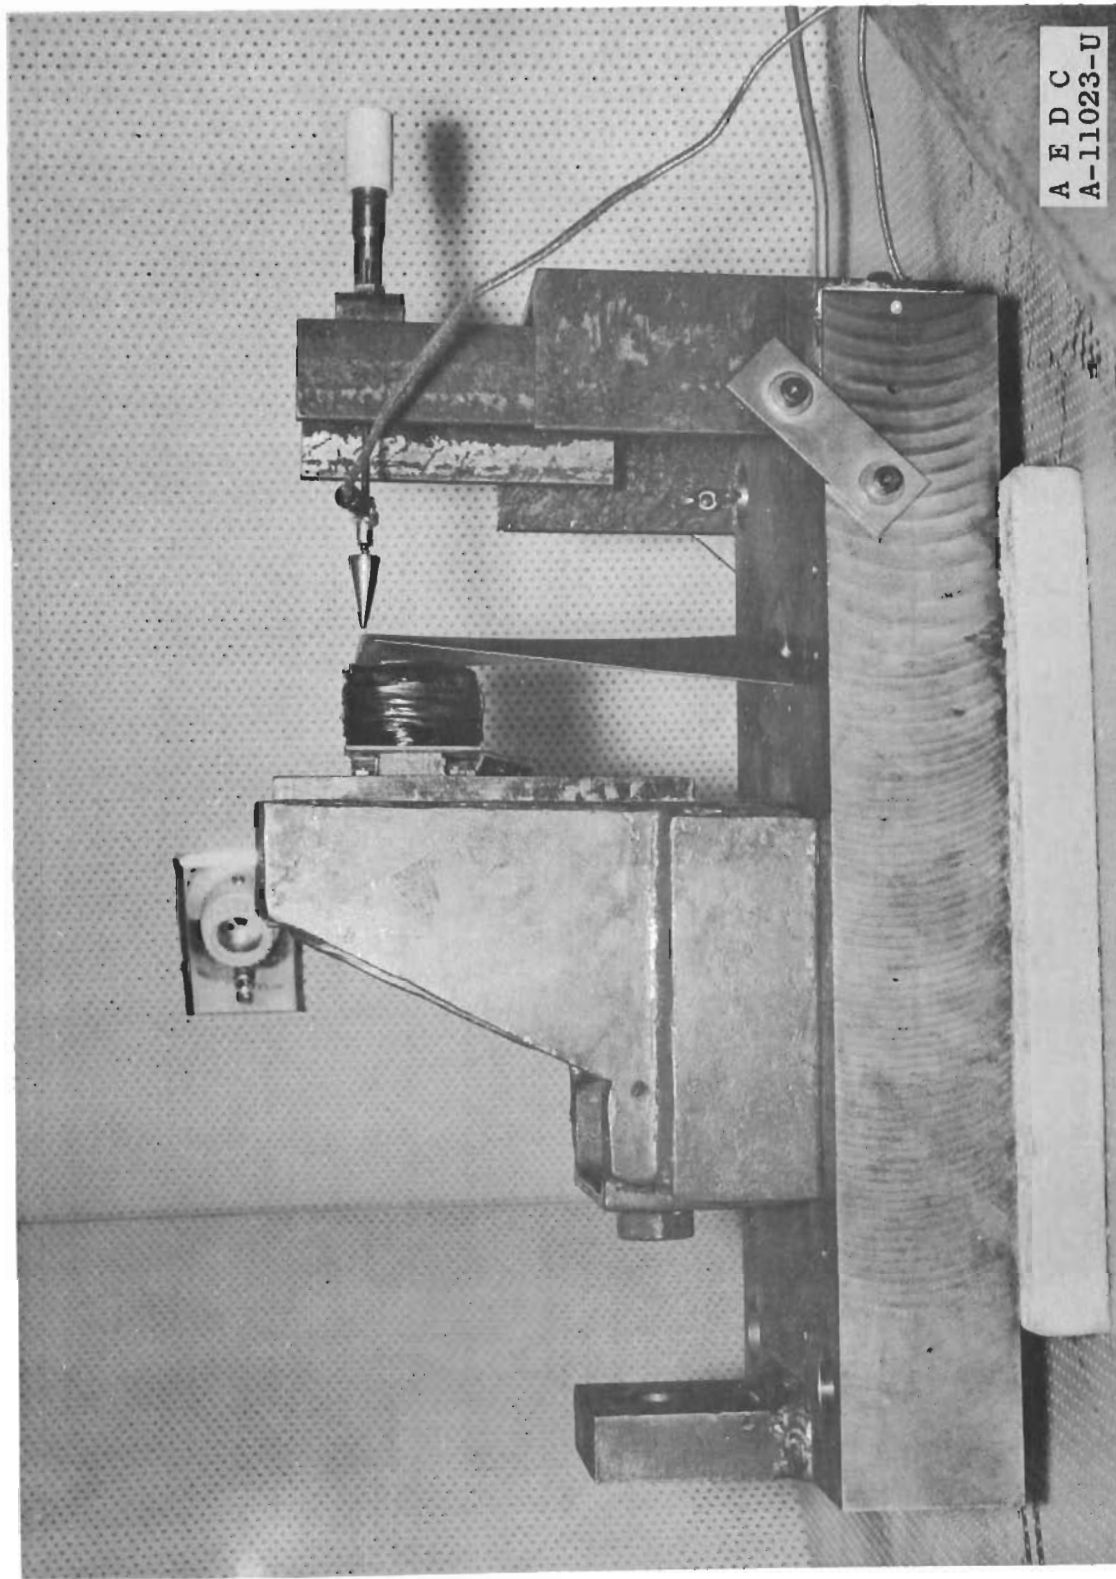
Fig. 1 Blade Test Stand

A stand to support the blade during fatigue testing was fabricated and bored to duplicate the mounting of a blade in its rotor (Fig. 1). The weight of the stand was approximately 125 lb, which was sufficient to provide a stable base when the blade was vibrated.

The coil used to transmit a magnetic force to the blade to excite vibrations was mounted to provide vertical and horizontal positioning relative to the blade. A probe was mounted on the opposite side of the blade to determine the tip amplitude of the blade. The test stand was placed on a one-inch-thick section of acoustical tile to reduce the amount of vibration transmitted to the test bench. The entire stand was placed inside a horizontally positioned telephone booth to reduce the noise level in the working area.

The coil core was constructed of type-8630 steel laminations, 0.031-in. -thick, forming an "E" shaped core with base dimensions of 2-3/4 in. by 1 in.; each leg length was 3-1/2 in. long and 3/8 in. wide. Two coils consisting of 1000 turns of gage number 22 varnished copper wire were wound on 1/8-in. -thick micarta forms. The coils were placed on the two outer legs of the core and fixed with Armstrong Al cement. The two coils were connected electrically parallel to the frequency generator. Each coil when completed had a d-c resistance of eight ohms.

A depth micrometer was modified and mounted on the test stand on the side of the test blade opposite the vibrating coil. The probe end of the micrometer assembly was made of tungsten to better withstand the destructive effect of an electric arc between the probe and the blade.

To avoid the difficulties associated with strain gages, the spark gap apparatus, shown by Figs. 1 and 2, was developed from ideas presented in Ref. 1. Blade tip amplitude was established by setting the output of the power supply to 500 volts, advancing the probe to the vicinity of the blade until an electric arc occurred, and then setting a value on the micrometer corresponding to the tip deflection desired. The blade was then excited by raising the output power of the frequency generator until an arc was produced. It is reported in Ref. 1 that the arc so produced is approximately 1/100 millimeter. The method used to compute the tip deflection for a given reference stress is given in the appendix.

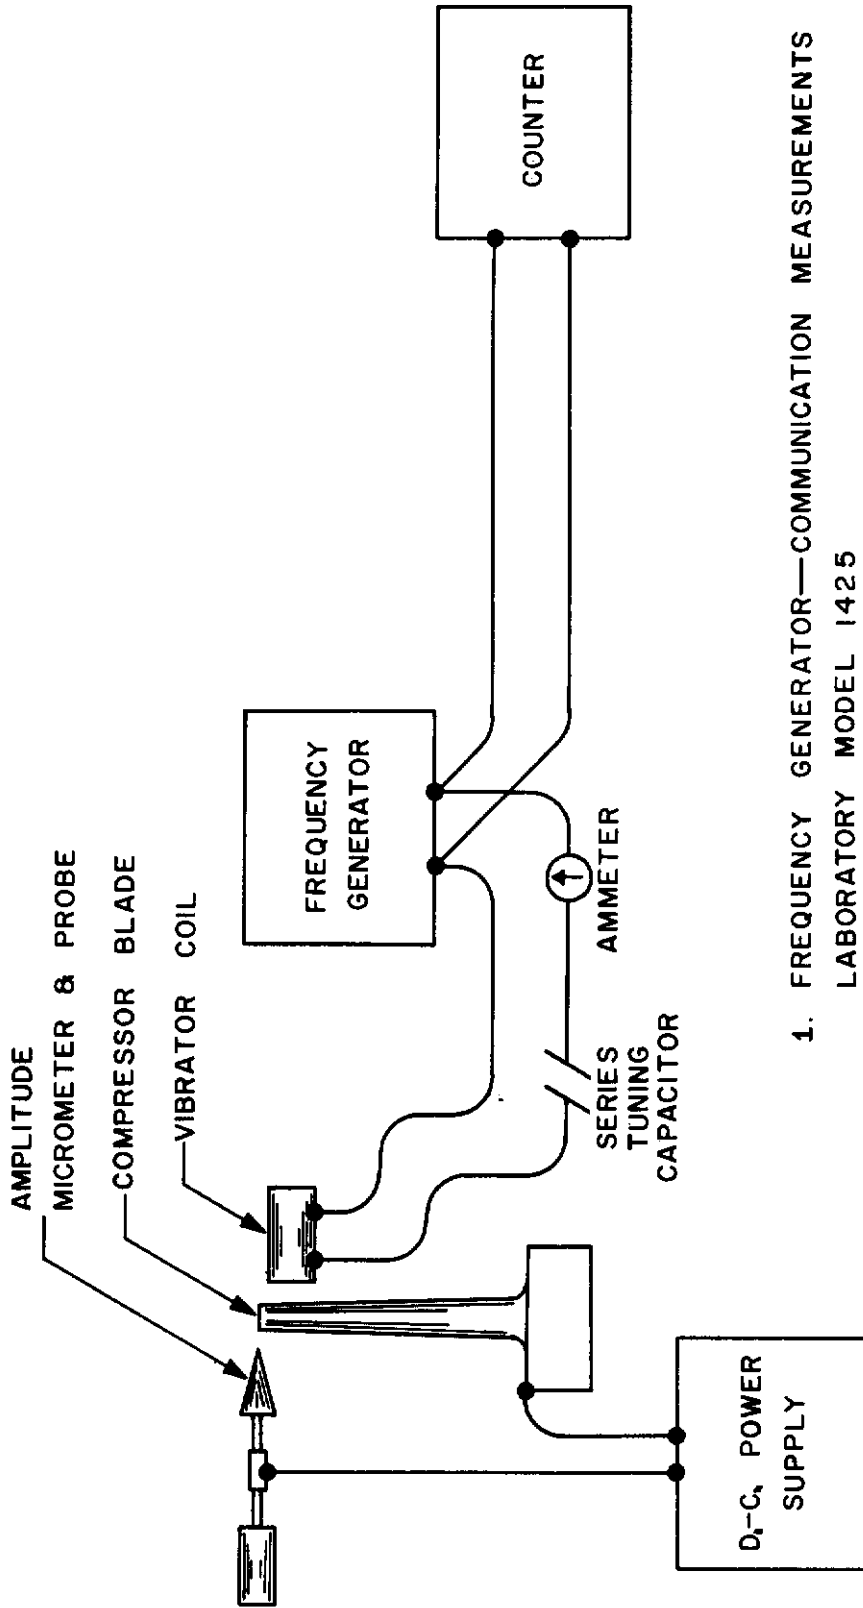
Fig. 2 Apparatus for Fatigue Testing Compressor Blades

Components and connections for the fatigue tests are shown in Fig. 2. The apparatus and connections used to obtain natural frequency data of installed rotor blades are shown in Fig. 3.

1. FREQUENCY GENERATOR—COMMUNICATION MEASUREMENTS LABORATORY MODEL 1425
2. D-C POWER SUPPLY—HEWLETT-PACKARD MODEL 712B
3. COUNTER—BERKELEY EPUT METER MODEL 554A
4. AMMETER—BURLINGTON MODEL 142

To vibrate the blade, the coil was positioned as close to the blade as possible, yet far enough away to provide a clearance between the blade and coil when the blade was vibrating. Approximately two microfarads were connected in series with the coil to approximate series resonance. The test components and connections are given in Figs. 2 and 3.

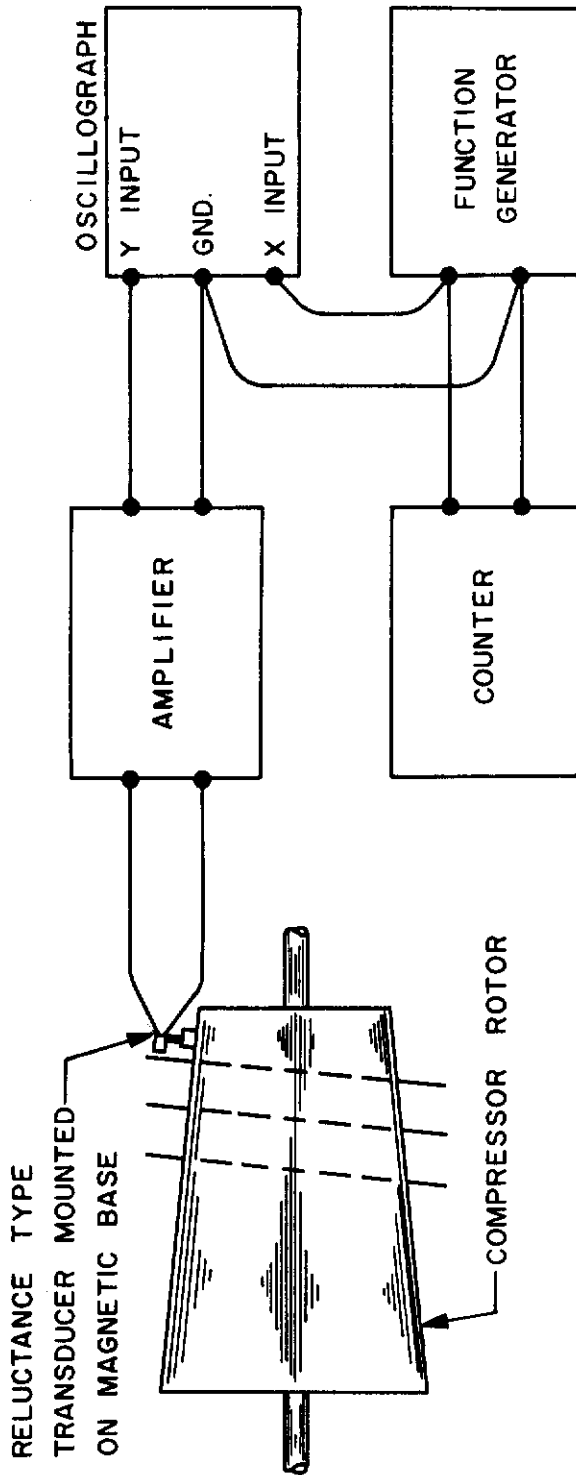
Fig. 3 Apparatus Used to Determine Frequency of Compressor Blades

Figure 3 indicates schematically the method used to determine the fundamental frequency of blades while they were installed in the compressor rotor. The same method was employed in the laboratory.

The blade was struck with a plastic hammer, and the vibrations produced were detected by the transducer, amplified, and applied to the y-axis input of the oscillograph. While the blade was vibrating,

the output frequency of the function generator, which was applied to the x-axis input of the oscillograph, was adjusted to obtain a Lissajous circle on the oscillograph. A Lissajous circle was produced as a result of blade frequency being equal to the function generator frequency. The function generator frequency was displayed by the counter, and this value was recorded as the fundamental frequency of the blade.

1. FUNCTION GENERATOR—HEWLETT-PACKARD MODEL 202A
2. COUNTER—BERKELEY EPUT METER MODEL 554A
3. AMPLIFIER—HEWLETT-PACKARD MODEL 450A
4. OSCILLOGRAPH—DUMONT TYPE 304A

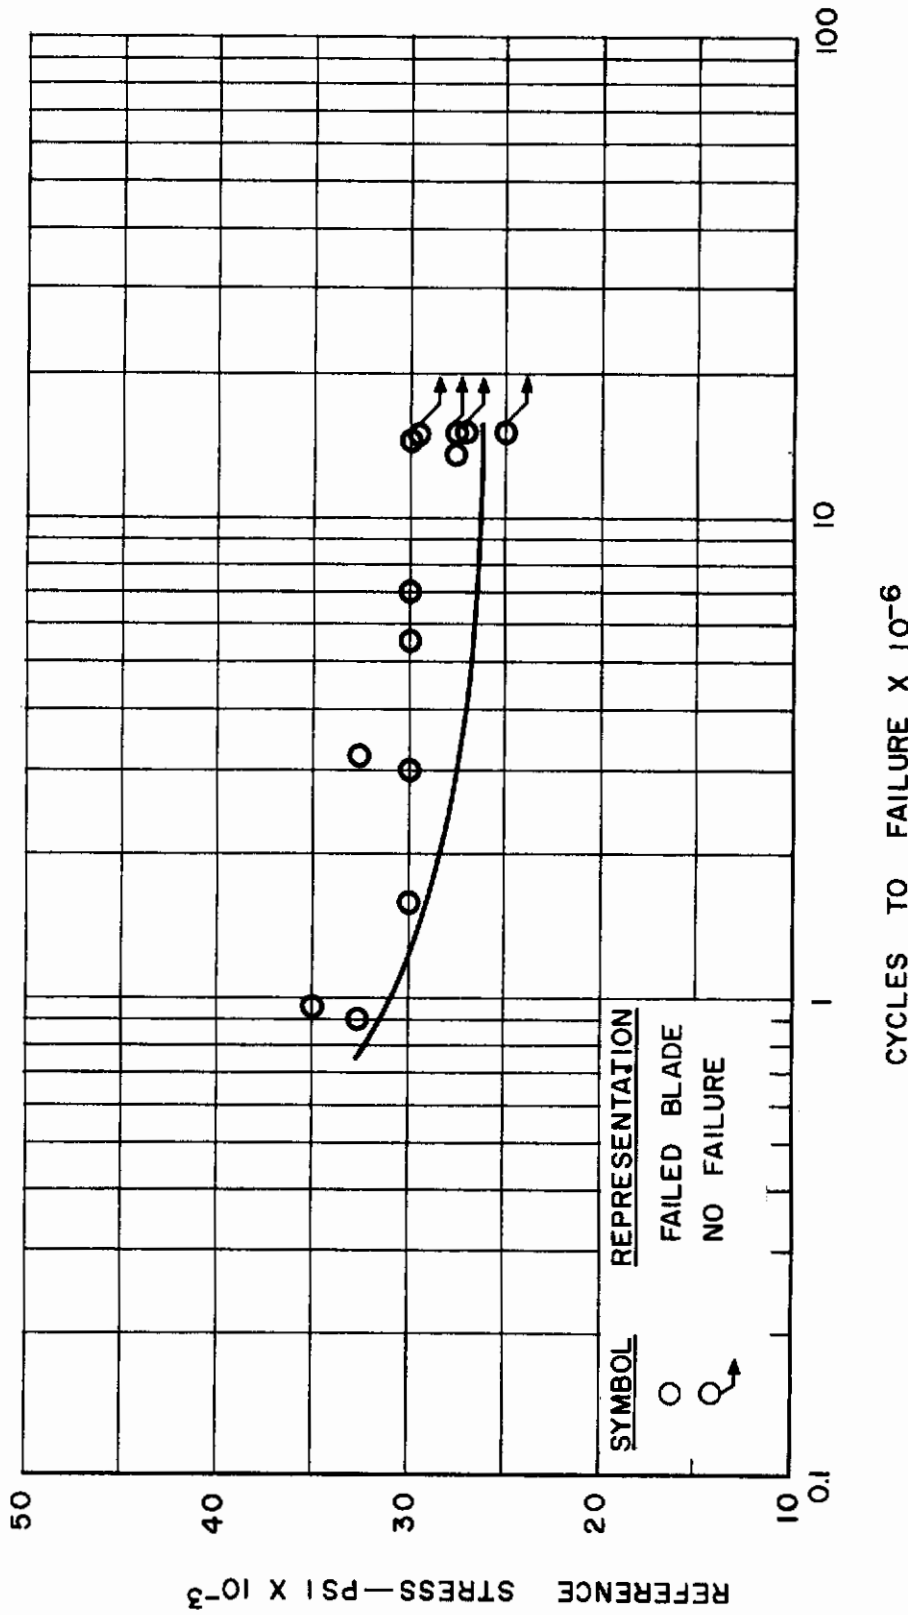
Fig. 4 Variation of Cycles to Failure under Completely Reversed Stress for Type-8630 Compressor Blades

Stress versus cycles to failure data are presented for each type of blade that has been used in VKF (Figs. 4, 5, and 6). The three curves were obtained to provide a comparison of the operating endurance limits of the blades and to form a basis for verification of failures when used blades were fatigue tested.

The data obtained indicates that the type-403 and type-8630 shot-peened blades have higher fatigue strengths than the original type-8630 blades. The most significant improvement is shown to be in the type-403 blade which has an indicated endurance limit of 44,000 psi as compared to an indicated endurance limit of 27,000 psi for the type-8630 blade.

When a drop in frequency of approximately 2 cps was detected, the blade was subjected to the magnetic particle test (MPT, Ref. 2) to verify the crack. If the defect could not be found with the MPT at this time, the blade was further vibrated at its new frequencies to aggravate the crack until it was detected by the MPT. The time when the initial frequency drop was detected was taken as a point for the S-N curve. Total cycles to failure of the blade was taken as twice the counter reading and was also computed from the time lapse of the test. From the data thus obtained, stress versus cycles to failure curves were prepared for type-8630 (Fig. 4), type-8630 shot-peened (Fig. 5), and type-403 (Fig. 6) rotor blades.

It was considered that the S-N curves of Figs. 4, 5, and 6 represent the fatigue life of a normal compressor blade as used in VKF. If a suspected blade failed to exhibit a fatigue life comparable to the curve, it was considered to have been in the process of failing when removed from the compressor. Conversely, when the fatigue life of a suspected blade compared favorably with the curve, it was considered to be a sound blade if other methods could detect no failure.

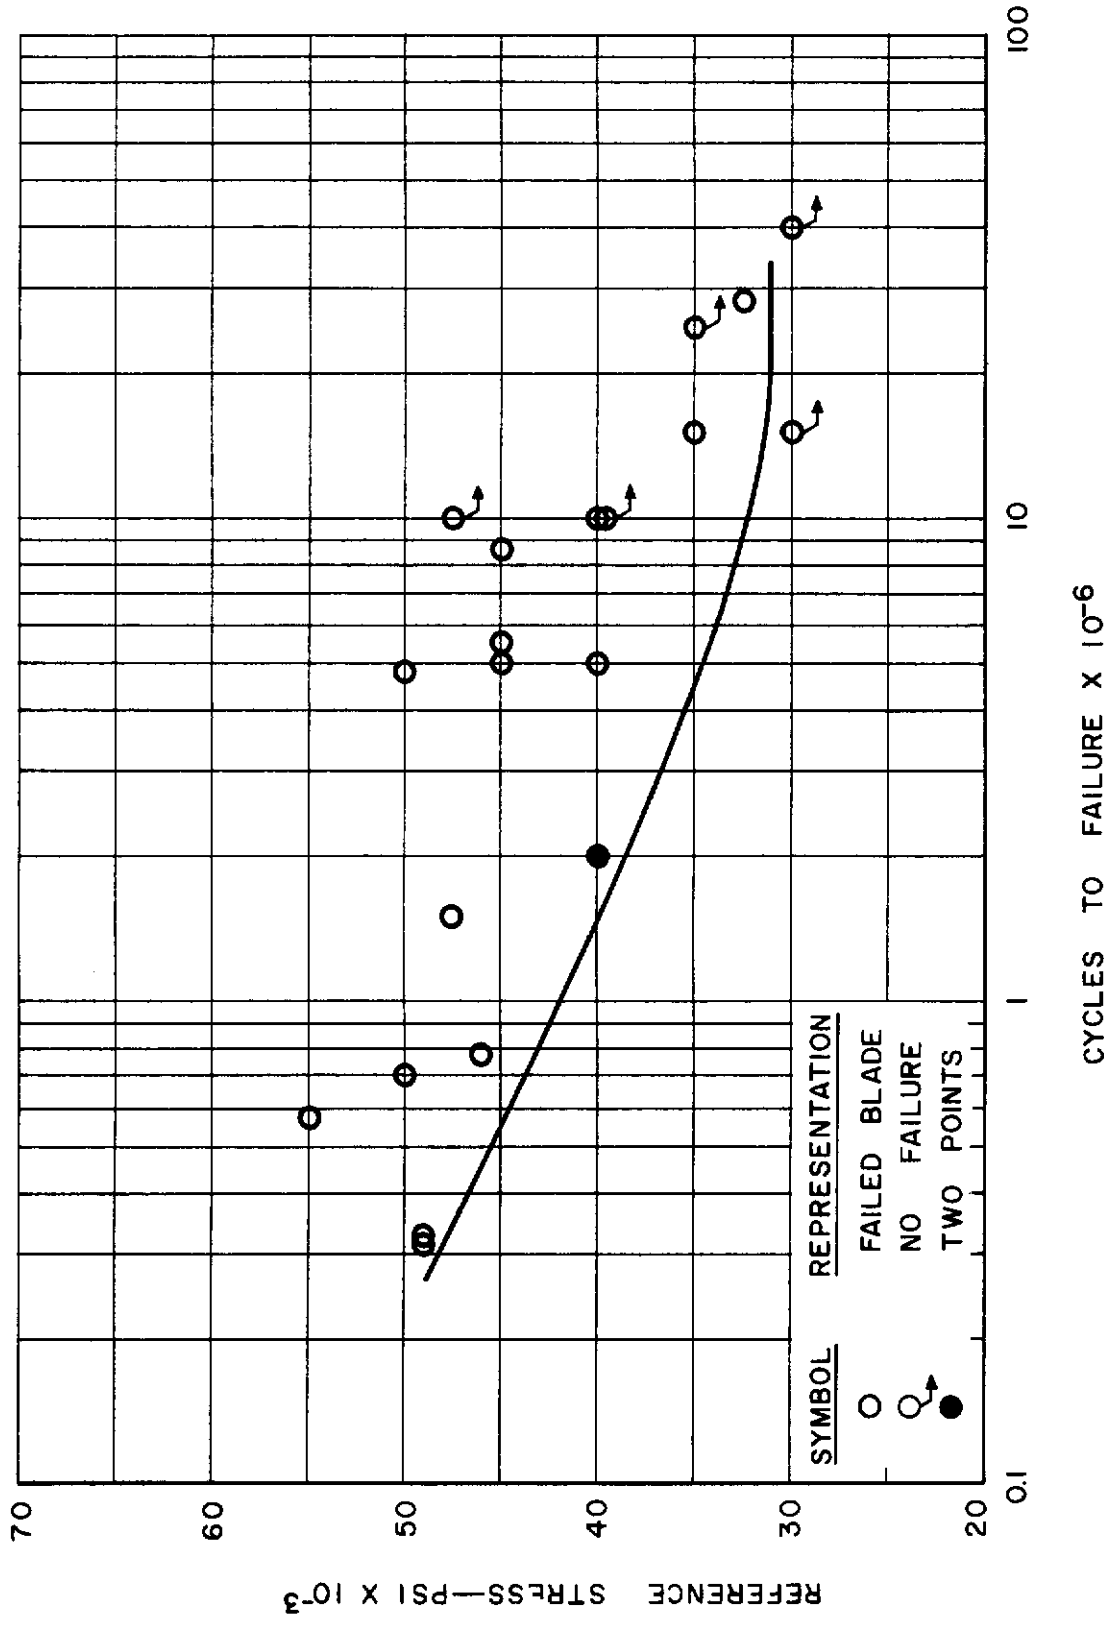
Fig. 5 Variation of Cycles to Failure under Completely Reversed Stress for Type-8630 Shot-Peened Compressor Blades

An increase of approximately 4000 psi in endurance limit is reflected as a result of shot-peening the type-8630 blades. A comparison of the curves shows that shot-peening improved the fatigue strength during the high stress part of the curve but that much of the beneficial effects were lost after prolonged cyclic stress.

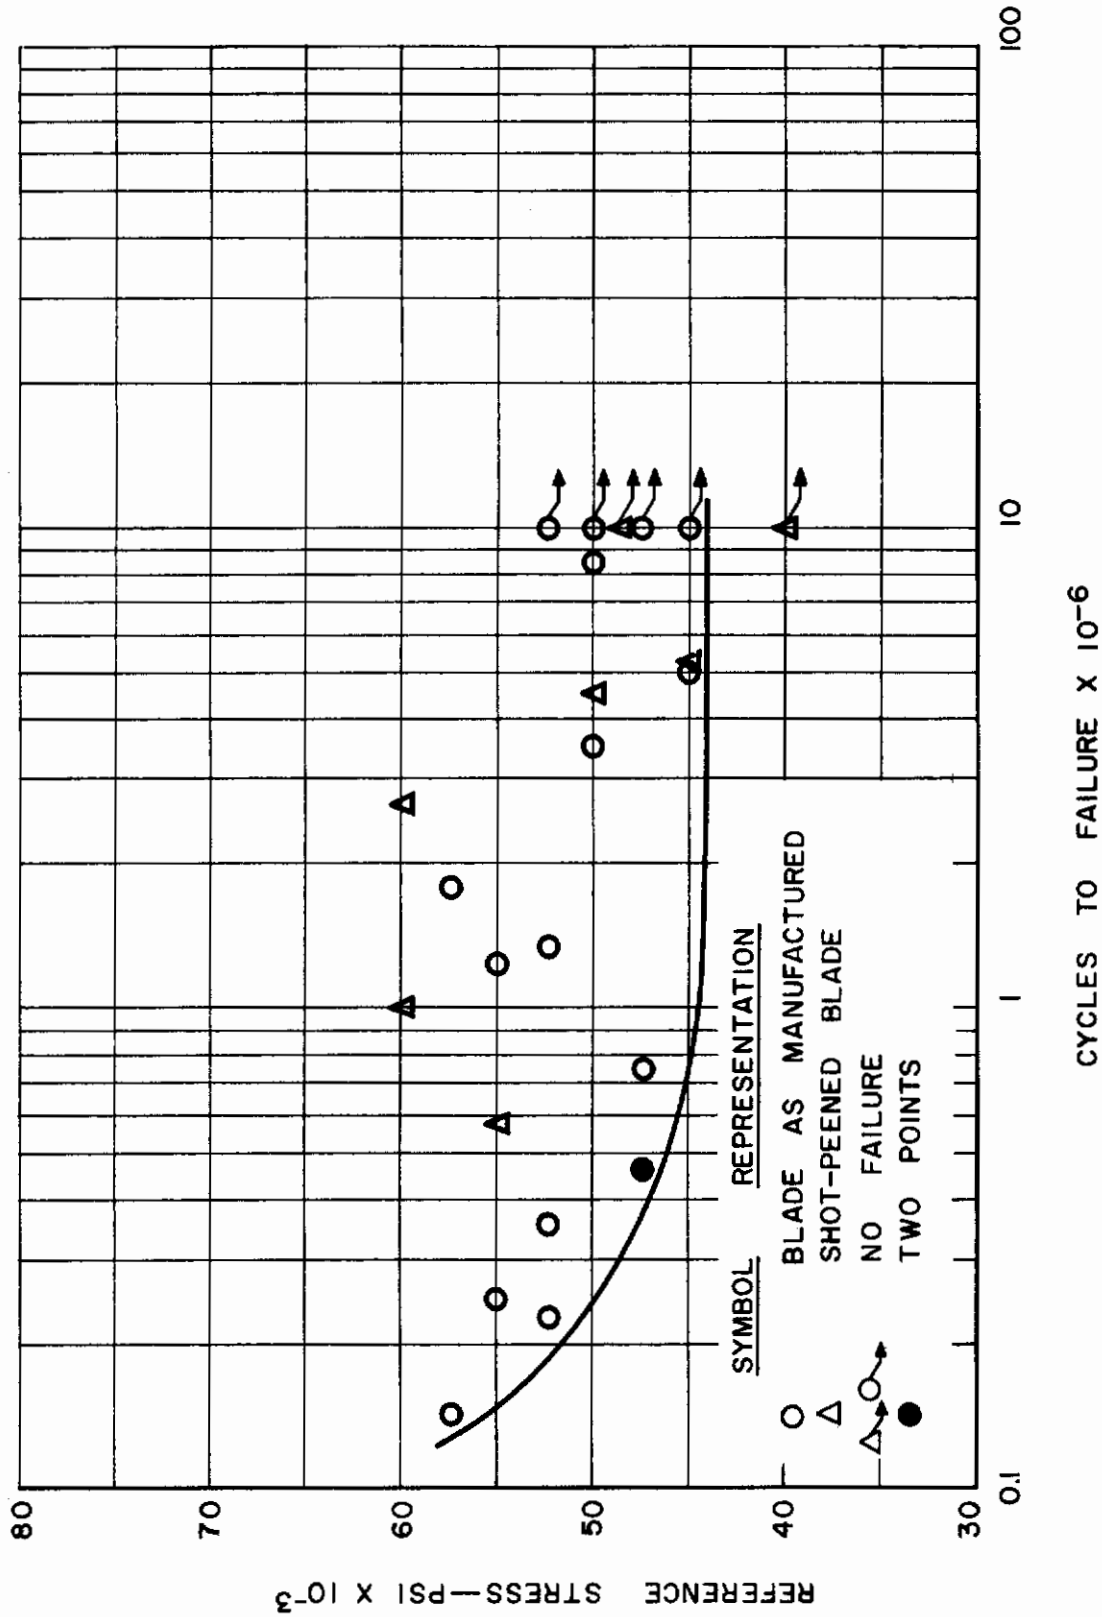
Fig. 6 Variation of Cycles to Failure Under Completely Reversed Stress for Type-403 Compressor Blades

The great amount of scatter of the data for shot-peened type-403 blades indicates that some of the type-403 blades were improved by shot-peening, whereas others were unaffected. Where an improvement of fatigue life in a given blade is indicated, it may be attributed to the results of shot-peening having removed some sharp edges and other stress raisers and may have smoothed out some roughness of machining. Shot-peening appears to offer unpredictable results when applied to a type-403 blade.

Of the types of blades tested, the type-403 blade offers the longest operating life because of its greater fatigue strength.

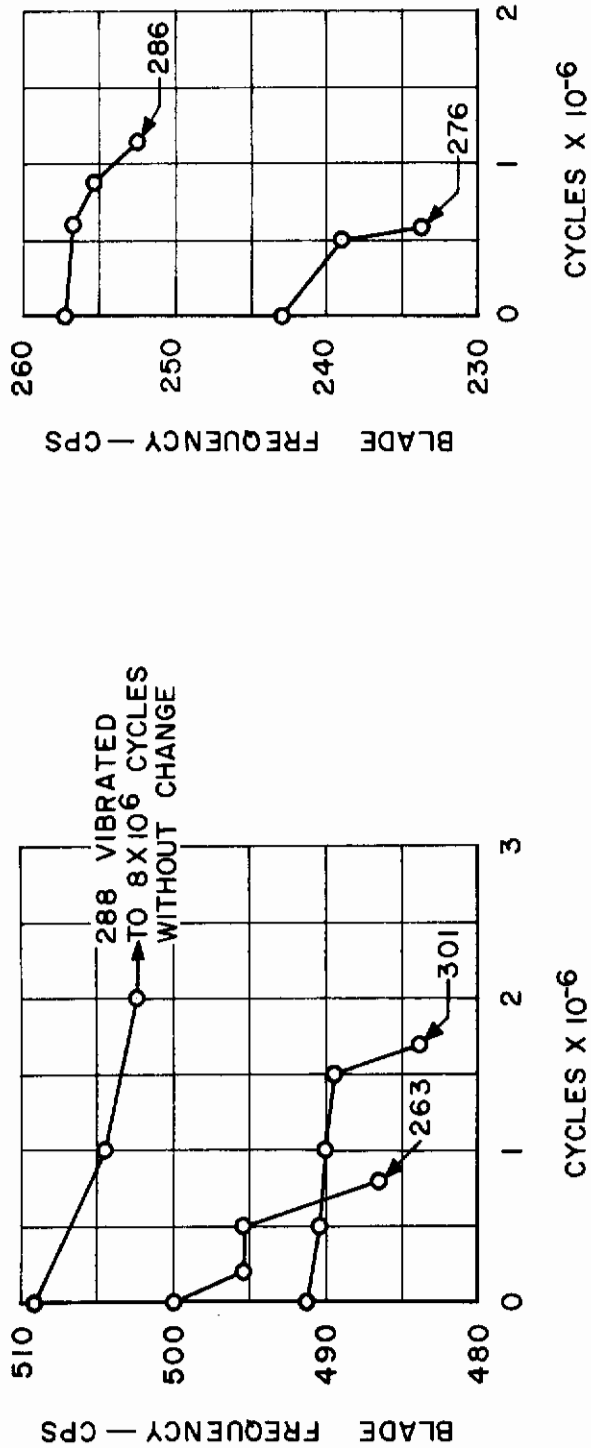
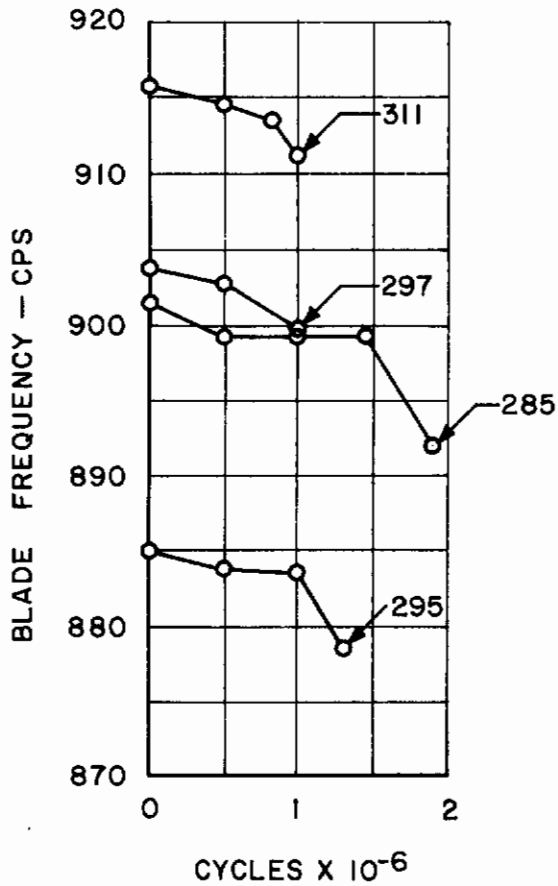
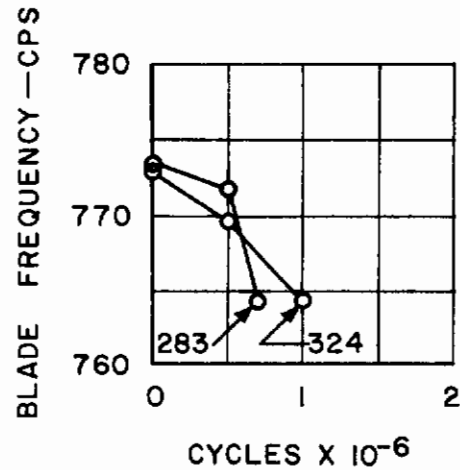
Fig. 7 Variation of Blade Frequency with Cycles of Vibration at 32,500-psi Stress

The degree of agreement between the fatigue life of a suspected blade and the controlling S-N curve may be seen by comparing Fig. 7 with the proper S-N curve. Figure 7 shows the fatigue test history of some representative type-8630 blades, all of which cracked during the test (with the exception of blade no. 288), and the crack was positively detected at the terminus of the frequency versus cycles to failure curve. When a blade such as no. 263 was compared to the S-N curve of Fig. 4, it was expected from the S-N curve that a failure should occur at better than 800,000 cycles at the stress level of 32,500 psi, whereas the history plot of Fig. 7 shows that the frequency of the blade decreased 5 cps during the first 300,000 cycles of testing. Since the S-N curve of Fig. 4 was compiled by plotting the point at which the blade made a sharp decrease in frequency rather than when the crack was discovered by conventional means, the comparison shows that the test blade was failing as soon as the fatigue test started. The failure point of all the blades of Fig. 7 (except 288) was considered to be at the start of the test. This is verified by the rates of frequency decrease at the beginning of the test which are greater than expected as a result of temperature increases.

Blade no. 286 of Fig. 7 does not show a rapidly decreasing frequency initially, but the rate of frequency change became larger as the test proceeded and did not become stable in frequency after warm-up as with sound blades. This blade gives the impression that failures were occurring slowly at the start of the test and most certainly between 600,000 and 800,000 cycles.

The other blades shown in Fig. 7 follow the characteristics of blade no. 263 initially, which is an indication of when the failures started; however, the manner in which the frequency decreased, and during certain periods did not decrease, may be an indication of the rate of growth of fatigue cracks. For example, blade no. 263 exhibited a stable frequency between 300,000 and 500,000 cycles and there after decreased until a large surface crack was detected. As a comparison, blade no. 276 never exhibited a stable frequency while being tested. The stable frequency periods of the plots may be periods when cracks are not growing, and the remaining section of the blade is being fatigued as if it were a blade of reduced cross section.

IN COMPRESSOR HISTORY			
BLADE NUMBER	ROW NUMBER	FREQUENCY — CPS & DATE RECORDED	
		3-60	9-60
276	1	239.3	242.0
286	2	256.4	255.9
263 *	5	—	—
288	5	513.0	512.2
301	5	486.9	491.4

IN COMPRESSOR HISTORY				
BLADE NUMBER	ROW NUMBER	FREQUENCY — CPS & DATE RECORDED		
		3-60	9-60	3-61
311	9	912.7	921.9	920.7
324 *	8	775.4	775.2	775.4
297	9	906.7	906.7	906.0
295	9	886.2	885.5	884.8
285	8	—	934.3	904.9
283	8	766.5	772.8	766.1

history of which is given as blade no. 276 in Fig. 7. The other blade exhibiting a 0.3-cps decrease was not proved to be defective.

Included in Fig. 7 is the history of blade no. 288 which has a compressor history of a decreasing frequency and fatigue test of a decreasing frequency until at two million cycles the frequency became fixed and did not change even to eight million cycles. A crack was not found on this blade by the MPT. X-ray inspection revealed inclusions near the tip of the blade, which is not uncommon for the type-8630 blades and is not necessarily a proof of internal cracking. Although blade no. 288 is the only case of its kind that was verified during this test, its history is included to show what may be one limitation to the frequency method. This blade has shown a severe decrease from the initial frequency, yet its frequency became stabilized and the expected life was not decreased.

Another limitation of the frequency method is shown by the shape of curves 263 and 285 of Fig. 7. Here the frequency starts decreasing, becomes constant for a period of time, and then continues to decrease. If two comparative frequency data were taken during the time the frequency was constant, no differences would be noted, and yet the blade would be cracked. Under these circumstances, the blade would not be detected by the frequency method. However, this limitation would not apply where periodic frequency readings are started with installation of the blade.

The effect of temperature was necessarily considered when interpreting the curves of Fig. 7. For rows 1 through 6 blades, an approximate 1-cps decrease in frequency during the first million cycles was attributed directly to the increasing temperature of the vibrating blade. For rows 7 through 9 blades, the temperature of the blade increased more during the first million cycles, and according to observation, the frequency decrease was approximately 2 cps. After the first million cycles, the blade temperature would stabilize, as would the frequency. A crack was detected by noting a frequency decrease rate greater than could be attributed to the temperature effect.

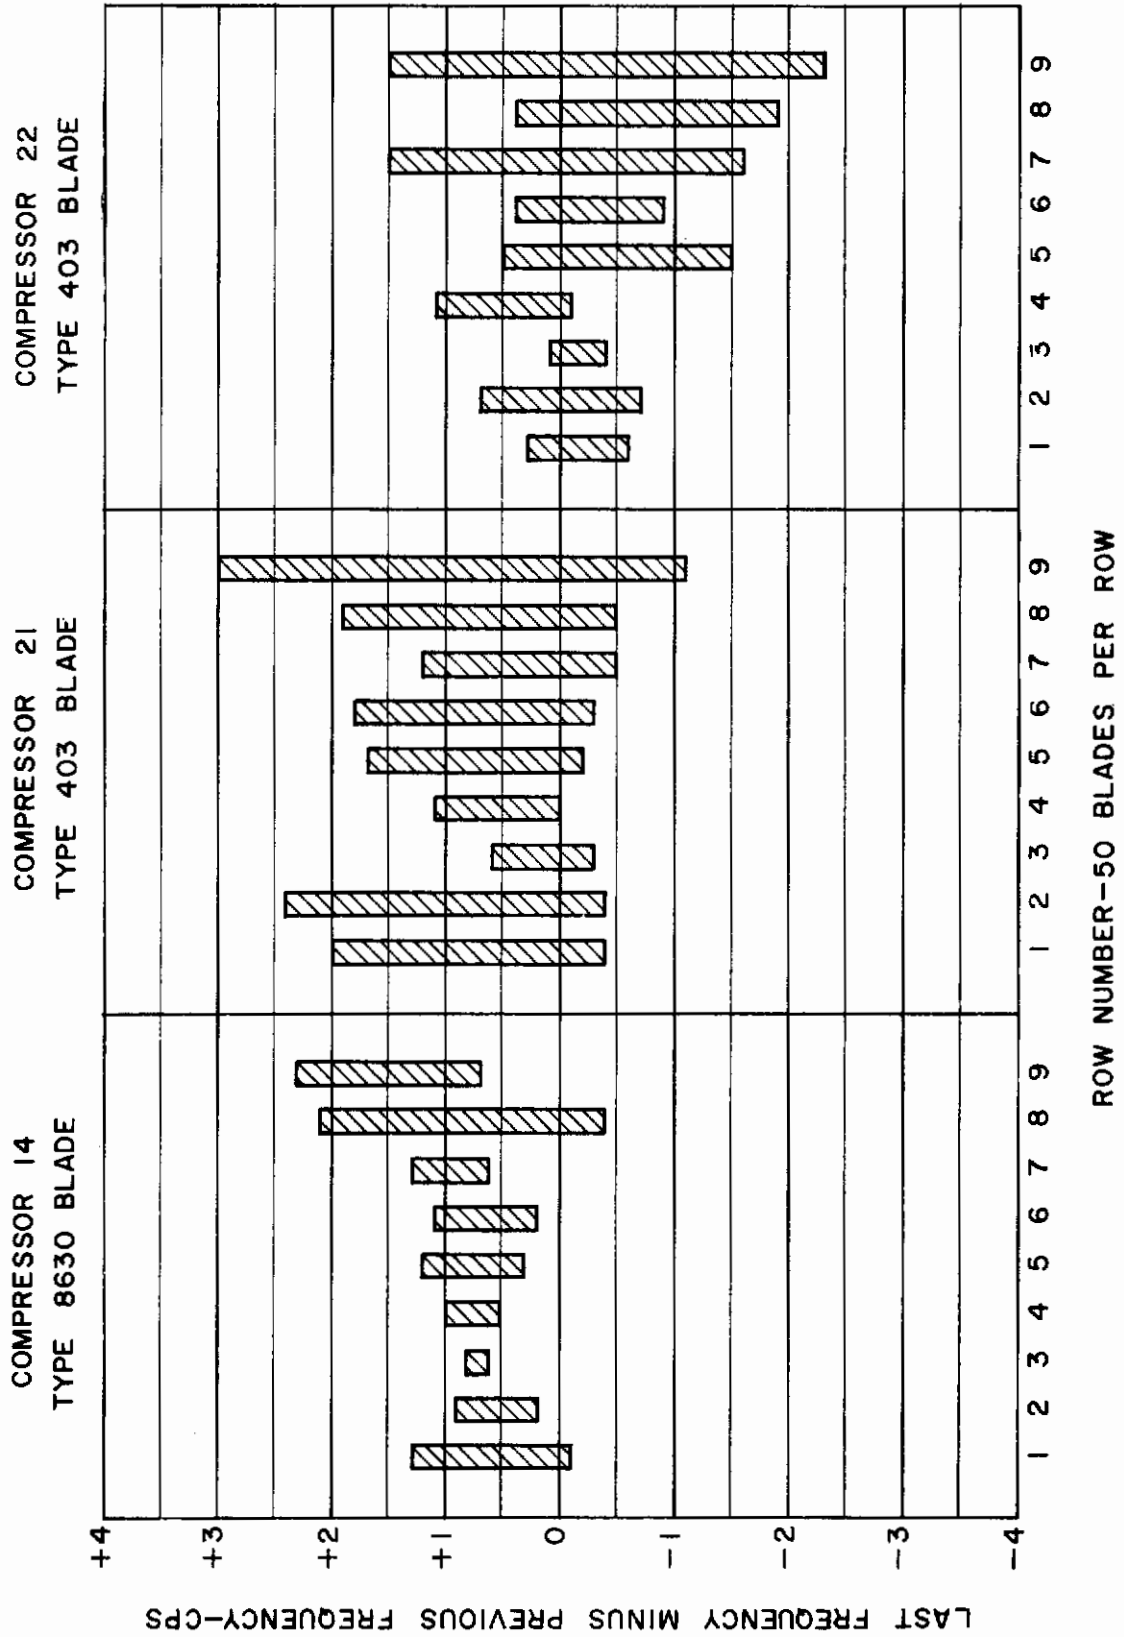
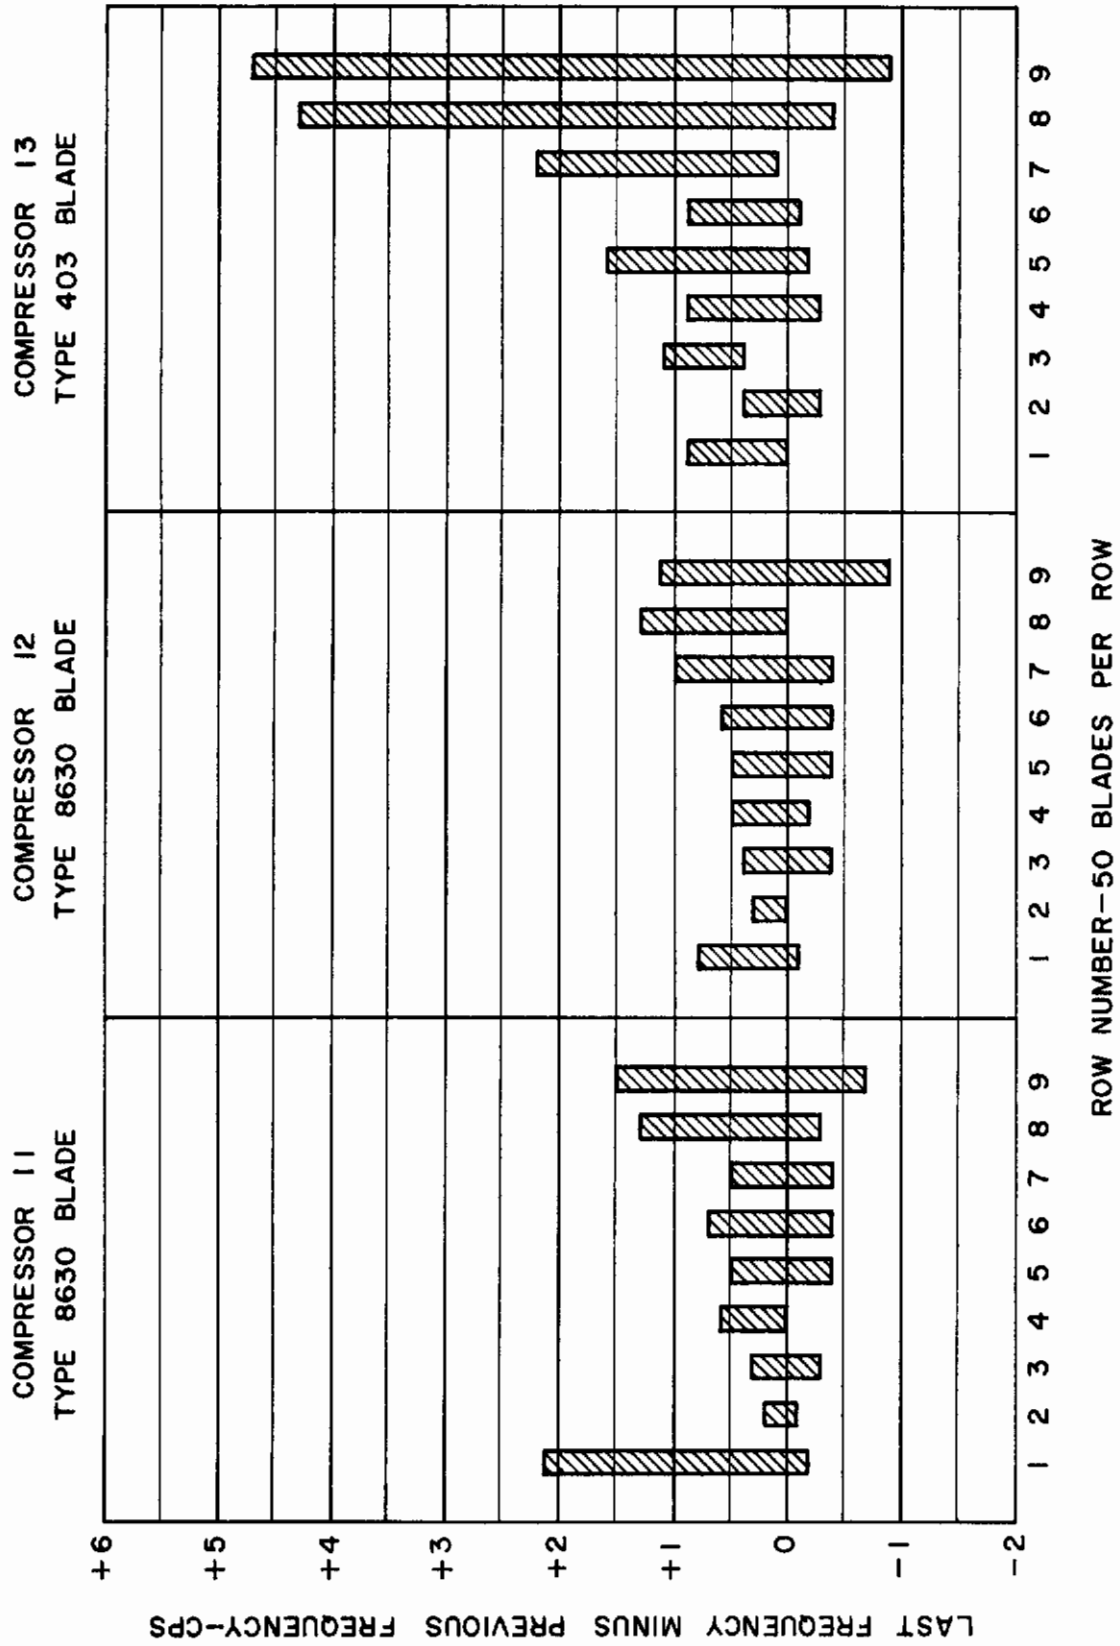
Fig. 8 Range of Differences between Two Rotor Blade Frequency Data

This example is given for row 1 of compressor no. 14 and is further represented as the first bar of the graph of Fig. 8. Figure 8 also shows a bar for the range of frequency differences of every row of each axial compressor in VKF. The graph of Fig. 8 shows such random behavior of frequency differences between row numbers that it appears impossible to fix any universal frequency change as a criteria for suspecting a defective blade.

The range of frequency differences between the November 1960 and March 1961 maintenance periods are presented in Fig. 8 and the following tabulation:

The success of such detection depended on controlling or accounting for all factors which would naturally change the frequency of the blades. Practically, such factors as ambient temperature could not be controlled. Therefore, the frequency differences were considered statistically so a normal variation of differences could account for the uncontrolled effects of temperature, accuracy, etc. With a normal grouping of frequency differences, a blade which was in the process of failing or undergoing an undesirable change, such as loosening of the fastening nut, the frequency decrease between successive investigations would be significantly outside the grouping of the distribution. Blades removed during the March 1961 maintenance period exhibited frequency decreases greater than the negative values of Fig. 8.

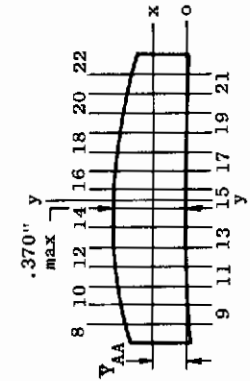
Section A-A (Not to scale)

$$A_{AA} = \frac{\sum y^2 A}{52} = \frac{12,8575}{25} = 0.514 \text{ in.}^2$$

$$I_{AA} = \frac{\sum y^2 I_{cg} + \sum I Ad^2}{54} = \frac{3,1991 + 0.094323}{625} = 0.005269 \text{ in.}^4$$

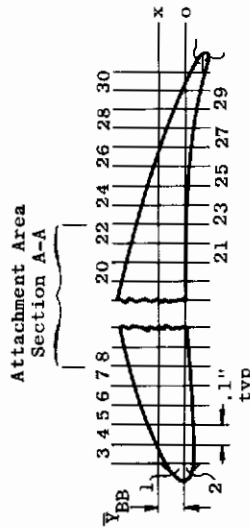
Section B-B (Not to scale)

$$A_{BB} = \frac{\sum y^2 A}{52} = \frac{19,50875}{25} = 0.78 \text{ in.}^2$$

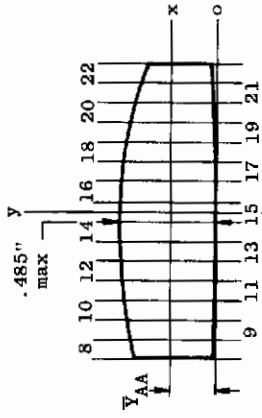
Section A-A (Not to scale)

$$A_{AA} = \sum_8^{22} A \times 5^{-2} = \frac{16.649}{25} = 0.666 \text{ in.}^2$$

$$I_{AA} = \frac{\sum_8^{22} I_{cg} + \sum_8^{22} A d_2^2}{5^4} = \frac{6.9961 + .08371}{625} = 0.01133 \text{ in.}^4$$

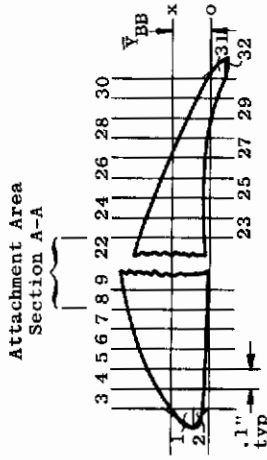
Section B-B (Not to scale)

$$A_{BB} = \sum_3^{32} A \times 5^{-2} = \frac{24.7715}{25} = 0.99 \text{ in.}^2$$

$$I_{BB} = \frac{\sum_3^{32} I_{cg} + \sum_3^{32} A d_1^2}{5^4} = \frac{8.30106 + 1.8545}{625} = 0.01625 \text{ in.}^4$$
