AIRCRAFT GROUND-FLOTATION INVESTIGATION

PART II. DATA REPORT ON TEST SECTION 1

W. BRABSTON, A. RUTLEDGE, and W. HILL

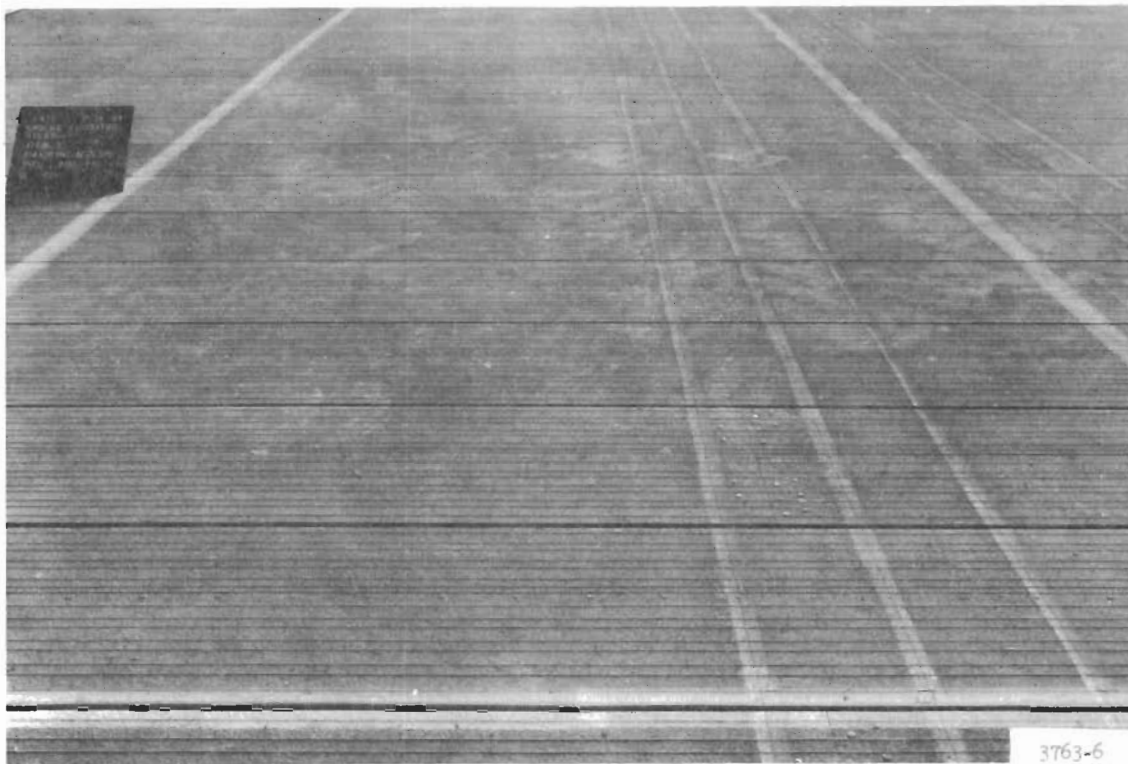
Figure 5. Lane 1, item 3, prior to traffic

Item 3. Item 3 prior to traffic is shown in **Figure 5**. After 20 coverages, there were slight differential mat deformations along with an initial soil depression of about 1 in. No significant mat damage was evident with continued traffic to 100 coverages. At 135 coverages, sheared rivets and increasing differential deformations were noted. At 200 coverages, cracks appeared in the mat surface, but the item remained in serviceable condition. Traffic was continued to 300 coverages, at which time the mat was considered failed due to excessive roughness and mat deterioration (**Figures 6 and 7**). The rated CBR for the item was 7.4.

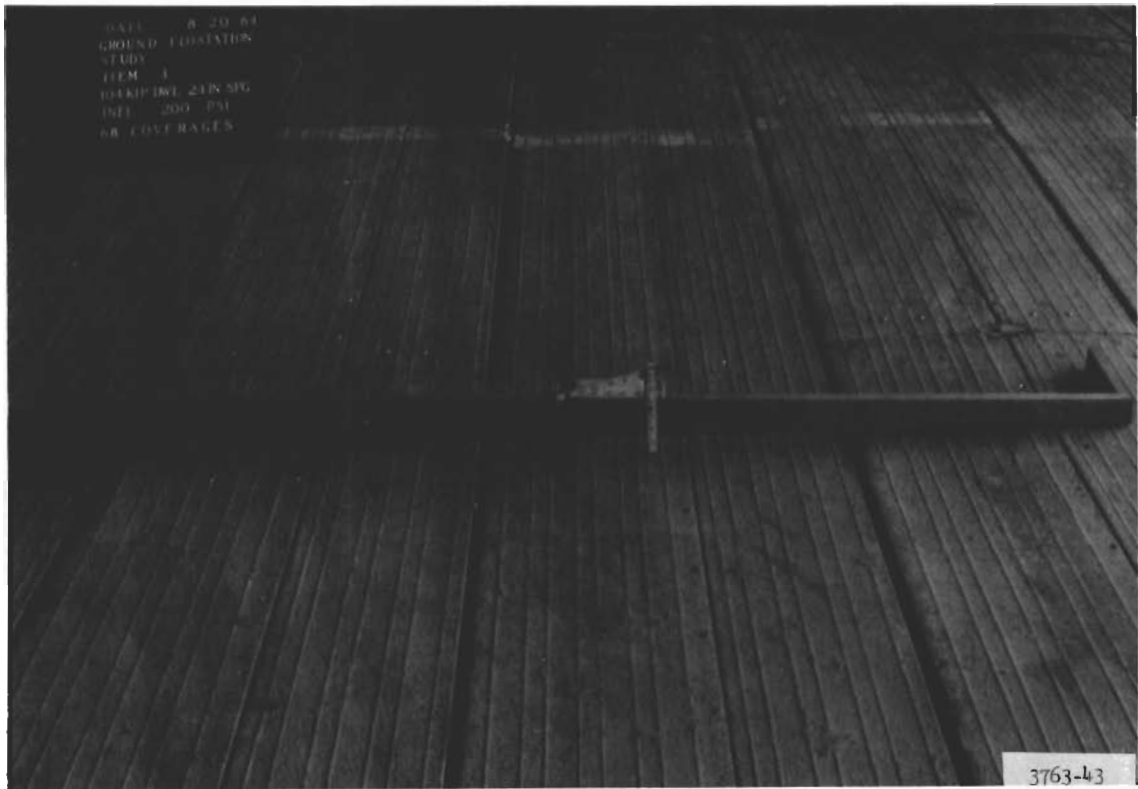
Figure 16. Lane 2, item 3, at 68 coverages (28 postfailure coverages). Longitudinal straightedge shows roughness and mat deformation

To observe the rate of mat deterioration under postfailure conditions, an additional 28 coverages of traffic were applied to item 3. Severe mat damage was rapid, and panels separated along their center lines (**Figure 15**). Shearing of drive rivets in end connectors occurred just outside the traffic lane, allowing the panel end joints to open (**Figure 16**). At 68 coverages, movement of the load vehicle over the item had become difficult, and traffic was suspended.
