**SOUNDPROOFING MATERIALS
AND THE INSTALLATION THEREOF
IN AIRCRAFT**

FRANK MAYER ENGINEERING COMPANY

CONTRACT No. AF 33(616)-2379

-USAF. WRIGHT AIR DEVELOPMENT CENTER
AIR RESEARCH AND DEVELOPMENT COMMAND
UNITED STATES AIR FORCE
WRIGHT-PATTERSON AIR FORCE BASE, OHIO

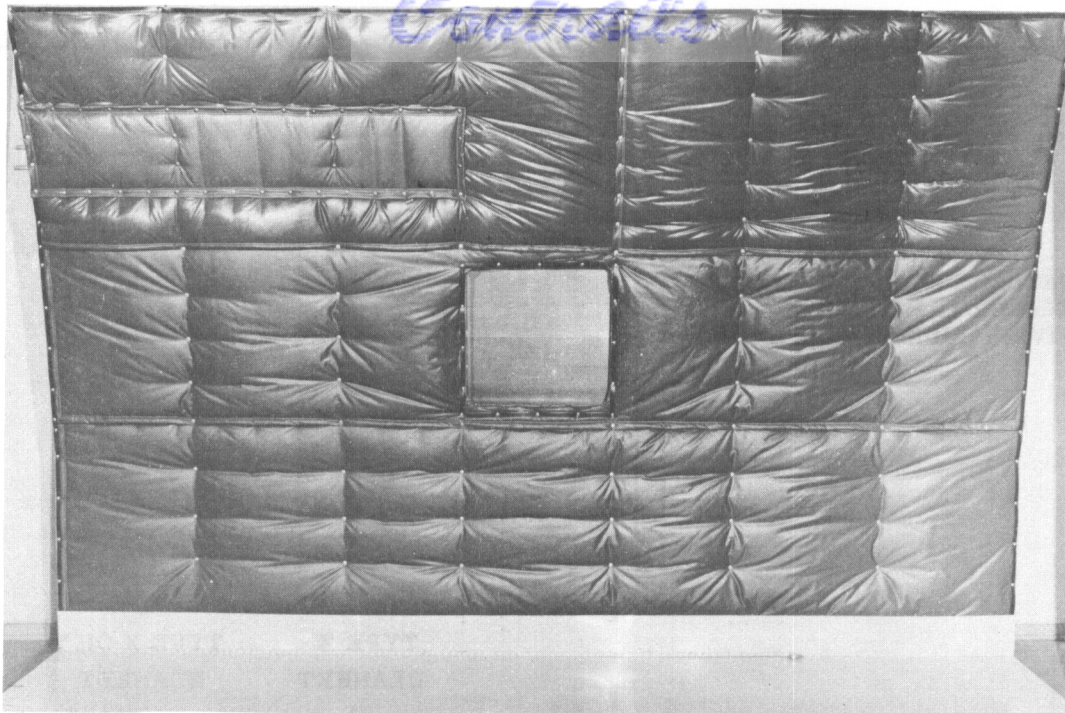
Figure 14. Test Installation of Optimum Blankets - Horizontal Method.

3.4.2 Horizontal method - See Figure 14. - This procedure consists of stretching the blanket horizontally starting with the lowest blanket, fastening one end at a frame and progressively attaching the blanket to the frame flanges. At the end of the first blanket, the second blanket is overlapped at the nearest frame, with its finished edge exposed and installation of the remainder of the blanket would proceed as for the first blanket. Fastening to frame flanges would be by means of Loop Type Trimount Stud ("Mae West") fasteners, spaced from five to six inches on centers, in one-fourth inch diameter holes drilled before installation. The second row of blankets would be installed with the finished edge overlapping the upper edge of the first row by approximately two inches. Succeeding rows would be installed in the same manner. Type Y material, if used, would be installed in upper or protected areas only.

3.5.4 Horizontal method installation - See Figure 14. - Type X and Type Y material was used for this installation. The two lower rows were of Type X blanket material; the upper portion of Type Y material. The installation was made using the method discussed in para 3.4.2. Inspection panel snap fasteners were installed per template. The procedure at the inspection panel opening and at the simulated window opening followed that described in para 3.4.4.

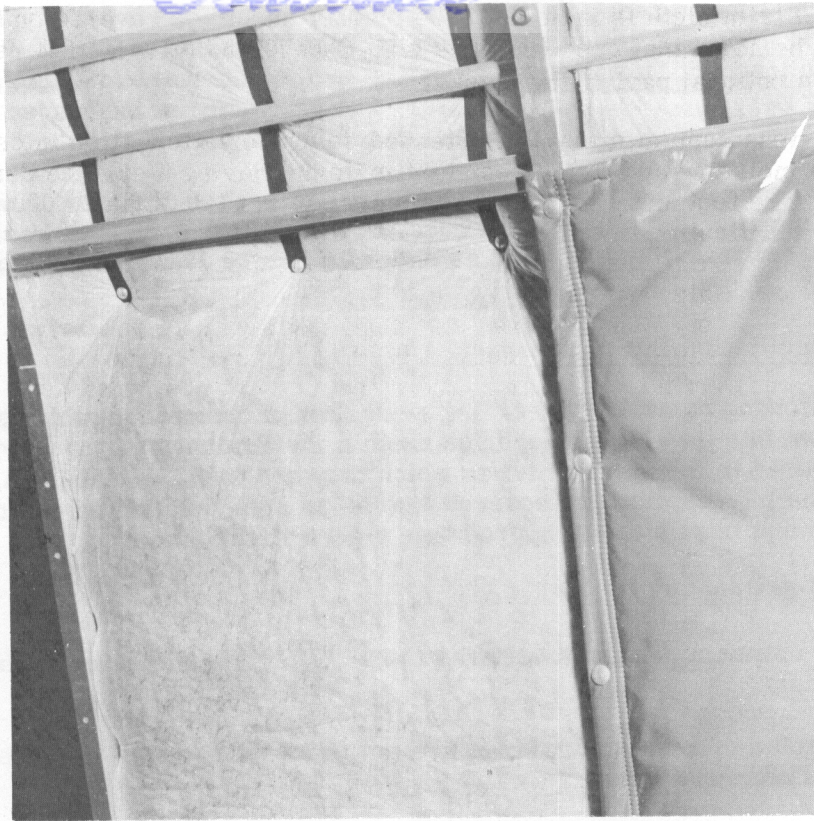
Figure 17. Type Z Blanket Installed on Test Panel.

3.5.3 Type Z blankets were installed between frames in three bays, using the method discussed in para 3.4.6. Vinyl straps were installed in the simulated control cable and piping locations as shown in Figure 17.

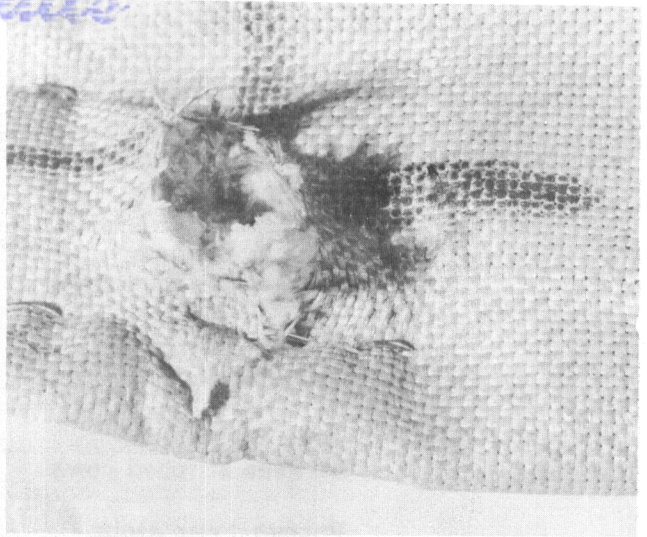
Figure 23. Blanket Edge Fastening Strength Test Specimens.
