AFFDL-TR-66-43
PART XIII

# AIRCRAFT GROUND-FLOTATION INVESTIGATION

## PART XIII. DATA REPORT ON TEST SECTION 13

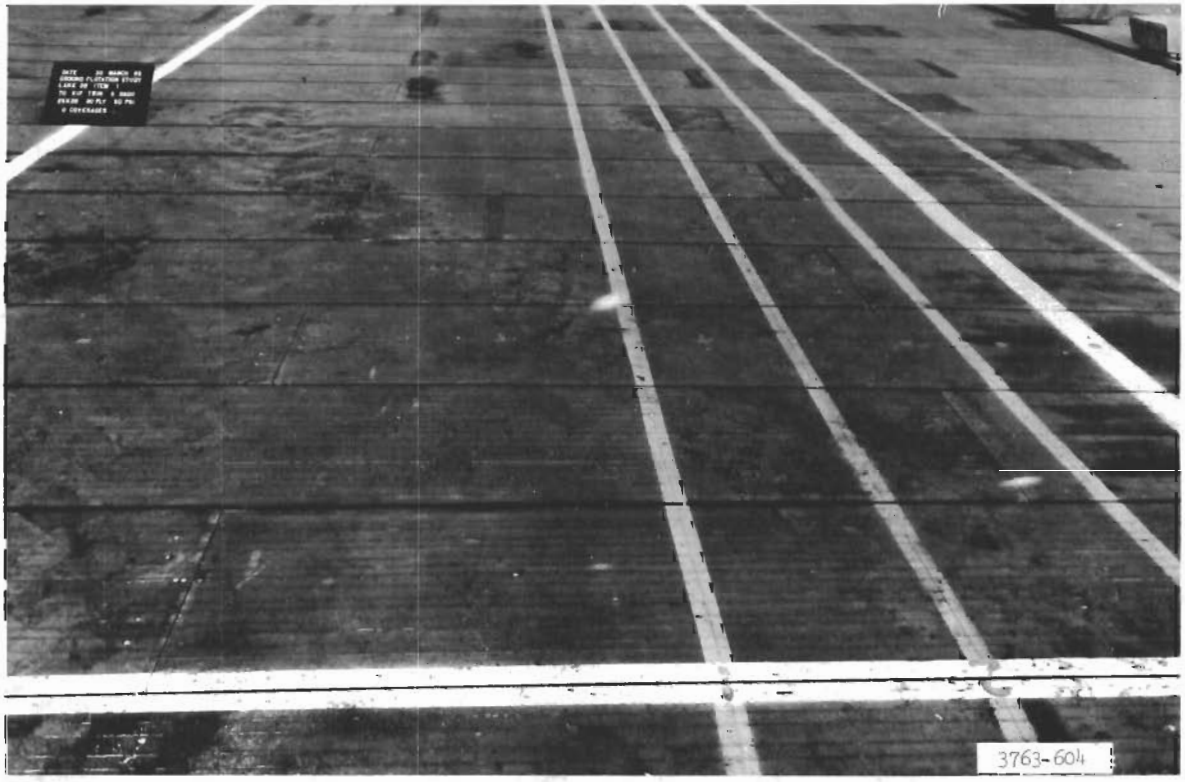
Item 1. Figure 3 shows item 1 prior to traffic. At 550 coverages traffic was temporarily halted because the tires were rubbing the saddle of the load cart. At this point all pertinent data were gathered including CBR determinations. The tires were respaced to 56 in. c-c and traffic continued. Item 1 was considered failed at 700 coverages due to elastic deflection (figure 4). The rated CBR was 2.1.

Figure 3. Lane 28, item 1, prior to traffic

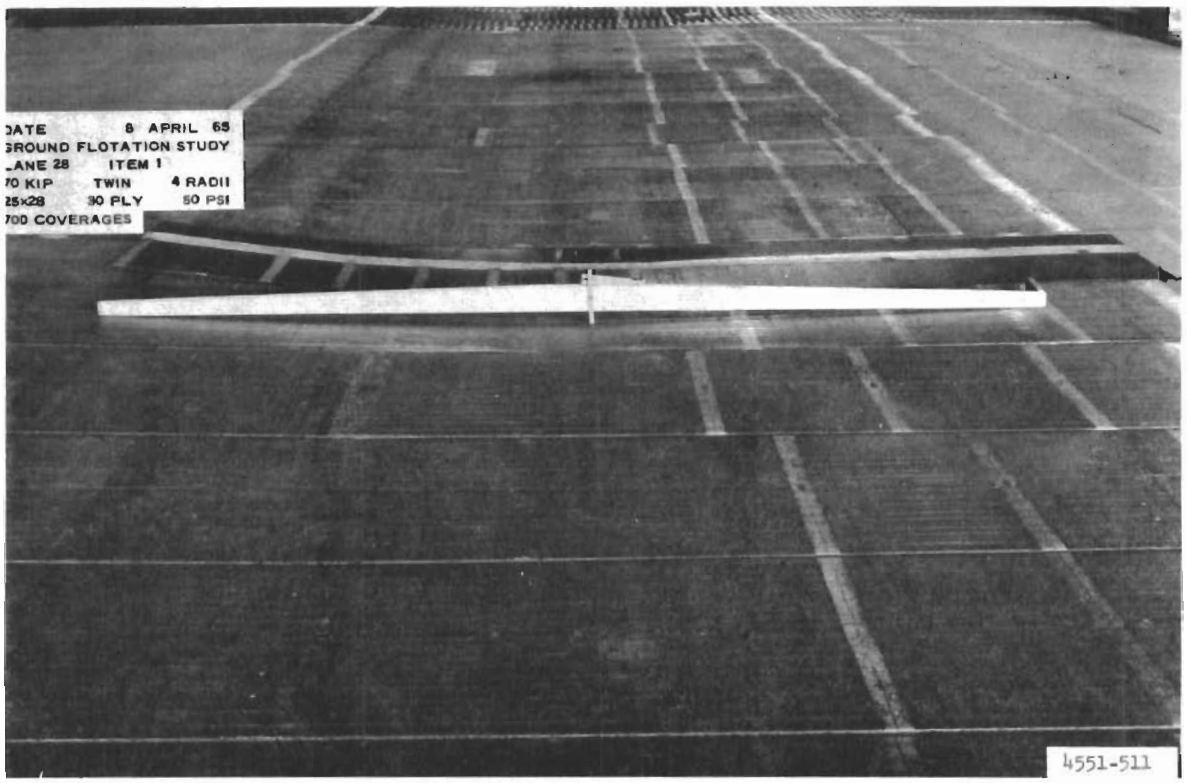
a. Roughness. At failure the average transverse and diagonal differential deformations were 1.35 and 1.54 in., respectively (table 1). Average dishing of individual panels was 0.38 in. at failure.

b. Deformation. Average cross-section and profile deformations are shown in figures 18 and 19, respectively, for several coverage levels. The figures show very little mat deformation although there was considerable subgrade settlement. The maximum profile deformation at failure was 1.7 in. along the joint line 1.5 ft west of the lane center line.

c. Deflections. Average elastic mat deflections shown in figure 20 increased generally with traffic. The largest average deflection (4.10 in.) was recorded with the load wheels centered on a panel end joint at the 700-coverage level. At the same coverage level, the elastic subgrade deflection was 1.1 in. Elastic mat deflections were greatly exaggerated by the mat standoff, or bridging effect resulting from settlement of the subgrade with traffic.

Figure 4. Lane 28, item 1, after 700 coverages of traffic (failure)

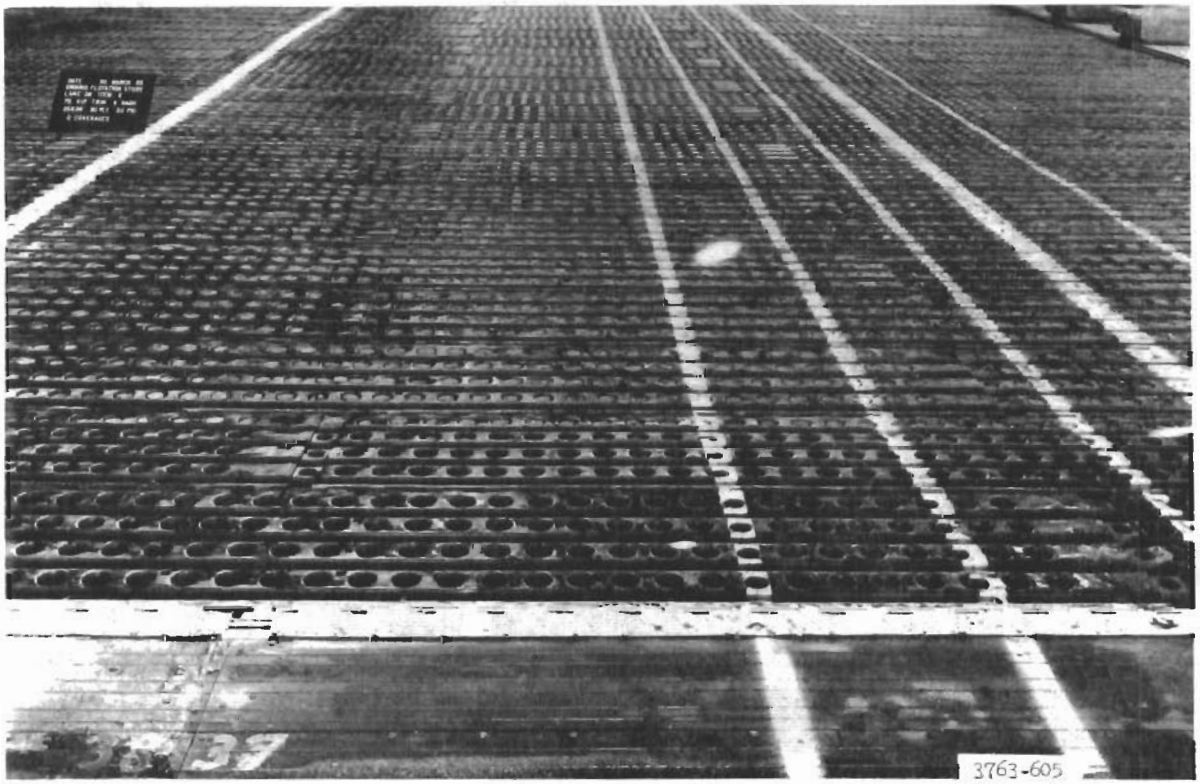
Item 2. Figure 5 shows item 2 prior to traffic. The item held up well under traffic with relatively few mat breaks and deformation which developed slowly. Item 2 was considered failed at 700 coverages due to roughness (figure 6). The rated CBR was 2.8.

Figure 5. Lane 28, item 2, prior to traffic

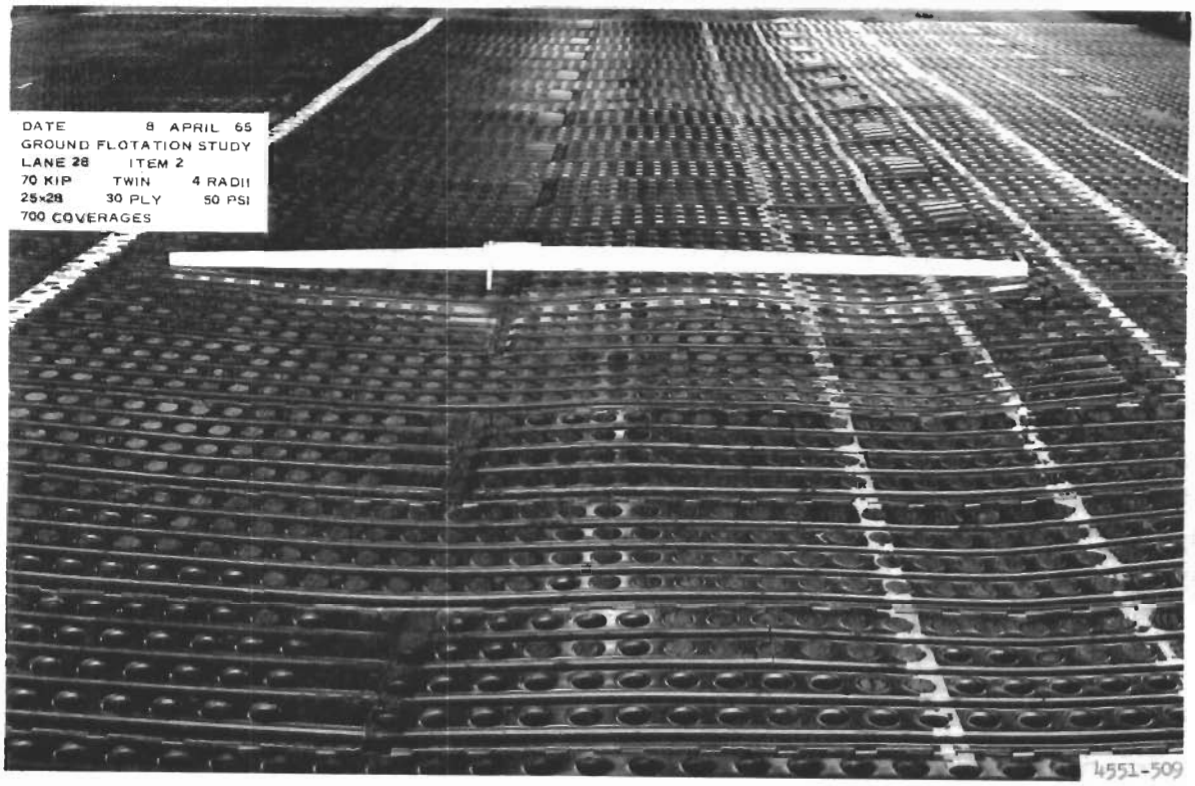
a. Roughness. At failure the average transverse and diagonal differential deformations were 2.88 and 2.50 in., respectively (table 1). The average dishing of individual panels was 0.23 in. at failure.

b. Deformation. Average cross-section deformations are shown in figure 18. The maximum average cross-section deformation at failure was 2.35 in. approximately 2 ft either side of the traffic lane center line. Profiles in figure 19 indicate the severe longitudinal deformations that existed in the item at failure, especially at the end adjacent to item 1.

Figure 6. Lane 28, item 2, after 700 coverages of traffic (failure)

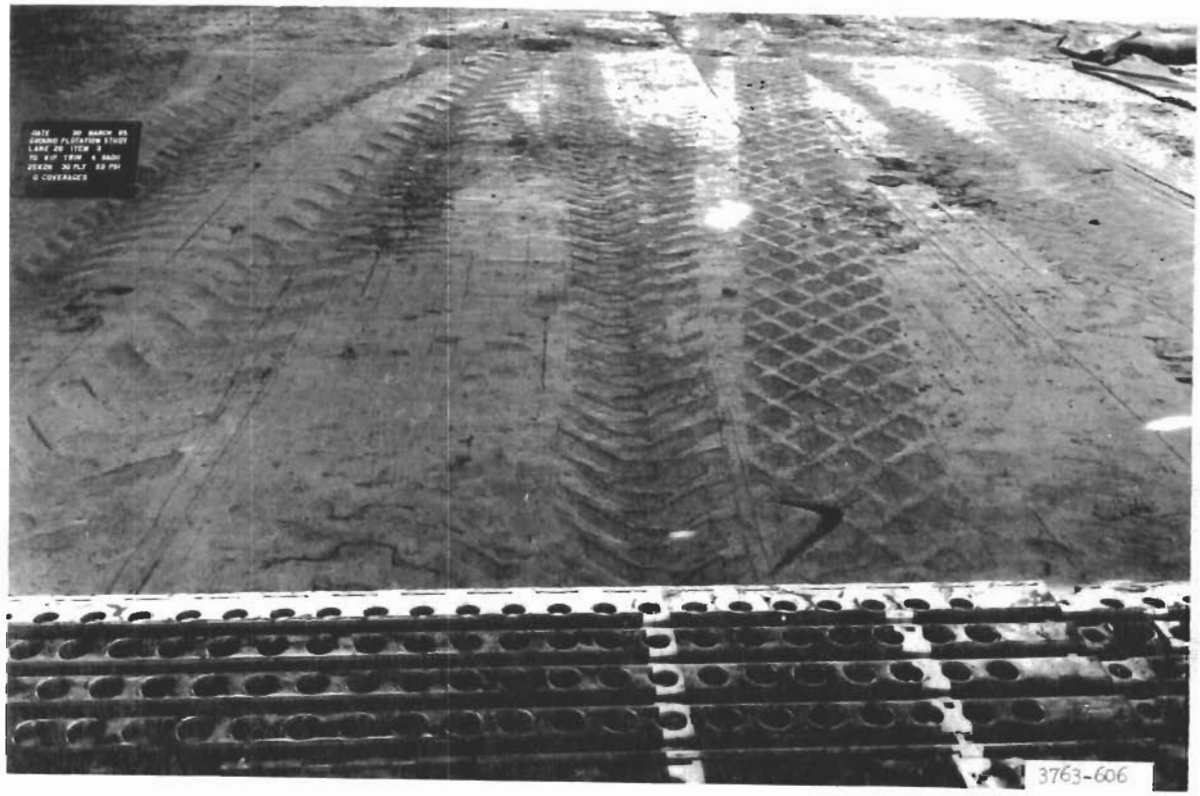
Item 3. Figure 7 shows item 3 prior to traffic. Considerable subgrade settlement occurred as trafficking progressed but differential deformations and rutting were slow in developing. The item was considered failed at 200 coverages (figure 8). At failure average transverse and diagonal differential deformations considerably exceeded rutting. The rated CBR of the item was 4.7.

Figure 7. Lane 28, item 3, prior to traffic

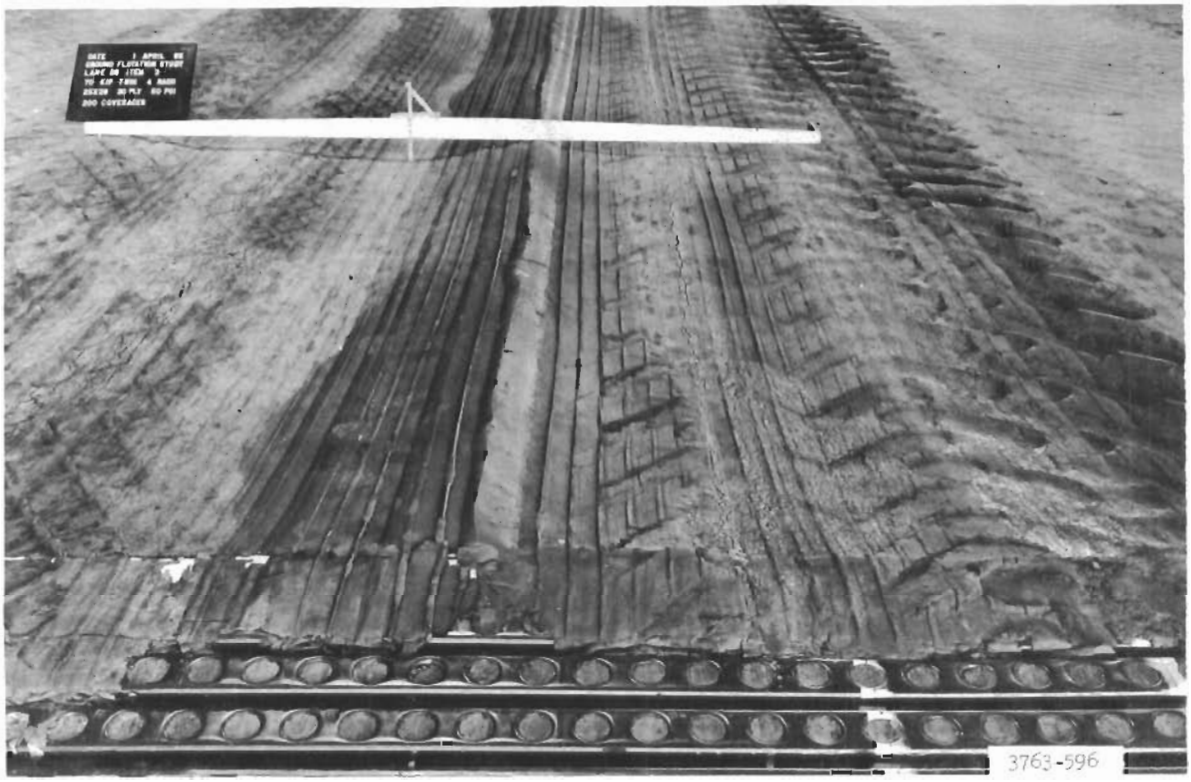
a. Roughness. At failure, the average transverse and diagonal differential deformations were 4.16 and 4.41 in., respectively (table 1). The average rut depth at failure was 3.28 in.

coverages are shown in figure 18. Considerable rutting developed between the two coverage levels. Figure 19 shows profiles for 40 and 200 coverages and illustrates the progressive subsidence of the item with traffic.

Figure 8. Lane 28, item 3, after 200 coverages of traffic (failure)

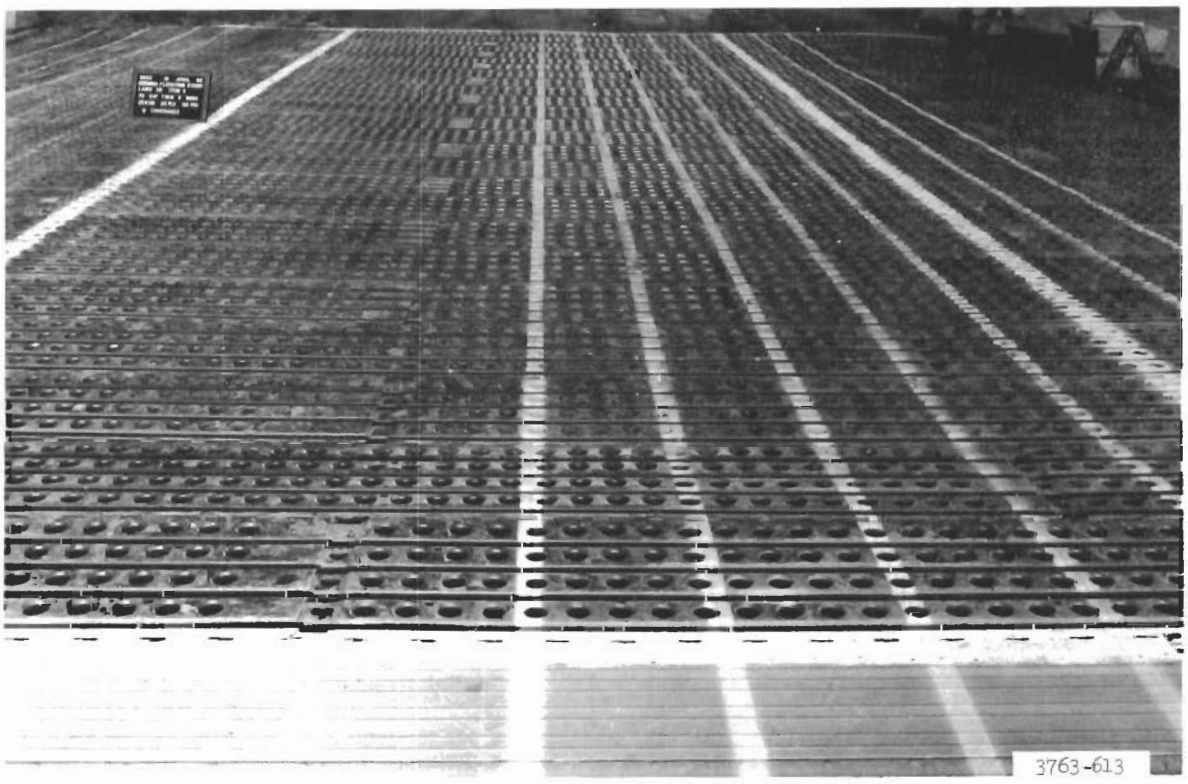
Item 2. Item 2 prior to traffic is shown in figure 11. The item was considered failed at 200 coverages due to roughness (figure 12). The rated CBR was 2.8.

Figure 11. Lane 29, item 2, prior to traffic

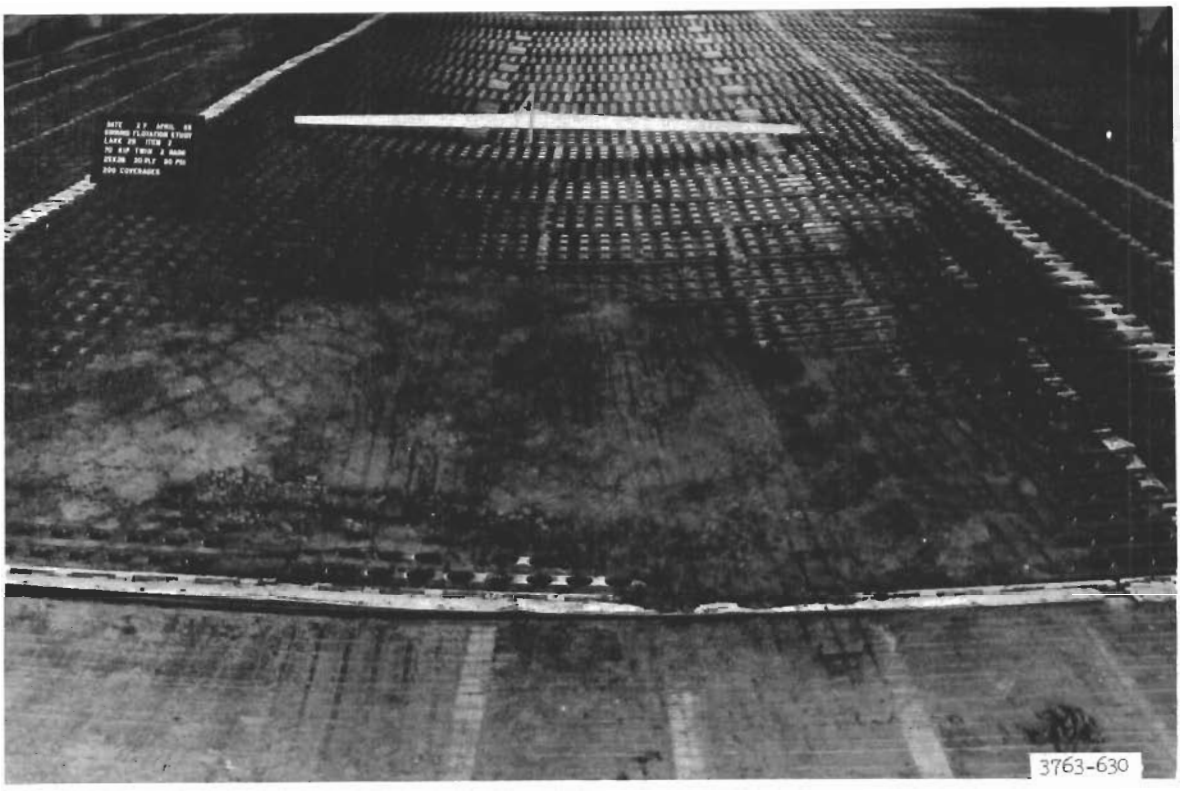
a. Roughness. At failure, the average transverse and diagonal differential deformations were 3.53 and 3.60 in., respectively (table 1). Dishing of individual panels was insignificant.

b. Deformations. Average cross-section deformations at 42, 140, and 200 coverages are shown in figure 18 for the two typical mat runs. The magnitude of deformations at 140 and 200 coverages is approximately the same, with both showing large increases over the 42-coverage values. Profiles along the item are shown in figure 19 for 42, 140, and 200 coverages. Very consistent increases in profile deformations occurred with traffic. The most severe deformation occurred at the south end of the item adjacent to the previously failed item 1.

Figure 12. Lane 29, item 2, after 200 coverages of traffic (failure)

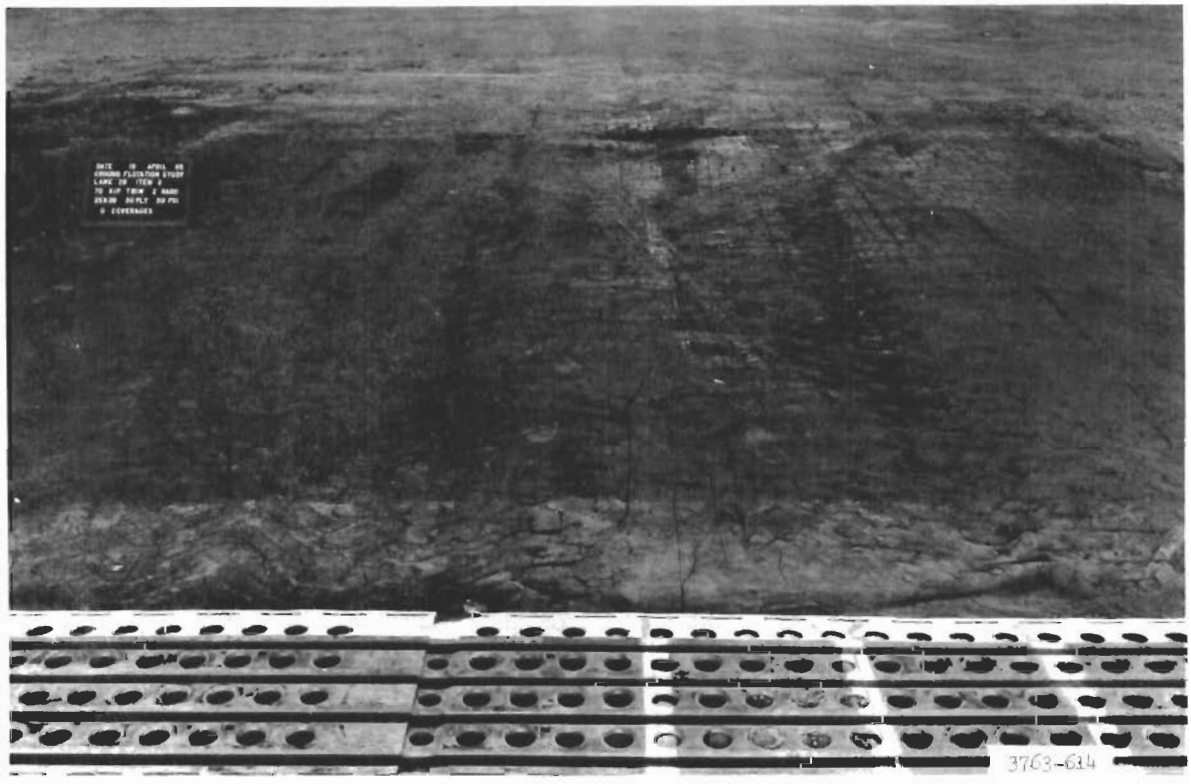
Item 3. Item 3 prior to traffic is shown in figure 13. The item was considered failed at 200 coverages due to roughness (figure 14). The rated CBR was 4.5.

Figure 13. Lane 29, item 3, prior to traffic

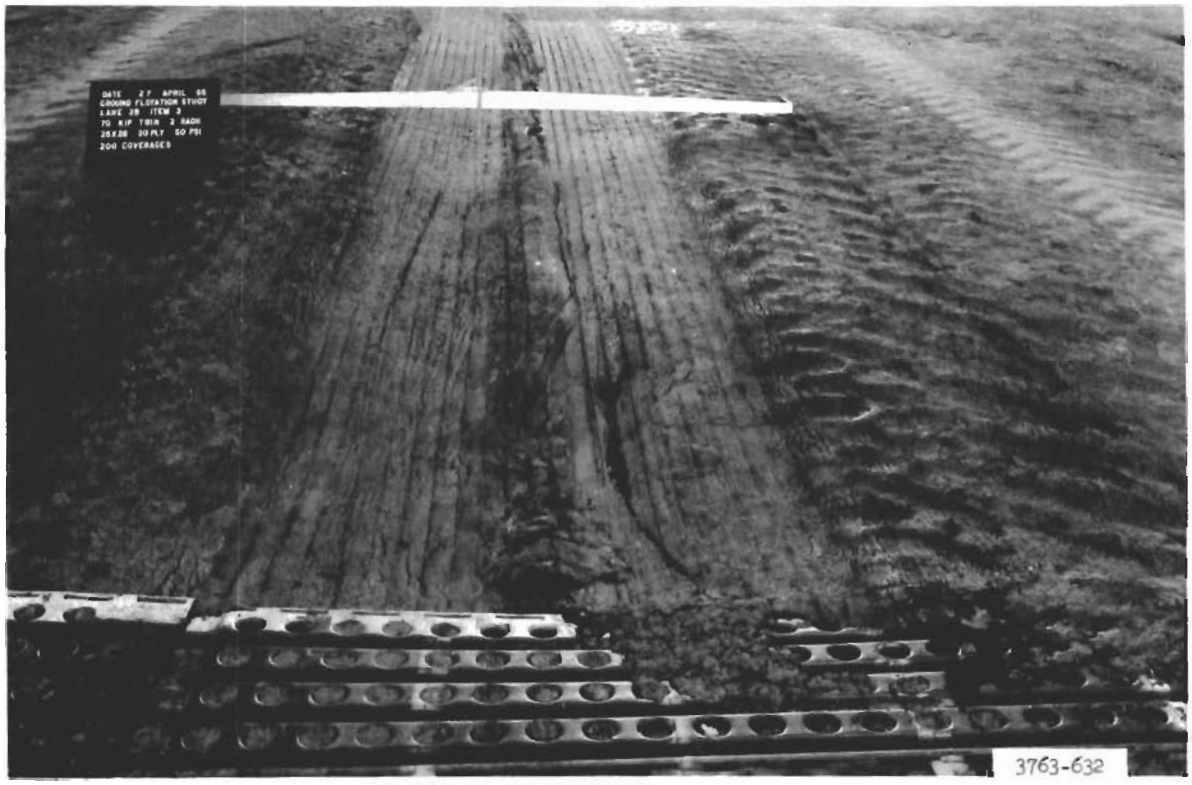
a. Roughness. Average transverse and diagonal differential deformations were 5.10 and 5.13 in., respectively, at failure (table 1). No rut depth measurements were made at failure because the close spacing of the tracking tires made individual ruts indistinguishable.

b. Deformation. Average cross-section deformations for 42, 140, and 200 coverages are shown in figure 18. Deformations became increasingly severe with traffic, reaching 4.0 in. at failure. Figure 19 shows profile deformations for the same coverage levels, illustrating the very large increase that occurred between 140 and 200 coverages, especially on the end adjacent to mat-surfaced item 2.

Figure 14. Lane 29, item 3, after 200 coverages of traffic (failure)

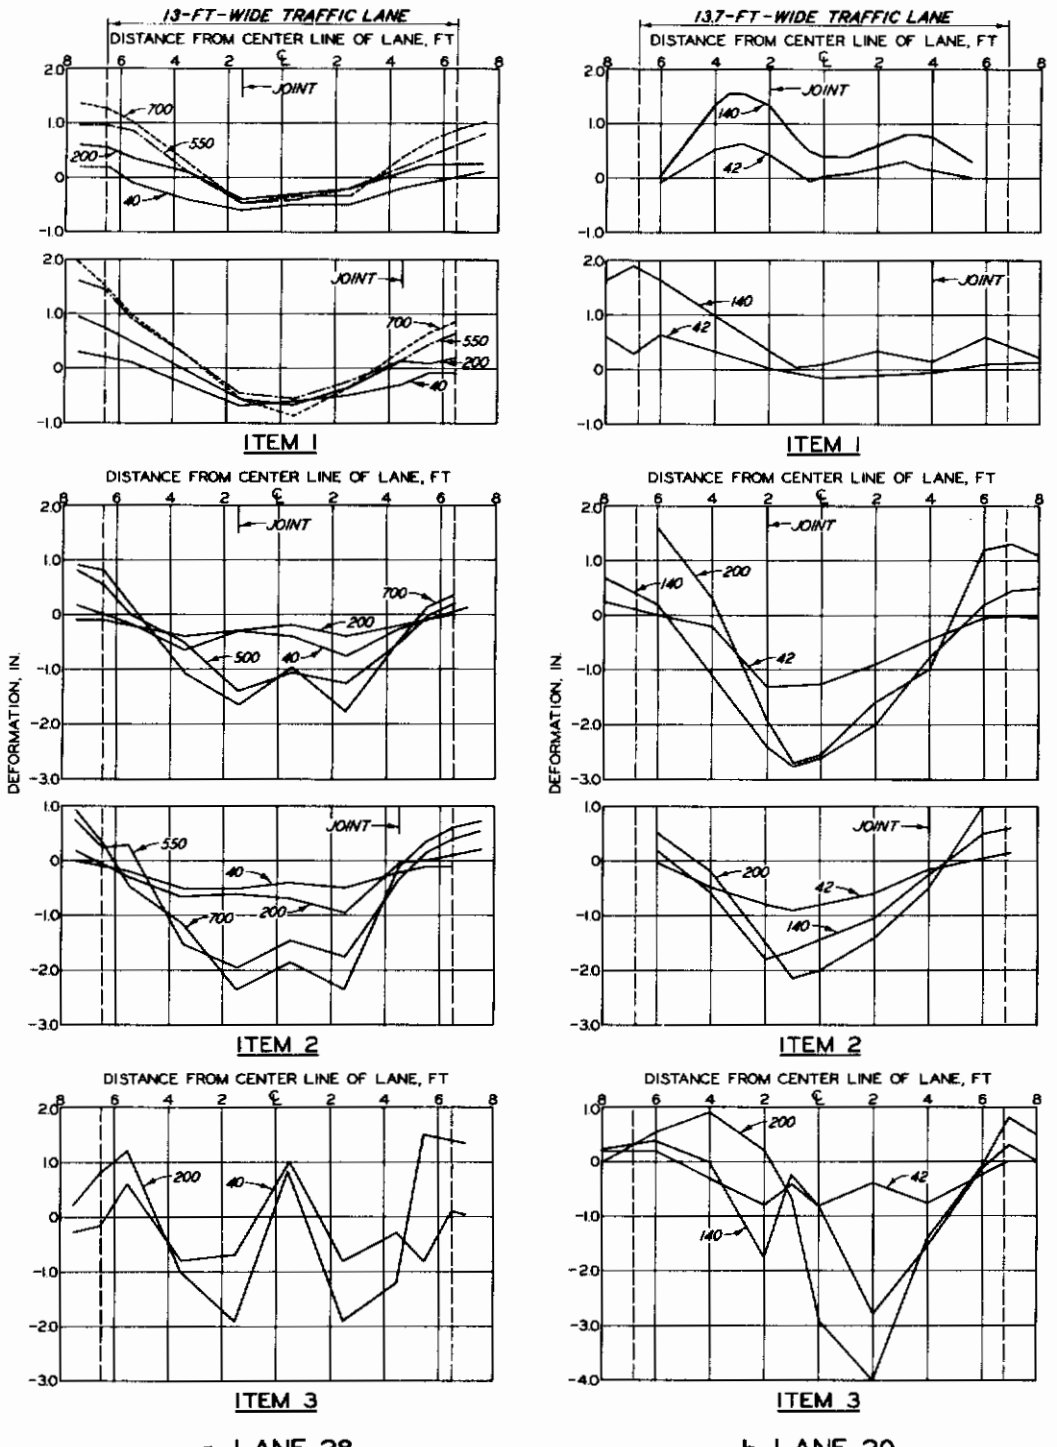
Figure 18

shown in figures 18 and 19, respectively. The maximum average cross-section deformation was +1.9 in. and occurred along the west side of the lane. This positive deformation was due to lateral displacement of the subgrade under traffic. Figure 19 shows deformations at 42 and 140 coverages. Displacement and subsidence of the subgrade under traffic caused bridging of the mat surface and consequently a number of positive deformation readings were recorded at 140 coverages.

AVERAGE CROSS-SECTIONAL DEFORMATIONS

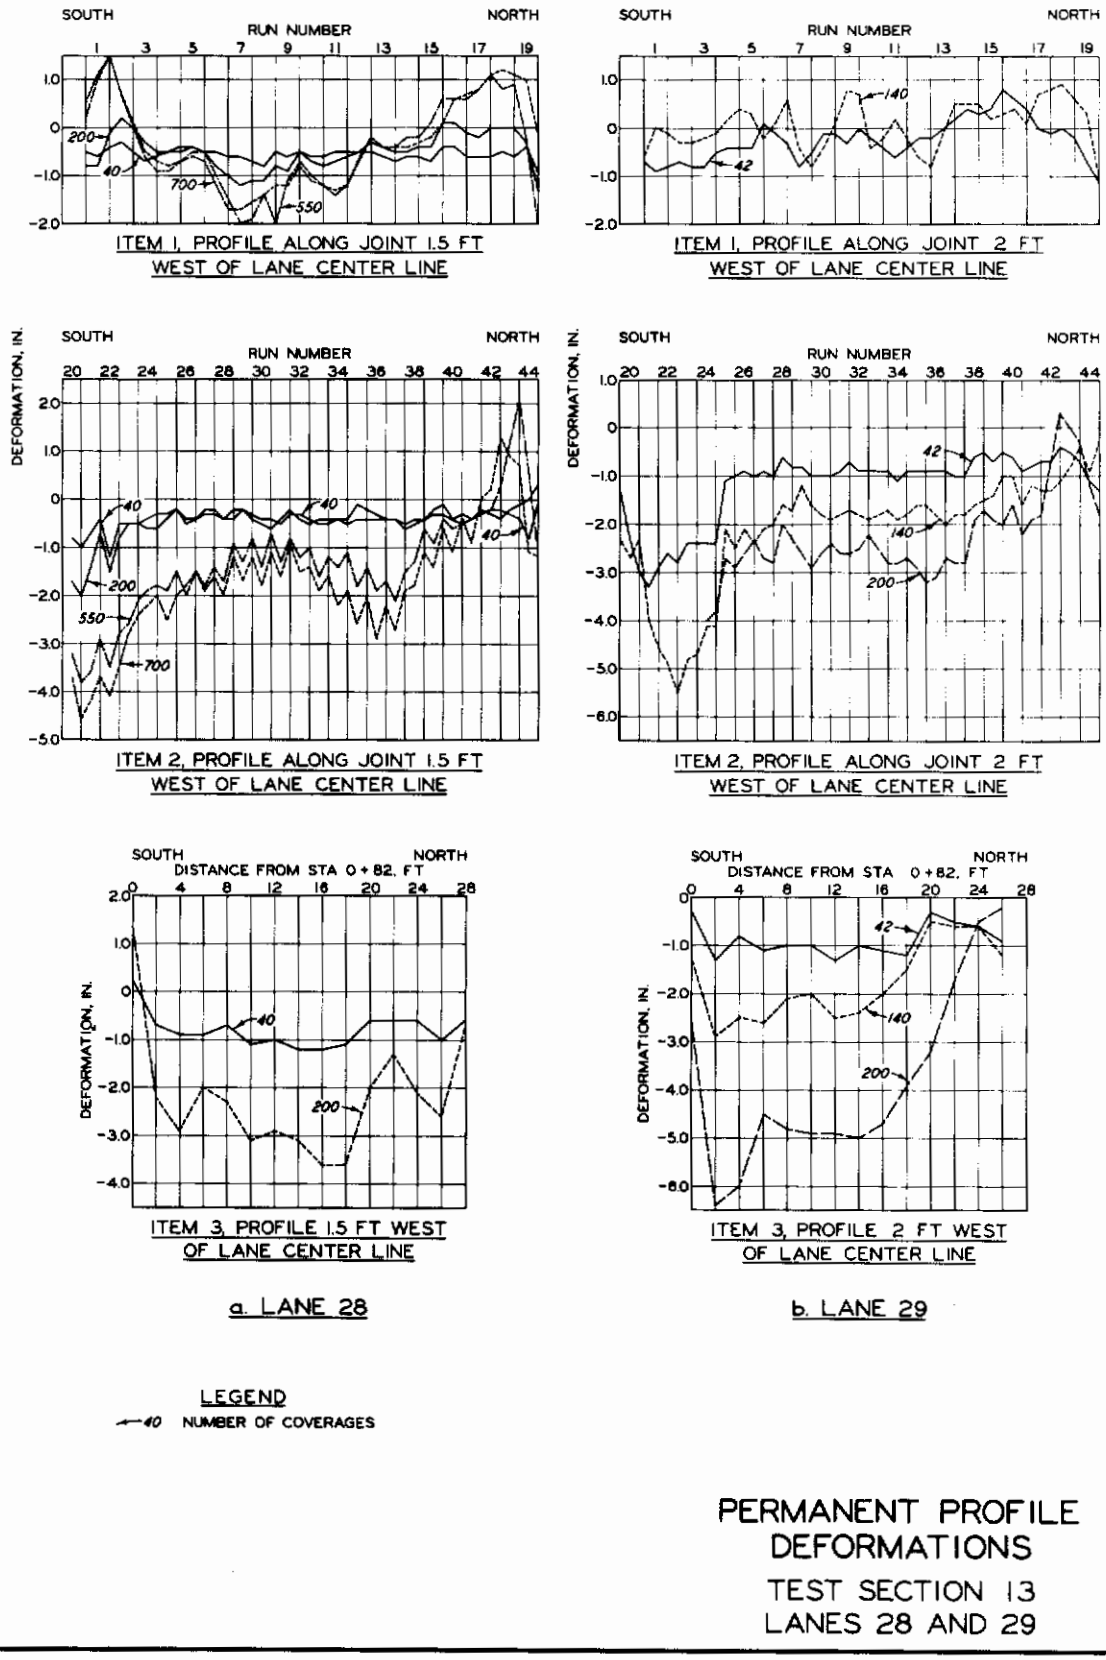
Figure 19

PERMANENT PROFILE DEFORMATIONS
TEST SECTION 13
LANES 28 AND 29

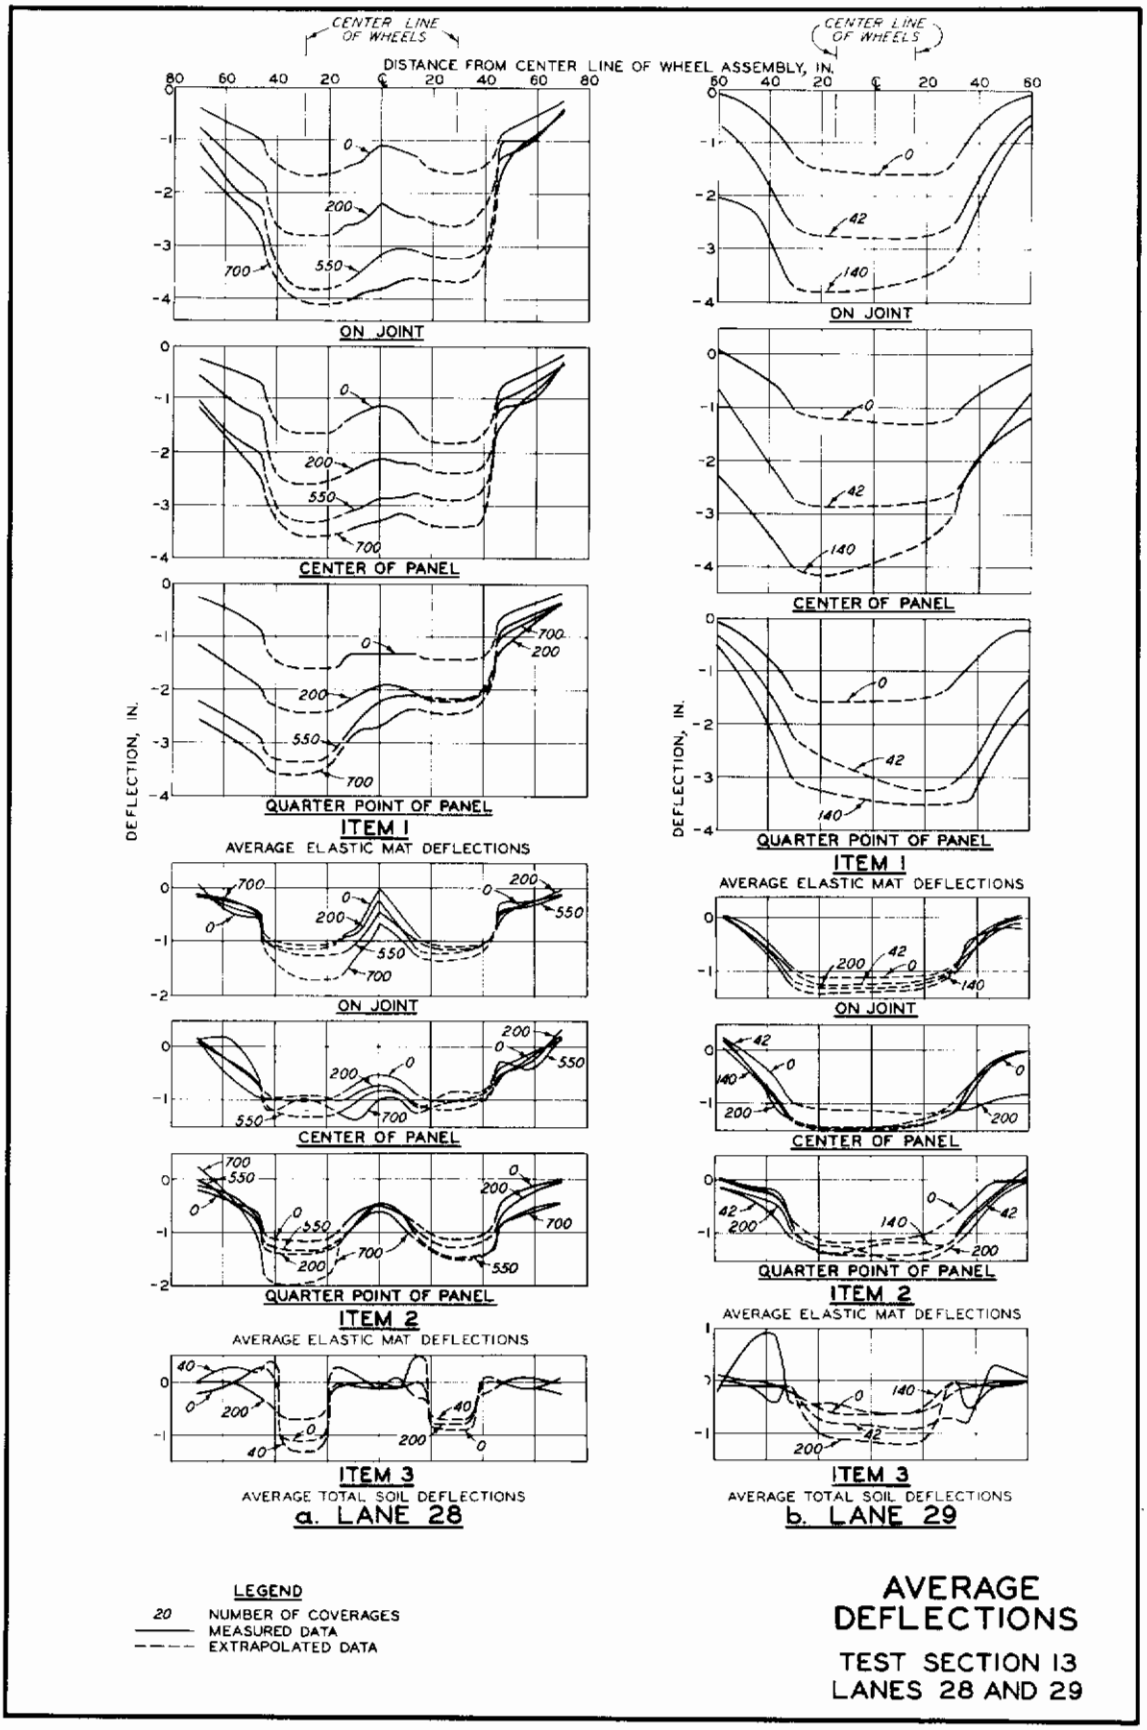
Figure 20

c. Deflections. Deflections shown in figure 20 increased consistently with traffic. The large deflection measurements were due to the mat standoff effect resulting from subsidence of the subgrade. Elastic subgrade deflection at failure was 2.2 in. (table 1).

c. Deflection. Average elastic mat deflections for three positions of the wheel assembly relative to mat joints are plotted in figure 20. Deflections did not vary greatly at the different coverage levels shown. Elastic subgrade deflection at failure was 1.50 in. (table 1).
