**AIRCRAFT GROUND-FLOTATION INVESTIGATION
PART V DATA REPORT ON TEST SECTION 4**

W. BRABSTON and W. HILL, JR.

AIRCRAFT GROUND-FLOTATION INVESTIGATION

PART V DATA REPORT ON TEST SECTION 4

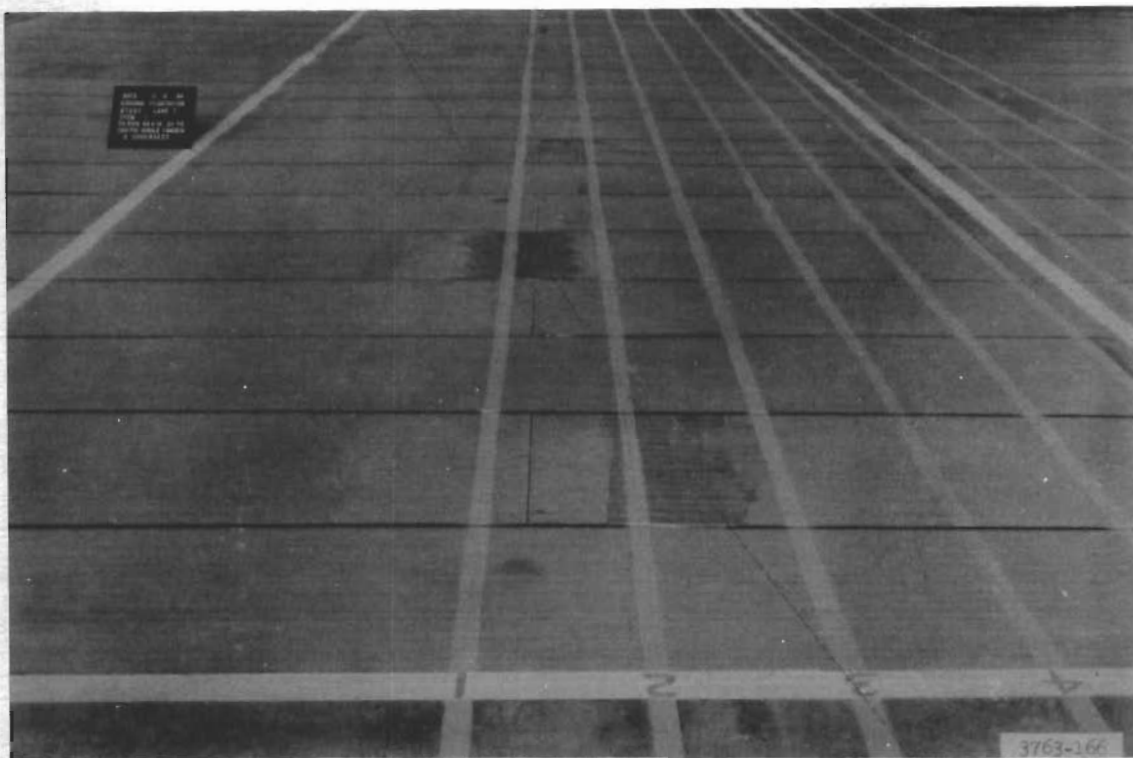
Fig 3. . Lane 7, item 1, prior to traffic

Item 1. **Fig 3** shows item 1 prior to traffic. The mat surface remained in excellent condition through 40 coverages and deteriorated gradually with trafficking thereafter. The item was considered failed due to roughness and mat deterioration at 300 coverages (**Figs 4** through **7**). At failure, many mat breaks and rivet failures were evident. The rated CBR of the item was 2.1.

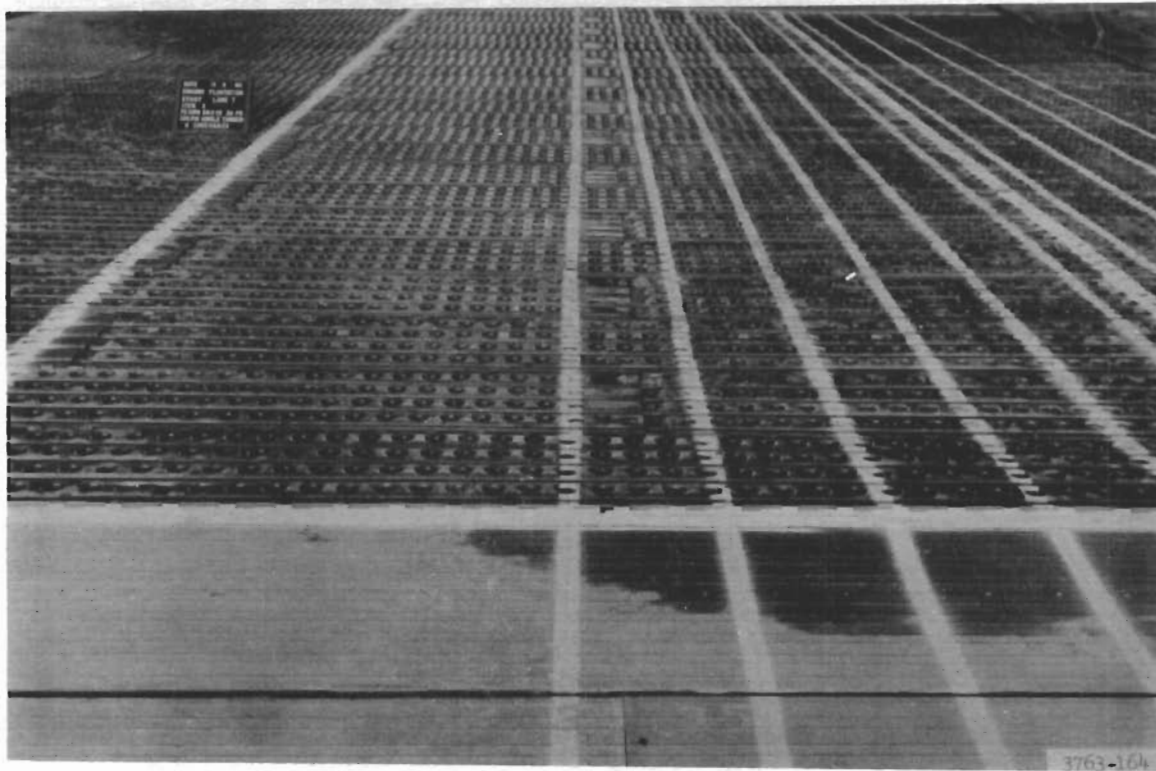
Fig 8. Lane 7, item 2, prior to traffic

Item 2. **Fig 8** shows item 2 prior to traffic. The M8 mat surface did not have a large number of breaks at 200 coverages when the item was considered failed due to roughness (**Figs 9** and **10**). At coverage levels near the failure point, the panel ends at the mat joint near the center line began to project upward (**Figs 9** and **10**). The rated CBR of the item was 4.9.

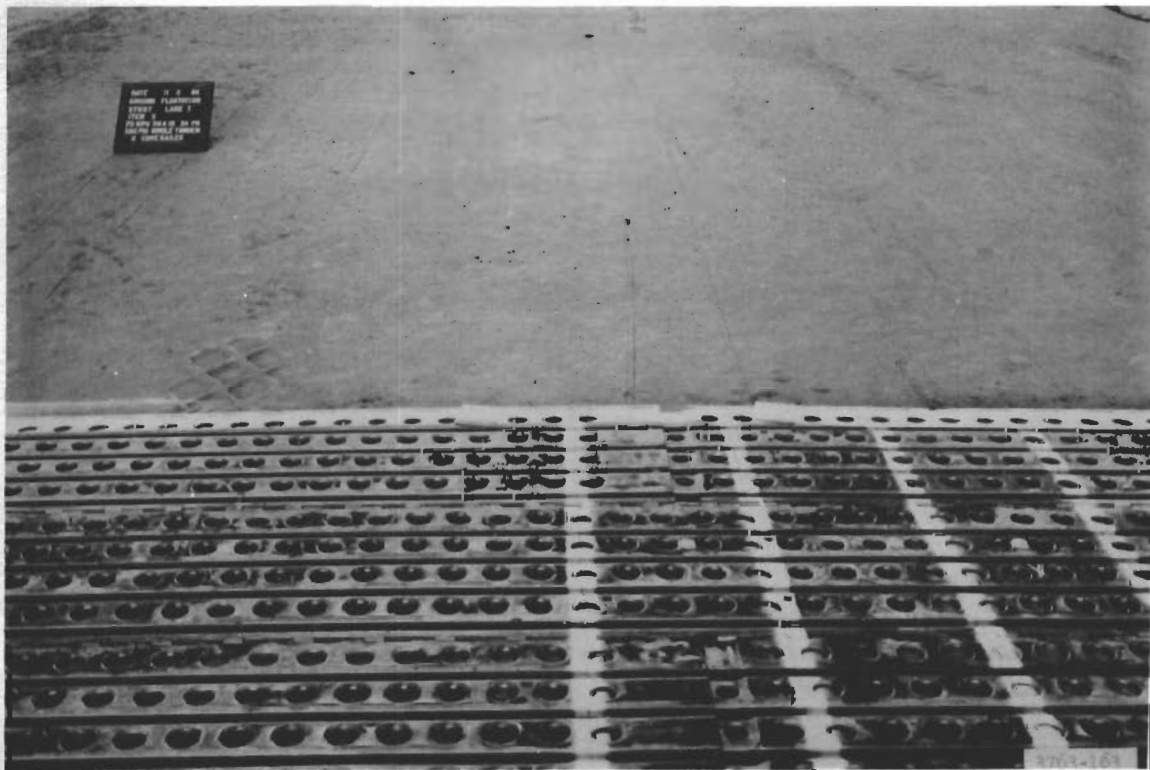
Fig 11. Lane 7, item 3, prior to traffic

Item 3. Item 3 prior to traffic is shown in **Fig 11**. The item was in serviceable condition at 80 coverages, but had greatly deteriorated when data measurements were again taken at 128 coverages (**Fig 12**). After studying data collected at 128 coverages, it was decided to antedate the time of failure to 100 coverages. Failure was due to excessive rutting. The rated CBR of the item was 9.3.

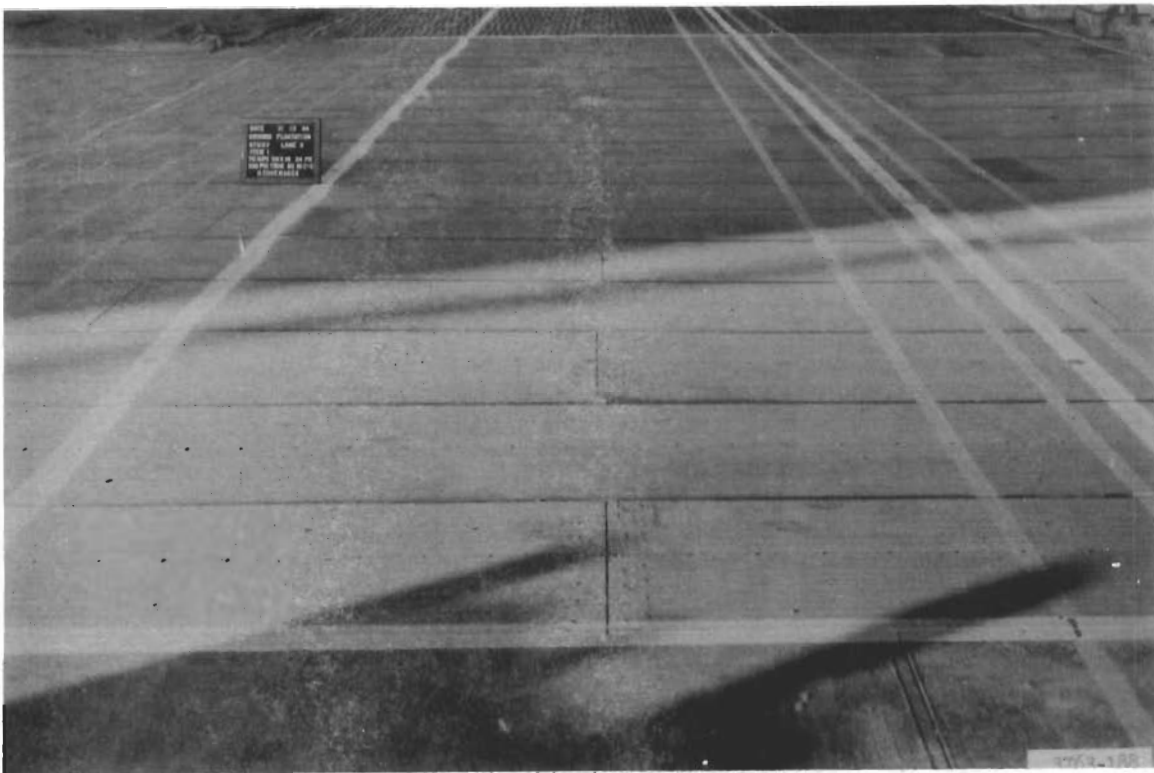
Fig 13. Lane 8, item 1, prior to traffic

Item 1. Item 1 is shown prior to traffic in **Fig 13**. The item held up well under traffic and did not have an excessive number of mat breaks at any time. Traffic was applied to the 460-coverage level when the item was considered failed due to roughness (**Fig 14**). The rated CBR for the item was 2.4.

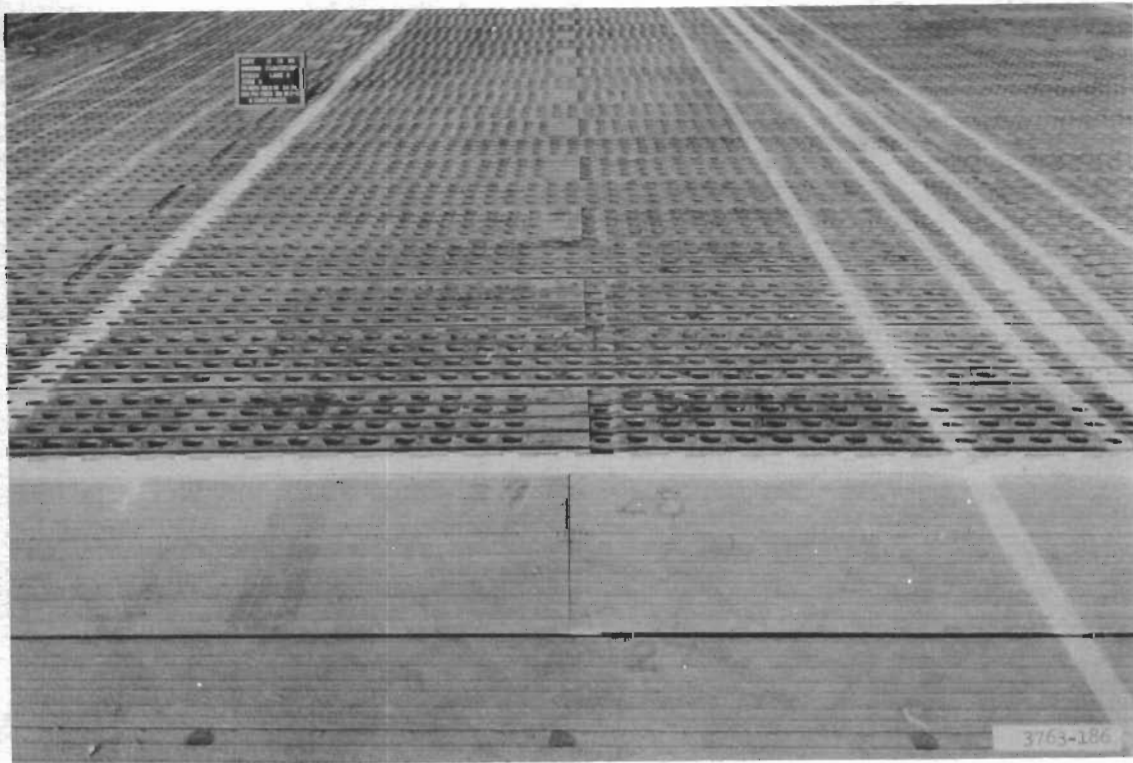
Fig 15. Lane 8, item 2, prior to traffic

Item 2. **Fig 15** shows item 2 prior to traffic. On mat runs having the mat joint located near the lane center line, the panels deformed in a concave upward shape along their length causing the panel ends to extend upward at the joint. This condition contributed to transverse and diagonal roughness in the lane. No mat breaks occurred during testing. At 142 coverages the item was considered failed due to roughness (**Figs 16** and **17**). The rated CBR was 4.0.

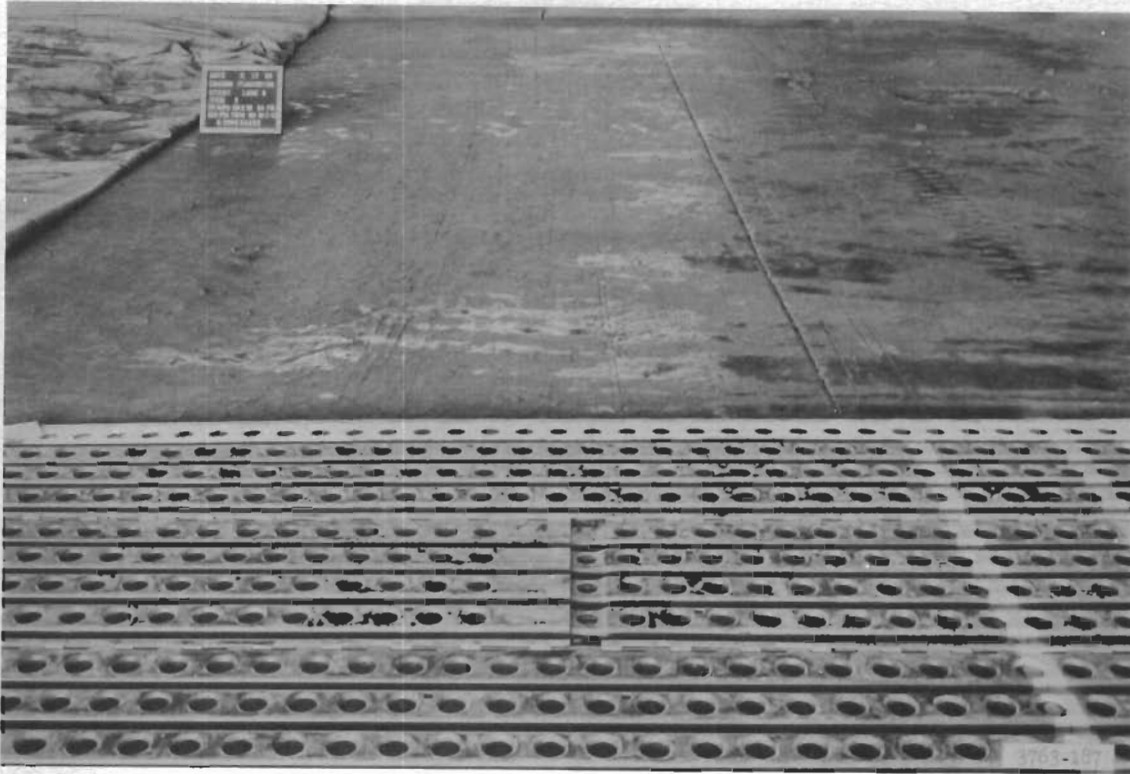
Fig 18. Lane 8, item 3, prior to traffic

Item 3. Item 3 prior to traffic is shown in Fig 18 . The item remained in good condition through 20 coverages with rut depths averaging 1.56 in. Continued trafficking resulted in progressive rutting and failure of the item at 62 coverages (Fig 19), . The rated CBR for the item was 9.8.

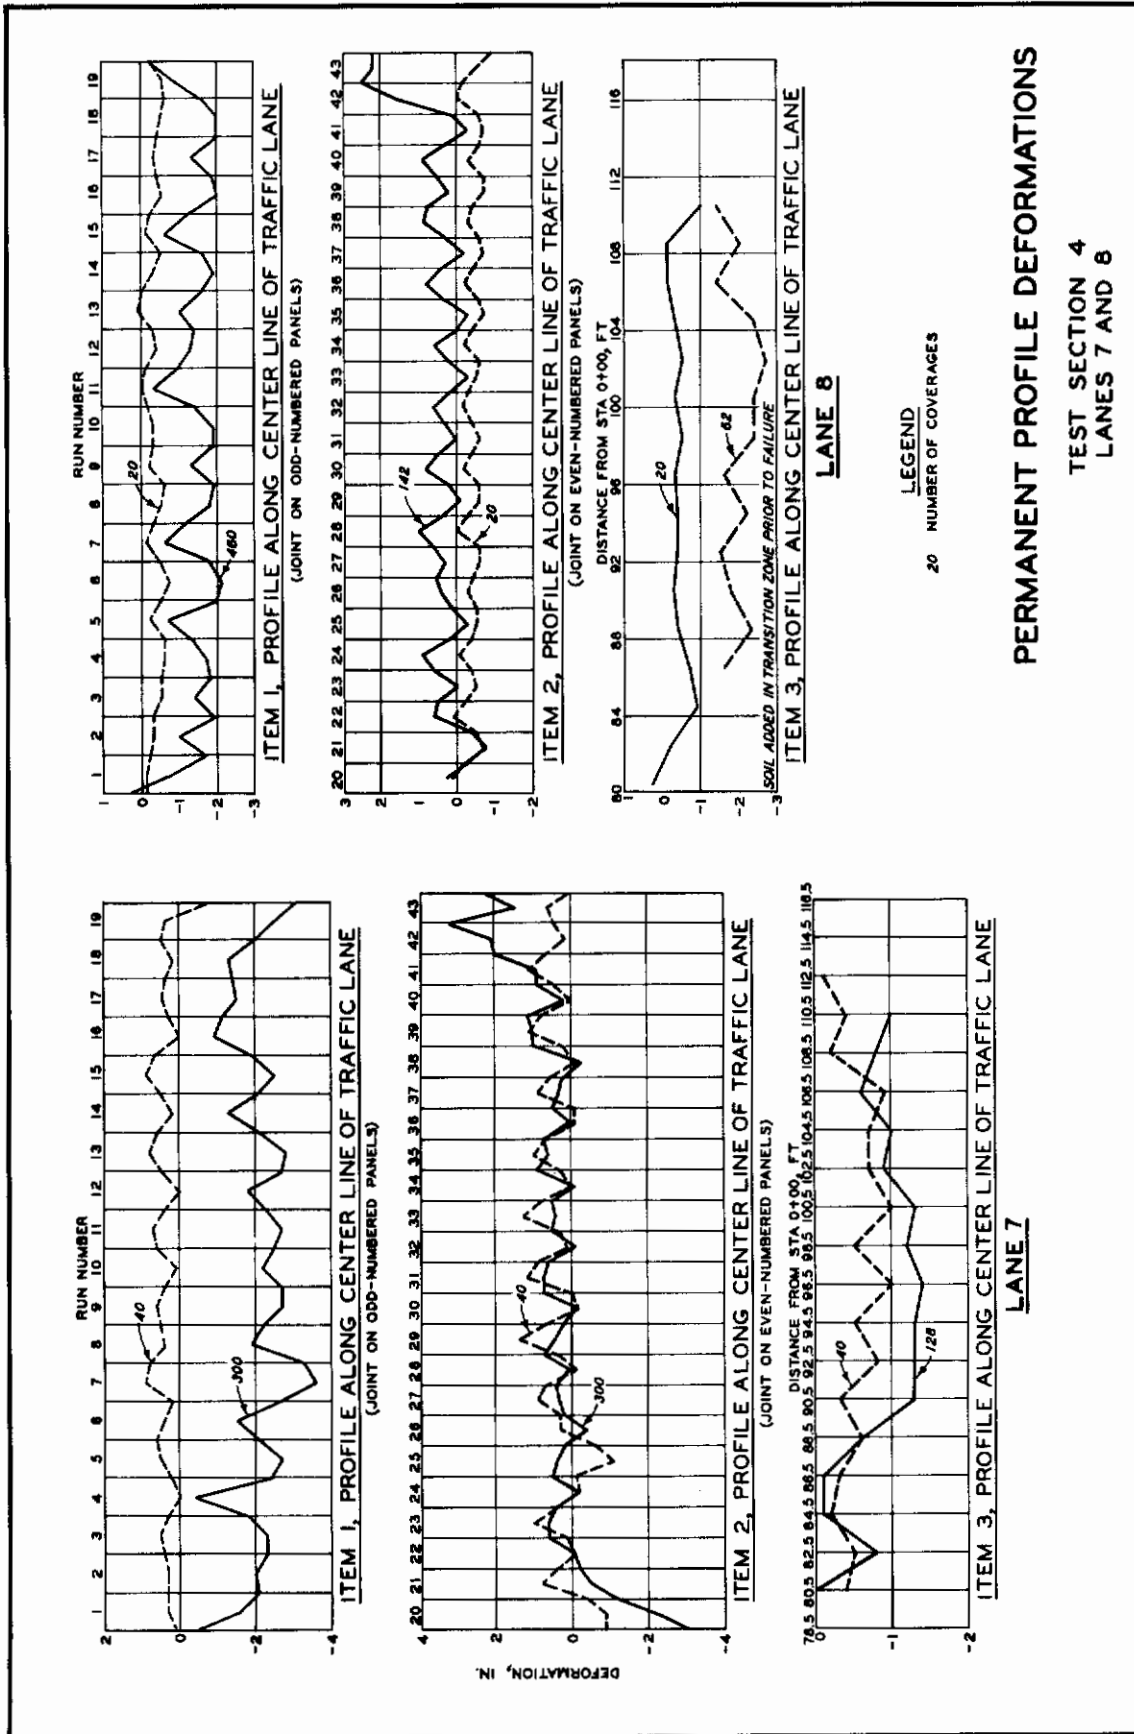
Fig. 24

- b. Deformation. Average cross-sectional deformations are represented in Fig 23 for the two typical mat runs. Deformations recorded at 20 and 142 coverages are shown. Maximum deformations occurred along paths on both sides of the lane center line. The center-line profile plot in Fig 24 illustrates the deflecting of panel end joints that developed with trafficking.

- a. Roughness. Differential deformations and rut depths at 20 and 62 coverages are shown in table 1. At failure the average rut depth was 3.72 in.
- b. Deformation. Average permanent soil deformations at 20 and 62 coverages are plotted in Fig 23 and 24 for cross section and profile, respectively. The cross-section plot reflects a ridge down the lane center line, as shown in Fig 19. Measurements for the profile plot in Fig 24 were made to one side of the center-line ridge to be more representative of the entire item.
