**AIRCRAFT GROUND-FLOTATION INVESTIGATION  
PART VII DATA REPORT ON TEST SECTION 6**

*W. BRABSTON and W. HILL, JR.  
U. S. ARMY ENGINEER WATERWAYS EXPERIMENT STATION*

PART VII DATA REPORT ON TEST SECTION 6

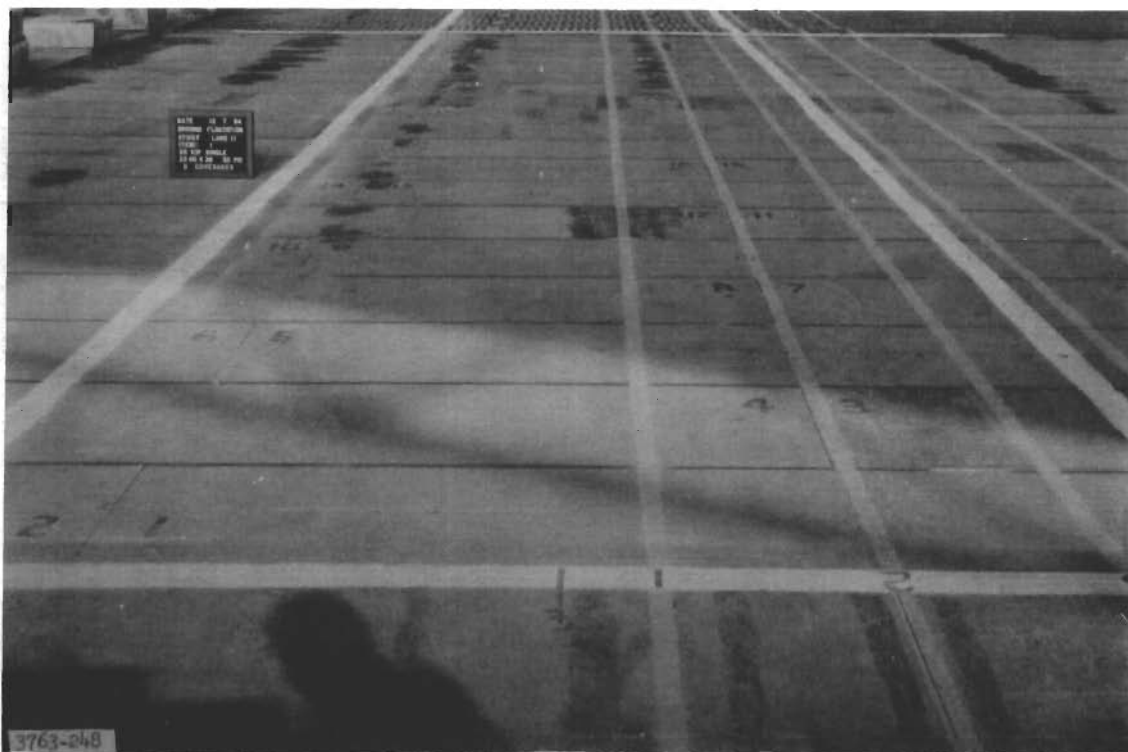
Figure 3. Lane 11, item 1, prior to traffic

Item 1. Figure 3 shows item 1 prior to traffic. The item sustained 600 traffic coverages without developing appreciable deformations or roughness. No signs of failure were in evidence when traffic was suspended at 600 coverages (figure 4). The rated CBR of the item was 1.5.

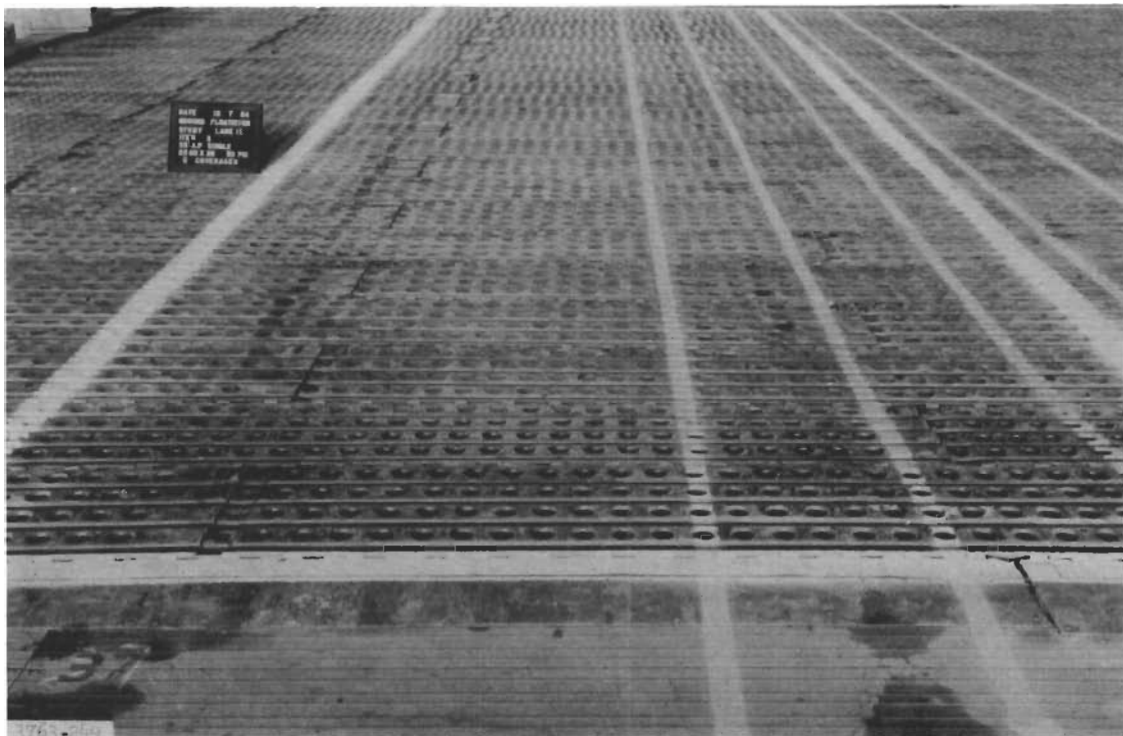
Figure 5. Lane 11, item 2, prior to traffic

Item 2. Figure 5 shows item 2 prior to traffic. Traffic was suspended at 600 coverages with no discernible damage evident (figure 6). The rated CBR was 4.1.

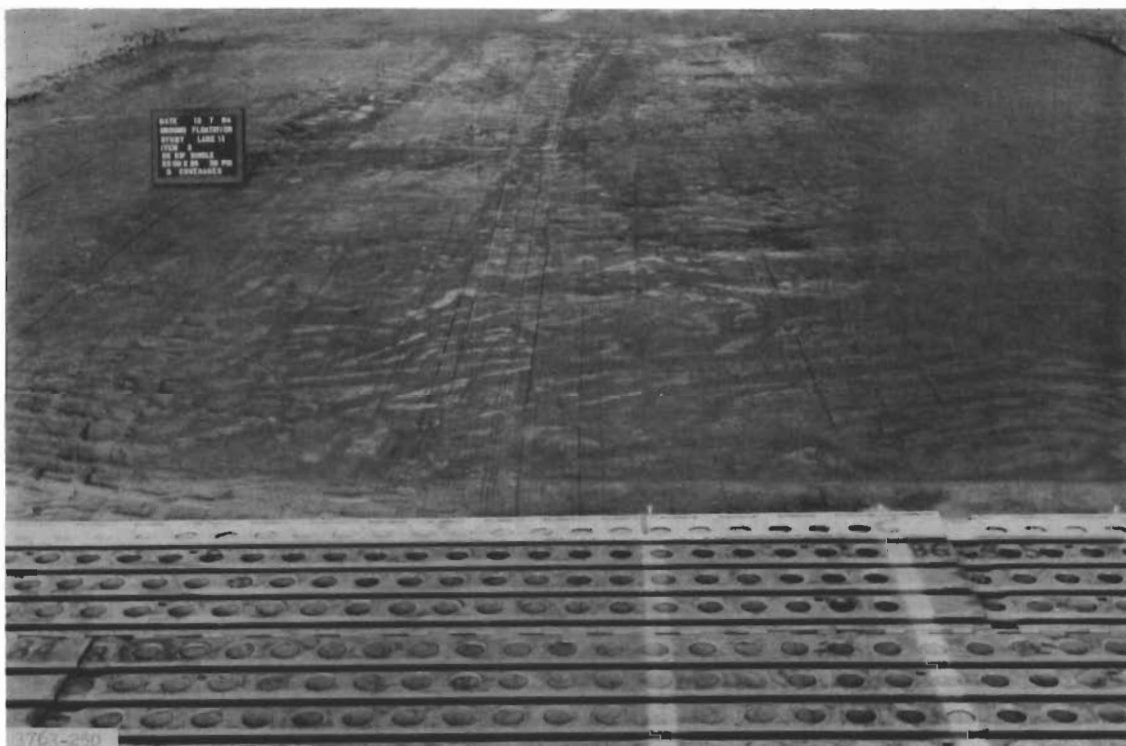
Figure 7. Lane 11, item 3, prior to traffic

Item 3. Figure 7 shows item 3 prior to traffic. Very shallow surface deformations were evident when traffic was suspended at 600 coverages (figure 8). The item remained in good condition. The rated CBR was 12.

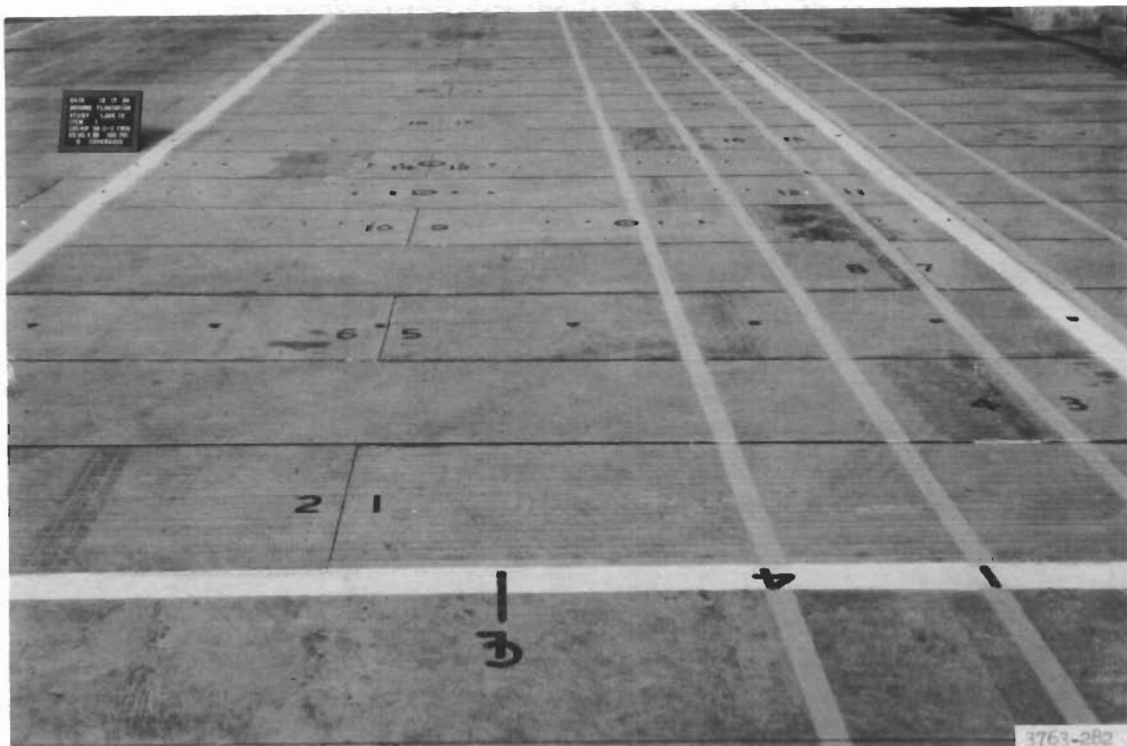
Figure 12. Lane 12, item 1, prior to traffic

Item 1. Figure 12 shows item 1 prior to traffic. The item was still in good condition when measurements were recorded at 44 traffic coverages. Additional trafficking produced progressive deterioration of the item until it was considered failed due to roughness at 90 coverages (figure 13). The rated CBR was 2.9.

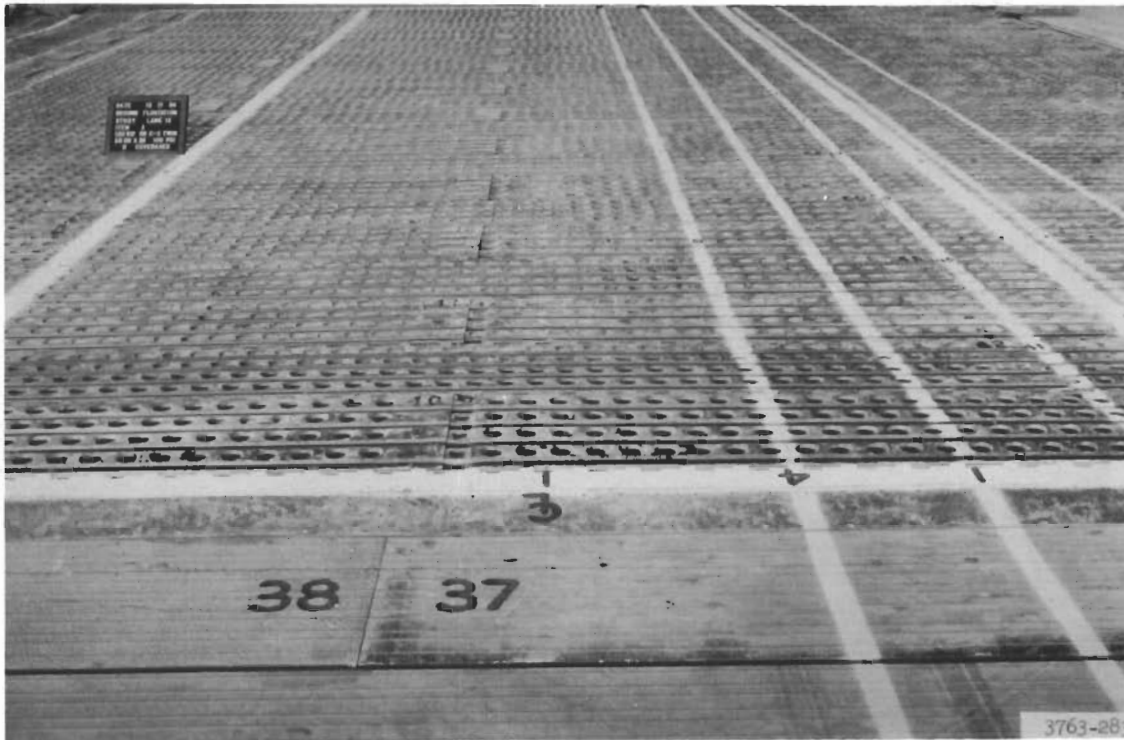
Figure 14. Lane 12, item 2, prior to traffic

Item 2. Figure 14 shows item 2 prior to traffic. The item was considered failed due to roughness at 44 coverages (figure 15). At failure the plank ends along the mat joint line near the lane center were bent downward into the subgrade in contrast to the upward protrusion of plank ends encountered in previous test lanes. The rated CBR was 4.2.

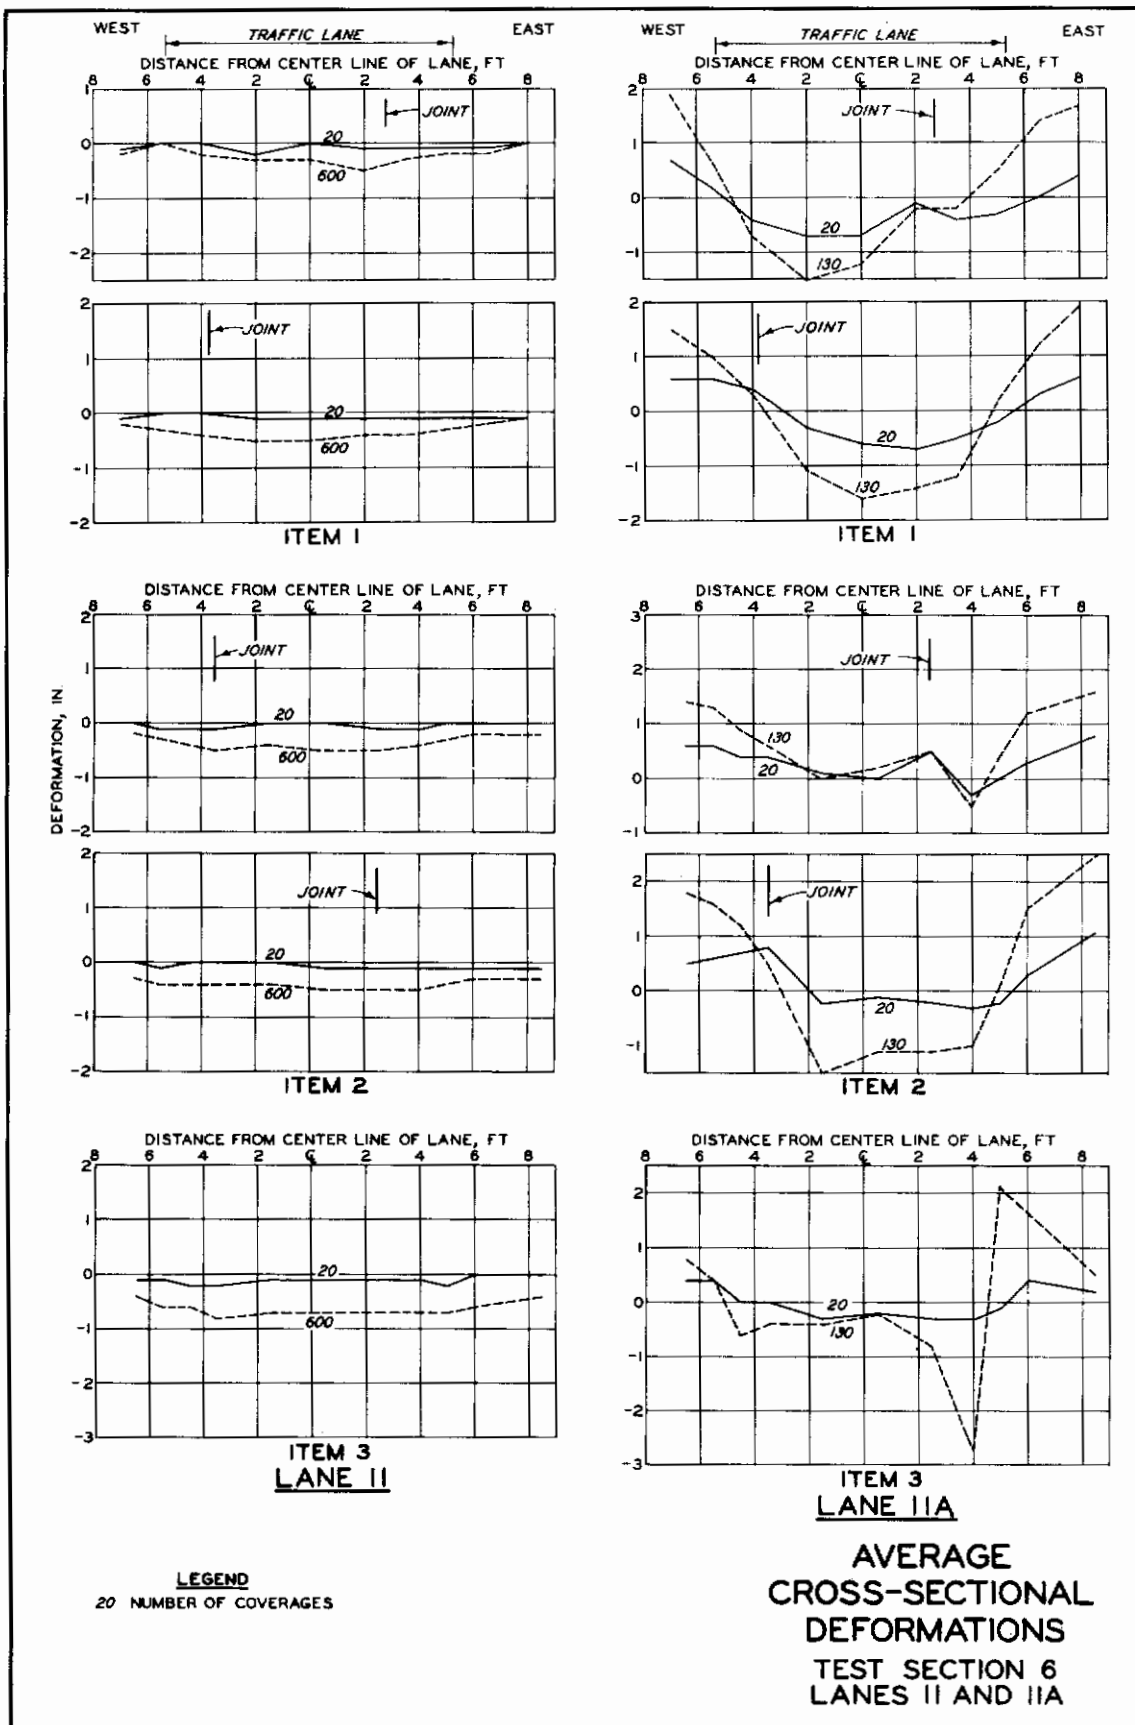
- b. Deformation. Average cross-section deformations at 20 and 600 coverages are shown in figure 21 for two typical mat runs. Center-line profiles along the item are shown in figure 22 for the 20- and 600-coverage levels. The profile plots illustrate the uniform subsidence of the item under traffic.

- b. Deformation. Figure 21 shows average cross-section deformations measured at 20 and 130 coverages. The severe rut that developed along one side of the lane is illustrated in the plot at 130 coverages. Center-line profiles along the item are shown in figure 22 for 20 and 130 coverages.
