WADC TECHNICAL REPORT 57 - 298

IRON-ALUMINUM ALLOY SYSTEMS

PART 14 WELDING OF IRON-ALUMINUM ALLOYS

**FORD MOTOR COMPANY
MANUFACTURING RESEARCH OFFICE**

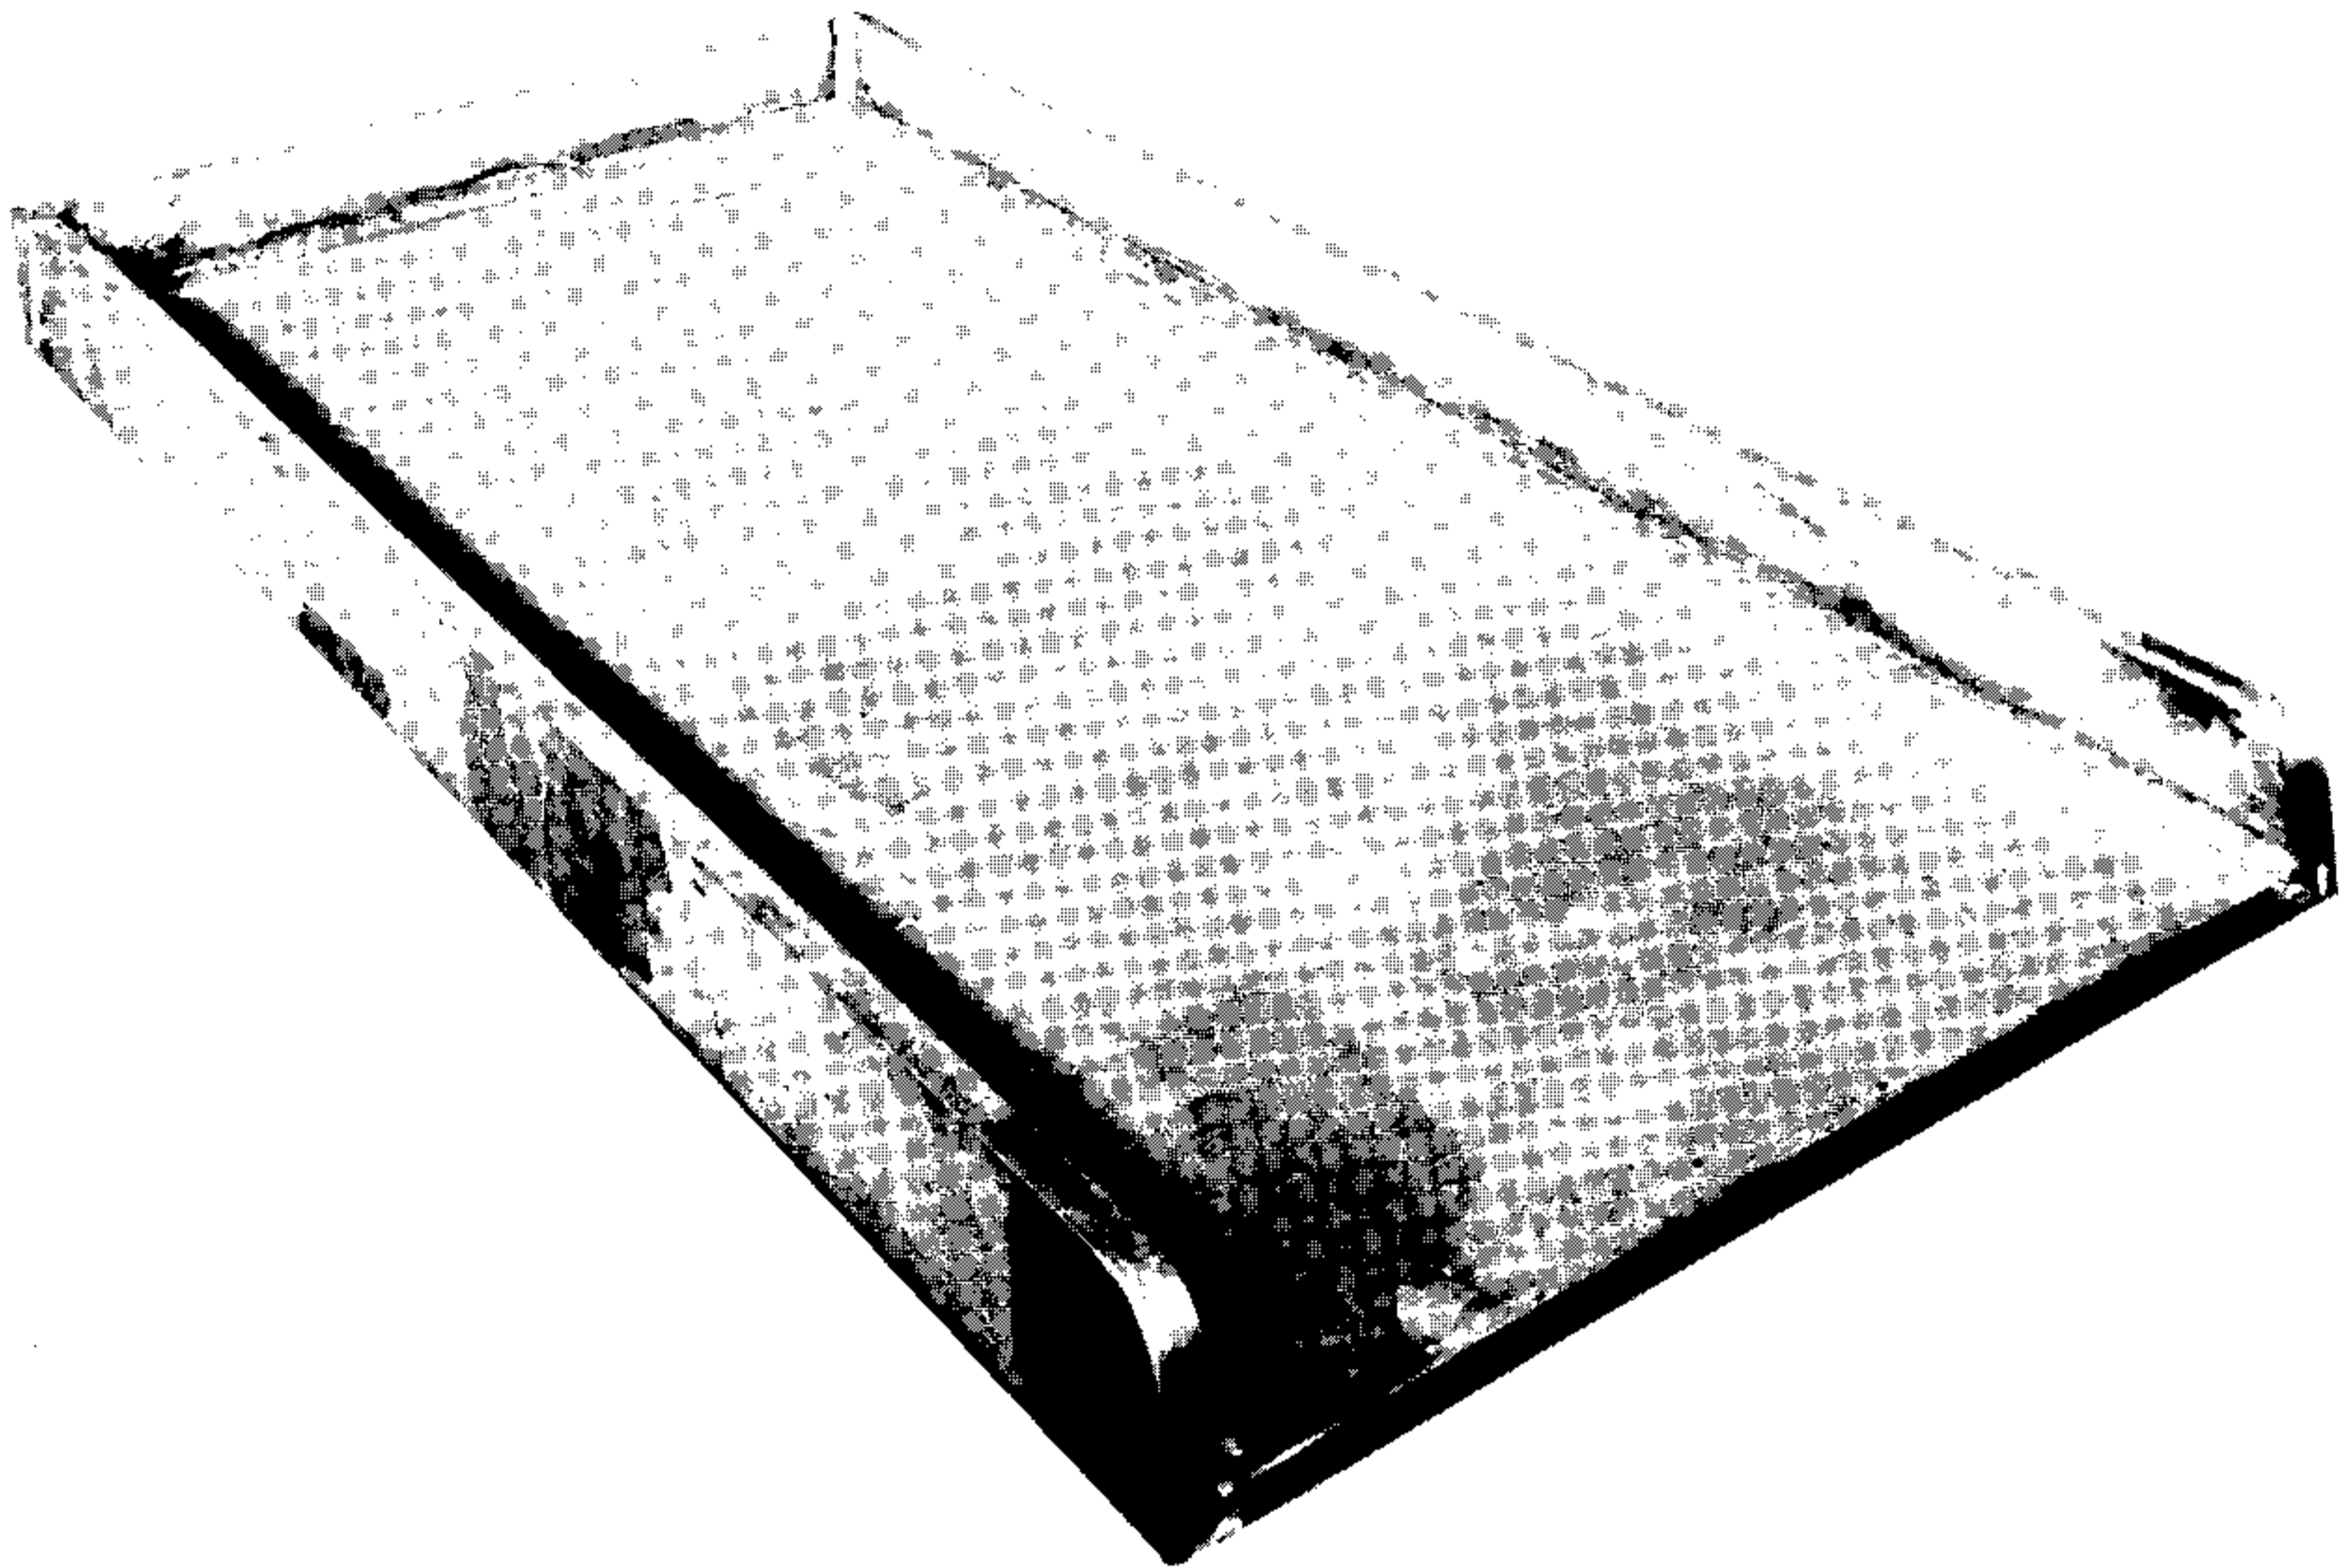
A furnace hearth employing iron-aluminum alloy material from Heat A-13361 was made and placed into service at the Tool and Die Heat-Treat Department. The assembled furnace hearth shown in Figure 3 was fabricated from .625" thick stock. Its dimensions were 2" deep x 19" wide x 38-3/4" long. The end and two side detail parts were attached to the bottom plate and to each other by welding. It was placed into service November 10, 1958 in an electric furnace operating at a maximum temperature of 1700°F.

The welding was done by the manual shielded metal arc welding process using 5/32" diameter 99.7% nickel electrodes. A current of 140 amperes was used and although no preheat nor postheat was required for crack-free welding of simulated test samples both were specified in this application. Due to the size of the furnace hearth and the required clamping pressure necessary to obtain good joint alignment, a preheat of 450°F was applied prior to welding. A postheat operation of 1200°F for 30 minutes followed by air cooling was employed to relieve internal stresses caused by clamping and welding. Radiographic examination of the furnace hearth, prior to entering service, did not reveal any cracks. No visible deterioration was observed after three months operation.

Figure 3 - Welded Furnace Hearth Fabricated from
Iron-Aluminum, Heat A-13361, .625" Thick

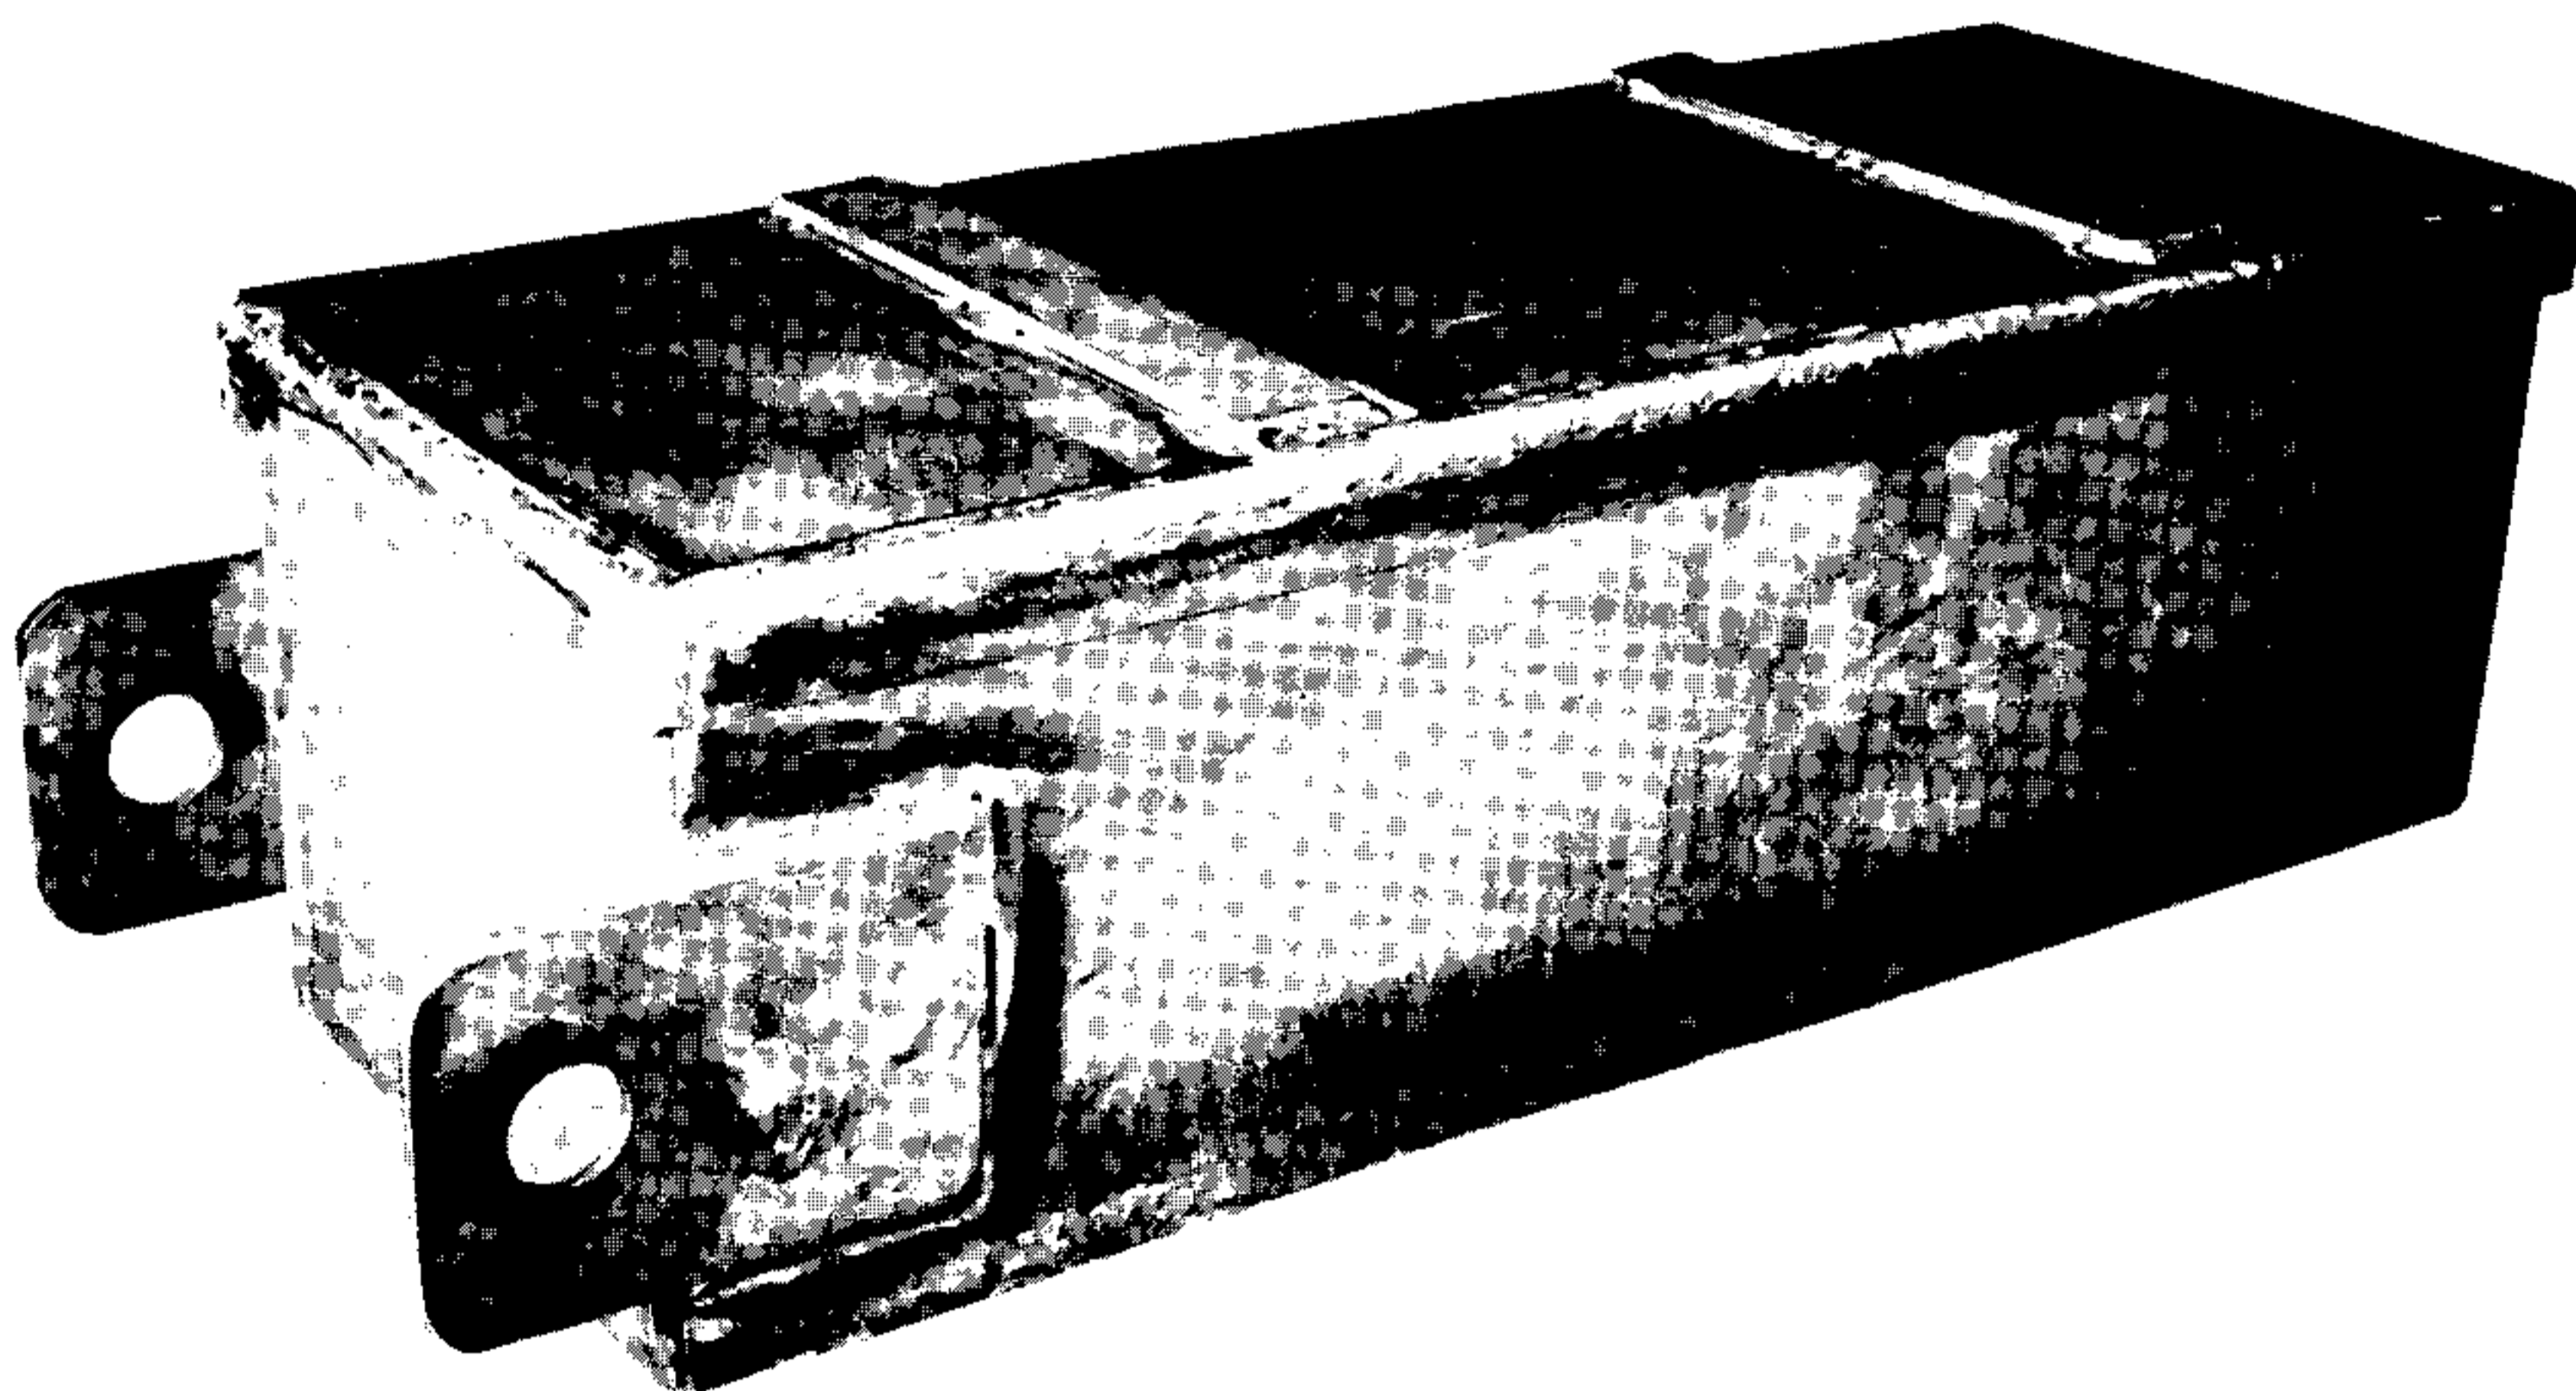
A heat-treat box and cover made from .25" thick iron-aluminum alloy heat A-13361 was also placed in service at the Tool and Die Heat-Treat Department. Figure 4 shows a photograph of the assembled box which was 10" deep x 12" wide and 34" long. At the time of this report it had been in service for only 22 hours at temperatures from 1650 to 1700°F. Additional service time must be accumulated for complete evaluation. The same nickel electrode and welding procedures which were used for the furnace hearth were employed in the welding of the heat-treat box.

Figure 4 - Heat-Treatment - Box and Cover Fabricated from Iron-Aluminum, Heat A-13361, .250" Thick

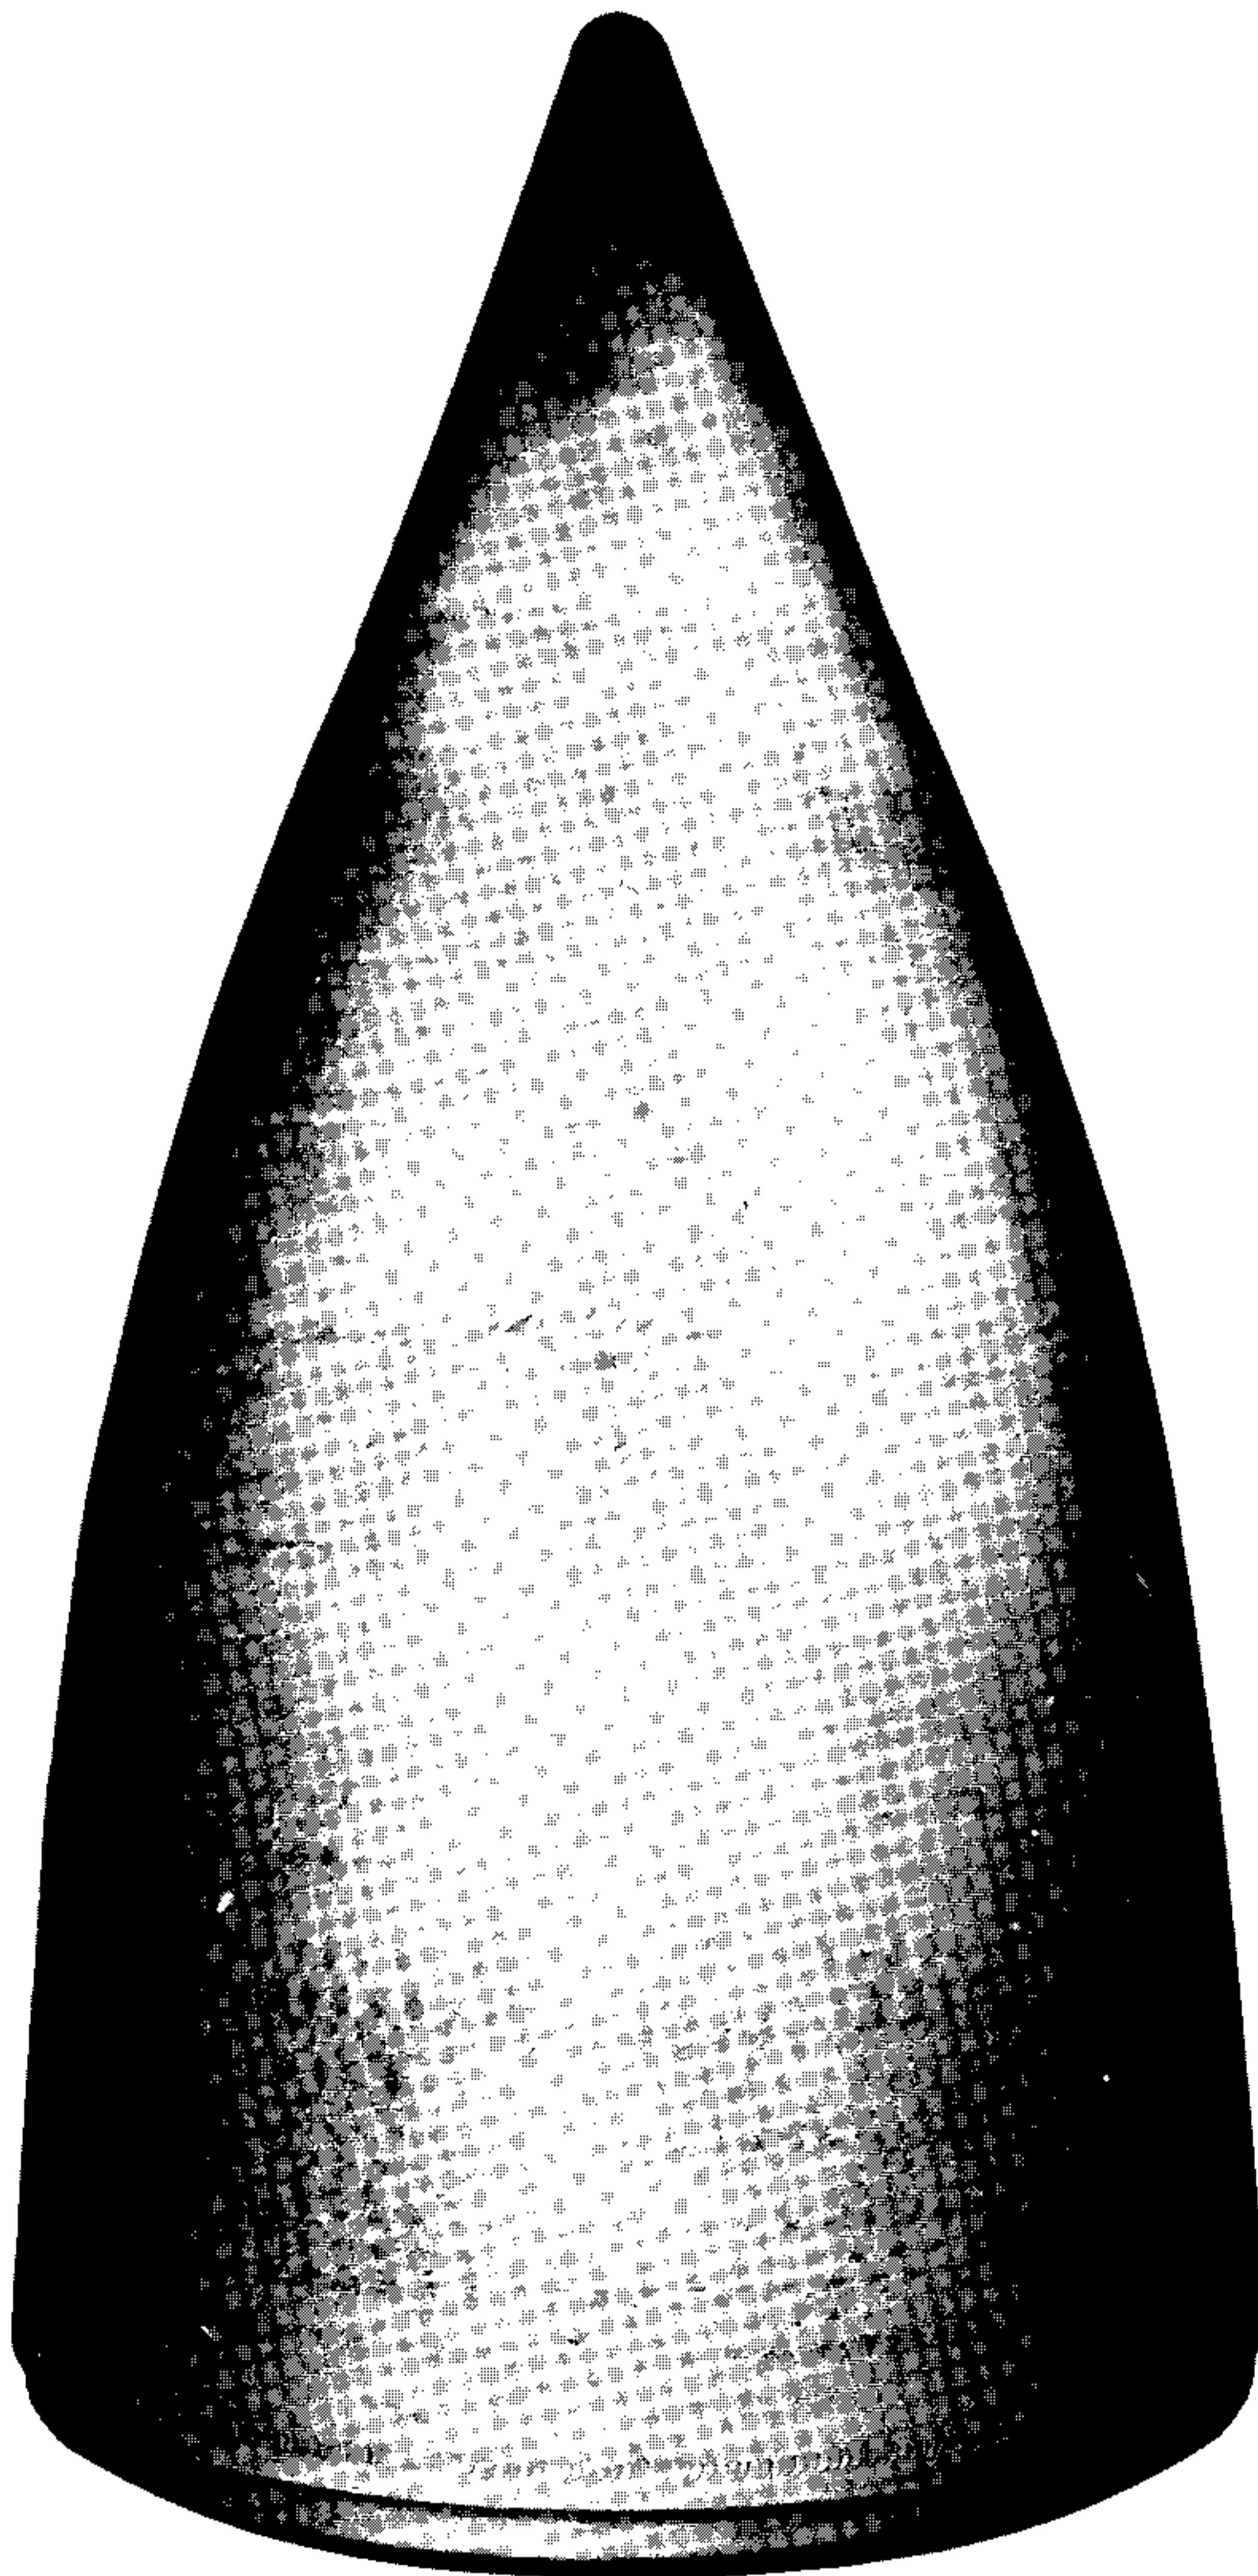
The fabrication method used for the J-57 Turbine Exhaust Cone Assembly, which was tested at the Ford Aircraft Engine Division in Chicago, was described in WADC Technical Report 57-298, Part 10. Figure 5 shows the cone assembly before testing.

Figure 5 - J-57 Turbine Exhaust Cone Assembly - Iron-Aluminum,
Heats E-1005 and E-1006 - View Before Endurance Test
