CORROSION PROBLEMS IN AIRCRAFT COMPONENTS--

CASE STUDIES OF FAILURES

W. R. Coleman, R. J. Block and R. D. Daniels
University of Oklahoma
Norman, Oklahoma 73019

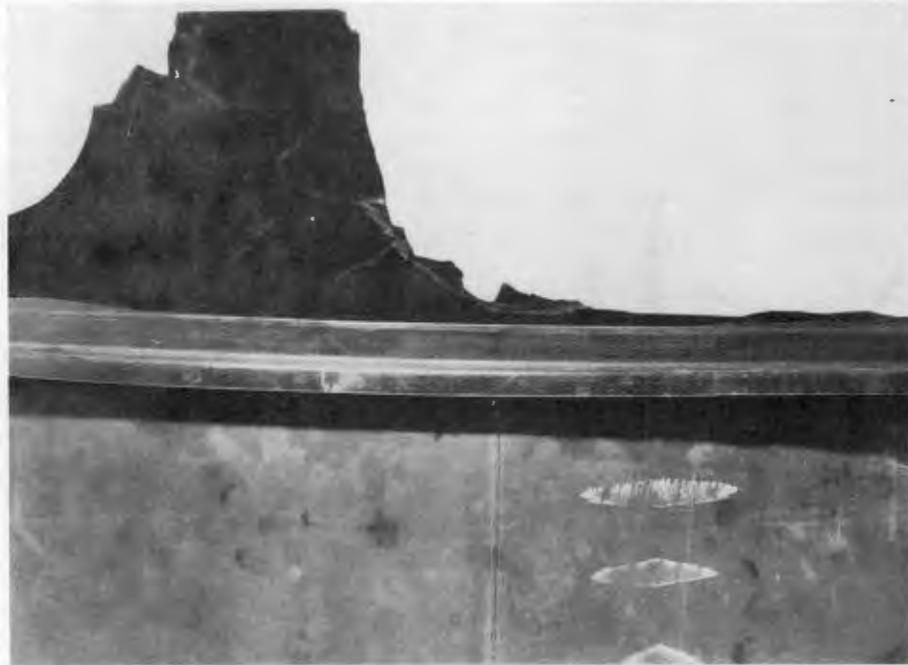
An unusual problem for which failure analysis was required involved the separation of a portion of the exhaust tailcone from an A-7D aircraft. About one-third of the assembly fell away from the airplane during a flight over Pittsburgh, Pennsylvania and the part was never recovered. Figure 10 shows an overall view of the portion of the cone that remained. The original cone tapered from about three to two feet in diameter, was about six feet long and was formed from sheet approximately 0.020 inches in thickness. The structure was stabilized with circumferential stiffeners on the outside. The piece that fell off in-flight was large enough to do considerable damage.

Figure 10. Overall view of the separated tailcone assembly. A-7D aircraft.

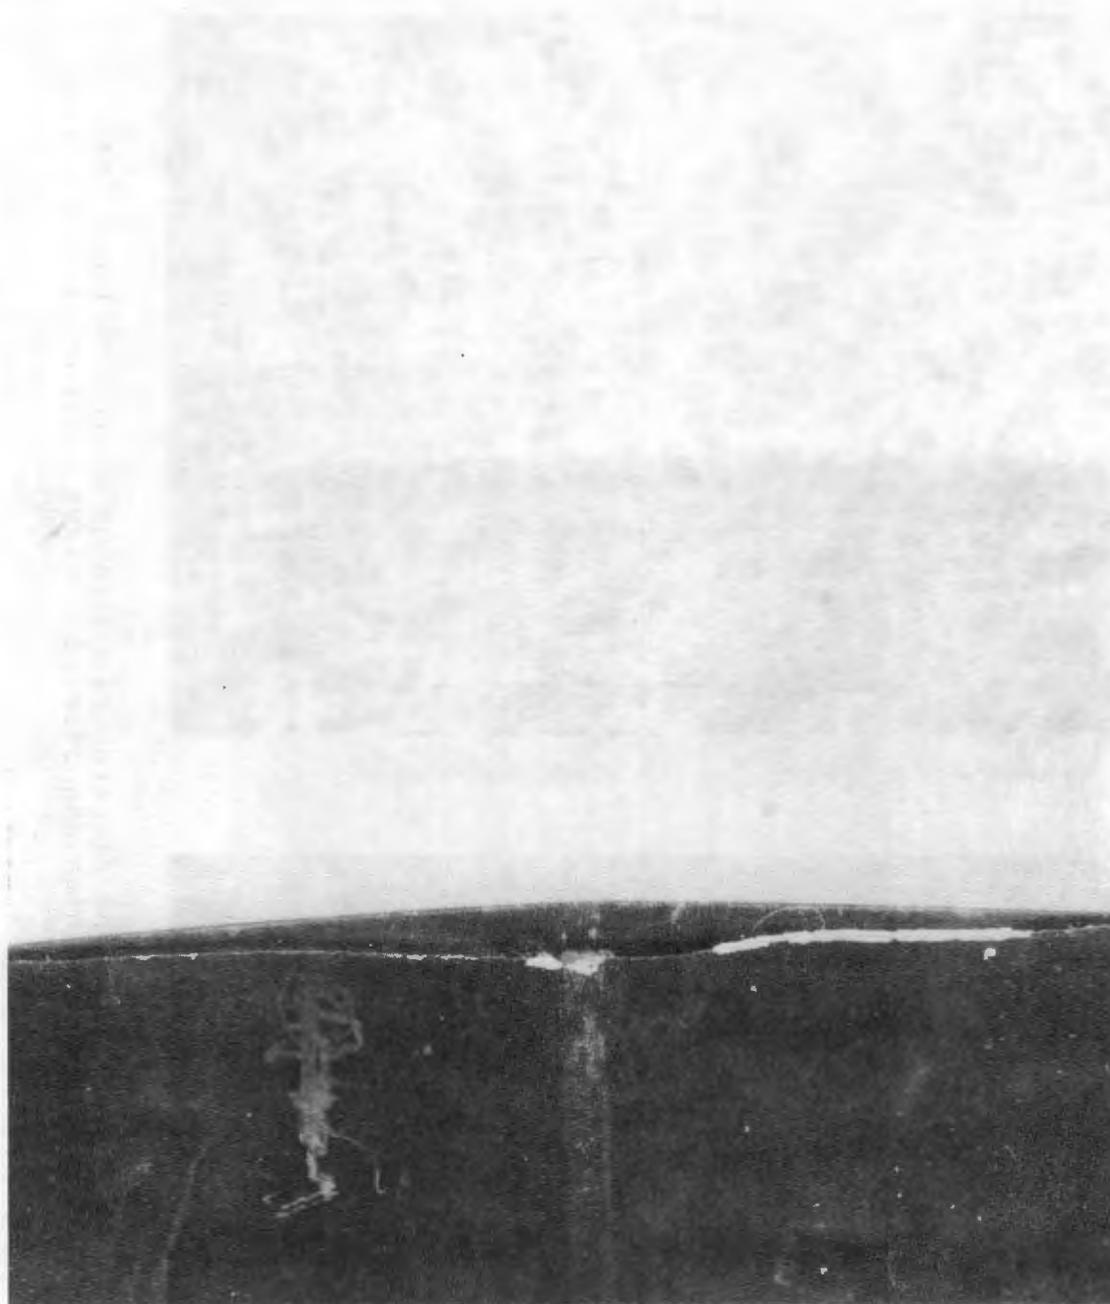
Figure 12. Detail of stiffener showing resistance stitch weld.

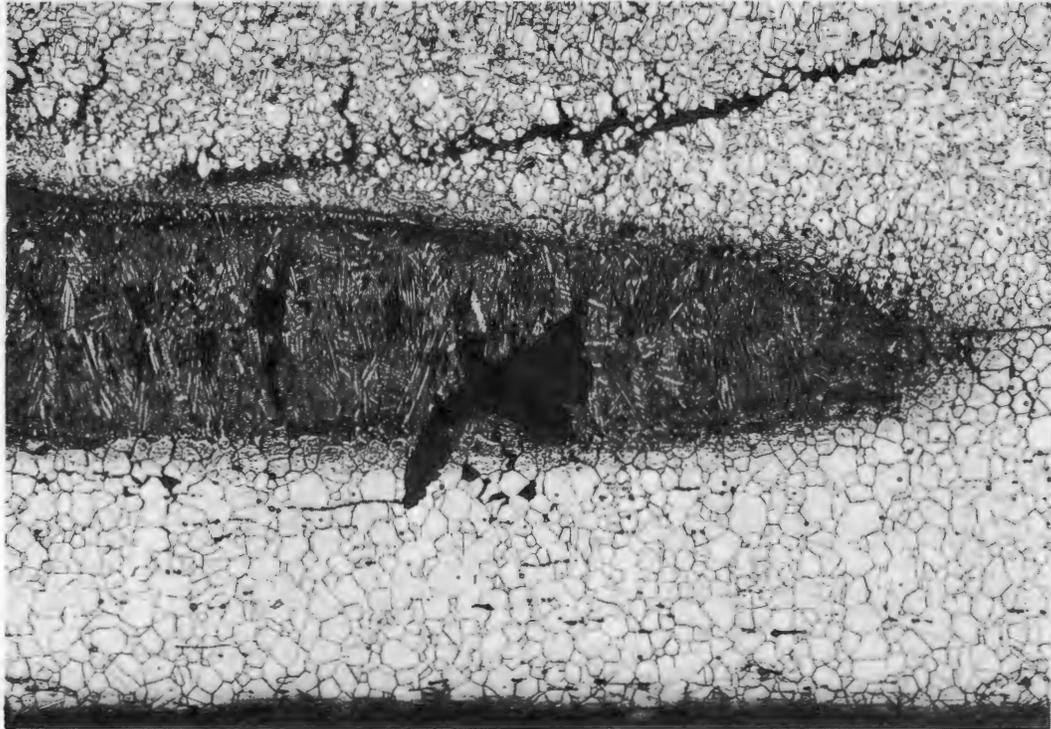
A cross-section was made through the junction of the longitudinal weld in the body and the circumferential stiffener weld at the stiffener adjacent to the large end of the cone (shown in Figure 10) where no failure had occurred. Figure 18 shows a photomicrograph of the weld nugget and the parent metal from both the stiffener and the body. In the more detailed view of Figure 19 one may note severe intergranular degradation of the weld which has isolated many of the metal grains. Figures 20 and 21 show intergranular attack of the parent metals.

Figure 18 230 X Electrolytic: 10% Oxalic Acid
Weld nugget and parent metal from the stiffener and the body.
Figures 19 and 20 show high magnification views taken near the
left extreme of the weld nugget.
