WADC TECHNICAL REPORT 53-192  
PART XIII

## **MECHANISM OF RAIN EROSION**

**Part XIII. Mechanism Studies on Neoprene Coatings**

*National Bureau of Standards*

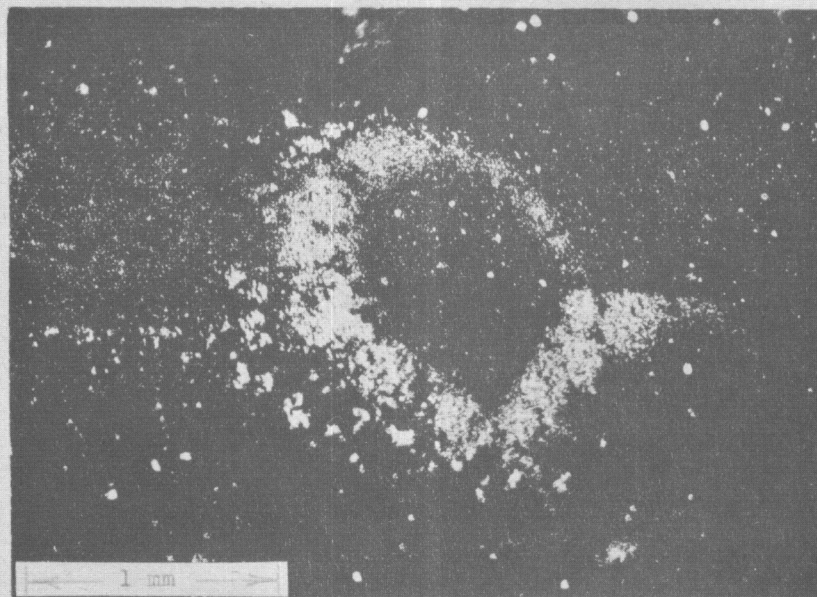
1

FIGURE 4 WATERDROP IMPINGEMENT ABRASION OF MMM EC-539 NEOPRENE

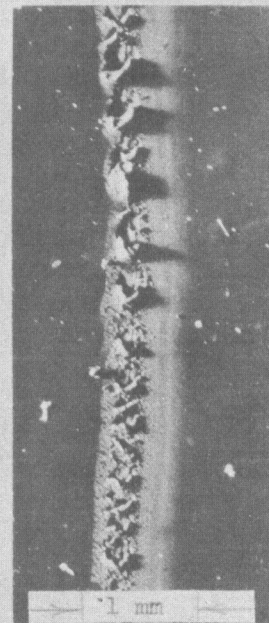
2

ABRASION BY TUNGSTEN-CARBIDE MARKING PENCIL MOVING DOWNWARD

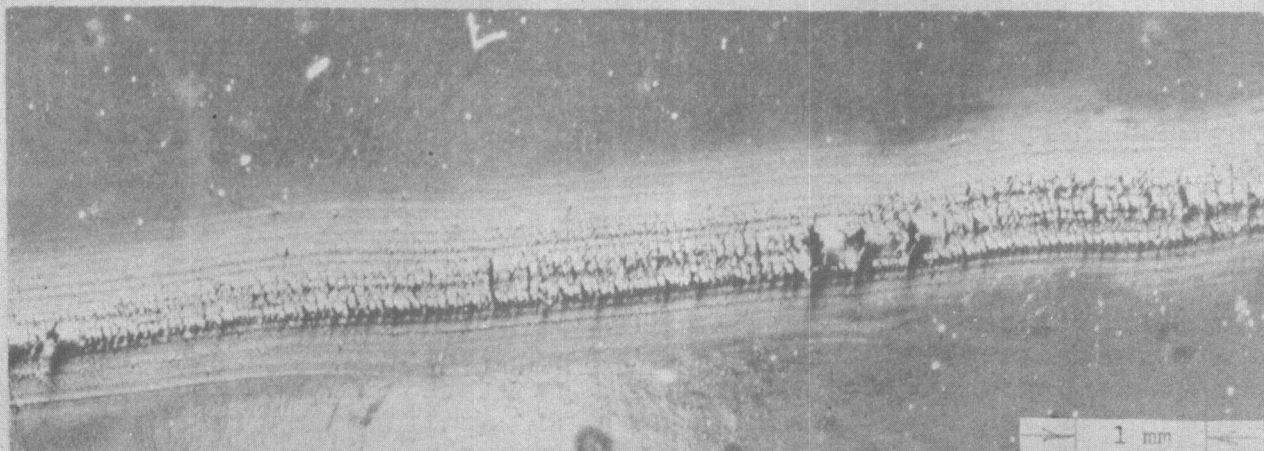
3

ABRASION BY RAZOR EDGE MOVING FROM LEFT TO RIGHT

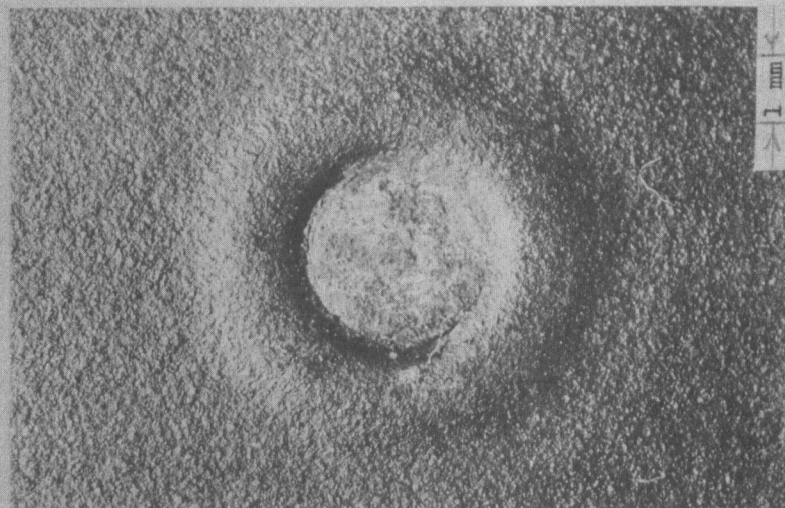
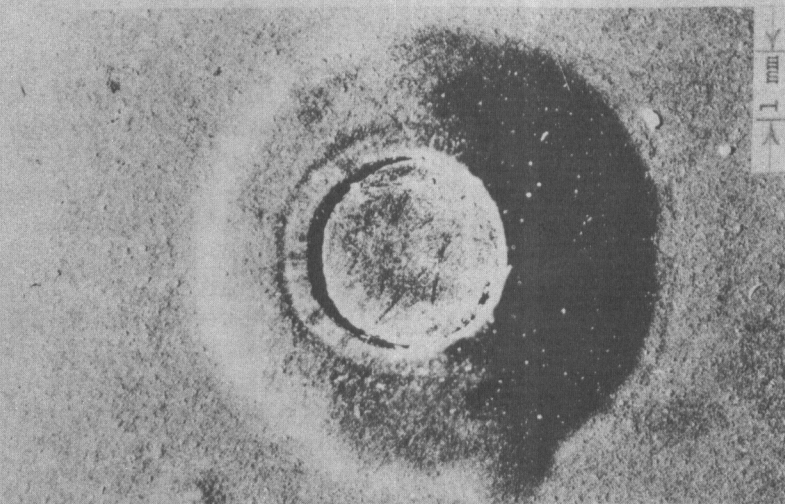
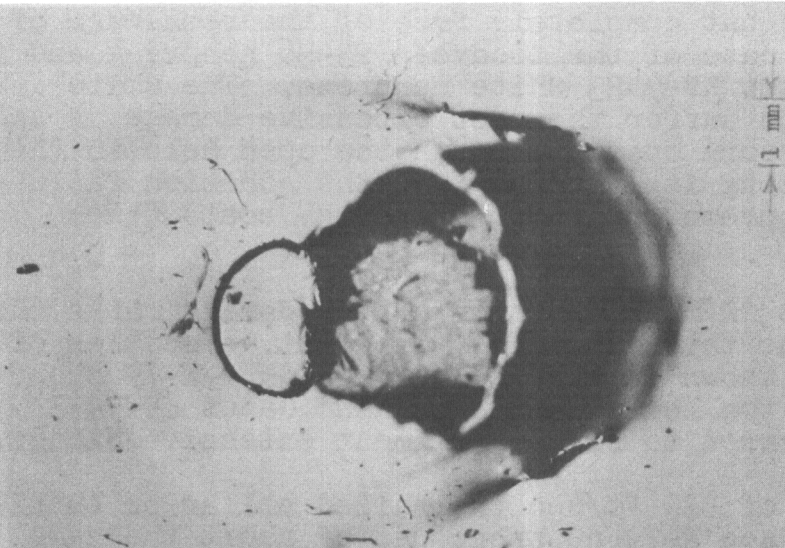
FIGURE 13 RESPONSE OF THREE NEOPRENE COATINGS TO IMPINGEMENT WITH  
AN OIL-FILLED GELATIN CAPSULE AT A VELOCITY OF 900 FT/SEC

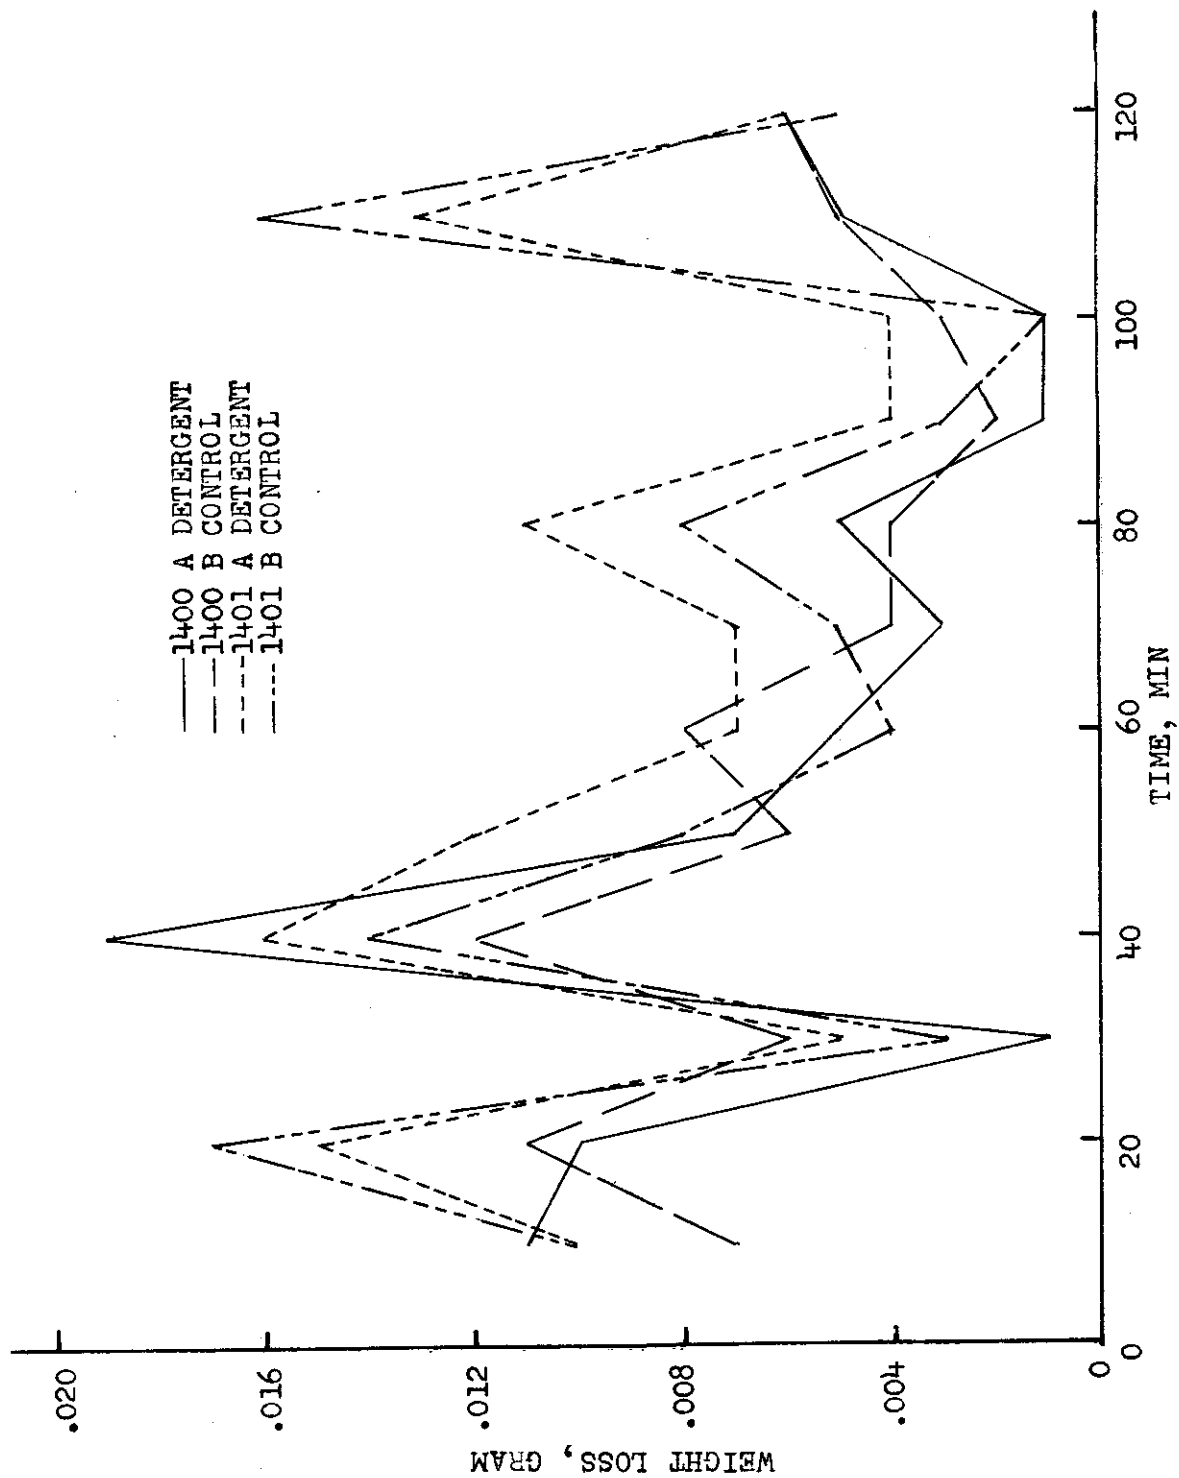
Inspection of the eroded specimens at X 20 magnification revealed that specimens 1400 A (treated with detergent) and 1400 B (control), which were tested for a total of 260 min, were in about the same state of erosion. There was a fairly distinct chevron pattern at the low-speed end of these specimens and small coating bubbles and torn-out spots at the high-speed end. Specimen 1401 A (treated with detergent) appeared to be slightly more eroded than specimen 1401 B (control). These specimens were tested for a total of 320 min. There was a strong chevron pattern at the low-speed end, a general beadiness in the central part of the leading edge, coating bubbles over most of the leading edge, and torn-out spots at the high-speed end of these specimens. All four specimens contained quite a few cracks or sutures that may be due to attack of the neoprene by ozone or by hydroxyl ion.

The microscopic inspection showed that there was little if any difference in the appearance of the specimens treated with the alkyl aryl sulfonate and the controls. From this it can be concluded either that the alkyl aryl sulfonate washed off too soon to be of any real benefit or that it was of little consequence to the erosion damage whether the surface of the coating was hydrophilic or hydrophobic.

FIGURE 23 WEIGHT-LOSS-VERSUS-TIME CURVE FOR FOUR NEOPRENE COATED SPECIMENS

TWO OF WHICH WERE TREATED WITH DETERGENT DURING TEST

The rain-erosion of neoprene coatings is a two-step process consisting of periods of preparation in which little loss of material occurs followed by periods of erosion or loss of material. This is clearly shown in the graphs of Figure 23 and 25. The gradual development of a network of ozone-type cracks with eventual breaking away of material between circumscribing cracks is such a two-step process.

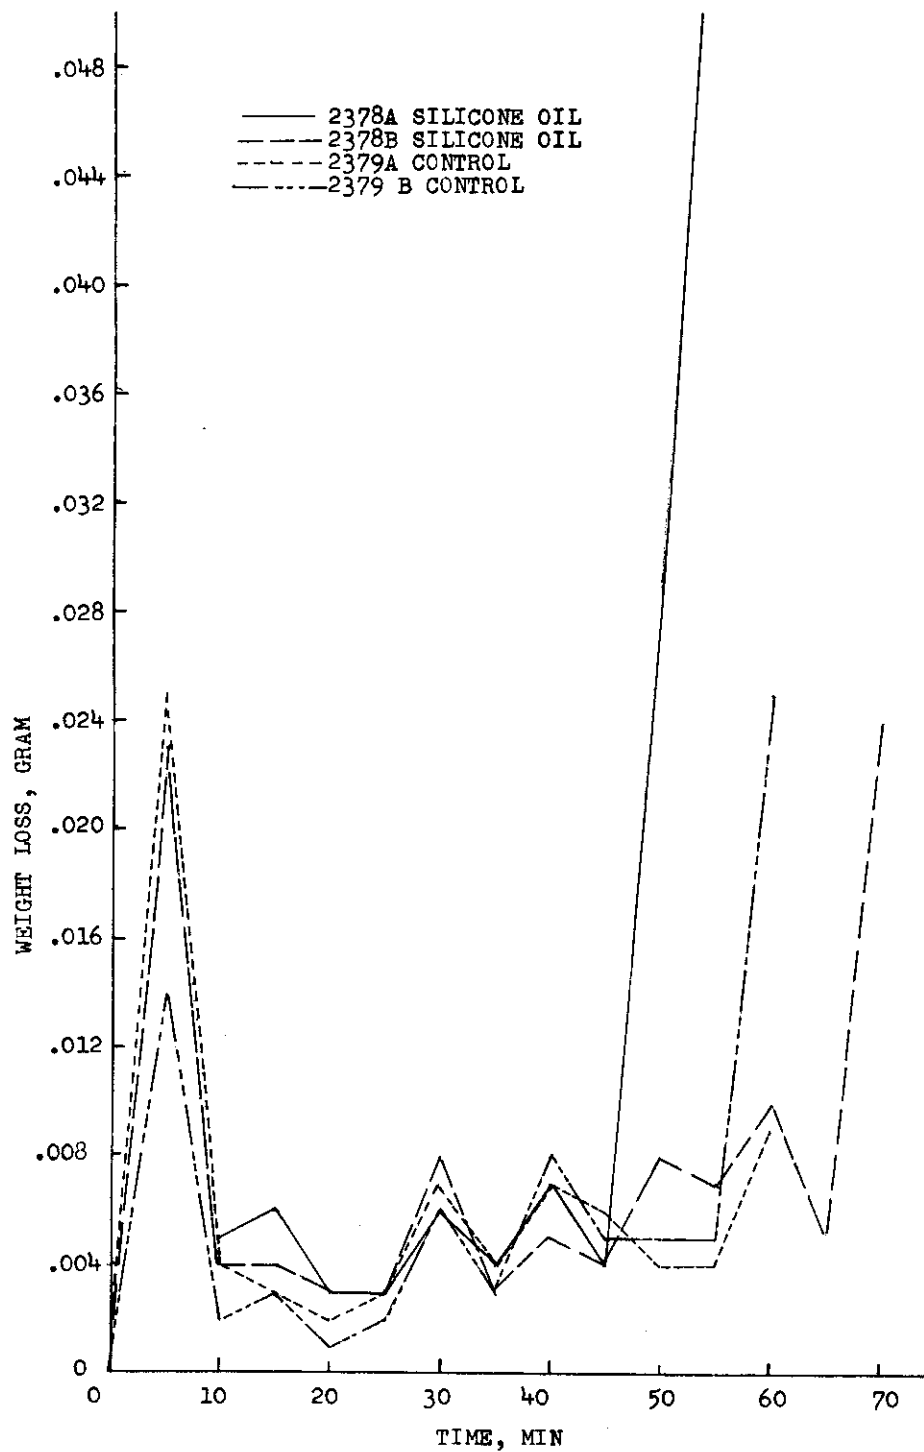
FIGURE 25 WEIGHT-LOSS VERSUS TIME CURVE FOR FOUR NEOPRENE COATED SPECIMENS TWO OF WHICH WERE COATED WITH SILICONE OIL DURING TEST

Microscopic examination of the specimens led to the conclusion that the type and degree of damage that was sustained by the oil-treated specimens and by the control specimens was about the same. In general, it consisted of a dim chevron pattern at the low-speed end of the specimen and of broken out spots at the low-speed end which increased in density toward the high-speed end until at the high-speed end there was a swath down the center of the specimen from which a complete layer of coating material had been removed. There was evidence of crack formation in the coating at both ends of the specimens.

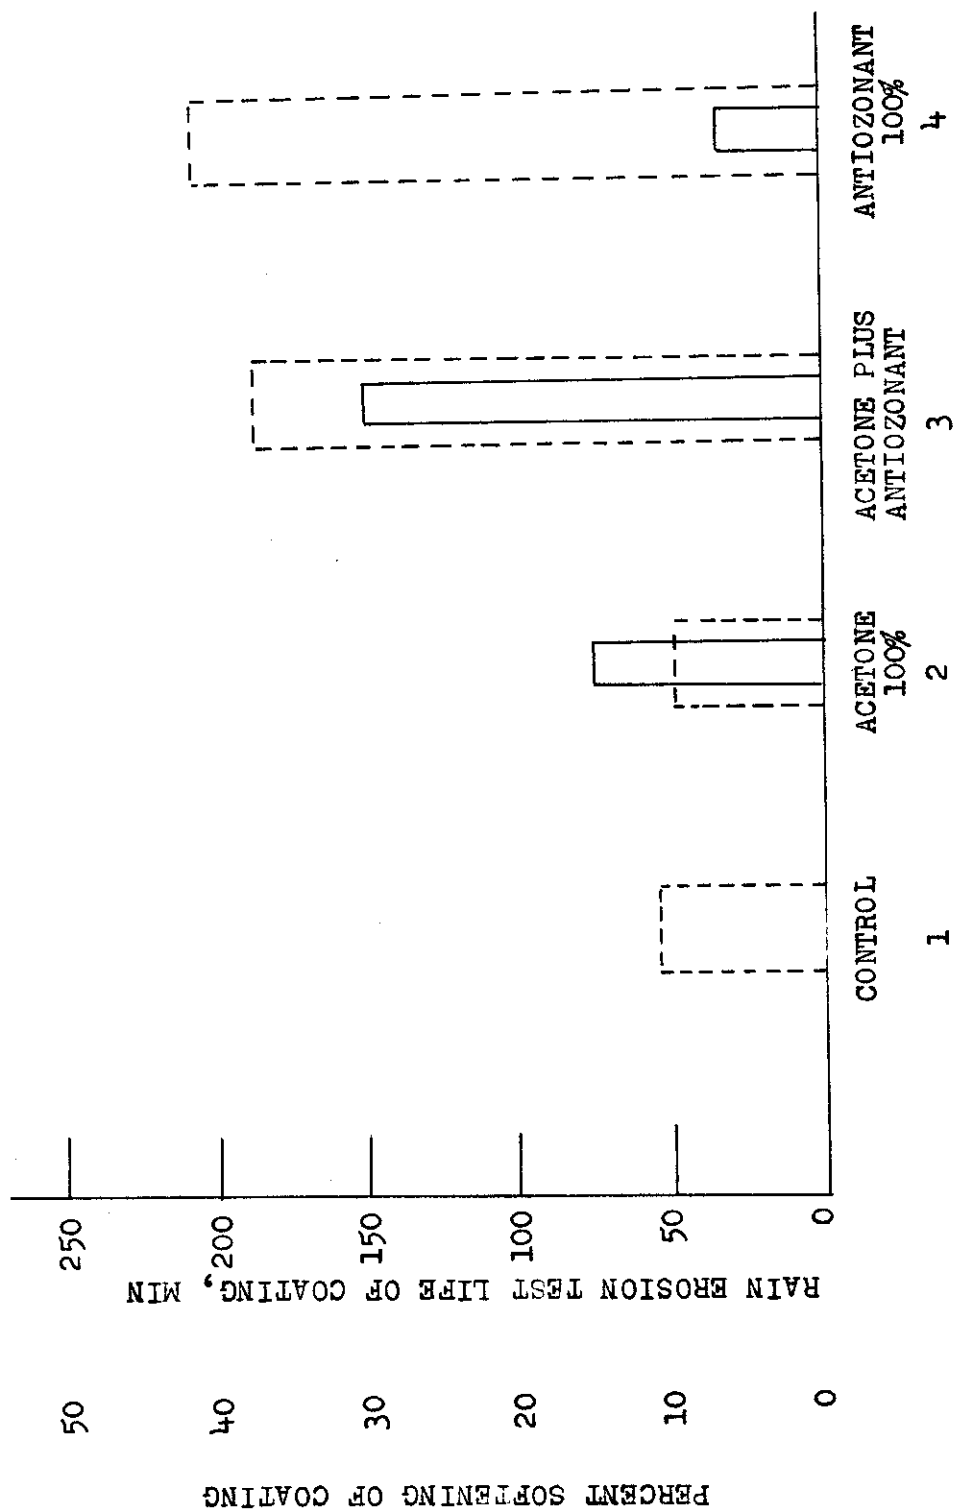
The Cornell Aeronautical Laboratory reported that the neoprene coatings were softened by the antiozonant alone, by acetone alone, and by the solution of antiozonant in acetone. For the three reagents that were used to treat the coatings, the greatest swelling and softening resulted from the use of antiozonant-acetone solution and the least swelling and softening resulted from the use of 100 per cent antiozonant. Their data are presented graphically in Figure 26.

Treatment of the neoprene with 100 percent acetone had no effect on its rain-erosion test life. The acetone evaporated very rapidly. Softness of the neoprene coating that resulted from the use of 100 per cent acetone vanished with the acetone. Therefore, whatever effect the softening of the neoprene had on its rain-erosion test life must be determined from the results obtained on treatment with the acetone-antiozonant solution and treatment with 100 per cent antiozonant. A comparison of bar graph 3 with bar graph 4 in Figure 26 indicates that a 30 per cent softening of the coating is associated with a 180-min test life when acetone plus antiozonant was used whereas a 7 per cent softening is associated with a 220-min test life when antiozonant only was used. From these data it cannot be concluded that test life was determined by the softness of the coating. Furthermore, Beal, Lapp, and Wahl [17] have concluded that "in the neoprene rubbers tested, those with the greatest resiliency, lowest permanent set, and high Durometer hardness, had the best resistance to rain erosion". Softness would therefore not appear to be the correct explanation. It has been suggested that the

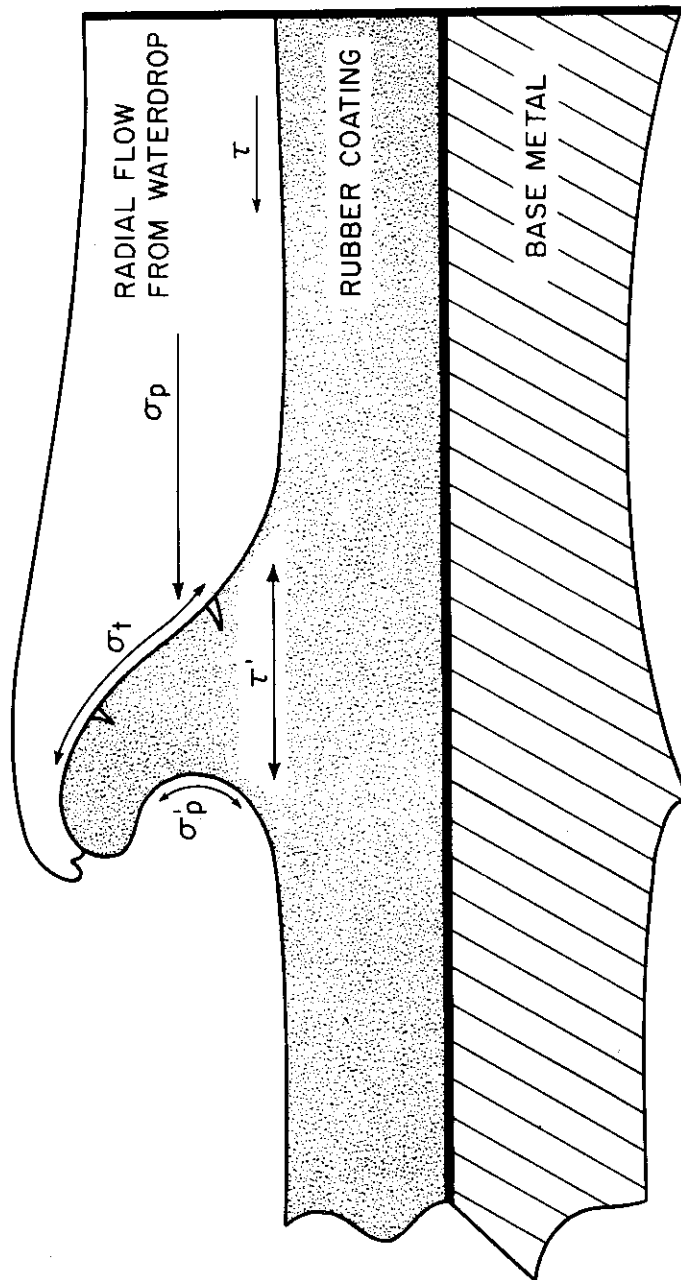
When the liquid from a drop that is flowing radially runs over a surface protrusion it exerts forces against the protrusion that are opposed by the restraint of the bonding of the protrusion to the underlying layers of material. Pressure,  $\sigma_p$  of Figure 27, is exerted against the protrusion by the flowing liquid. The pressure that is exerted by the liquid tends to move the protrusion along the planar surface of the solid and results in a shear stress,  $\tau$  of Figure 27, at the base of the protrusion. The flow of the liquid results in the shear stress  $\tau$  that was discussed above.

The pressure exerted by the liquid also results in a turning moment that tends to bend the protrusion over. The turning moment is the integrated cross product of the compressive force exerted by the liquid and the elevation of the protrusion above the planar surface of the solid at the point where the force is applied. As the protrusion bends, a tensile stress,  $\sigma_t$  of Figure 27, appears on the side of the protrusion against which the compressive force is applied and a compressive stress,  $\sigma_c$  of Figure 27, appears on the opposite side of the protrusion. If the force exerted by the rapidly running liquid is sufficiently great or if the protrusion has a sufficient elevation above the planar surface, failure may occur. Whether the protrusion is simply bent over, whether it is broken off, or whether part of the solid material below the surface is torn out with it depends on the strength of the material and on where failure occurs first. Likely points of failure are marked with notches in Figure 27.

FIGURE 27 STRESSES THAT RESULT WHEN A WATERDROP RUNS OVER A SURFACE PROTRUSION

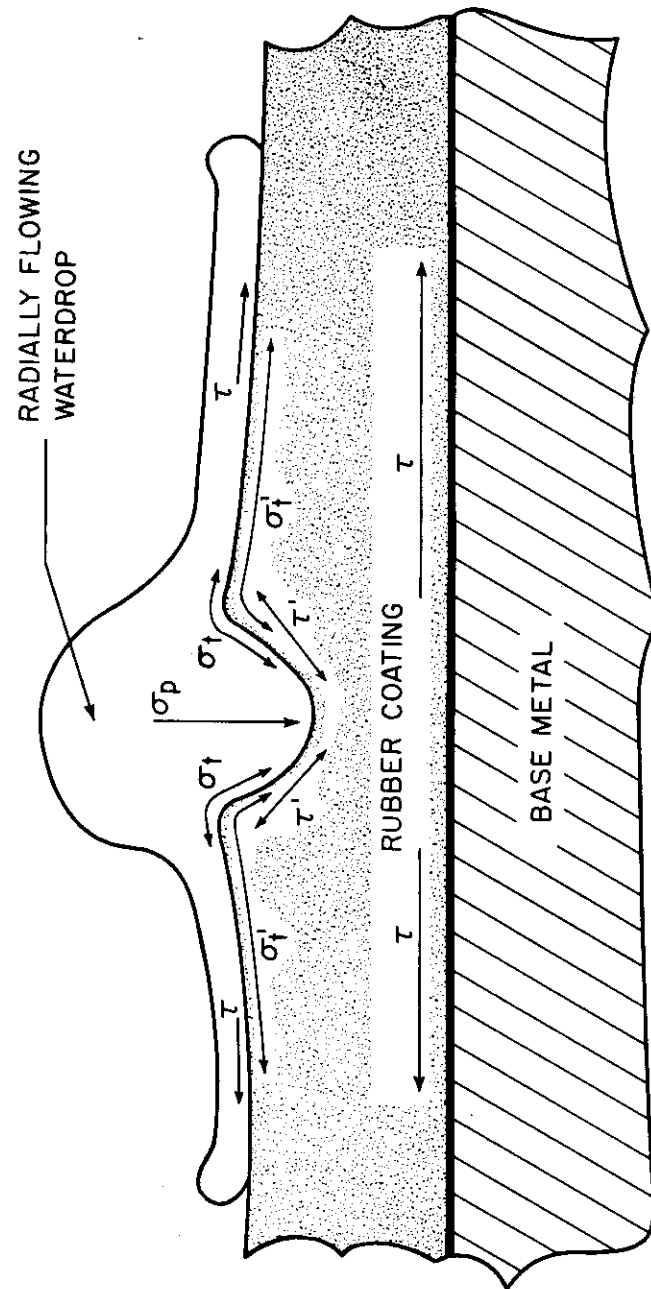
If a waterdrop impinges against a rubber-like material the effect of the compressive stress,  $\sigma_p$  of Figure 28, which is the direct result of the collision, is to compress the solid material at the point of impingement. The local compression results in a dimple or cup-shaped cavity. Tensile stresses,  $\sigma_t$  of Figure 28, appear in the sides of the dimple and especially in the knee in the solid material at the rim of the dimple. If these tensile stresses are sufficiently great tears may form in the surface layers of the solid material. The material that formerly occupied the volume that now forms the hollow of the dimple is displaced. It is moved radially outward and upward around the dimple and this results in a shear stress,  $\tau$  of Figure 28.

FIGURE 28 STRESSES THAT RESULT FROM THE COLLISION OF A WATERDROP WITH  
A RUBBER-COATED SURFACE

The radial flow of the liquid of the drop imposes a radial tensile stress,  $\sigma_r$ , of Figure 28, and a shear stress  $\tau$ , which was discussed above. In the case of very thin rubbery coatings it is possible that the shear stress  $\tau$  may be transmitted through the coating to the primer bonds, which hold the coating to the base metal, and that it may cause failure of the primer-to-rubber or of the primer-to-metal bond. See pictures 2(c) and 3(c) of Figure 10 and the discussion relating to these pictures.
