This report was prepared by the University of Dayton Research Institute on Air Force Contract No. AF 33(616)-7838. This contract was initiated under Project No. 7381, "Materials Application," and Task No. 738103, "Materials Information Development, Collection, and Processing." The work was administered under the direction of the Air Force Materials Laboratory, Wright-Patterson Air Force Base, Ohio, with Lawrence N. Hjelm as the project engineer.

ABSTRACT

A metallographic analysis of coating failures in the XLR-99 thrust chamber of the X-15 research aircraft and the subsequent development of a thermal shock test with the plasma-jet for sprayed ceramic coatings are discussed. The results of an extensive evaluation of protective coatings and the field test verification of these results are presented.

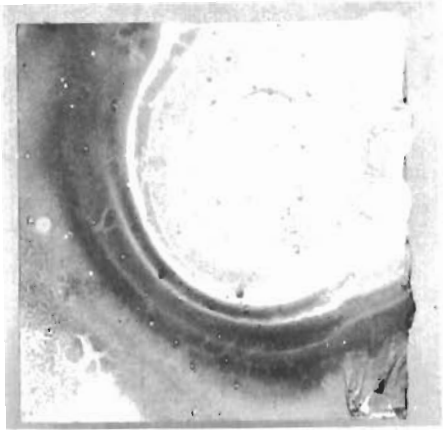
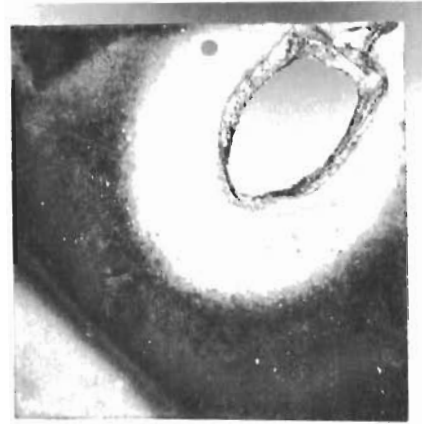
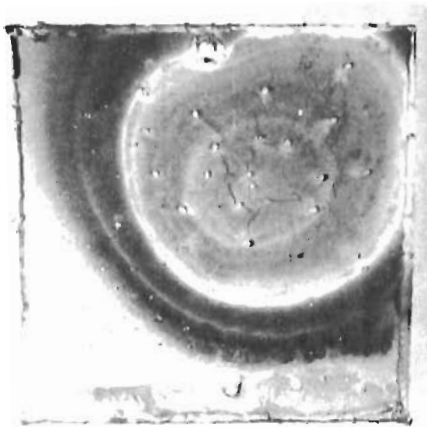
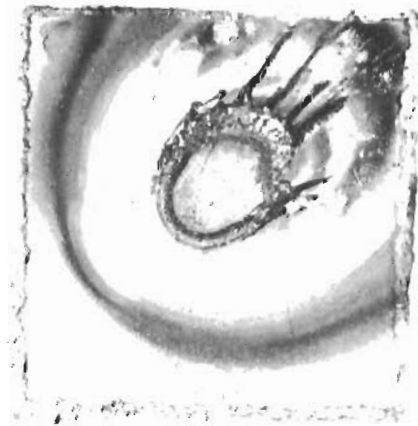
Continuous exposure tests of the Ta-10% W alloy indicated the coating would provide substrate protection at temperatures to 3340°F for 5 minutes, despite considerable warpage of the specimen. Similar coatings provided comparable protection for molybdenum and tungsten, although a columbium specimen failed at 2820°F after very short-term exposure. Photographs of typical specimens after continuous exposure are shown in Figure 110.

Figure 110. Photographs of Typical Manufacturer SY Specimens after Continuous Exposure Test in Arc-Plasma-Jet Effluent.

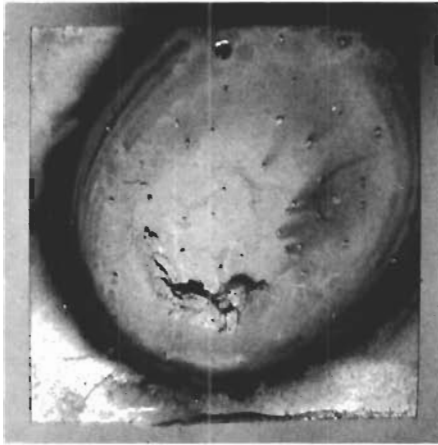
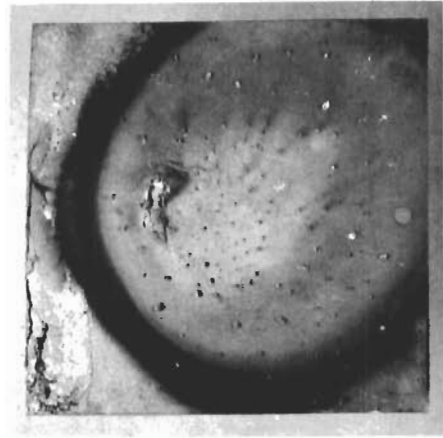
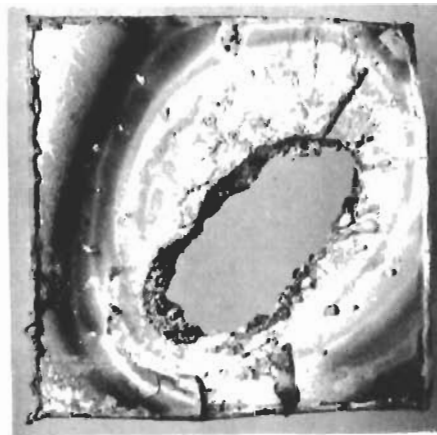
Figure III. Photographs of Typical Manufacturer SY Specimens after Thermal Cycling Test in an Arc-Plasma-Jet Effluent.

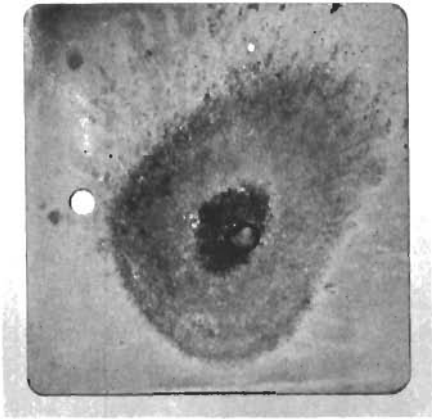
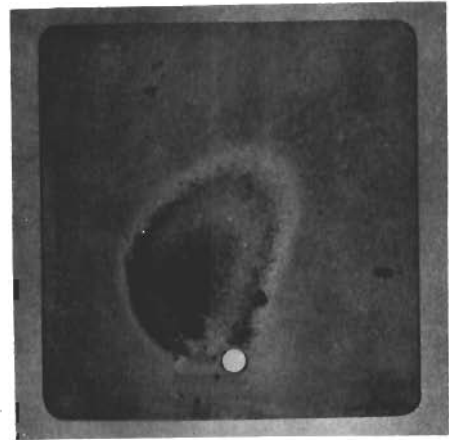
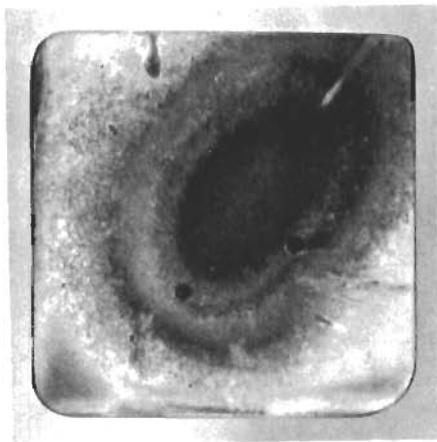
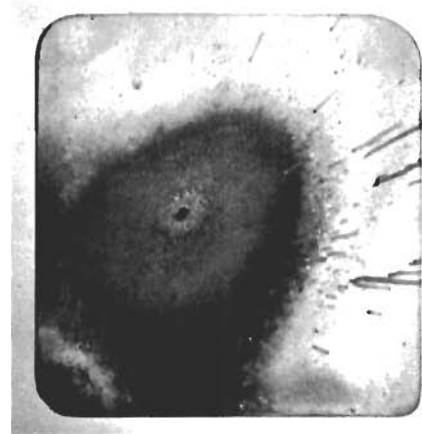
In both tests specimen temperatures were measured at the back of the sample with a two color pyrometer and periodically checked with an optical pyrometer. Samples were exposed at an angle of 45° to the arc effluent in a cast alumina holder and were positioned such that the edges, particularly those in contact with the holder, remained relatively cool during test. The results of these tests are compared with the results of oxyacetylene test by the Air Force in Table 41. Photographs of these samples after tests are shown in Figures 112 through 117.

Figure 112. Photographs of Coated Mo-1/2 Ti Samples after 3000°F Arc-Plasma-Jet Test.
