AIRCRAFT GROUND-FLOTATION INVESTIGATION
PART III. DATA REPORT ON TEST SECTION 2

W. BRABSTON, A. RUTLEDGE, and W. HILL

PART III DATA REPORT ON TEST SECTION 2

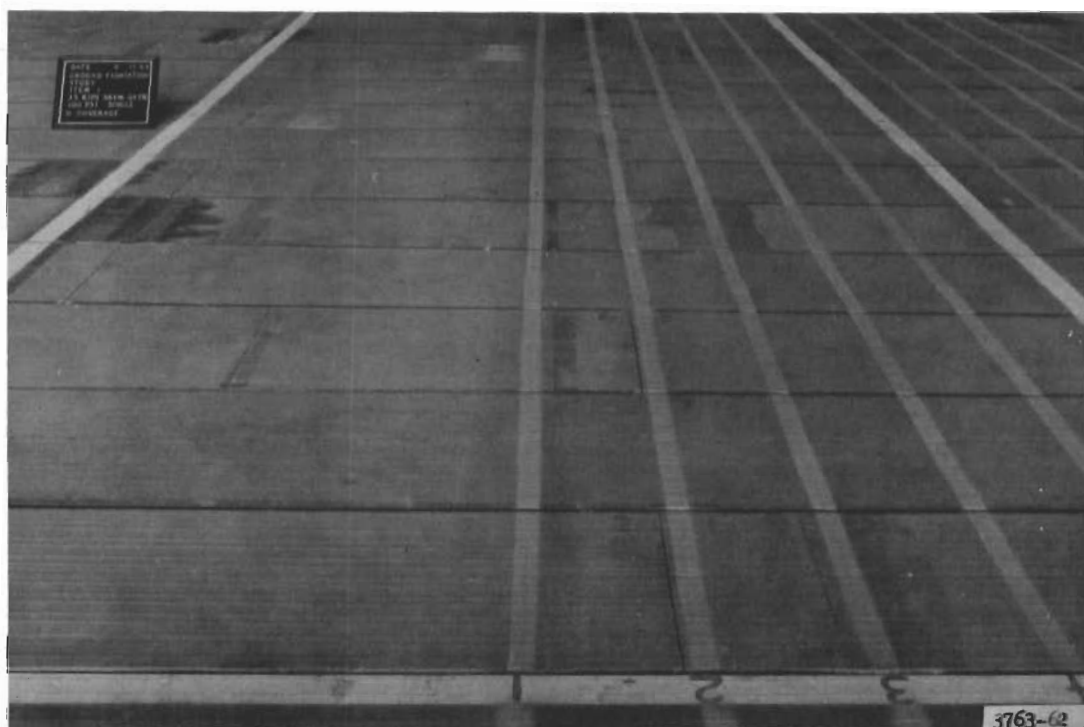
Item 1. A general view of item 1 prior to traffic is shown in **Figure 3**. Prior to 200 coverages, displacement of subgrade at the transition between item 1 and the previously failed item 2 (see profile in **Figure 29**) became evident. At 458 coverages, it became necessary to remove mat runs 15 through 19 (**Fig 27**) and level the subgrade prior to mat replacement. **Figures 5 and 6** show the hump which had developed at the transition. After replacement, the five affected mat runs were no longer considered in performance evaluation, as transition zones are not considered representative of item condition. Item 1 was judged failed at 600 coverages due to excessive roughness (**Figures 7 and 8**). The rated CBR was 2.6.

Figure 3. Lane 3, item 1, prior to traffic

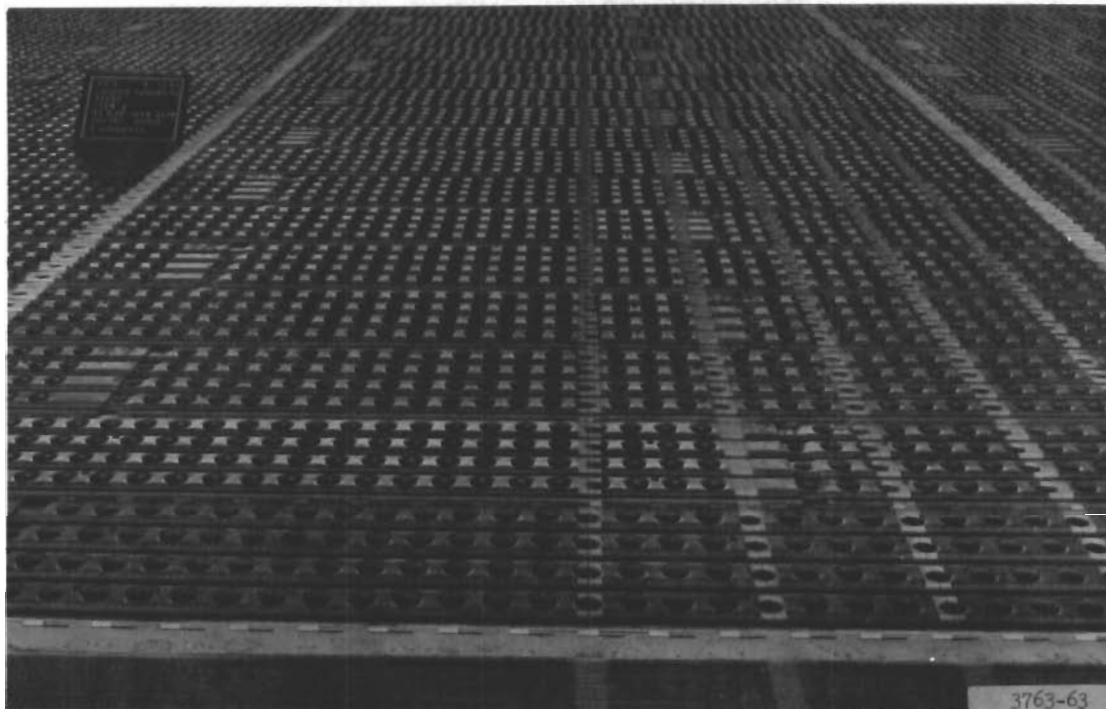
Item 2. Item 2 is shown prior to traffic in **Figure 8**. By 20 coverages, bending of the mat panels along their long axis resulted in a "standoff" of the mat from the subgrade at the end joints of the mat panels. Embedment of the mat at midpoint of the panels remained good. The ductility of the M8 mat allowed a wide variation in the degree of embedment of the ends of the mat panels. Immediately following a pass by the load wheel directly over the mat end joints, reasonable embedment was attained. However, the ends of the panels became unembedded after a pass off the line of joints. At 120 coverages, the item was considered failed due to roughness (**Figures 9 and 10**). Traffic was continued beyond 200 coverages to observe postfailure behavior of the mat (**Figure 11**). The rated CBR for item 2 was 5.1.

Figure 8. Lane 3, item 2, prior to traffic

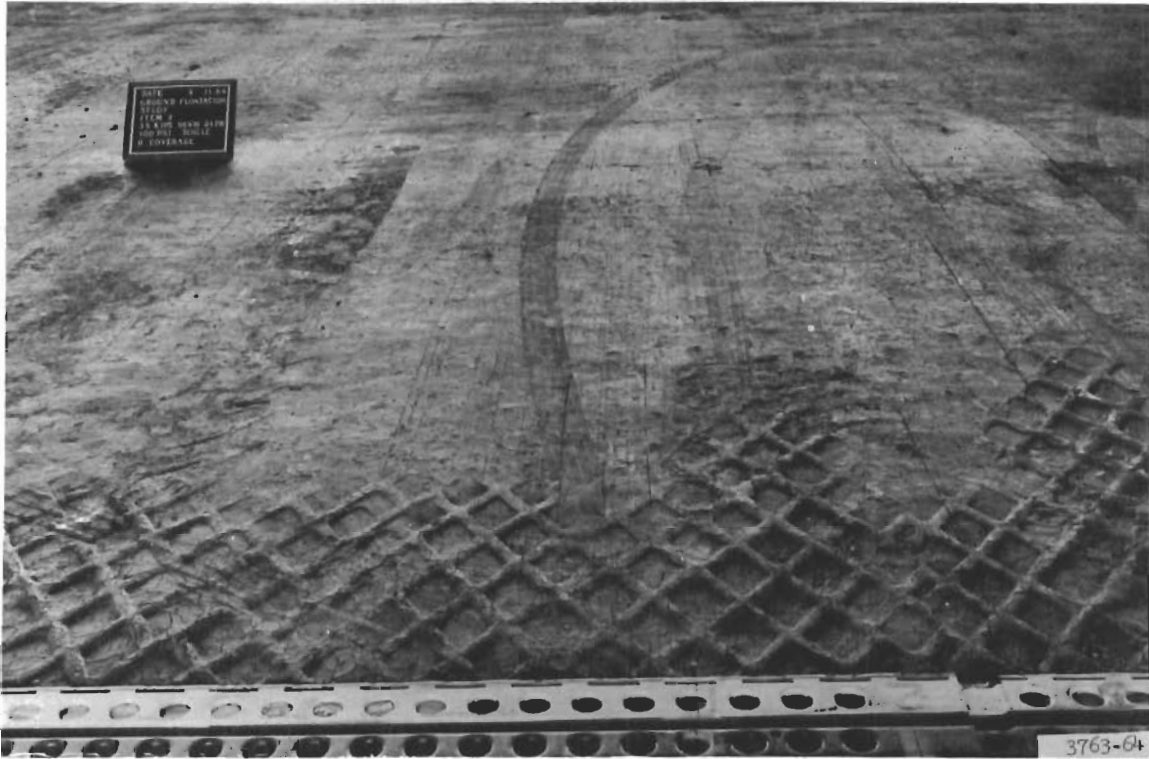
Item 3. Item 3 is shown in **Figure 12** prior to trafficking. Ruts had begun to develop by 20 coverages (**Figure 13**), and at 60 coverages the ruts were severe enough to constitute failure of the item (**Figure 14**).

Figure 12. Lane 3, item 3, prior to traffic

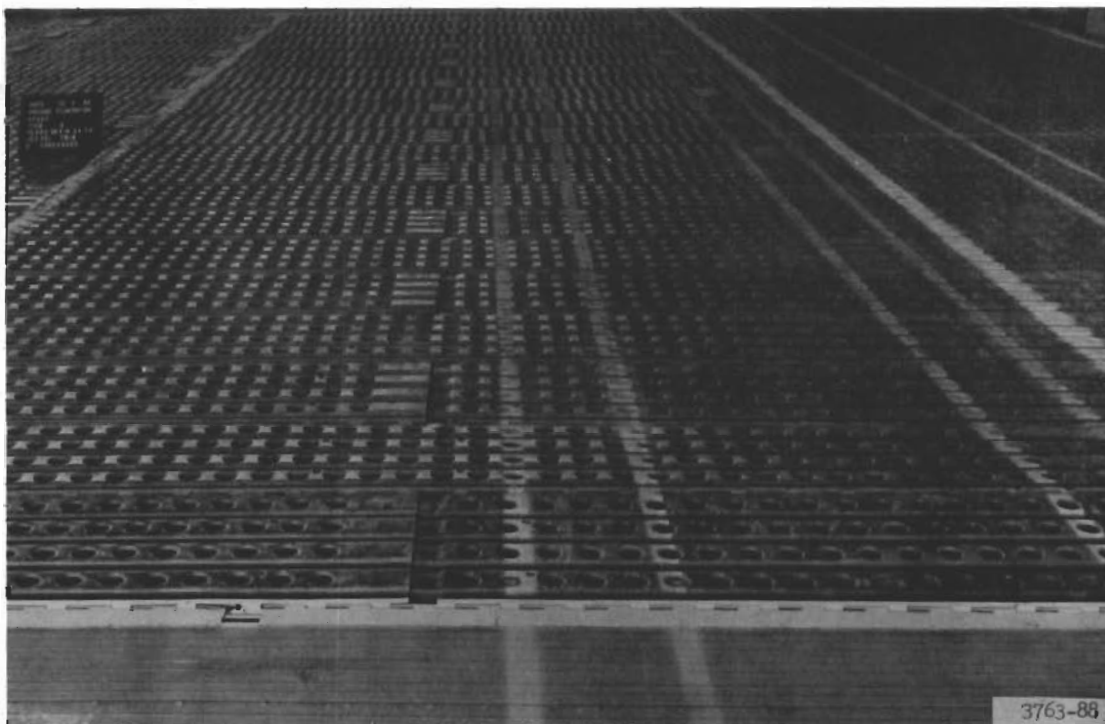
Item 2. Item 2 prior to traffic is shown in **Figure 19**. Preliminary passes of the load cart over the item to record drawbar pull data caused considerable extrusion of subgrade soil through the tubular holes of the M8 mat, as shown in **Figure 20**. At 20 coverages the item was

Figure 19. Lane 4, item 2, prior to traffic

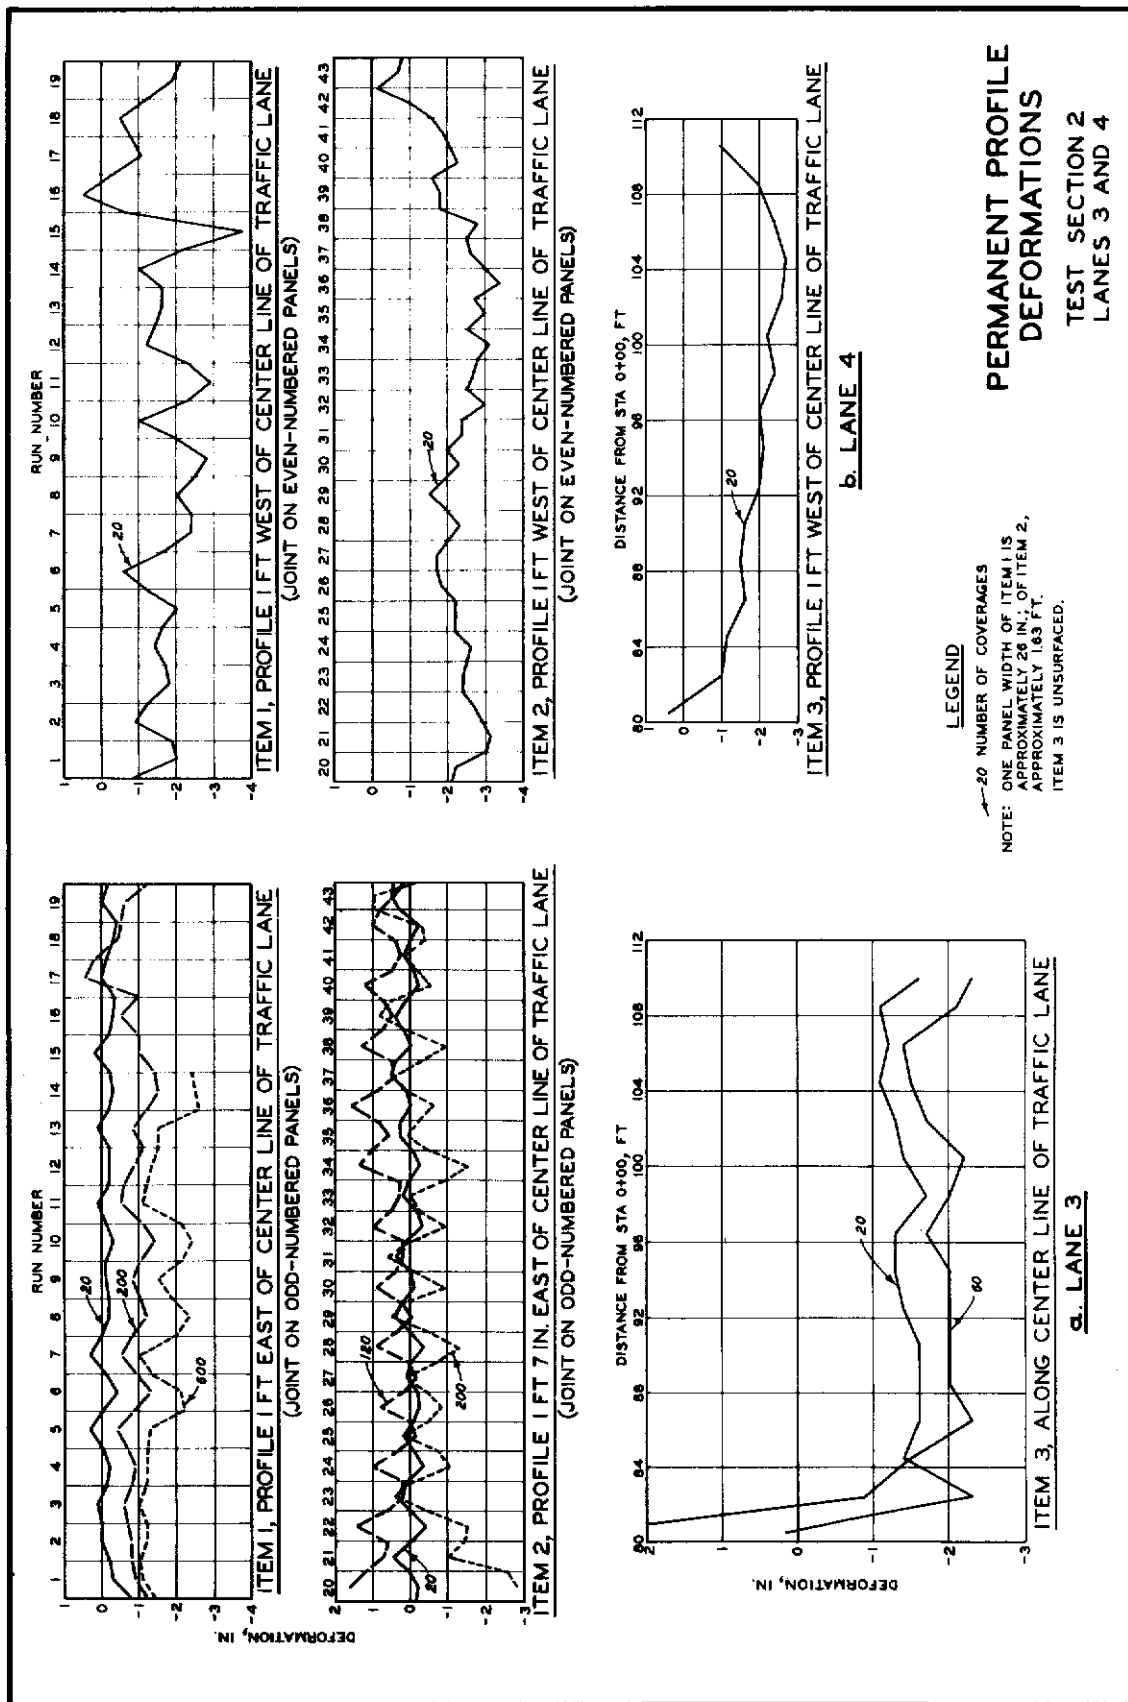
Figure 29

- b. Deformation. Average profile and cross-section deformation plots are shown in **Figs 29 and 30**, respectively, for three different coverage levels. The inconsistency observed in the profile plots for item 2, lane 3, where the 120-coverage points are higher than the 0-coverage points is thought to be due to the standoff effect (mentioned on page 5) caused by the last pass of the load wheel being made off the joint line. Cross-section plots in **Fig 30** show the progressive increase in deformations with traffic coverages and illustrate the upheaval that was prevalent at panel joints.

b. Deformation. Average profile and cross-section deformations are shown in **Figures 29 & 30**, respectively. Maximum deformation occurred along a line near the end joints on the west side of the lane.

b. Deformation. Average cross-section deformations are plotted in **Fig 30** for the 20-coverage level. Significant changes in the cross section occurred with each pass of the load vehicle due to severe rutting beneath the load wheels. The profile plot in **Fig 29** indicates a general subsidence along the longitudinal direction of the traffic lane.

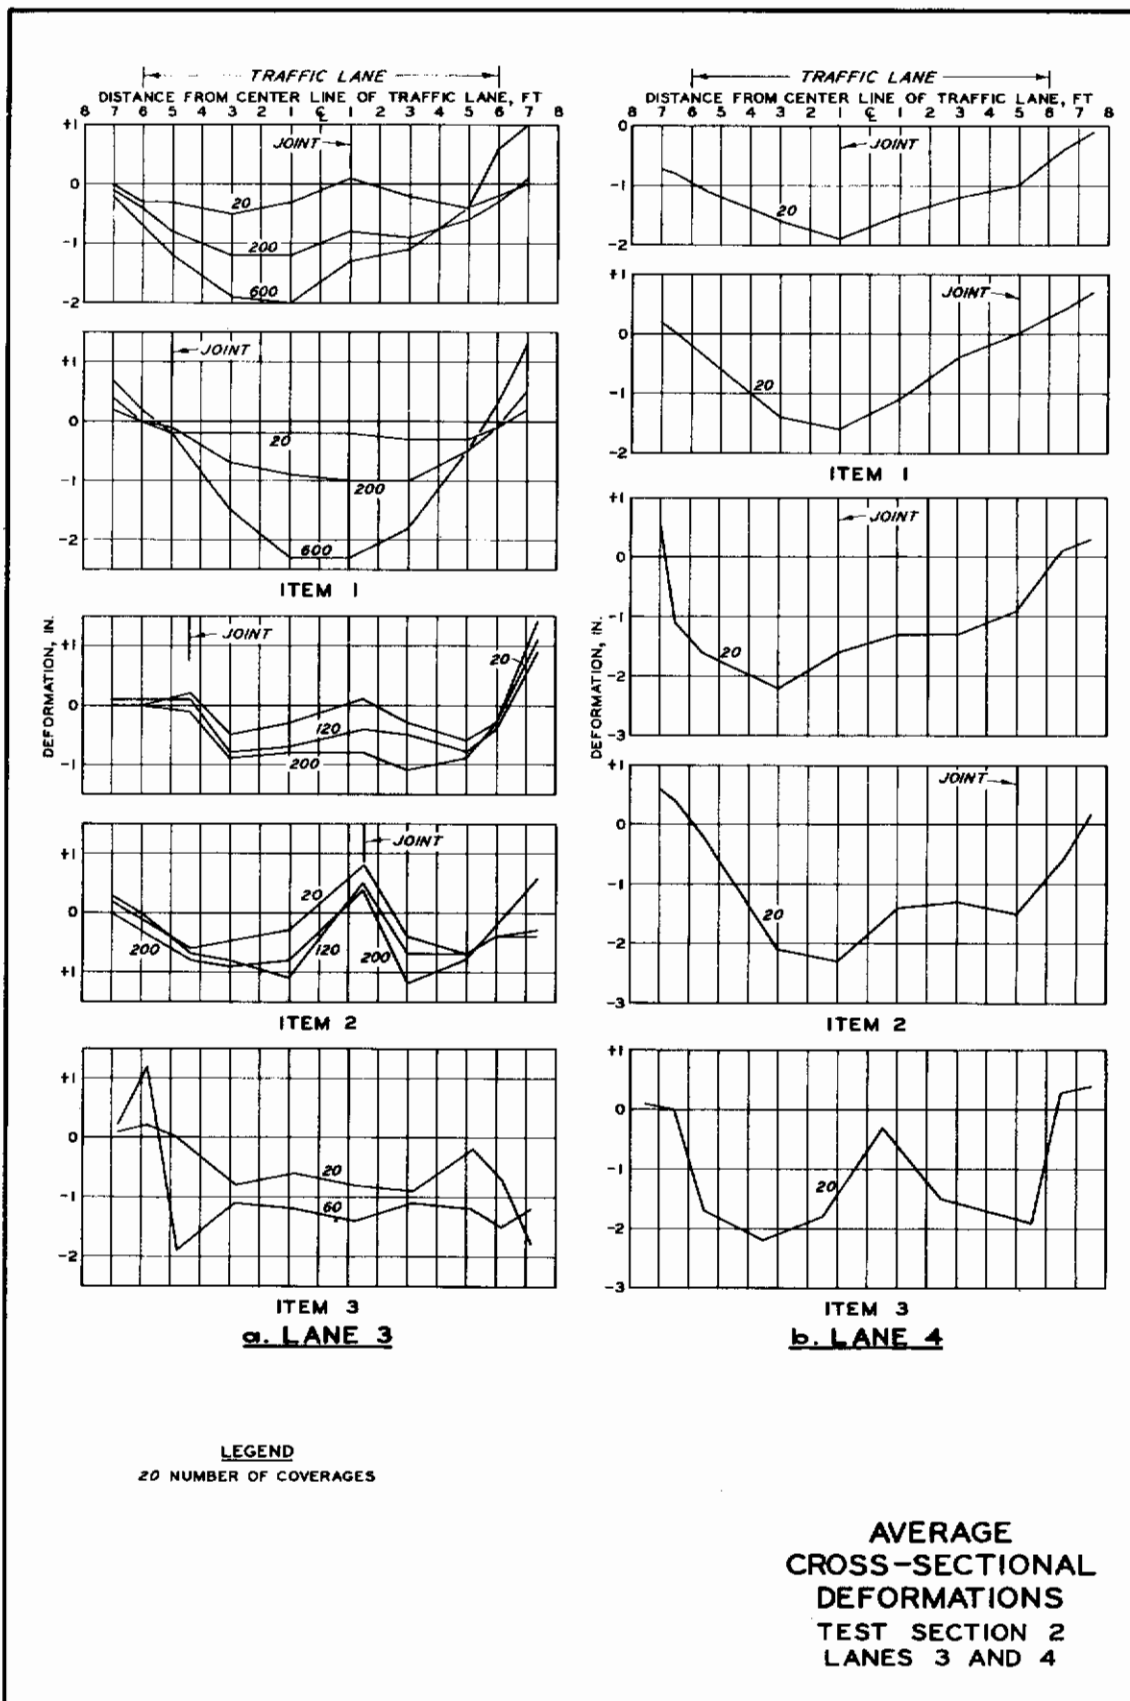
Figure 30

- b. Deformation. Average profile and cross-section deformation plots are shown in plates 4 and 5, respectively, for several coverage levels. General subsidence of the traffic lane is evident in each of the plots. A maximum average cross-section deformation of 2.3 in. was measured at failure (**Fig 30**).

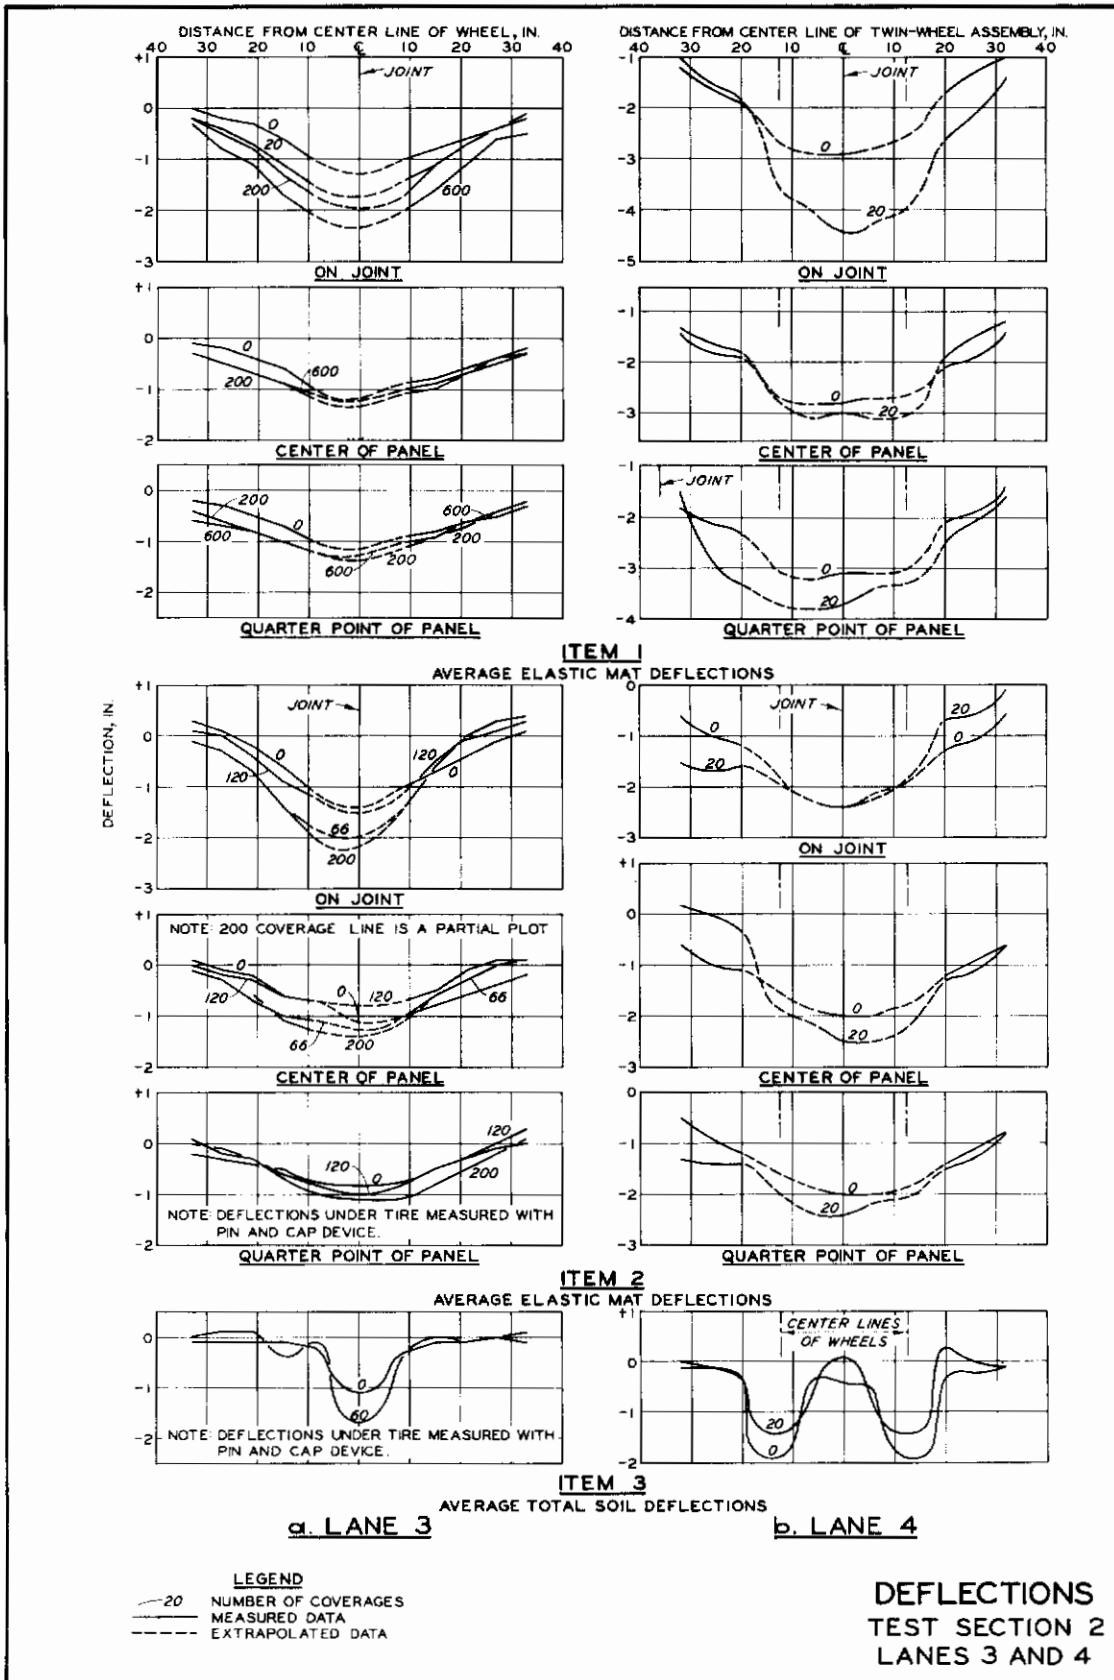
Figure 31

- c. Deflection. **Fig 31** illustrates the mat deflection under static load of the wheel assembly at various coverage levels with center line of the assembly located at different points relative to panel joints. The largest deflection (2.3 in.) was recorded with the load wheel resting on a panel end joint at 600 coverages. At the same coverage level, the pin and cap device showed the elastic subgrade deflection to be 1.5 in. directly beneath the load wheel at the midpoint of a panel.

- c. Deflection. **Fig 31** illustrates mat deflections under static load of the load wheel at various coverage levels with the center line of the assembly located at different points relative to panel joints. Elastic subgrade deflections (table 1) remained between 0.5 and 0.6 in. throughout trafficking. Subgrade deflection

c. Deflection. Elastic mat deflections under static load of the test cart are represented in **Fig 31**. Mat deflections are plotted for three positions of the wheel assembly relative to panel end joints. Maximum mat deflection occurred at the center line of the wheel assembly. Tabulated values of mat deflection and subgrade deflection are given in table 1. The elastic subgrade deflection was 0.8 in. prior to traffic and at failure.

c. Deflection. Soil deflections under static load of the load wheels are represented in **Fig 31**. Elastic deflections (table 1) were greater at 0 coverages than at the 20-coverage level.
