WADC TECHNICAL REPORT 54-451

**EVALUATION OF SURFACE TREATMENTS  
FOR LOW-ALLOY STEELS**

**Part 1. Test Method for Heat-Resistant  
Corrosion Protective Coatings on Steel**

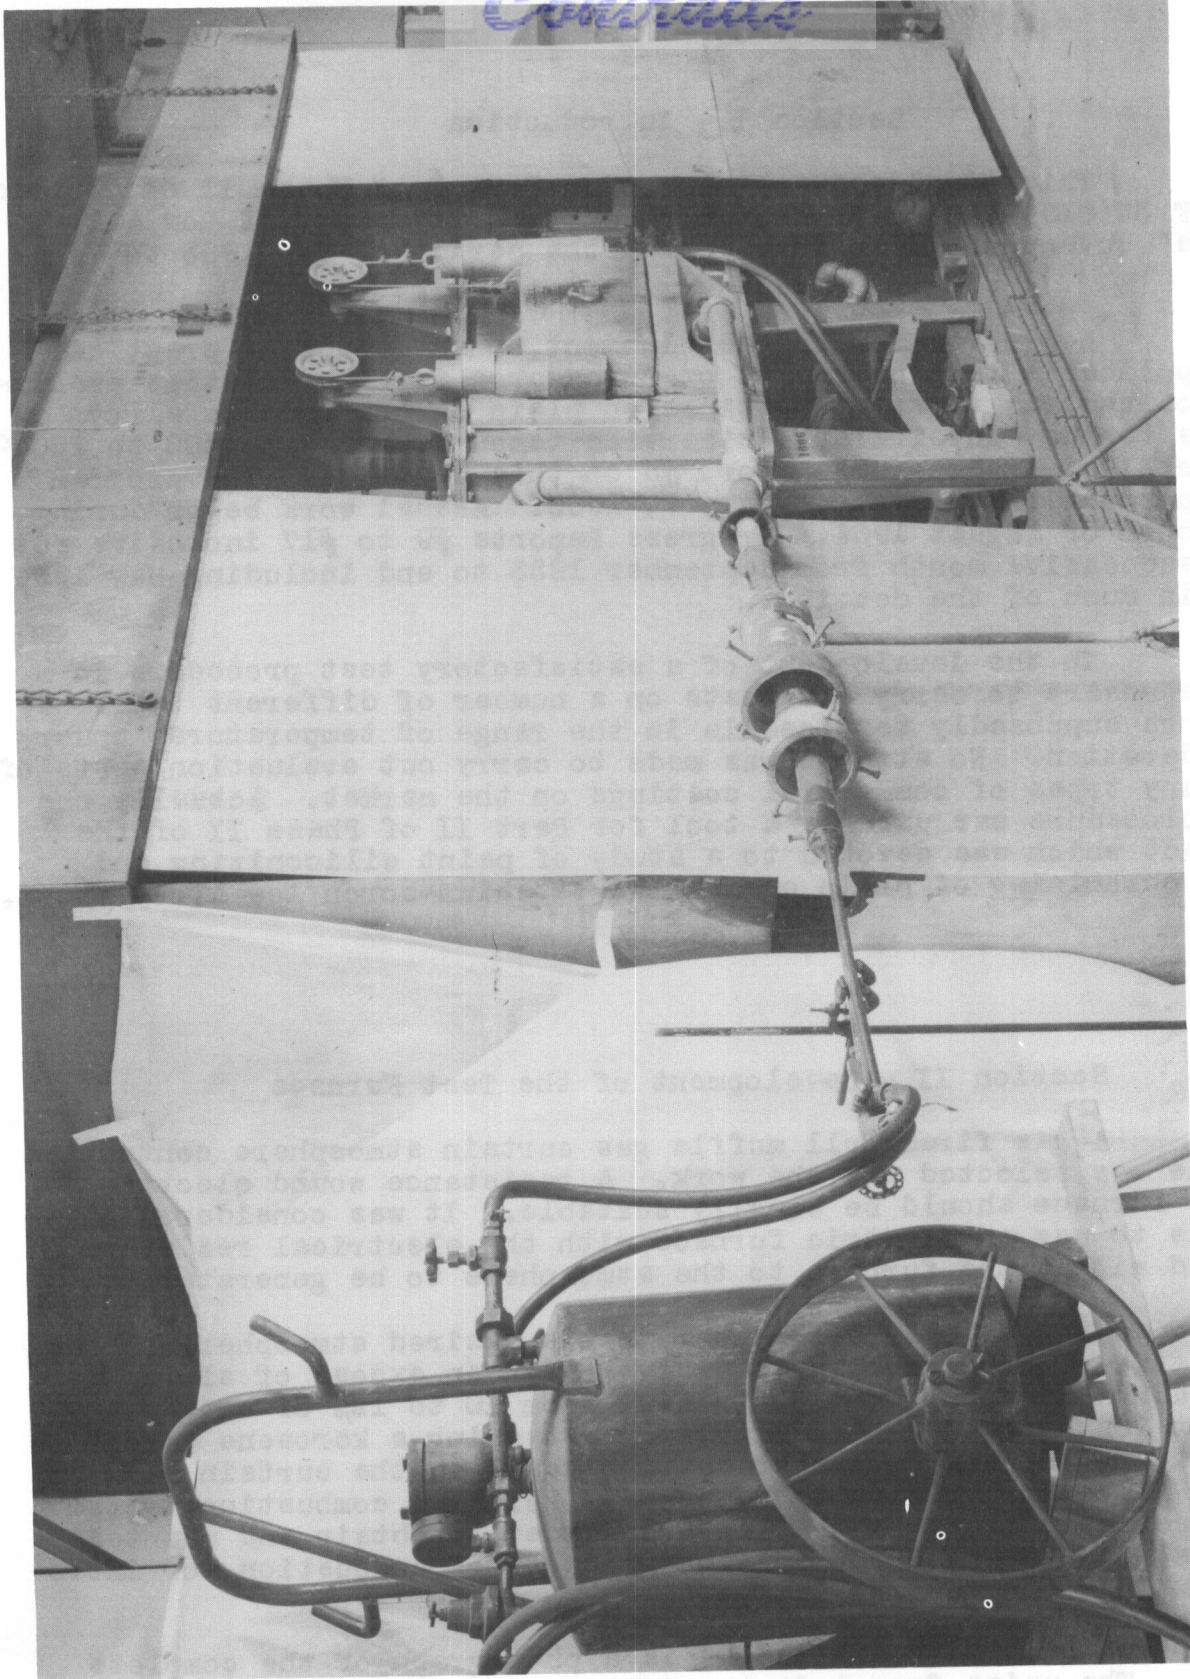
FIG. 1 (PLATE 15862)  
TEST FURNACE SYSTEM

Figure 1 (Plate 15862) is a photograph of the complete system. The units from left to right are the kerosene pressure vessel, the regulating valves, the torch, three Venturi couplings, a bleed off pipe, the combusted gas supply pipe and the gas fired full muffle furnace.

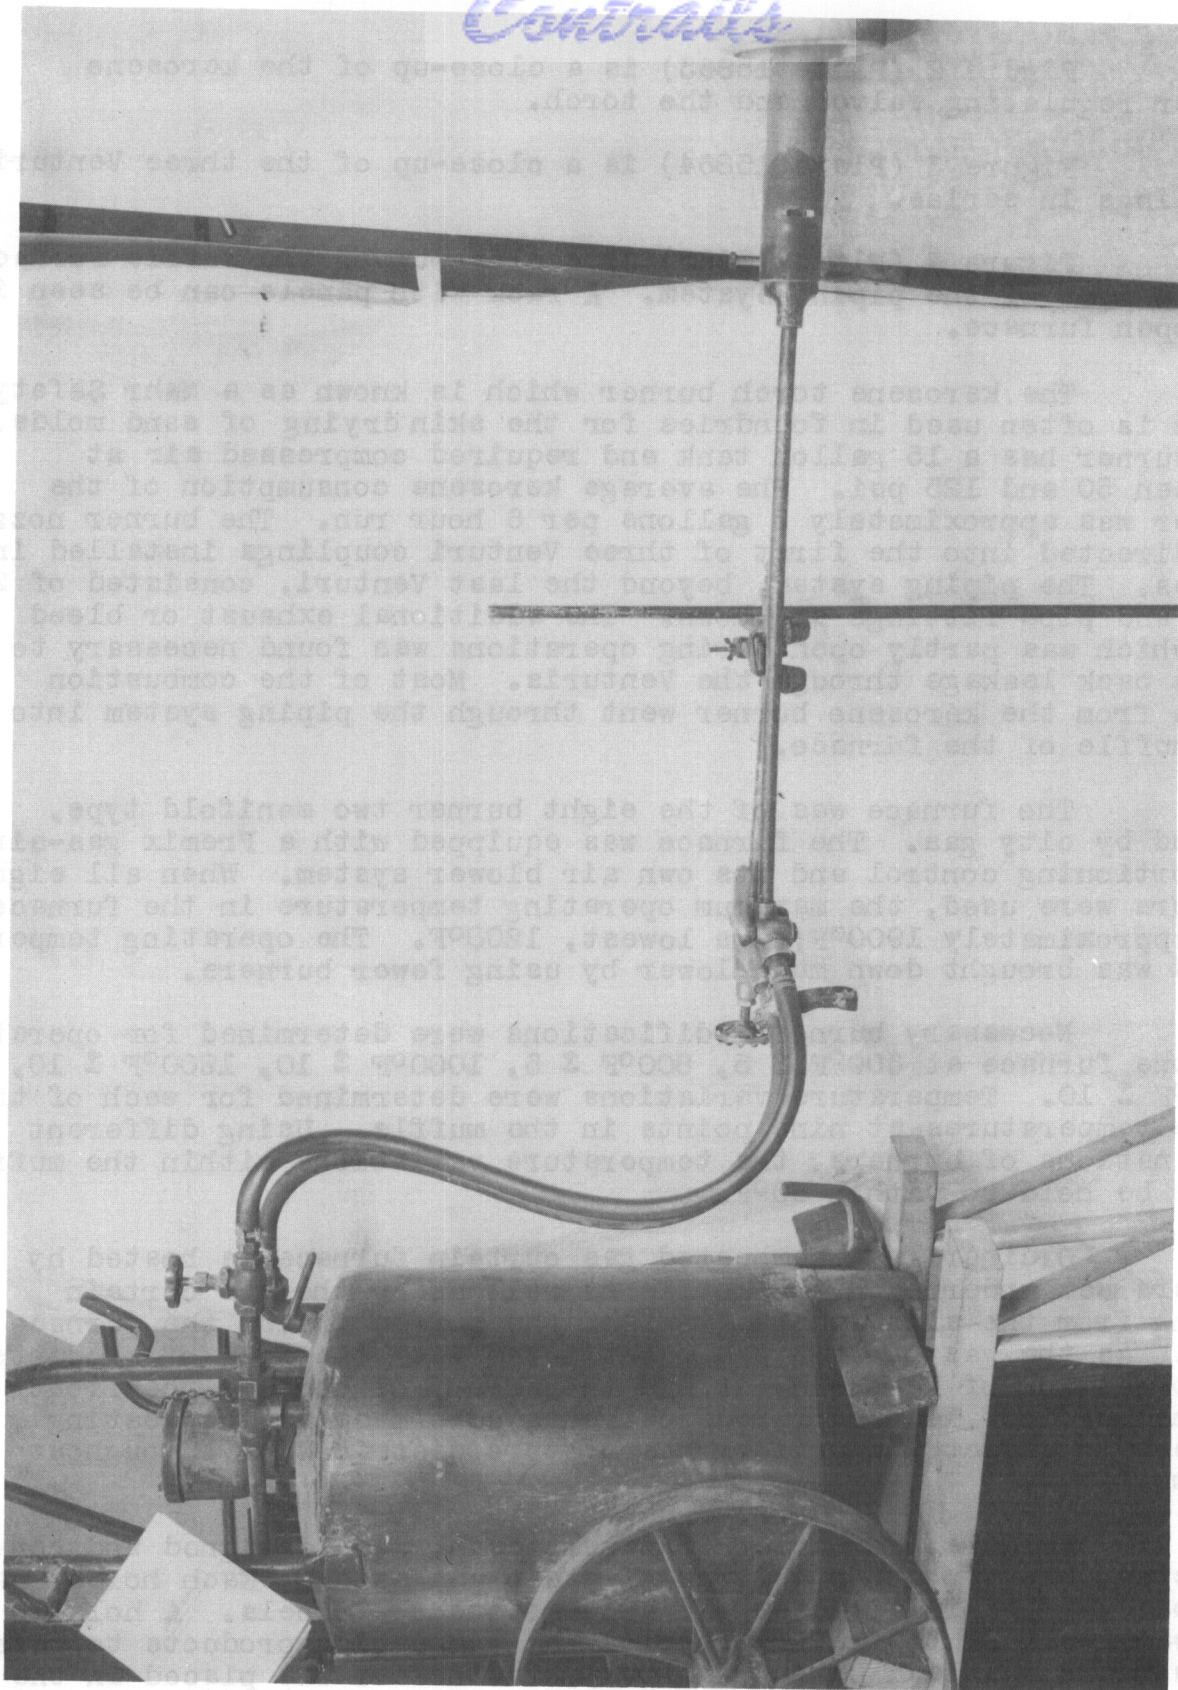
FIG. 2 (PLATE 15863)  
KEROSENE BURNER

Figure 2 (Plate 15863) is a close-up of the kerosene burner regulating valves and the torch.

The kerosene torch burner which is known as a Mahr Safety Torch is often used in foundries for the skin drying of sand molds. The burner has a 15 gallon tank and required compressed air at between 50 and 125 psi. The average kerosene consumption of the burner was approximately 5 gallons per 6 hour run. The burner nozzle was directed into the first of three Venturi couplings installed in series. The piping system, beyond the last Venturi, consisted of 2" pipe and pipe fittings as shown. The additional exhaust or bleed off which was partly open during operations was found necessary to avoid back leakage through the Venturis. Most of the combustion gases from the kerosene burner went through the piping system into the muffle of the furnace.

To obtain the above ends, the following modifications were made. The air orifice, the kerosene orifice and the cap outlet on the kerosene burner were made smaller, resulting in a decrease in the intensity of the flame. The air hose and kerosene hose were shortened between the kerosene tank and the torch. The kerosene tank was raised three feet above the floor level. A regulating air valve was inserted into the air line to obtain a steady air flow into the system. The wide nozzle of the kerosene burner was replaced with a narrow one. Two such nozzles were made; one of low carbon steel and one of stainless steel. To increase the amount of oxygen present in the combustion products, the Venturi couplings were placed in series in the line to the furnace. Adjustment of the position of the entrance pipes to the Venturis made it possible to control the oxygen content of the products entering the furnace muffle.

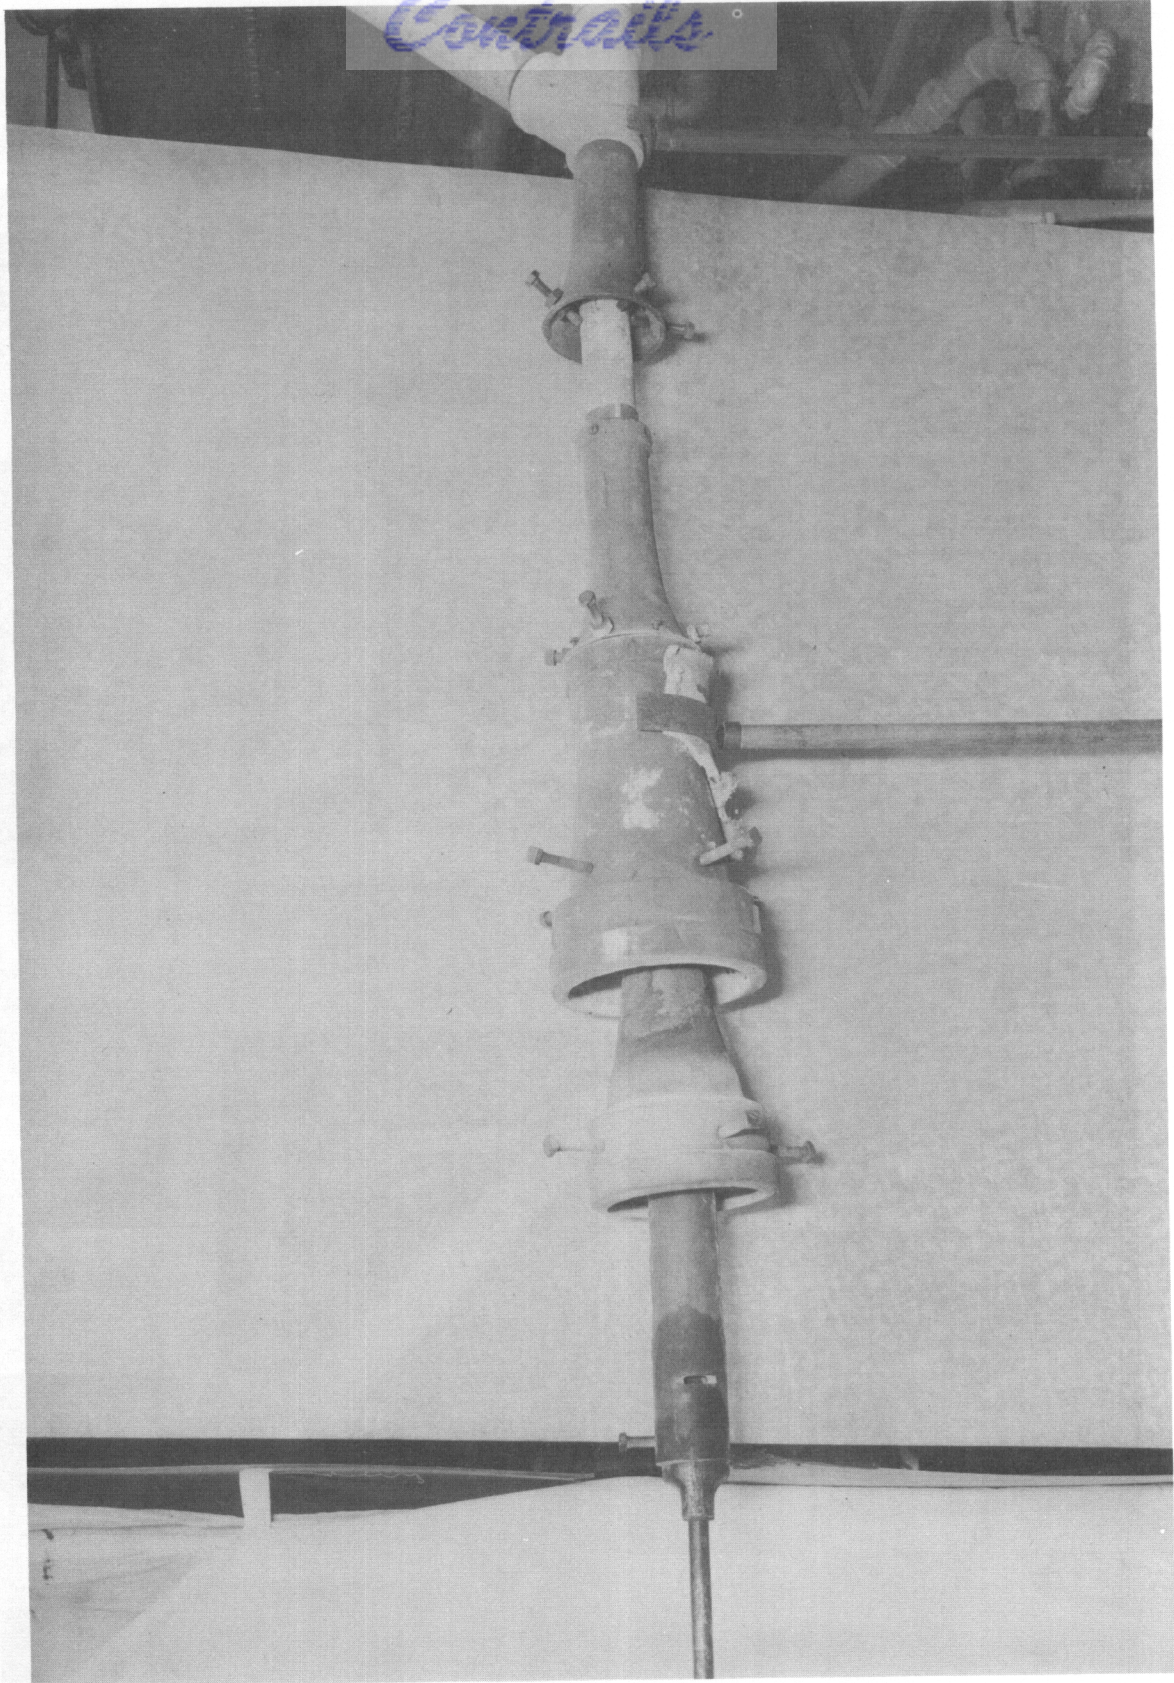
FIG. 3 (PLATE 15864) (MIRRORED)  
VENTURI COUPLINGS (MIRRORED)

Figure 3 (Plate 15864) is a close-up of the three Venturi couplings in series.

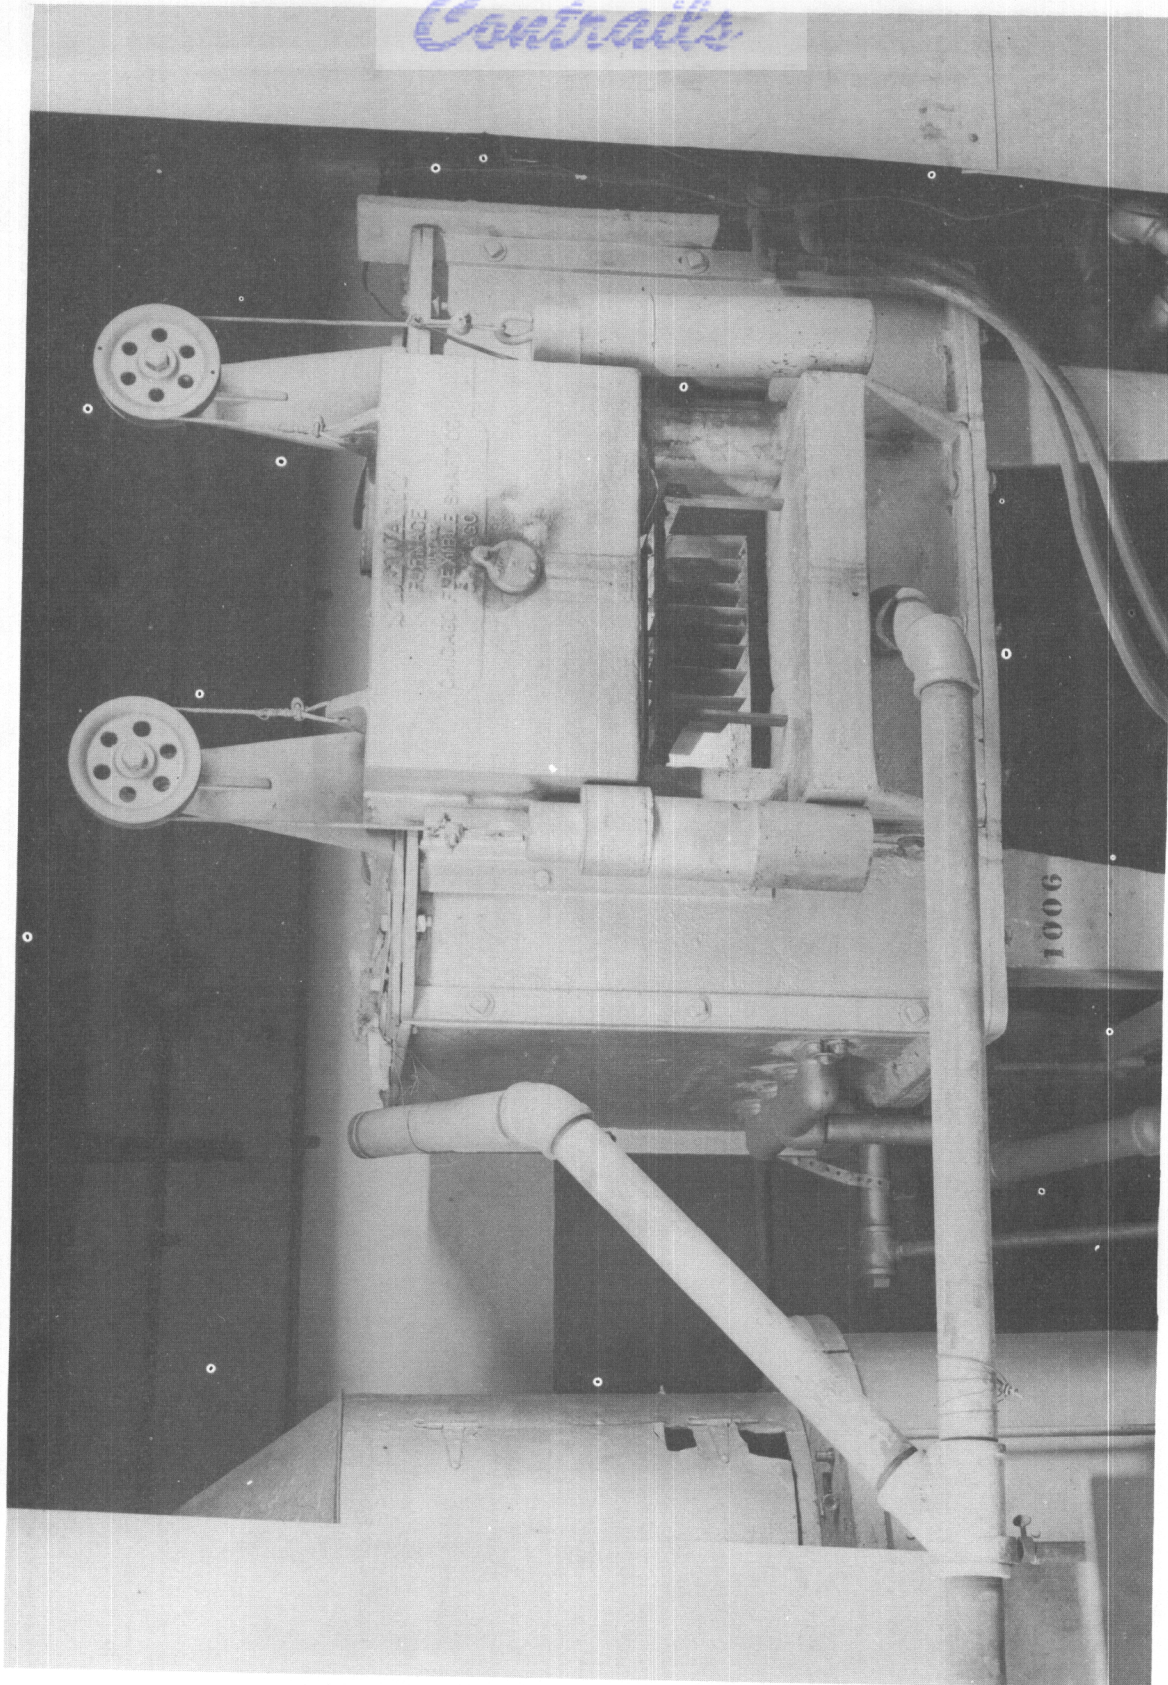
FIG. 4 (PLATE 15865) MUFFLE FURNACE

Figure 4 (Plate 15865) is a close-up of the muffle furnace with a part of the piping system. A rack with panels can be seen in the open furnace.

The furnace was of the eight burner two manifold type, heated by city gas. The furnace was equipped with a Premix gas-air proportioning control and its own air blower system. When all eight burners were used, the maximum operating temperature in the furnace was approximately 1900°F; the lowest, 1200°F. The operating temperature was brought down much lower by using fewer burners.

Holder, for about 40 panels each, were designed and constructed, one of carbon and one of stainless steel. Each holder had two bars, 5/16" in diameter, to accommodate the panels. A hole in the back wall of the muffle enabled the combustion products to pass through the muffle. During all runs, the holder was placed in the muffle in such a position that the panels were parallel to the flow of gases.

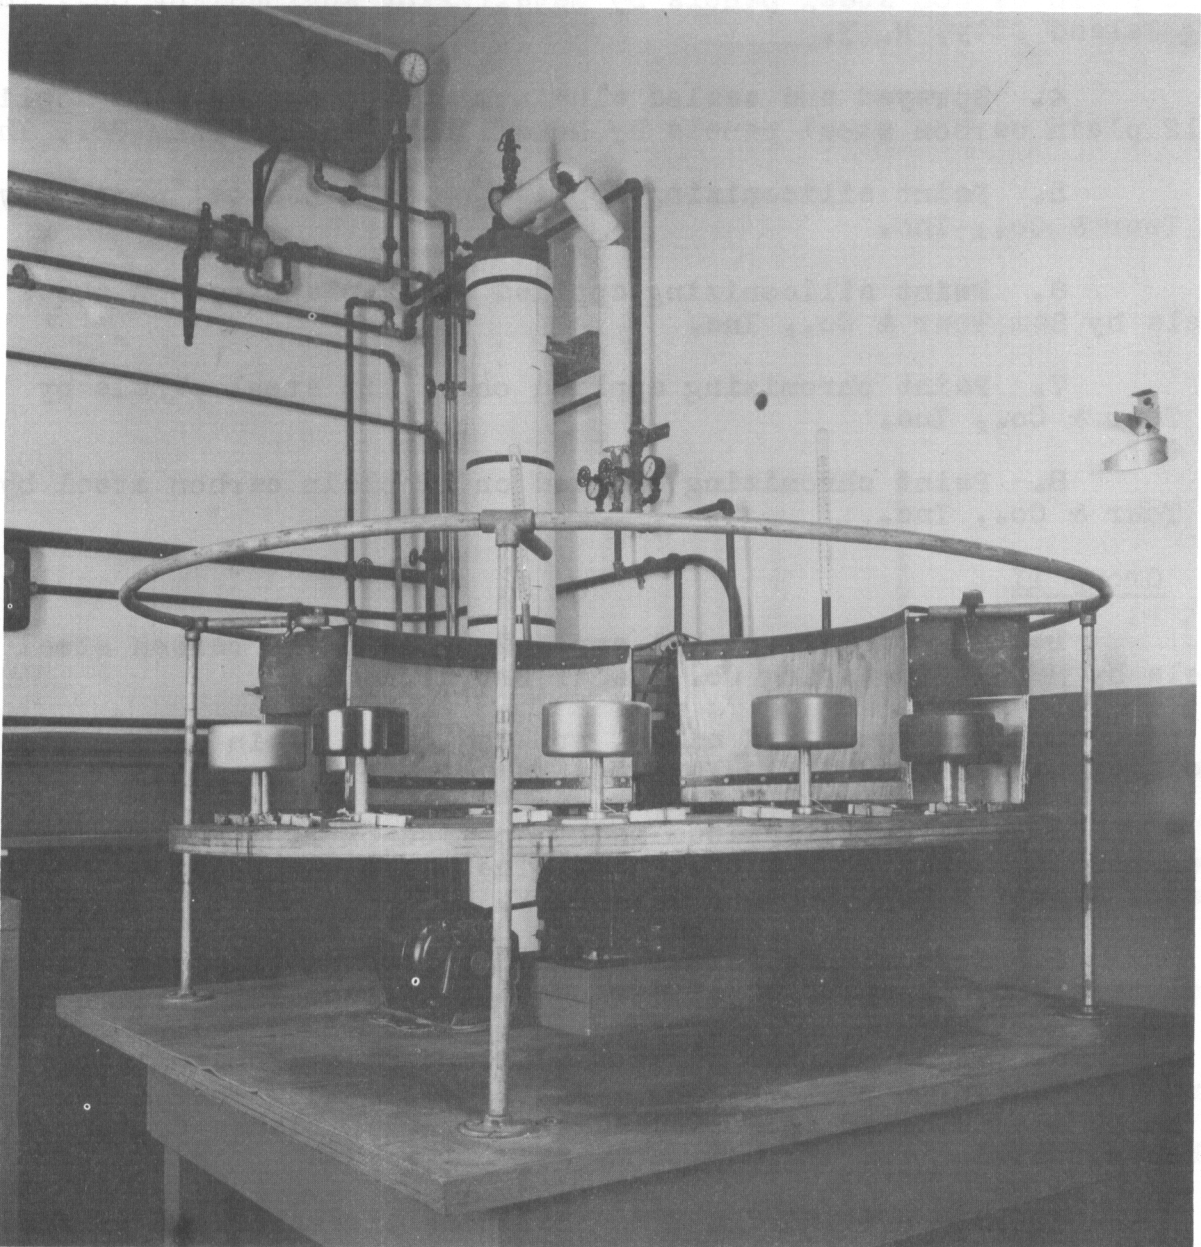
FIG. 5  
ALTERNATE CONDENSATION CORROSION TESTER

Figure 5 is a photograph of the alternate condensation tester in operation in the test of coated steel drums.
