ASD TECHNICAL REPORT 61-73

**EFFECT OF CREEP-EXPOSURE  
ON MECHANICAL PROPERTIES OF RENE' 41**

**THE UNIVERSITY OF MICHIGAN**

**DIRECTORATE OF MATERIALS AND PROCESSES  
CONTRACT No. AF 33(616)-6462  
PROJECT No. 7381**

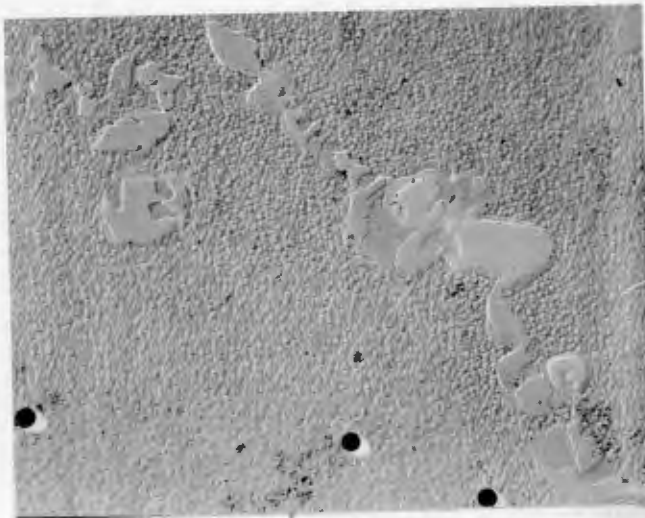
**Figure 6** Udimet 500 - As Heat Treated  
(2150°F - 2 hr + Air Cool  
1975°F - 4 hr + Air Cool  
1550°F - 24 hr + Air Cool  
1400°F - 16 hr + Air Cool)

**Figure 7** Udimet 500 - Exposed 100  
Hours at 1200°F and 75,000 psi

**Figure 8** Udimet 500 - Exposed 100  
Hours at 1700°F and 12,000 psi

Creep-exposure at 1200°F had no discernible effect on the microstructure of the strengthening gamma prime precipitate in both alloys (See Figures 3 through 8). Exposure at 1700°F caused considerable growth of the gamma prime particles and gamma prime agglomerated at the grain boundaries.

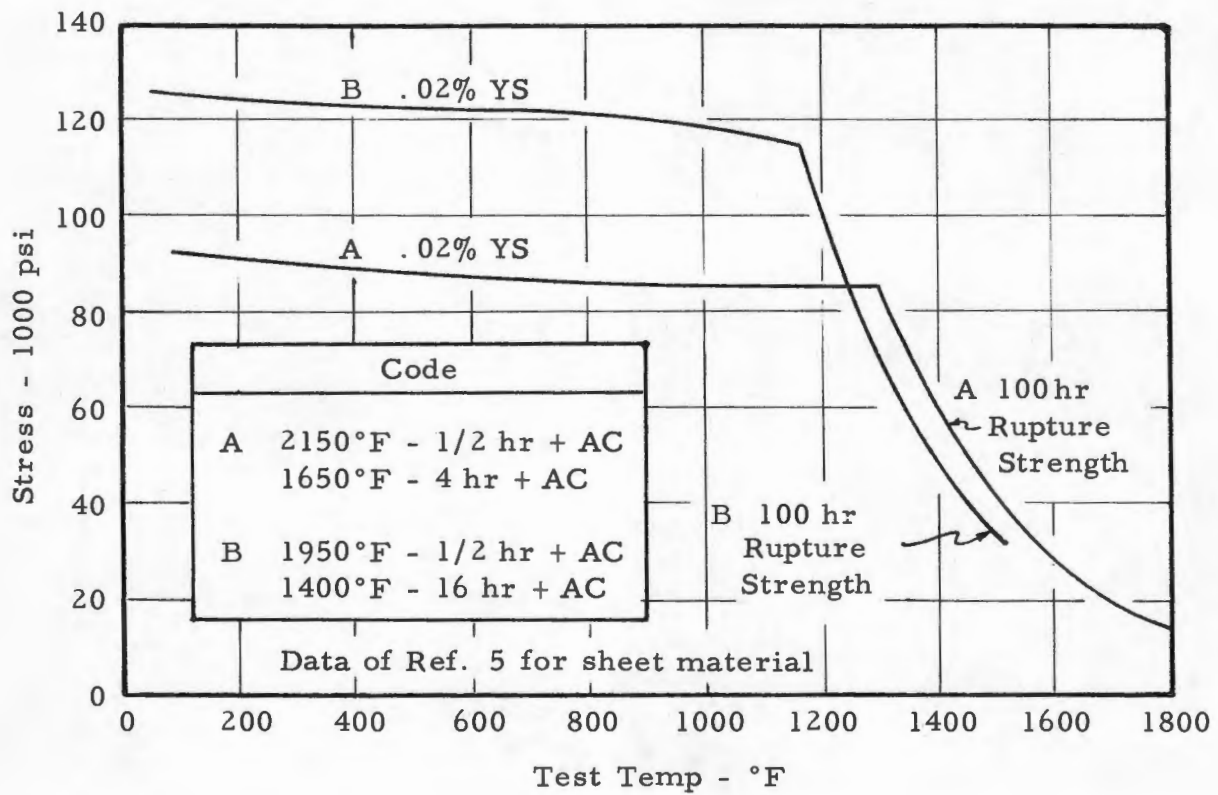
Figure 9 Data of Jahnke and Frank (Ref. 5) On Effect of Temperature and Heat Treatment On Properties of Rene' 41.

hours at 1650°F and air cooled. A later perusal of a survey article by Jahnke and Frank (Ref. 5) indicated that although the above treatment produced a high level of rupture strength at temperatures above 1300°F, it was at a sacrifice of lower temperature yield strength in comparison with a treatment utilizing a 1950°F solution treatment followed by aging at 1400°F. As shown in Figure 9, the latter treatment, on the other hand, resulted in somewhat lower elevated temperature rupture strength. It appeared that the latter treatment offered a better all-round combination of mechanical properties over the range down to room temperature and, consequently, it was adopted as the primary condition for the studies of creep damage to mechanical properties using the newly procured material.

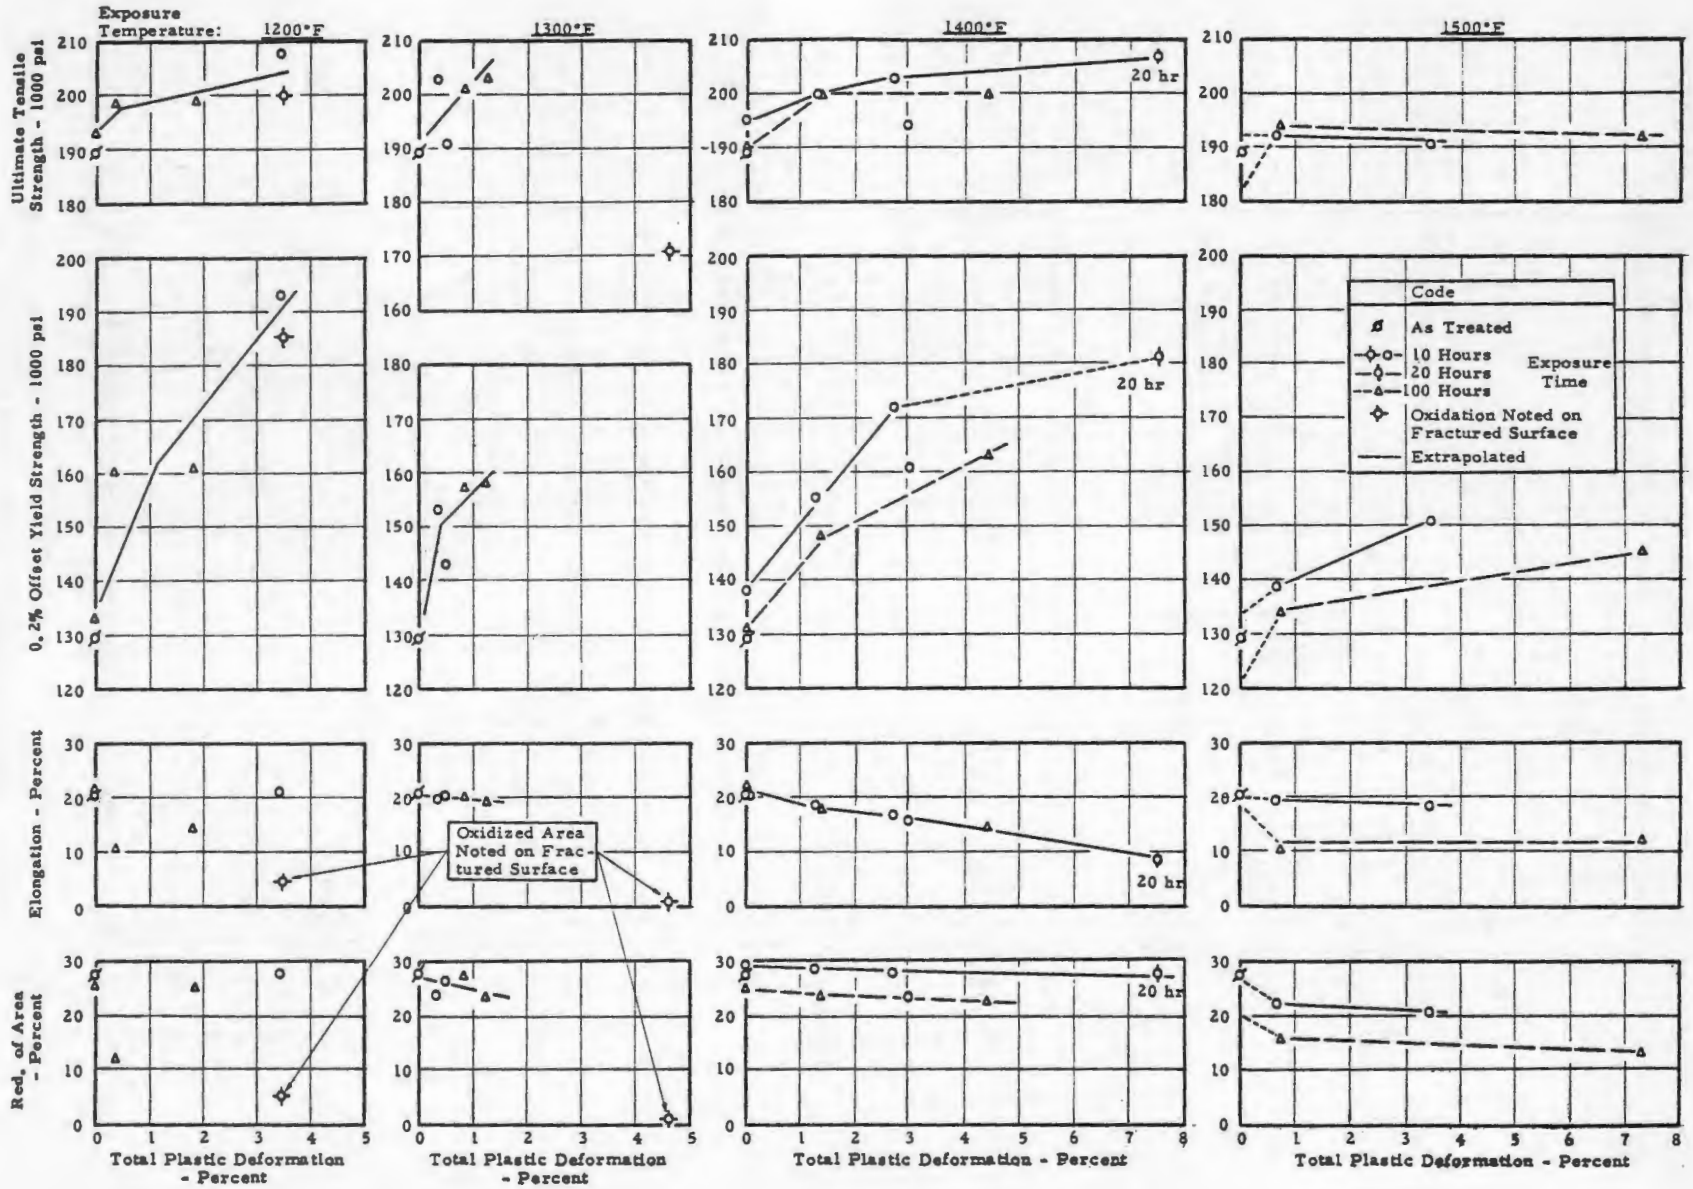
Figure 15 Effect of Prior Creep at 1200°-1500°F On Room Temperature Mechanical Properties of Rene' 41 (Condition "R")

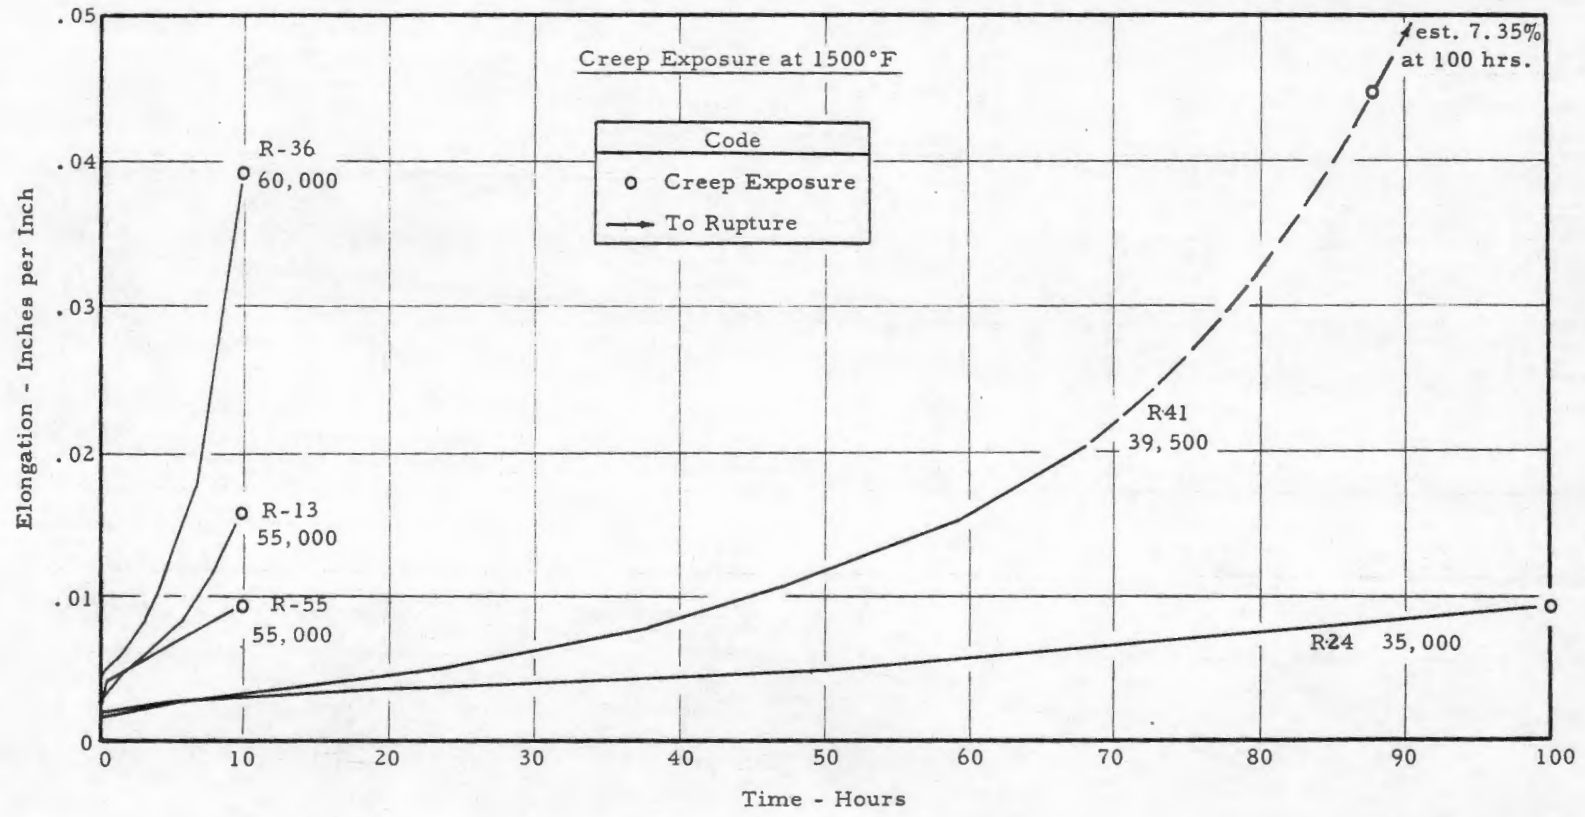
Figure 19 Time-Elongation Curves for Rene' 41 at 1200°F

Figure 20 Time-Elongation Curves for Rene' 41 at 1300°F

Figure 21 Time-Elongation Curves for Rene' 41 at 1400°F

Figure 22 Time-Elongation Curves for Rene' 41 at 1500°F

Figure 23 Time-Elongation Curves for Rene' 41 at 1600°F

Figure 24 Time-Elongation Curves for Rene' 41 at 1700°F

Figure 25 Time-Elongation Curves for Rene' 41 at 1800°F

All the rupture data from the present investigation are summarized in Table 3. The master-rupture curve is plotted in Figure 10 together with the curves derived from References 5 and 9. The time-elongation data are included with the creep curves for the creep-exposure tests (Figs. 19 through 25).

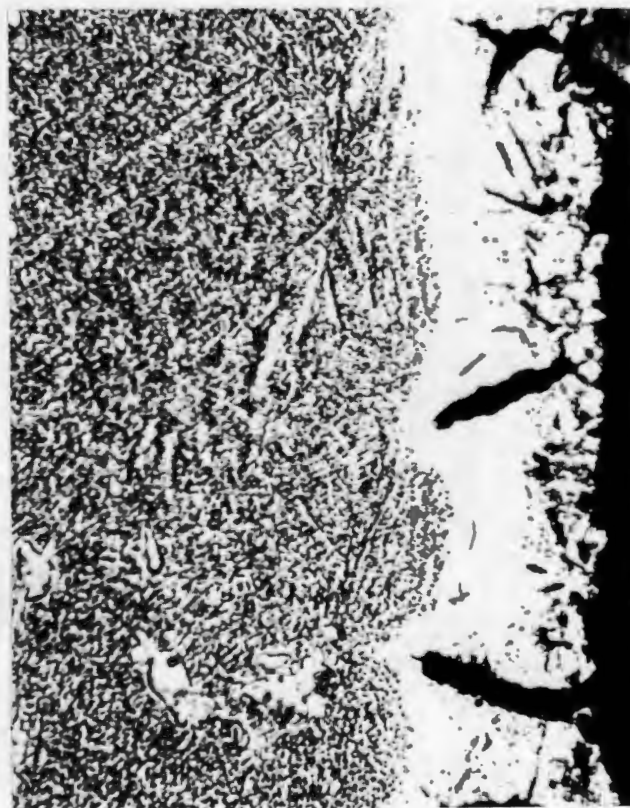
Figure 30 Specimen R-63 (Oxidized Areas on Fracture Surface)  
 Creep-Exposure 10 Hours at 1300°F to 4.60% Deformation  
 (0.033-inches machined from dia. prior to tensile test)  
 Elongation: 0.4%  
 Red. of Area: 0.7%

Figure 31 Specimen R-12 (Longitudinal Section to Show Surface Attack)  
 Exposed Without Stress 10 Hours at 1800°F  
 (Not remachined before tensile test)  
 Elongation: 9.5%  
 Red. of Area: 10.5%

Figures 30-31 Optical Micrographs Showing Surface Attack on Rene' 41

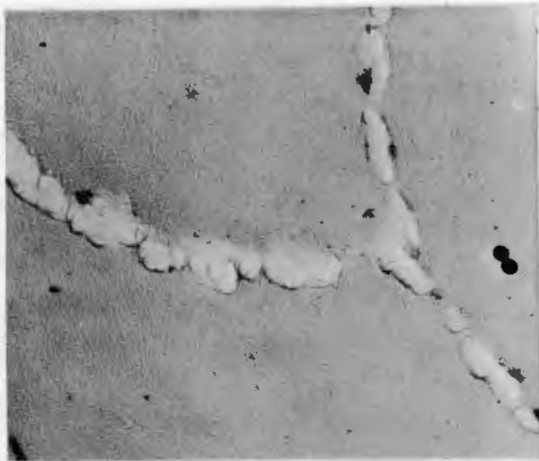
Figure 36 8200x  
As Heat Treated  
(Condition "R")

Figure 37 16000x  
As Heat Treated  
(Condition "R")

Figure 38 8200x  
Specimen R-24 Creep-Exposure 100  
Hours at 1500°F to 0.71%  
Deformation

Figure 39 8200x  
Specimen D-1 Exposed 436 Hours  
at 1550°F in Dilatometer Furnace

Figures 36-39 Electron Micrographs of Rene' 41 After Creep-Exposure

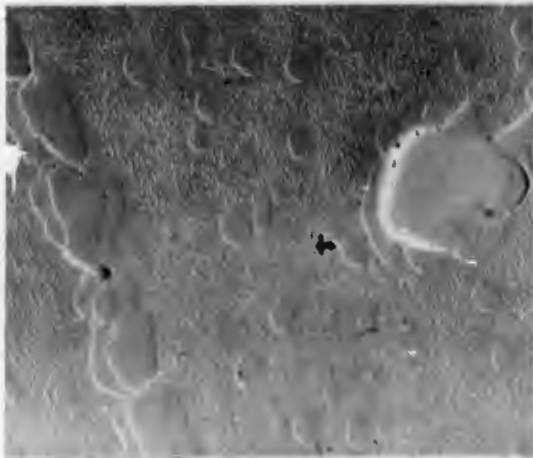
Figure 47 8200x  
Specimen R-61 Exposed Without  
Stress 10 Hours at 1800°F

Figure 48 8200x  
Specimen R-45 Creep-Exposure  
100 Hours at 1800°F to 5.17%  
Deformation

Figure 49 8200x  
Specimen R-79 Creep-Exposure 200  
Hours at 1800°F to 1.80%  
Deformation

Figure 50 8200x  
Specimen R-46 Exposed Without  
Stress 10 Hours at 1900°F

Figures 47-50 Electron Micrographs of Rene' 41 After Creep-Exposure

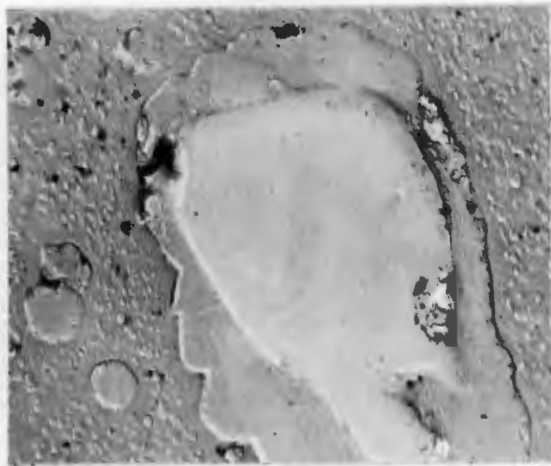
Figure 52  
Normal Etch 8200x

Figure 53  
Selective Etch to Remove  $\gamma'$  8200x

Figure 54  
Normal Etch 16000x

Figure 55  
Selective Etch to Remove  $\gamma'$  16000x

All Pictures are Specimen R-26  
Creep-Exposed 100 Hours at 1800°F  
to 1.70% Deformation

Figures 52-55 Electron Micrographs of Specimen R-26 Selectively Etched to Show  $\gamma'$  Location
