**STABILITY CHARACTERIZATION OF
REFRACTORY MATERIALS UNDER HIGH
VELOCITY ATMOSPHERIC FLIGHT
CONDITIONS**

**PART II. VOLUME I: FACILITIES AND TECHNIQUES
EMPLOYED FOR CHARACTERIZATION OF
CANDIDATE MATERIALS**

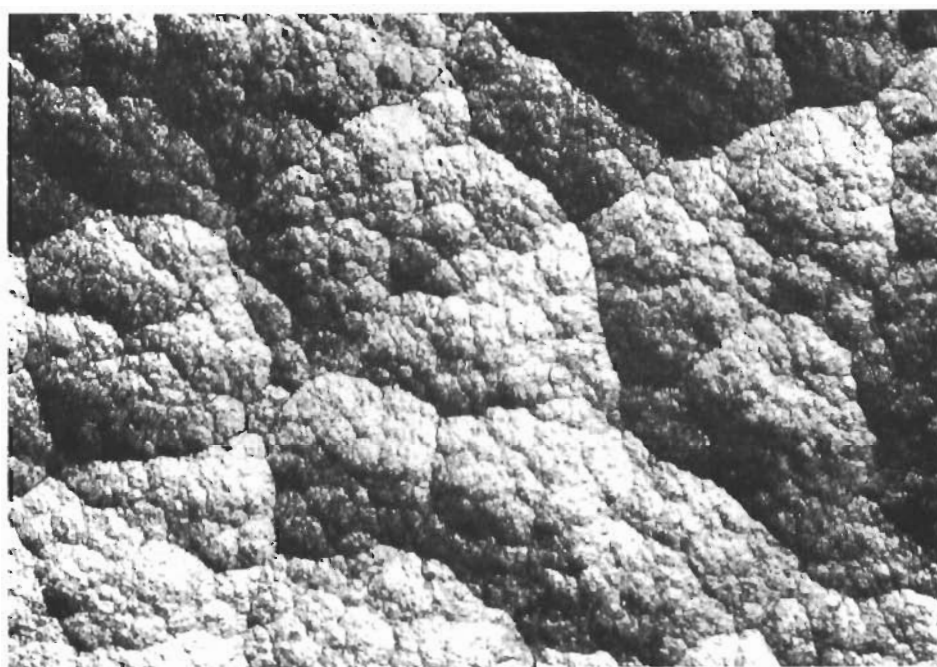
Plate No. 8159

Figure 21. Pyrolytic Graphite (B-6), Transverse Section,
Polarized Light.

The pyrolytic materials shown in Figures 20-23 are more dense than the RVA and display the typical oriented microstructures with the "C" direction perpendicular to the transverse sections. The RVA(B-5) material, illustrated in Figure 19, was supplied by AFML in the form of a 6 inch diameter x 12 inch high cylinder. Pyrolytic graphite plate, 1 inch x 2 inches x 1/2 inch was purchased from the Metallurgical Products Division, General Electric Co., Detroit, Michigan. The High Temperature Materials Division, Union Carbide Corp. of Lowell, Mass., supplied one inch diameter disks which were one half inch thick. In the latter cases, the half inch thickness was parallel to the "C" planes of the graphite. The chemical analyses and microstructures presented here for (B-5), (B-6) and (B-7) are quite typical. Electron microprobe and chemical analyses of BPG(B-7) were performed and difficulties were encountered in obtaining accurate analysis of the boron level in BPG. The boron level indicated by the supplier was 2%.

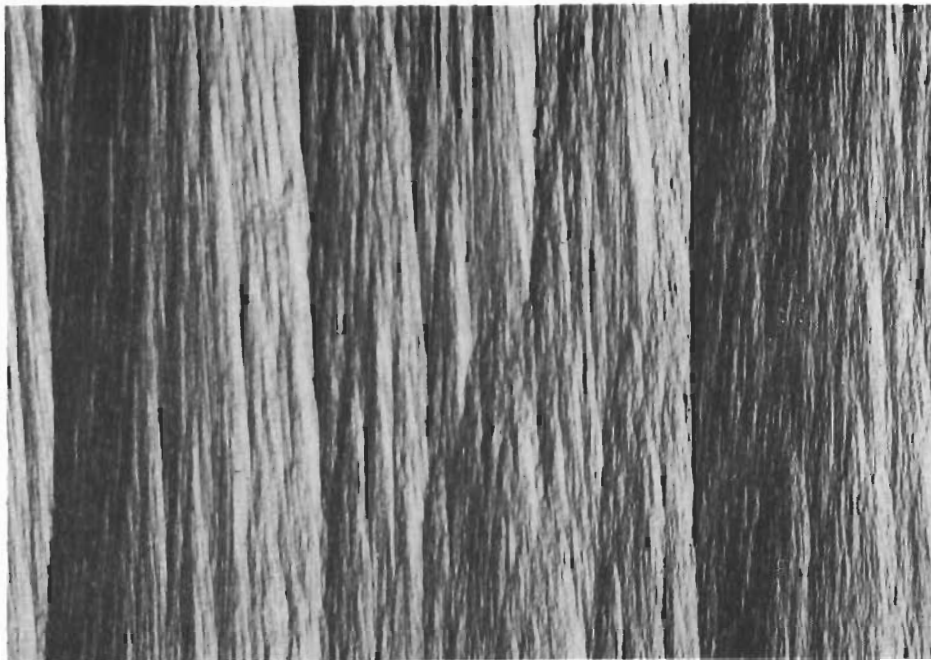
Plate No. 8146a

Figure 22. Boron Pyrolytic Graphite (B-7), Longitudinal Section, Polarized Light.

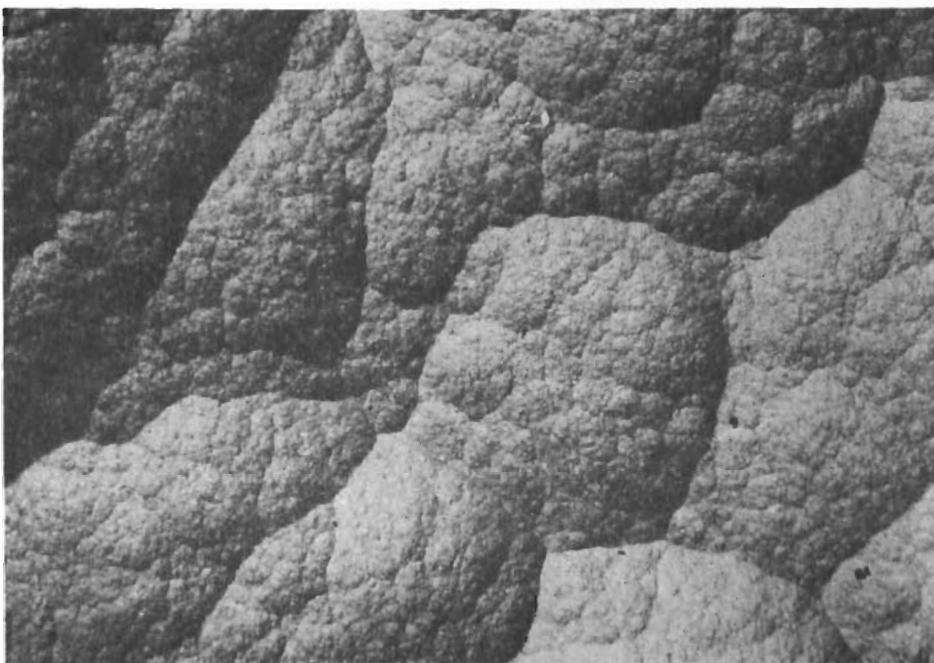
Plate No. 8147

Figure 23. Boron Pyrolytic Graphite (B-7), Transverse Section, Polarized Light.

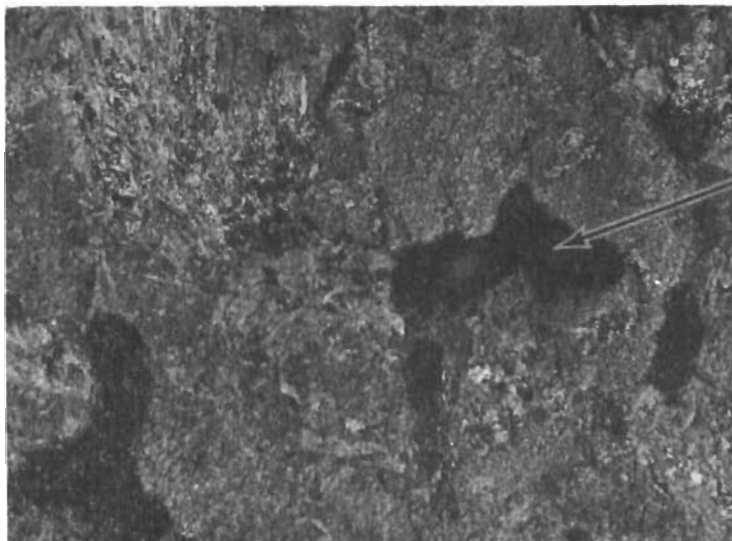
Plate 4711

Porosity

Figure 25. Microstructural Characteristics of RVC Graphite (B-8) Transverse Section.

Siliconized RVC(Si/RVC(B-8)) was obtained from the Union Carbide Corp. Table 5 provides characterization data, while Figures 24-27 illustrate the microstructural features of the matrix and the 4 mil coating of SiC. The RVC graphite is employed as the matrix due to the fact that it exhibits a coefficient of thermal expansion which is compatible with SiC.

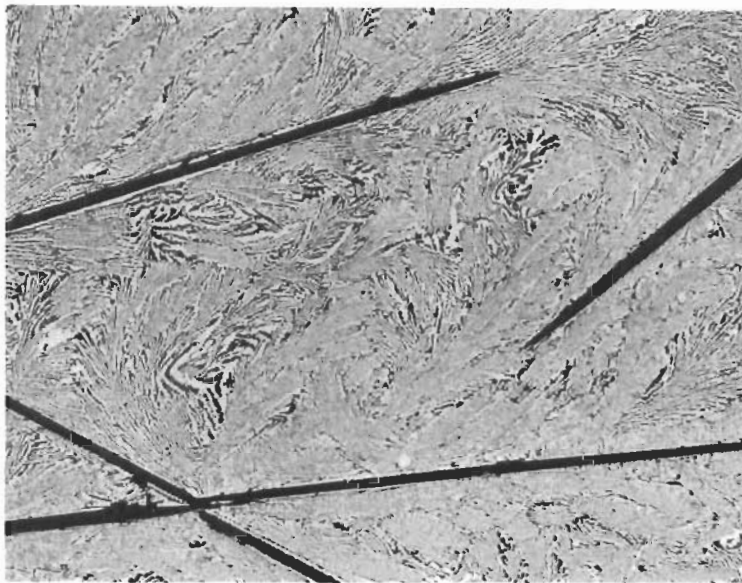
Plate No. 4874

Figure 36. Microstructural Characteristics of HfC + C (C-11), Transverse Section.

Characterization data for arc cast hypereutectic carbides ($\text{HfC}+\text{C}$ (C-11) and $\text{ZrC}+\text{C}$ (C-12)) are contained in Tables 5, 7 and 8. Typical microstructures are shown in Figures 35-38 which illustrate the flake graphite in a eutectic matrix. Figure 39 shows radiographs of several of the hypereutectic carbide billets in which internal voids were detected.

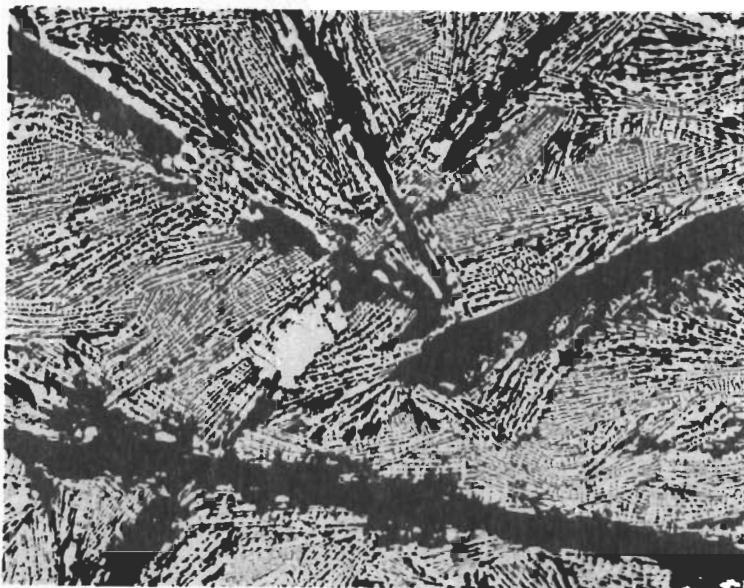
Plate No. 4868

Figure 37. Microstructural Characteristics of ZrC + C (C-12), Longitudinal Section.

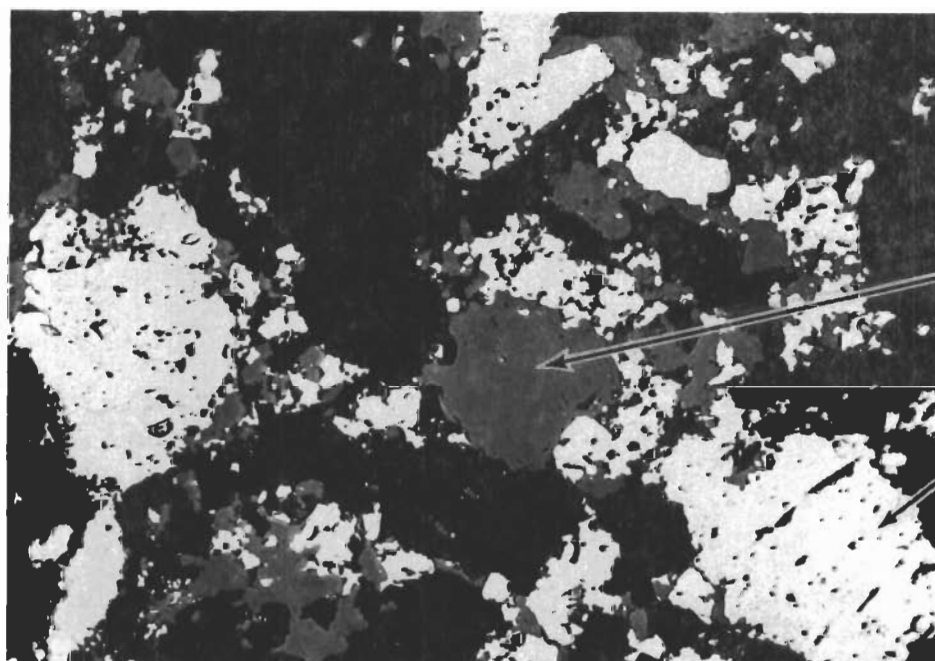
Plate No. 4342

SiC

Figure 41. JTA (D-13), Transverse Section.

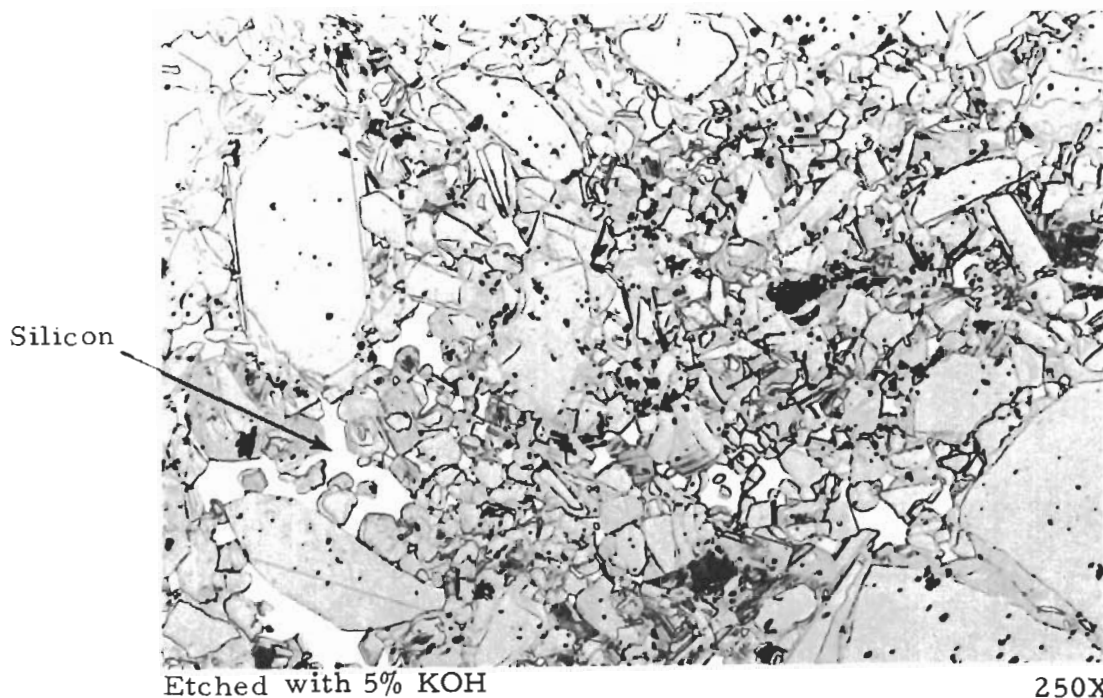
Figure 42. "KT" SiC (E-14), Longitudinal Section. While Most of the Black Areas Are Probably Pull-Out, Some Have Been Found to Be Carbon.

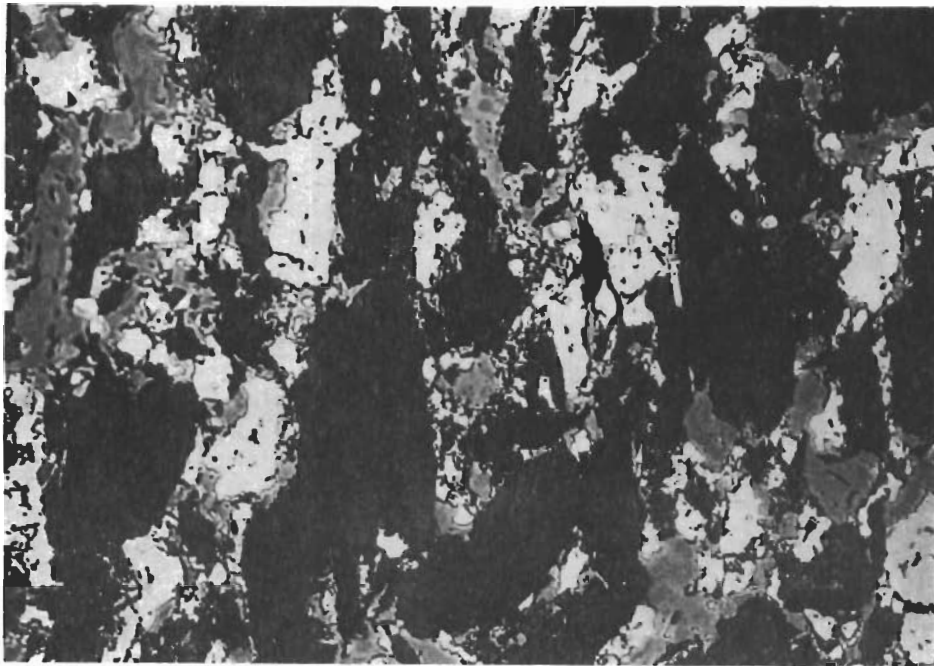
Plate No. 4336

Figure 45. JT0992 (F-15), Longitudinal Section.

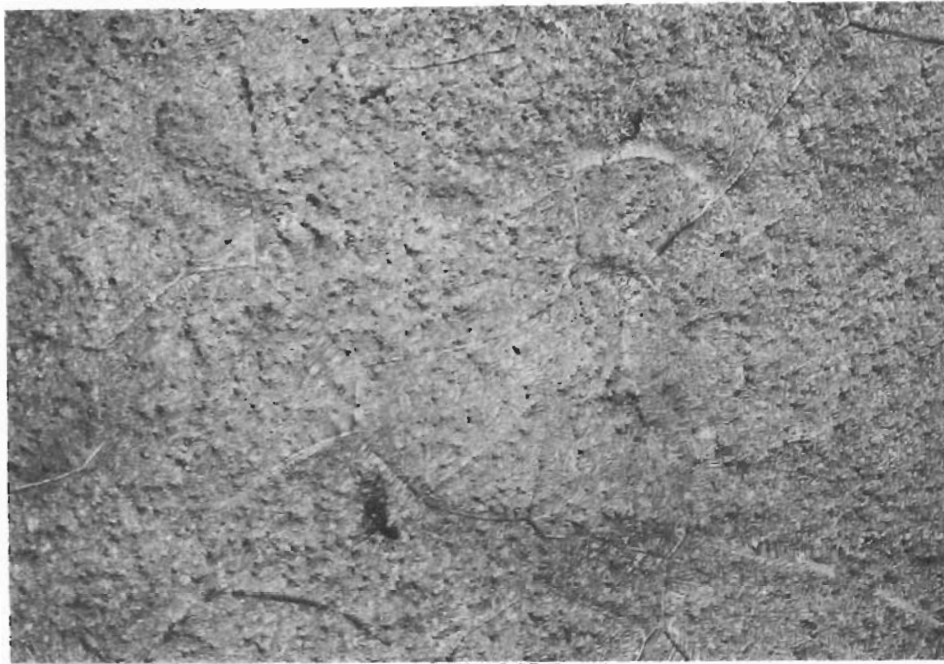
Plate No. 4397

Figure 62. Hf-20Ta-2Mo (I-23), 1" Diam. Bar, Transverse Section. Notice the Outline of the Grain Boundaries of the Preceding Structure.

Characterization data for Hf-20Ta-2Mo(I-23) rod obtained from Wah Chang Corp. are shown in Table 12 and Figures 62-65. The microstructure 1 inch diameter rod shows α (hcp) hafnium-rich plates in a β (bcc) tantalum-rich matrix, while the 1/2 inch diameter rod shows only the β (bcc) structure.
